1 25593_m 109-6970 PUID 25593 211109 1 209 109 Waverly Place

Backyard Cistern Greenwich Village, New York

Memo Report

ARCHAEOLOGICAL MEMO REPORT

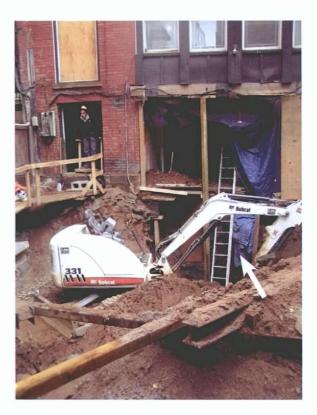
3 109 Waverly Place looking south toward the building from the yard under excavation. An exposed and partially disturbed brick cistern feature located under a later house extension, is under the lower tarp (arrow), behind the ladder. (Geismar 11/14/08)

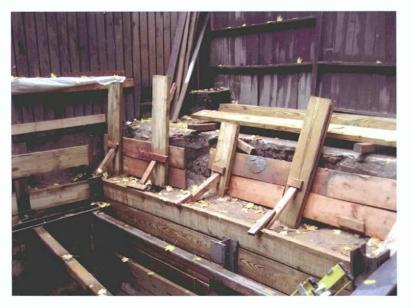
4 North end of yard (behind wood shoring) not scheduled for excavation at this writing. (Geismar 11/14/08)

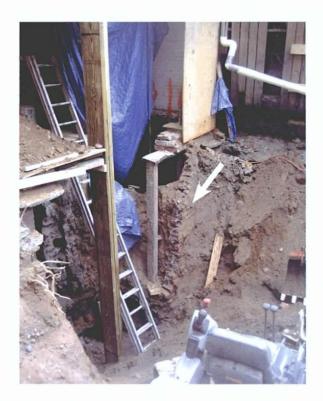
North side of truncated brick cistern partially exposed (arrow). (Geismar 11/14/08)

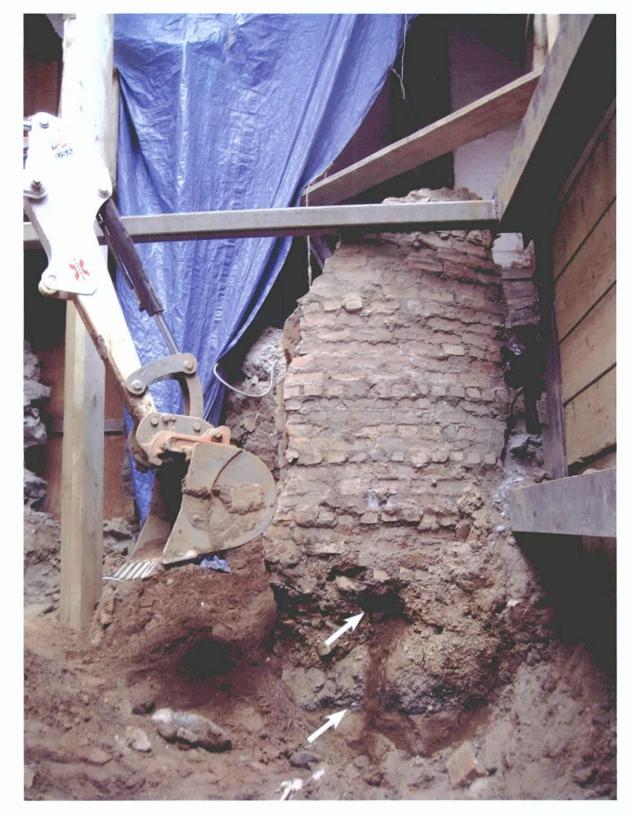
While the cistern's deposit did not contain significant cultural material, the feature itself was an interesting artifact. Meant to collect and store water, cisterns are constructed to hold water. Typically, this entails mortared brick sealed on the inside with a coating of mortar. While the wall of the 109 Waverly Street cistern was well constructed of mortared bricks and sealed with mortar, the feature did not have a mortar-sealed bottom. Instead, a black, impermeable layer was noted that appeared to comprise pitch and stone. The current contractors apparently found a layer of a similar if not identical material throughout the yard. It is more than likely that both served as a water control: the one at the bottom of the cistern to retain water in the feature, the other throughout the yard to keep groundwater, which proved to be high enough to call for a change in construction plans, out. The depth of the cistern was also unique. While most are typically about 6 feet deep, the depth of the 109 Waverly Place cistern was 7.5 feet and its diameter about 7 feet. It is more than likely that 111 Waverly Place, also built by Mr. Stone, would have, or would have had, a similarly constructed cistern behind the house.

6 Cistern wall exposed in the southwest corner of the yard where a frame overhang is depicted on early maps (see Figure 2). The approximately 7.5-foot deep and 7-foot diameter cistern, constructed from the inside-out, displays a random pattern of header and footer bricks. A thick layer, possibly stones and tar, was located under the cistern (upper arrow) and a deeper layer (lower arrow), under rocky soil, was found throughout the yard. (Geismar 12/8/08)

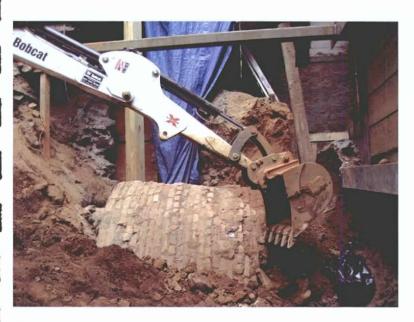
Remnant of cistern wall during its removal by backhoe to expose the fill deposit. (Geismar 12/8/08)

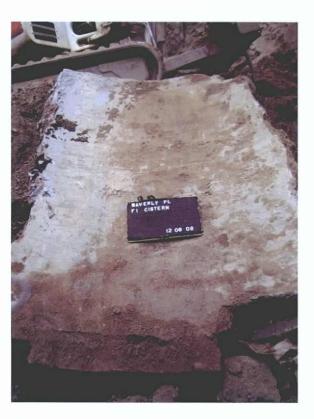
8 Mortared interior of the removed remnant of the cistern's north face. (Geismar 12/8/08)

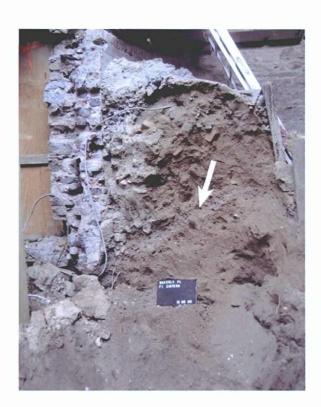
episodes had occurred (divided by the thin layer of pink sand) after the cistern was abandoned, and that that both fills complied with sanitary laws that called for filling with clean sand².

9 Exposed cistern deposit, a rubble-filled sand separated from a cleaner sand by a diagonal band of pink sand (arrow) that indicates two fill episodes, both devoid of significant cultural material. (Geismar 12/8/08; also see profile, Figure 10)
