**Summary Report of Archaeological Monitoring**

**City of New York Department of Parks and Recreation  
Sylvan Grove Cemetery (Independence Park)  
Victory Boulevard and Glen Street  
Block 2767, Lots 9 and 22  
Staten Island, Richmond County, New York**

May 2011

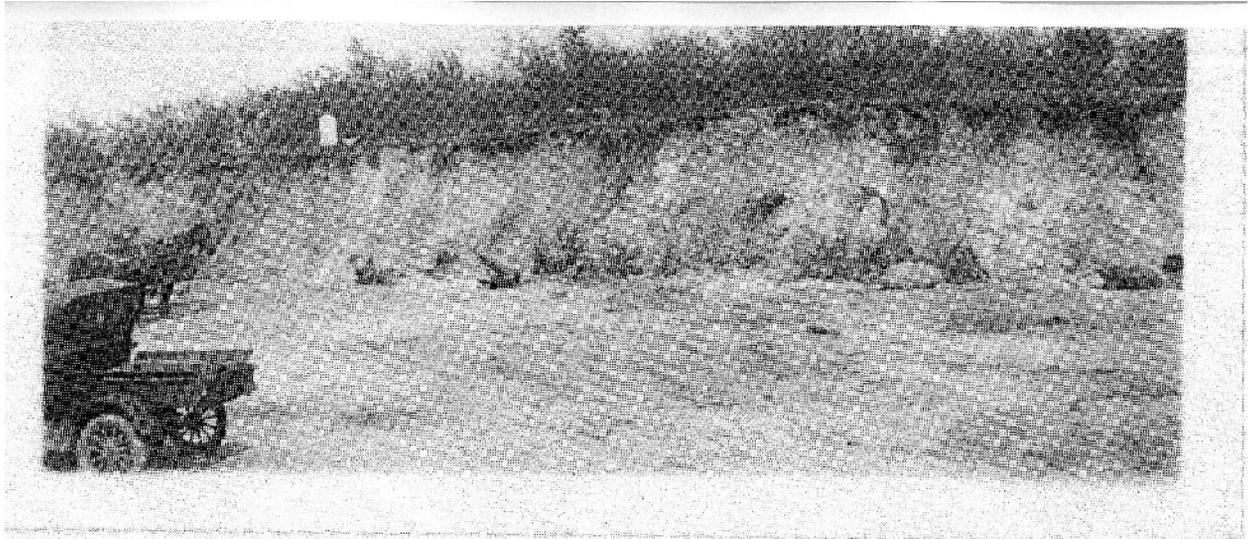
There has been significant disturbance to the original ground surface on the project site along the Glen Street frontage, specifically from sand quarrying in the 1920s on Lot 9, which may have extended into Lot 22 in places (Photograph 5). This area was excavated to more than 10 feet (3 meters) below grade, and then backfilled. Evidence of this grading and filling is still obvious on the project site in this area (Photographs 6 and 7). As noted in the IA, Lot 22, the smaller of the two lots, once contained a ravine that was filled in by FACSI. It is presumed that this ravine was man-made, as it does not appear on a 1912 topographic map.

Photograph 5: Historic photograph from 1923 showing sand mining on Lot 9. Note gravestones in left background. View looking northeast from Glen Street. Courtesy Staten Island Museum.

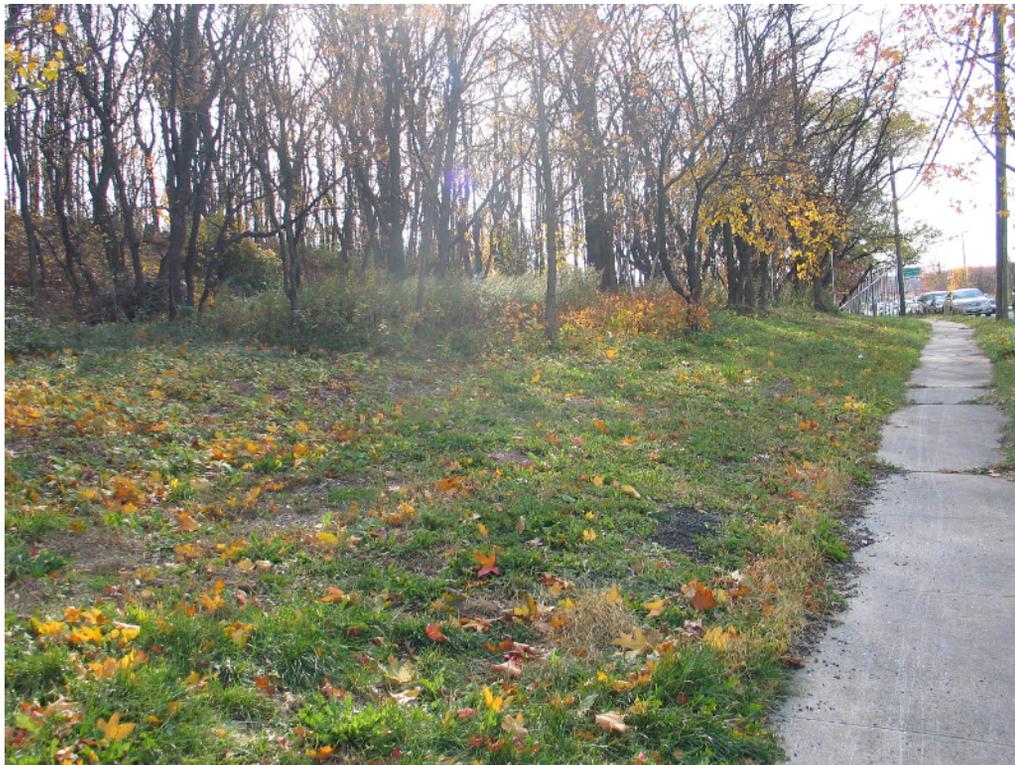
Photograph 6: Previously mined area on Lot 9 today. Note artificially flat topography from backfilling. View looking south from Glen Street.

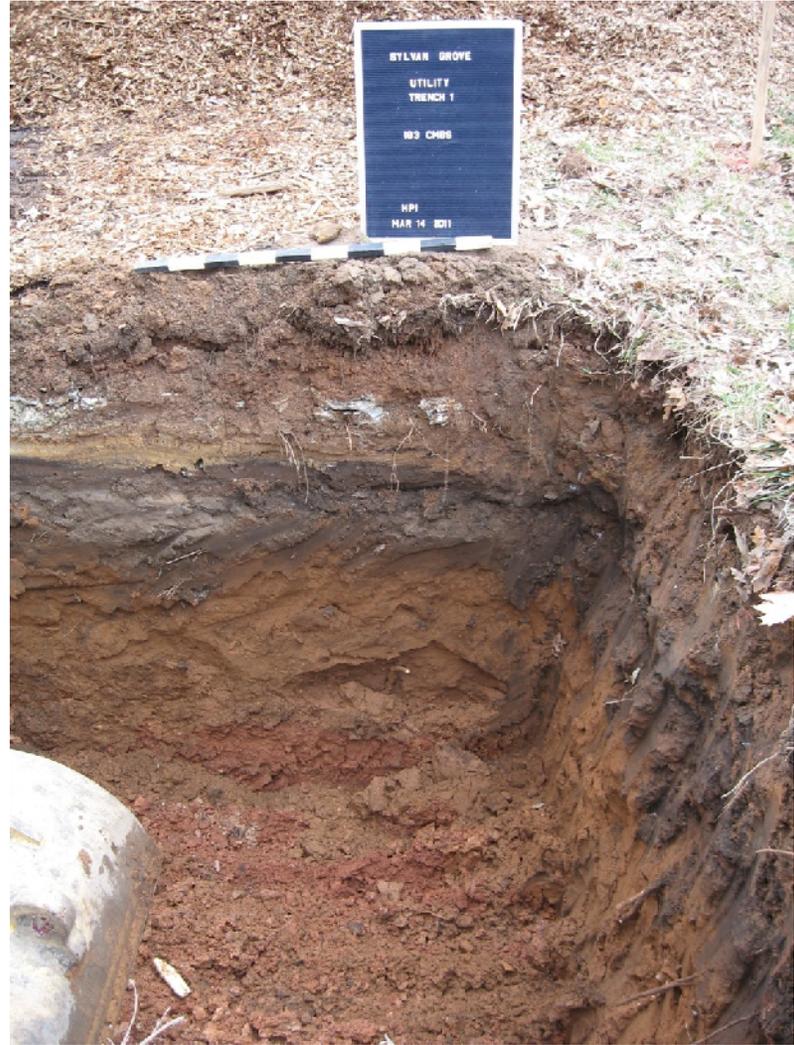
Trench 4, located near Glen Street, was excavated for the installation of a large concrete utility box for water connections (Figure 4, Photograph 14). A hand-excavated shovel test was conducted first to ascertain the stratigraphy. Numerous fill layers were present. The trench was 2 m (6.6 feet) wide north/south and 2.8 m (9.2 feet) wide east/west, and was 2.2 m (7.2 feet) deep. It showed the same concrete layer, along with some macadam, at 25-30 cmbs (10-12 inches).

Photograph 14: Trench 4 (trenches were renumbered after photo was taken) showing concrete and other fill layers, looking south.

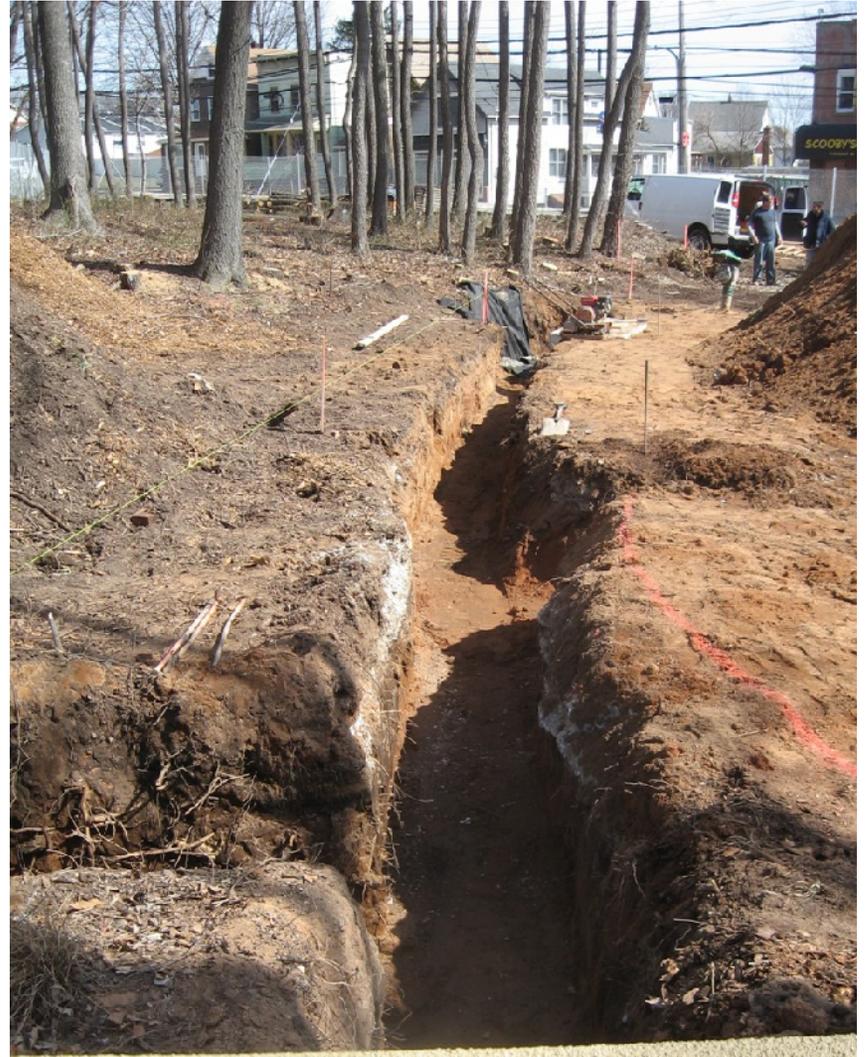
Trench 8 was excavated as a dry well for the utility box in Trench 4 (Photograph 16). It was located 1.4 m (4.6 feet) east of Trench 4 and adjoined Trench 5. It was 1x2.4 m (3.3x7.9 feet), and was 1.57 m (5.2 feet) deep. It had a similar stratigraphy to Trench 5 at the 2-meter mark. Trench 5 at the 2-meter mark contained a layer of dark brown (7.5YR 3/2) topsoil/silty sand from 0-10 cmbs (0-4 inches), a layer of dark brown (7.5YR 3/4) coarse silty sandy fill with gravel from 10-25 cmbs (4-10 inches), a layer of concrete from 25-40 cmbs (10-16 inches), a layer of dark brown (7.5YR 3/4) silty sand from 40-65 cmbs (16-26 inches), and a layer of strong brown (7.5YR 4/6) sand from 65-100 cmbs (26-39 inches).

Trench 9, located 6.2 m (20 feet) east of Trench 4, and also adjoining Trench 5, was excavated for a ground hydrant (Photograph 16). The trench was 1.3 m (4.3 feet) long and 80 cm (2.6 feet) wide, and was excavated to a depth of 98 cmbs (3.2 feet). It had a similar stratigraphy to Trench 5 at the 4-meter mark. It contained a layer of dark brown (7.5YR 3/2) topsoil with woodchips and fill from 0-10 cmbs (0-4 inches), a layer of concrete from 10-23 cmbs (4-9 inches), a layer of very dark gray (7.5YR 3/1) sandy silt with roots from 23-30 cmbs (9-12 inches), a layer of dark brown (7.5YR 3/3) silty sand with roots from 30-50 cmbs (12-20 inches), and a layer of strong brown (7.5YR 4/6) sand from 50-98 cmbs (20-39 inches).

Photograph 16: Trench 5, looking southeast from Trench 4 to Trenches 6 and 7. Trench 8 is on the near left, and Trench 9 is center right. Note concrete layer in western half of trench.

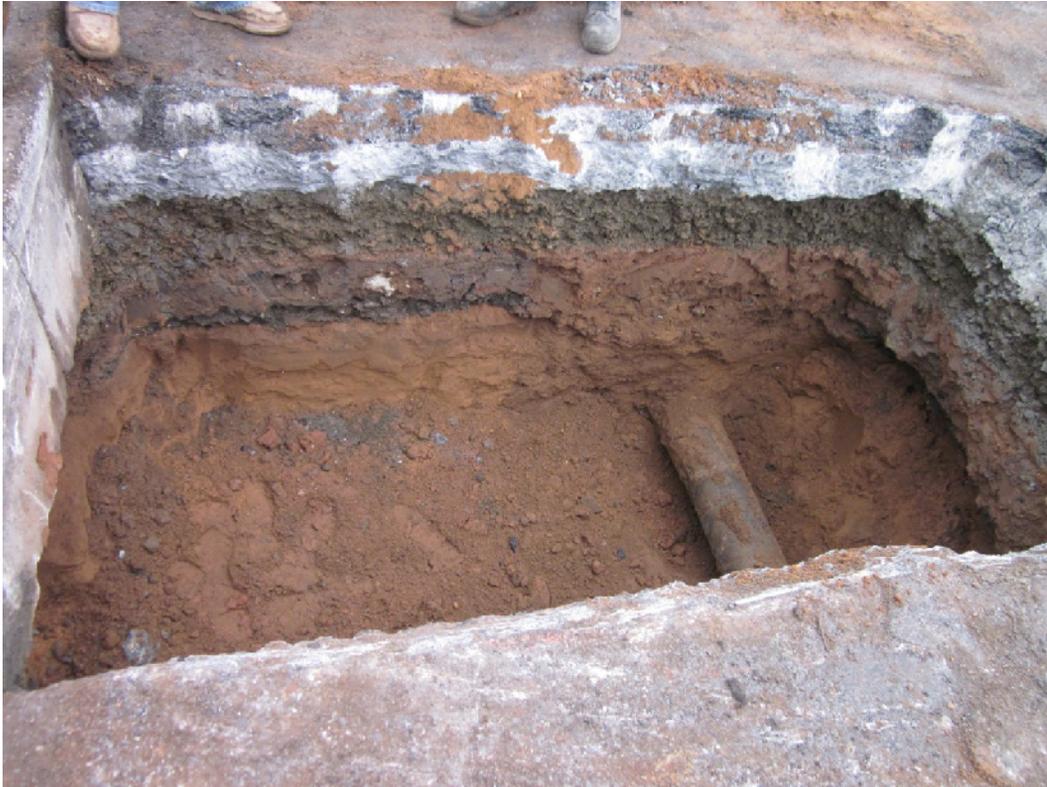
Trench 4 was later extended to the sidewalk and into Glen Street, in order to connect to the public water main. Although the sidewalk and street portion were outside the project boundaries, the trenching activities were observed, and the original road surface, predating the installation of the water main, was identified approximately one meter (39 inches) below the current street grade (Photograph 18). The street level was probably raised during the construction of Route 440 to the west. This observation, in conjunction with the known quarrying activities dating to the 1920s along the west side of the project site, may explain the depth of the fill found all over the southern and western portions of the site.

Photograph 18: Extension of Trench 4 into Glen Street, showing original asphalt road surface approximately one meter below current surface, cut by utility trench for water main. Looking south.

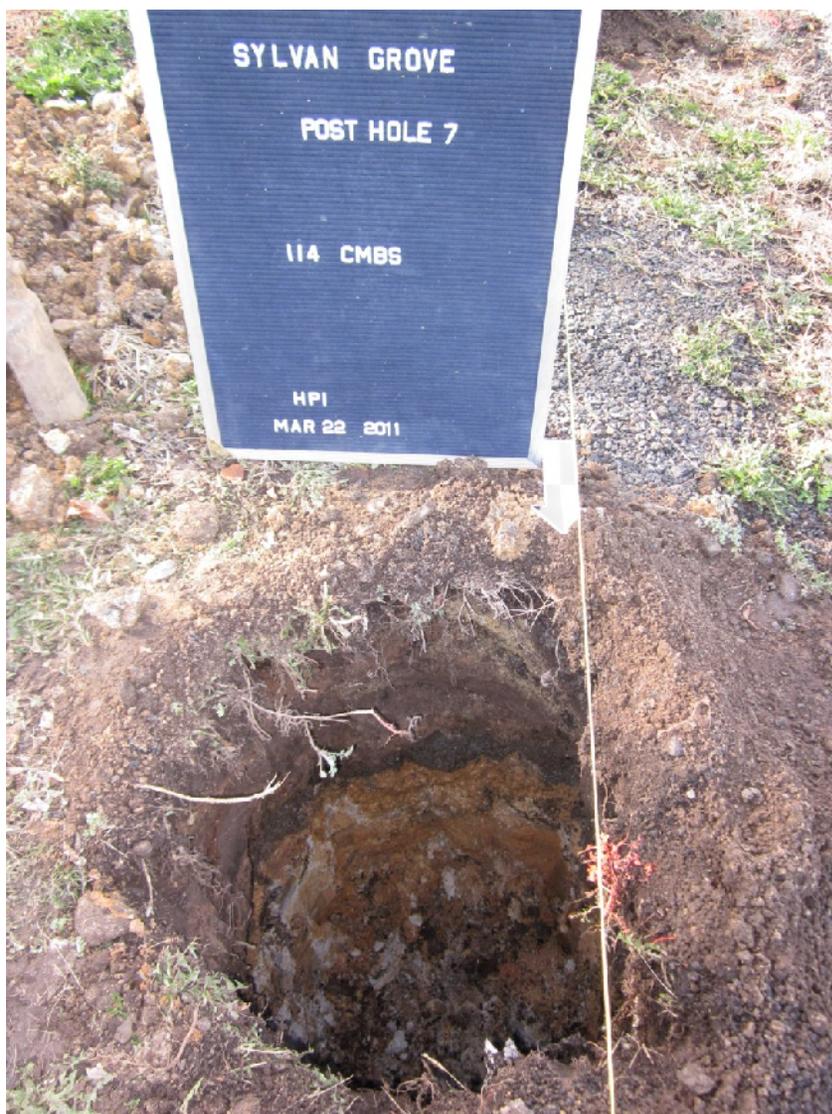
Photograph 21: Posthole 7, showing chunks of gley in lowest level, looking south.

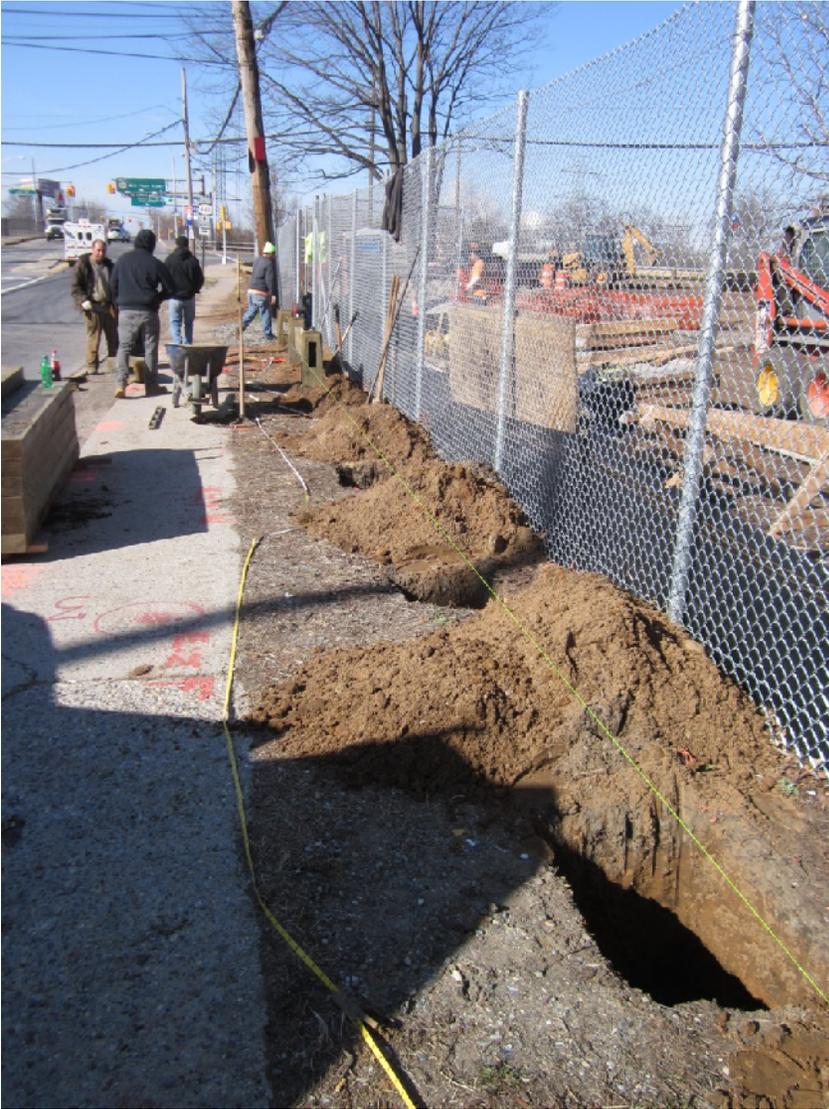
Victory Boulevard, showed highly disturbed soils, some containing fill with no discernible stratigraphy other than a very shallow topsoil layer (Photograph 23).

Photograph 23: Fence construction along Victory Boulevard, Lot 22, looking southwest.

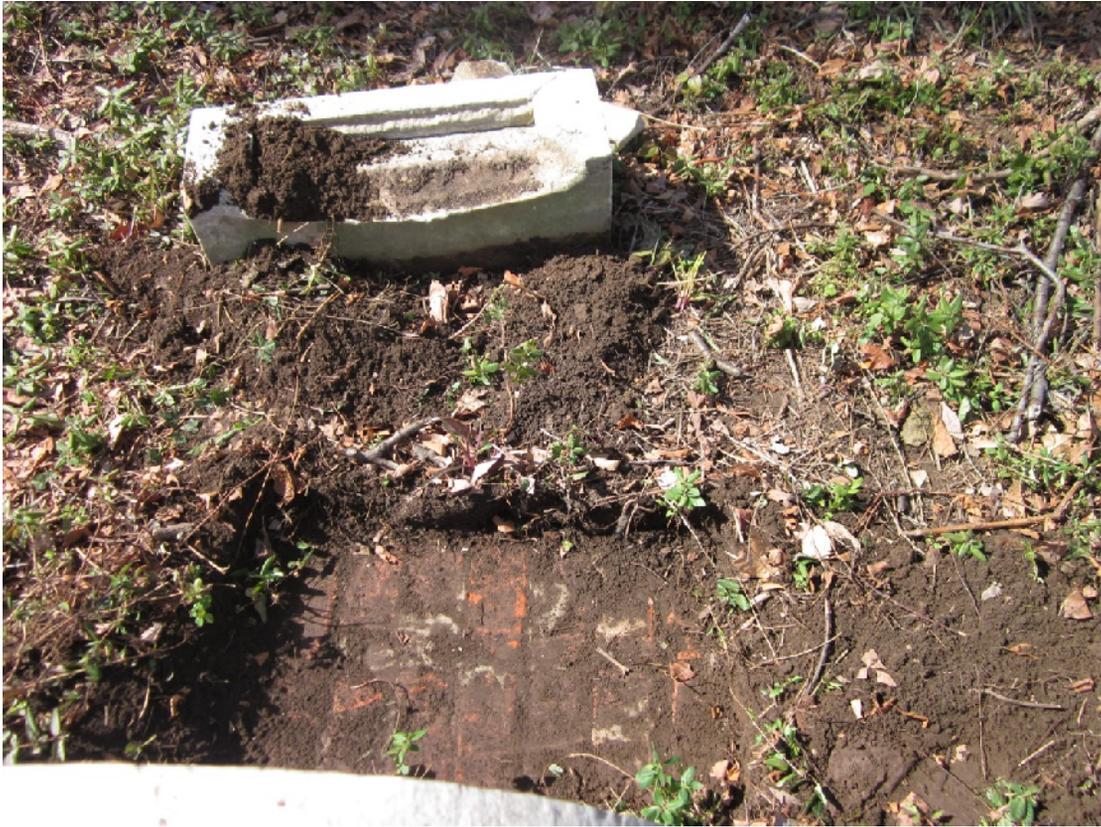
Photograph 29: Brick foundation upon which stone base (in rear) had originally been set.

First were those headstones that had a marble (or other stone) rectangular base, upon which the engraved stone had been mounted. Many of these had been broken off at the joint between the base stone and the headstone. In these cases, the base was carefully removed from the ground. Generally the bases had initially been installed at a depth of 20-30 cmbs (8-12 inches), often with a brick foundation providing support for the base (Photograph 29). The original rectangular hole was lined with boards, and a new concrete base was poured, into which the original headstone was set (Photographs 30 and 31).

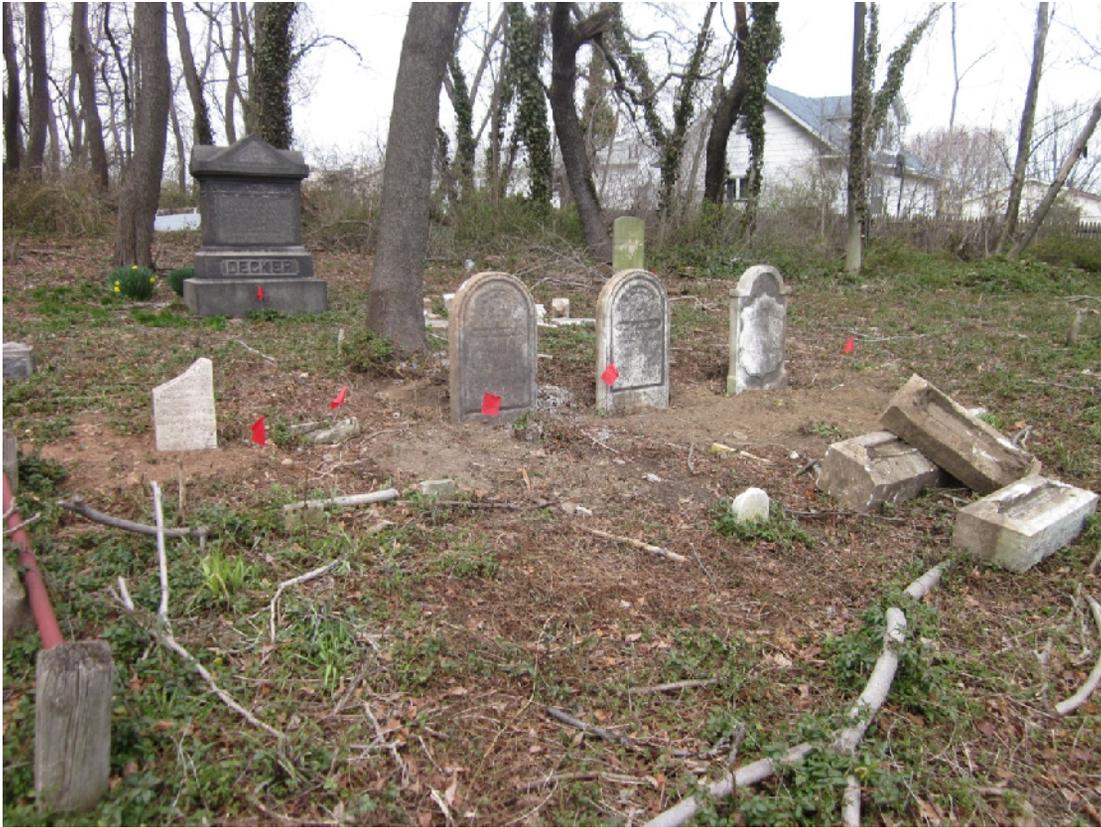
Photograph 30: Reset gravestones with original bases at right.

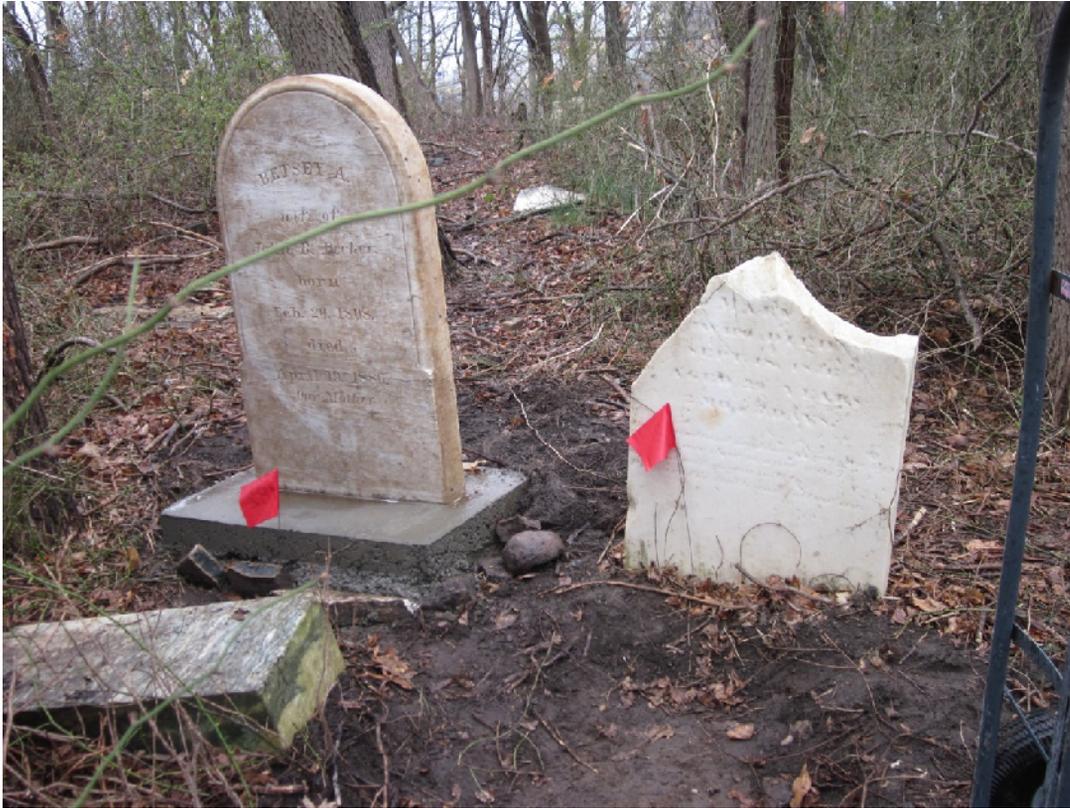
Photograph 31: New concrete base for gravestone.

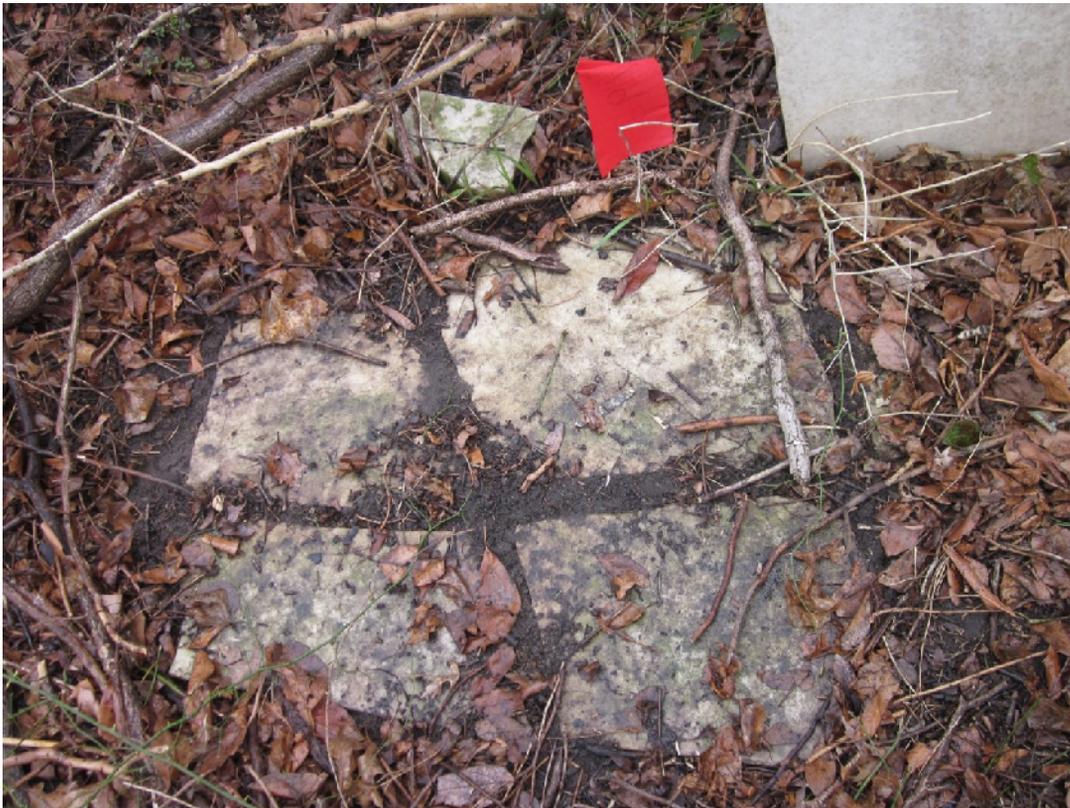
Second were those gravestones that were single slabs installed directly into the ground, which had been broken off at some part above the ground. Some stones were too badly broken to be repaired and were left *in situ* (Photograph 32). If the stone had been broken off at the bottom, a new rectangular cavity was excavated directly in front of the original location, usually to a depth of about 20 cmbs (8 inches). Then a concrete base was poured, into which the headstone was set (Photograph 33). If the gravestone had been broken midway, then a new base would be constructed adjacent to the original location, and the top part of the stone installed facing out (Photograph 34).

Photograph 32: Badly broken gravestone left *in situ*.

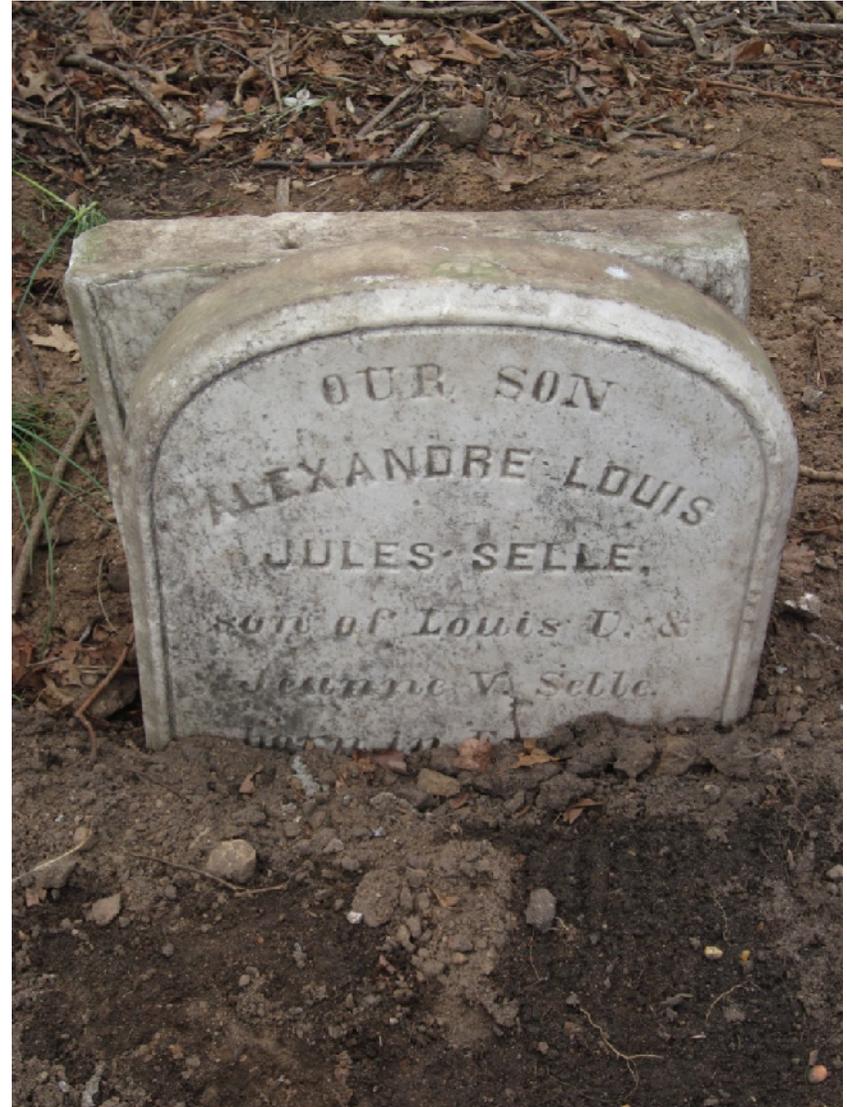
Photograph 34: Reset broken gravestone.

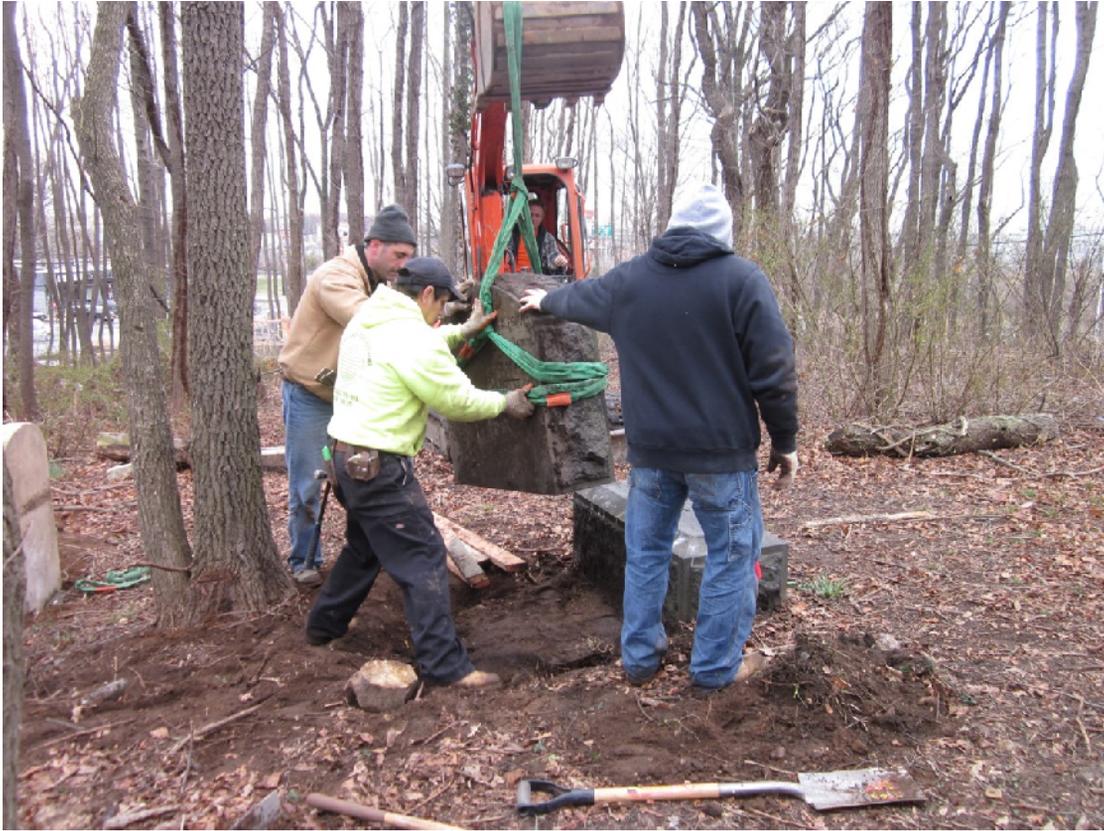
Photograph 35: Resetting a large monument upon the original base.

Third were those gravestones, mainly some of the largest ones present in the cemetery, which had been knocked over, but could be reset upon their original bases. For the larger monuments, it was necessary to bring in a small trackhoe to reposition them (Photograph 35). All movement of the trackhoe was monitored to ensure that no gravestones or plantings were damaged.

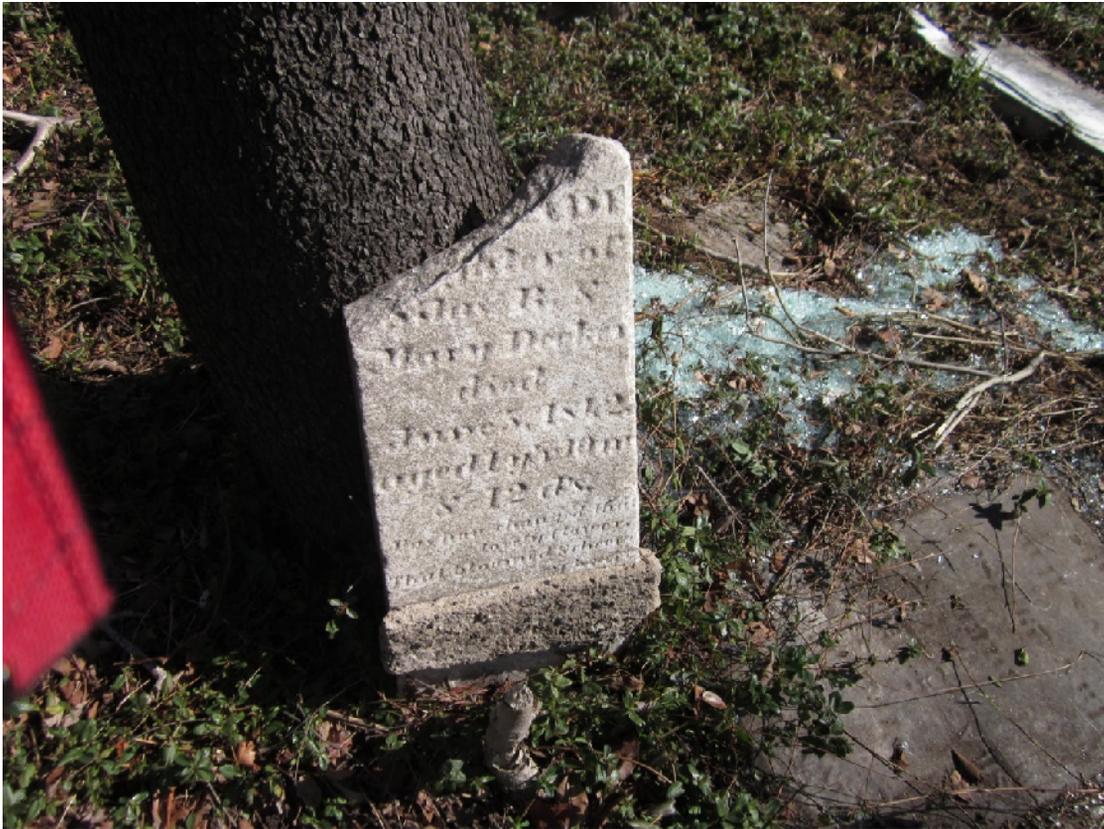
Some gravestones had been completely removed from their original placement in the ground (Photograph 36). In these cases, the document entitled *Staten Island Gravestone Inscriptions From The Sylvan Grove, Merrell and Hillside Cemeteries in the former town of Northfield...* (Davis, Leng, and Vosburgh 1924) proved enormously helpful in finding the correct location for the gravestones. While the map of the cemetery that was apparently originally attached to the document is no longer available, the descriptions of the monuments were arranged by rows. Although some of the original 12 rows were difficult to discern because of missing and damaged monuments, as well as heavy overgrowth, the verbatim epitaph transcriptions meant that even a small fragment could be identified, and matched to a specific plot or at least a general location. As a result, broken portions of stones that were far from their original location were able to be reunited with the rest of the monument. A number of footstones had also been pulled out of their original locations, and probably because of their smaller size, were often found far from the matching headstone. Luckily many of the footstones had engraved initials, and were able to be returned to their correct location. During the course of monitoring, the 1924 gravestone list was annotated to note the existence and condition of the remaining monuments (Appendix C). A map identifying the location of the rows was also created (Figure 8).

Photograph 36: Gravestone that was able to be relocated to its original burial plot.
