Re: Technical Report, Archaeological Monitoring
Utilities Installation, Seneca Village, Central Park, New York

ARCHAEOLOGICAL MONITORING: SENECA VILLAGE, CENTRAL PARK, NEW YORK

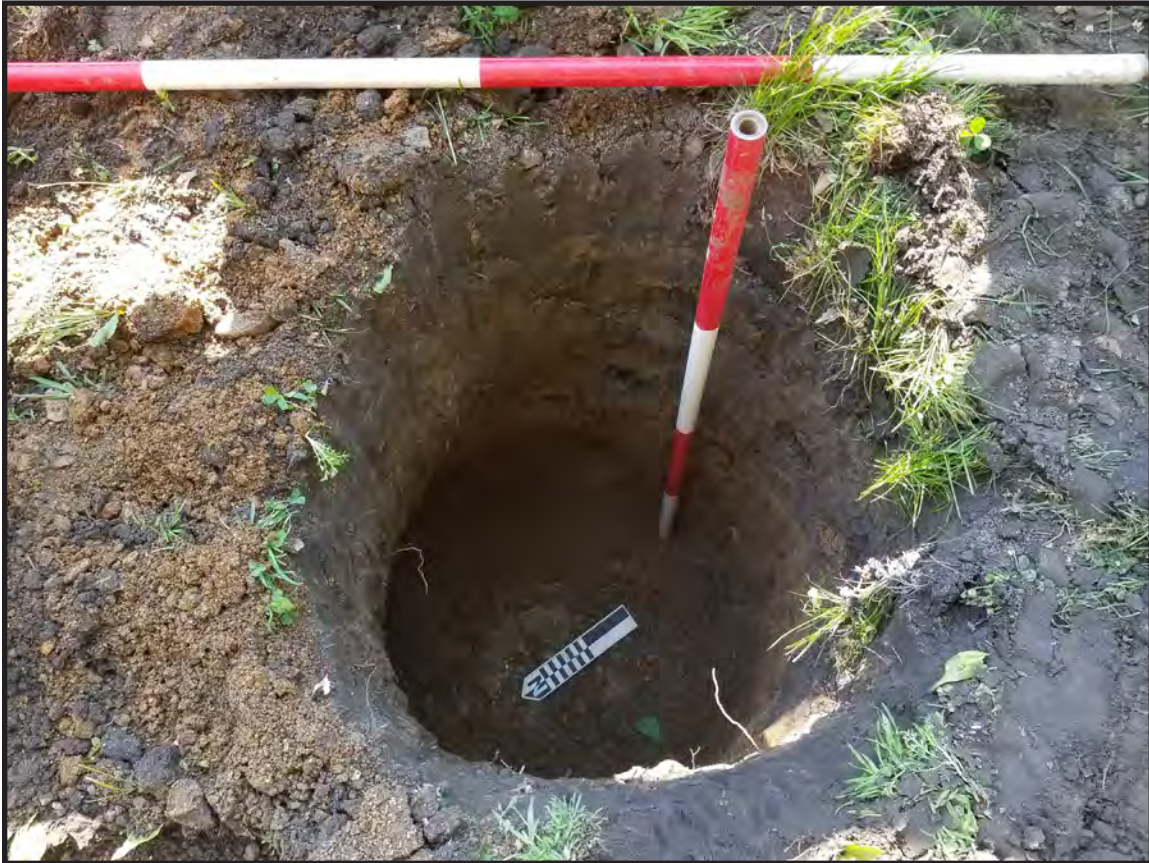
In most excavations, a dark compact loamy silt or silty sandy loam topsoil overlay a mottled loamy sandy silt, the latter being interpreted as 20th-century grading fill (Photograph B.1). In most cases, these deposits overlaid late 19th- or 20th-century grading fill deposits that were often disturbed by extant utilities (Photograph B.2). Modern electrical conduit was encountered in at least six excavations (SLB #6 and 12, SLF #1, 3, 10 and 12). The edges of existing utility boxes or foundations were encountered in several excavations, (e.g., SLF #1, 3, 6, 7, 10 and 12) (Photograph B.3). A possible buried A horizon or historic occupation layer was encountered in the soil profiles documented for SLB #1, SLB #2 and SLF #2 (Photograph B.4). This deposit, typically encountered 30 cm below the ground surface, was a dark brown loamy silt that was 25 cm thick. Subsoil consisting of a yellow, medium to coarse sand or silty sand with crystalline inclusions and/or decayed schist rocks was encountered in 13 of the monitored excavations: SLB #1, 2, 3, 4, 5, 11 and SLF #2, 4, 7, 9, 10, 11 and 12. These natural deposits were typically encountered between 85 and 100 cm below the ground surface. Solid schist bedrock was encountered at three locations in SLB #6, SLF #2 and SLF #10 (Photograph B.5). The depth of bedrock, where encountered, varied between 60 and 115 cm below the ground surface.

Photograph B.1. View facing southeast showing SLF #4 (Photographer: Joshua Butchko, May 2021 [HRI Neg.#21036/D1:091]).

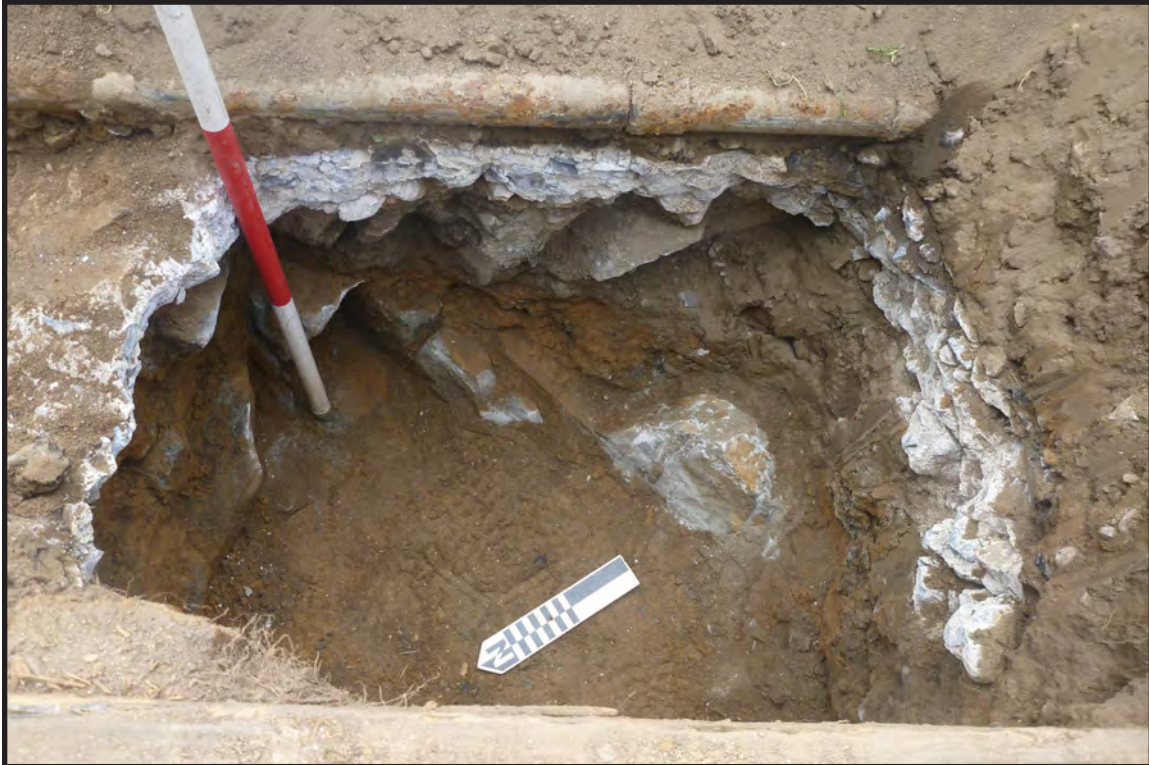
Photograph B.5. View facing southeast showing natural bedrock outcrop in the completed excavation of SLF #10 (Photographer: Joshua Butchko, May 2021 [HRI Neg.#21036/D2:048]).

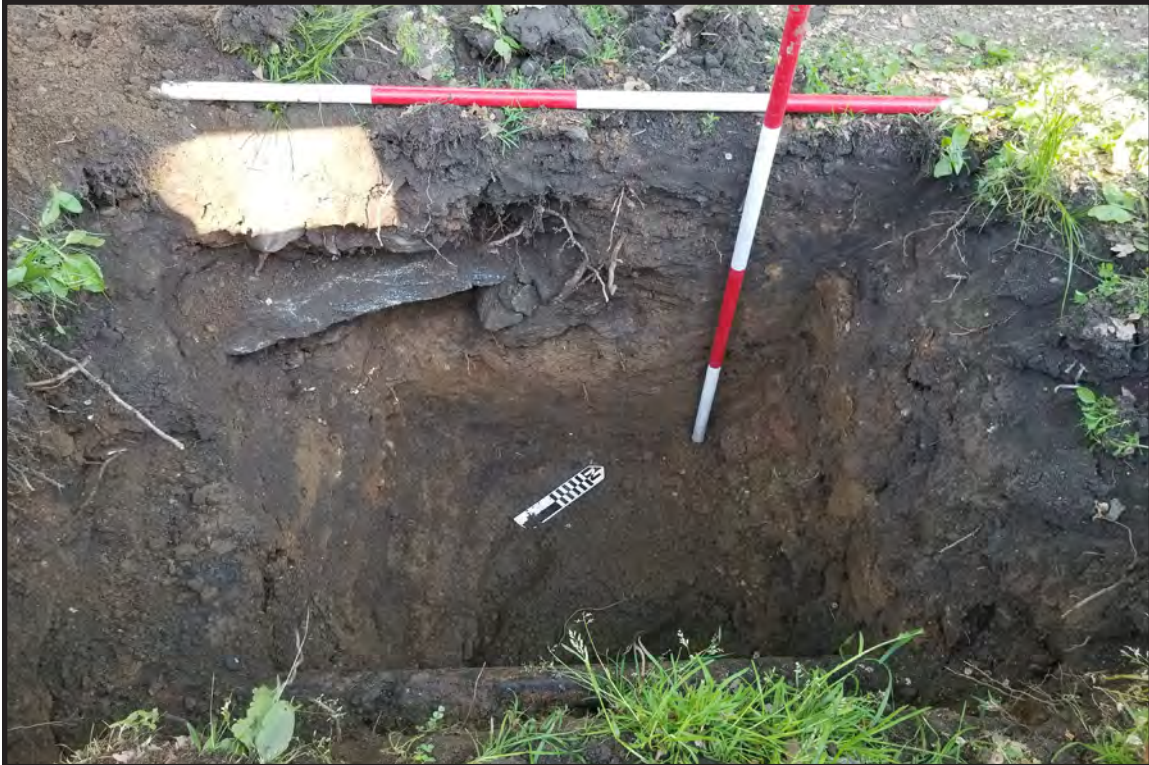
Excavations of particular interest were those which revealed stone or concrete footings and surfaces. In SLB #3, excavation began with the removal of topsoil [Context 1] which extended to 15 cm below the ground surface. This overlaid a 15-cm thick deposit of mottled loamy sand with rocks interpreted as grading fill [2]. Under this deposit, a dry-laid, schist stone footing [3] was identified in the west profile of the excavation (Photograph B.6). This feature was approximately 30 cm thick and its construction cut [4] into a deposit of mottled loamy sand

interpreted as fill [5]. This fill [5] overlaid deposits of mottled sand loam [6] and clayey sand with decayed schist [7] which extended to 76 cm below the ground surface. A deposit of medium to fine sand [8] encountered from 76 cm to 90 cm below the ground surface was interpreted as culturally sterile subsoil. Based on the Gardner Sage maps of 1856, this location is close to the street frontage of two parcels owned by Andrew C. Zabriskie which contained tenant dwellings occupied by O. Landin and J. Landin (Figure A.3). Josiah Landin was listed as a Black laborer in the 1855 New York state census. It is possible that the stone footing in SLB #3 is a foundation remnant of one of the tenant dwellings or part of a property boundary wall and thus dates from the mid-19th century. Alternatively, it could be related to a more recent landscaping action and be part of a pathway edge. Further archaeological excavation would be needed to clarify the true nature of this feature.

Photograph B.6. View facing northwest showing stone footing in SLB #3 (Photographer: Joshua Butchko, May 2021 [HRI Neg.#21036/D1:072]).

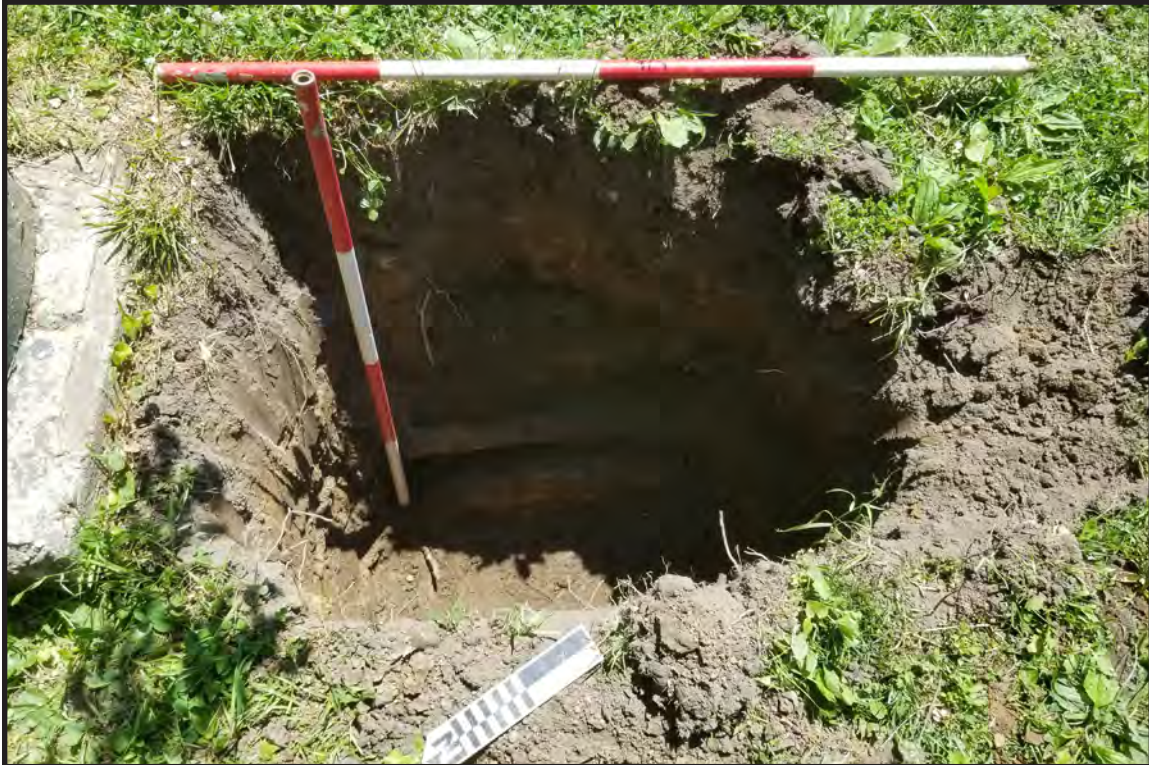
A second, more substantial stone footing was identified in SLF #3 (Photograph B.7). This excavation was situated immediately south of an existing streetlight foundation. In this instance, excavation began with the removal of topsoil [Context 1] which extended to only 6 cm below ground surface. This overlaid an 82-cm thick deposit of mottled loamy sandy silt interpreted as fill disturbed by modern utilities [2]. In the east profile of the excavation, a 6 cm-diameter iron pipe [3] was encountered approximately 80 cm below the ground surface. This utility appeared to connect to the extant streetlight foundation at the north end of the excavation. A partially truncated, dry-laid, dressed stone footing [4] was encountered beneath and running parallel to the utility pipe at approximately 92 cm below the ground surface. The full width and thickness of this footing could not be ascertained within the limits of the excavation. The soil deposited against the west side of the footing was a mottled loamy sand with schist rubble [5], suggesting that the debris from the truncated footing feature had been pushed up against it. This deposit extended beyond the full depth of the excavation at 92 cm below the ground surface. This location, according to the georeferenced Gardner and Sage maps, is within the front of a vacant property owned by John Orser (Figure A.3). Further archaeological excavation would be needed to clarify the true nature of this stone footing, although it seems likely that it is part of a building foundation or a shaft feature such as a well.

Photograph B.7. View facing southeast showing extant utility and stone footing in SLF #3 (Photographer: Joshua Butchko, May 2021 [HRI Neg.#21036/D1:049]).

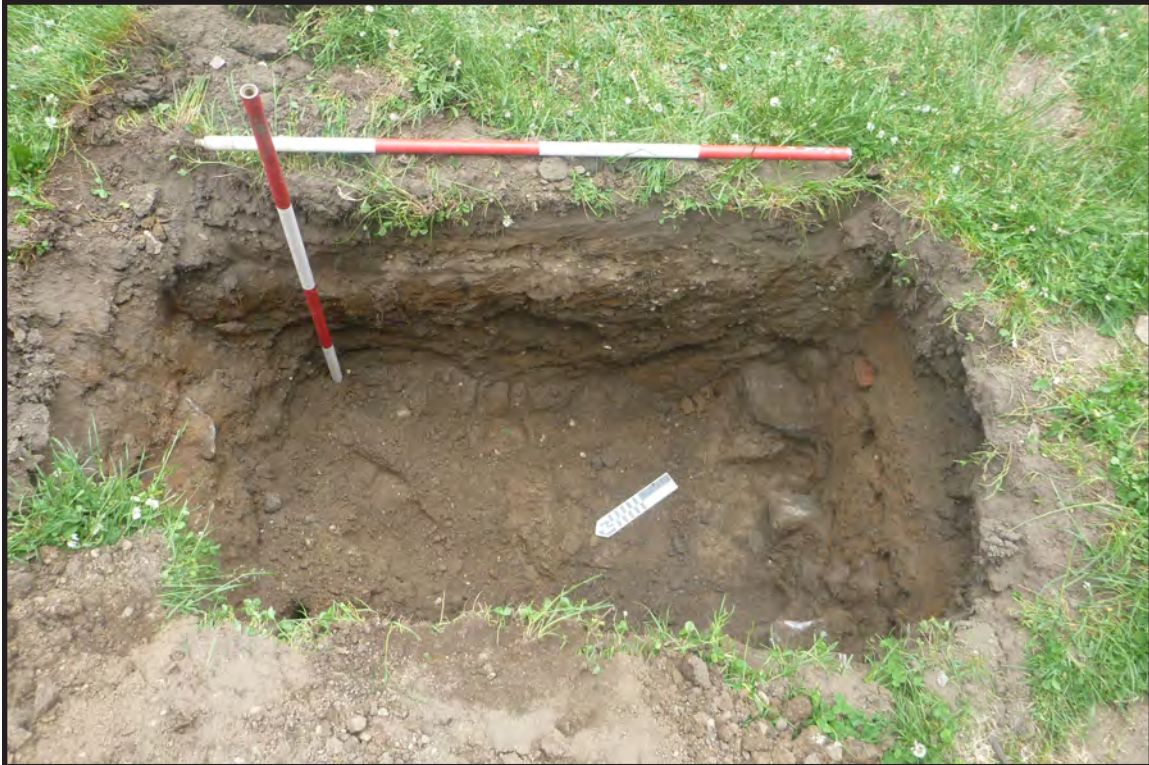
Excavation of SLB #10, near the intersection of West Drive and the 85th Street Access Drive, revealed apportion of a dry-laid, stone sett surface (Photograph B.8). In this excavation, topsoil [Context 1] extended to 25 cm below the ground surface and overlaid a 5 cm-thick lens of coarse sand with gravel [2]. This in turn overlaid a deposit of mottled silty sand [3] that extended to 70 cm below the ground surface. This latter fill layer [3] overlaid a surface of dry-laid stone setts [4]. The stones each measured approximately 18.3 by 15.25 by 11 cm. Approximately one dozen stones were observed, photographed and left in place (Photograph B.9). The stones were situated in a thin bedding deposit of clayey sand with gravel [5] which extended to 80 cm below the ground surface. This feature was cut into a deposit of mottled loamy sand with decayed schist [6] which extended to the depth of excavation. Based on the Gardner Sage maps of 1856,

this location is situated in the rear yard of an historic property of unknown owner/tenant status that once fronted on 83rd Street, immediately east of a property owned by Lucy Celia Wallace with a tenant dwelling occupied by S.W. Hutchins and a shanty rented by John White. Salmon W. Hutchin[g]s was a Black laborer; John White was also Black and listed his occupation as a rag picker in the 1850 federal census and as a sailor in the 1855 state census. The stone sett surface may relate to a path or yard and, owing to its depth, could be of mid-19th-century age; however, it may also be part of a more modern landscape feature as it resembles the many stone sett surfaces that define road or walkway aprons at the present-day ground surface in this general vicinity. Again, further archaeological excavation would be needed to clarify the true nature of this stone surface.

Photograph B.8. View facing southeast showing stone sett surface in profile (right of frame) in SLB #10 (Photographer: Joshua Butchko, May 2021 [HRI Neg.#21036/D2:036]).

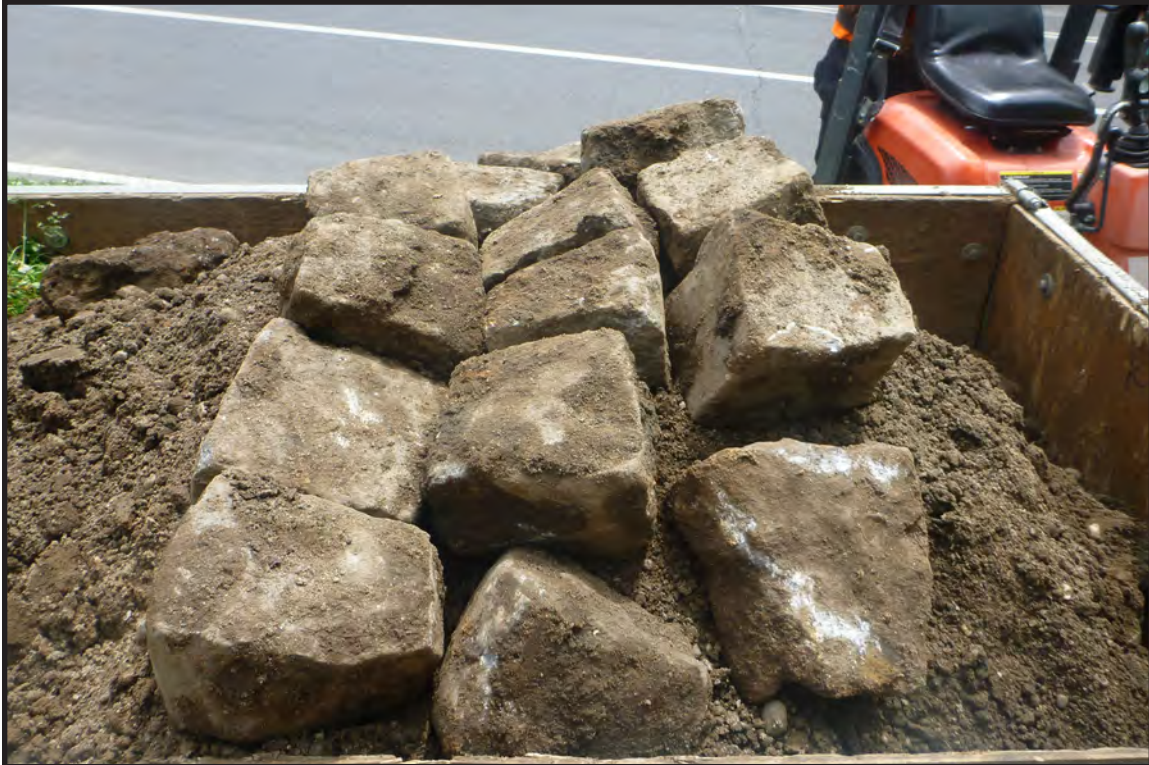
Photograph B.9. View facing east showing an example of stone setts that were excavated from SLB #10 (Photographer: Joshua Butchko, May 2021 [HRI Neg.#21036/D2:042]).

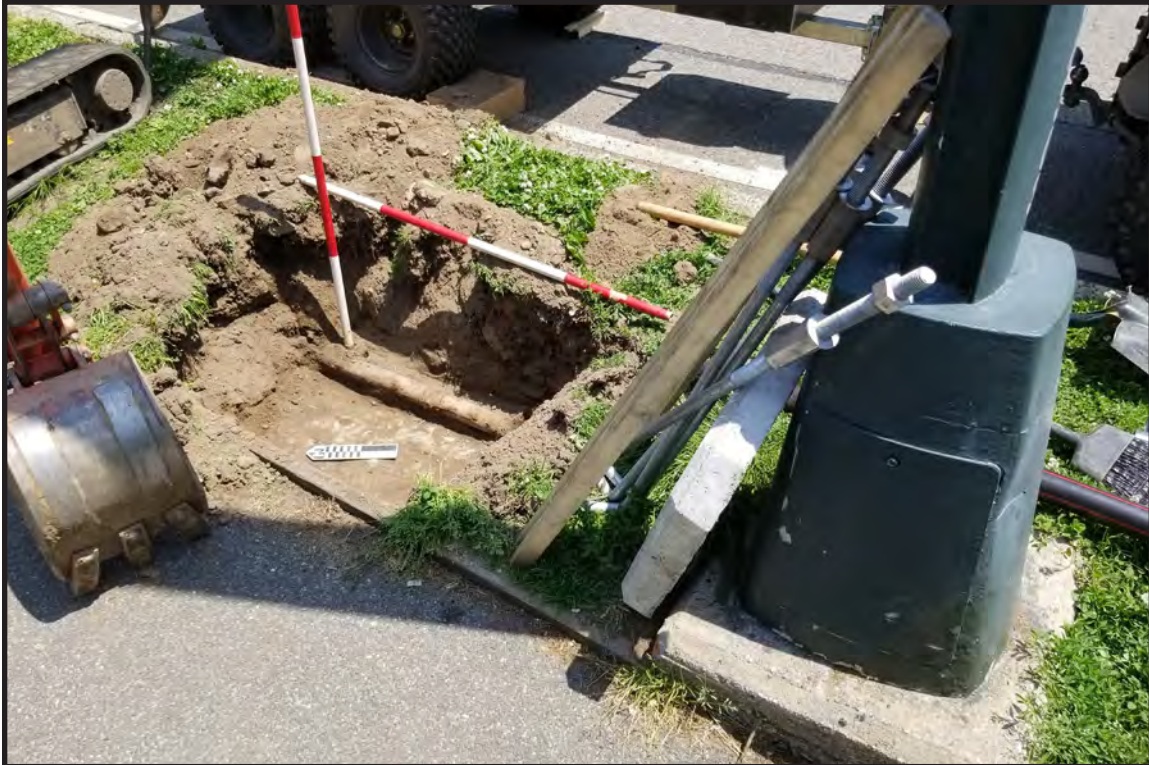
During excavation of SLF #10 and SLF #12, two concrete surfaces and a concrete foundation were identified. In SLF #10, topsoil [Context 1] extended to 20 cm below the ground surface (Photograph B.10). This overlaid a deposit of mottled silty loam [2] that extended to 40 cm below the ground surface. Under this fill deposit [2] a 6 cm-diameter iron pipe [3] for an extant utility was found partly overlying a solid concrete surface [4]. This concrete surface was 15 cm thick and overlaid a deposit of mottled clayey sand [5]. This was interpreted as fill and extended to 75 cm below the ground surface. This fill overlaid subsoil and an outcropping of schist bedrock which was encountered at 95 cm below the ground surface (Photograph B.5). In SLF #12, a similar concrete surface was encountered under topsoil [1] and fill [2] at approximately 60 cm below the ground surface.

Photograph B.10. View facing east showing utility pipe and concrete surface exposed in SLF #10 (Photographer: Joshua Butchko, May 2021 [HRI Neg.#21036/D1:167]).

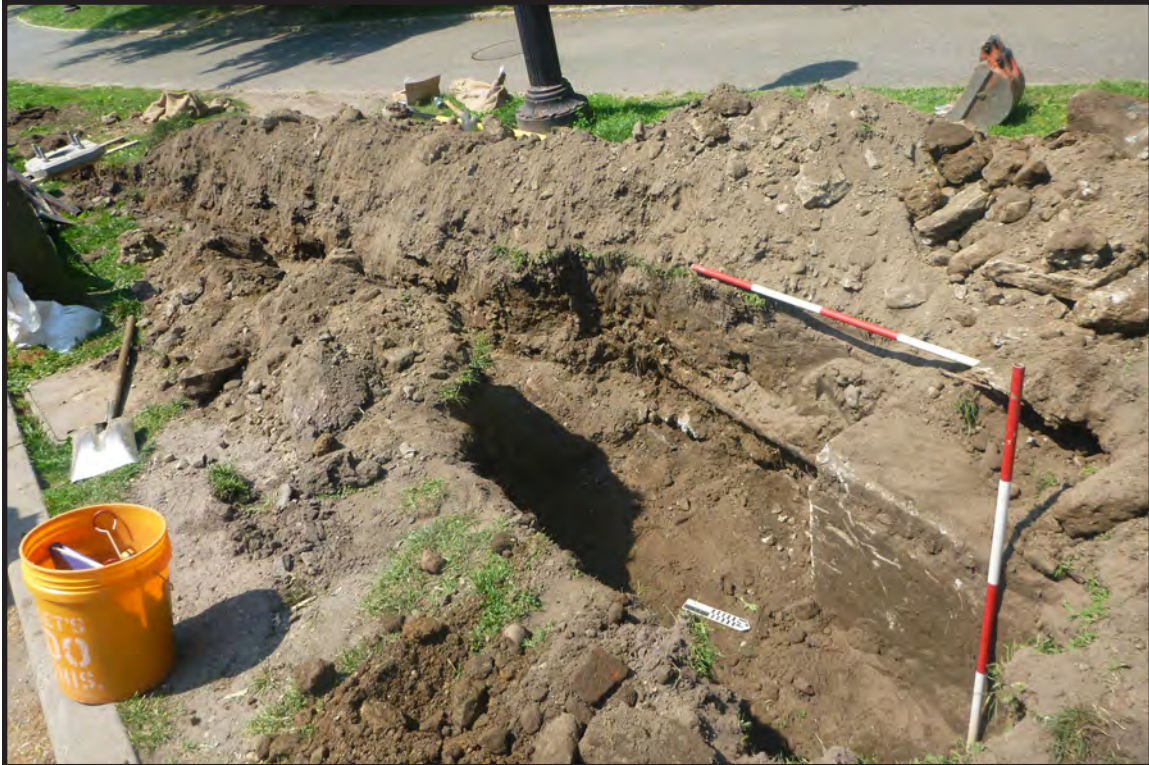
The excavations for SLB #12 and SLF #12 showed disturbance from the installation of extant utility boxes and pipes (Photograph B.11). The soil stratigraphy was comparable to that encountered in SLF #10. In a connector trench which extended along the west side of SLF #12, a shallow concrete foundation was also exposed (Photograph B.12). This foundation, from which protruded a fractured iron conduit, was interpreted as an abandoned streetlight foundation probably dating from the mid-20th century or later. Based on the Gardner and Sage maps, SLB #12 and SLF #12 were located within a cluster of four historic lots owned by John J. Washington containing four structures rented by James Morgan, a Black laborer. However, no evidence of this historic occupation was observed at this location.

Photograph B.11. View facing southwest showing completed excavation and partial installation at SLB #12 and SLF #12 (installed top left of frame) (Photographer: Joshua Butchko, May 2021 [HRI Neg.#21036/D2:095]).

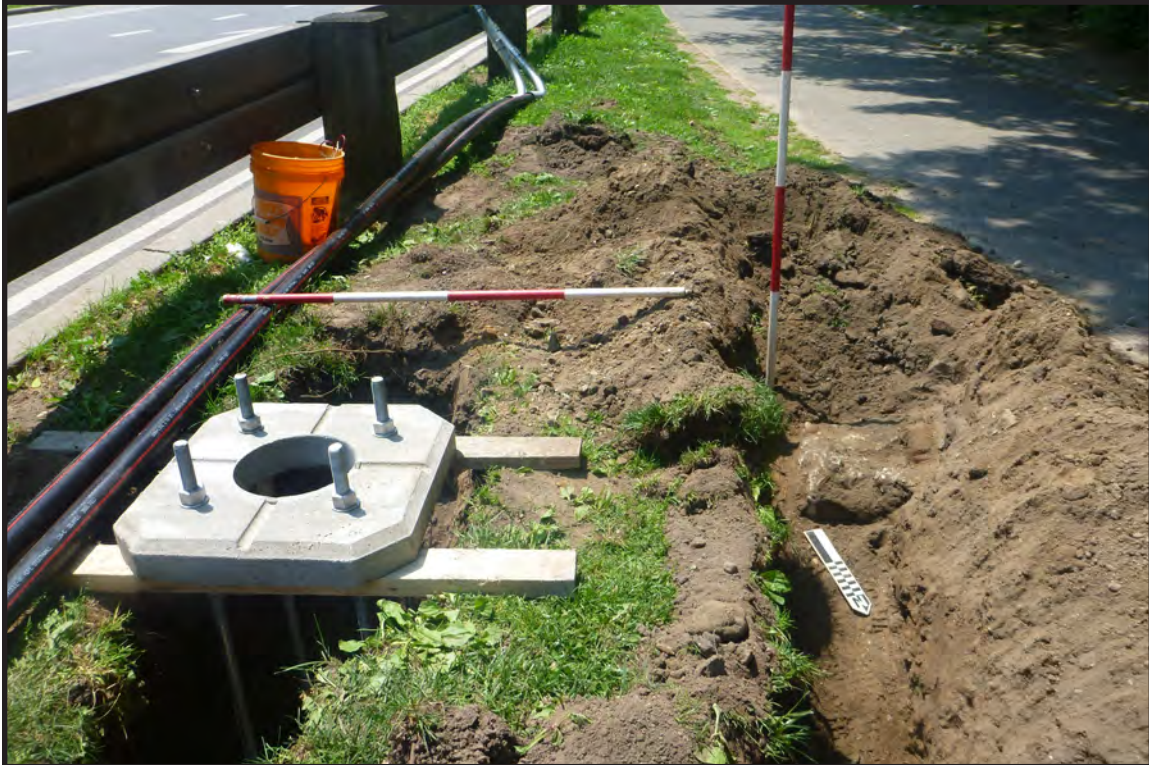
Photograph B.12. View facing southwest showing completed excavation and partial installation at SLF #12 showing concrete footing in connector trench (right of frame) (Photographer: Joshua Butchko, May 2021 [HRI Neg.#21036/D2:105]).
