Re: Letter Report, Unanticipated Discovery, 1763 86th Street, Brooklyn Borough, Kings County, New York (PO Number: 4500371572)

Archaeological Documentation, December 2, 2024

Letter Report, Archaeological Documentation
1763 86th Street, Brooklyn
December 13, 2024
Page 5

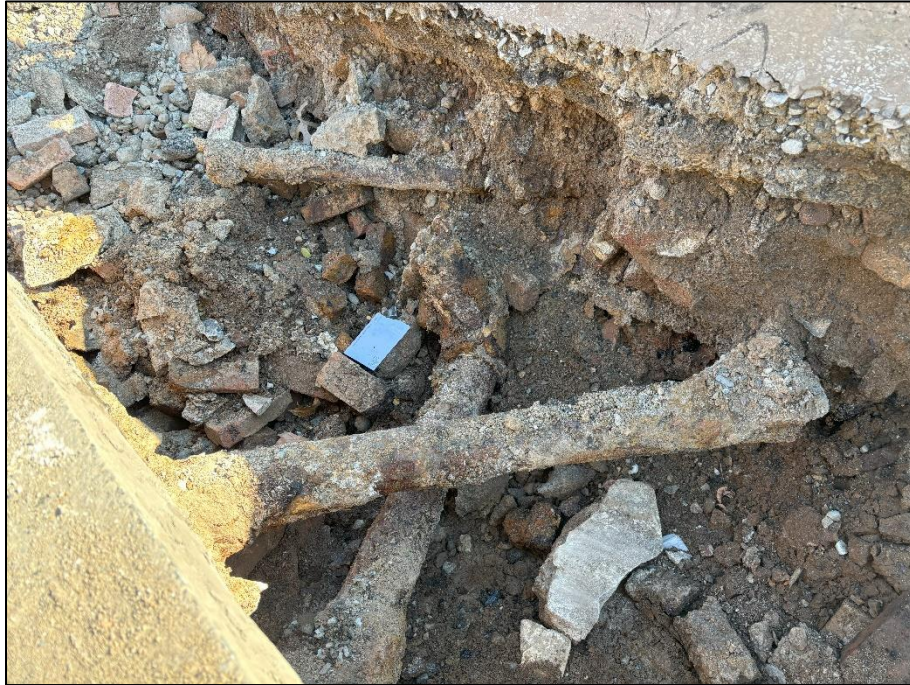
the existing grade may be slightly higher than when the school was in operation. The exposed sewer or water lines likely connected the school to existing utilities infrastructure. The utility lines are certainly not recent.

Plate 1: North edge of trench, closeup of three pipes within the rubble.

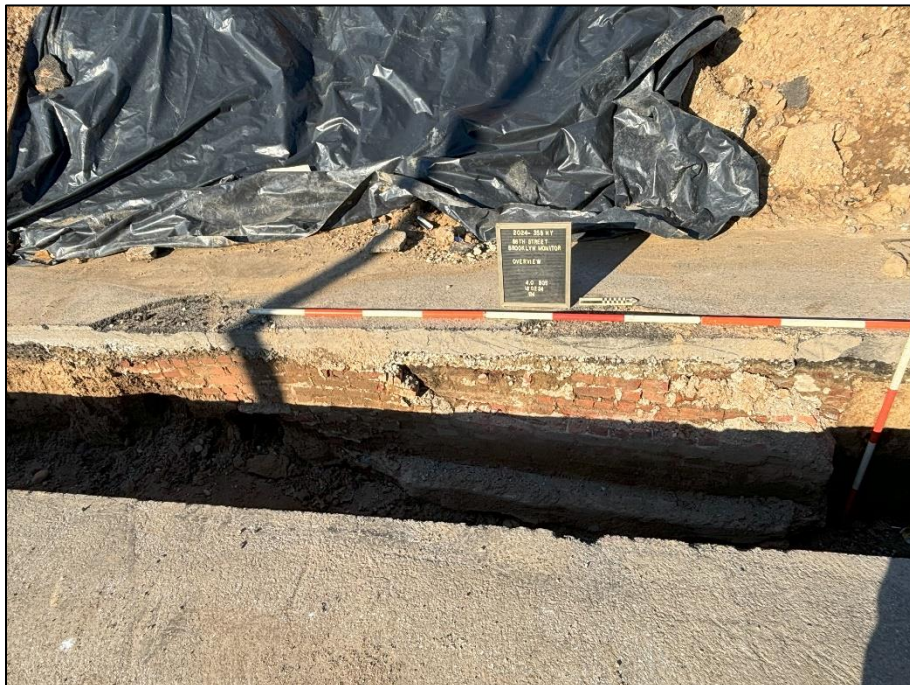
The brick wall was located within the western trench wall directly below the asphalt laid for the existing parking lot. The brick portion of the wall was a little over two feet at its deepest point and was abutted by concrete directly below it. The concrete underlying the brick wall was just under a foot thick. The brick portion was not a perfectly square section and had sharp, clear boundaries. At least six courses of brick was documented. Disturbance was observed south of the brick wall. Soil was observed beneath the asphalt in locations where the brick wall had been removed. The soil consisted of a brown (10YR 4/3) sandy to silt loam that was mixed with cobbles and rubble. Some cobbles of various sizes were observed. A brick wall traversed the trench (perpendicular) and could represent the remnants of a former partition wall. The brick wall extends beyond the trench for an unknown distance further east toward the library.

It is possible that the brick represents the remnants of an exterior wall to PS #101. Based on an examination of historic photographs of PS #101, the section of wall exposed during construction may be near the base of the school building, perhaps just above or associated with the foundation. A review of historic aerials suggests that the brick wall could represent the lower portion of the eastern façade of the school. If that were the case,

Plate 2: Profile view of intact brick wall section in the western trench wall.

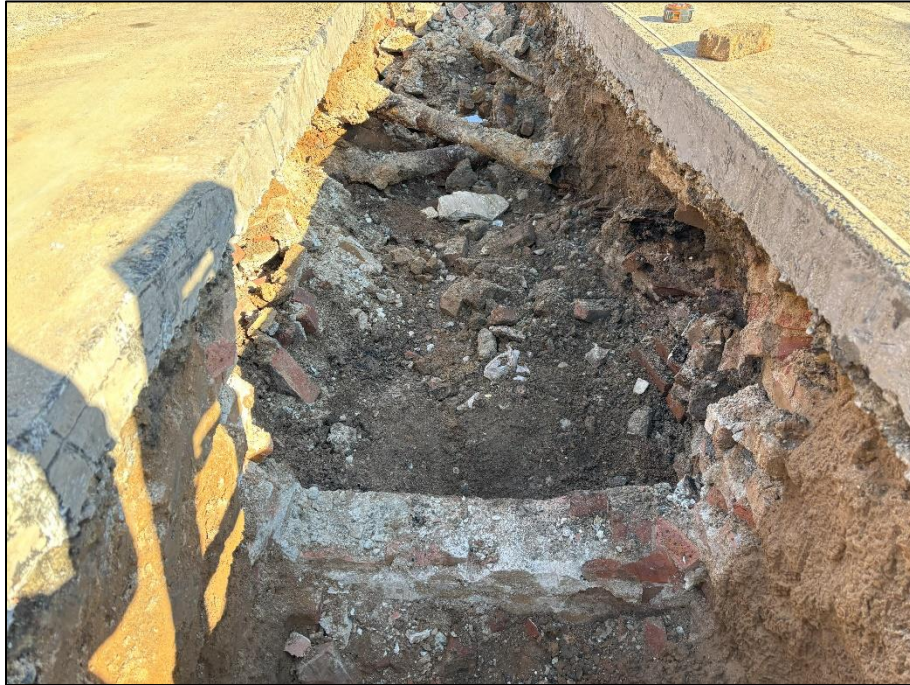
Plate 3: Brick footing with pipes in background.

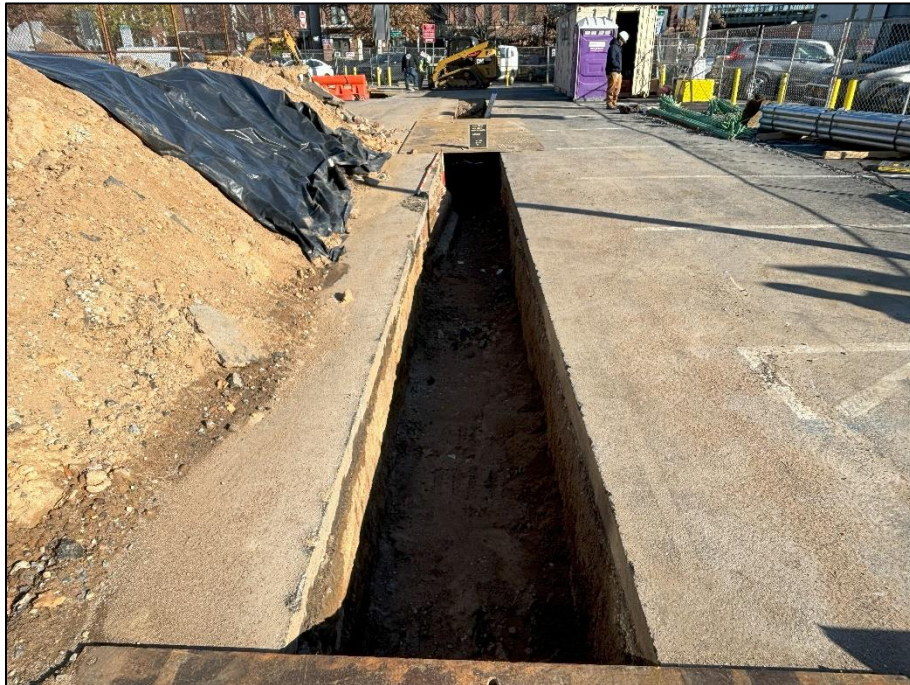
Plate 4: Full trench plan view/ overview of area.

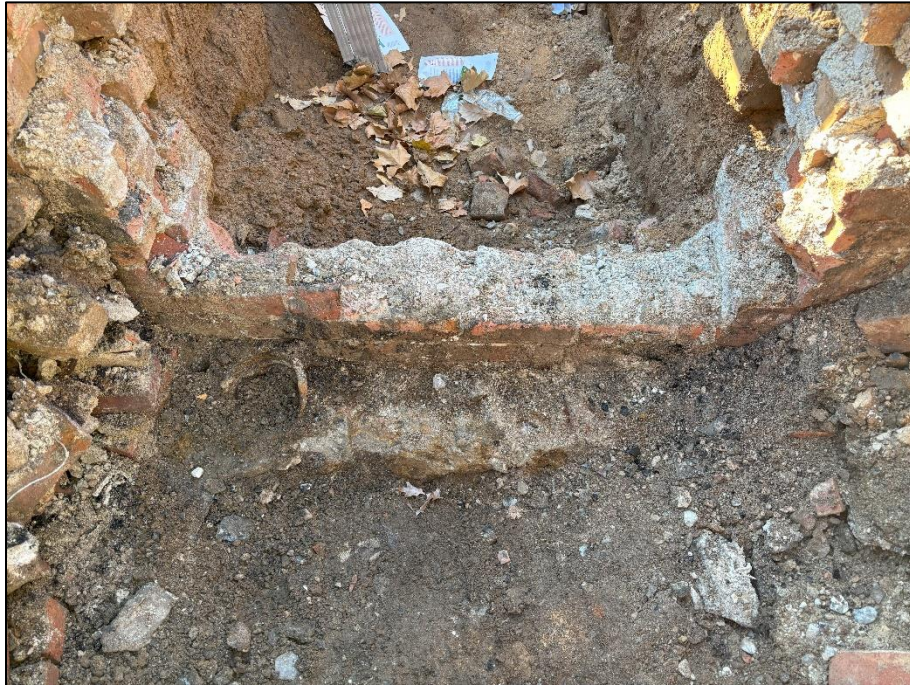
Plate 5: Close up of brick footing and pipe.

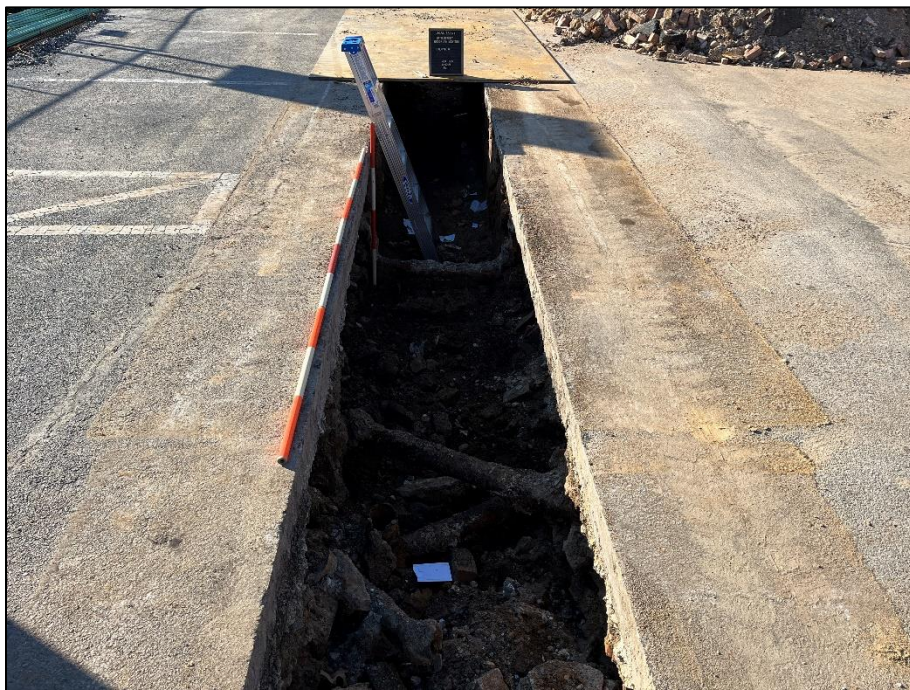
Plate 6: Trench overview.

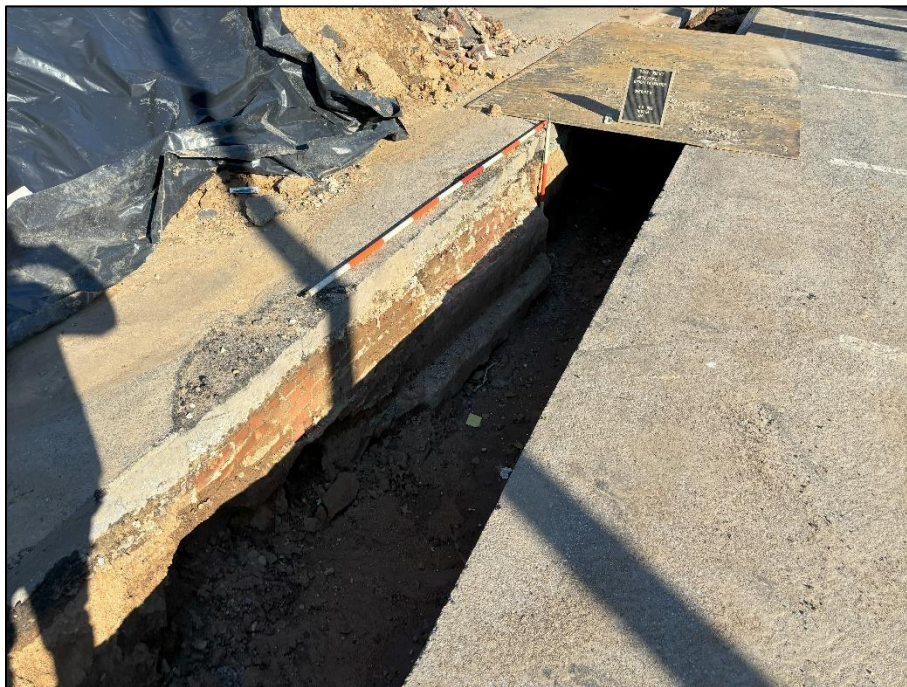
Plate 7: Side view of brick wall showing whole profile and floor.

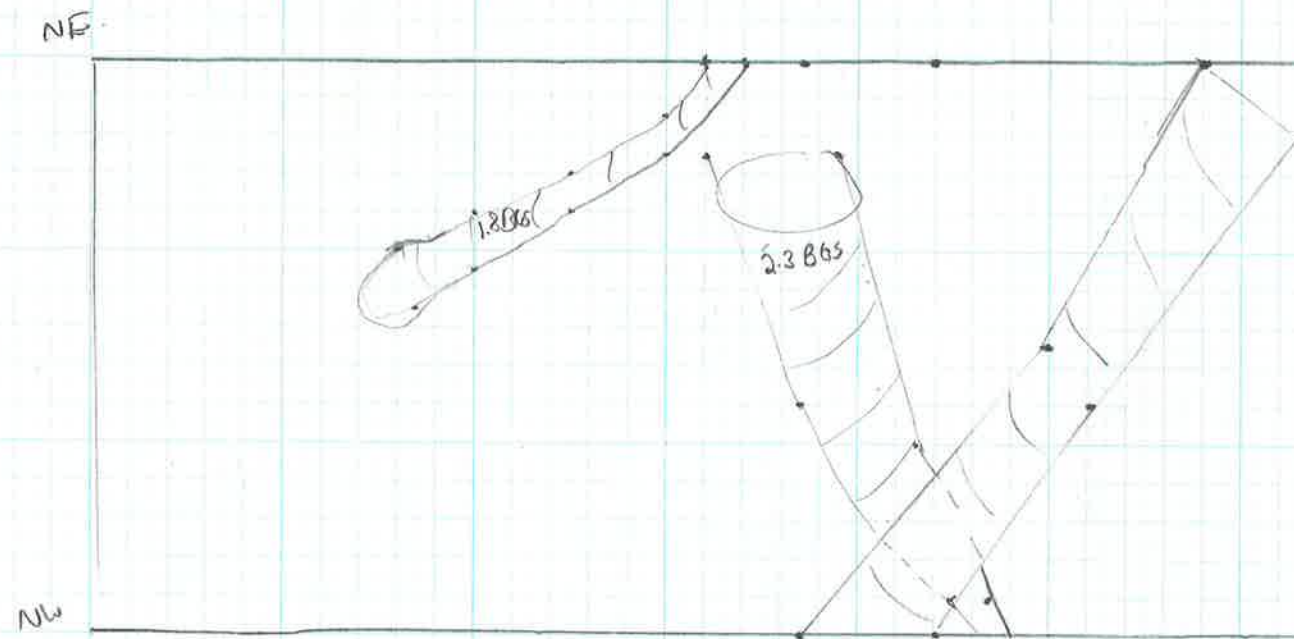
Pipe / Brick Footing
of Trench

2.7' BGS
at top
