SUMMARY OF FINDINGS OF THE ARCHAEOLOGICAL
INVESTIGATION ON IDENTIFIED AREAS OF THE
PIETER CLAESEN WYCKOFF HOUSE PROPERTY PRIOR
TO DISTURBANCE BY ARCHITECTURAL RESTORATION
STAGES A&B

Prepared for The City of New York

Landmarks Preservation Commission

September, 1977

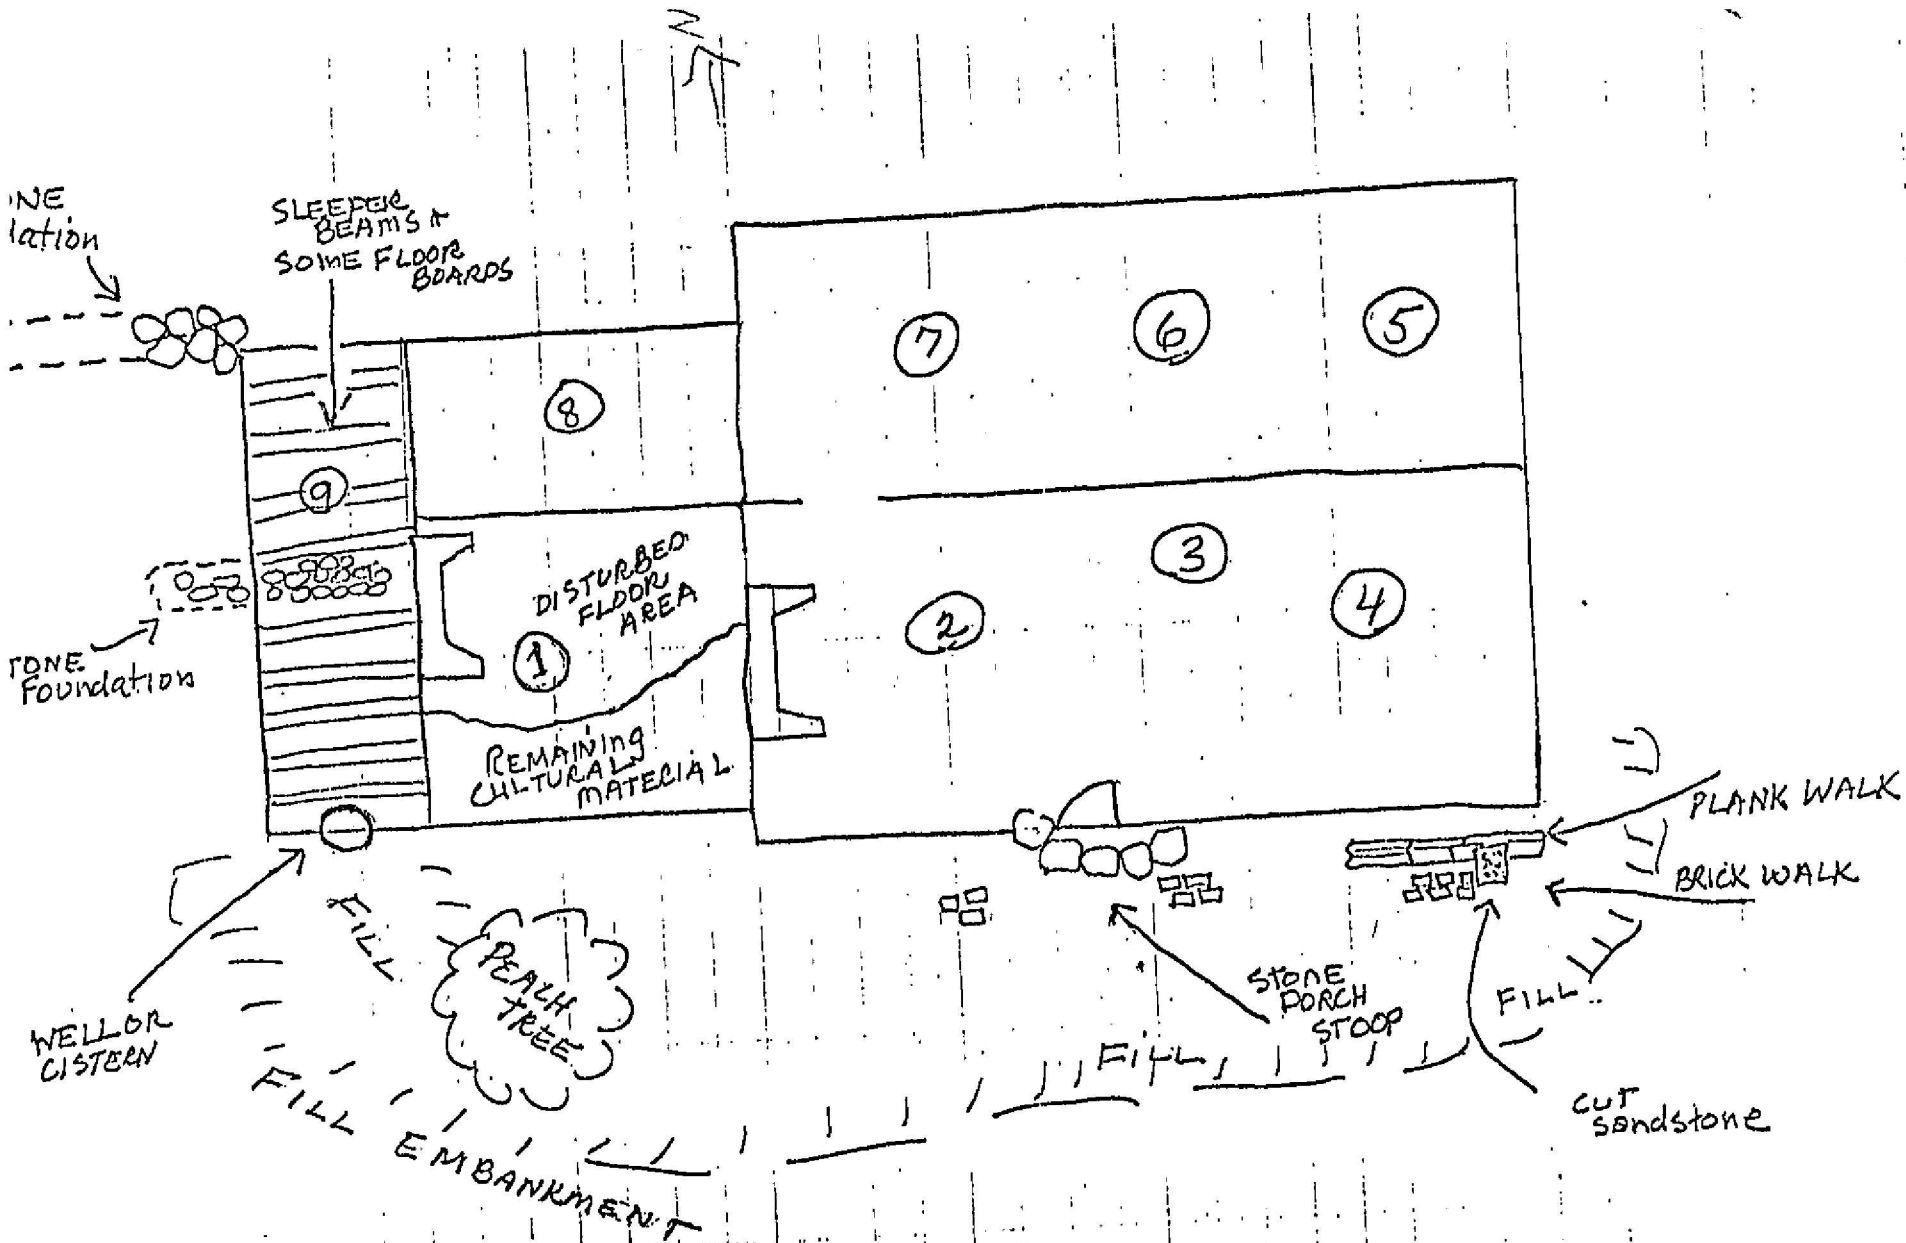
SCHEMATIC DRAWING SHOWING
ARCHAEOLOGICAL FEATURES
DISCOVERED AT THE WYCK

b) Near the front door, the cellar stairs on each side of it, and the southeast corner, we found a curved stone foundation for a historic porch, stoop, or similar superstructure. Beyond (south of) this, there was a walk or pavement of bricks and brick-bats, edged with a wooden plank and Belgian-block paving stones. On the basis of brick style, this is tentatively dated to some time during or after the latter third of the 19th century. A wooden plank walk, at one time painted green, was found underlying a cut brown-stone which was part of the plank-edged brick walk. The plank deck or walk was thus earlier, perhaps of early 19th century date, and appears to be in excellent condition. Some artifacts of 19th and 18th century age were found in these tests.

c) Inside Room 1, we found the badly rotted remains of beams for a floor that preceded the wooden floor beams which are now partially exposed where recent concrete has been taken up. This earliest remaining floor evidence was at a lower elevation than the wooden floor still partly preserved. A number of probably 18th century artifacts were found in loose association with this earliest floor, but we are not able to ascribe even a tentative period to it until we have further analyzed the data.

d) Several features were uncovered in Room 9 (the shed addition at the west end of the house). There was a wooden floor of north-south running planks supported east-west beams or sleepers which rested on or in the ground. In the middle of the Room 9 space was a stone feature (foundation) which probably related to an outstructure. This irregular "foundation" of stones does not contact the west wall of Room 1 (at one time an exterior fireplace wall of the house), and extends beyond the west wall of Room 9. It also pre-dates Room 9. A deep cavity, possibly a well or cistern was found just outside the location where the south wall of Room 9 should have been. This cavity of unknown maximum depth was loosely filled with large stones and was capped or covered with cement which formed a 20th century garage entrance into Room 9.

Outside the northwest corner of Room 9 there was a large stone foundation, obviously for some earlier structure which extended west (rather than east and south, as does Room 9) from this point. Again, some apparently 18th and 19th century artifacts were found inside and outside Room 9.

2) The same trench, as it enters Room 9 and runs toward the north end of it, will pass over a filled-in well or cistern, and will cut through the rotted remains of floor beams, and a stone feature which we assume is the foundation of an earlier outstructure. We suggest excavation of the cistern, and complete exposure and plotting of the floor beams and stone feature, before the utility trench is dug. Other than these features, all cultural material has been removed by us from the proposed trench location inside Room 9. Except for the stone feature noted above, excavation into the ground here will not disturb earlier cultural strata as it would outside the structure.

3) More complete study should be made of the unknown foundation found to extend west from under the northwest corner of Room 9, before concrete supports are placed to support reconstruction. Mr. Oppenheimer has also suggested that the location of this pillar can be relocated so as not to destroy this foundation.

4) There appears to be particularly valuable cultural and structural information buried under Room 1. The remaining significant deposit has been sealed under a cement floor, and is still protected where that recent floor exists. Most of the diagonal line which the utility line will pass through has already been disturbed by high school "digs" and probings to find foundation walls. We recommend that before reconstruction or during its very earliest stages, the remaining cement floor be removed under archaeological supervision, and that the earth beneath it (ca. 40% of the room) then be salvaged. Otherwise this uniquely preserved deposit will be destroyed. If utilities are to run diagonally across Room 1, this is an absolute necessity, because the cement prevented us from testing near the southwest corner of the room.

5) Reconstruction of the south porch should be held in abeyance until archaeological excavation can produce more information about early porch, stoop, or related structures, which these tests have shown are present. We suggest preservation of the brick walk and plank sidewalk which are intact. Additional archaeological work outside the house can reveal more data about the earlier plank walk, but some of the thick (up to 5 ft.) recent overburden must be removed first.
