STADT HUYS BLOCK
ARCHITECTURAL ANALYSIS

PREPARED BY
MARY B. DIERICKX

JUNE, 1981

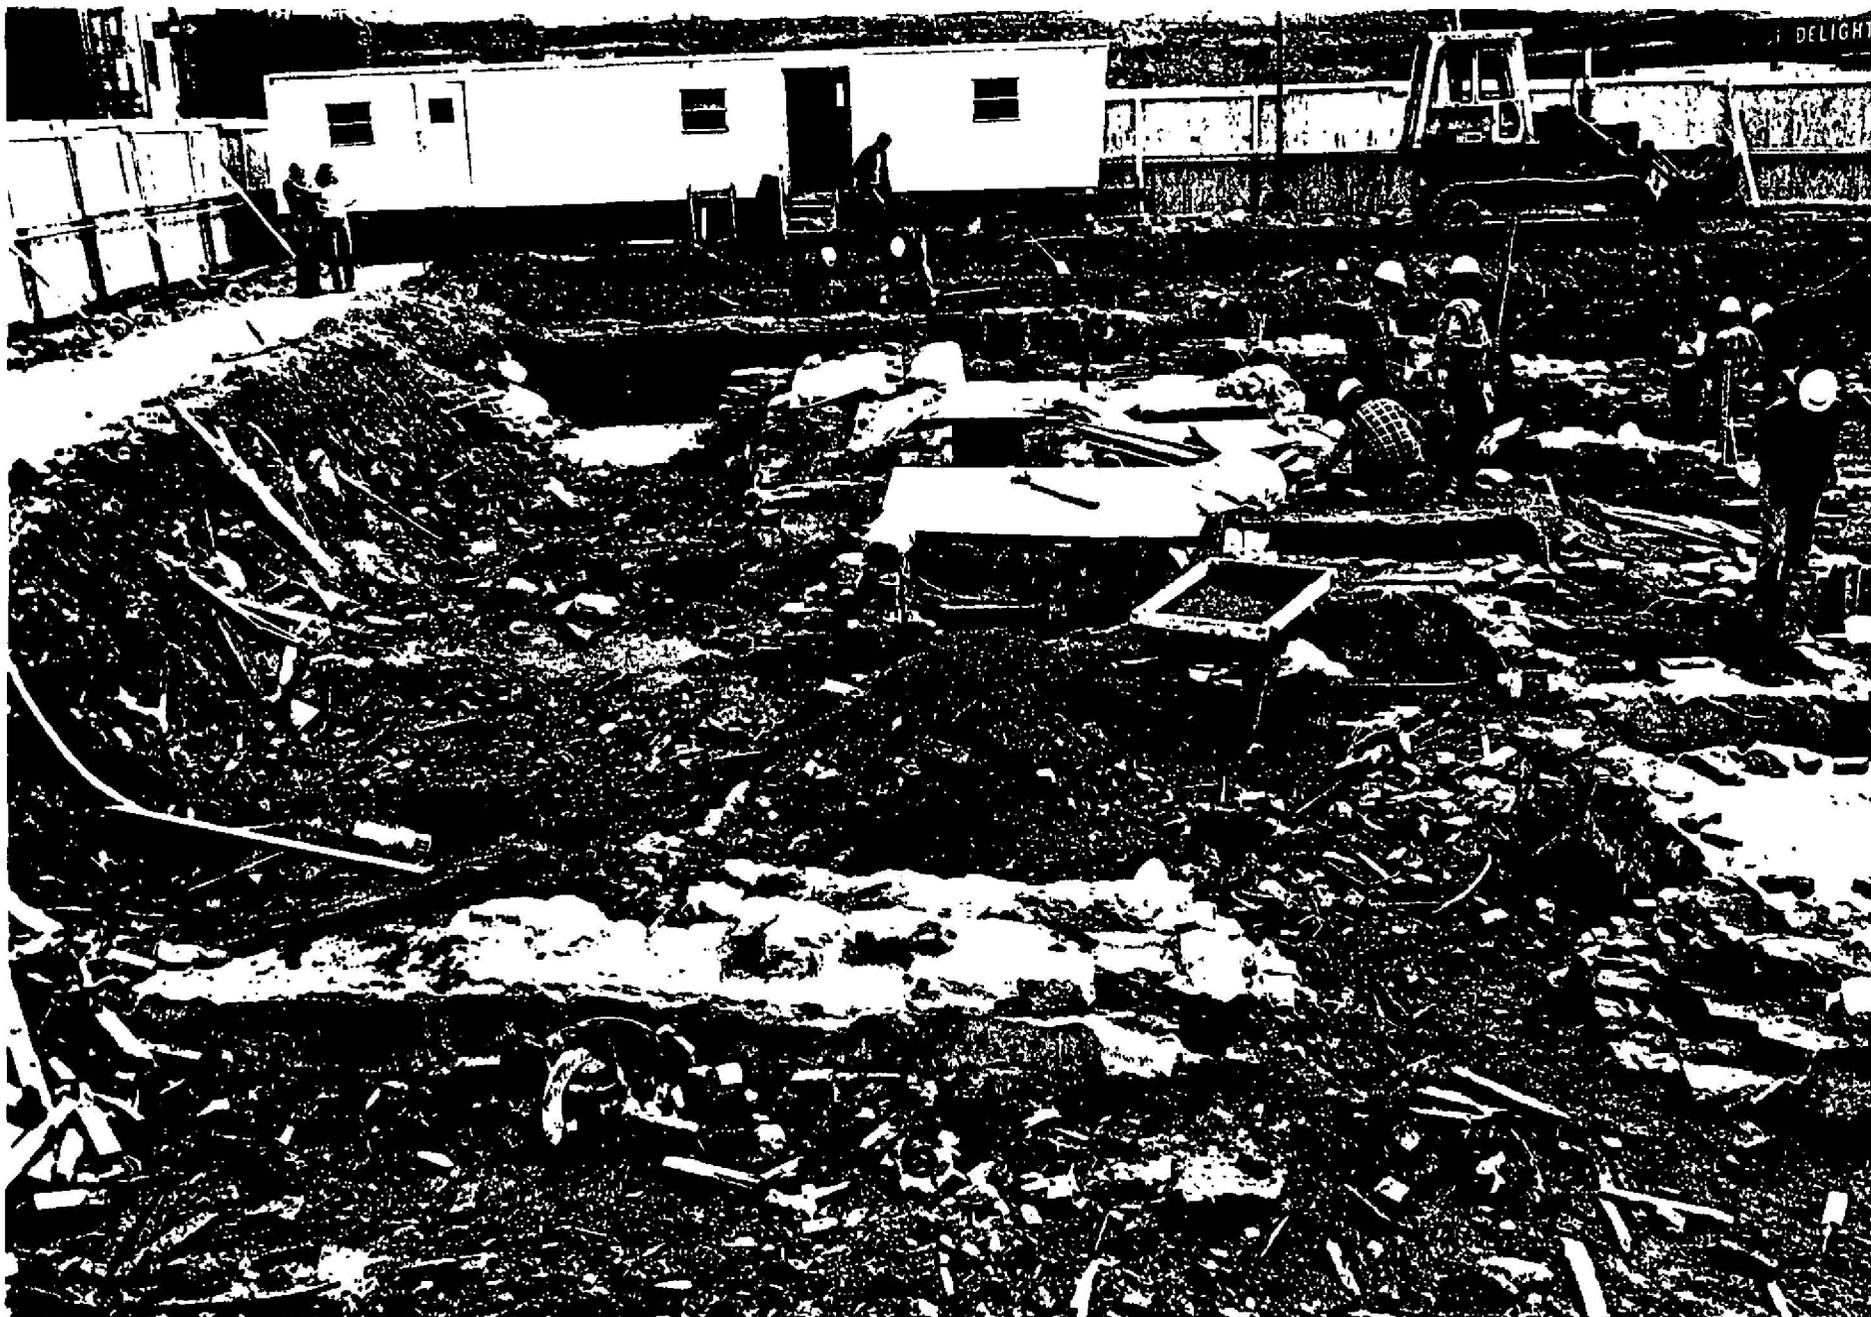
Dutch State House Site, looking east at the Stone Street lots
Photo by Mary, B. Dierickx 10/79

There is not enough evidence to date the wall. The last building on the site appears to have been a 4 story brick-faced Greek Revival structure, probably from the 1830's or 1840's (see page 1 illustration). It has the typical Greek Revival ground floor stone piers and a dentillated cornice. The wall could have been built at the same time as the last building, or they could be left over from a previous structure.

HEIGHT/WIDTH lot 6 was used at one time as a bulldozer path, and there is very little left of the above-ground wall

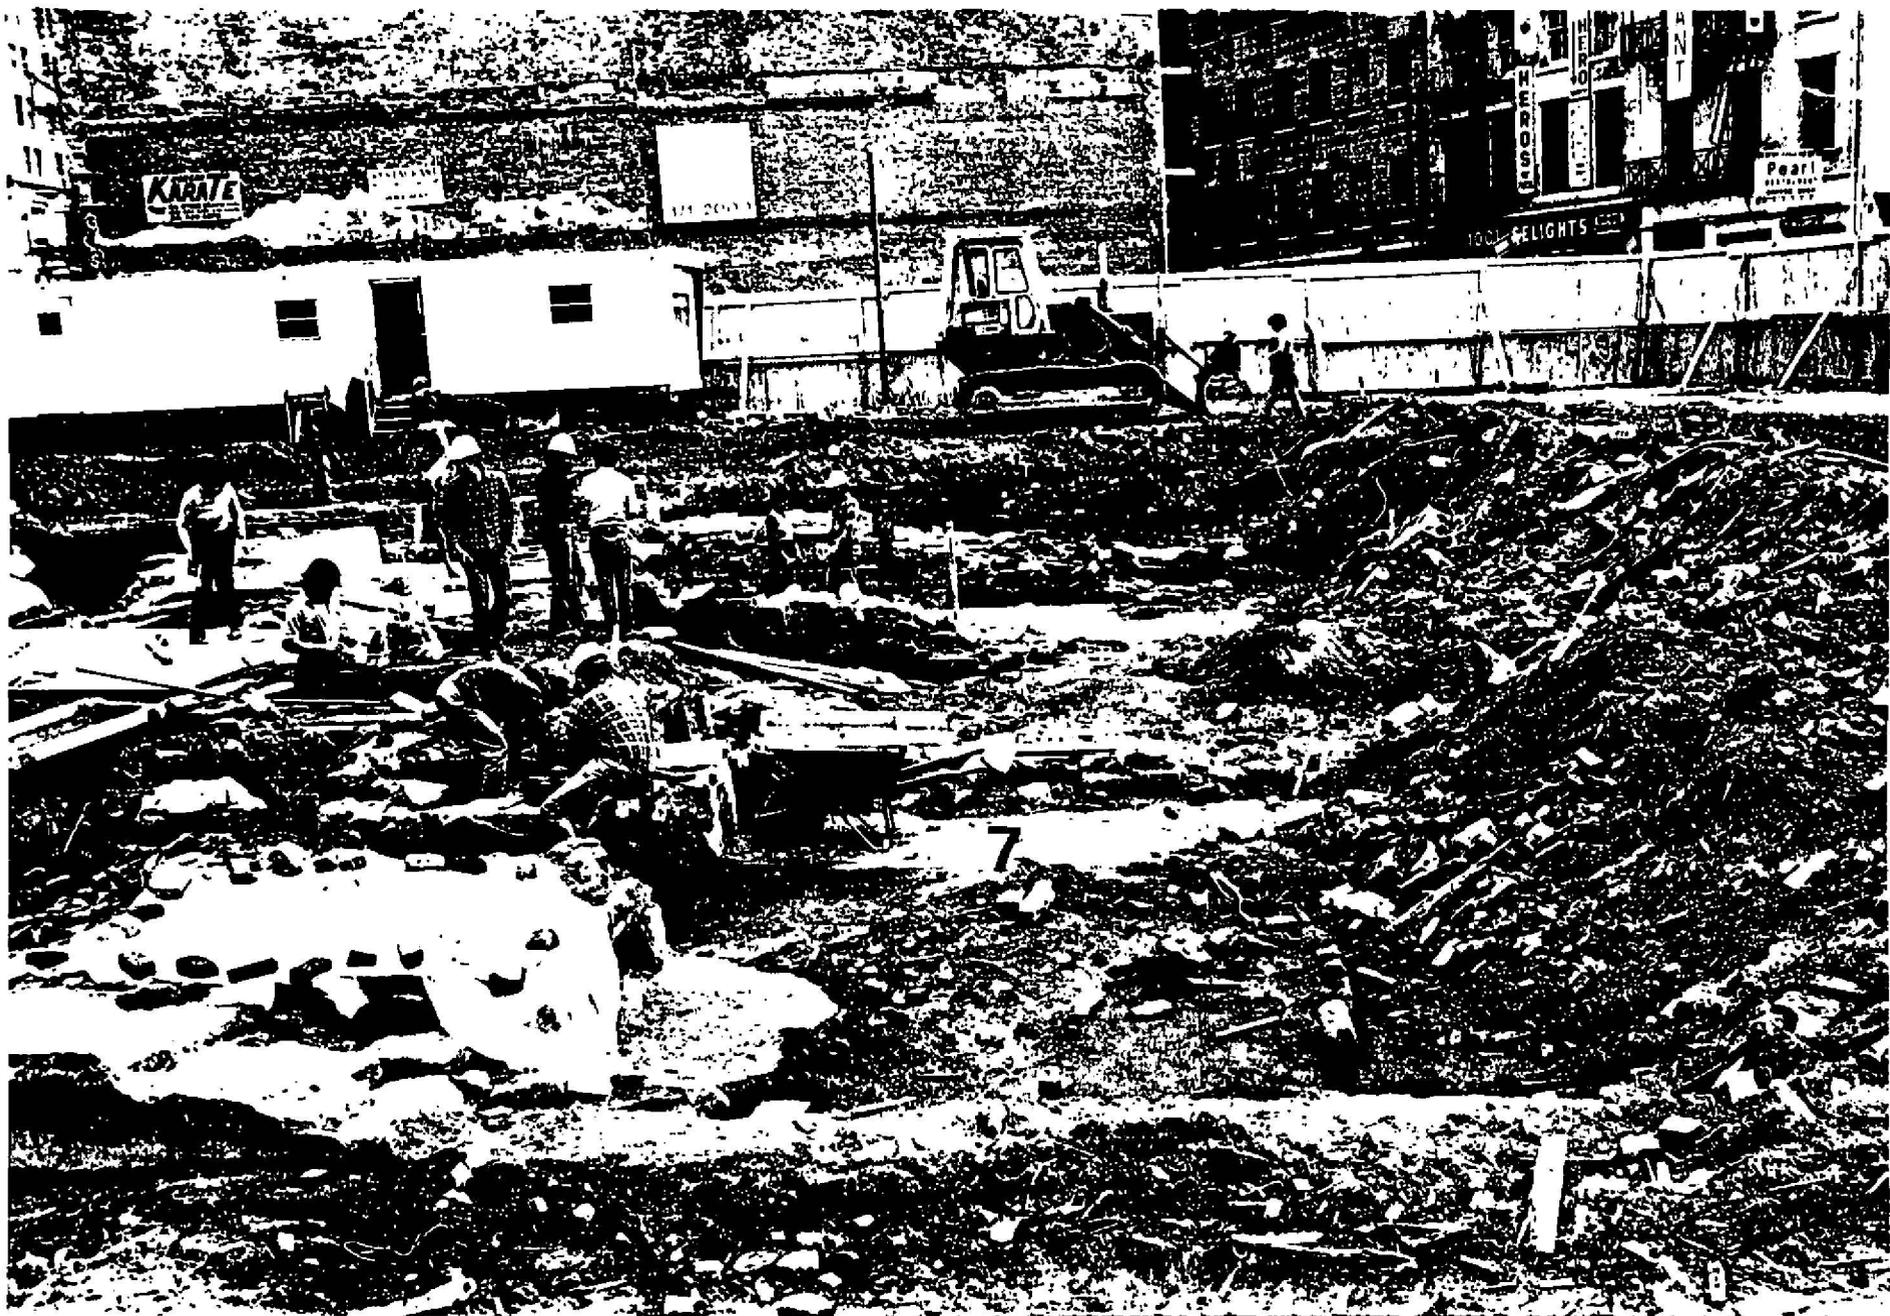
Dutch State House Site, looking east at the Pearl Street lots
Photo by Mary B. Dierickx 10/79

MATERIAL stone, covered in concrete in patches, and some brick, including the small yellow brick which might be Dutch brick. The brick matches Albany-area yellow brick in size. (Frank Matero, State House Site consultation, 1980, see NY State reports on Fort Crailo and the Van Rensselaer House)

DATE The presence of reused materials (the brick) in the wall implies that this was not one of the first walls built in New York. The method of construction is traditional, and there is not enough evidence to determine whether the wall dates from the 17th, 18th or 19th

MATERIAL stone, and brick on the south end. The yellow, possibly Dutch brick is also incorporated in this wall. One size of the red brick on the south end is $7\frac{1}{2}$ "x3 $7\frac{7}{8}$ "x2".

PLACEMENT two rectangular structures located at the back of the lot form the rear walls of lots 7 and 14. The rectangles are separated by about a 6' passage in the center of the lot.

NOTES -----
The easternmost wall contained a rectangular pit which might have been a chimney. The westernmost wall contained one half of a brick cistern, made of red brick with some yellow.

DATE There is not enough evidence to date this wall. From its placement, it might have been an earlier (before the 19th century) rear wall. A short stretch of stone wall abuts this wall and runs north, toward the east side.

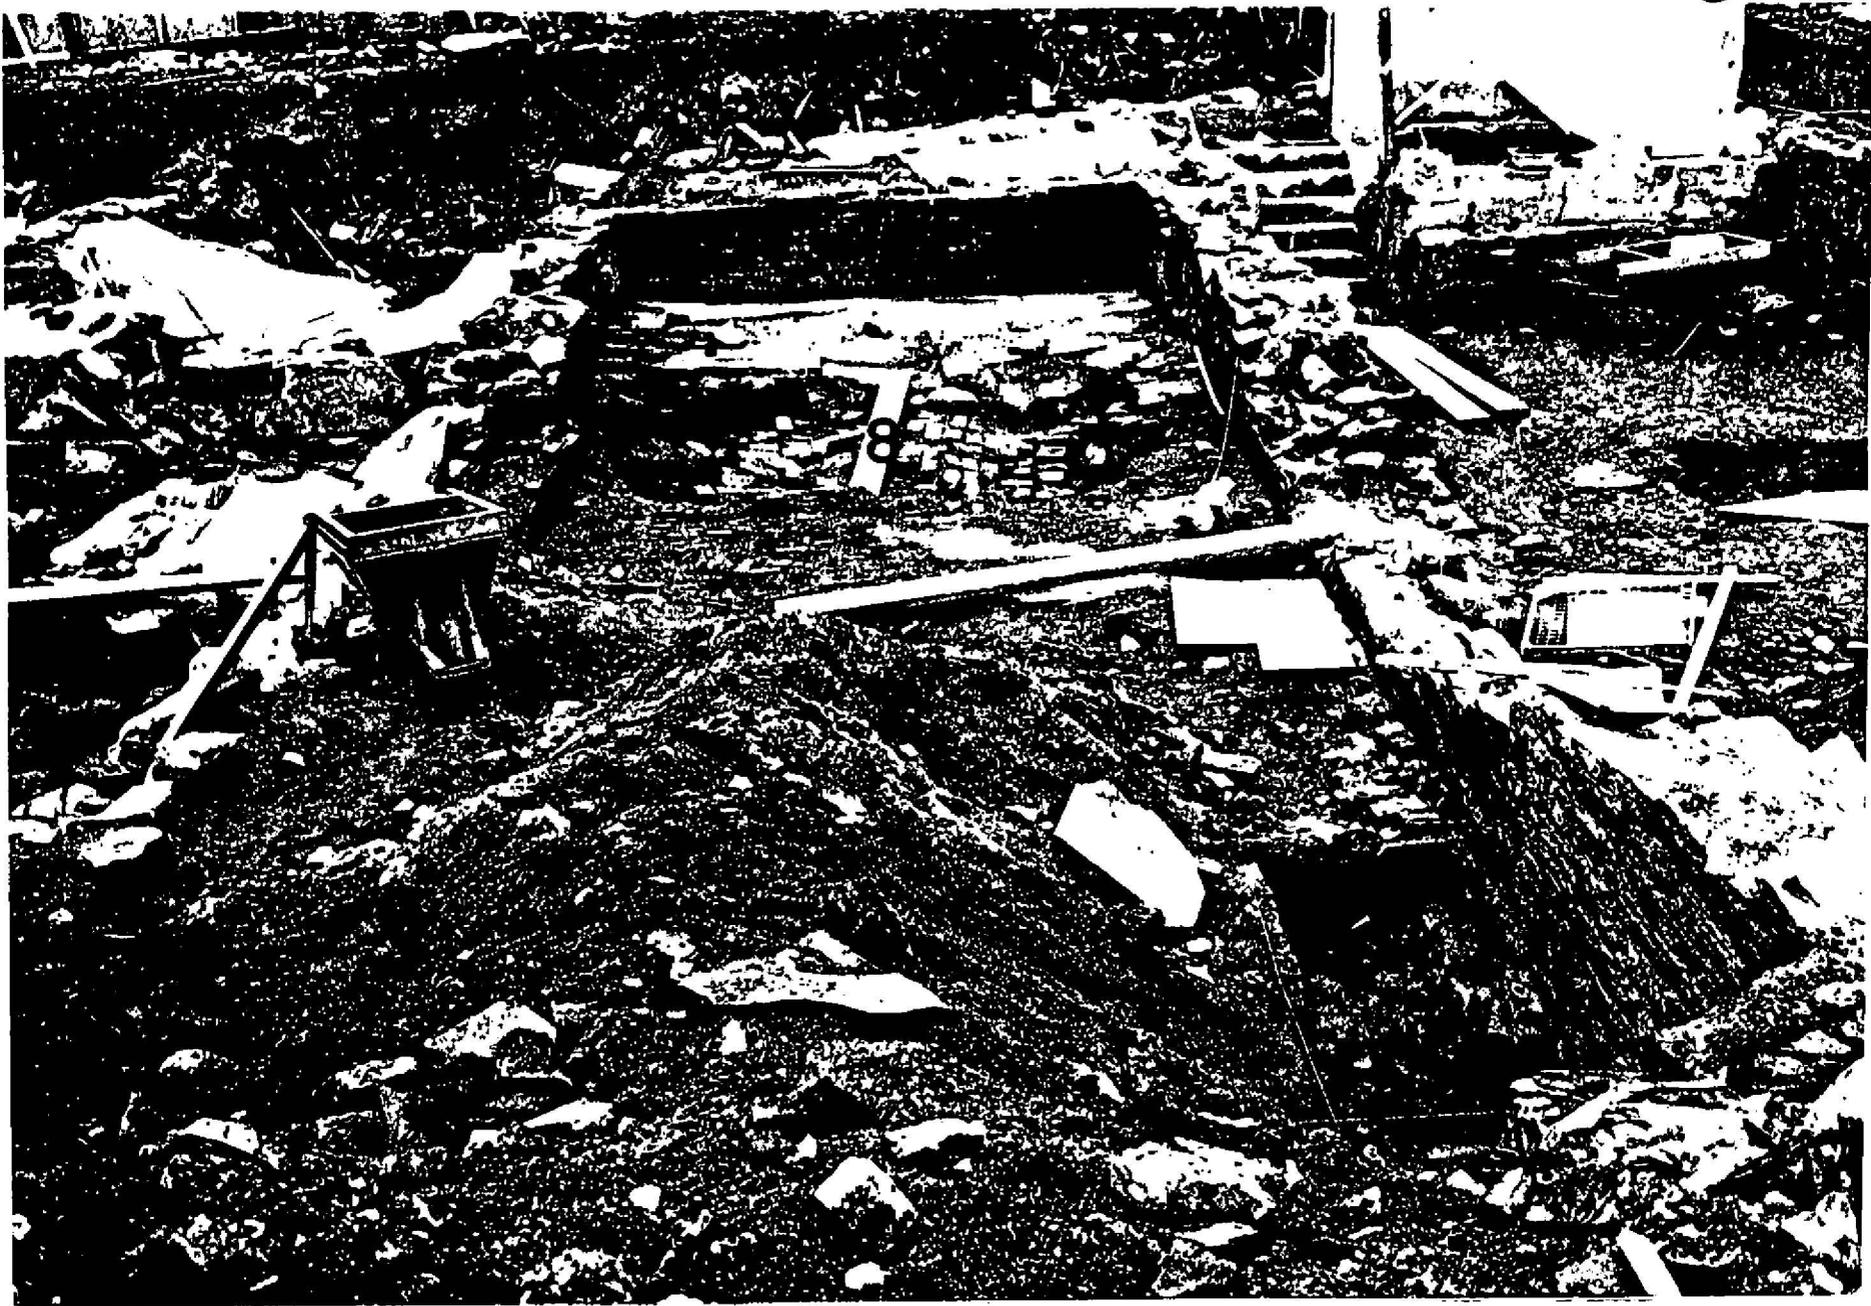
Dutch State House Site, looking north, lot 8
Photo by Mary B. Dicrickx, 1/80

MATERIAL stone, and brick at north end
There is evidence of the reuse of building materials in this wall. There is a small amount of yellow brick mixed in with the stone.

CONSTRUCTION There is also a small amount of squared-off stone in the wall. It is much more finished than the rest of the stone, and might have been previously used on a wall where it could be seen.

TYPE -----
coursed rubble laid up in mortar, brick laid up in mortar at the north end. The mortar is largely disintegrated

MATERIAL stone and a patch of brick at the north end as well as a small patch of brick in the center, possibly used to create an even opening such as a door or window

DATE In 1867 there was a small yard in back of 67½/68 Pearl Street, according to the Dripps map. It is possible that this wall was constructed after that, when the building was extended to the end of the lot. However, the wall might have simply enclosed a yard at some point, which would show up as a yard on the Dripps map. The wall, with its even, regular bricks, is consistent with material and construction of this late date. It was

granite blocks, post-1820's, but probably
dating from the 19th century, were used
as fill in two places. The blocks were
laid on top of one another, several blocks
deep. Archaeological evidence suggests that
this filling was done after the 1930's.

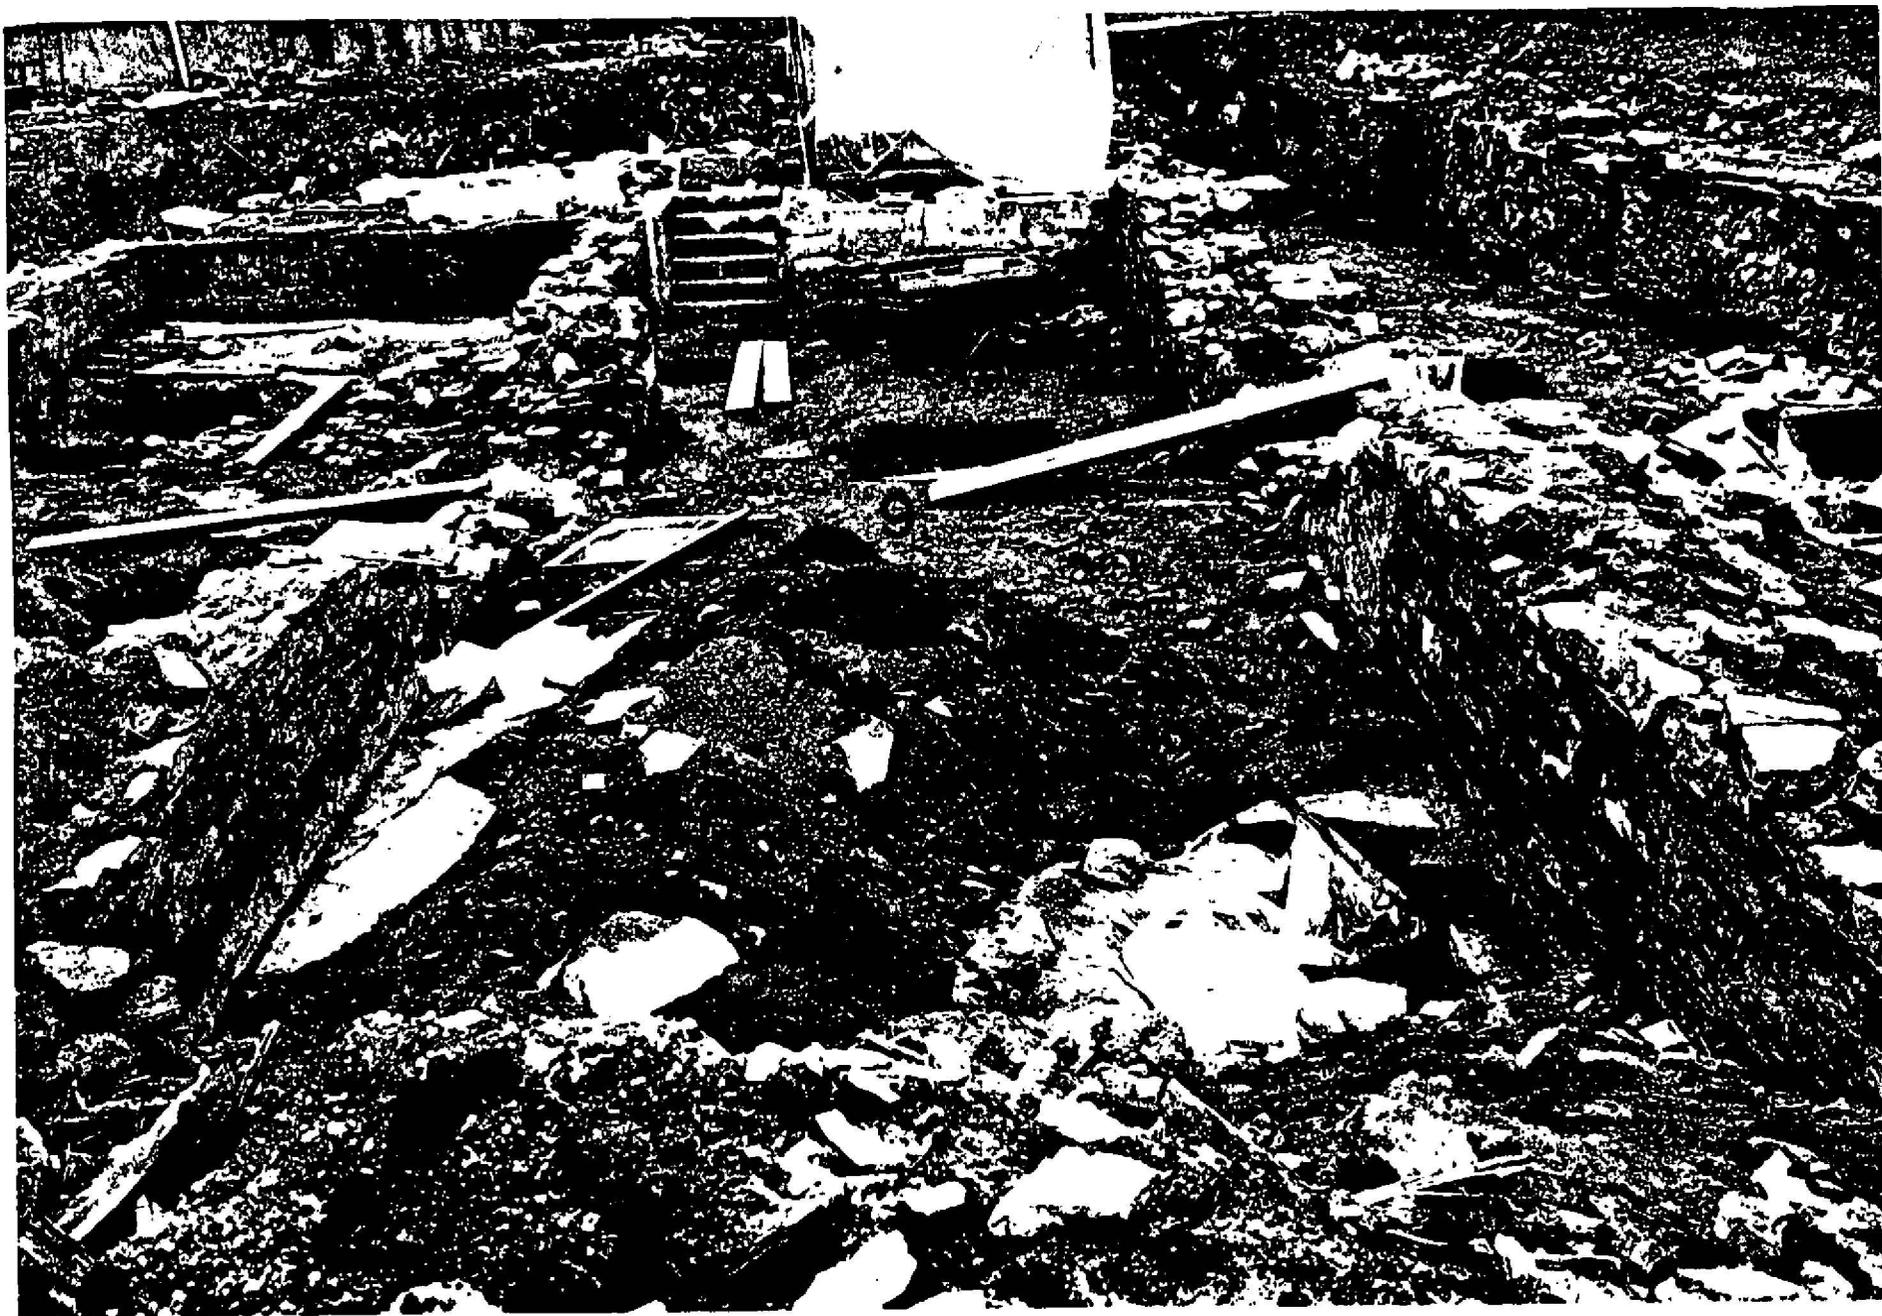
Dutch State House Site, looking north, lot 9
Photo by Mary B. Dierickx 1/80

MATERIAL stone. There are a very few pieces of tooled stone in this wall, indicating that at least the tooled pieces were previously used on the facade of another building - or somewhere where they would have been seen.

CONSTRUCTION coursed rubble laid up in mortar with some patches of brick, also laid up mortar - the mortar is badly disintegrated

NOTABLE ARCHITECTURAL FEATURES The brick patches indicate the presence of openings, either doors or windows, or of something else which might need an even and regular line.

NOTABLE ARCHITECTURAL FEATURES a flight of concrete steps on the west side, leading to a raised concrete-floored platform between lots 9 and 16. This was apparently the small yard for lot 9.

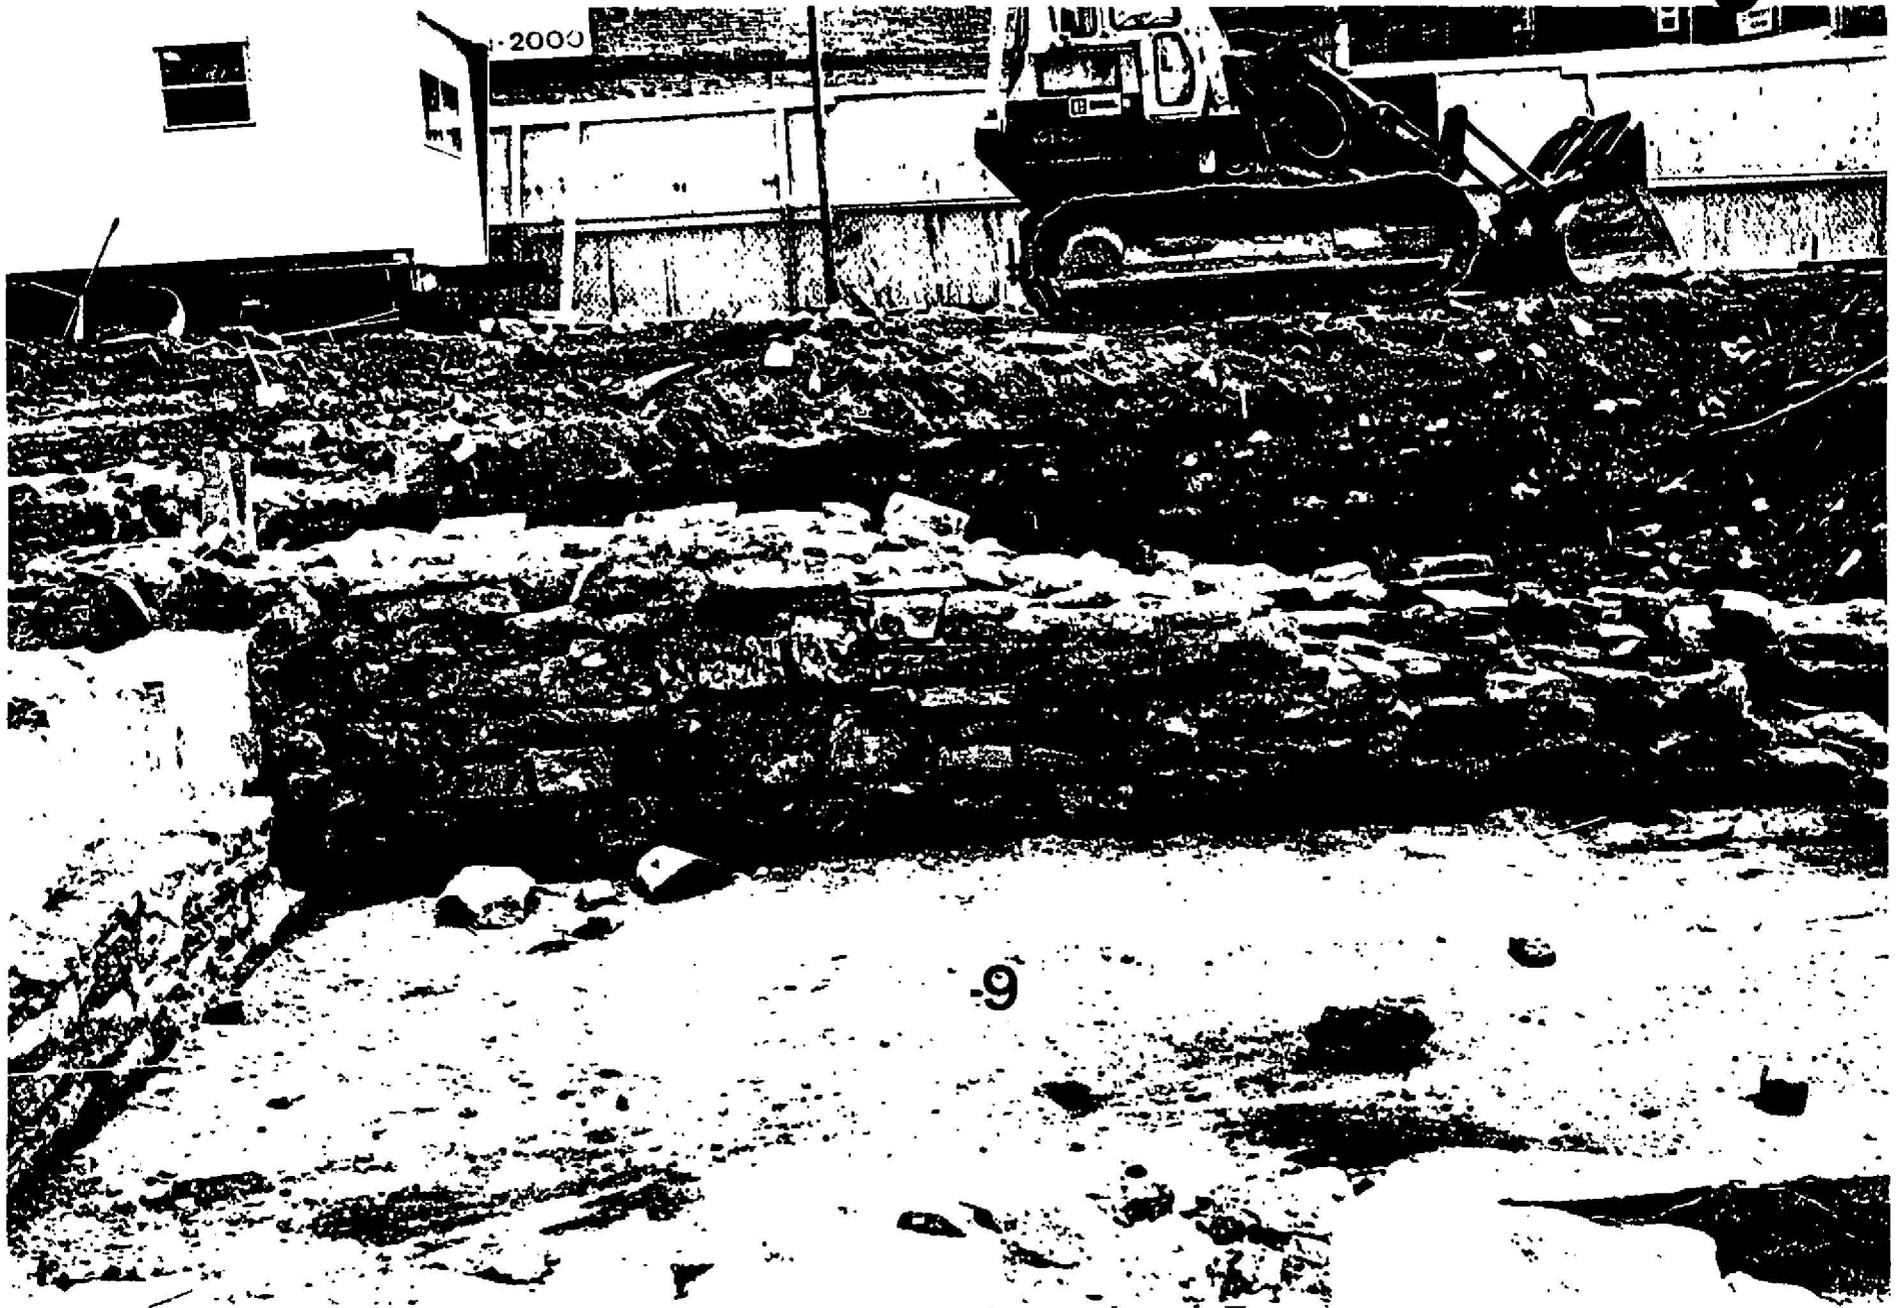
DATE #69 Pearl split into two lots (8 & 9) in 1829, according to tax records. It is possible that two buildings were built at about this time.

Dutch State House Site. looking east at east wall of lot 9
Photo by Mary B. Dierickx 10/79

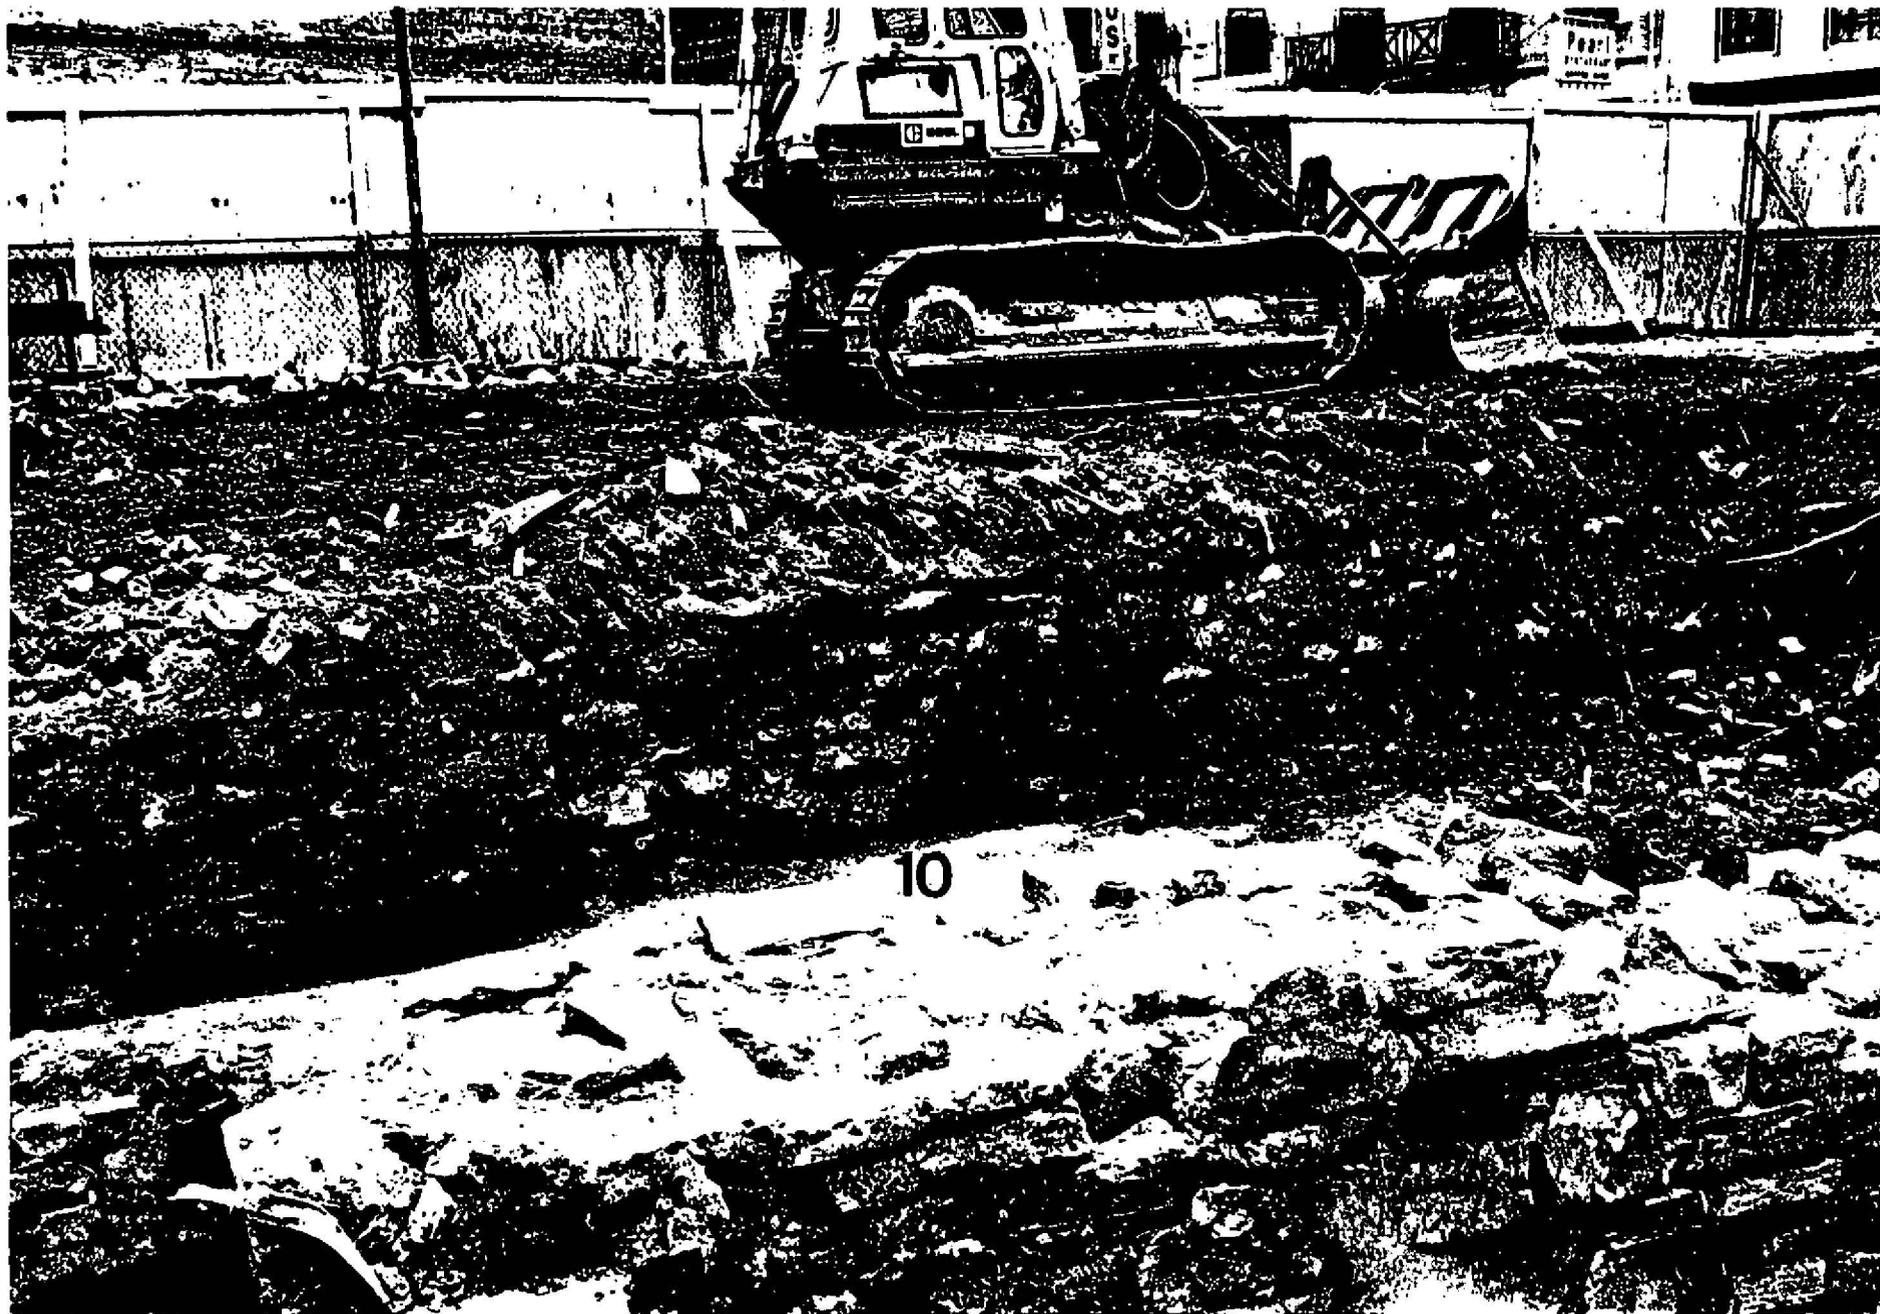
Dutch State House Site, looking east, lot 10 east wall
Photo by Gary B. Dierickx 10/79

MATERIAL stone - local stone such as diabate from the Palisades, available from the 17th century on. (Sidney Horenstein, State House Site consultation on stone, 1980) The wall was covered with concrete, or a concrete-like material, now partially eroded.

NOTABLE ARCHITECTURAL FEATURES A small window-sized hole was filled in (apparently at a later date) with stone. It is near the top of the wall at the north end. A vertical slot, at the north end toward the center, probably held a piece of wood, perhaps to level the wall or for a partition. A row of bricks, in this same area, is tilted at a 45° angle and sits above a small cavity. There is not enough evidence to determine what it was.

constructed in 1826, after Pearl Street was widened and straightened (in 1825). The east and west stone foundation walls, therefore, were built before 1826. However, they might have been constructed earlier, to be reused in 1826. There is no hard evidence to date the walls further.

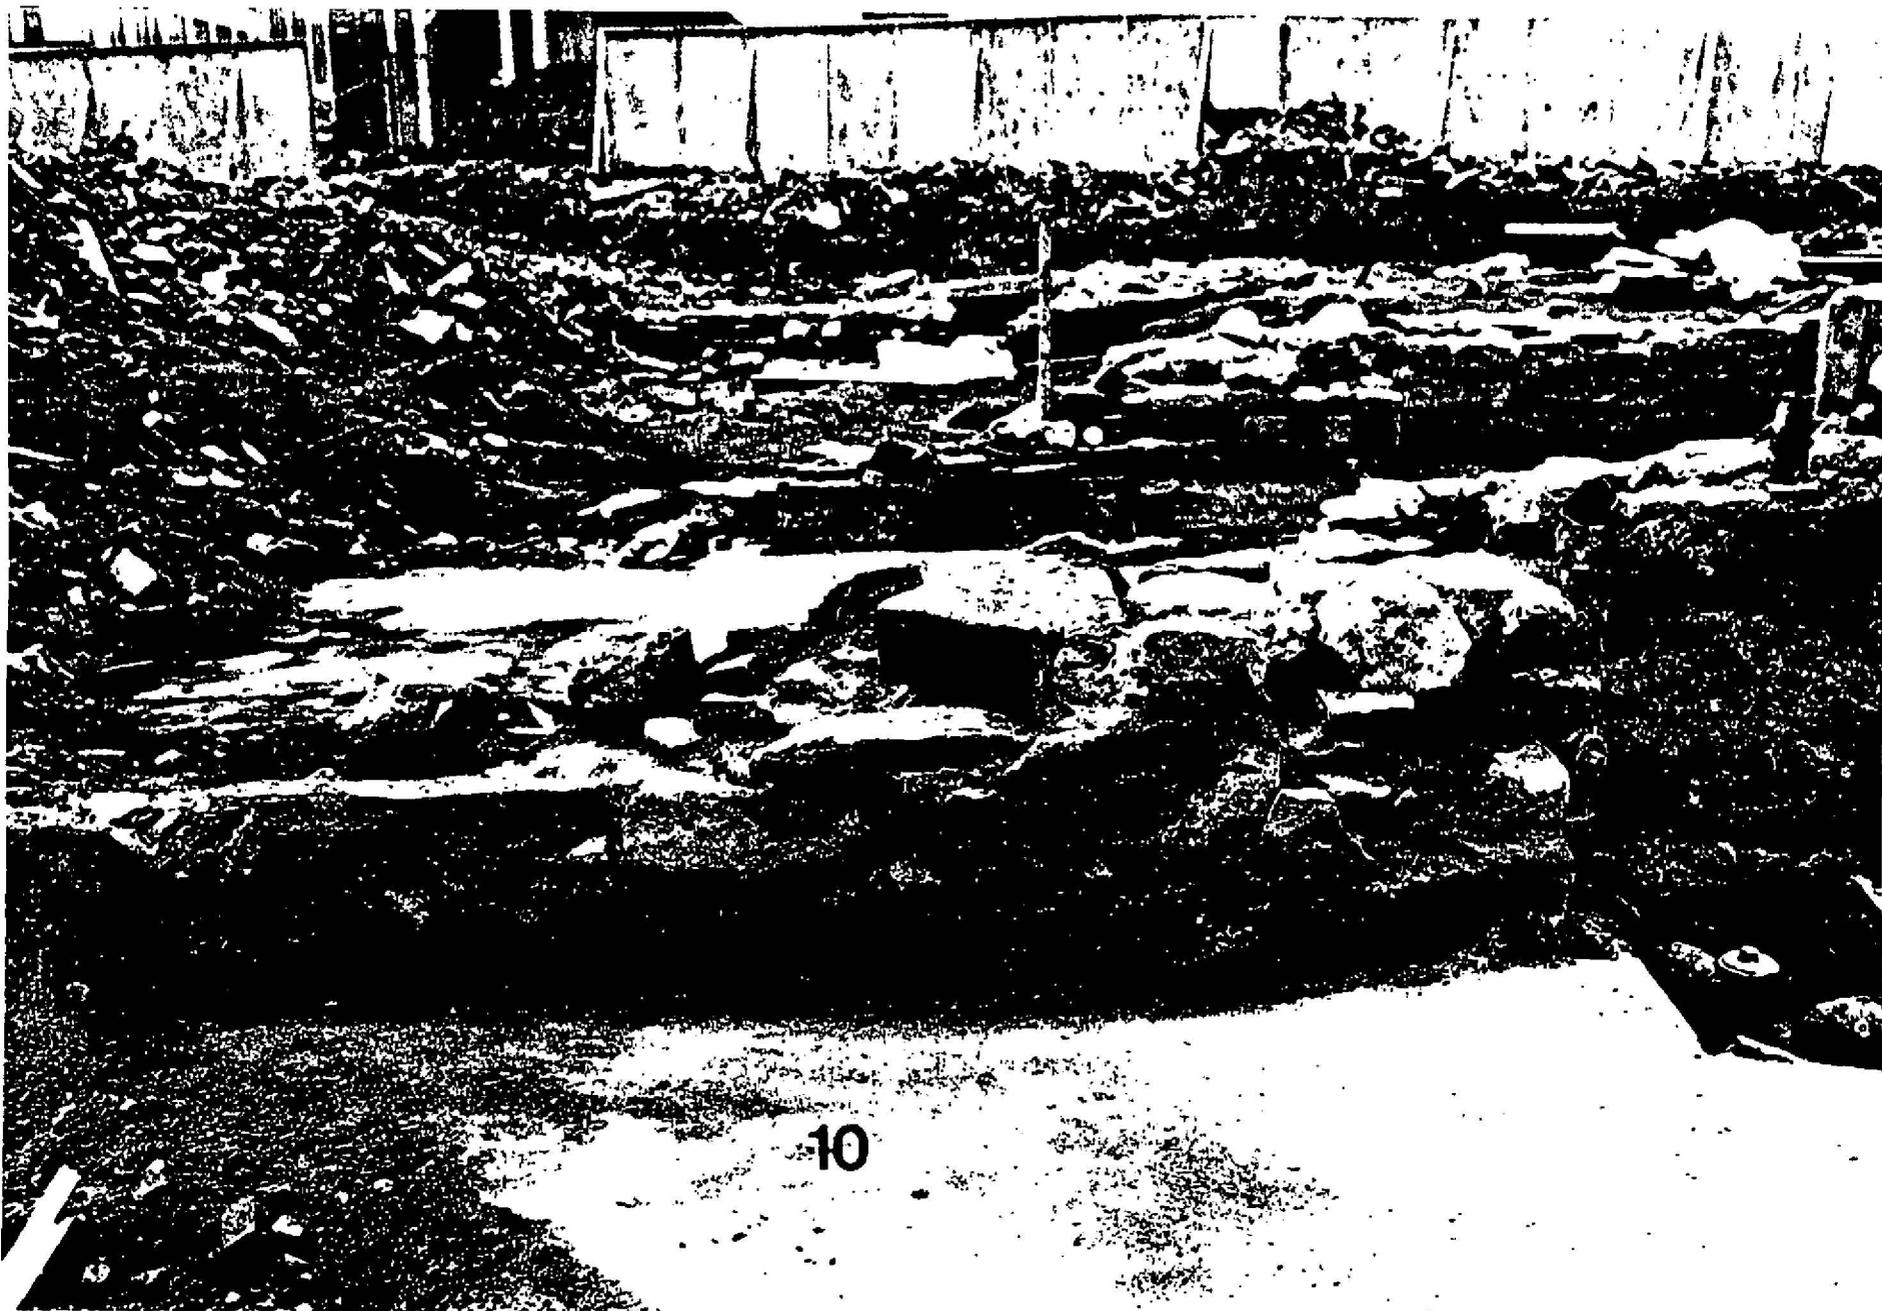
Dutch State House Site, looking west, lot 10 west wall
Photo by Mary B. Dierickx 10/79

MATERIAL stone - local stone such as Manhattan schist, glacial boulder, brownstone, available from the 17th century on. (Sidney Horenstein, State House Site consultation on stone, 1980).
CONSTRUCTION There is dressed and tooled stone in the wall, indicating that at least that stone had been used previously on another building. The wall was patched with concrete or a concrete-like material.

NOTABLE ARCHITECTURAL FEATURES There is a square pit on the south side which could be a chimney

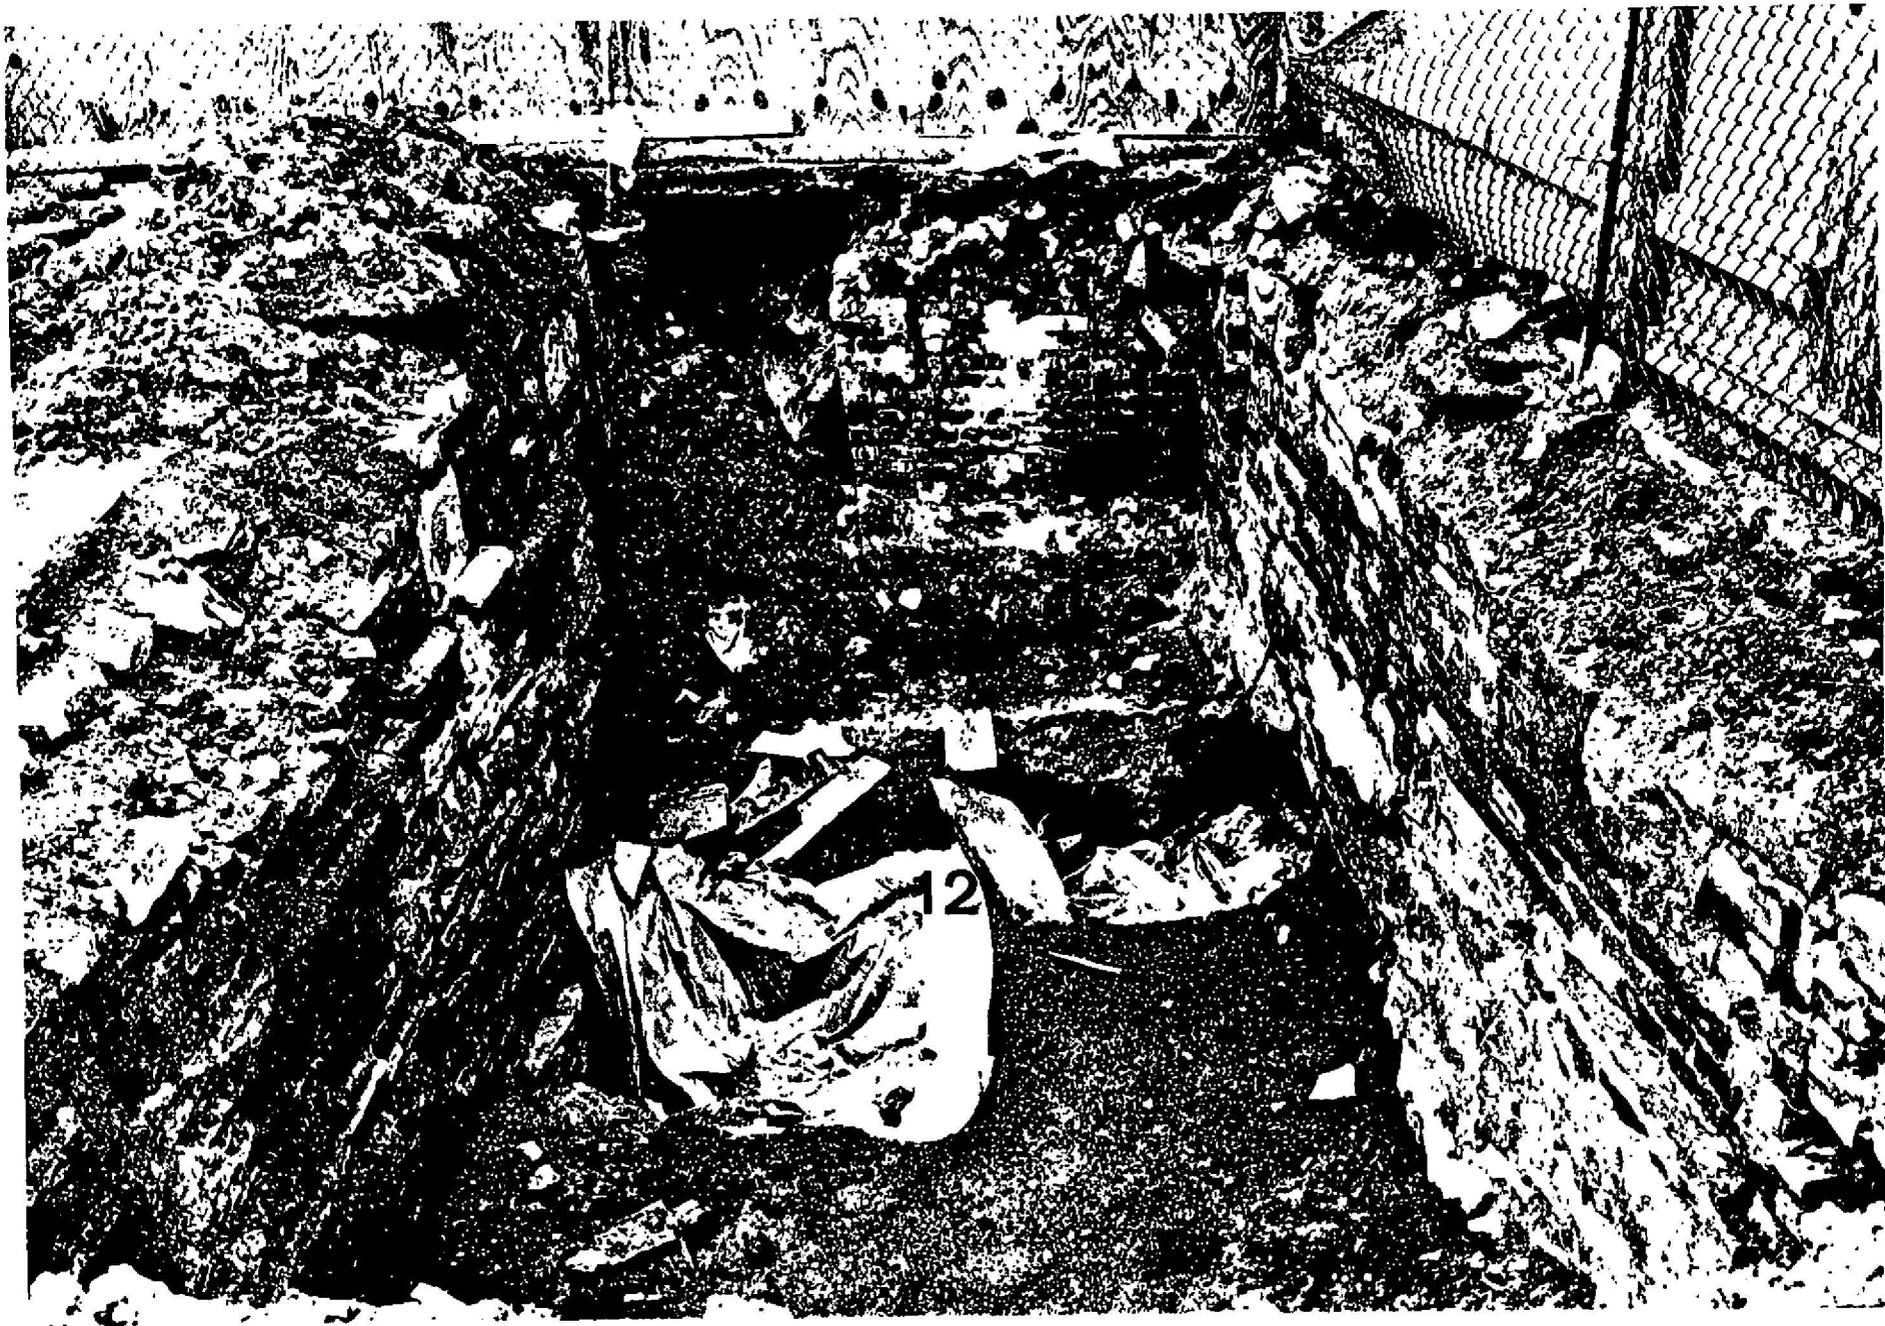
Dutch State House Site, looking west, lot 12
Photo by Gary B. Dierickx 1/80

NOTABLE ARCHITECTURAL FEATURES the south half of the wall contains an even, rectangular opening, perhaps a door or window

DATE There was a 1907 brick 1 story structure
on the site, and the Building Department's
New Building form for the structure details
2' thick stone foundation walls. From the

NOTES thickness and material, it is likely that the
walls were built at an earlier date and reused
by the architect of the 1907 structure.
