STADT HUYS BLOCK
ARCHITECTURAL ANALYSIS

PREPARED BY
MARY B. DIERICKX

JUNE, 1981

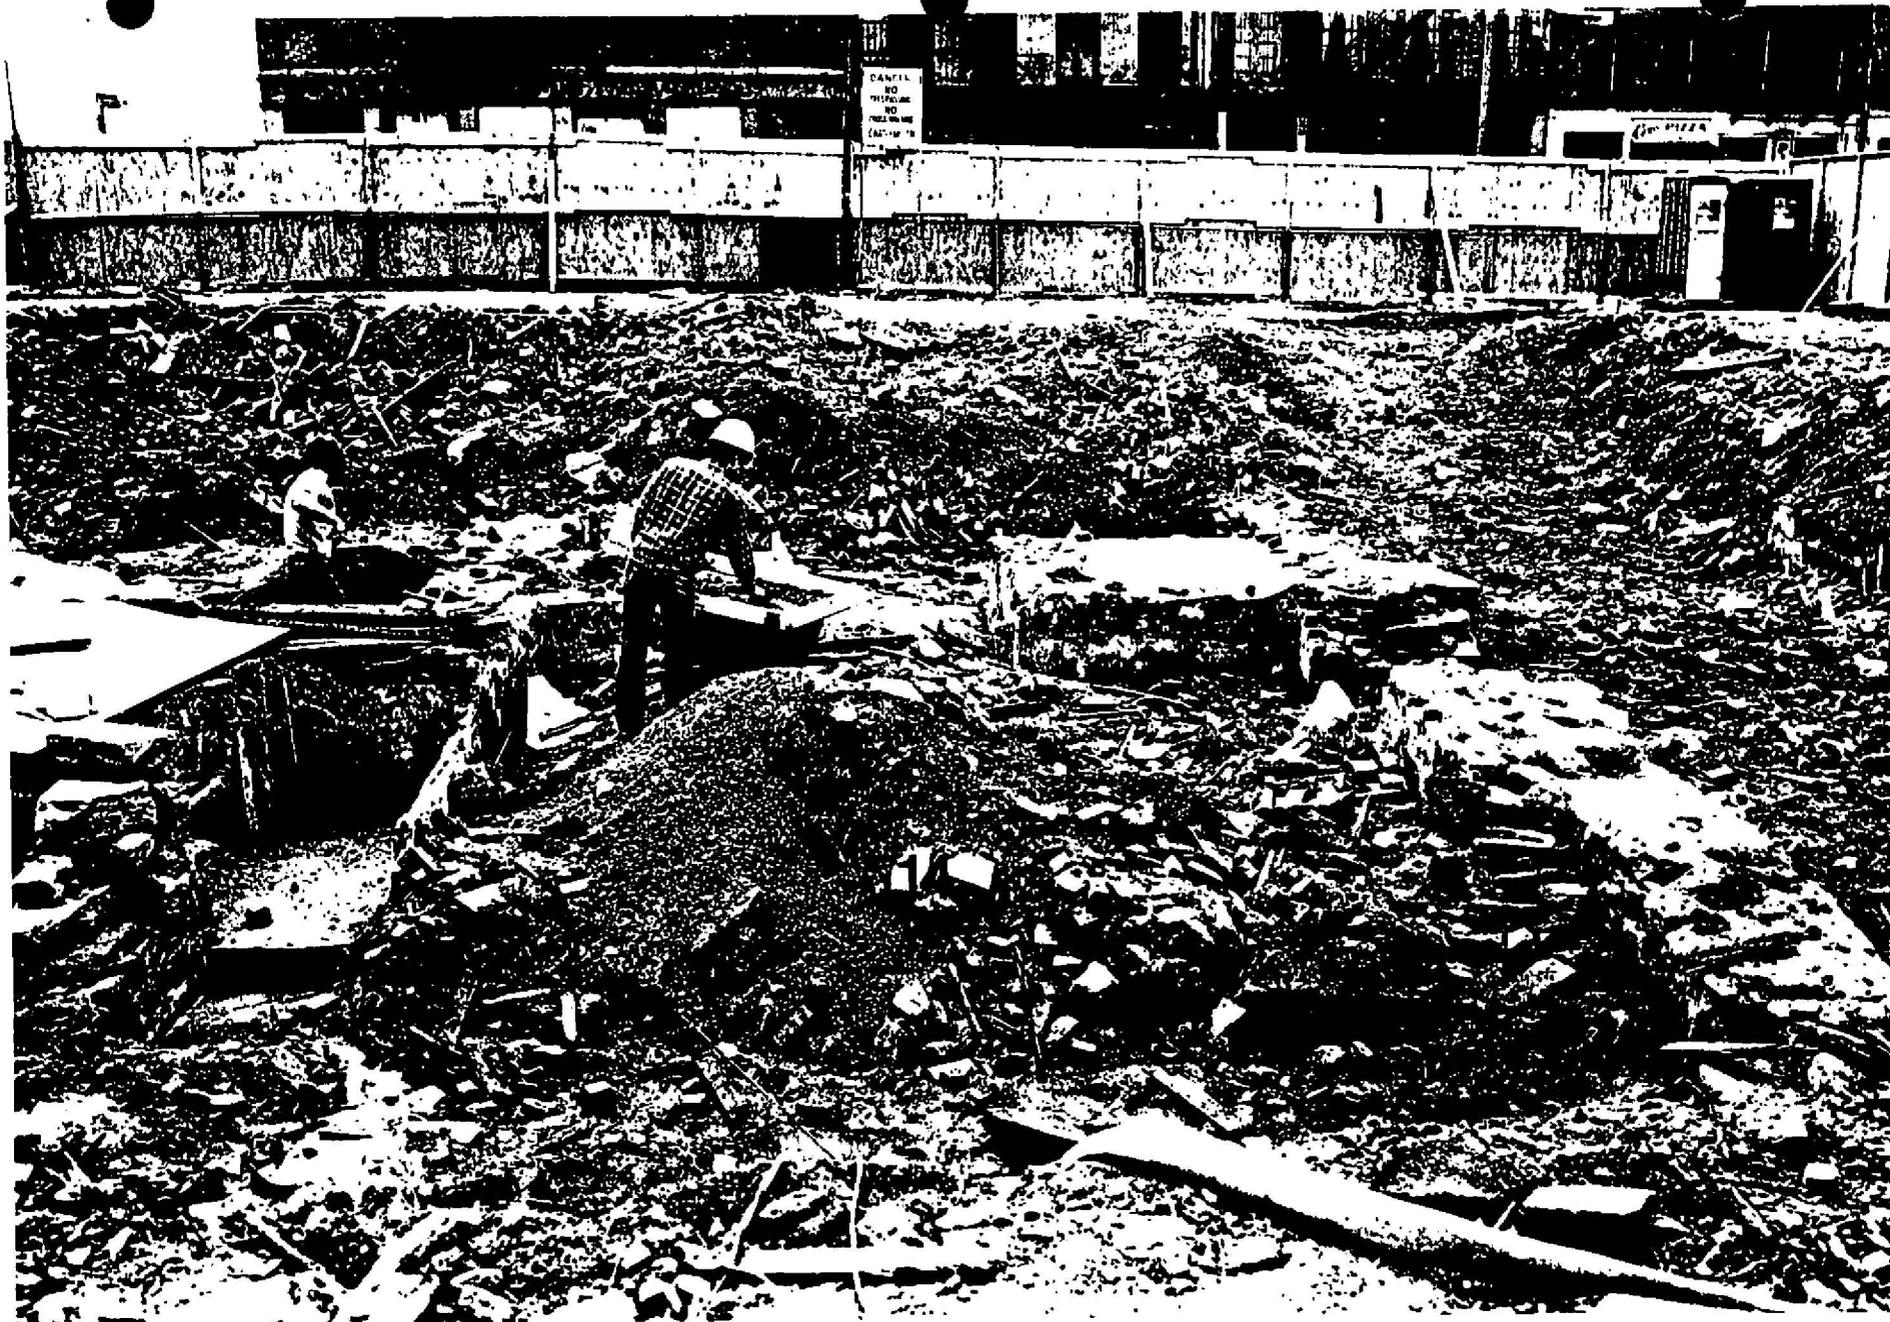
Dutch State House Site, looking south, lot 14
Photo by Mary B. Dierickx 10/79

MATERIAL concrete and concrete-covered stone

NOTABLE ARCHITECTURAL FEATURES there is a small room on the east side, about 4' x 6' with plumbing - probably a toilet

DATE There is not enough evidence to date the wall. It appears that the last building on the site was a handsome 3 story brick-faced structure with a Flemish gable (see page 3). Stylistically, the building dates from the late 19th to early 20th centuries. The caption on the back of the above-mentioned 1920 photo stated that the building was over 100 years old (in 1920). From tax records, it looks as though a house was built on this lot

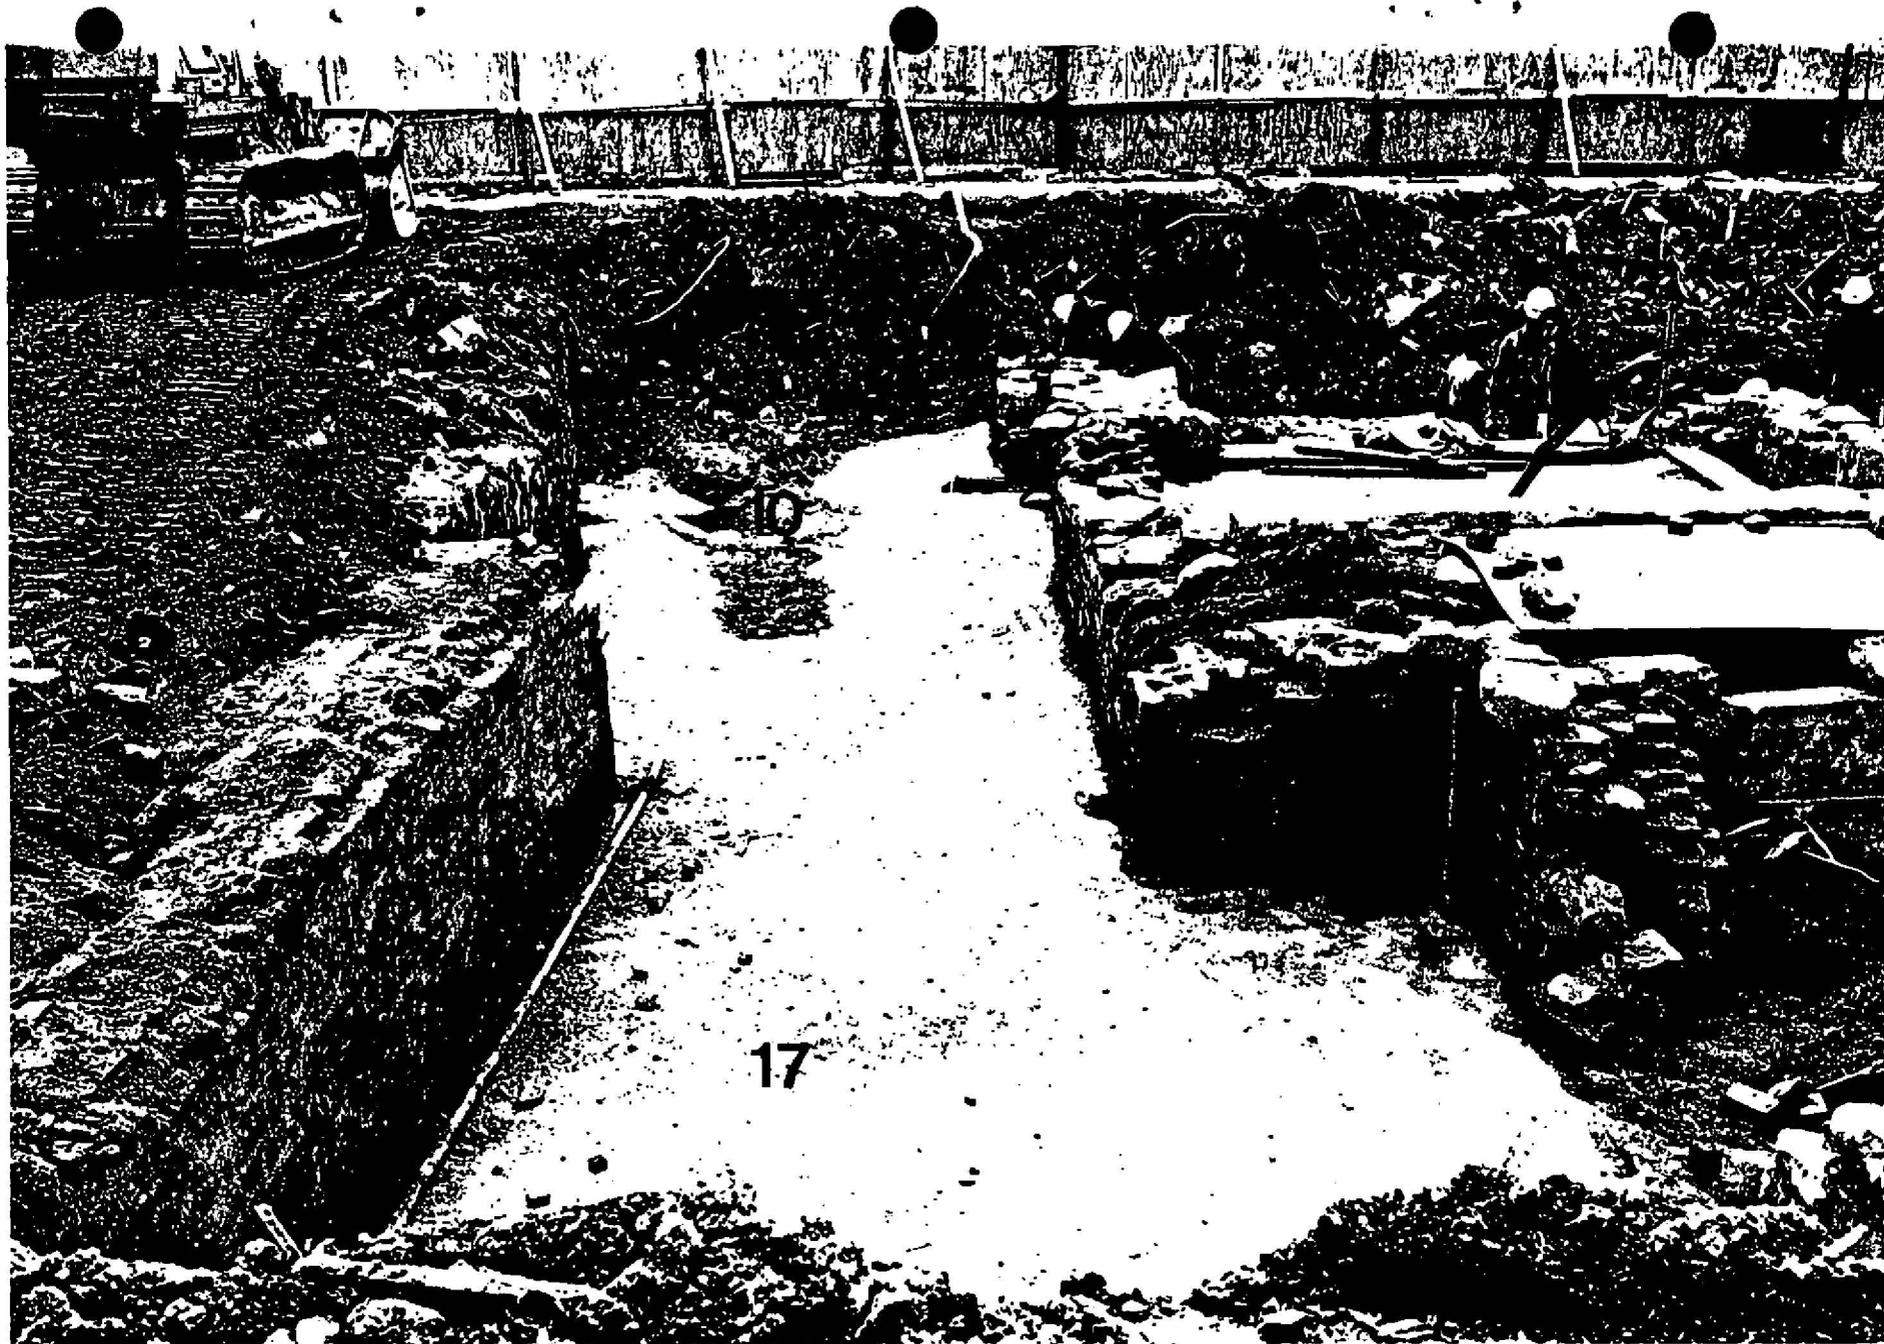
Dutch State House Site, looking south, lots 10, 17
Photo by Mary B. Dierickx 10/79

DATE The wall's construction and material provide no solid evidence for dating this wall.

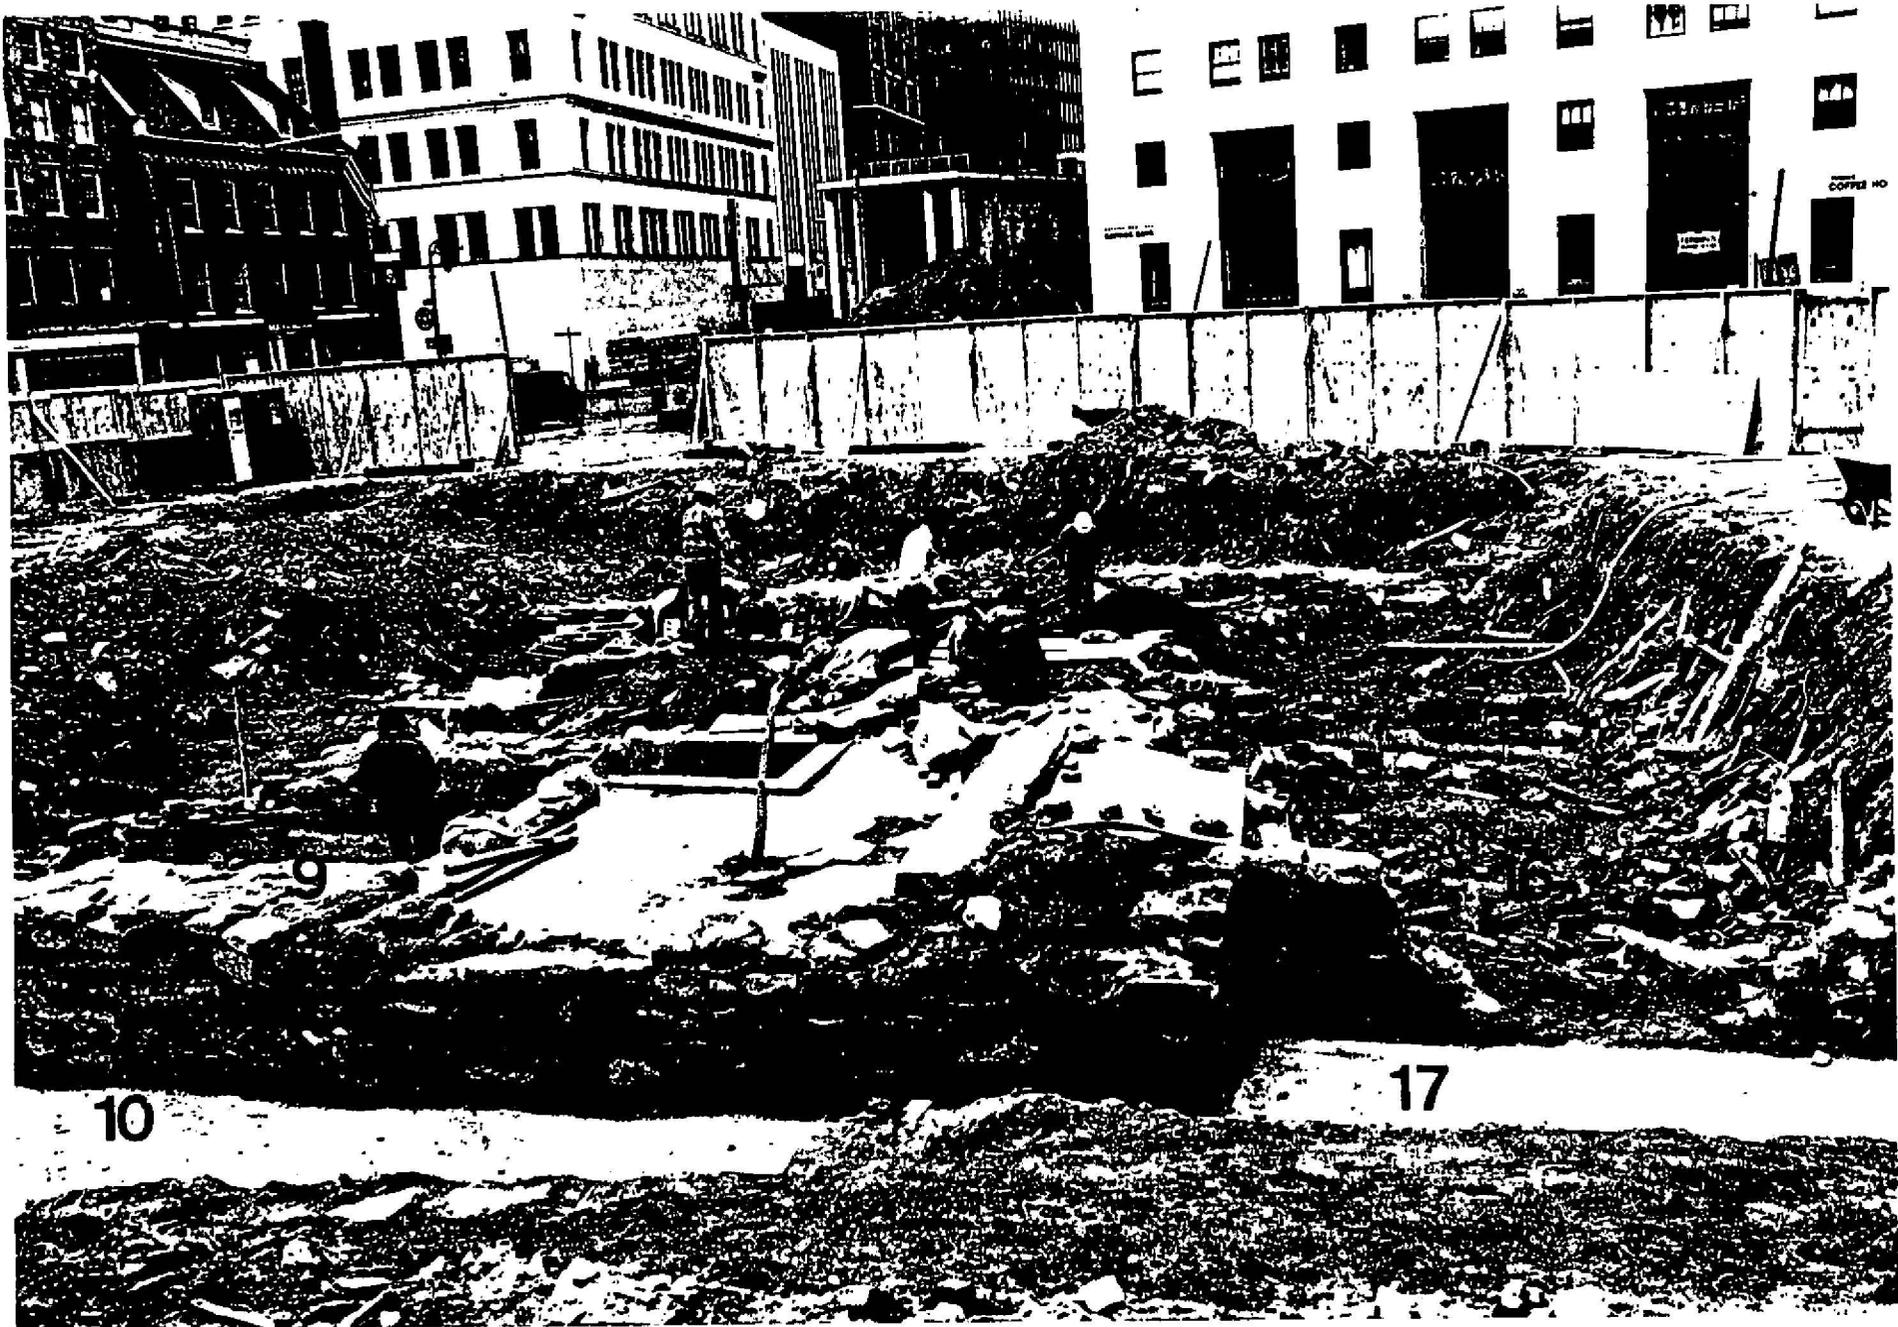
Dutch State House Site, looking west at the west walls of lots 10,17
Photo by Mary E. Dierickx 10/79
