Joan H. Geismar, Ph.D. Archaeologist

February 20, 2002

Re: Block 1770, Lot 49 (160 East 122 Street), Manhattan: Letter Report on Field Findings

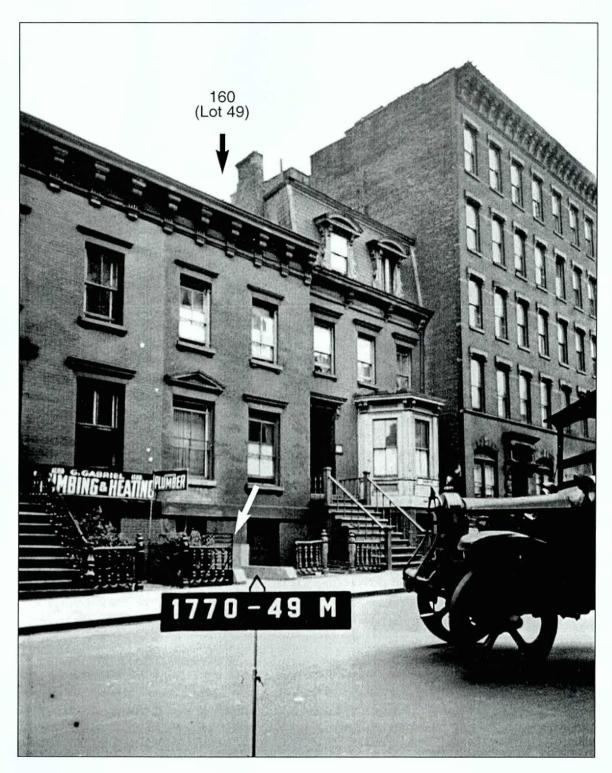
As outlined in the work plan, all tests were to be taken to sterile soil, but, as it turned out, bedrock was reached in most cases. Bedrock, which was found to slope up to the north and east, was at its deepest in the southern part of Trench 1 (TR1) in the center of the yard where it was 8 feet below the ground surface (BGS). However, its depth varied: it was exposed just below the ground surface along the eastern property line and approximately 4 feet BGS in the northern part of the trenches, near the rear foundation wall of the former house structure on the lot. Its depth in this part of the yard would have accommodated only a half-basement under 160 East 122 Street and the 1940 tax photo shows this to be the case (see Figure 4).

4 Tax photo of 160 East 122 Street c. 1940. Note half basement (white arrow).

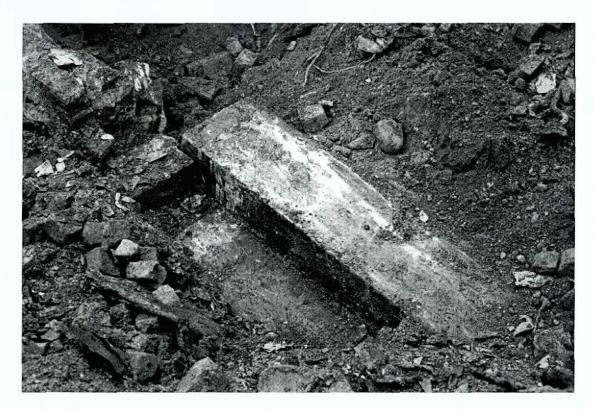
5 Stone steps exposed in southwest corner of Feature 1. (Geismar 2/12/02)

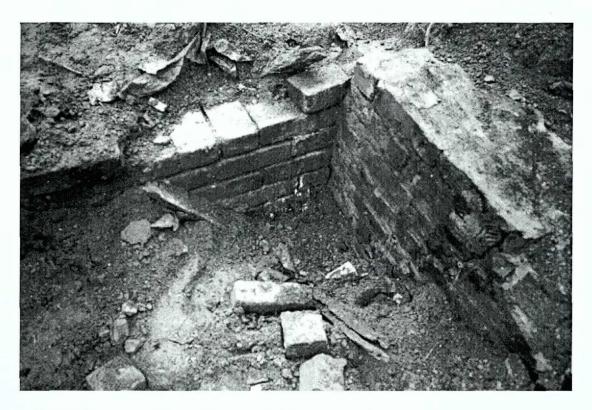
6 Exposed southeast corner of Feature 1 in TR2. Note that brick courses in the east wall (left) do not align with the feature's more crudely-made south wall (right). (Geismar 2/12/02)

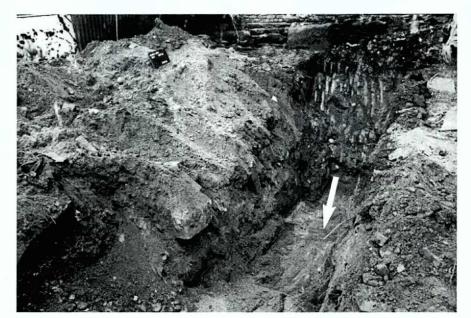
8 Trench 1, looking south toward back of yard. The deepest bedrock exposed during testing (arrow) was found in this trench. (Geismar 2/12/02)

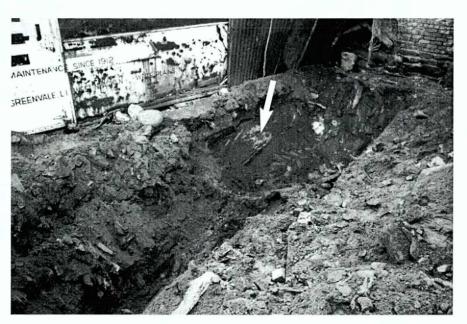
9 Trench 3 (TR3) along eastern edge of backyard. View is looking south. Note shallow bedrock (arrow) to the left. (Geismar 2/12/02)

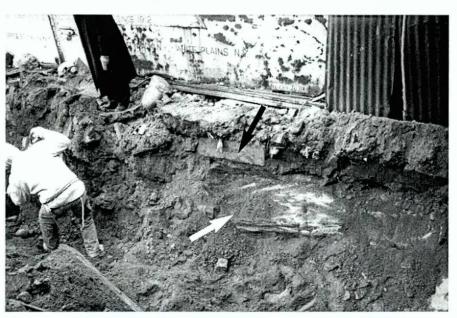
10 Same as above, looking slightly northeast. Note stone facing (black arrow) that was under a stone ledge in this part of the yeard. Also, note bedrock exposed under the dressed stone (white arrow). (Geismar 2/12/02)

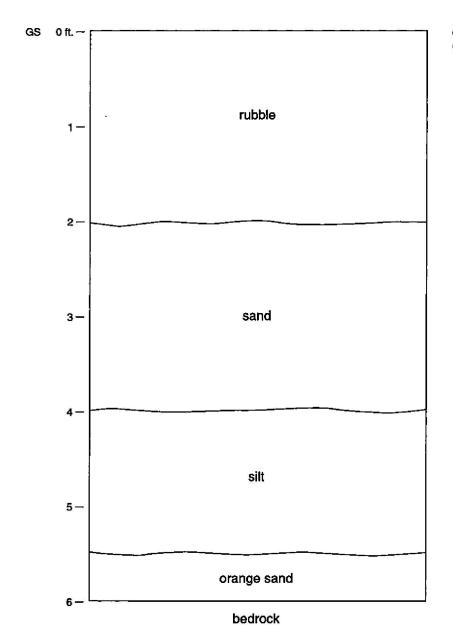
The three trenches were plotted (see Figure 3) and photographed (for example, Figures 8 - 10), but the excavations were far from photogenic. In addition, a schematic profile was made of a section of the east wall of TR1 (Figure 11). Testing was completed by 11:30 AM, and all trenches were backfilled.

ca. 8 ft. from back fence (southern property line)
