USP  
544m  
1994

**Grossman and Associates, Inc.**

**RE:** End of Field Report and Recommendations from the Presence and Absence  
Archaeological Test Results within Six Rear Lot Areas of the Police Service Area  
Facility 4 Project Site, New York, New York, CEQRA #: 94HPD302M.

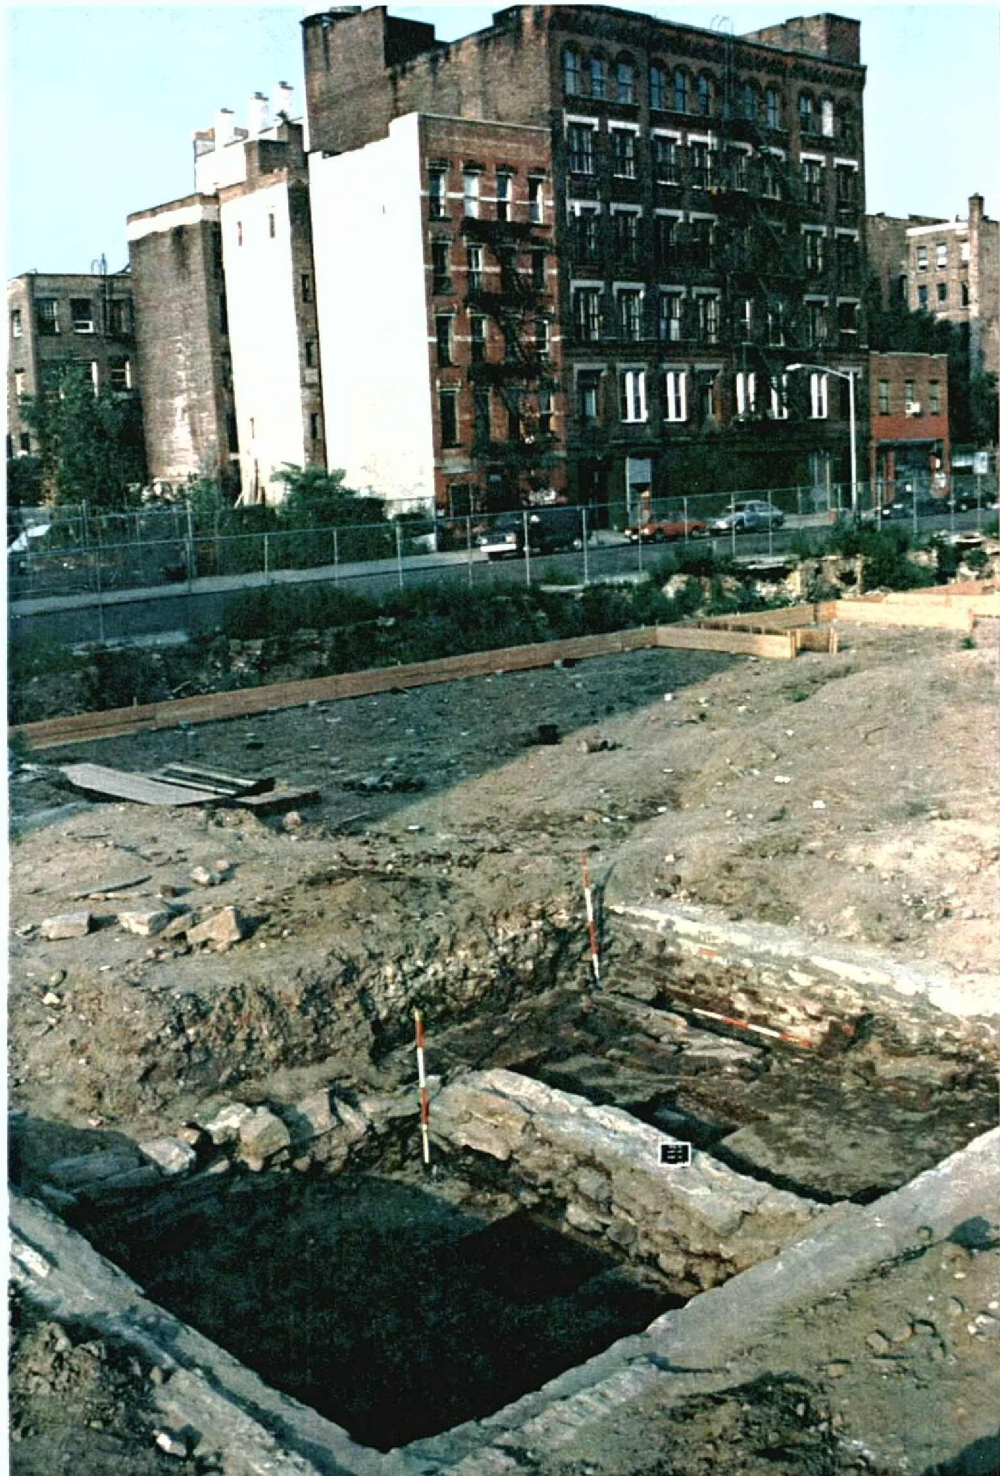
Lot 17 was one of the 2 lots out of the 6 tested found to contain surviving early 19th century structural remains in the form of a ca. 12 by 12 foot northeast corner wall section, which was capped and built over by poured cement and lot party walls at later date. The identification of this wall element was important because it demonstrated that the late 19th century maps and lot lines had changed significantly from those of the early 19th century building locations. The early stone wall corner section of Lot 17 was aligned north-south 8 to 12 feet west of the later cement lot walls. In other words, the archaeological evidence showed that the late 19th century map depictions were not consistent, or reflective of early 19th century conditions. Deep strata cuts to the south in Lot 55 and to the west in Lot 16 established that no rear yard elements, or surviving sections of the Lot 17 stone wall element existed to the south (Lot 55) or to the west (Lot 16).

The archaeological research potential and relative significance of the historic early 19th century stone wall corner section was investigated through the use of two, 3 by 3 foot, strata control units on either side of the north-south section of the stone wall. The purpose of these strata control tests was to establish three categories of information or criteria for evaluation: 1) the potential presence and stratigraphic integrity of an interior living surface within the stone wall corner section, 2) the presence and potential chronological utility of a possible builder's trench on the exterior of the wall of the building, which would, through the recovery of datable artifacts, document the date of construction, and 3) the potential presence and possible stratigraphic integrity of a living surface containing contemporary cultural materials, which would have dated to the time period of the stone wall construction. The tests unequivocally documented that none of these criteria or conditions were encountered or found to survive in association with the buried stone wall of Lot 17 (See Figure 1 and Figure 2).

**Figure 1:** General view looking northeast towards 9th Street showing historic stonewall in Lot 17 beneath more modern cement lot line parting walls.

Based on these lines of archaeological evidence and the level of data control established by the archaeological testing, it was recommended to LPC that, given the lack of an interior surface, the lack of a builder's trench, and the lack of an associated exterior living surface, no additional data recovery or mitigation work was warranted beyond the already completed graphic and photo documentation of the plan, profile, structural, and stratigraphic context of the stone wall and brick feature. Based on an on site conference call between Dr. Grossman and Mr. Pagano, all parties concurred that, aside from the plan and profile recordation of the stratigraphic context and structural characteristics of these elements within Lot 17, no additional data recovery activities were warranted, or should be recommended. All elements within Lot 17 were precision measured with a computer transit and photo documented. Once completed, this lot was also cleared verbally by LPC, and the Lot 17 exposure was filled and compacted as of 7:00 p.m. Wednesday, August 3, 1994.

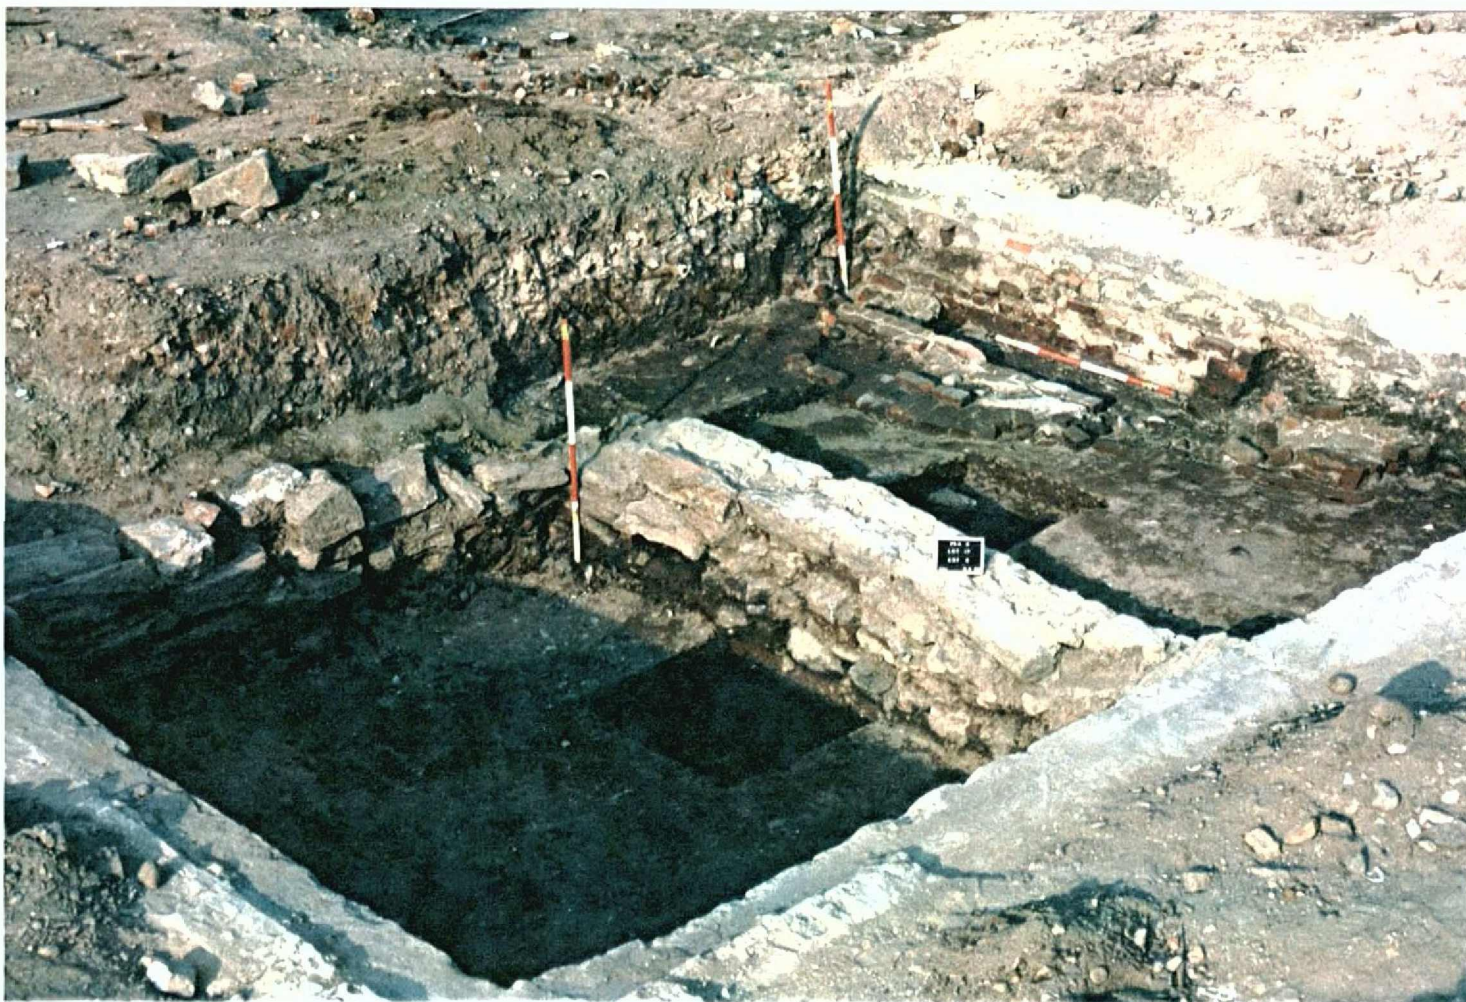
**Figure 2:** Detail of excavated and stratigraphically evaluated historic wall remains within the rear of Lot 17. Note the presence of a more recent brick and cement support structure (boiler base?) which post dates the earlier mid 19th century stone structural remains.

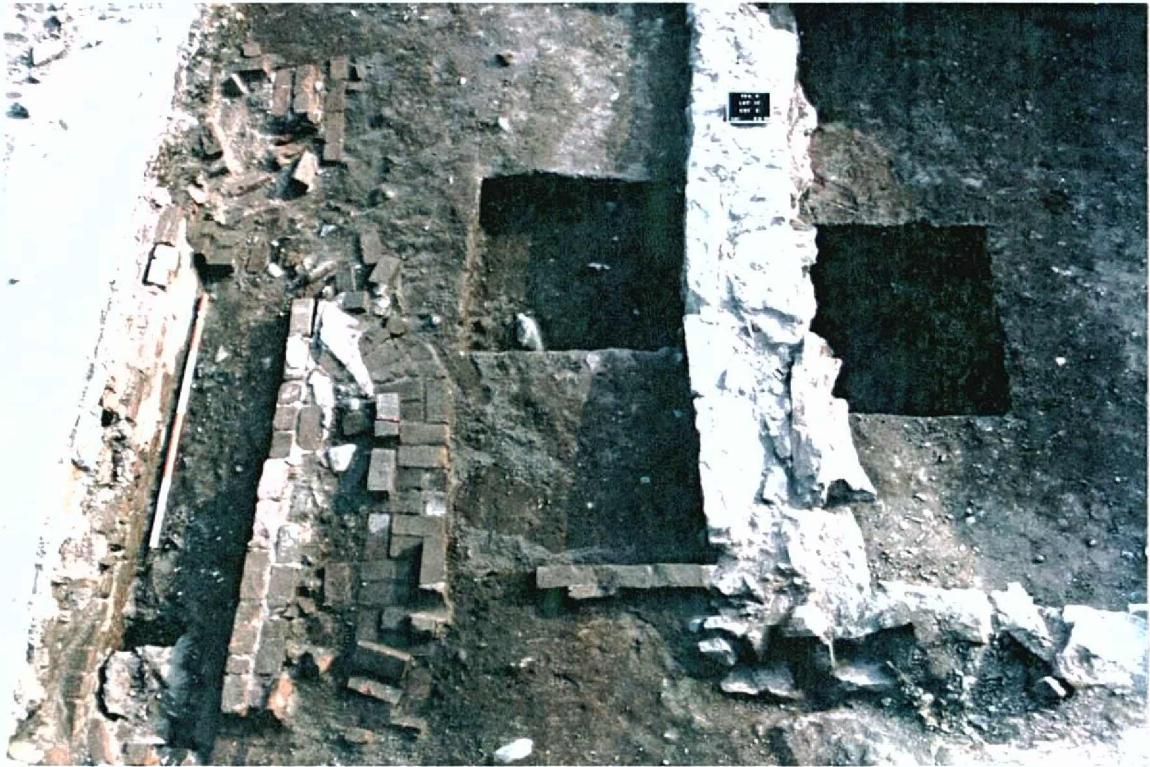
excavation of the interior strata control unit through the pre construction fill beneath the stone wall resulted in the recovery of a copper coin which was electrolytically cleaned and found to date to 1845. This chronological evidence and its stratigraphic position beneath the building establishes that both the fill and the subsequent stone wall construction were deposited, and built, after 1845. The only feature encountered within Lot 17 consisted of a rectangular brick and cement platform with a long basin, or trough down its center, which appeared, from its structural elements and the presence of a cement top, to significantly post date the era of the stone wall (see Figure 3 through Figure 6).

**Figure 3:** Overhead photo looking due south at Lot 17 showing the placement of two, 3 by 3 foot test units on either side of the early historic stone wall with an unassociated and later brick and cement feature to the left (east) of the stone wall.

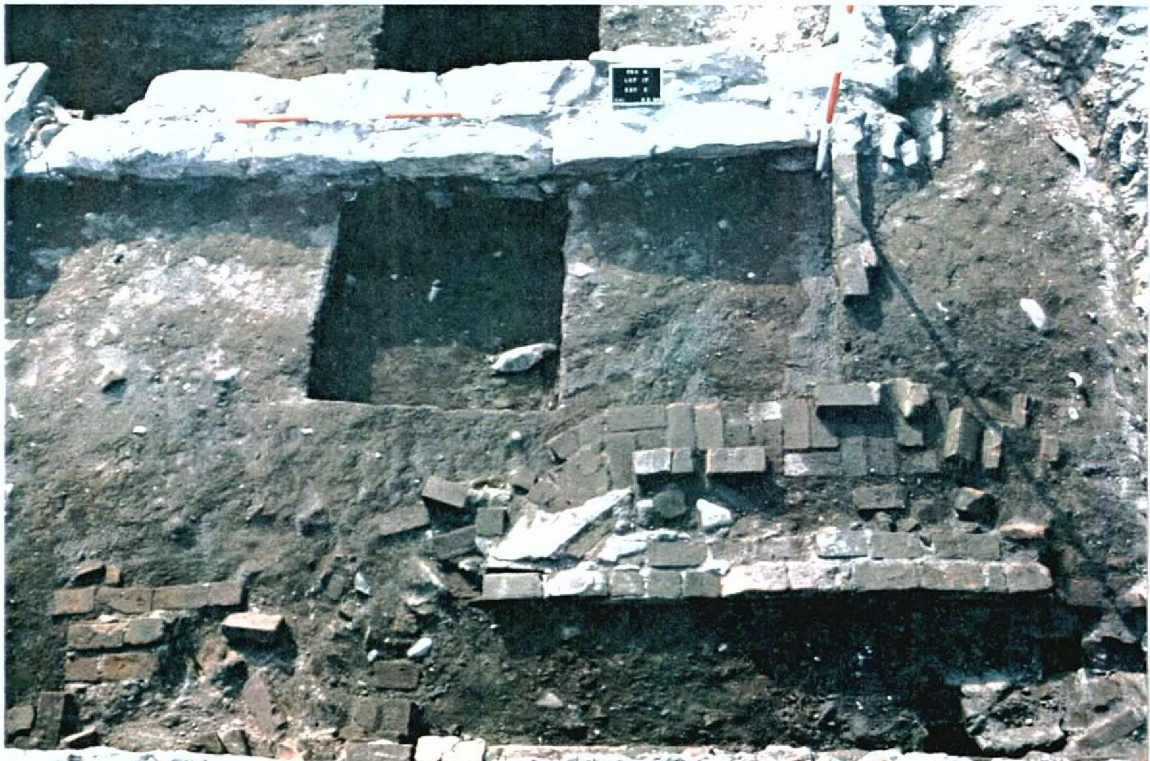
**Figure 4:** Overhead view of Lot 17 looking due west showing a historic stone wall at the top of the photo and a plan view of the rectangular brick and cement boiler base (?) feature with rubble fill in the interior.

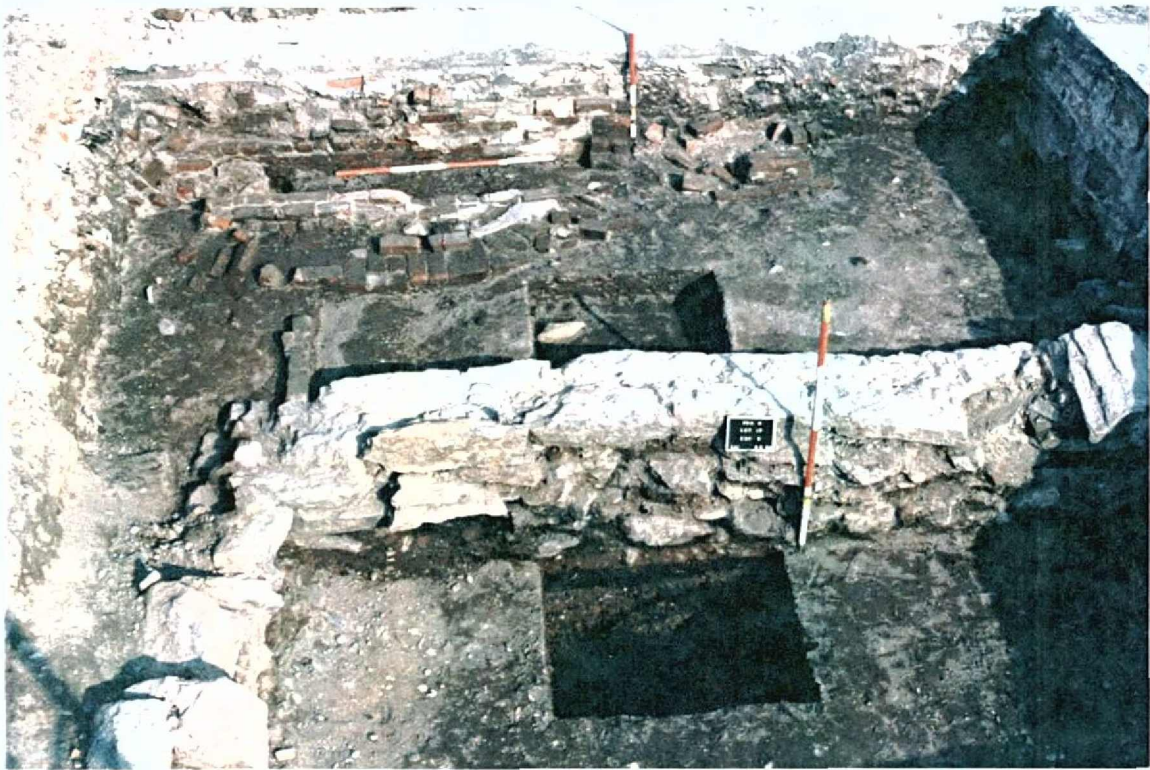
The interior strata control unit was excavated to depth of ca. 2.5 feet and exposed the presence of a laminated series of ash and soil fill layers, which pre-dated the construction of the stone wall, and documented the lack of a surviving interior living surface which was historically associated with the building and period of use of the stone wall. Likewise, the exterior strata control unit documented the lack of any builder's trench, and the lack of any well defined living surface associated with the stone wall. In addition to a large number of datable ceramic pipes, the

**Figure 5:** Detail looking east at the Lot 17 exposure showing a strata control unit on both interior and exterior of the historic stone wall.

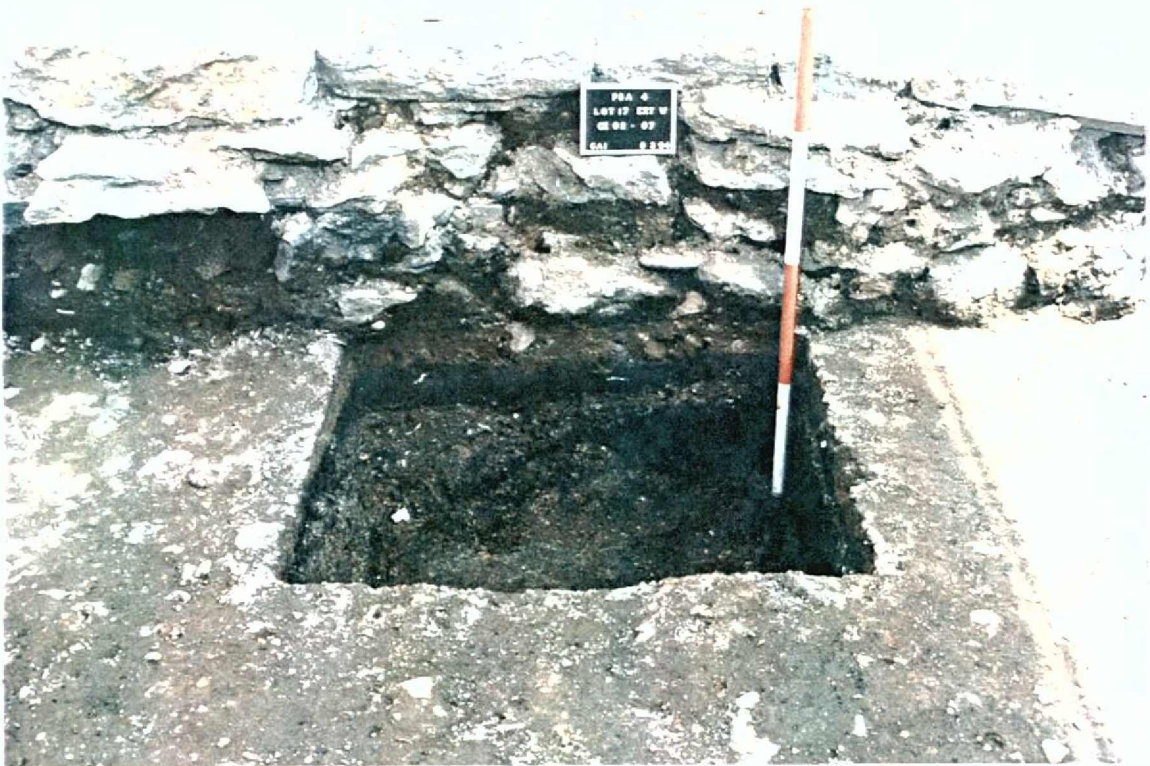
**Figure 6:** Detail looking east within Lot 17 showing the sequence of pre construction fill levels beneath the early 19th century stone wall which documented the lack of an intact floor.

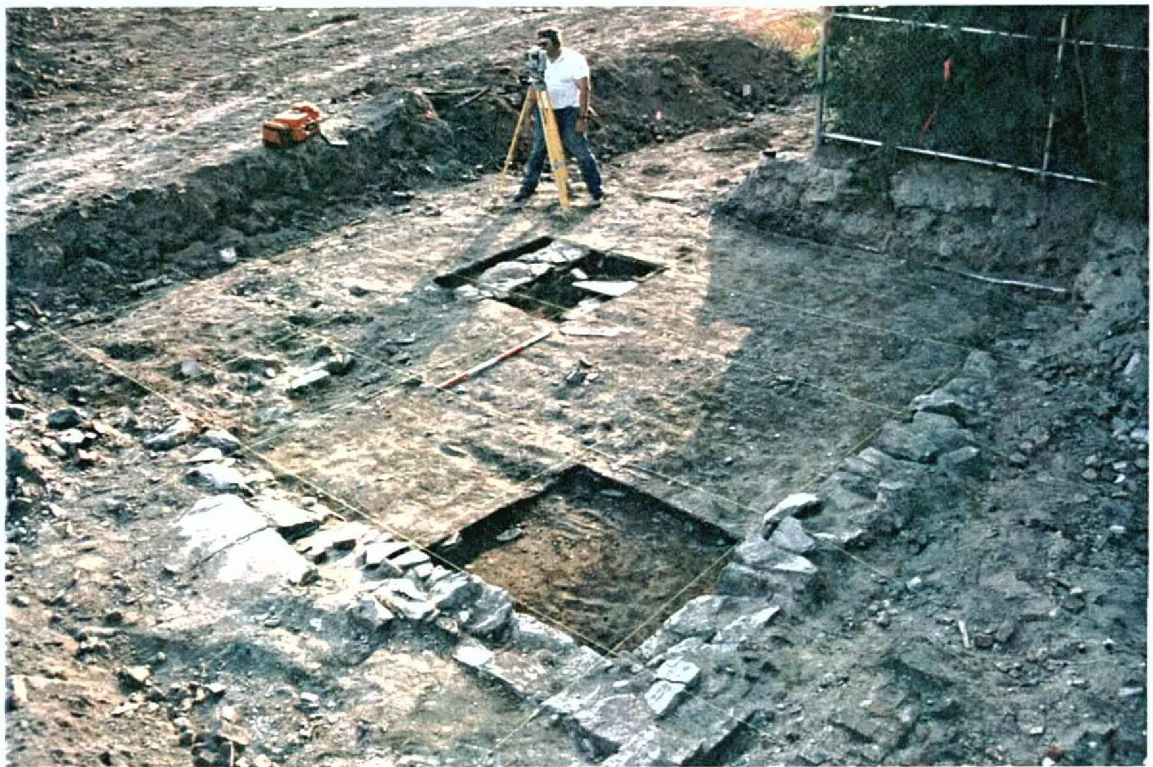
The archaeological investigation of Lot 58 established the presence of early 19th century brick and stone features, and unmixed deposits of early 19th century artifacts. Once delimited and exposed, the extent of the rectangular stone wall suggested the former presence of only early 19th century materials in this rear lot section. No late 19th century or 20th century materials were recovered. Because of the density of early 19th century artifacts exposed on the buried surface 4 feet below modern grade, this area was divided into a grid of 5 by 5 foot horizontal control units, and two, 5 by 5 foot strata control units were excavated to establish the nature and stratigraphic integrity of cultural materials within Lot 58. In addition to the recovery of large quantities of diagnostic early 19th century artifacts, the age of the building itself was established by the recovery of a well preserved Dutch coin within the matrix of the stone wall itself, apparently placed there by

**Figure 7:** General view looking southwest across the rear of Lot 58 showing the partially exposed intact remains of a post 1823 stone structure and the general placement within a 5 foot grid of two test units, which established the stratigraphic integrity of the interior deposits within the stone structure.

the builder, and once electrolytically cleaned and conserved, documented a date of 1823 for the building (See Figure 9). As detailed below, based on these findings, it is strongly recommended that this lot be further investigated and mitigated through controlled excavation, prior to clearance for demolition and construction.

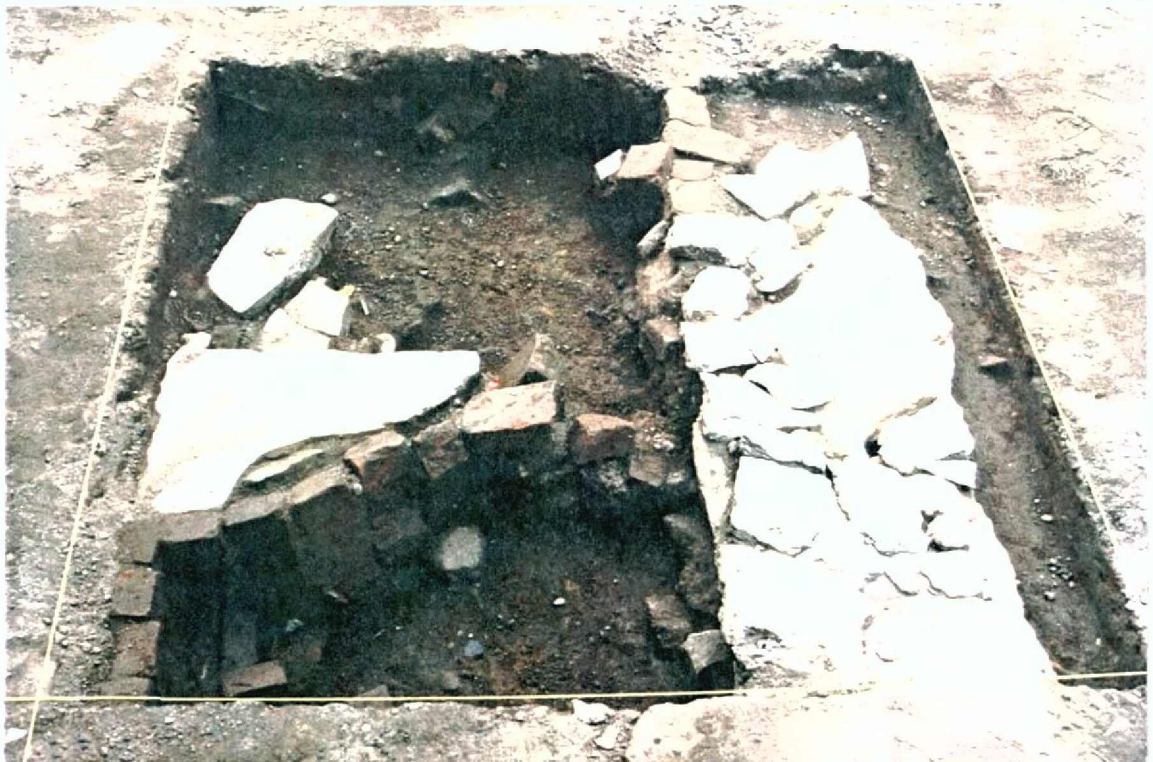
**Figure 8:** Detail looking west of a 5 by 5 foot test excavation unit showing a well preserved stone wall to the right and in tact, partially exposed brick and stone slab feature of undetermined function within Lot 58.

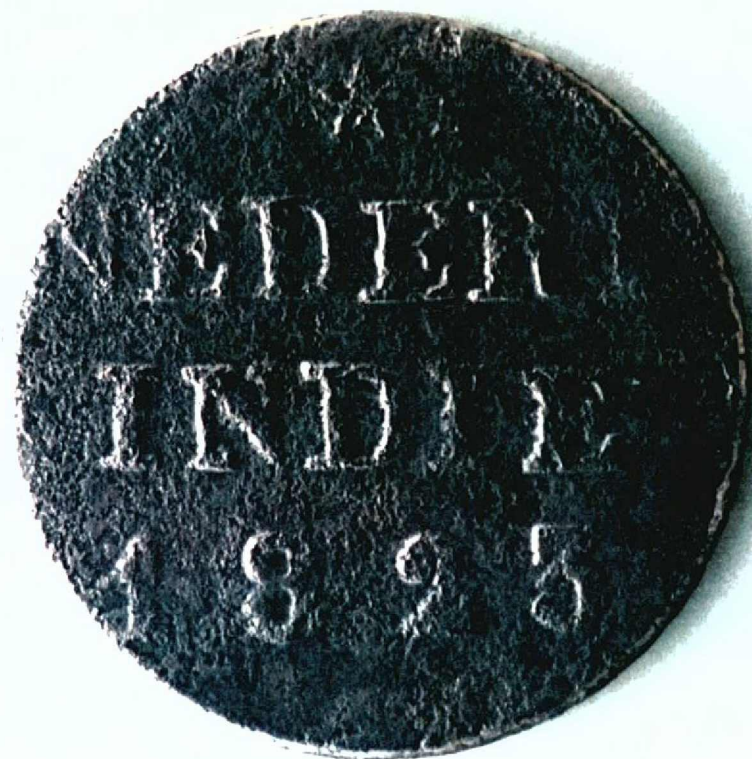
**Figure 9:** Detail of electrolytically conserved and reconstructed ca. 1823 Dutch coin which was found within the wall matrix of the historic stone structure within the rear of Lot 58, which documents that the wall was constructed some point after the date of the coin.

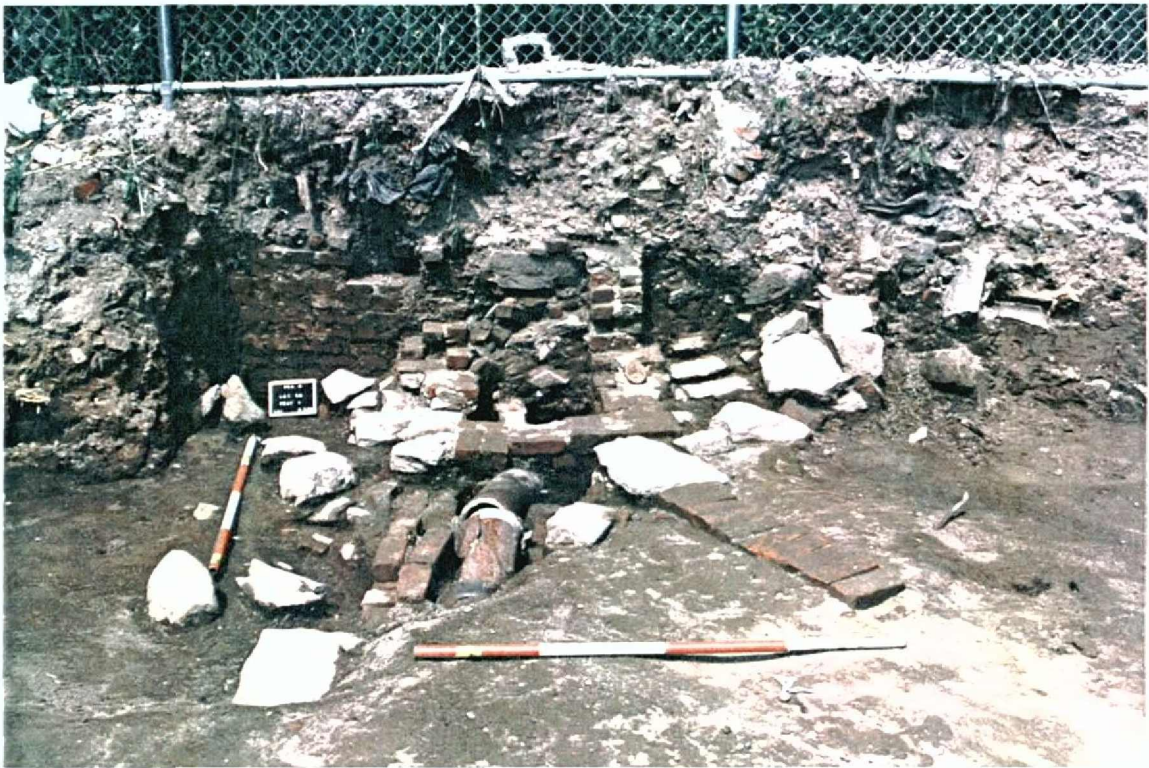
At the rear of Lot 62, the field team identified the presence of a stone and brick privy feature, cutting down from a higher surface, which was formerly extant ca. 1 foot below modern grade and ca. 2 feet above the disturbed and historic surface. This brick privy was found to contain a stone base and an associated brick drain, running underground to the southeast. At the suggestion of LPC, efforts were made to further evaluate the structural and chronological integrity of this feature as a basis for making recommendations concerning the need for additional work. This expanded feature definition process revealed the presence of a later phase of construction, which involved the placement of a metal pipe within the drain feature connected to a more modern sanitary sewer pipe on its exterior. Although limited in volume, the recovery of ca. 1 cubic feet of interior fill, resulted in the recovery of 2 late 19th century Indian Head pennies. When electrolytically cleaned, these late 19th century coins yielded dates of 1874 and 1882, suggesting that the privy was filled and abandoned sometime after 1882 and probably later, given the metal and ceramic pipe alterations to it. The feature was fully exposed both in plan and profile and measured in with a computer transit (See Figure 10 and Figure 11). Based on the level of information recovered, and the fact that the

Figure 10: Profile view looking due north towards the rear parting wall of Lot 62 showing the excavated profile of a late 19th and 20th century brick privy which was altered with the addition of 20th century iron and ceramic sewer pipes. The recovery of 2 Indian Head pennies (1874 and 1882), within the small amount of interior fill documents that it was abandoned sometime after the first decade of the 20th century.

privy was altered in the late 19th and 20th centuries, no additional data recovery or documentation is being recommended beyond the already completed level of recordation.

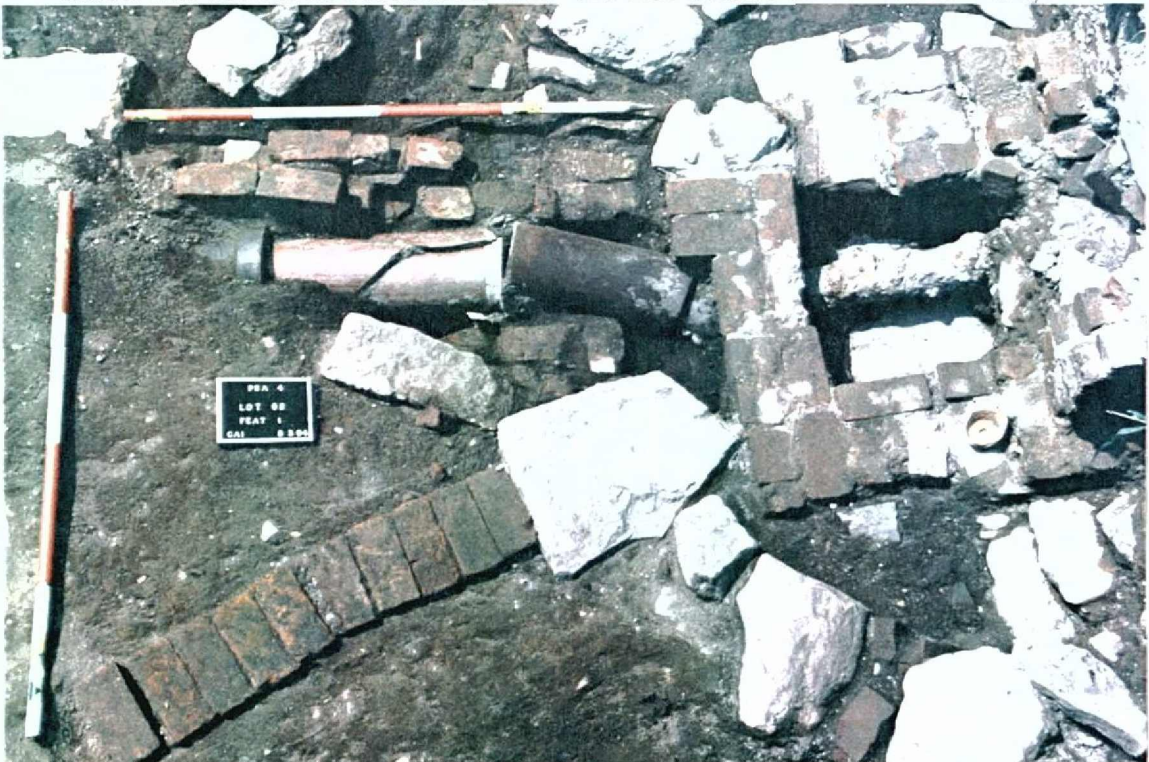
Figure 11: Overhead view of brick privy at the rear of Lot 62 showing an original brick drain at the bottom of the photo with the addition of later iron and ceramic sewer pipes dating to the turn of the century.
