RECONNAISSANCE OF MARINE CULTURAL RESOURCES
AT THE NEWARK BAY SITE
STATEN ISLAND, NEW YORK

NEW YORK CITY LONG RANGE SLUDGE MANAGEMENT
GEIS III/NEW YORK CITY DEPARTMENT OF ENVIRONMENTAL PROTECTION

April 10, 1992

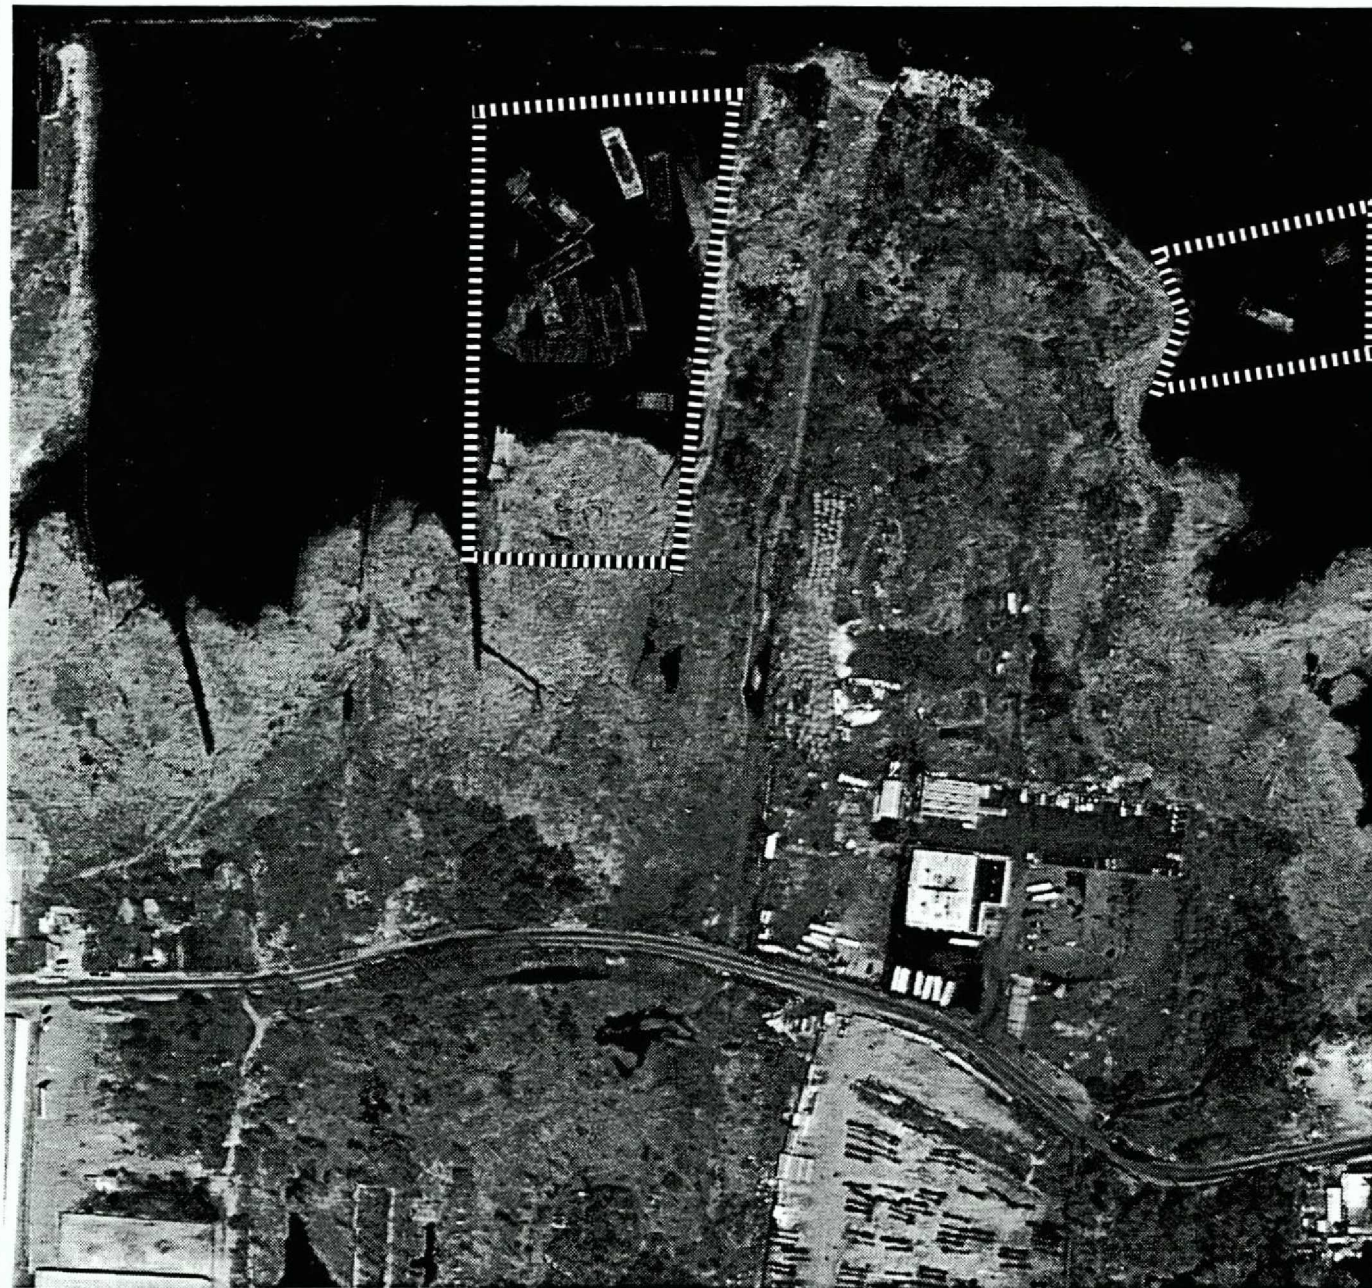
We find that the hulks within the two areas delineated on Fig. 3 constitute a site potentially eligible for the State and National Registers of Historic Places as a marine archeological site containing accessible information about the arrangements and types of construction used in typical wooden harbor craft. These physical remains exemplify a traditional type of craft, with several variations, that was important in the history of the Port of New York, and the nation's commerce as a whole. They also embody vernacular construction

The boundaries on Fig. 3 are drawn to include most of the unpowered barges in both areas, including Vessel 13, which lies against the shore of the site; the areas extend no further onto land than the line of high tide. The boundary of the first area extends south of the main collection of hulks to include a number of wooden barge parts that exemplify the methods of wood ship construction used in this type of vessel.

FIG. 3: Vertical aerial photograph of site with added boundary lines indicating the two areas within which all marine resources are of historic significance and should be considered potentially eligible for the State and National Registers of Historic Places. These boundaries should be considered as coinciding with the high water line where they contact the shoreline.

Should there be an impact from the proposed work on items within the potentially eligible sites, then it is recommended that mitigation take the form of a recording based on the guidelines of the Historic American Engineering Record (HAER). Such a recording could consist primarily of large format photography using simple photogrammetric procedures to allow retrieval of dimensions from the photographs; this would make it possible to prepare drawings at a later date if desired and would greatly reduce the amount of measurement necessary on the site. To make such a recording more efficient it is recommended that specific research topics appropriate to this site be formulated in advance; a list of these is provided above on page 8.

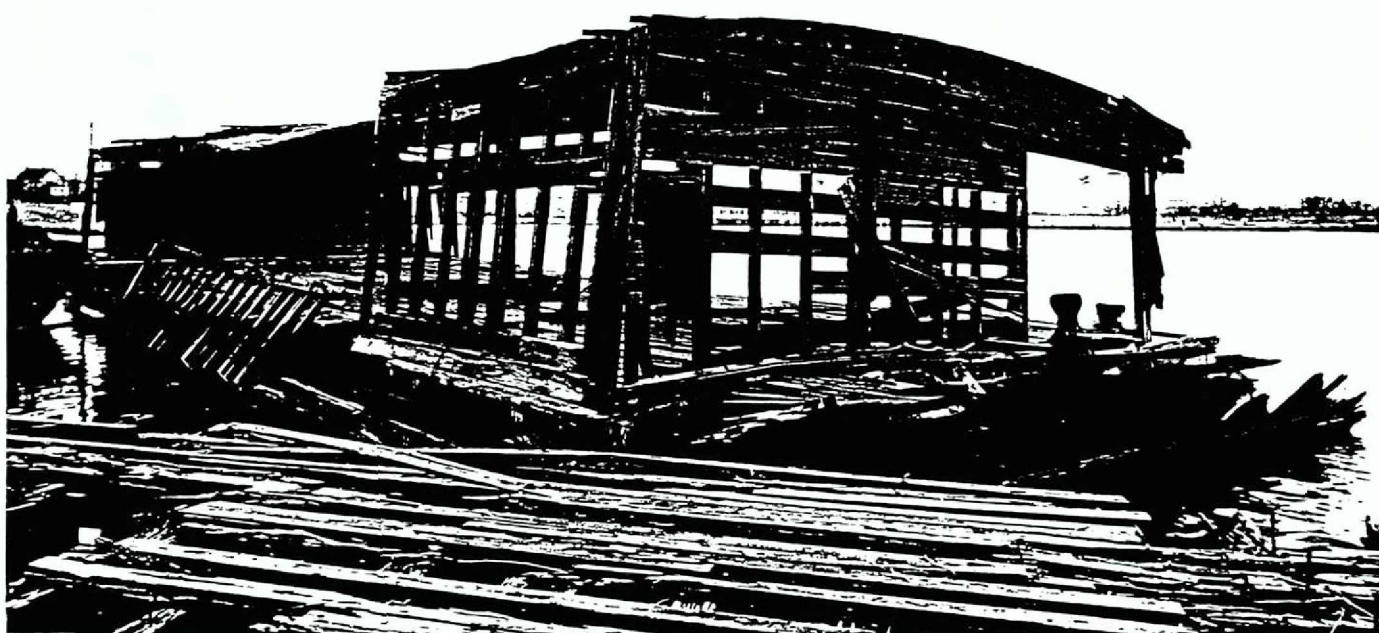
PHOTO A: Vessel 1, a covered barge, 3/4 view toward southwest, showing part of starboard side framing collapsed into water. Note capstan to right, which bears date of 1918, though the barge itself was probably built later. (Neg. 101-28)

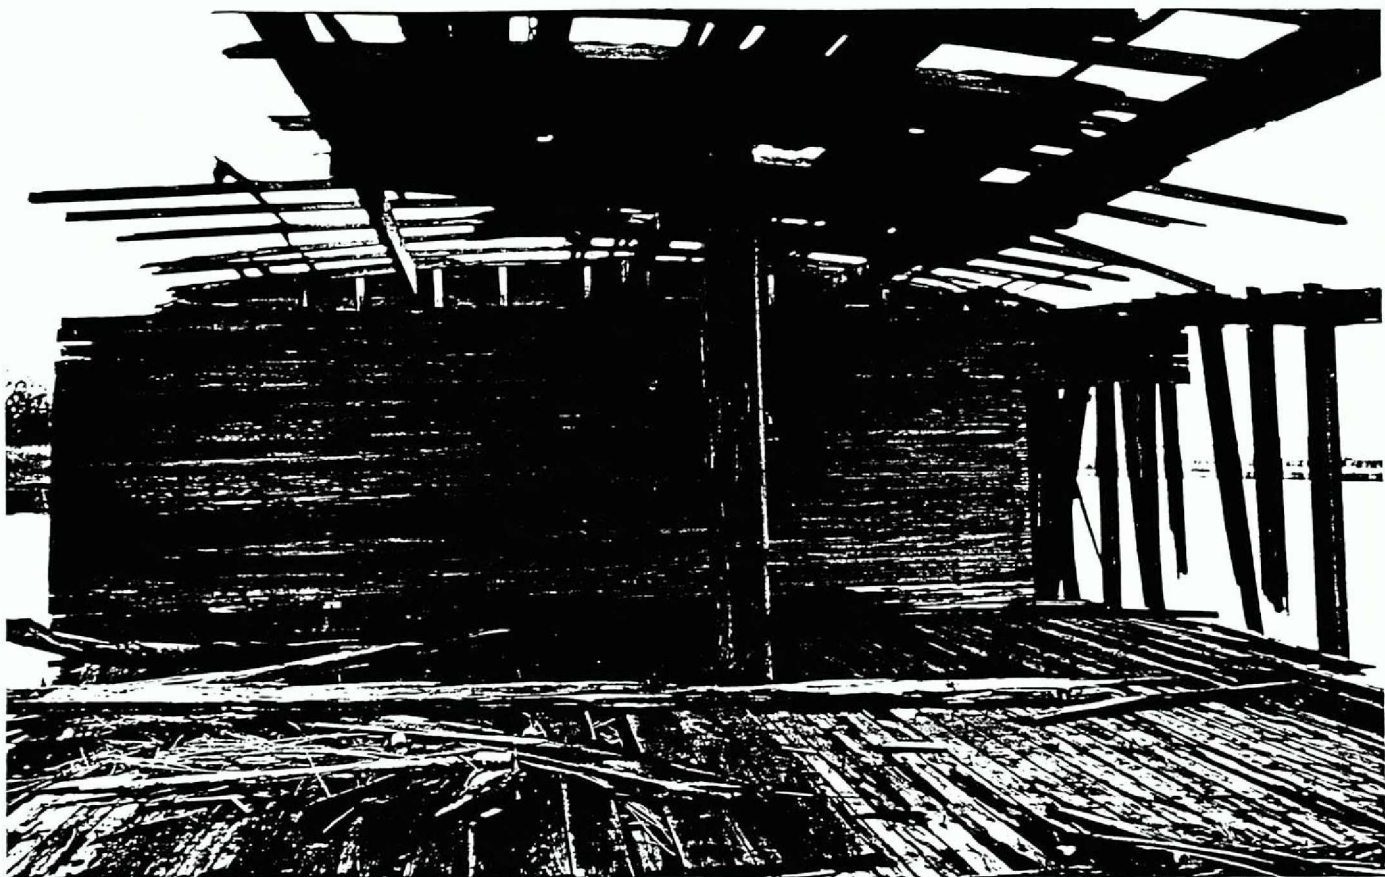
PHOTO B: Vessel 1, view south (toward stern) to rear wall of cargo space, cabin is on other side of this wall, interior doorway to cabin to right. Most of side walls and some of roof of the covered cargo space are missing. Note roof support post and cross timber. (Neg. 101-22)

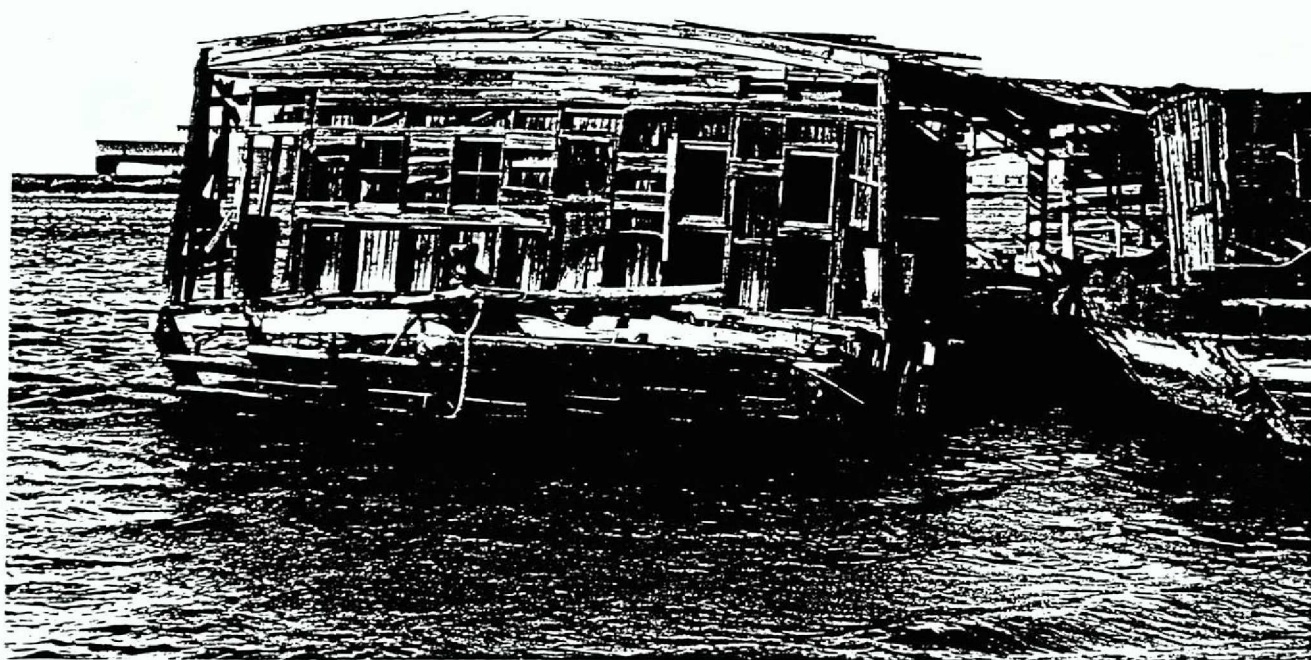
PHOTO C: Vessel 1, view north from land, showing outer stern wall of covered cargo space, which is also the outer wall of the cabin, which was placed within the covered cargo space on this particular vessel (on other covered barges, the cabin was placed outside the covered cargo space). The outer siding has fallen away from the wall in many places here, revealing the cabin framing and the back side of the interior wall boards. The slant of the hull end is easily seen here, as is its structure. The stern capstan is also visible. The bowed fascia provided at the junction of the roof and end of the deckhouse is typical. Vessel 2 is to the right. (Neg 404-37)

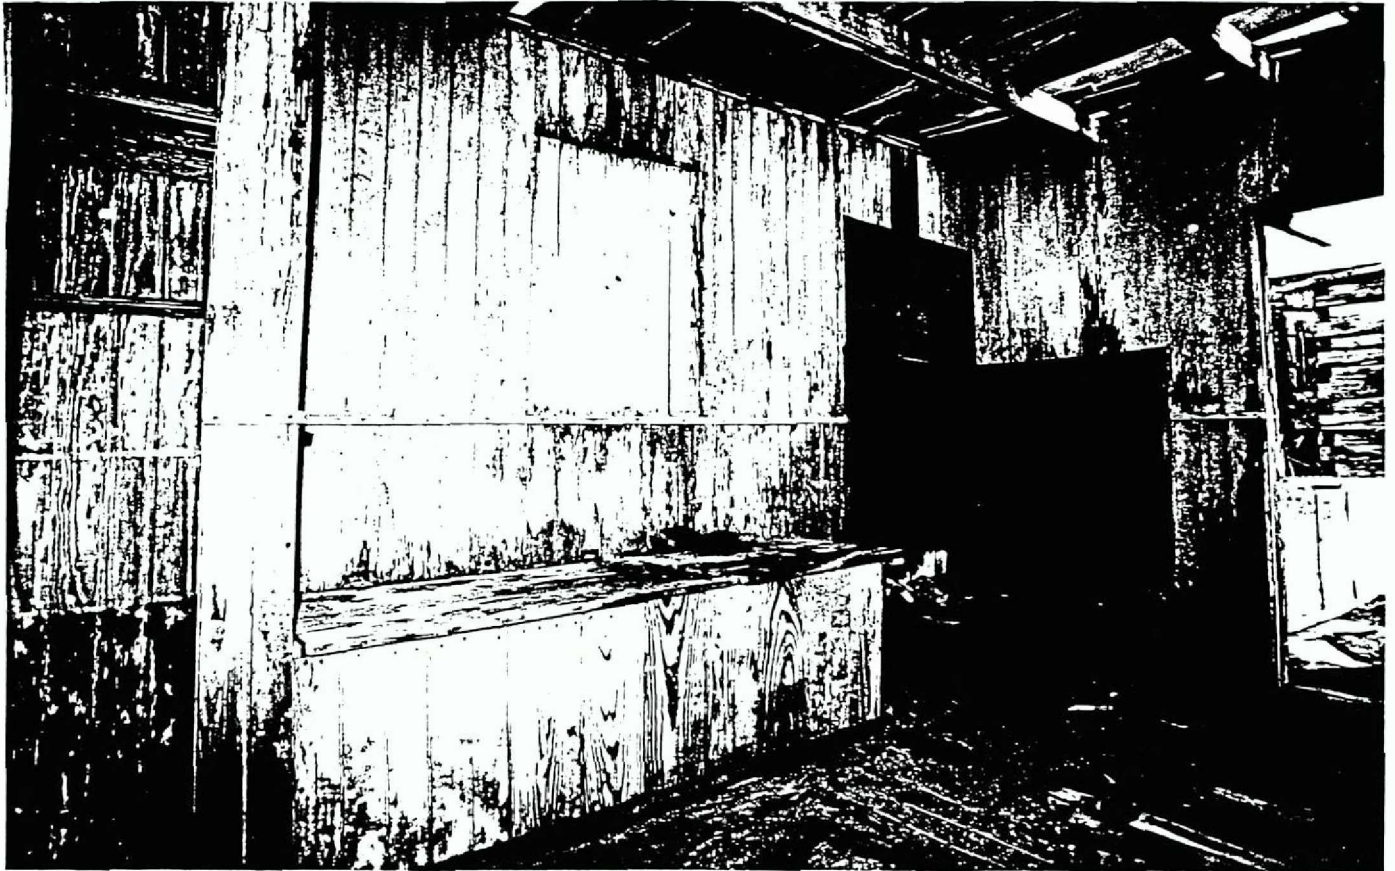
PHOTO D: Vessel 1, view northeast, showing interior of cabin. The wall on the left backs onto the covered cargo space. Just right of center is the space for the stove, with wall protected by metal. Left of center is the coal bunker, also used as a bench. To right is the doorway to the bedroom. The walls are faced with vertical tongue-and-grove boards. (Neg. 401-25)

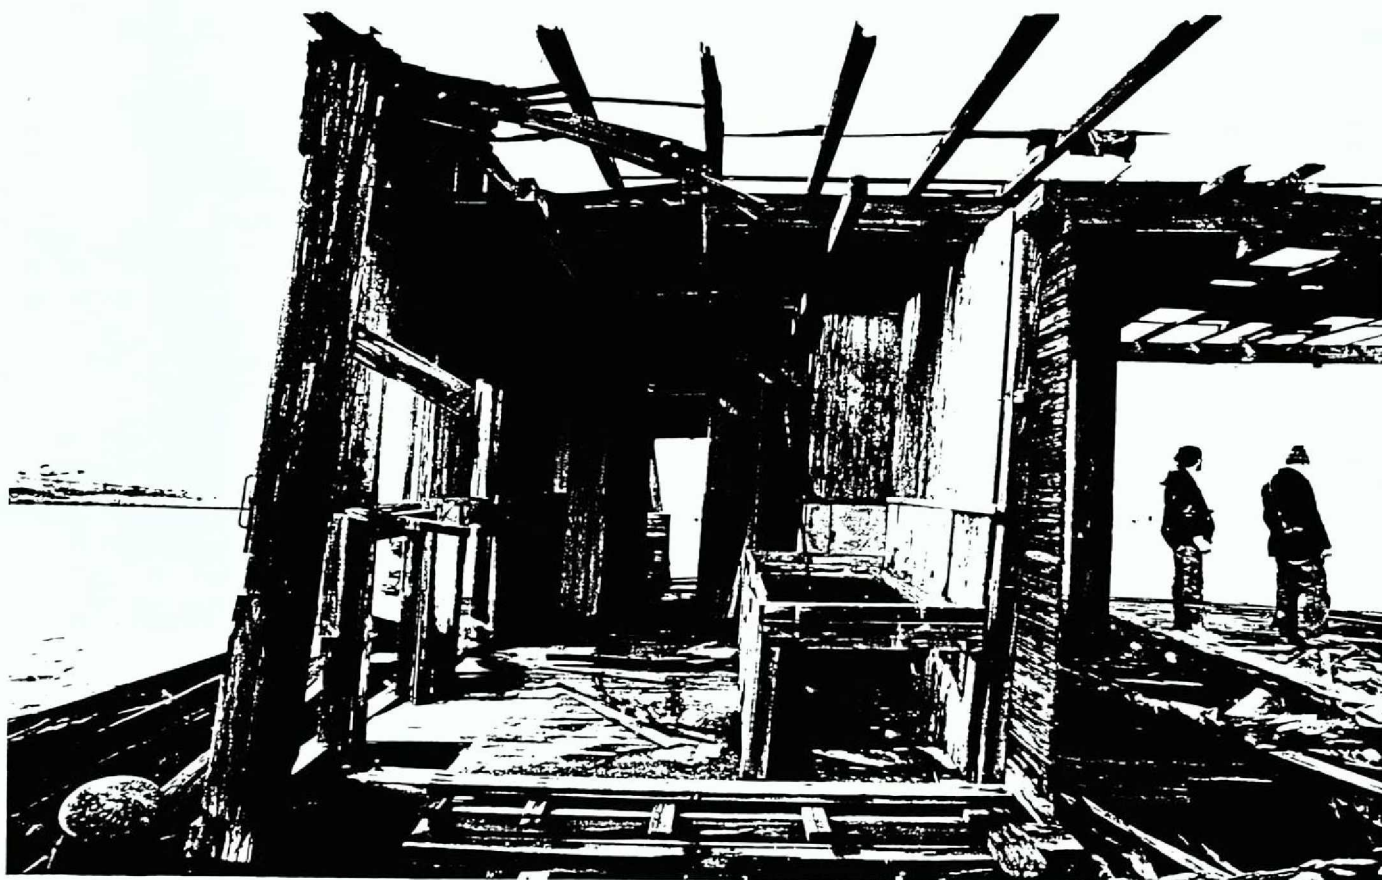
PHOTO E: Vessel 1, view northwest, showing interior of cabin as seen from vessel 2. The southeast (starboard) wall of the cabin is entirely missing, allowing the camera to look directly into the cabin from outside, and showing how the cabin was built within the barge's deckhouse, with the cabin's ceiling located about 2.5 ft. below the crossbeams of the deckhouse roof. To the right is a bunk attached to the wall. The two members of the survey team are standing in the former cargo space of the deckhouse. (Neg. 101-15)

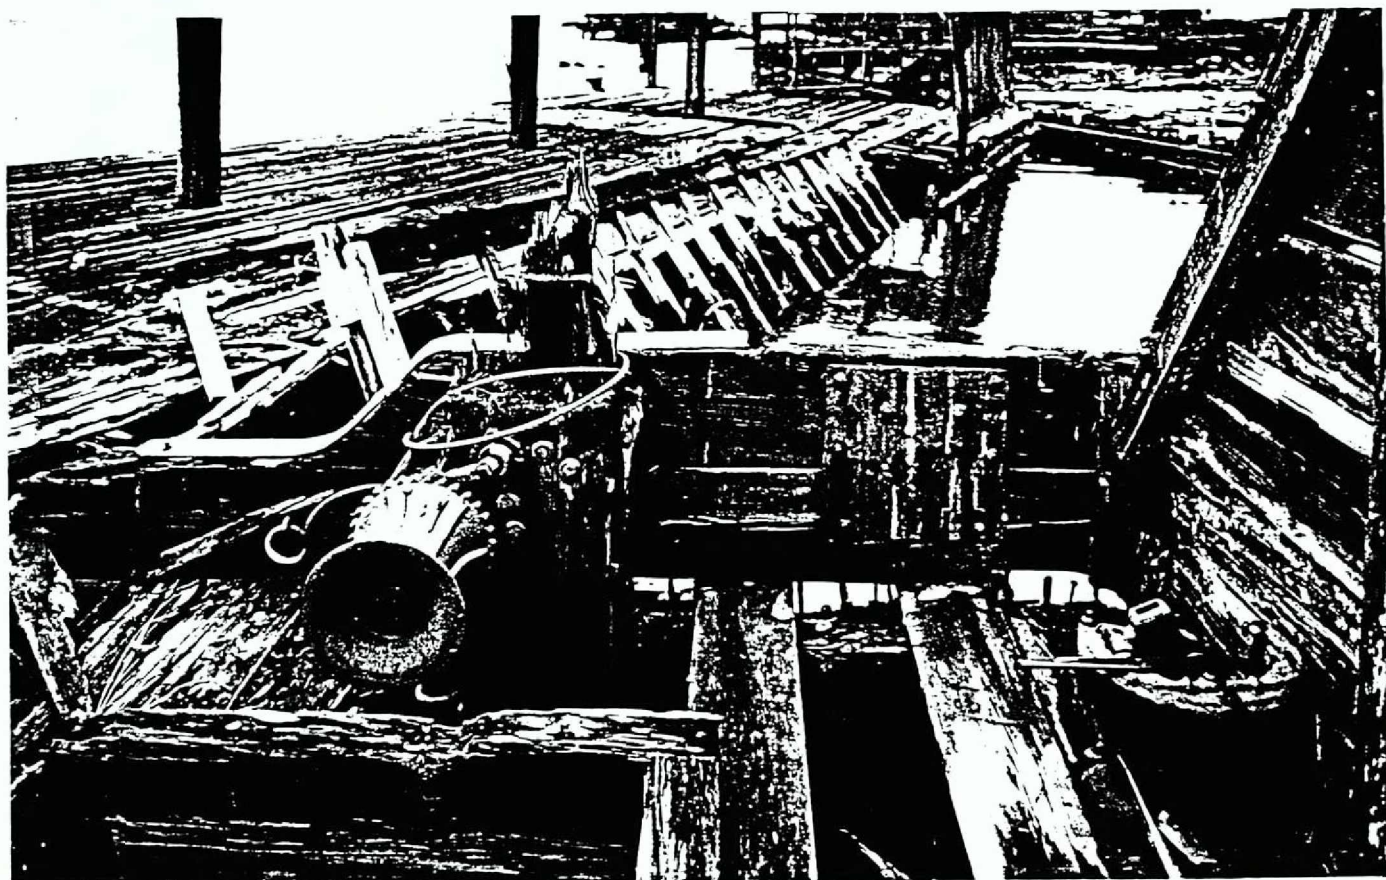
PHOTO G: Vessel 2, view north, showing aft end of port-side coaming, in the opposite direction from that of Photo F. This view shows the port end of the bulkhead seen in the Photo F, as well as the remains of a wooden bitt (left of center) and of a winch, and in the foreground the coaming around a hatch down into the barge's hold. (Neg. 101-8)

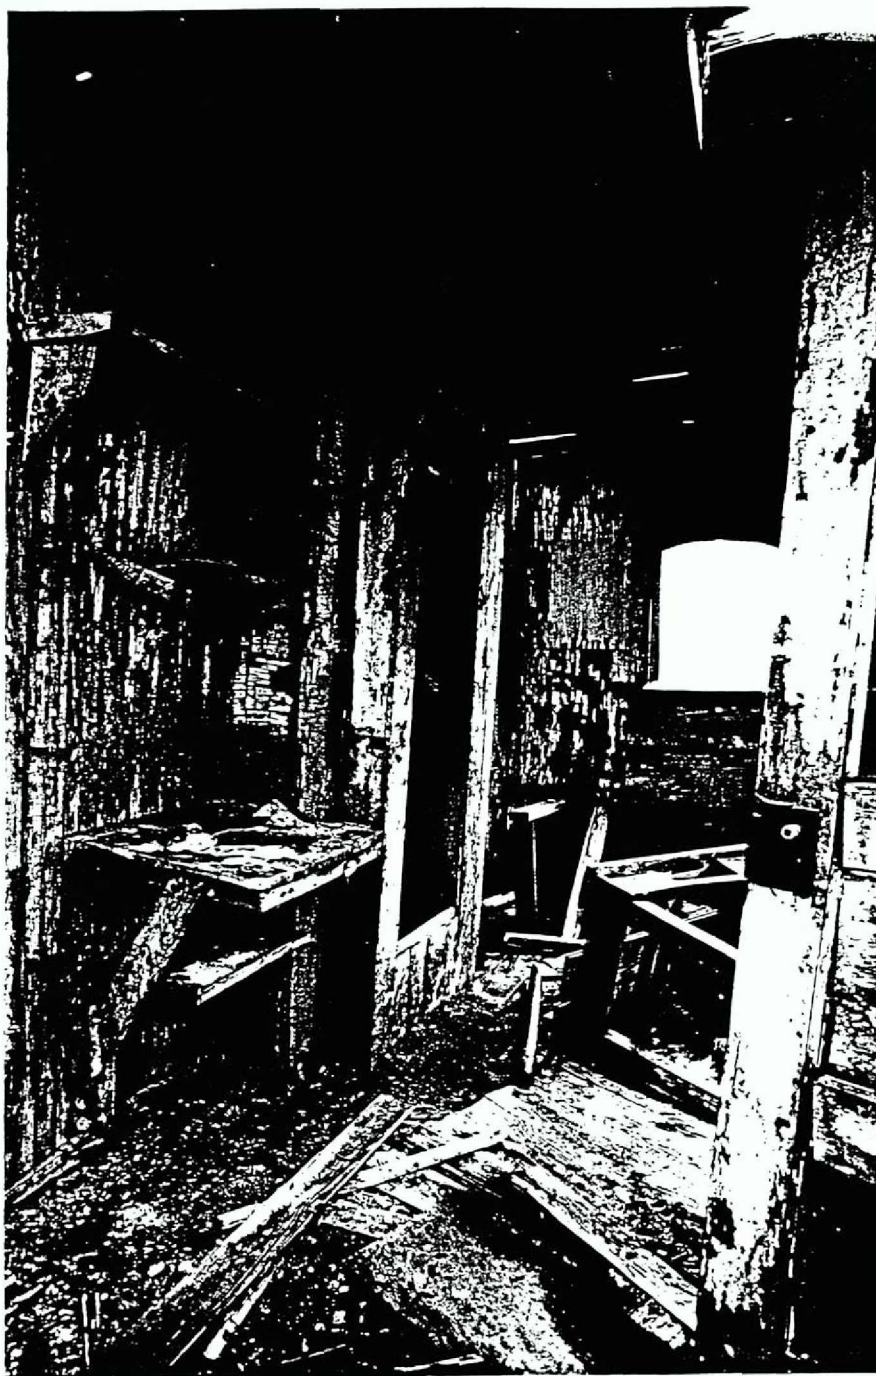
PHOTO H: Vessel 2, view south, showing interior of cabin. Open doorway in center marks a shallow closet. (Neg. 401-22)

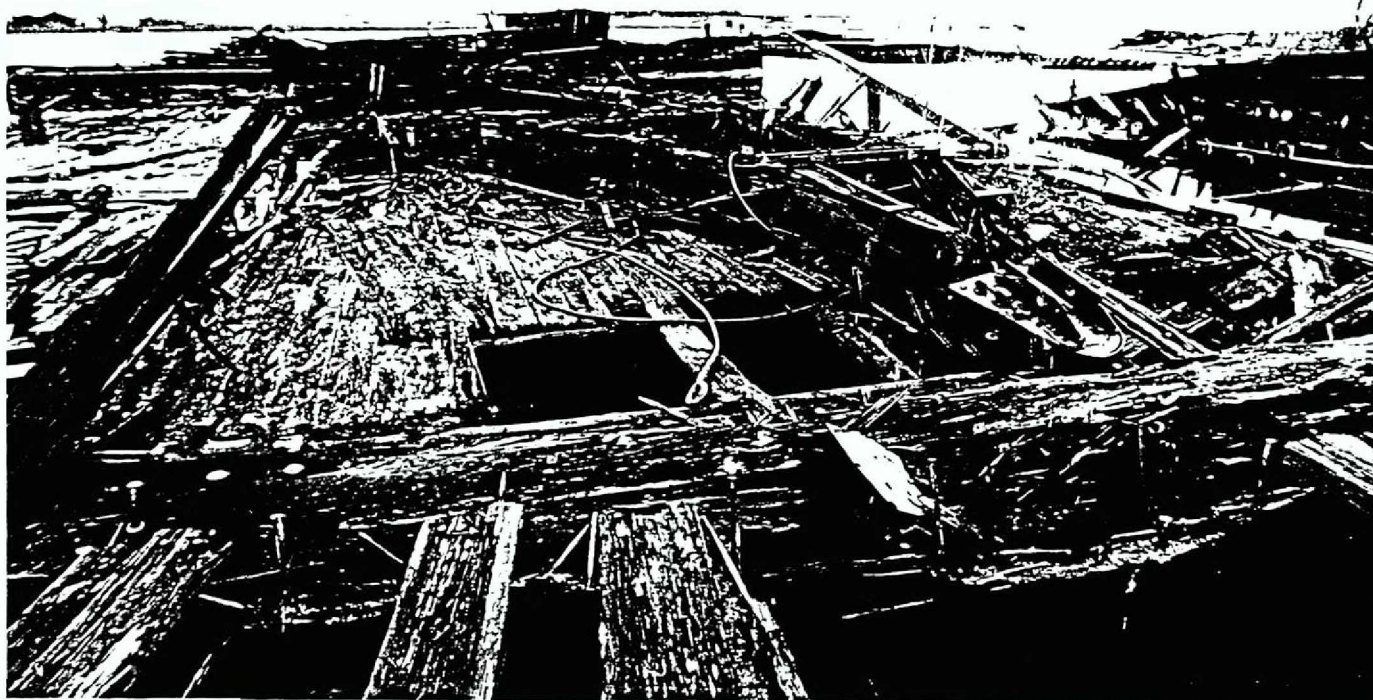
PHOTO I: Vessel 4, view north, looking aft on a crane barge, showing part of the structure of the A-frame derrick that once stood upright on this barge. It is now flat on the deck, with the casting that formed the apex of the A-frame in the center of the right half of the photo. The rest of the A-frame consisted of laminated wood beams. Many pieces of hardware litter the deck of this vessel. The cabin in the distance is on another vessel. (Neg. 101-6)

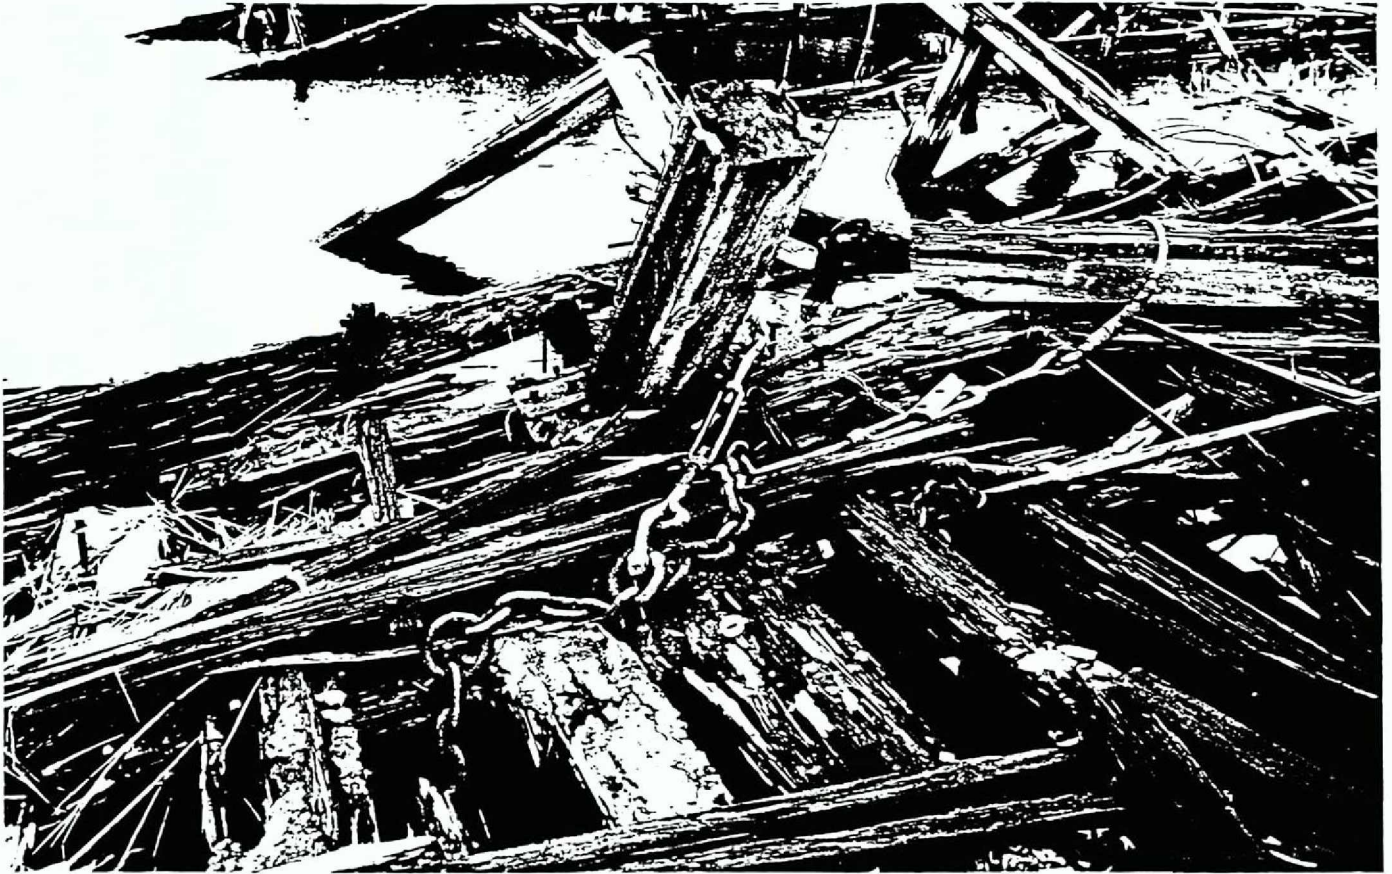
PHOTO J: Vessel 4, view east, showing a detail of the "chain plates" that once braced the A-frame of this crane barge. This is the port side of the barge, aft quarter. (Neg. 401-6)

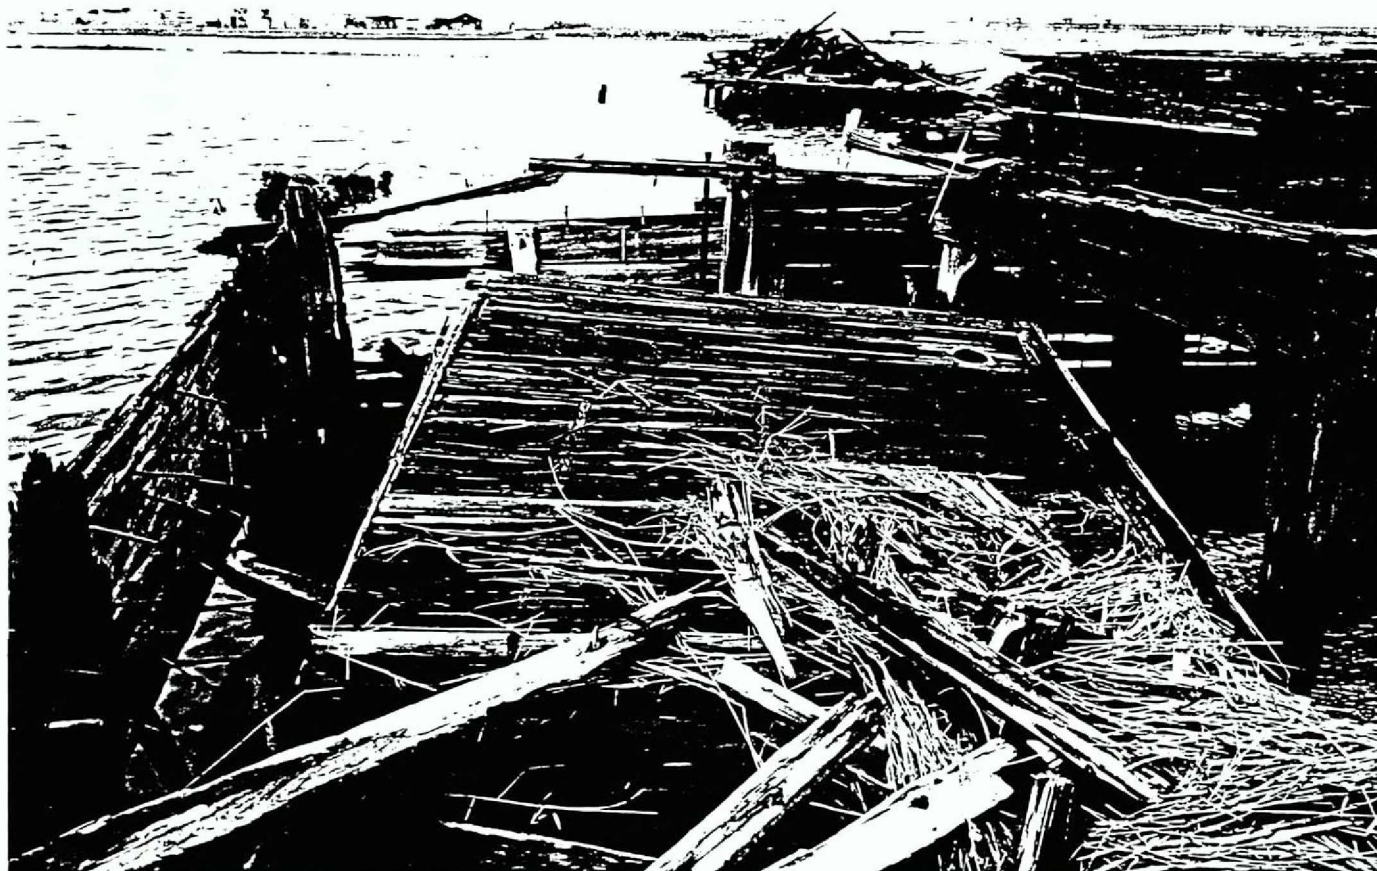
PHOTO K: Vessel 5, view north, showing stern area. The horizontal surface is actually the cabin roof, collapsed into the hold of this "coal box" type of barge. Note the hole in the roof for the chimney pipe. To the right is one of the structural members of this barge, consisting of a vertical post strapped to a horizontal athwartships beam; this beam is composed of two pieces of lumber, one on top of the other. (Neg. 101-35)

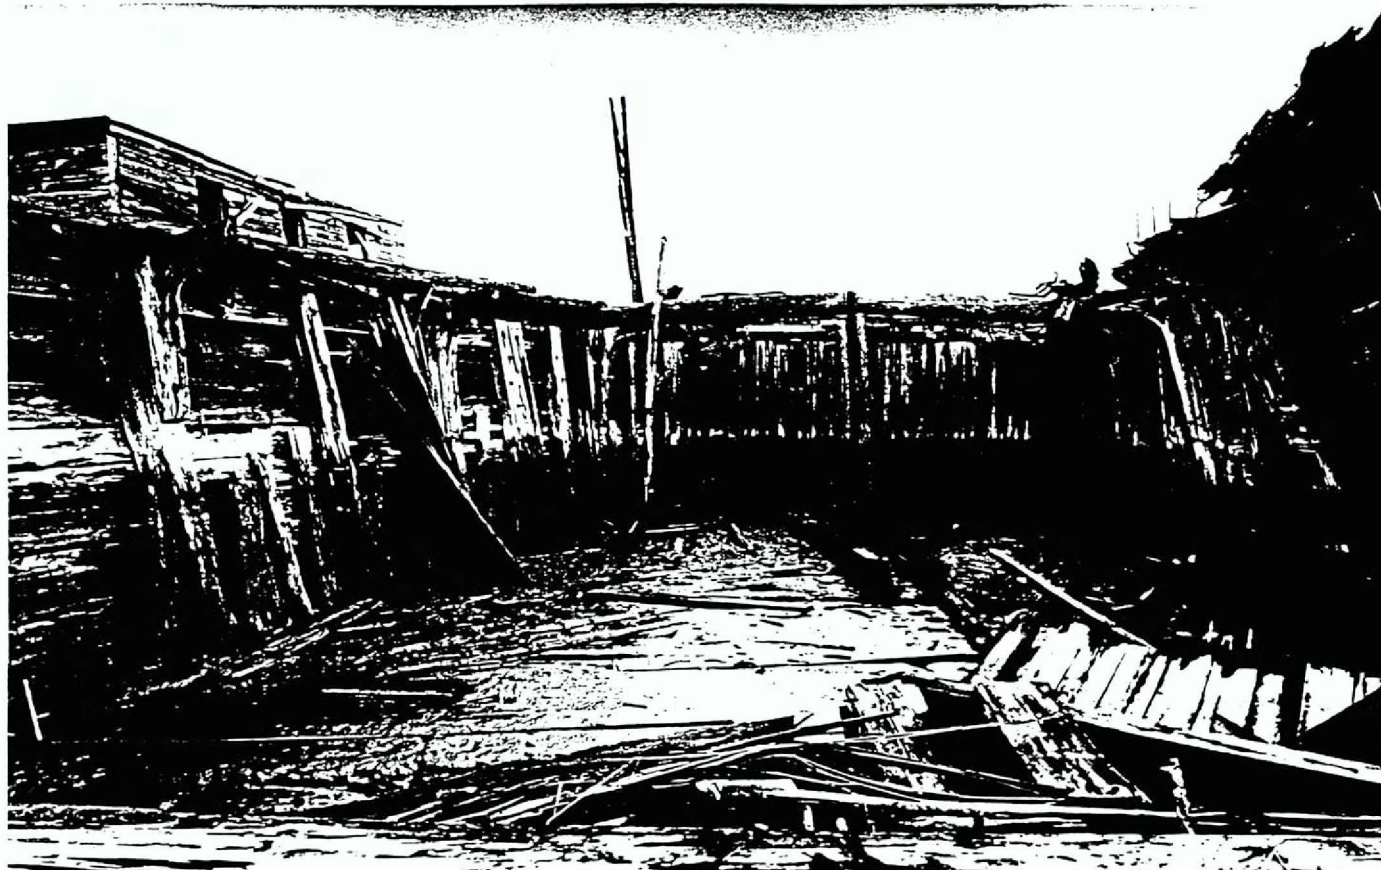
PHOTO L: Vessel 6, view south, looking down the centerline of the interior of a "hold barge" or "coal box". In the distance is a vertical post carrying a horizontal athwartships beam. Originally there was a row of these posts along the centerline but most of them are now gone, some lying on the mud. The points along the sidewalls of the hold where the athwartship beams connected are still visible, many with their wooden "hanging knees" still remaining. These knees supported the ends of the beams. The cabin seen at the upper left belongs to a different vessel. (Neg. 402-12)

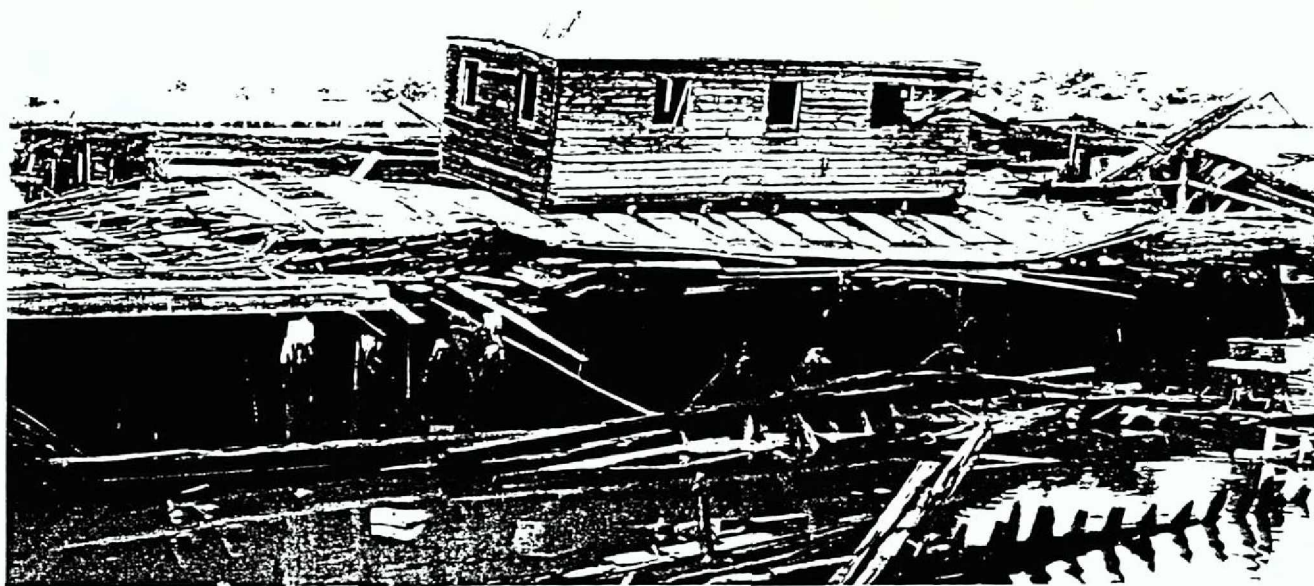
PHOTO M: Vessel 7, view southwest, showing remains of covered barge. Cabin at center was located on the roof of the deckhouse containing the cargo space of the barge (a relatively unusual location), but the deckhouse has collapsed onto the barge's deck. Thus the material around the base of the cabin consists of the former deckhouse roof. The cabin is in quite good condition, with its exterior wall covered by clapboards. The side planking of the hull is almost entirely absent, giving a view of some of the structural elements of the hull. The ribs of vessel 17 are visible in the water in front of vessel 7. (Neg. from fig. 8 of Flagg 1991 report).

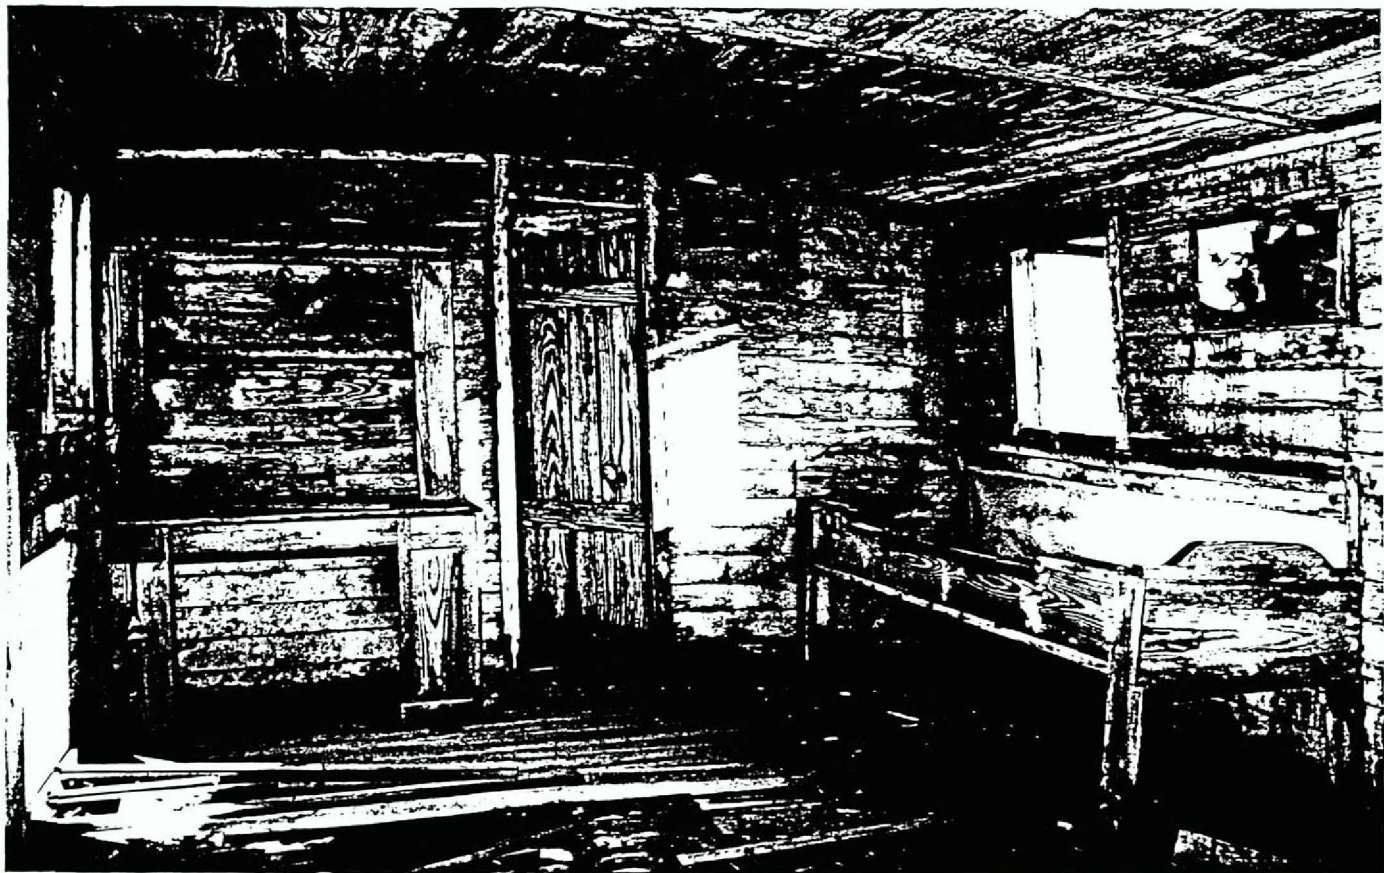
PHOTO N: Vessel 7, view south, showing interior of north room of cabin. To the right is a carved wooden bunk. Unlike other cabins, the wall lining here consists of horizontal boards. (Neg. 402-27)

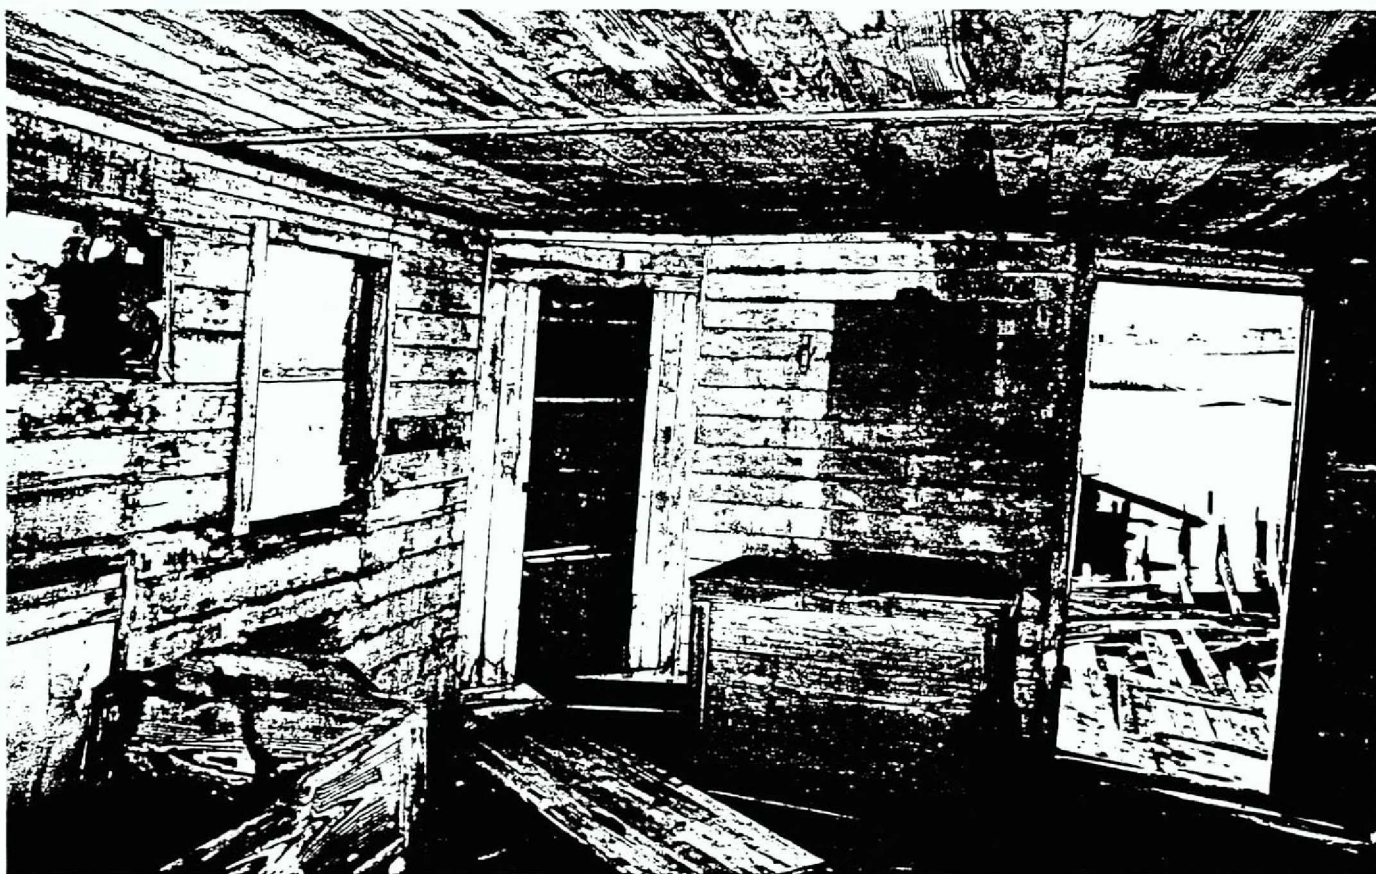
PHOTO O: Vessel 7, view north, showing interior of same room as Photo N but facing in opposite direction. A closet occupies the corner of the room. (Neg. 402-31)

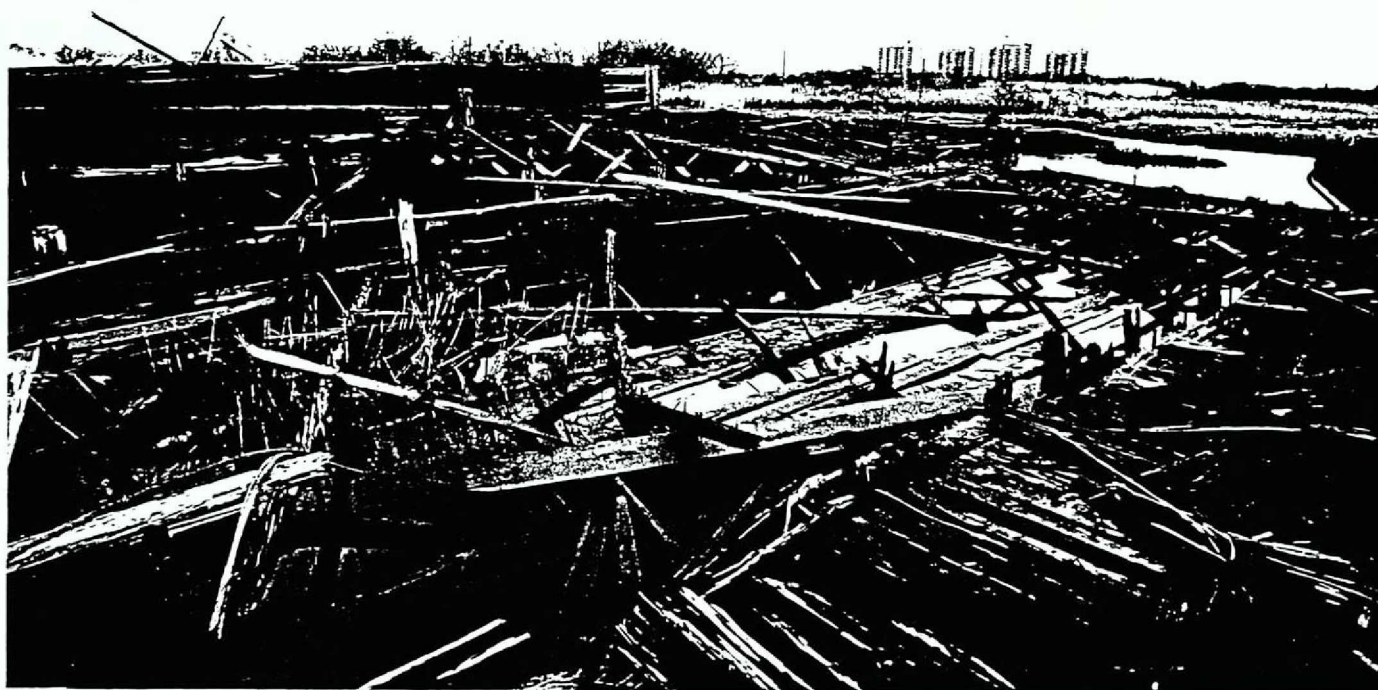
PHOTO P: Vessels 8, 9 and 10 (from near to far), viewing to southeast. In right foreground is the deck of vessel 4, from which the photo was taken. Vessels 8 and 9 may have been deck scows. Only a few of the structural elements of vessel 8's hull remain, including some cross-bracing, plus some side planking. Vessel 9 retains some of its side planking and some coaming. These are typical of the less intact hulks at the site, but they do exhibit some structural elements difficult to observe in the more intact hulks. Vessel 10 is another "hold barge" and is also shown in Photo Q. (Neg. 401-35)

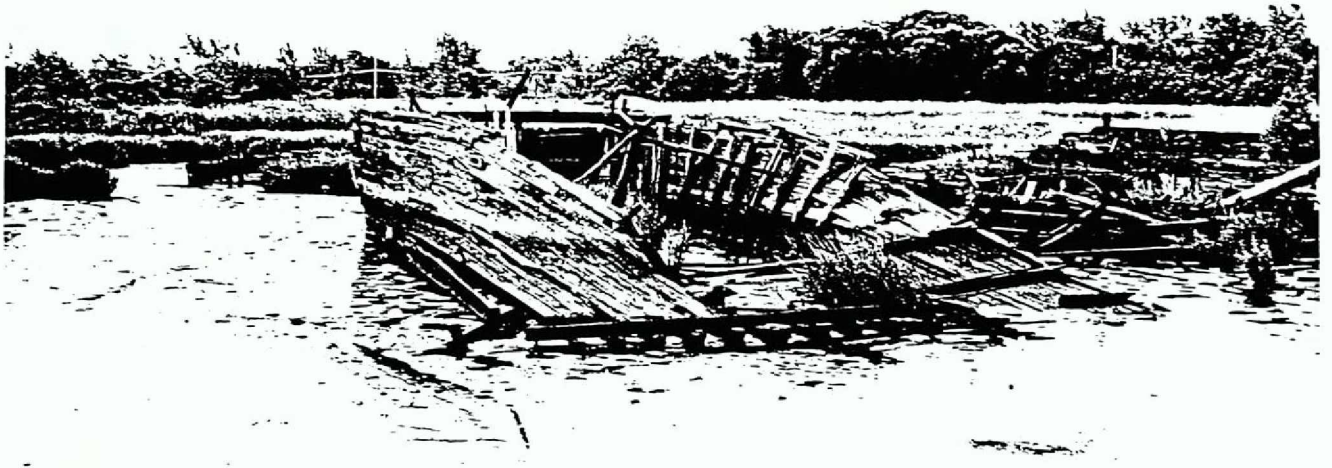
PHOTO Q: Vessel 10 (center) and vessel 9 (right), with vessels 11 and 11A in the distance. View is to south. Although the near end of vessel 10 is missing and the near ends of its sides are collapsed, its similarity to the other hold barges (vessels 5 and 6) is apparent. (Neg. of Fig. 9 from Flagg, 1991).

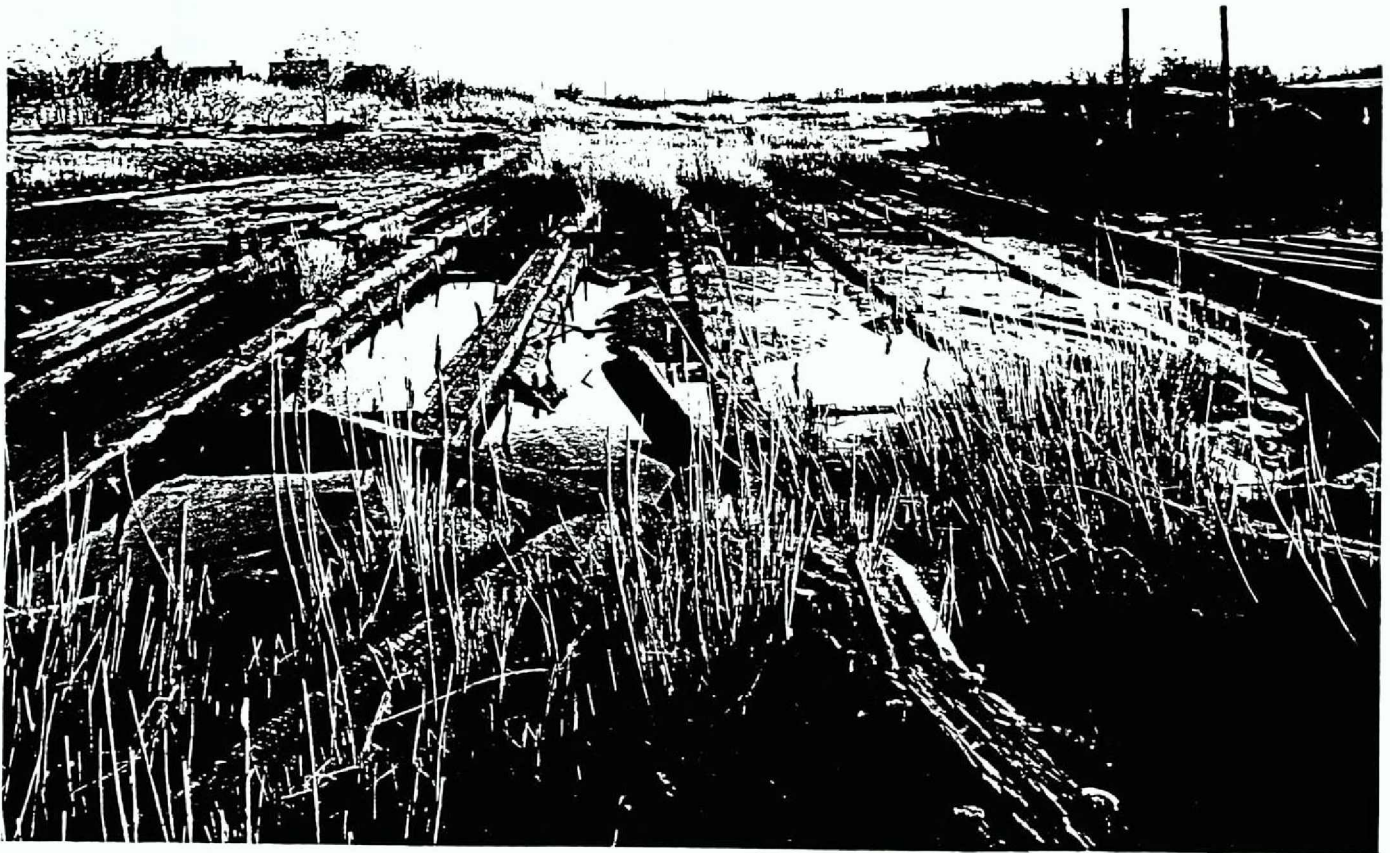
PHOTO R: Vessel 13, view to southeast, showing wooden carfloat. Only the bottom of the hull structure remains, showing the fasteners that once held other structural members. There appear to have been six longitudinal truss members, providing the great strength necessary in these vessels. In 1969, when most of the other barges at this site were relatively intact this vessel was already only a hulk showing little more above water than it does now (Figs. 5, 6), suggesting that it has been here much longer. This is not surprising, as wooden carfloats were largely replaced by steel carfloats in the 1920's and 1930's. Few, if any, hulks of wooden carfloats remain elsewhere in the harbor. This one may be able to provide valuable information about the structure of these craft. (Neg 402-37)
