RECONNAISSANCE OF MARINE CULTURAL RESOURCES
AT THE NEWARK BAY SITE
STATEN ISLAND, NEW YORK

NEW YORK CITY LONG RANGE SLUDGE MANAGEMENT
GEIS III/NEW YORK CITY DEPARTMENT OF ENVIRONMENTAL PROTECTION

April 10, 1992

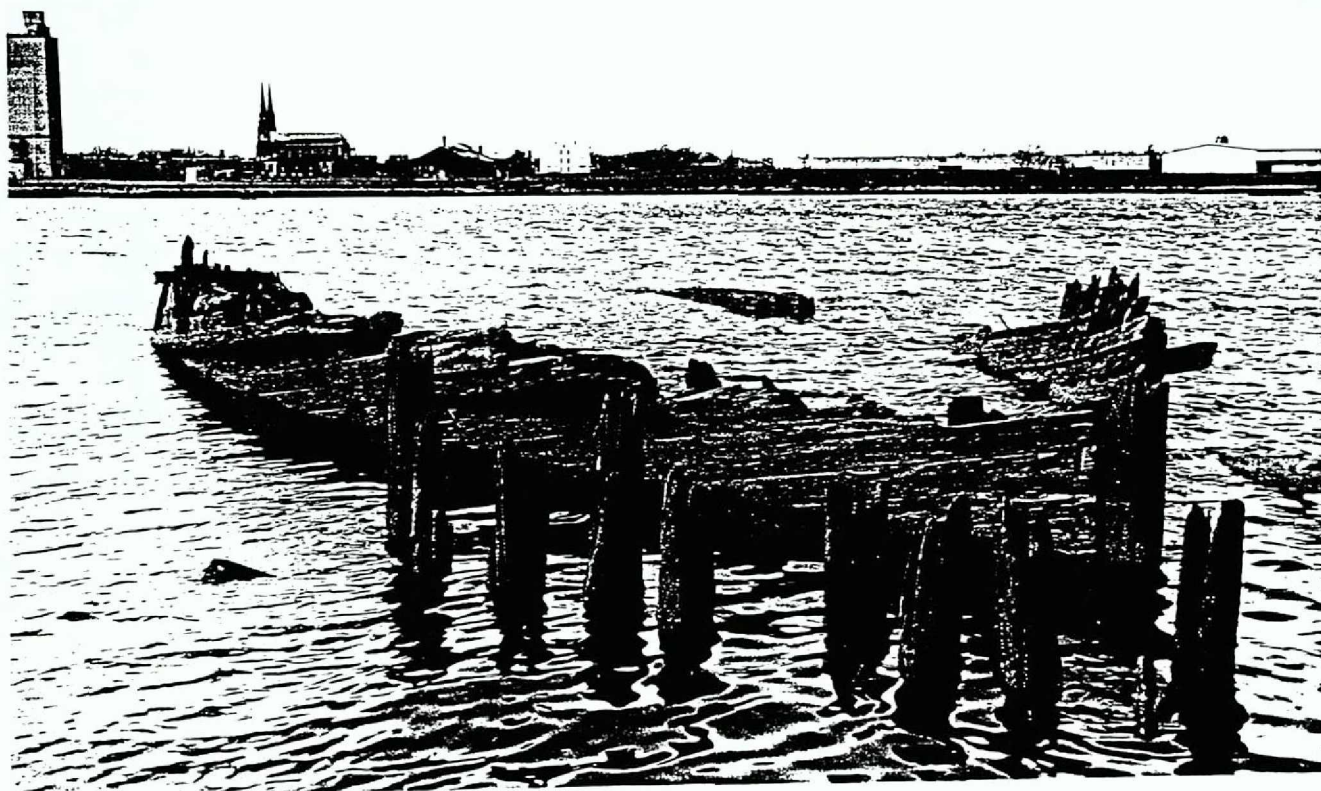
PHOTO S: Vessel 15, view northwest, showing remains of a powered vessel, probably an early tugboat approx. 100 ft. long. Like the carfloat (vessel 13), this was already only a hulk in 1969. Although a fine example of wooden craftsmanship, the methods of construction used in this type of vessel are relatively well documented. Vessel 15 is not within the historic areas delineated in Fig. 3. (Neg. 102-2)

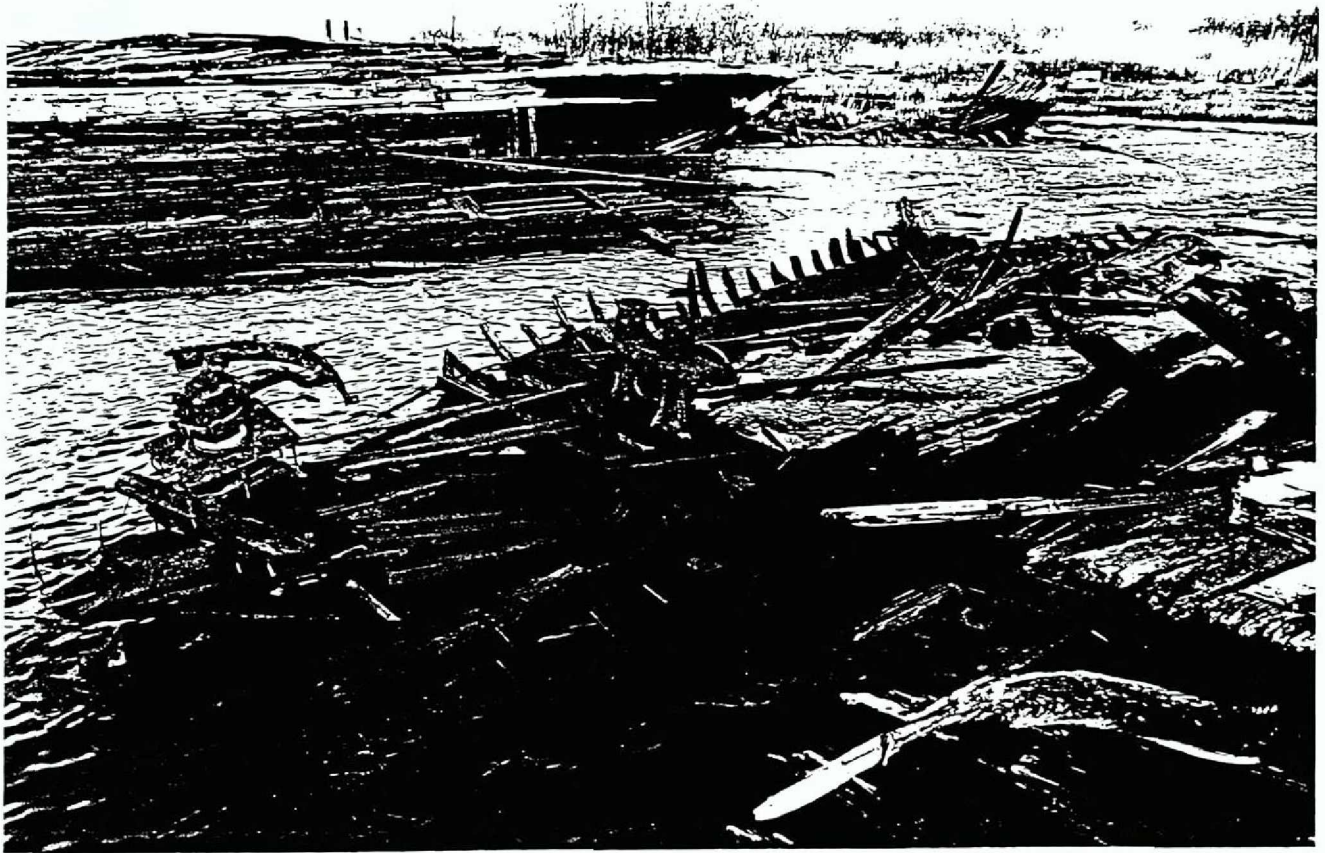
PHOTO T: Vessel 17, view southeast, showing the remains of a wooden tugboat. In the center are visible the towing bitts characteristic of a tug, and to the left are the remains of a steering apparatus. (Neg. 102-13)

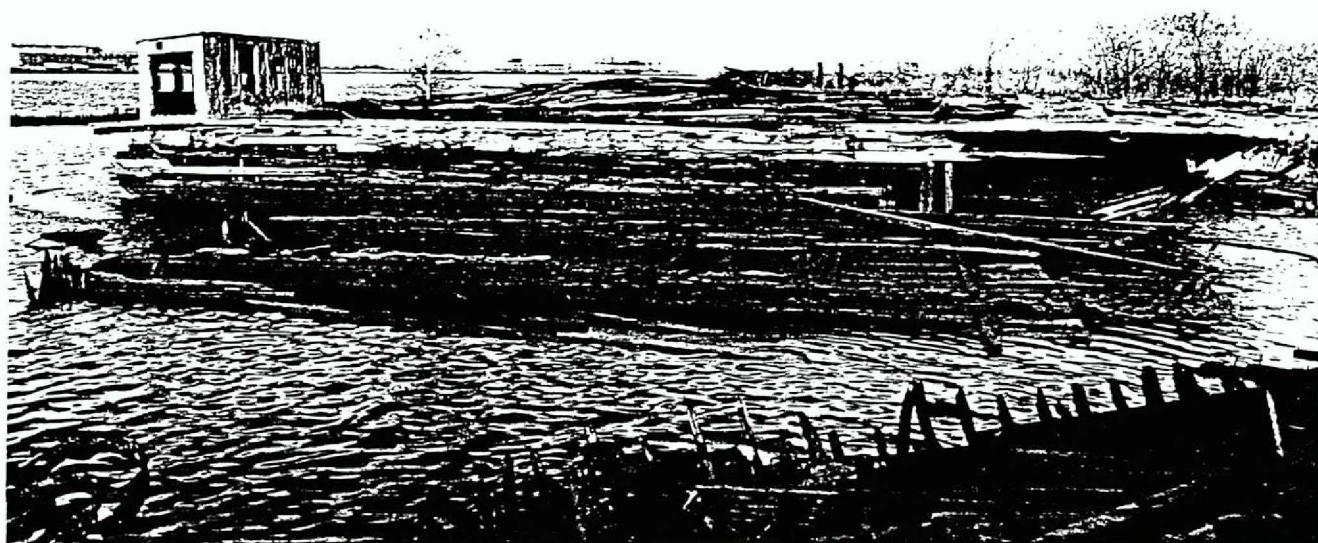
PHOTO U: Vessel 18 (hull in center) and vessel 19 (with cabin), view east. Only the bottom and a small amount of the side of vessel 18 remains; it may have been a deck scow. The absence of side planking near the front of vessel 19 provides a good view of the interior structure of its bow. (Neg. 102-9)

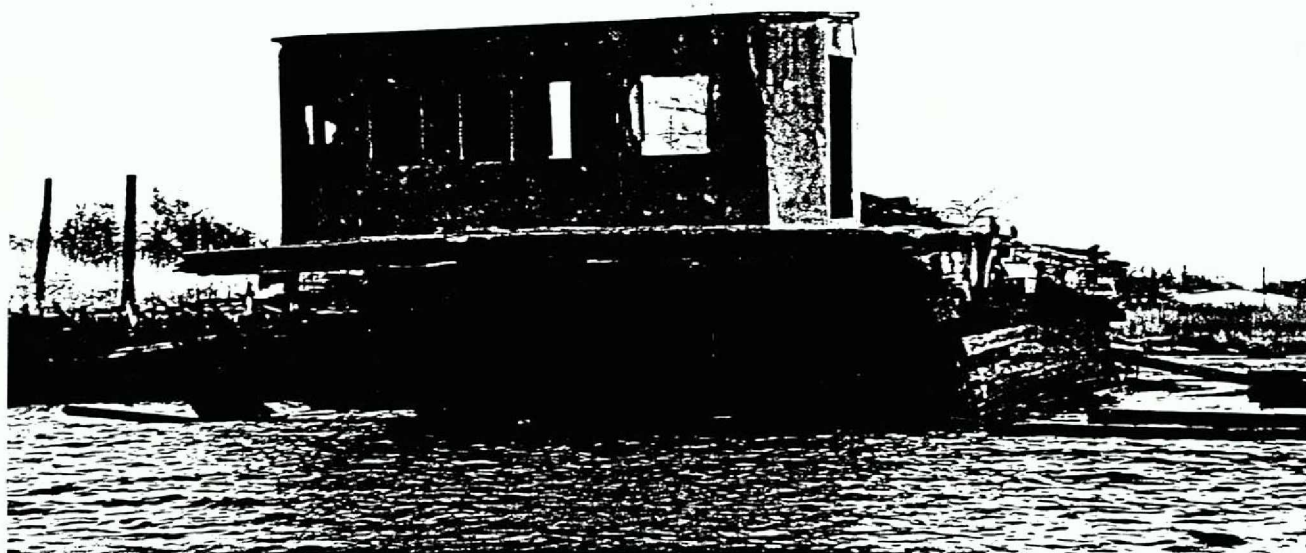
PHOTO V: Vessel 19, view south, showing stern. The concrete cabin and deck of this deck scow are extremely unusual, and were probably added in later years, for reasons that are unclear. The hull structure beneath the deck is, however, typical of standard wooden barges. (Neg. 102-17)

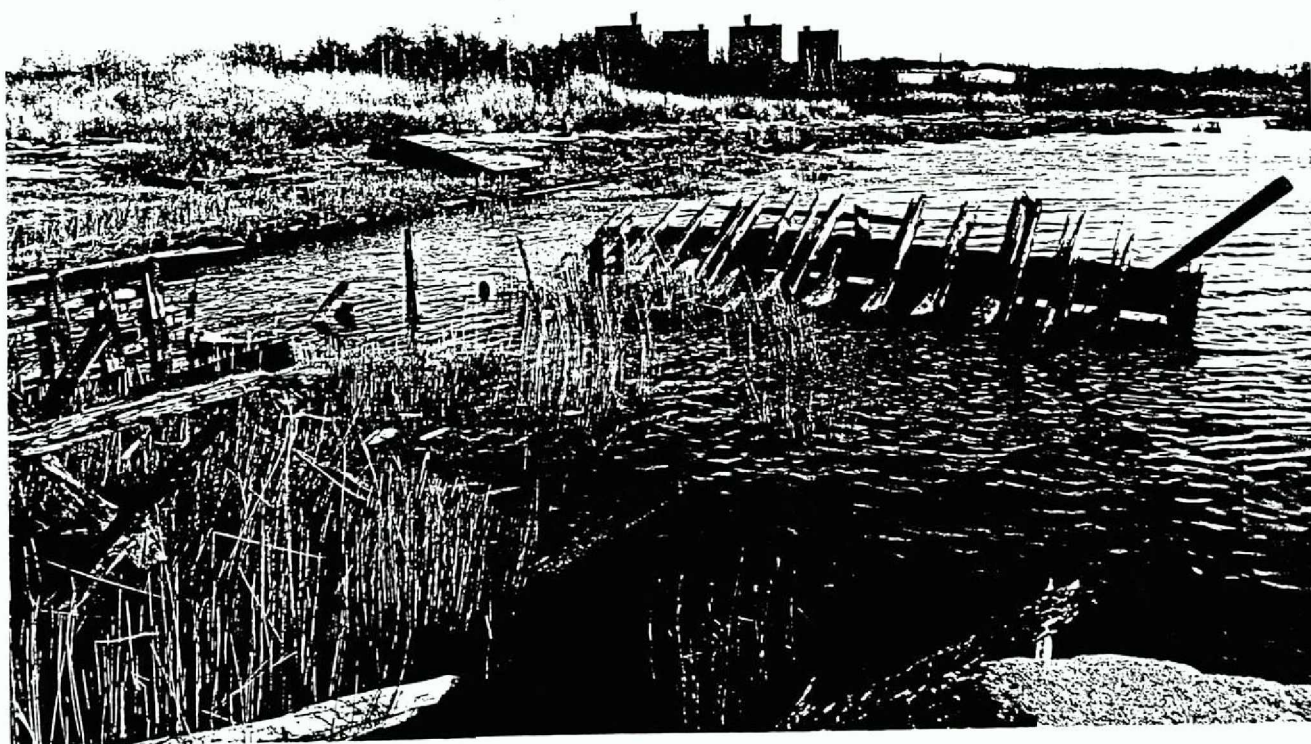
PHOTO W: Vessel 20, view southeast, showing interior structure of a deck scow of the sand barge type. (Neg. 404-27)

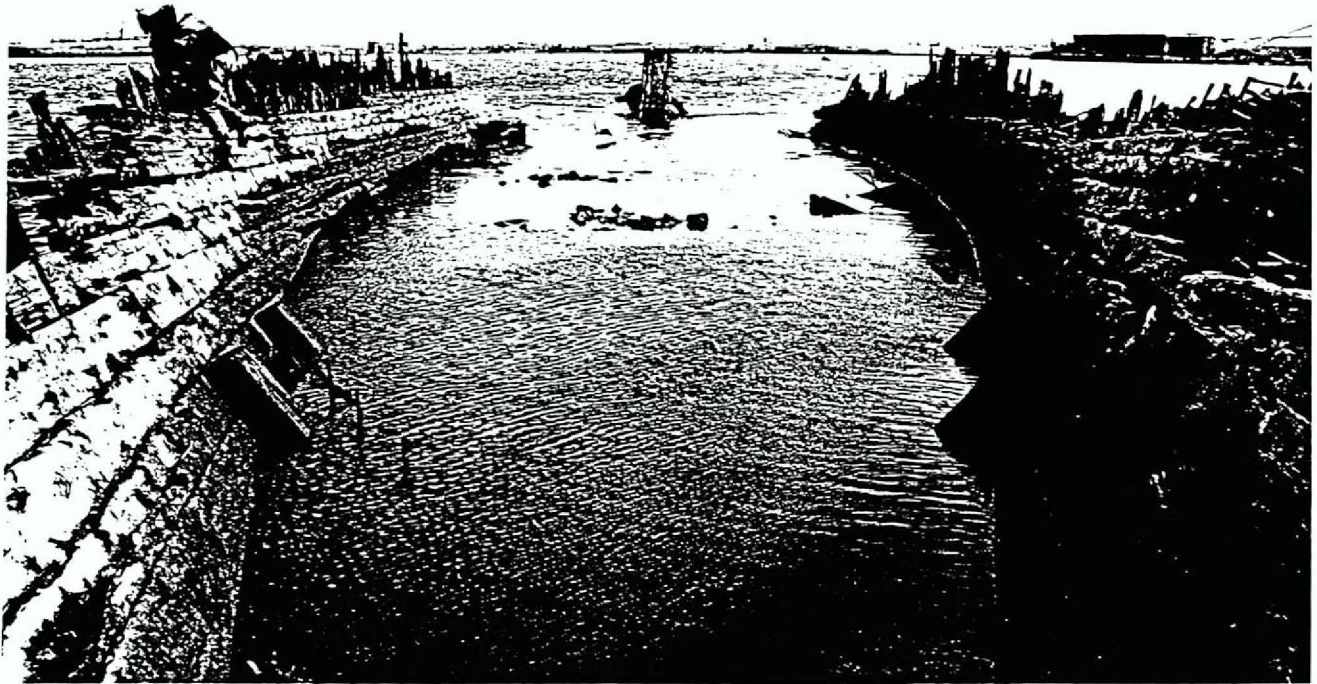
PHOTO X: Vessel 23, view northeast, showing interior of hulk of a powered vessel. This may have been a tugboat or another type of powered vessel such as a steam lighter. Its propeller remains, just visible in the center of this picture behind the sternpost. This vessel was already a hulk in 1969. Although a fine example of wooden craftsmanship, the methods of construction used in this type of vessel are relatively well documented. Vessel 23 is not within the historic areas delineated in Fig. 3. (Neg. 403-15)

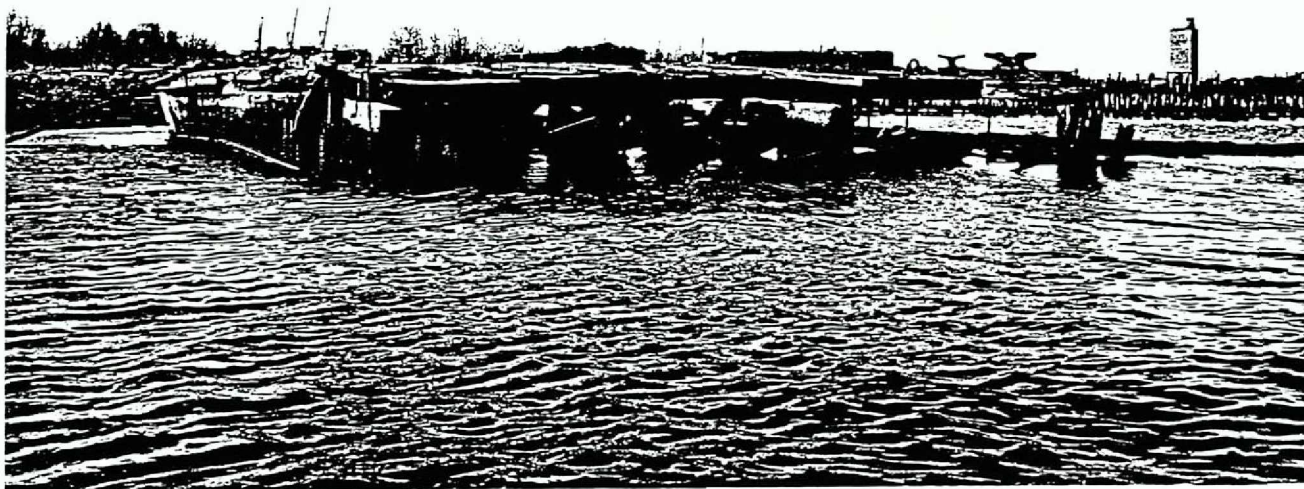
PHOTO Y: Vessel 24, view east, showing overall view of the remains of this covered barge. This is the most intact hulk within the easterly of the two historic areas delineated in Fig. 3. (Neg. 403-21)

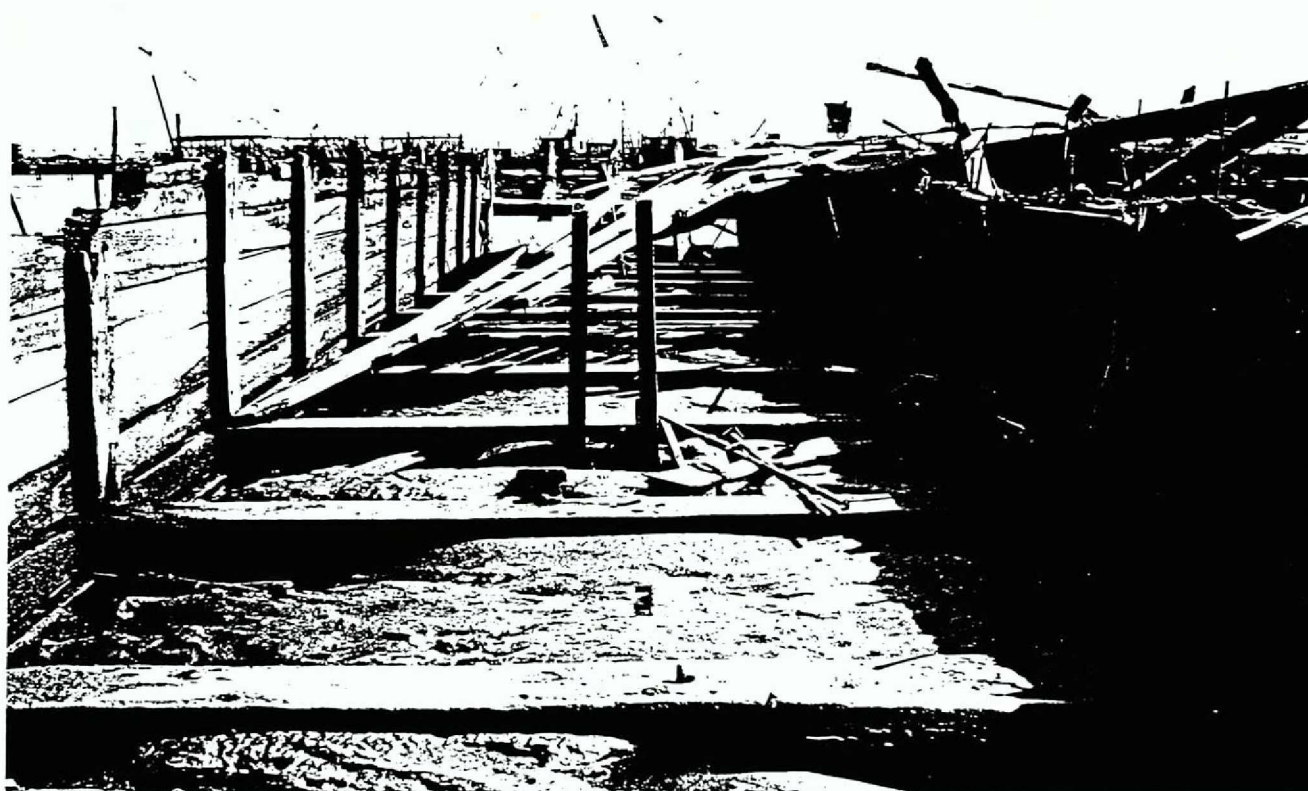
PHOTO AA: Vessel 24, view east along the centerline of the vessel toward its stern. At the sides of the picture are two longitudinal bulkheads which formed part of the hull structure, about halfway between the centerline and the sides of the hull. These bulkheads consist of thick timbers piled on each other; they are bolted to each other and to the vertical posts alongside. The two vertical posts in the center of the photo helped steady a vertical post (now entirely missing) that extended up to the roof of the deckhouse. (Neg. 404-15)

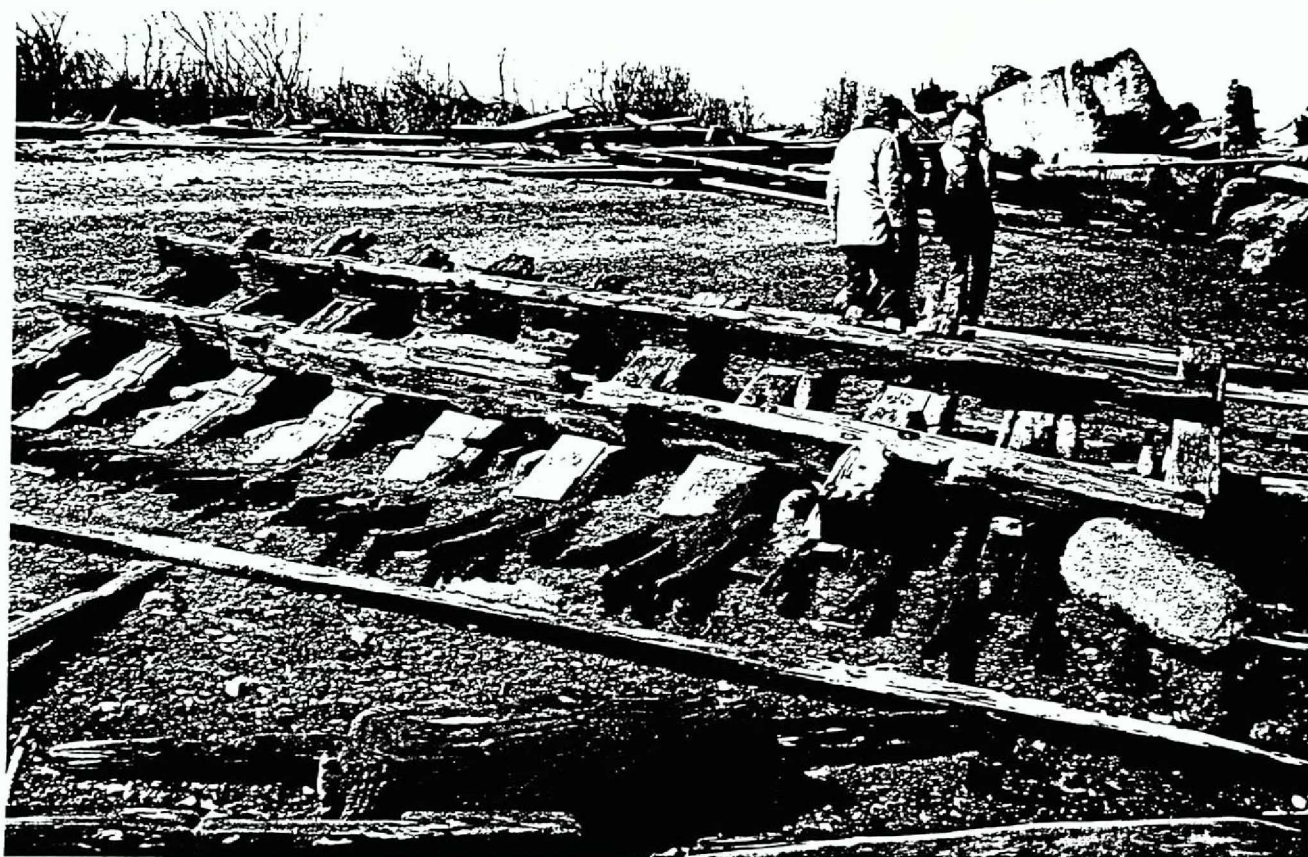
PHOTO BB: Vessel 31, view to northwest, on land just southwest of the former shipways. This is a fragment of the hull of a powered vessel; detailed analysis of its structure suggests it was the engine bed and may have served in a paddlewheel boat. The remains of the vessel's ribs are the darker curved pieces of wood extending from the bed. This fragment, like the rest of the vessel remains scattered along the shoreline, lacks sufficient context to reveal more than the information already obtained from the field survey. (Neg. 403-31)

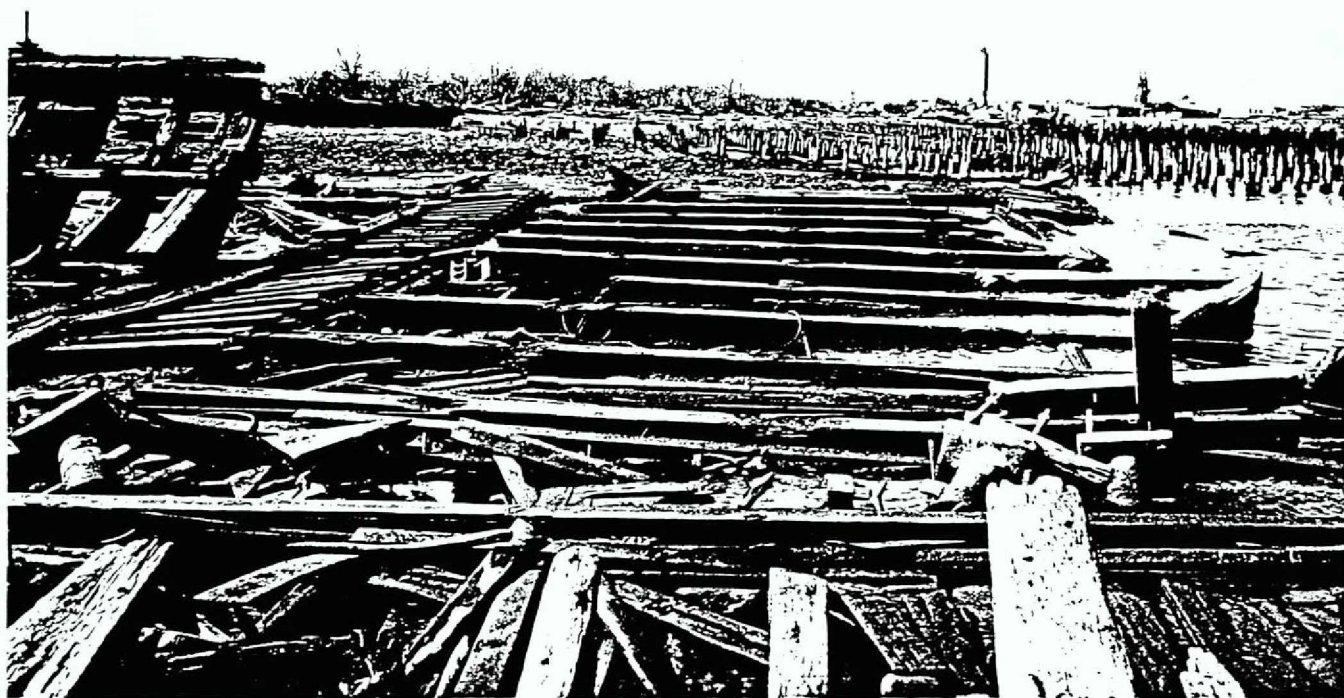
PHOTO CC: Vessels 26 (foreground), 25 (middle), 27 (left distance), and 24 (upper left corner), showing most of the remains within the easterly of the two historic areas delineated in Fig. 3. The portion of vessel 24 seen here is the same as that seen close up in Photo Z. Vessel 25's remains consist of its bottom planking and a fallen side. (Neg. 404-7)
