1B Field Testing Report for 361 Great Kills Road

(Poillon-Seguine-Britton House) Block 5195 Lot 6, Great Kills, Staten Island, NY

LPC 91-1594

April 1997

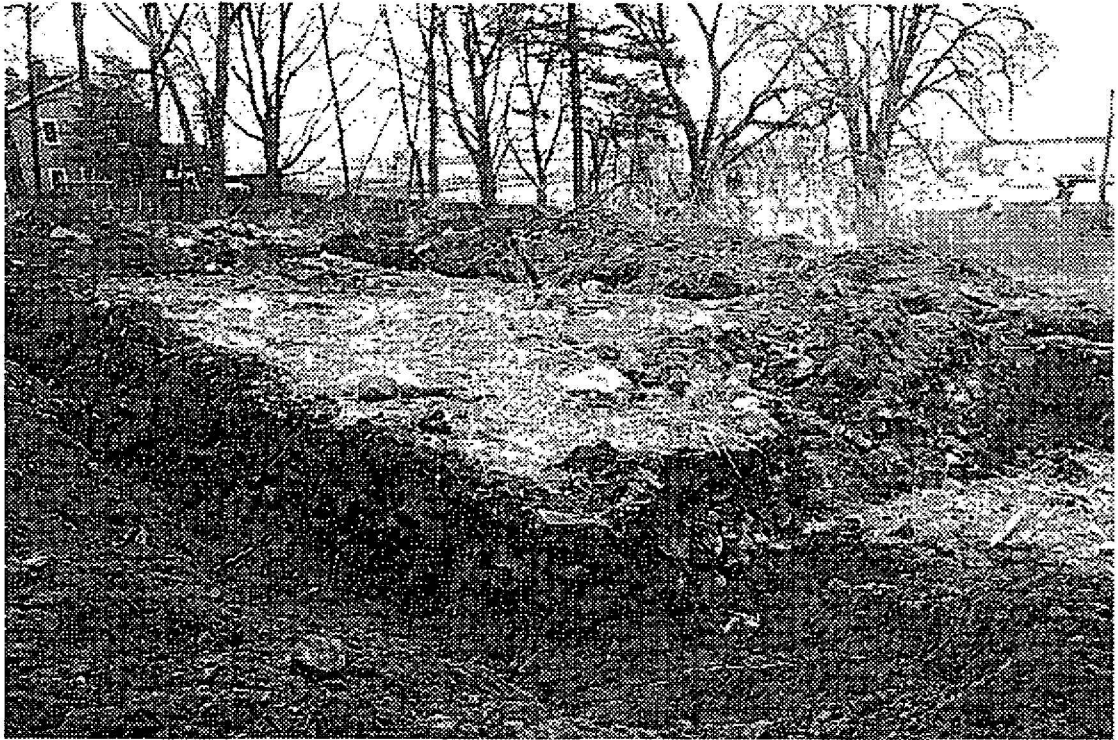
4 Northwest corner of the original Poillon house foundation exposed in foundation trench 1 (FT1) on the right and 4 (FT4) on the left. The view is south toward Great Kills harbor. (3/17/97)

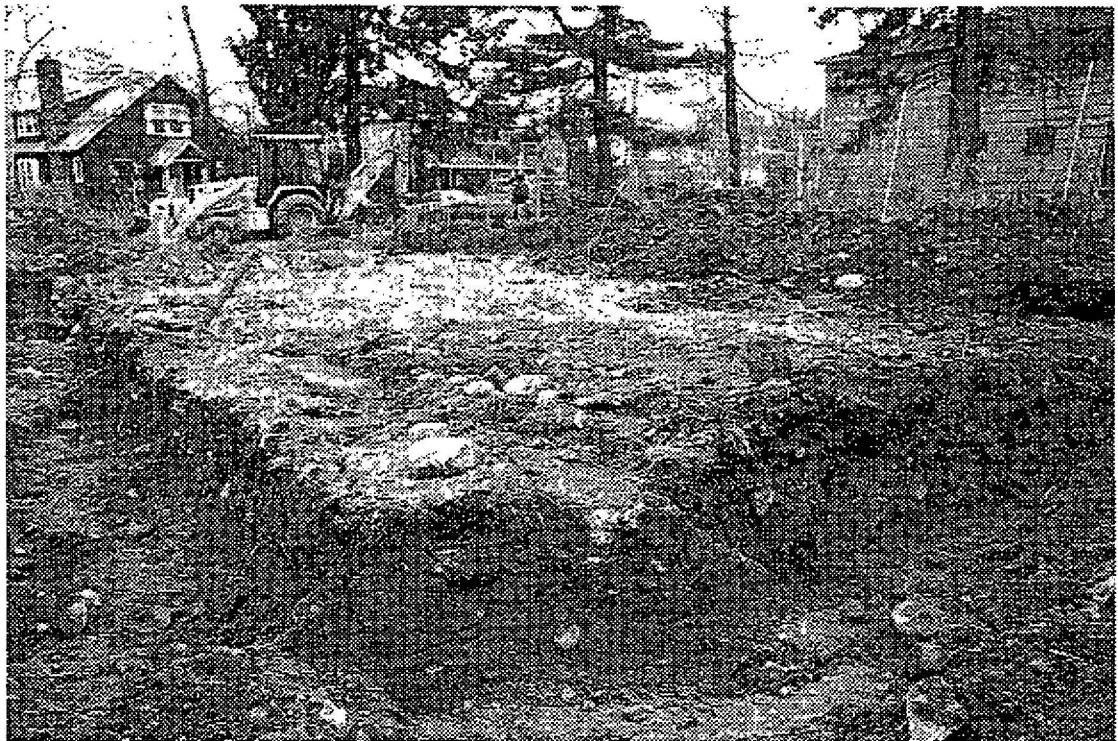
5 Foundation trench 2 (FT2) on the left and 3 (FT3) on the right. The view is northwest toward Great Kills Road. Note that the eastern foundation wall in FT3 (right) is less well-defined than the southern wall in FT2. Damage from fire and demolition was greatest in this part of the structure. (3/17/97)

most complete and in the best condition (see Figure 7), but it lost much of its definition as it extended east toward what was known as the "kitchen wing." This was the frame structure moved into place and altered when the Poillon house was enlarged by John G. Seguire, Jr., in 1845 (Johnson 1997:personal communication). It was also where the building was most severely damaged by the two fires that destroyed the house between 1989 and 1993. The most intact elements exposed in FT3 on the eastern side were cement structural supports that may have been related to a hearth located on this side of the building as mentioned by William McMillen, Chief of Restoration at Richmondtown, during a conversation about the house (McMillen 1997:personal communication; see Figure 5).

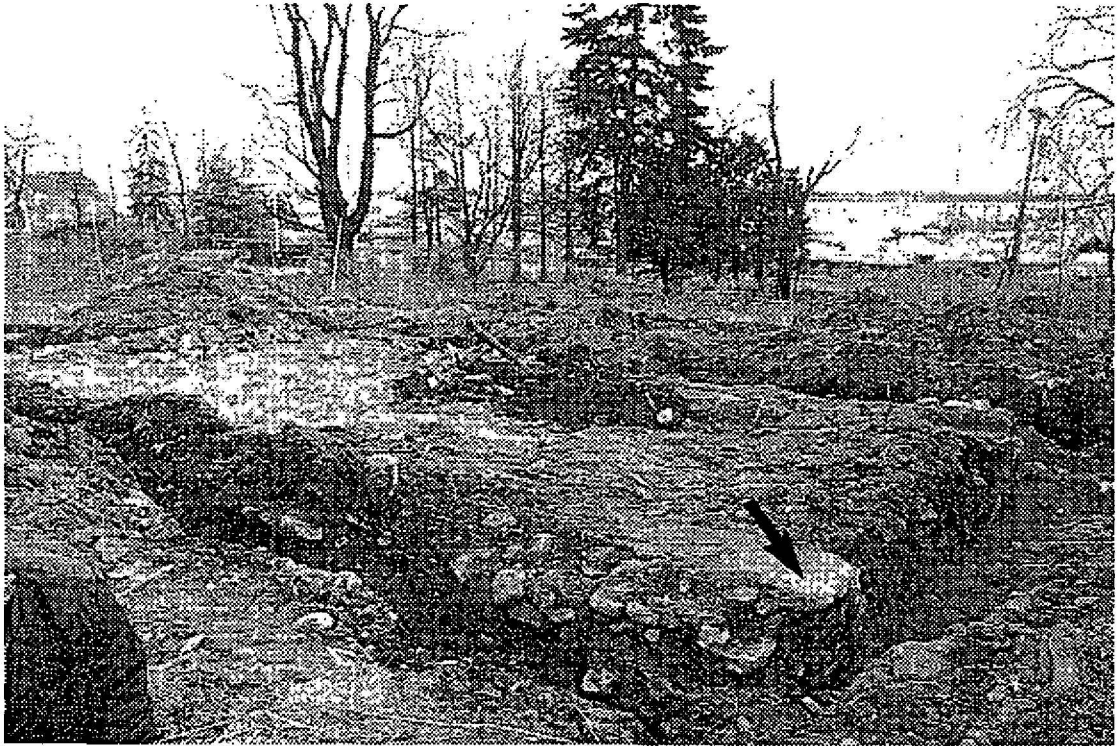
6 The outside of the Poillon house foundation traced in four backhoe trenches. The view is from the northwest corner of the foundation looking southeast. The northern wall in FT4 is in the foreground, the western wall in FT1 is on the right. Great Kills harbor is in the background. Note structural support (arrow) possibly for a former hearth. Similar supports were noted in the eastern wall. (3/18/97)

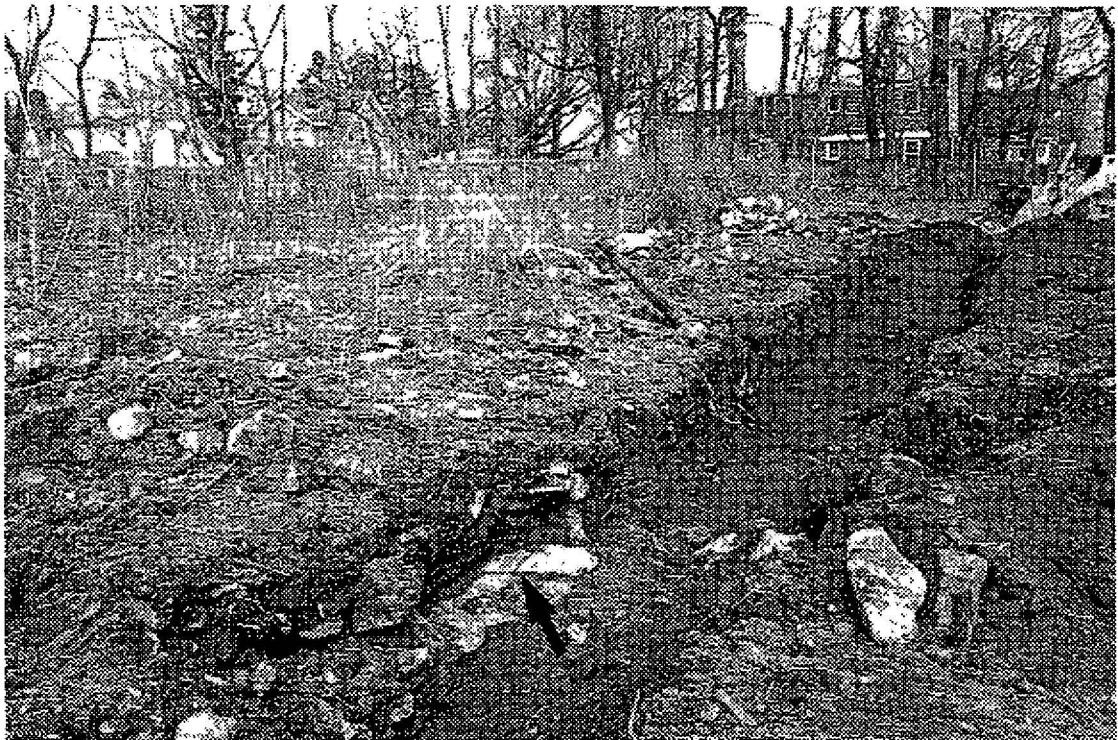
7 Southwest corner of the original Poillon house foundation is in lower left corner of the picture. Foundation trench 2 (FT2) extends to the right. The view is east. Note the paving stones (arrow) that purportedly marked the entrance to where a boiler and furnace were located (see Figure 13 for detail of steps). (3/18/97)

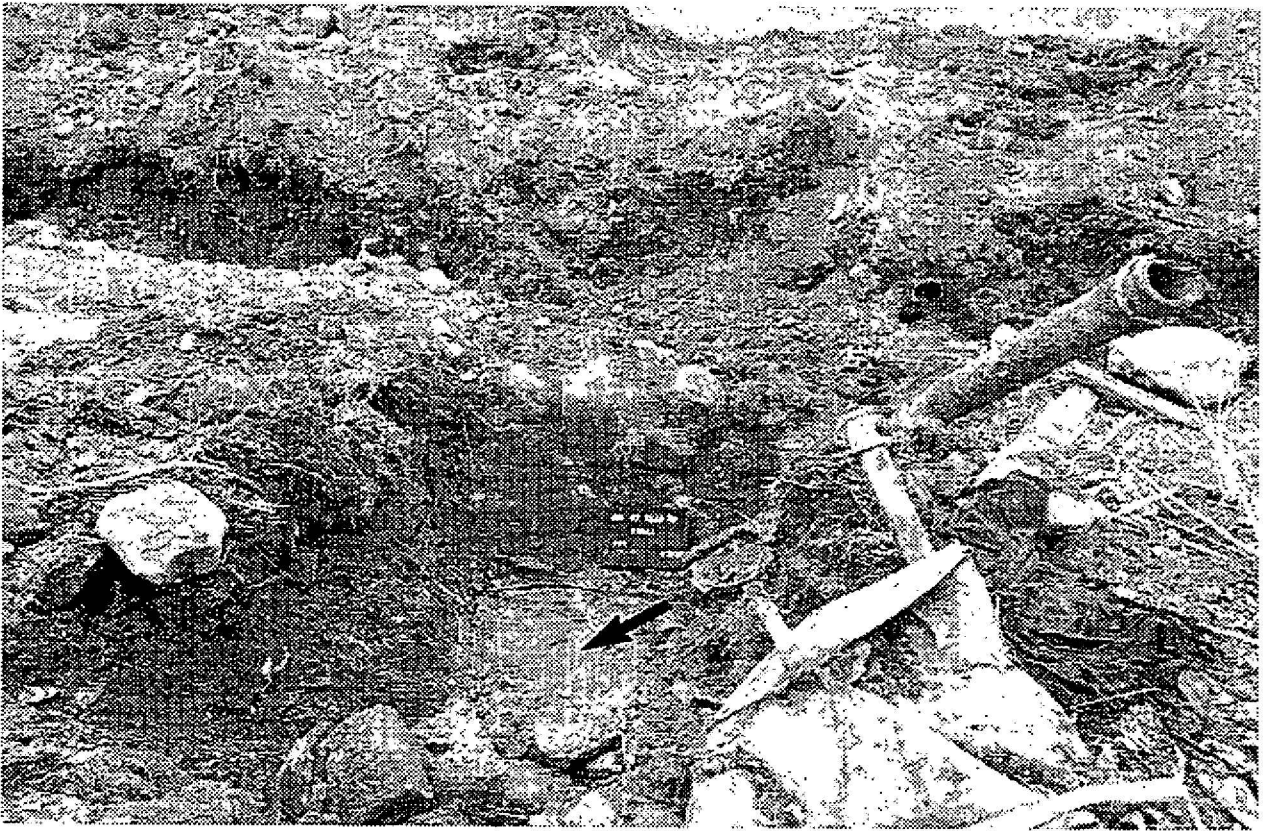
8 Interior section of the southern foundation wall, its smooth side, abutting a concrete floor (arrow). Excavating this pit (BP1) revealed charring and building debris including stones, wood, and pipes. (3/18/97)

The backhoe pit (BP1) placed on the north side of the southern foundation wall exposed in FT2 was intended to allow examination of the inside of the wall to confirm the assessment that the foundation was built from the inside out. Based

on the findings, it appears that a rectangular cellar hole was excavated and the dry-laid stone walls laid from the inside, thus eliminating the need for a builder's trench. The evenness of the inside of the wall exposed in the backhoe pit (BP1) confirmed this assessment (see Figure 8). In addition, as noted earlier, the excavation determined that a concrete floor had been poured or laid in this section of the cellar.

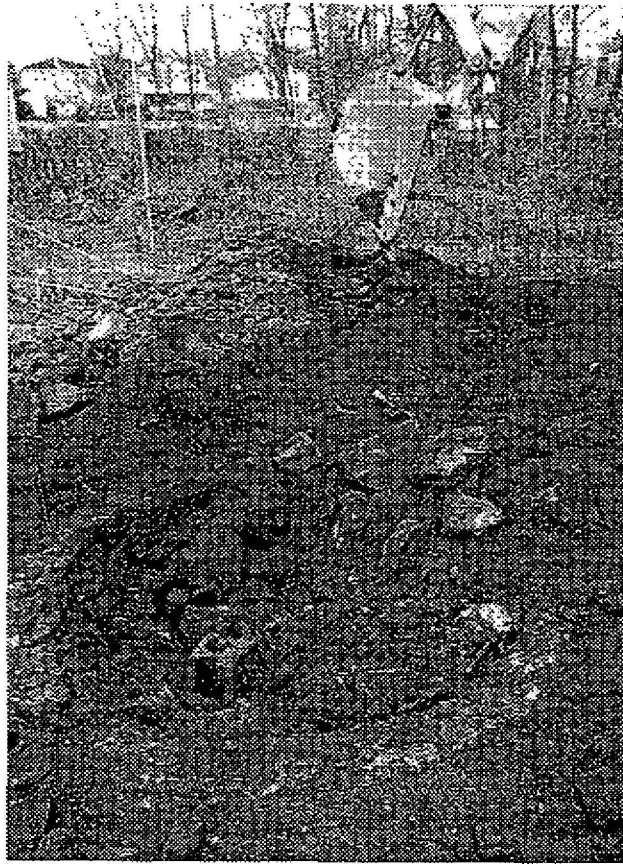
9 Top of a mortared brick feature (F1) filled with stones and cinder block. Thought to be a dry-well, the mortar sealing the interior and its location next to the house indicates it was probably a water cistern. (3/18/97)

The mortared brick cistern (F1) was located just northeast of the corner formed by FT3 and FT4 (see Figure 3). When the Poillon-Seguine-Britton house was standing, this feature was located on the north side of the kitchen wing, between a kitchen entrance and the northeast corner of the old foundation (see Figure 3 for location in relation to the former structure). It is more than likely its construction dates to the mid-19th century occupation of Joseph G. Seguine, Jr. (see Dibble 1981 in Geismar 1996:33). The mortared brick walls, sealed with additional mortar, and probably a floor of similar construction although it was obscured by standing water, indicates it was intended to hold liquid. Its location suggests it was meant to collect and store rainwater from the roof of the building (if it were a dry-well, it would have had an open bottom so water could drain away). Backhoe excavation of the feature revealed that it was filled with cinder blocks, bricks, and foundation-type stones but was still holding water. No artifactual material of archaeological significance was noted during this excavation which was virtually complete (see Figures 9 and 10).

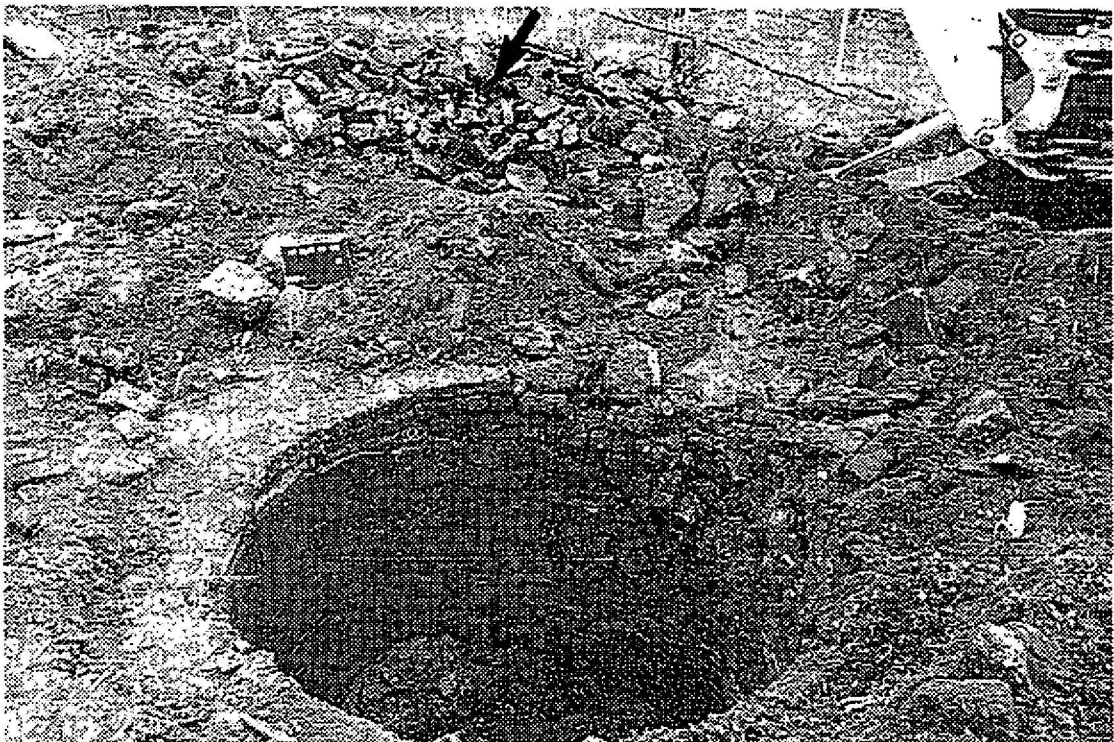
Just before going into the field, a question to Marjorie Johnson regarding the whereabouts of any known features resulted in the aforementioned information about the circular brick feature next to the house. Known to be located on the north side of the building and believed to be a dry-well, this feature (F1) was sought, found, excavated, and identified as a former water cistern (Figures 9 and 10 and below). Daniel Pagano, director of archaeology at the New York City Landmarks Preservation Commission, was on site when F1 was located and tested using the backhoe (testing virtually emptied the feature; see Figure 10).

10 The cistern (F1) almost completely emptied by the backhoe. Note stone, brick, and cinder block debris in background (arrow) that filled the feature which still held water. (3/18/97)

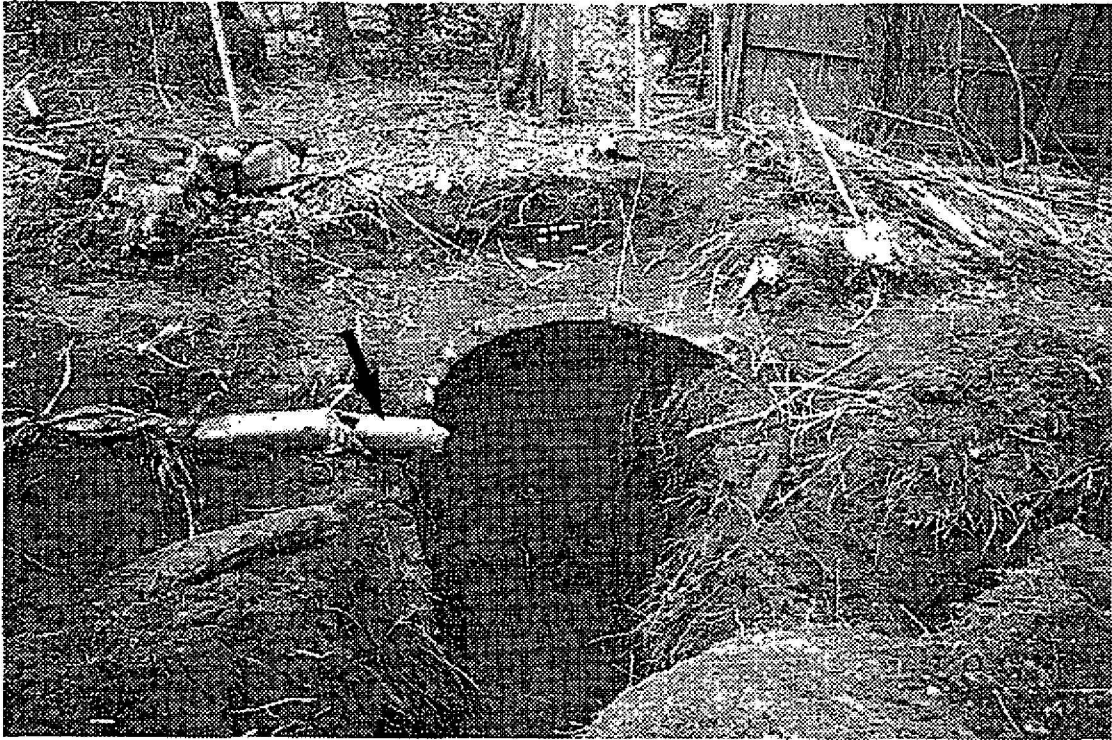
To determine the feature's size, the backhoe was used to excavate outside its western quadrant, but the depth of the excavation made it unsafe for close inspection. Instead, the bricks on the feature's western side were removed with the backhoe and, like F1, virtually the entire feature was excavated (see Figure 11).

11 Beehive-domed, mortared brick cesspool with a terra-cotta-pipe (arrow), broken by the backhoe but in place, discovered in TT1. Although the brick dome was broken, the open-bottomed feature was well made. The backhoe broke away the western brick wall to test the deposit inside which was virtually sterile fill. (3/18/97)

The cesspool (F2), its mortar-sealed domed top partly destroyed (see Figure 11), was exposed about 1.2 ft. below the ground surface on the east side of the trench (if the dome were intact, it would have been located just under the surface). A stone and sand fill with ash was found inside. The cesspool feature (F2), like the cistern (F1), was intensively tested with the backhoe and proved devoid of significant artifactual material. While the fill contained some shell, only four distinctive artifacts were noted: a corroded shovel blade, two iron rods that may have been cast-off hinges,³ and an 1.5-ft. long corroded iron spike. All were found near the bottom of the feature which was open ended and founded on ash and sand.

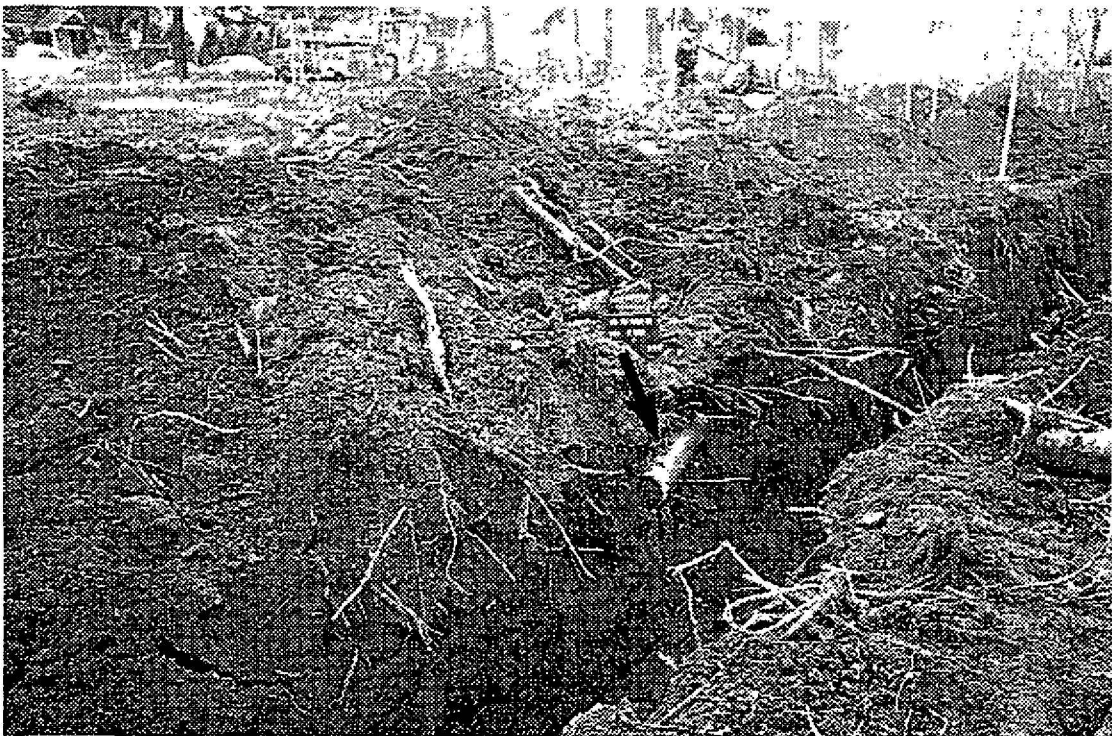
A second brick feature, the beehive-domed cesspool (F2) mentioned earlier, was later located in TT1 on the eastern side of the property as was a slag deposit that contained at least some household trash since it included a long bone from a cow. The well-made cesspool feature was fully exposed, revealing that a terra-cotta sewer pipe entered it from the north (Figure 11). Other sections of this pipe were later found further north (nearer the kitchen wing) in TT1 (Figure 12).

12 Northern part of test trench 1 (TT1). Note the terra-cotta sewer pipe (arrow) *in situ*. This apparently carried sewage from the Poillon-Seguine-Britton house to the cesspool (F2) and was probably a late 19th-century construction. (3/19/97)

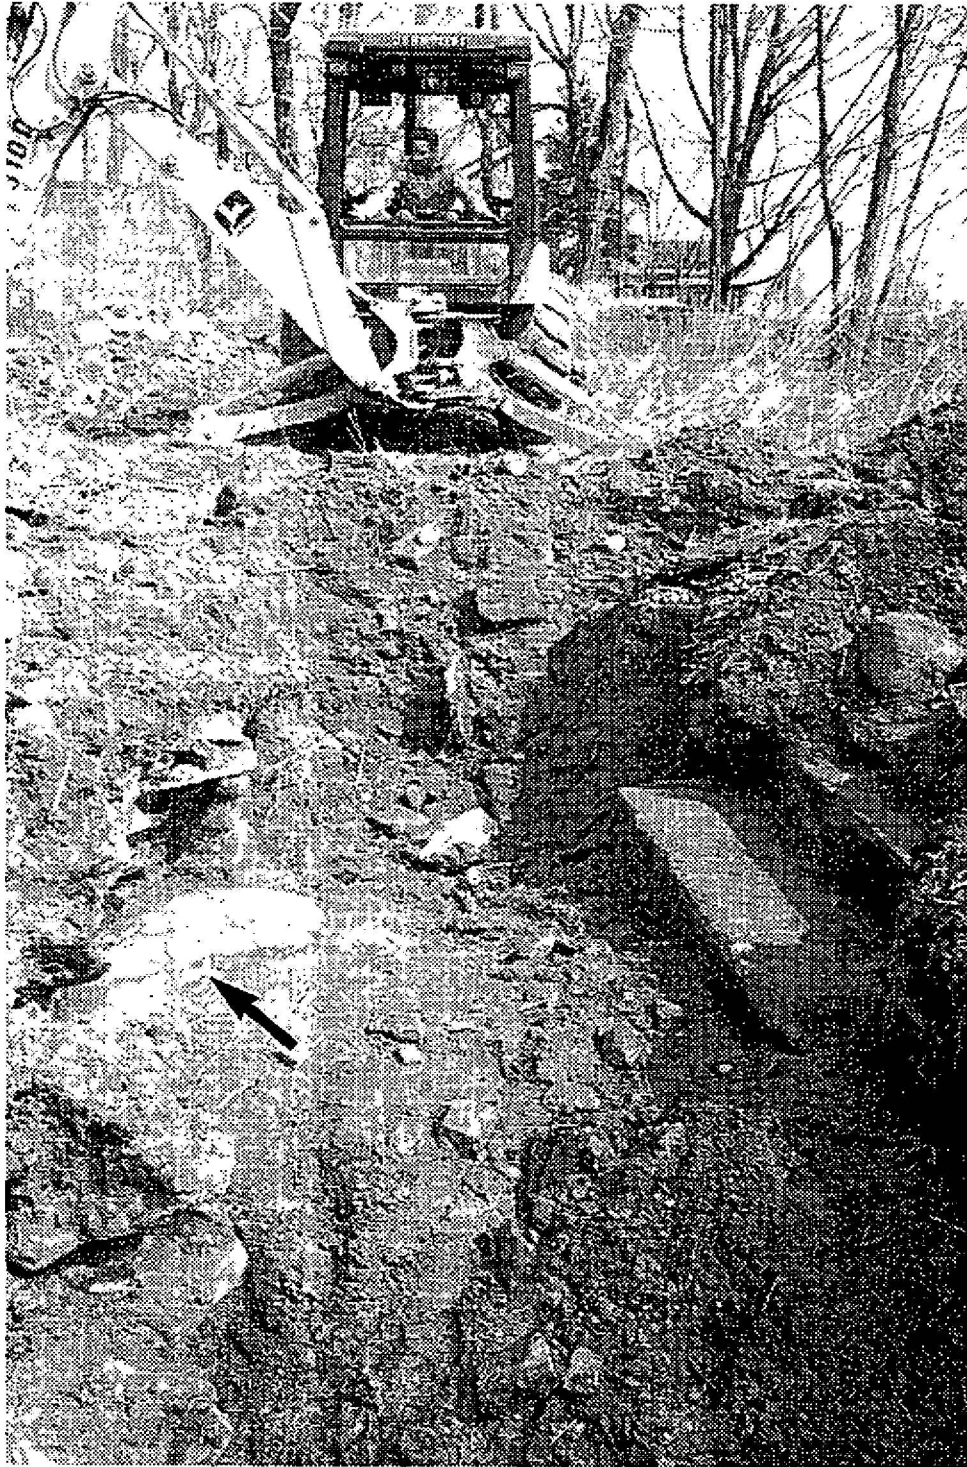
Tracing the building's southern wall in FT2 exposed where a boiler and furnace had been located (Thompson 1997:personal communication) and the concrete steps that led to this area from the far side of the trench. The steps provided access to the foundation under the veranda added in 1845. Excavation of the steps and the opening in the foundation marked by paving stones revealed a charred wooden sill at the base of the opening. Both the paving stones and the concrete steps were photographed (Figure 13; see also Figure 7). Further backhoe exploration and shovelling indicated that the foundation wall on this side, and therefore throughout, was about 2 ft. thick and extended about 3.25 ft. below the current ground surface where it was founded on a natural clay-like, reddish-brown soil. The unevenness of the foundation stones exposed in the backhoe trenches and the lack of a builder's trench suggested the foundation had been built from the inside out. This was confirmed when the backhoe exposed part of the interior side of the foundation wall and its concrete floor in BP1. Here, inside the foundation, the stones formed an even, neatly-laid wall (see Figure 8) as opposed to the rough texture of the outer surface exposed in the foundation trenches.

13 Detail of paving stones (arrow) and steps found during excavation of foundation trench 2 (FT2). The steps on the right allowed access under the veranda added to the house in the mid 19th century. The steps, which are concrete, were apparently added after the foundation was built. A badly charred wooden sill at the base of the foundation (not illustrated) abutted the paving stones. (3/17/97)

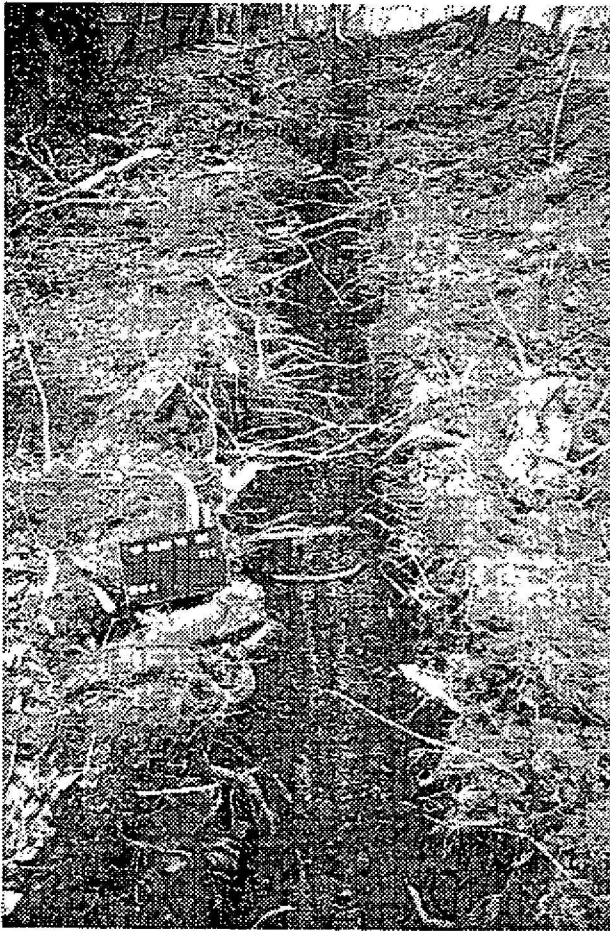
14 Test trench 1 (TT1), the longest of the test trenches, looking north. Sterile soil was encountered almost immediately below the surface in the southern part of the trench. (3/19/97)

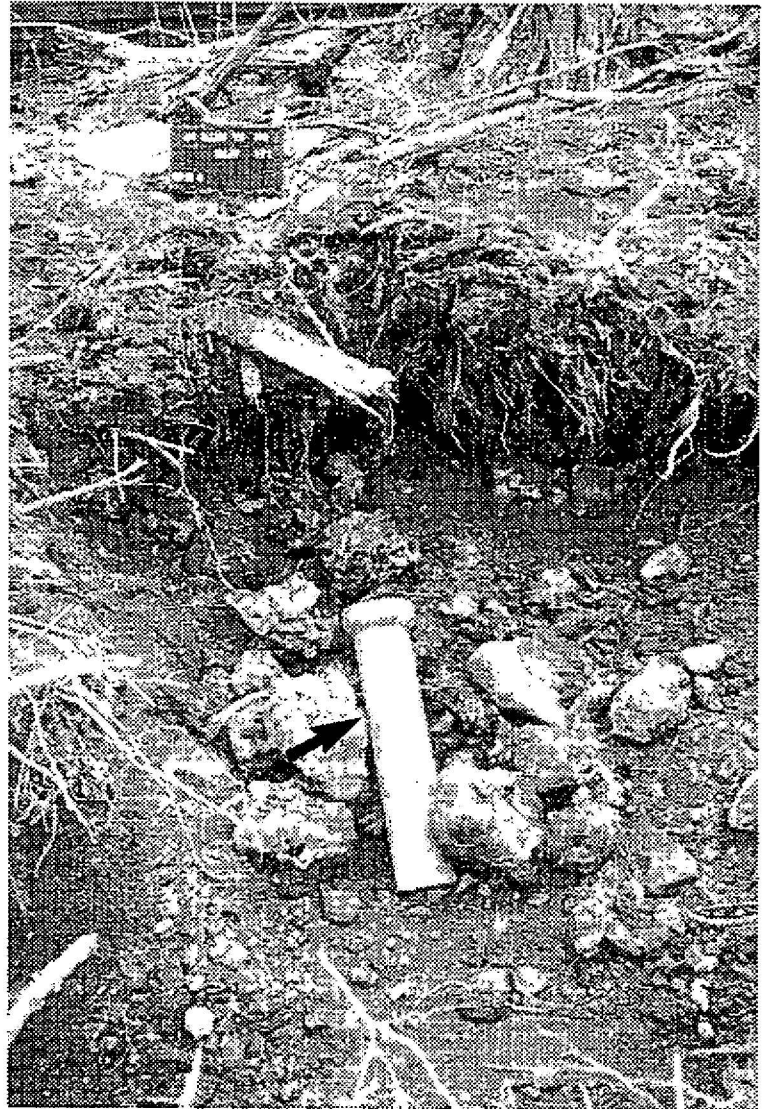
15 A large slag deposit found about 77 ft. north of the southern property line. A segment of a terra-cotta sewer pipe (arrow) in the deposit may be trash or have been dislodged by the backhoe. An animal bone (a cow tibia) was found in the slag. This deposit possibly provided drainage and served as an overflow for a cesspool (F2) found about 8 feet further north, nearer the house. (3/18/97)

Excavation of TT1, the 140-ft. long test trench that began at the southern property line and continued north into the area tested in 1985 (Kardas & Larabee 1985a, 1985b), indicated that the southeastern part of the property was not filled. As testing continued north and approached the plateau where the house once stood, not only was fill present, but the dense deposit of slag noted previously (see Figure 15) was encountered about 77 ft. north of the southern property line. Here large chunks of slag were mixed with some household trash (a cow tibia was identified in the field by Shelly Spritzer). This was apparently fill used to create a drainage area or perhaps an overflow for the cesspool (F2) found just to the north, although no pipe leading from the brick feature (F2) to the slag deposit was noted in the test trench. However, a section of unattached pipe was found in association with the slag deposit (see Figure 15).

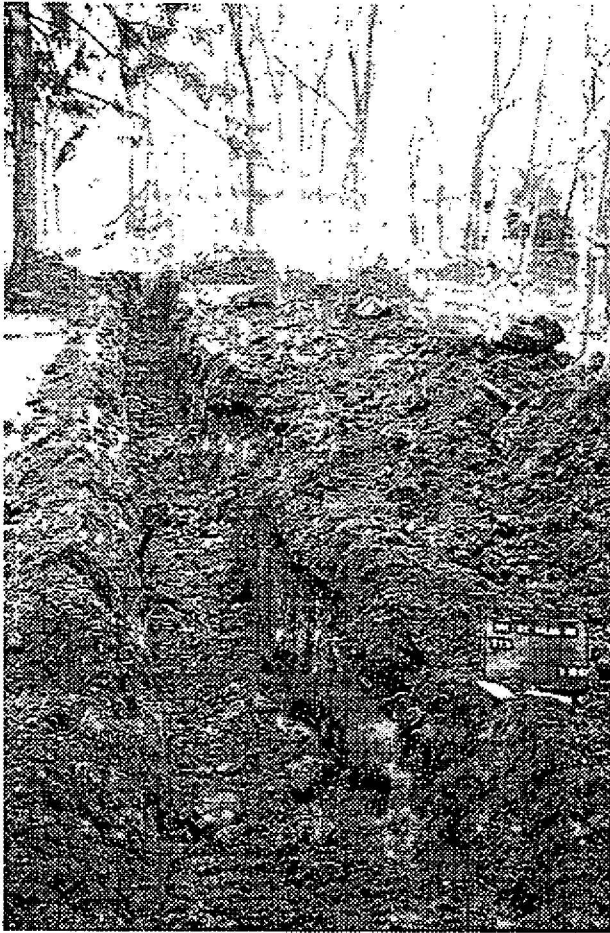
16 Test trench 2 (TT2) looking east. Fill was deepest near the eastern end. (3/19/97)

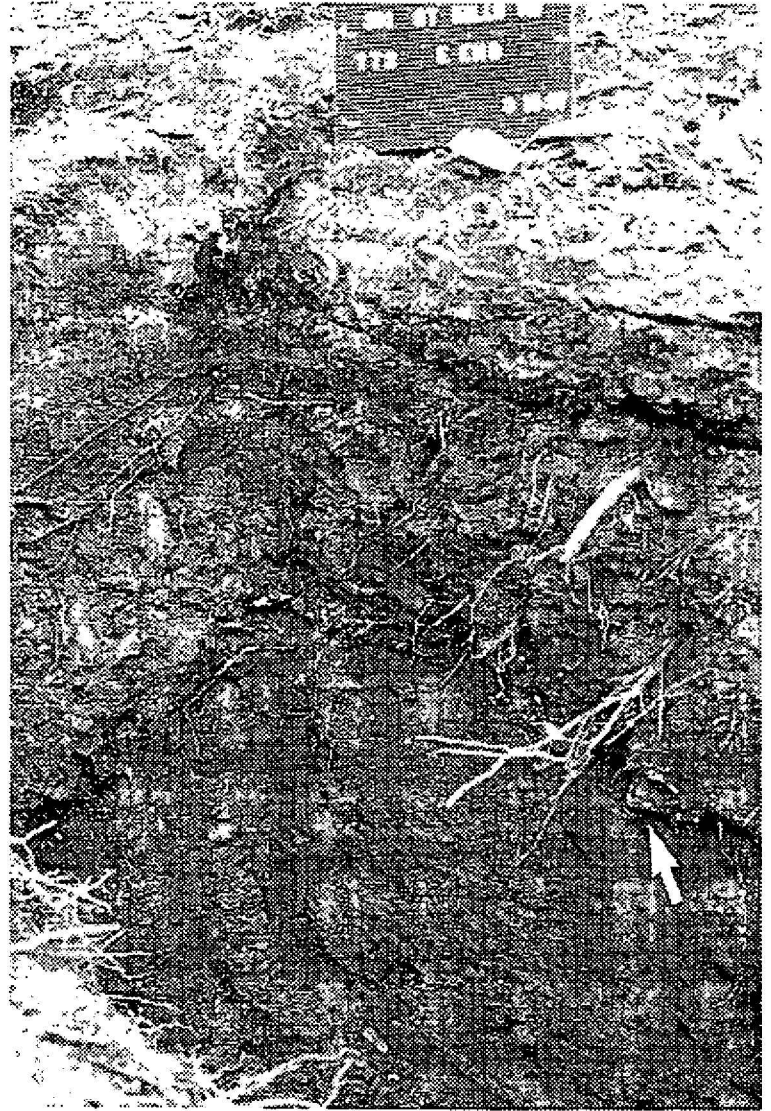
17 Eastern end of test trench 2 (TT2) in the vicinity of a concrete footing for the demolished garage. The fill on the south side of the trench included a shell deposit with a brick beneath it (arrow) indicating it is a relatively recent deposit. (3/19/97)

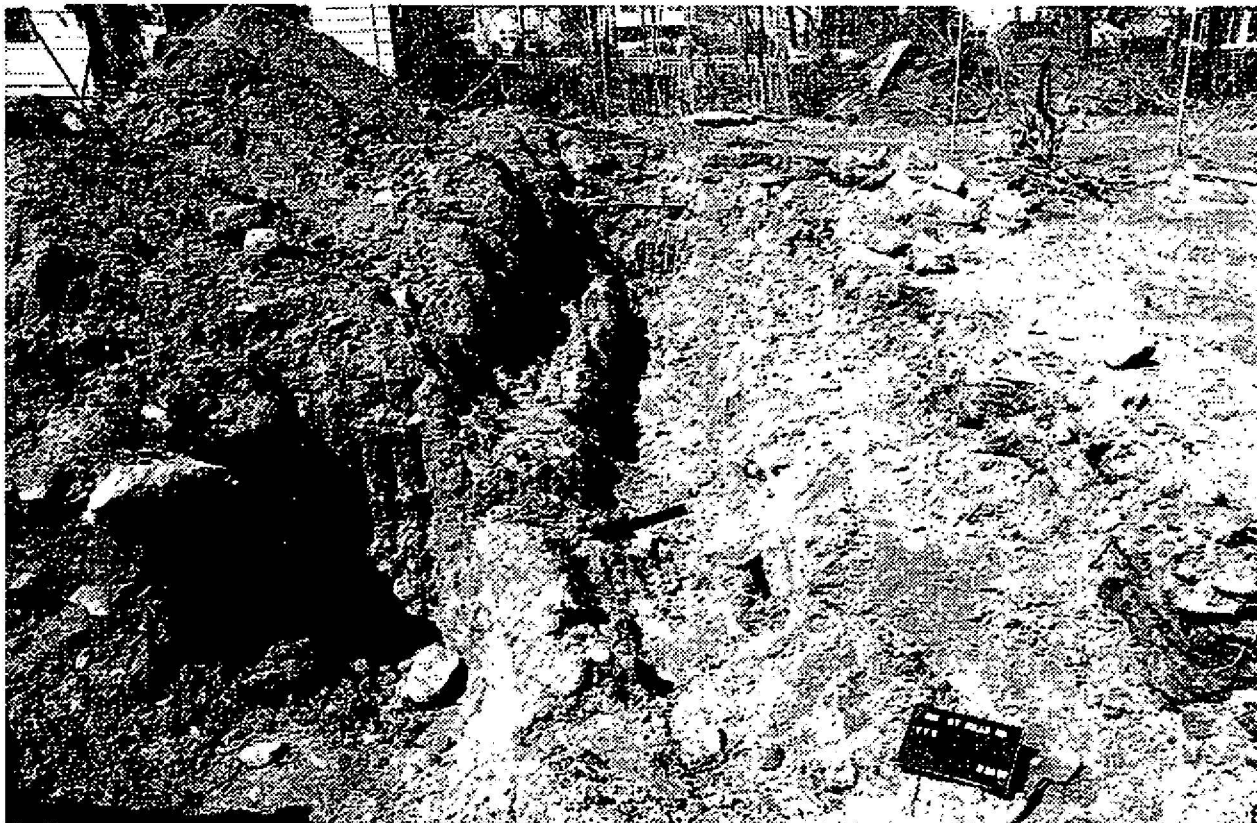
Undocumented stone footings or foundations were found in two trenches near the house. A small footing was exposed in TT5, a north-south trench that cut through the site of the former 19th-century kitchen wing (Figure 18), and part of a relatively substantial dry-laid stone foundation or footing was found in TT7, an east-west trench that ran south of the house foundation (Figure 19). Backhoe testing on either side of the construction in TT7 revealed it did not extend much beyond the trench and its function remains unknown. The stone footing in TT5 may have provided support for the kitchen wing that had no basement.

18 Test trench 5 (TT5), a wide trench through the former mid-19th century kitchen wing site on the east side of the house. A dry-laid stone footing (arrow) was located and a trench extension was run west (TT5 ext) to trace the footing that proved to be little more than a pile of rocks. (3/24/97)

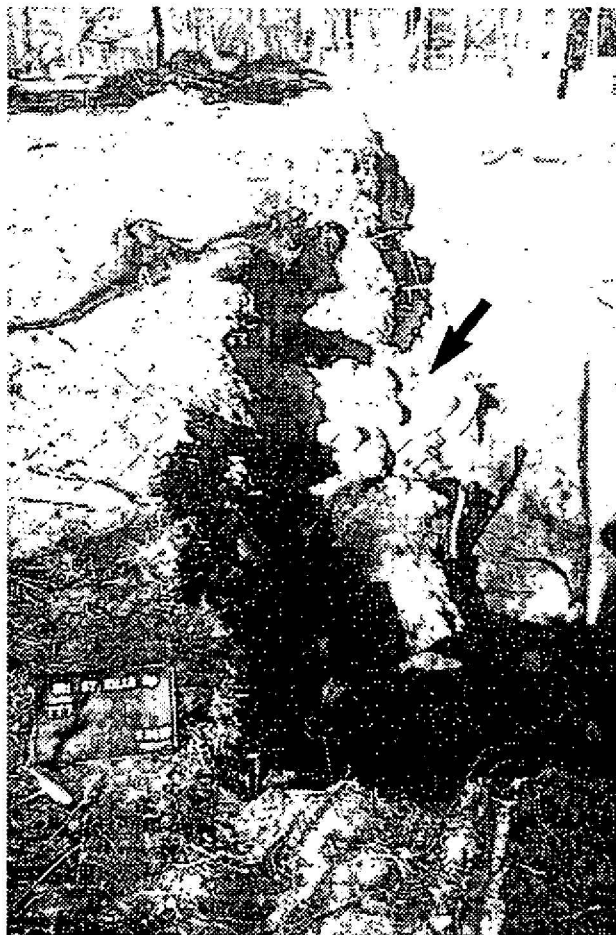
19 Test trench 7 (TT7) looking east with a substantial dry-laid stone construction exposed (arrow). The trench was widened to the north and south to determine if this construction continued, but it was confined to what is shown here and remains unexplained. (3/24/97)

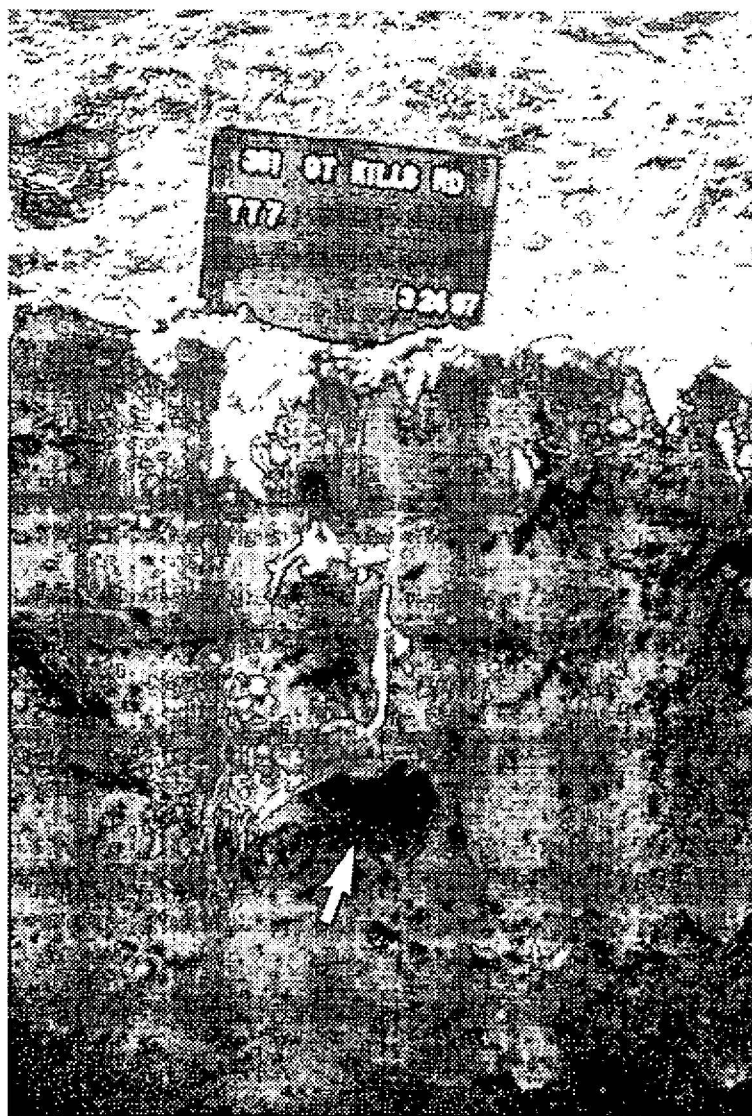
20 A broken terra-cotta drain pipe (arrow) *in situ* on north side of test trench 7 (TT7). The pipe, with fill above it, was broken by the backhoe and was also found on the south side of the trench. (3/24/97)

undisturbed ground surface buried under fill. (See Figure 20 for photos of a north-south running terra-cotta drain in TT7.) The absence of a buried surface under the fill also suggested that Native American deposits protected by fill were not likely to be an issue on the site, and, indeed, no evidence of Native American material was found in any of the trenches. Nor, as discussed below, was it found in any of the test pits where the excavated material was fully screened.

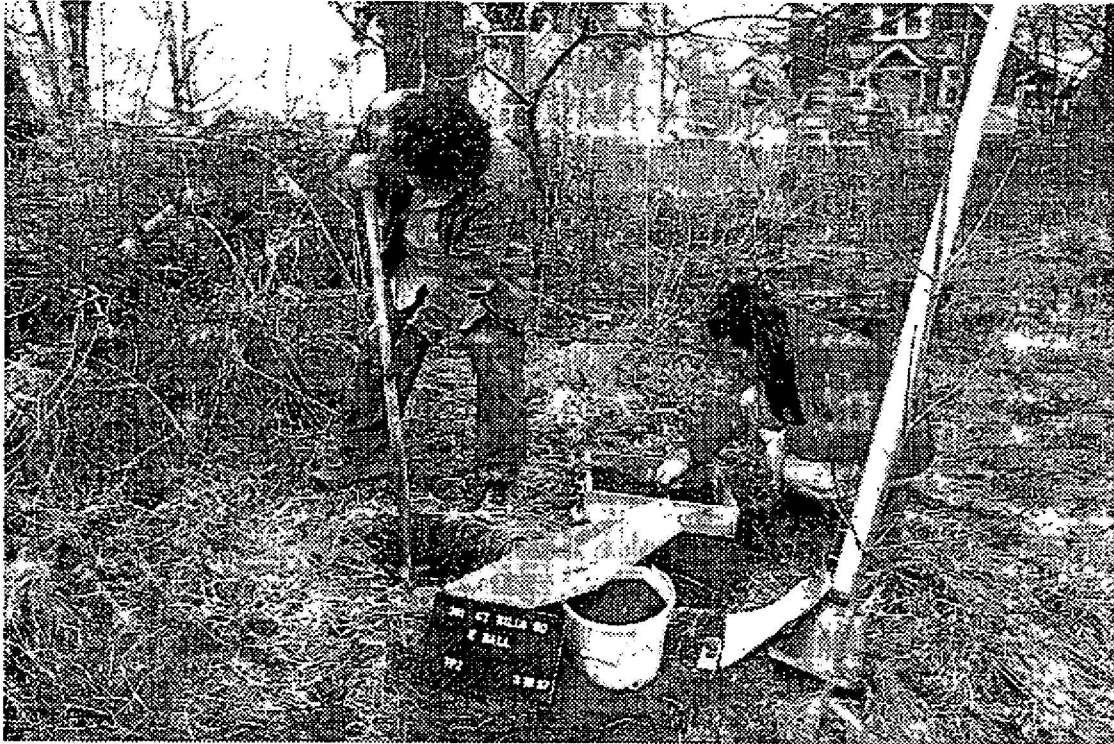
Excavation of the three test pits located north of the foundation (TP1, TP2, and TP2A; Figure 21) revealed a dark brown or dark gray-brown² sandy soil with silt, some clay, and stones that was difficult to dig. As mentioned earlier, although sterile soil was reached north of the house site in TP2, dense rocks made it impossible to continue to excavate much beyond the interface with fill. Artifacts were notably sparse, and the fill extended 2.45 ft. below the surface (TP2). South of the house, some fill was noted in TP5, TP6, and TP7, but natural soil was reached between 1.2 and 1.6 ft. below the surface in these tests (the water pipe in TP5 was about 1 ft. below the surface; Figure 22).

21 Excavating test pit 2 (TP2) north of the former house. The test pits were shovelled and all material screened through 1/4-in. wire mesh. TP2 was terminated in sterile soil when dense rocks made it impossible to continue. TP2A was opened nearby. (3/18/97)

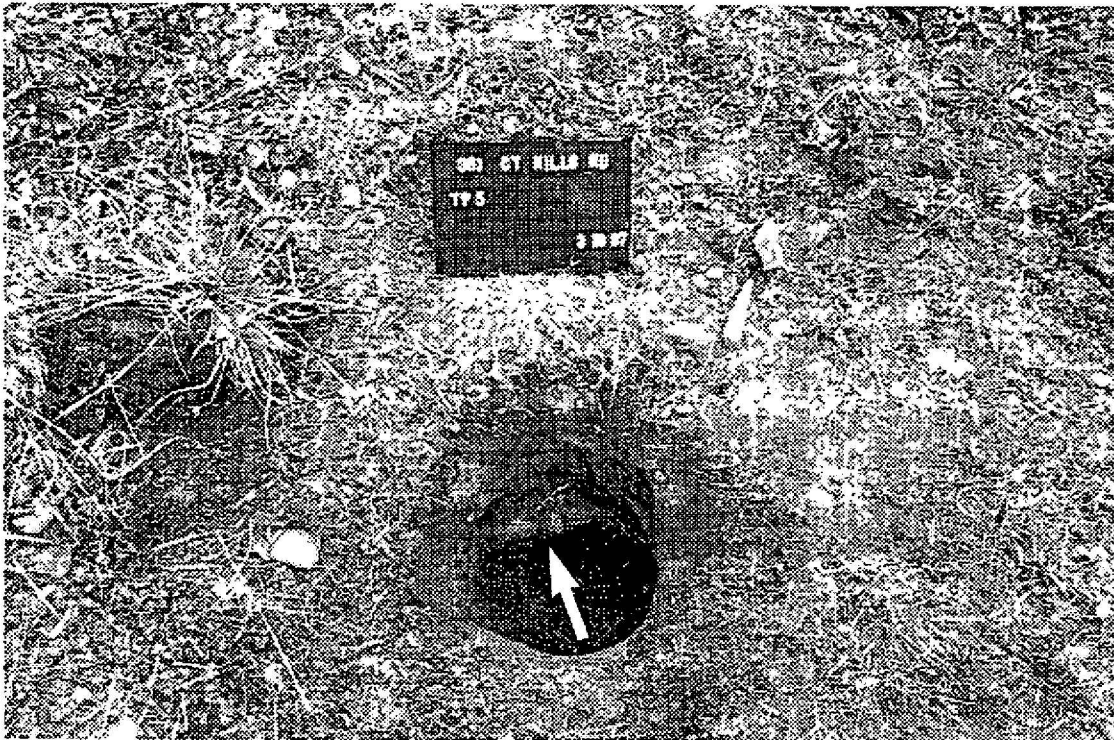
22 A metal water pipe encountered at .9 ft. BSG in test pit 5 (TP5) on the south side of the former house structure. The 10-in. trowel indicates north. TP5 was terminated at 1.55 ft. BGS at the top of sterile soil because the pipe (arrow) and stones made it impossible to continue. (3/18/97)
