ARCHAEOLOGICAL FIELD TESTING
THE NEHEMIAH PROJECT
BOROUGH OF THE BRONX, NEW YORK
CEQR 93-HPD-015X

by
Arnold Pickman

Submitted to
South Bronx Churches

June 1995

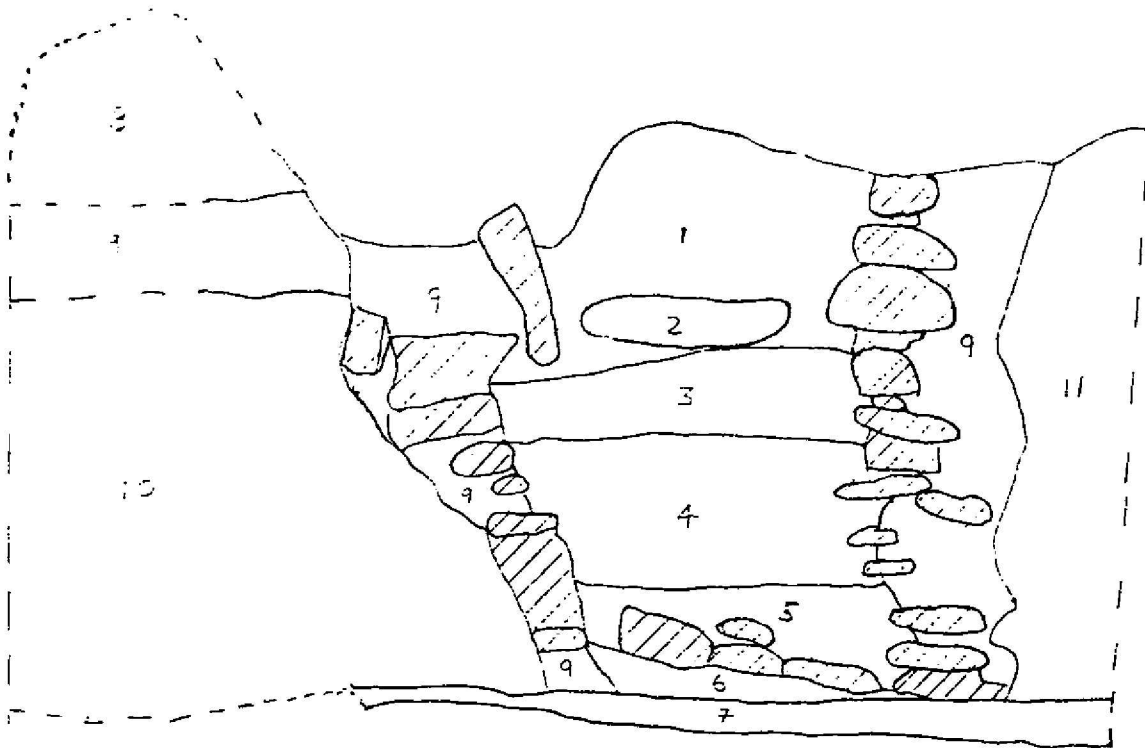
As noted in the discussion of BHTR 2, an intact portion of a second feature, designated as Feature 2, was noted in the northern profile of this backhoe trench. The feature was located in the southeastern corner of the Lot 15 backyard area. A profile drawing of the feature as it appeared in the backhoe trench wall is shown in Figure 4.

feature. This possible backyard surface is indicated as stratum 9 on Figure 4. This stratum also was noted at other locations in the north profile of BHTR 2 and the southern portion of the east profile of BHTR 1.

Figure 4
 North Profile Backhoe Trench 2 - Feature 2
 Scale: 1" = 1'

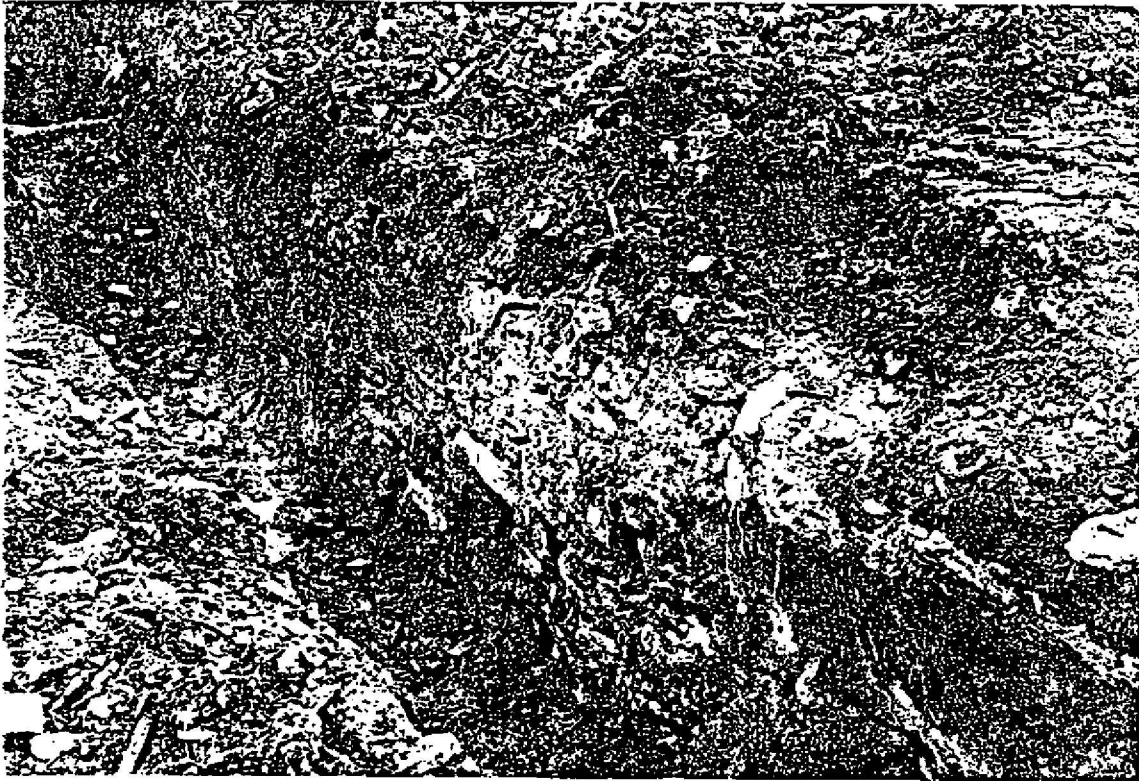
Backhoe trench 1 exposed the rear walls of buildings 13 and 14 (designated as W13 and W14 respectively on the site map - Figure 3; see also Plate 1). The 19th century maps (see Appendix B) indicate that as constructed in 1877, buildings 13 and 14 were separated by an alley located in the northern portion of lot 13. Between 1909 and 1923, a one story extension was added to the north side of building 13, covering the former alleyway. The rear wall of this extension (wall W13ext) was noted in the west profile of the backhoe trench (see Plate 1). It extended to the same depth as the walls of buildings 13 and 14, suggesting that the basement of building 13 was also extended across the former alleyway.

Plate 1
Backhoe Trench 1
View Southwest Showing Walls W13,
W13ext, and W14 (in Foreground)

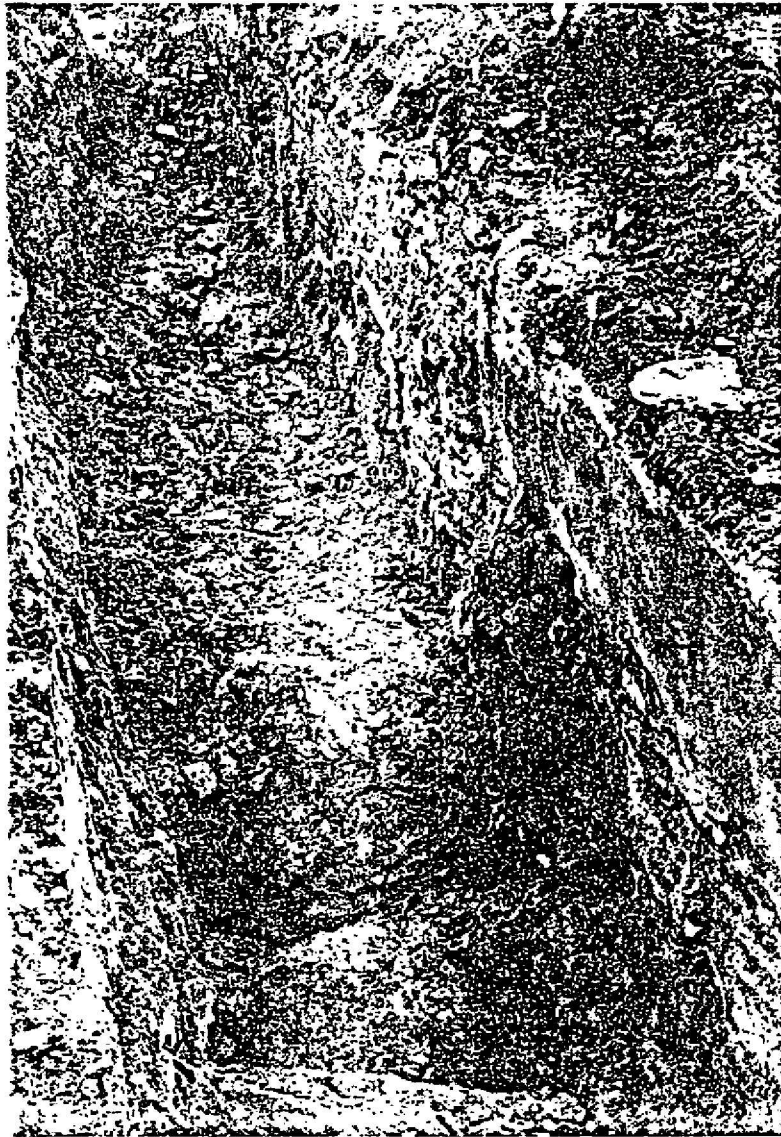
At the base of BHTR 1, at a depth of ca. 83-87" below datum we encountered the top of two "rock features", designated on the site map (Figure 3) as R1 and R2 (see Plates 2 and 3). These rock features appeared to extend westward beneath the base of foundation walls W13 and W14, and R2 also extended eastward beneath the later extension wall W15ext. Because of the depth of

Plate 2
Backhoe Trench 1
View South Showing Walls W13, W13ext, and W14 (at right),
W13ext (left foreground),
and top of R2 at Base of Trench (center foreground).

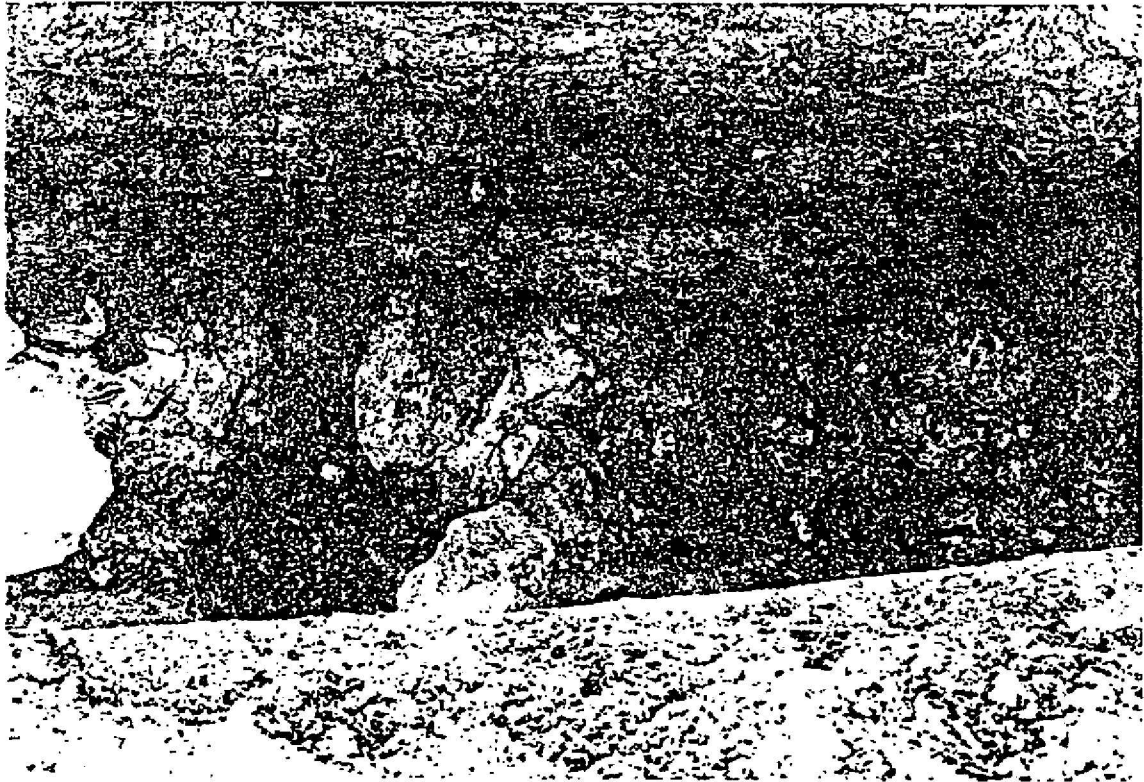
Plate 3
Feature R1
View from Surface Showing Top of R1 at Base of 38TR1
East Wall of Backhoe Trench at Top of Photograph

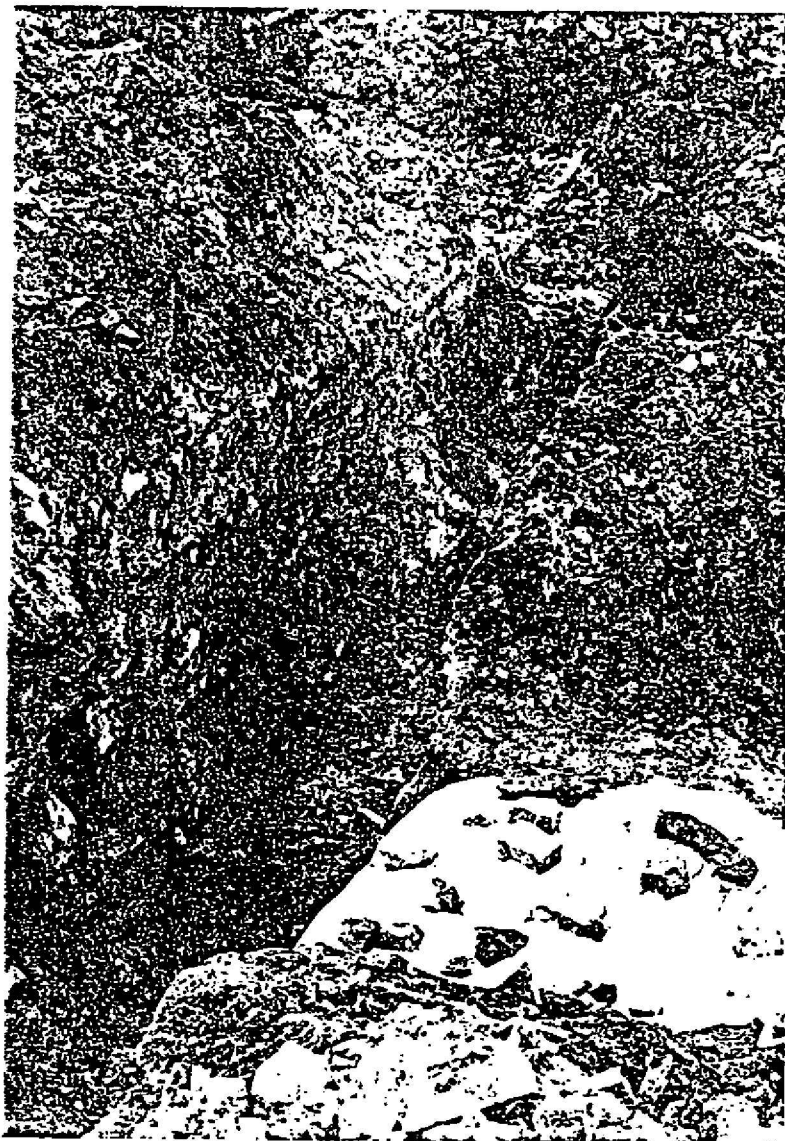
Since the feature walls were not solidly constructed (see Chapter III), Feature 2 was not noted during the process of excavation of BHTR 2, and its excavation may have resulted in the inadvertent removal of the southern portion of the feature. However, the southwestern corner of the feature was located only some 1 1/2

feet east of the northeastern corner of building 12 (see Figure 3 and Plate 4). Thus, some disturbance of the feature may have occurred during the construction of the latter building. This may also account for failure to note the feature during the course of the backhoe trench excavation.

Plate 4
Backhoe Trench 2
View Southwest Showing Wall W.C. at Left
Feature C (covered with plastic sheeting) in Right Foreground

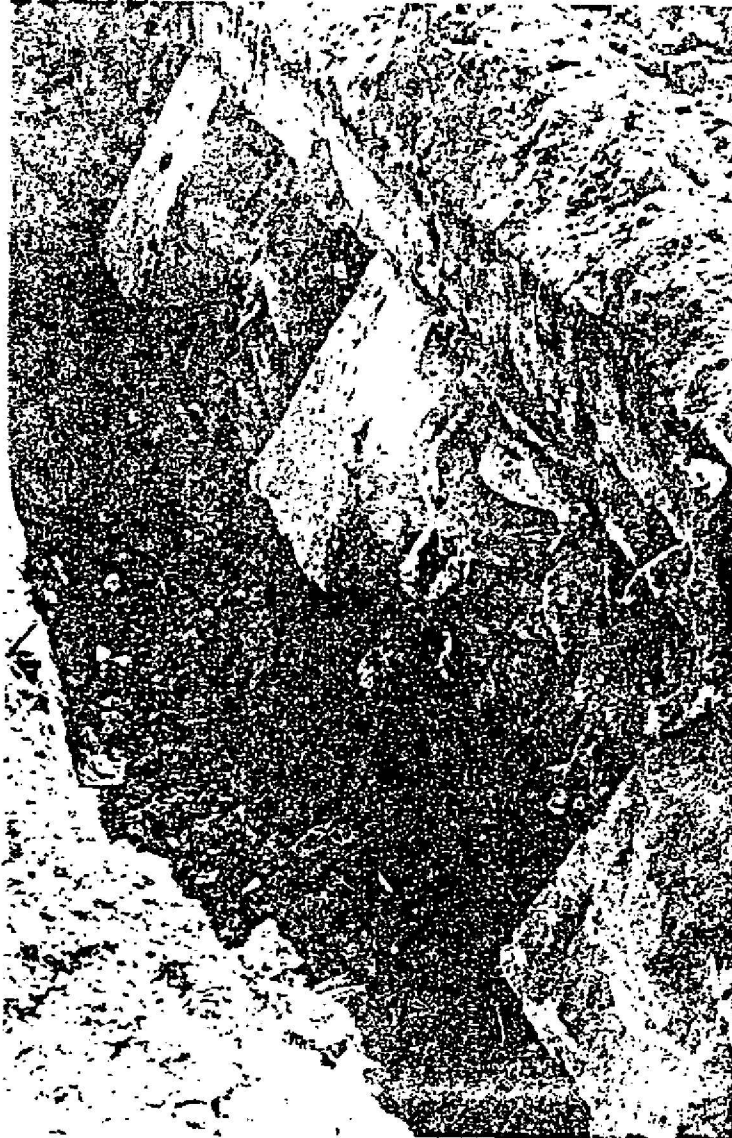
Plate 5
Backhoe Trench 7
View Southwest Showing West Foundation Wall of
Building 12 and Overlying Concrete Supports and Slab

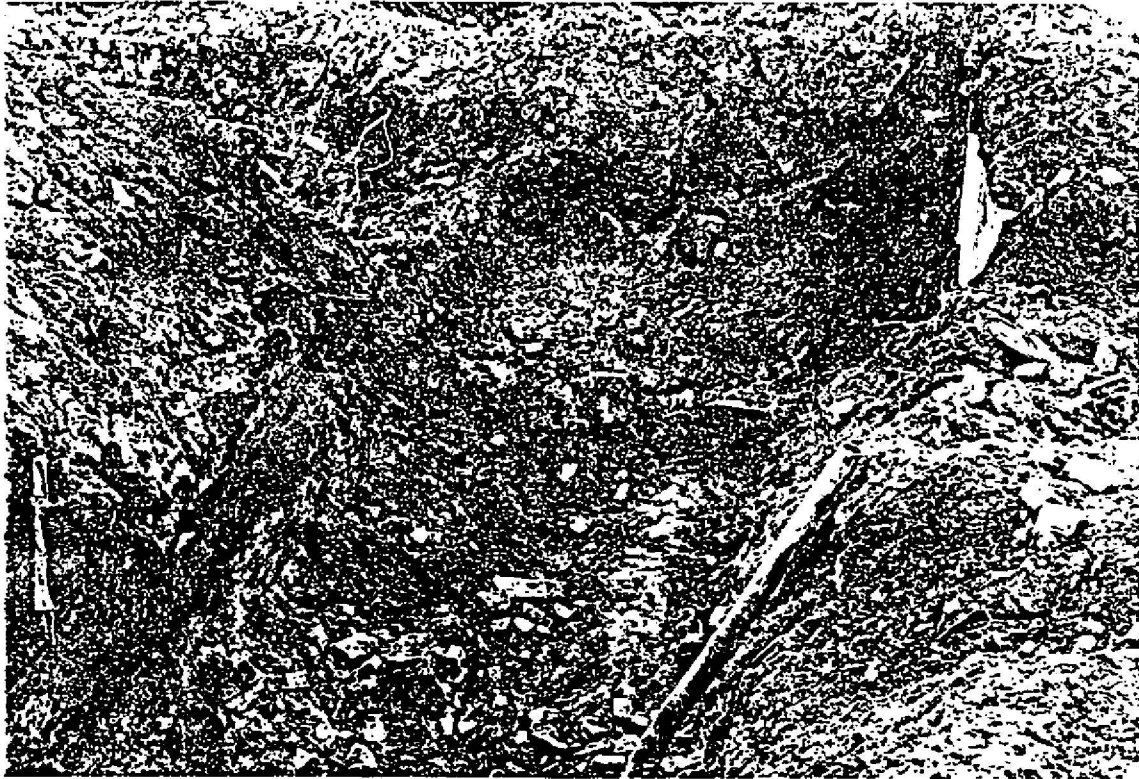
In lot 11, twelve feet west of the eastern boundary of the lot, BHTR 9 encountered the rear (eastern) wall of the stone foundation of the apartment building which was constructed on lots 10 and 11 between 1909 and 1923 (see Plate 6). As indicated on the site map (Figure 3), the northern end of this wall was aligned with the boundary line between lots 11 and 12. The base of this wall was approximately eight feet below datum.

BHTR 9 also encountered a low stone wall (see Plate 6) which appeared to be at the northern end of the alleyway pavement. The top of the remaining portion of this wall was approximately one foot below the level of the cement floor. The western extent of the stone wall was not fully exposed. Probing indicated that there were no additional wall courses below the single course exposed and no artifact deposits were noted in association with this wall.

Plate 6
Backhoe Trench 6
View North Showing Eastern Wall of Apartment Building Foundation
on Lot 11 (Left Foreground) and Low Stone Wall at
Northern End of Alley (Center of Photograph)

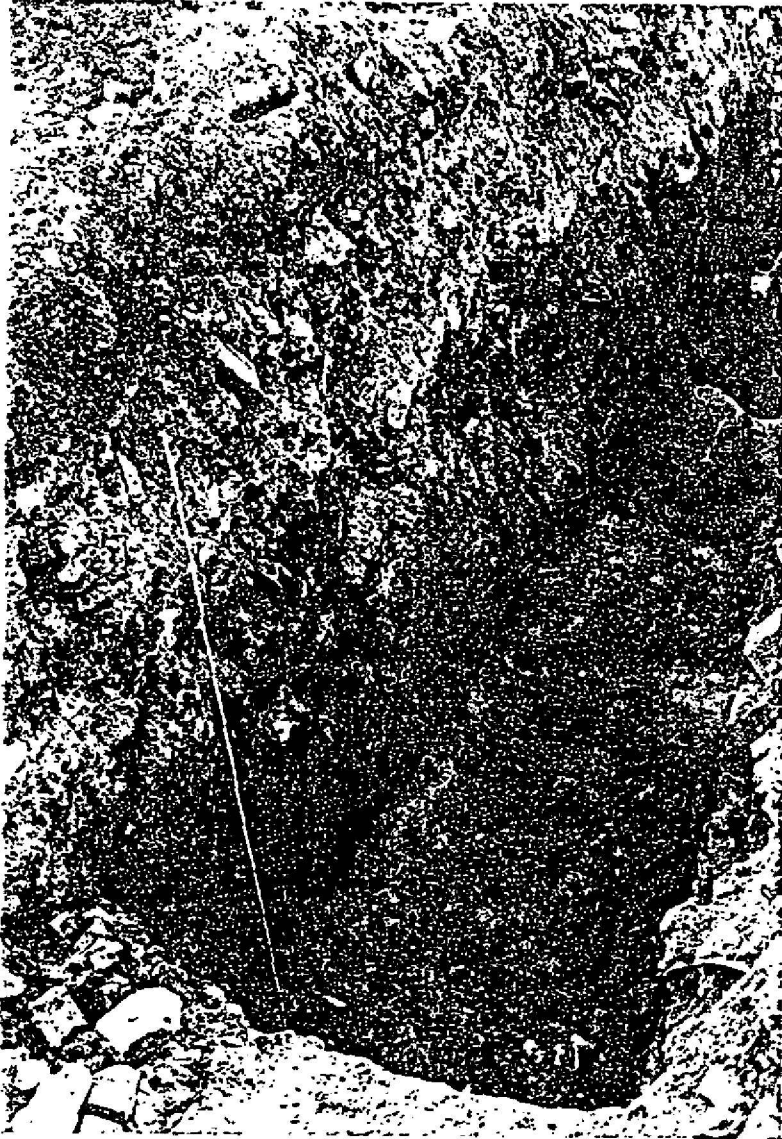
Approximately 12 1/2 feet east of the western end of BHTR 8 a large boulder was encountered (see Plate 7), the top of which was at an elevation of approximately 68 inches below datum. It appeared that a trench or pit had been excavated through the overlying deposits to install this boulder, but a detailed examination was not undertaken. During the excavation of BHTR 2 similar boulders were noted at the base of the trench. However, these latter boulders were not mapped prior to removal. It is possible that these boulders were installed to mark lot boundaries at the time of the subdivision of the land in the mid-19th century.

Plate 7
Backhoe Trench B
View Northeast Showing North Profile at Western End of BHTR B
and Boulder at Base of Trench at Upper Right

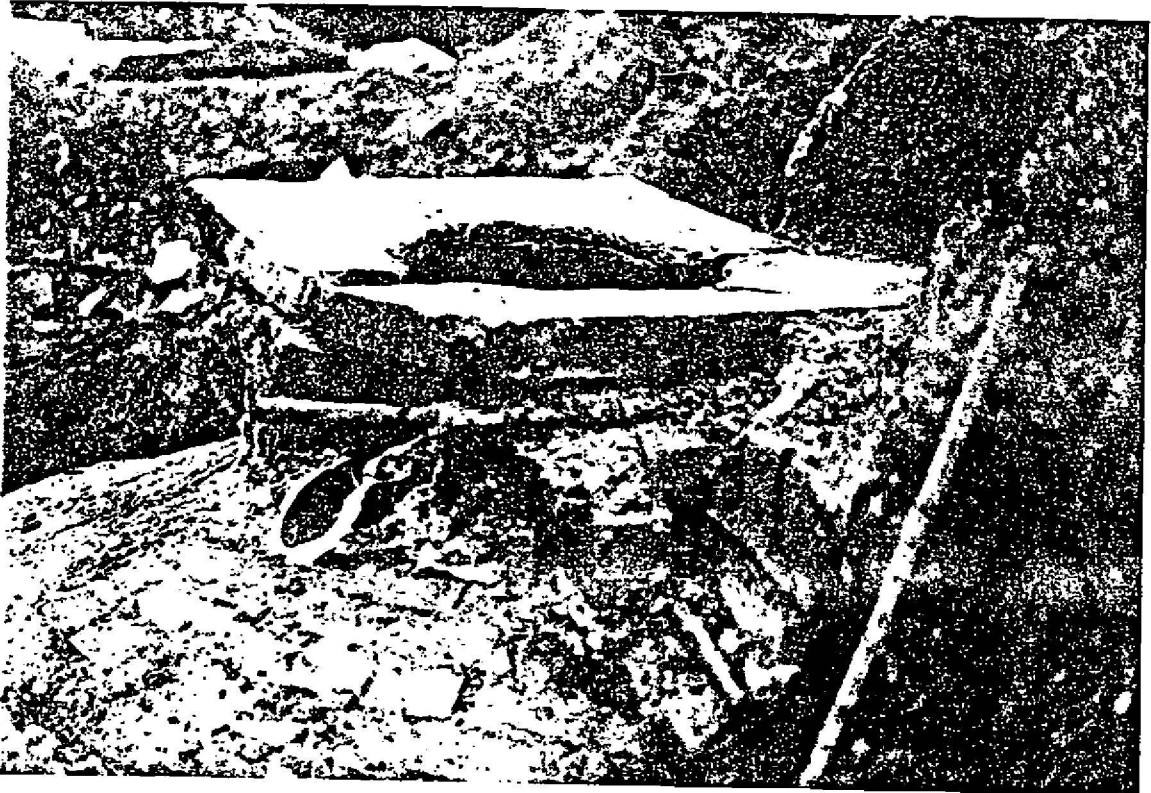
View Southeast: Showing Detail of Brick Support for Metal Pipe
(Foreground) and Remains of Ceramic Overflow Pipe (Left Center)

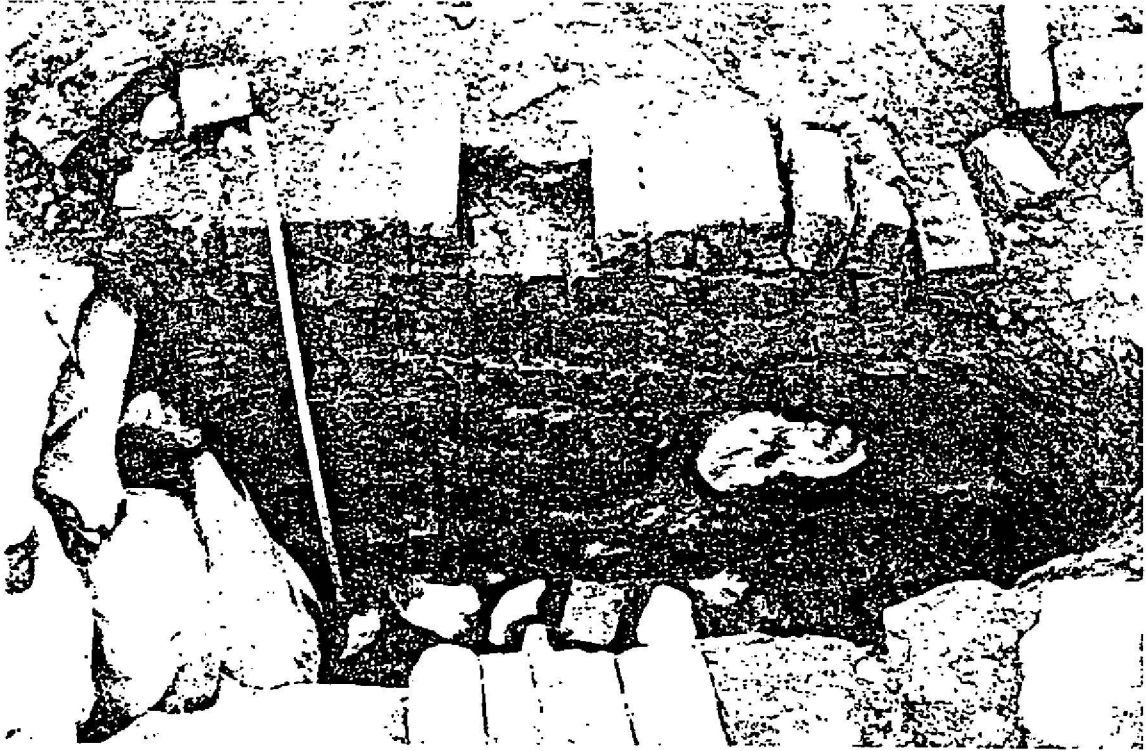
After the archaeological examination of Feature 3 was completed (see Plates 16-17) its north wall was found to consist of brick, with dressed stone underlying the its eastern portion. The west and south walls of the feature, however, consisted of loosely laid rocks and the east side of the feature did not have a wall. This portion of the feature consisted merely of the side of the pit dug to install the brick and stone walls noted above.

Plate 17
Feature 3
View North
North Wall of Feature After Excavation

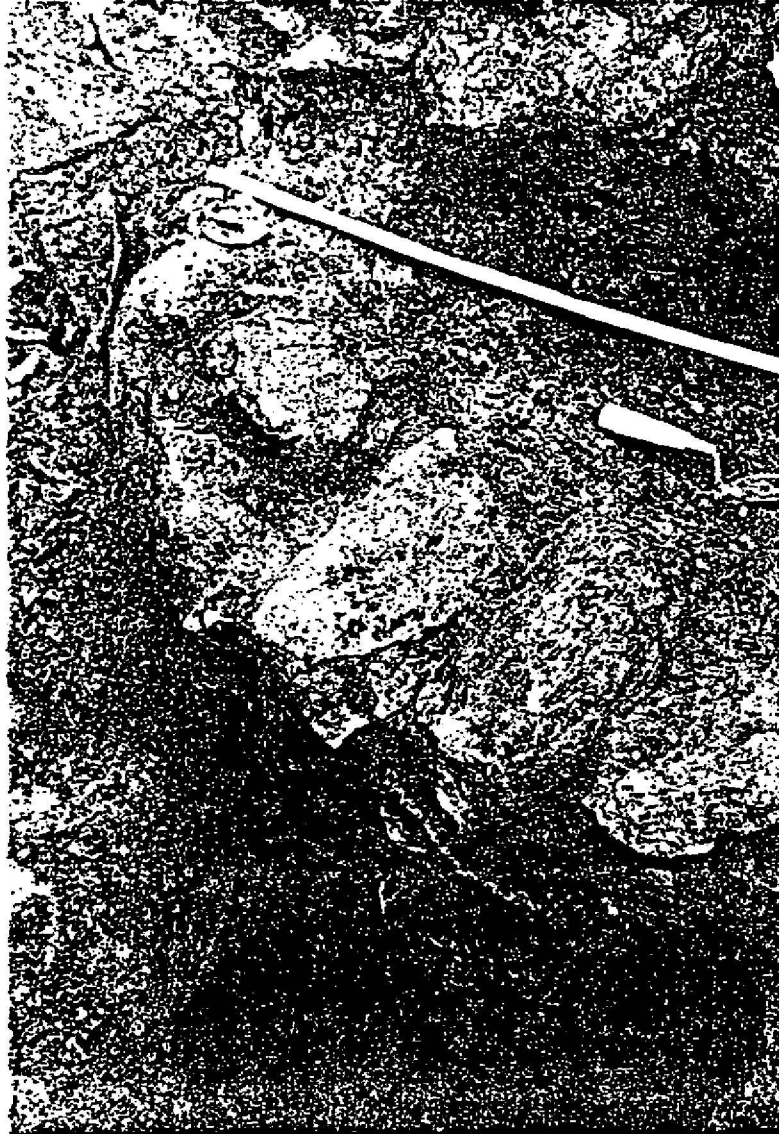
The base of the stone wall of Feature 4 was encountered at the base of stratum III. The underlying tan fine-medium sand was noted both inside the feature in shovel test 2 and in the test hole exterior to the feature. This represents the naturally occurring subsoil at this location and depth.

Plate 19
Feature 4
View Southwest
Detail Showing Base of Feature Wall Exposed in External Test Hole

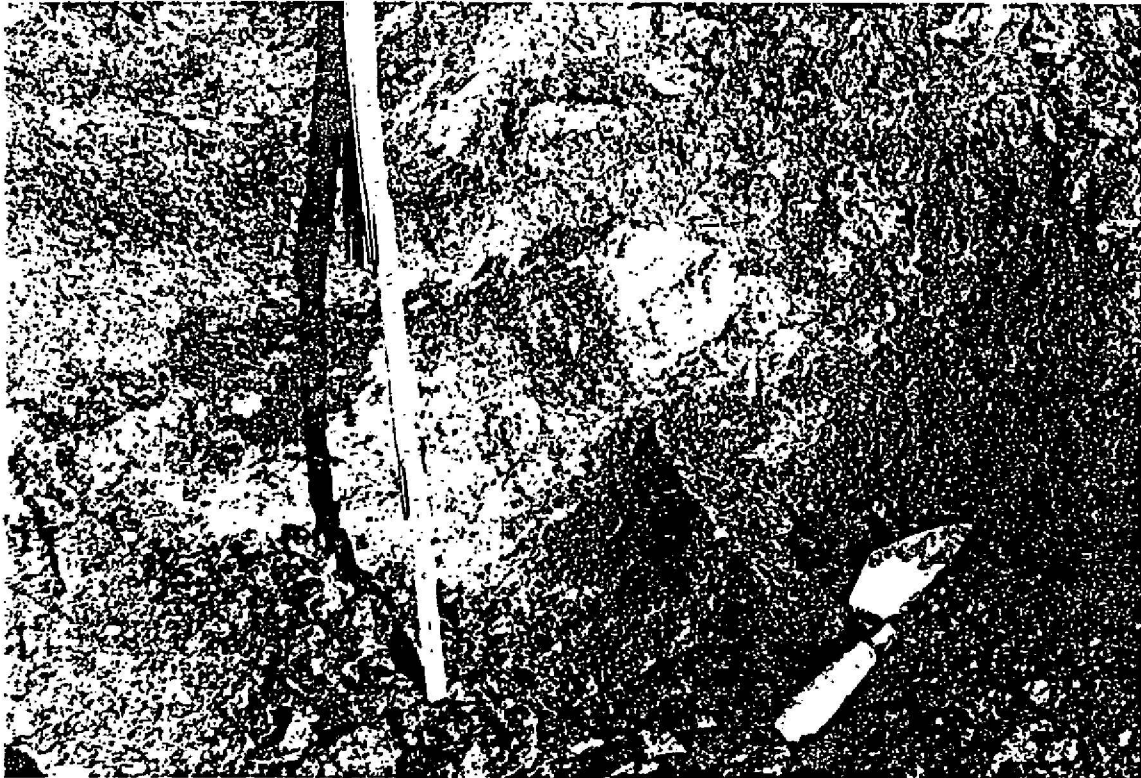
Plate 20
Profile of West Wall of BHTR 1 Showing
Rock Feature R1 and Associated Stratigraphy

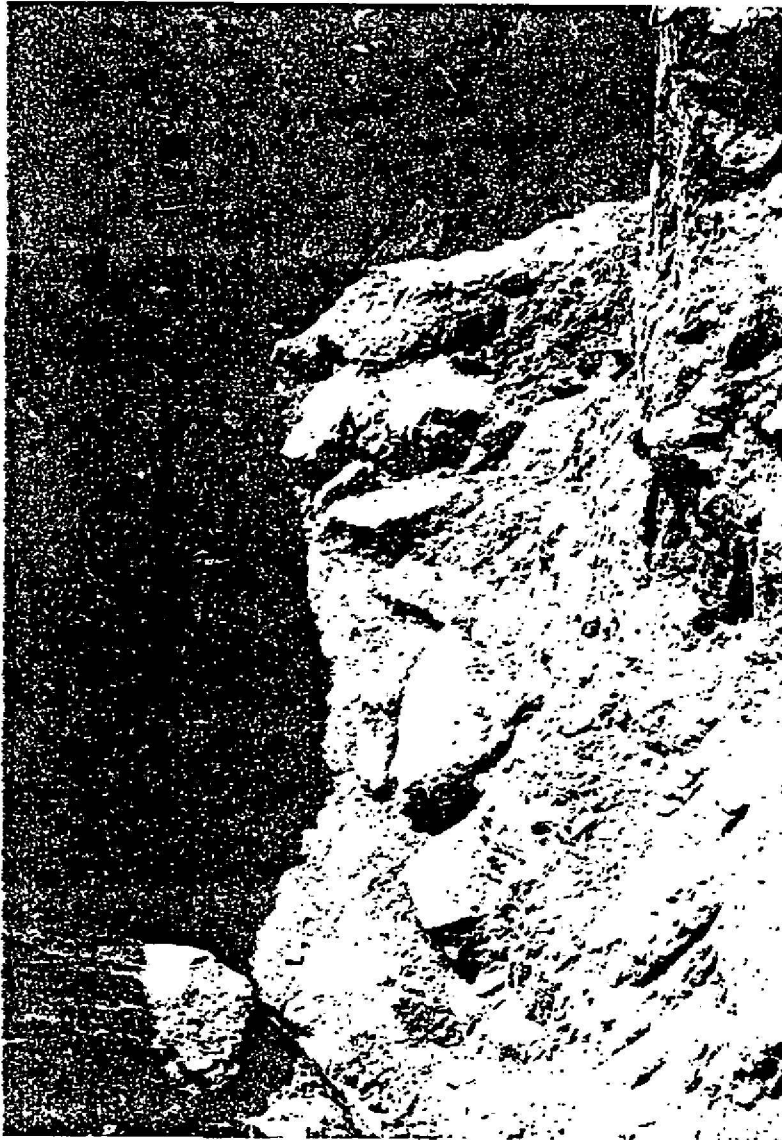
Plate 21
Rock Feature R1
View West from East End of Exposed Portion of Feature
Feature R1a at Bottom Left

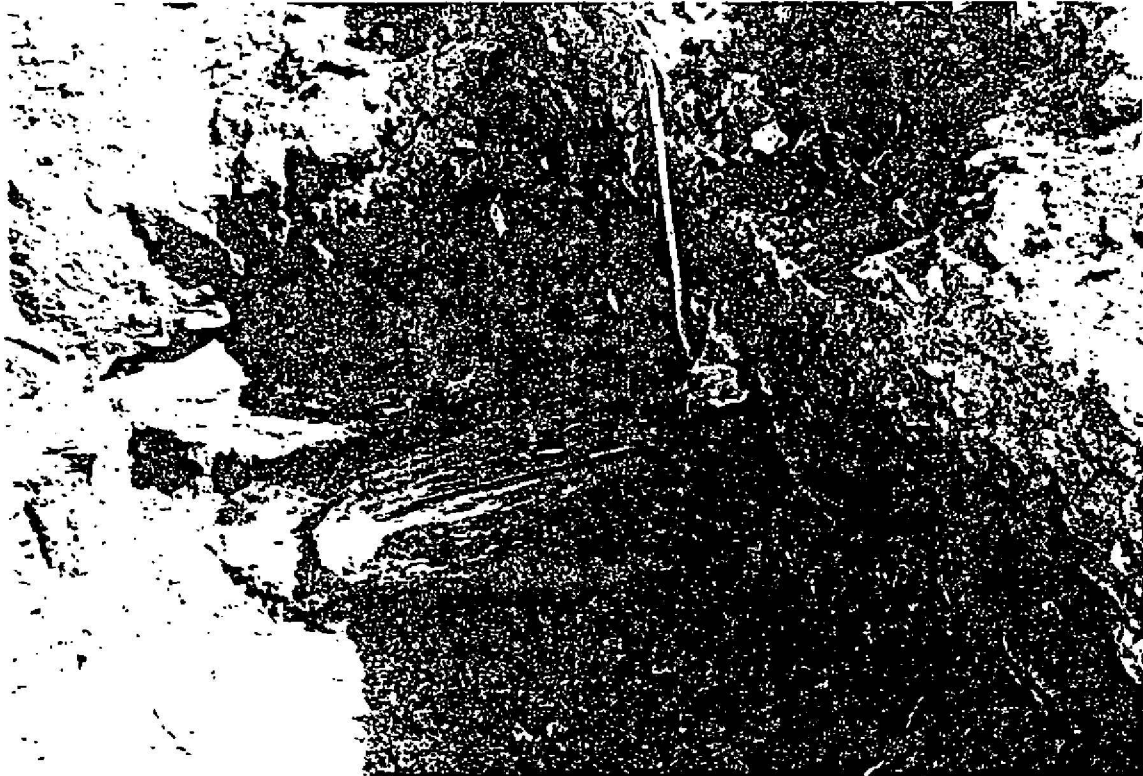
Plate 22
Rock Feature R1a
View Southeast Showing R1a Running Underneath Wall W12
Feature R1 Continues Eastward into Wall of Backhoe Trench
at Left Center of Photograph

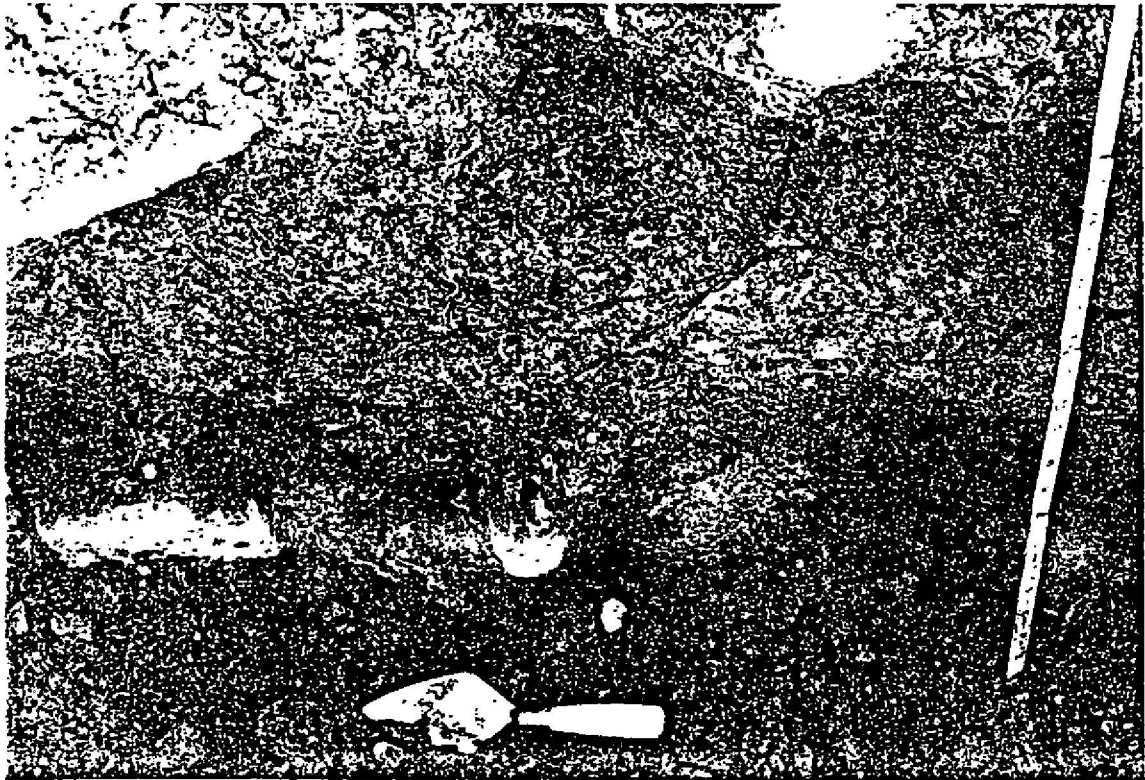
Plate 25
West Profile of Backhoe Trench 6
Showing Rock Feature R3 and Associated Stratigraphy

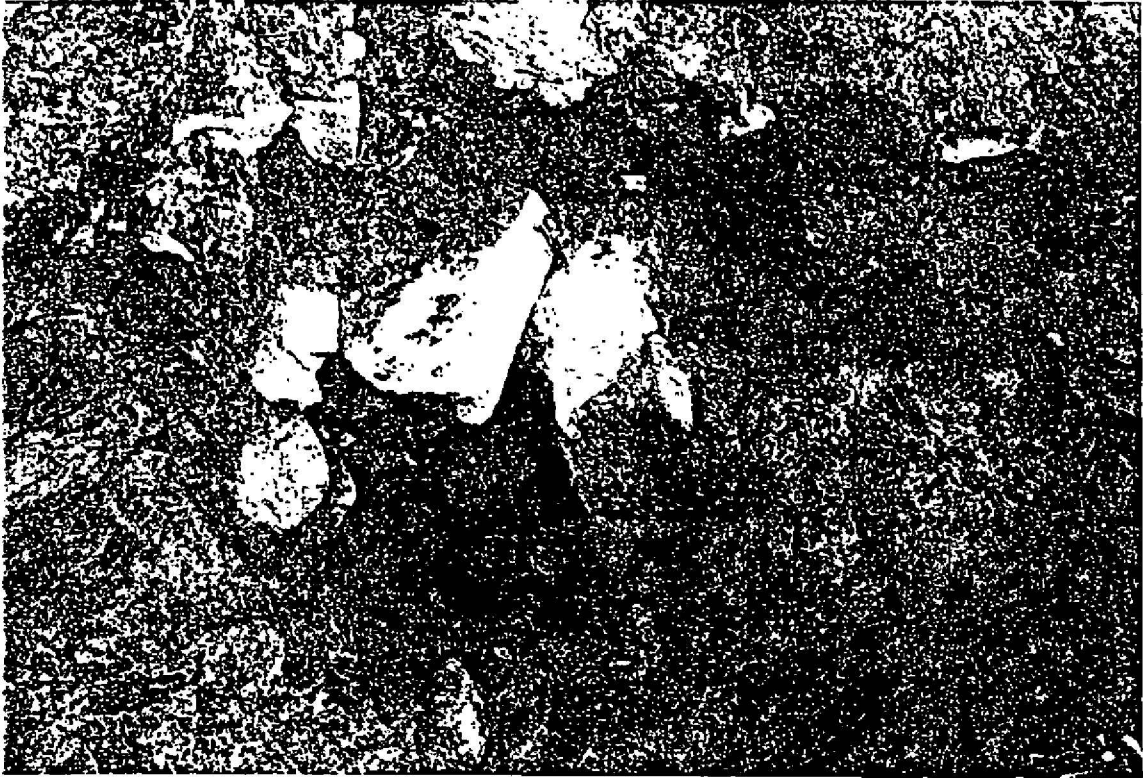
A rock-filled trench was also noted in the eastern profile of BHTR 4 (see Plate 26). This trench appeared to be aligned with rock feature R3 as exposed in lot 17. However this trench did not appear to contain large stones similar to those exposed at the base of R1 and R3. The trench contents appeared to be more like the loose stones noted at the top of the exposed portions of the rock features (see further discussion in Chapter III). A stratum of gray/black sandy silt noted adjacent to the upper portion of this trench (see Plate 26) may correspond to the stratum noted in other backhoe trenches which is interpreted as representing the pre-construction ground surface on this site (see also discussion in Chapter III).

Plate 26
East Profile of Backhoe Trench 4
Showing Rock-Filled Trench
