# **ARCHAEOLOGICAL FIELD MONITORING**

**IKEA RETAIL SITE  
RED HOOK, BROOKLYN,  
NEW YORK**

**GRAVING DOCK No. 2**

April 2008

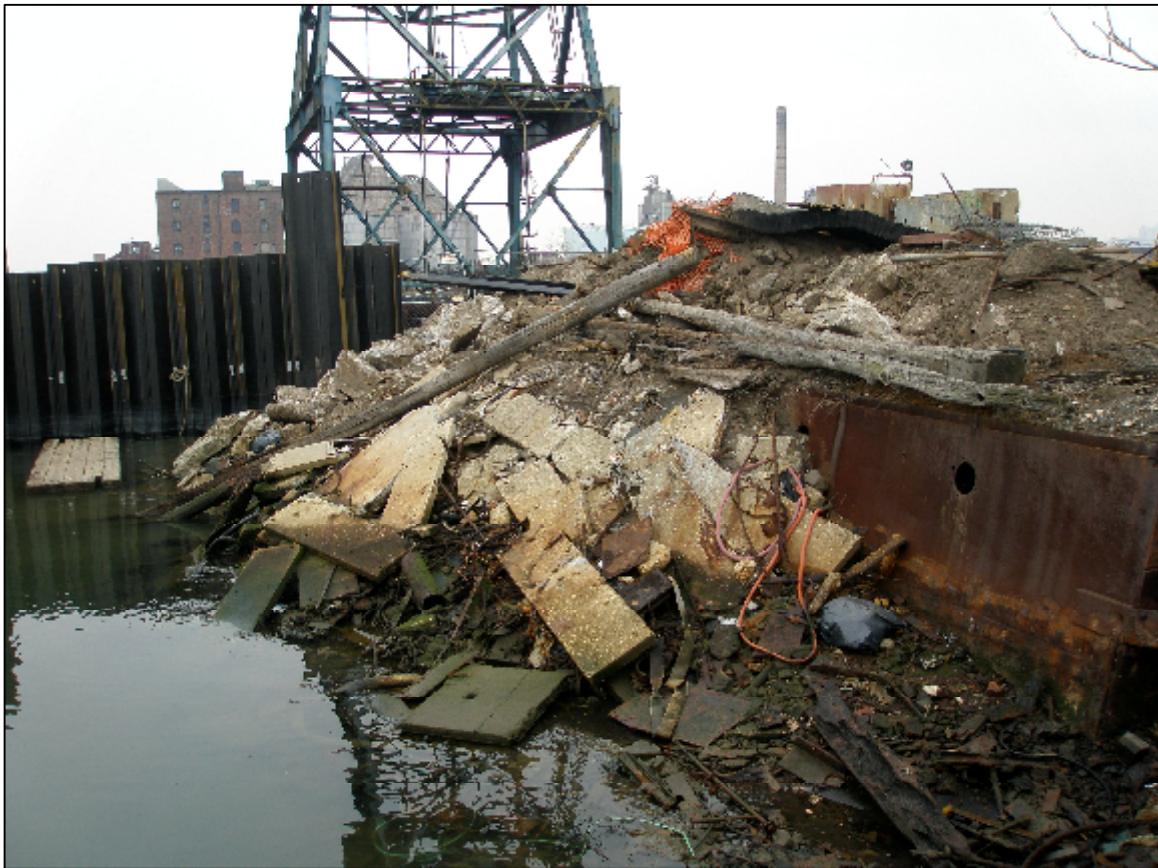
**Photo 2.1.** Site Conditions, Graving Dock No. 2 Caisson Gate, February 2, 2007

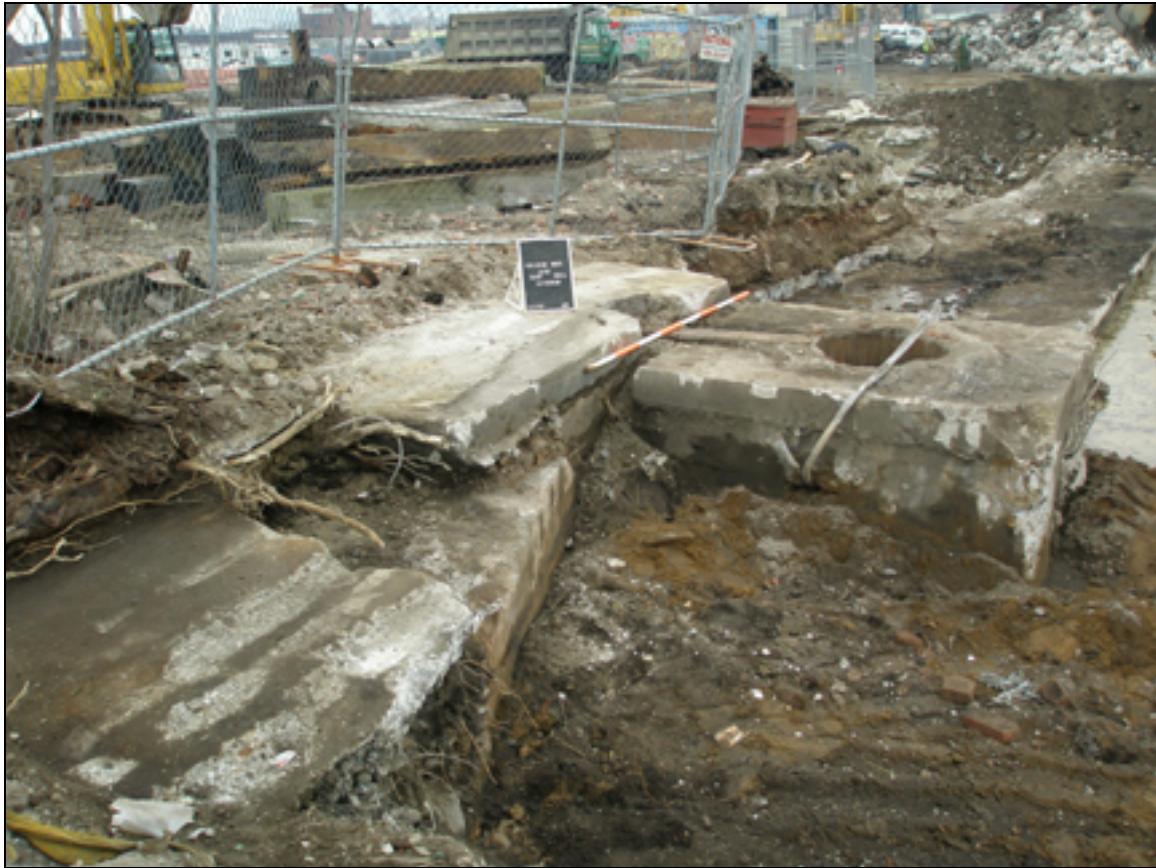
**Photo 3.1.** Bulkhead Trench/15-Foot Apron, Looking Northeast. Electrical vault and related conduit are located on the right hand side of the photo. The intact graving dock elements are manifest as poured concrete and appear on the left hand side, on or above grade. The electrical vault is connected to the graving dock by metal pipes.

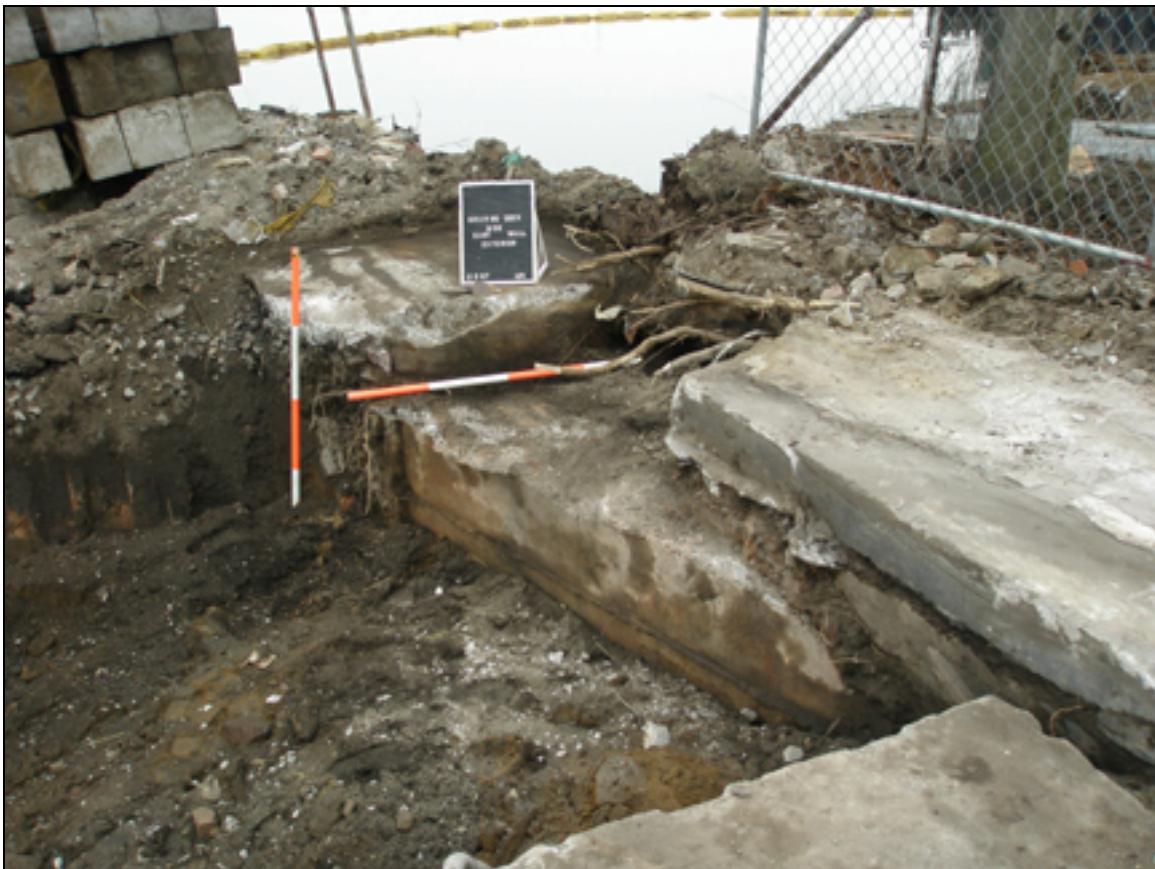
**Photo 3.2.** View of intact graving dock elements/Erie Basin looking southwest from Electrical Vault. East Wall of Graving Dock No. 2 is manifest as poured concrete. The Caisson Gate is just beyond the concrete on the right, out of view.

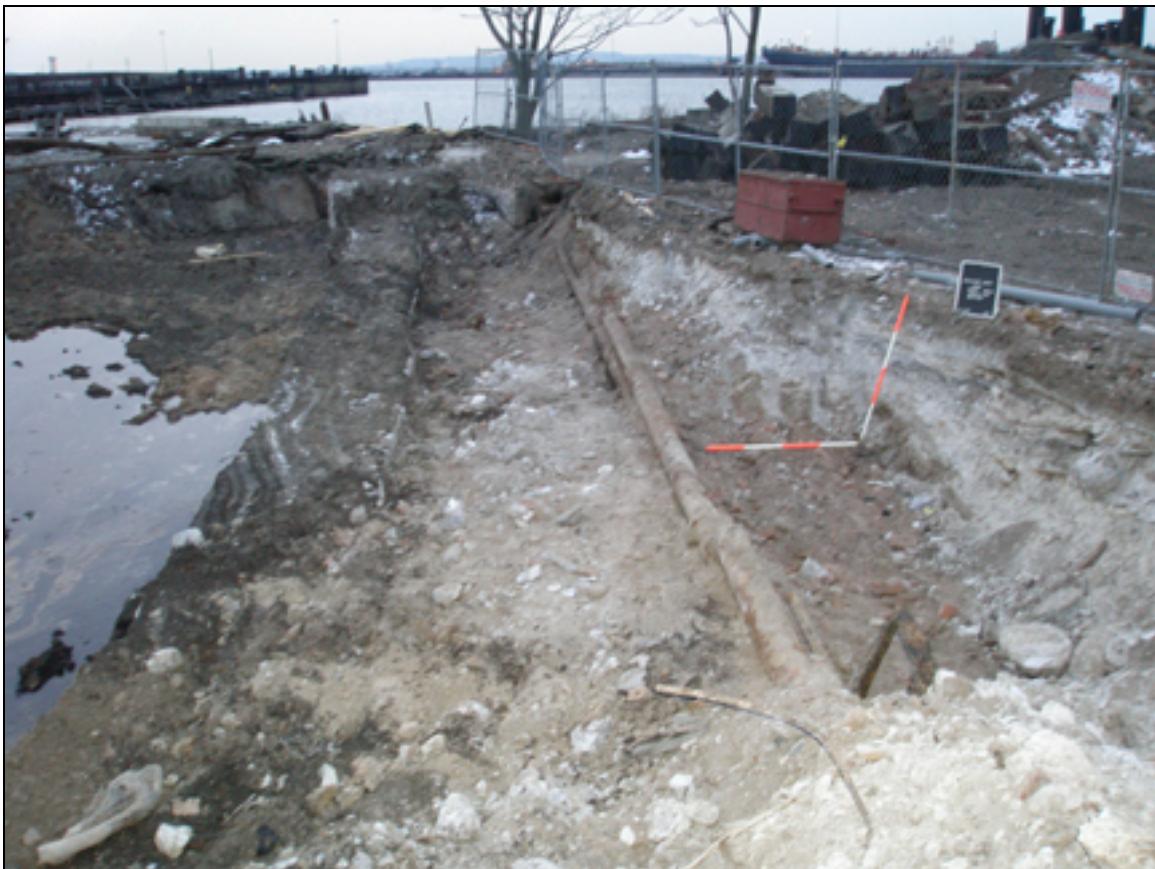
**Photo 3.3.** Southeast view of Bulkhead Trench/15-Foot Apron. Two eight-inch pipes run along the eastern wall of the graving dock (right hand of photo) parallel with an electrical conduit (left hand of photo). The pipes were laid on the Stepped Altars of the dock.

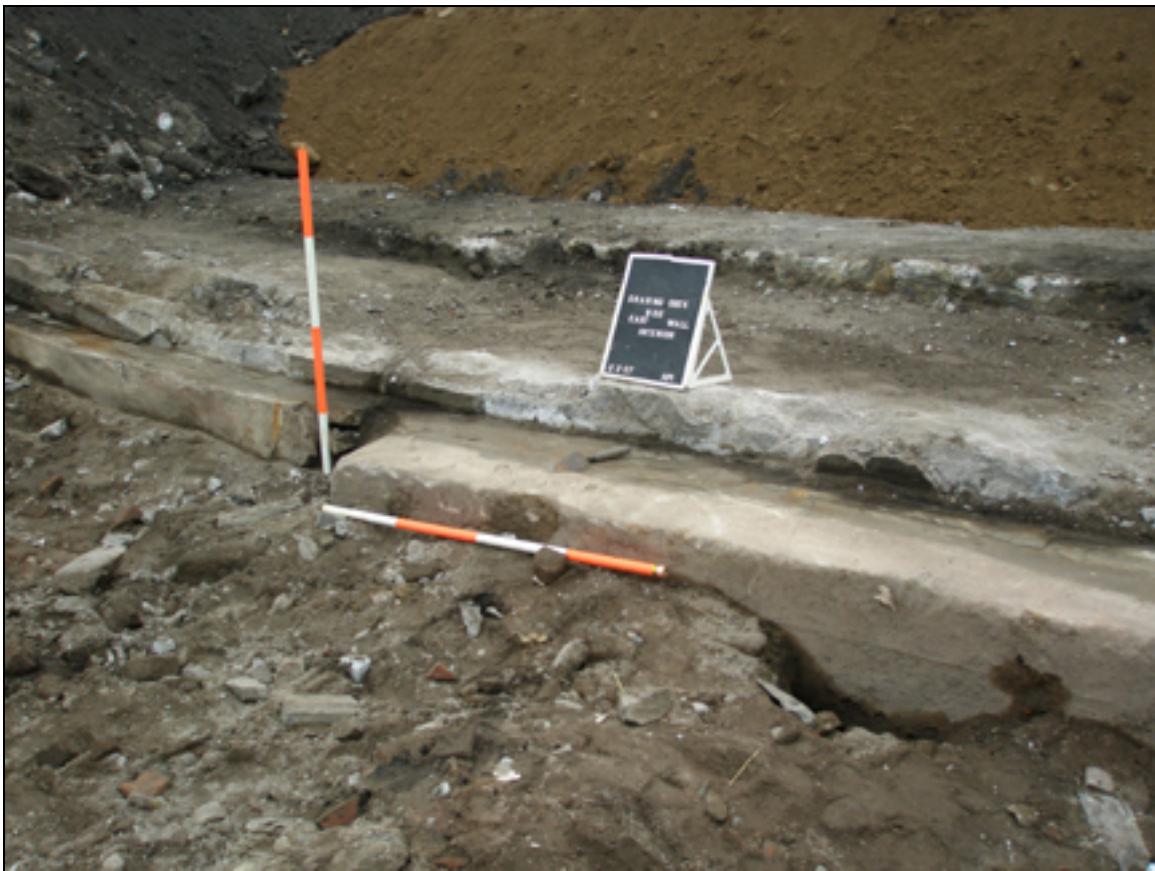
**Photo 3.4.** Looking Northeast toward Eastern wall of Graving Dock No. 2 within Bulkhead Trench/15-Foot Apron. Intact elements of the East Wall of Graving Dock No. 2 were composed of poured concrete. The steps of the wall are known as Stepped Altars. A void opened along the face (lower right hand corner of photograph) and wooden supports were identified (see Photo 3.5).

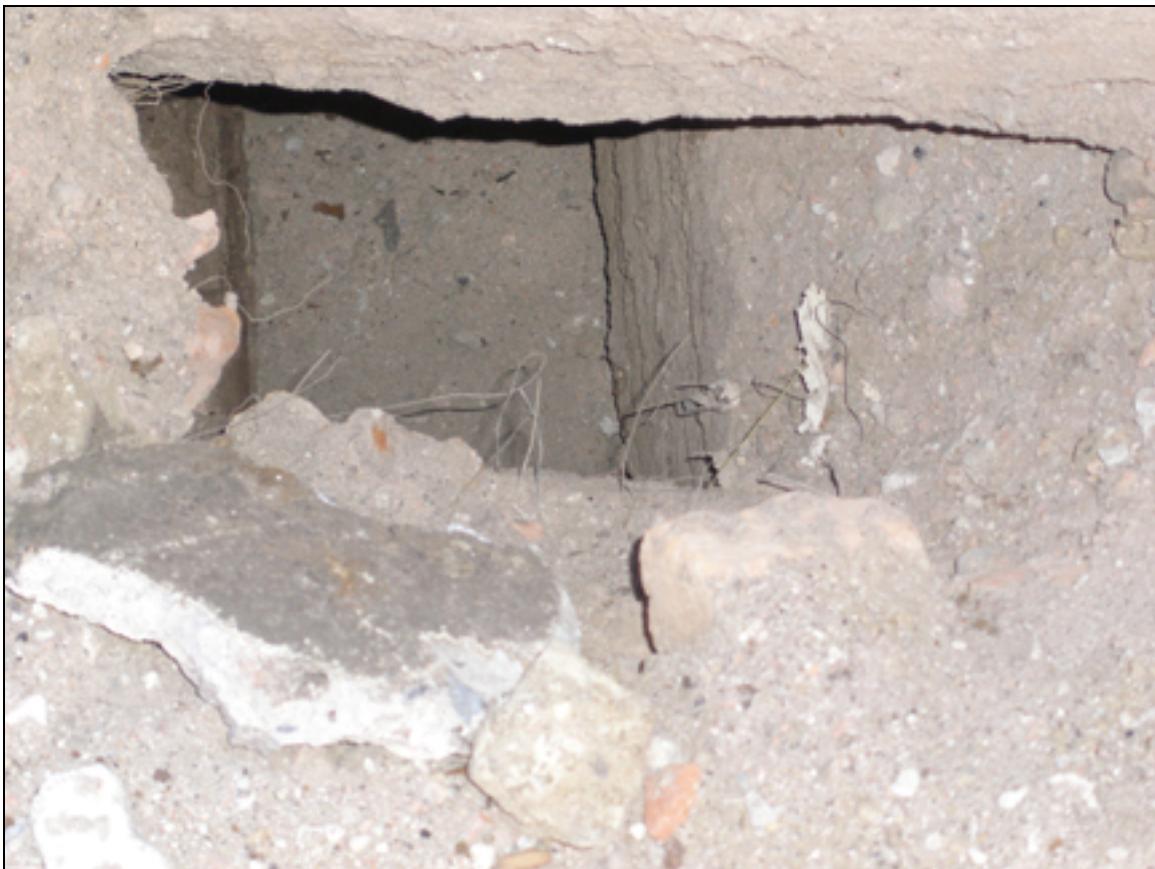
**Photo 3.5.** Void along eastern face of Eastern Wall of Graving Dock No. 2. Horizontal wooden elements are visible below the poured concrete cap.

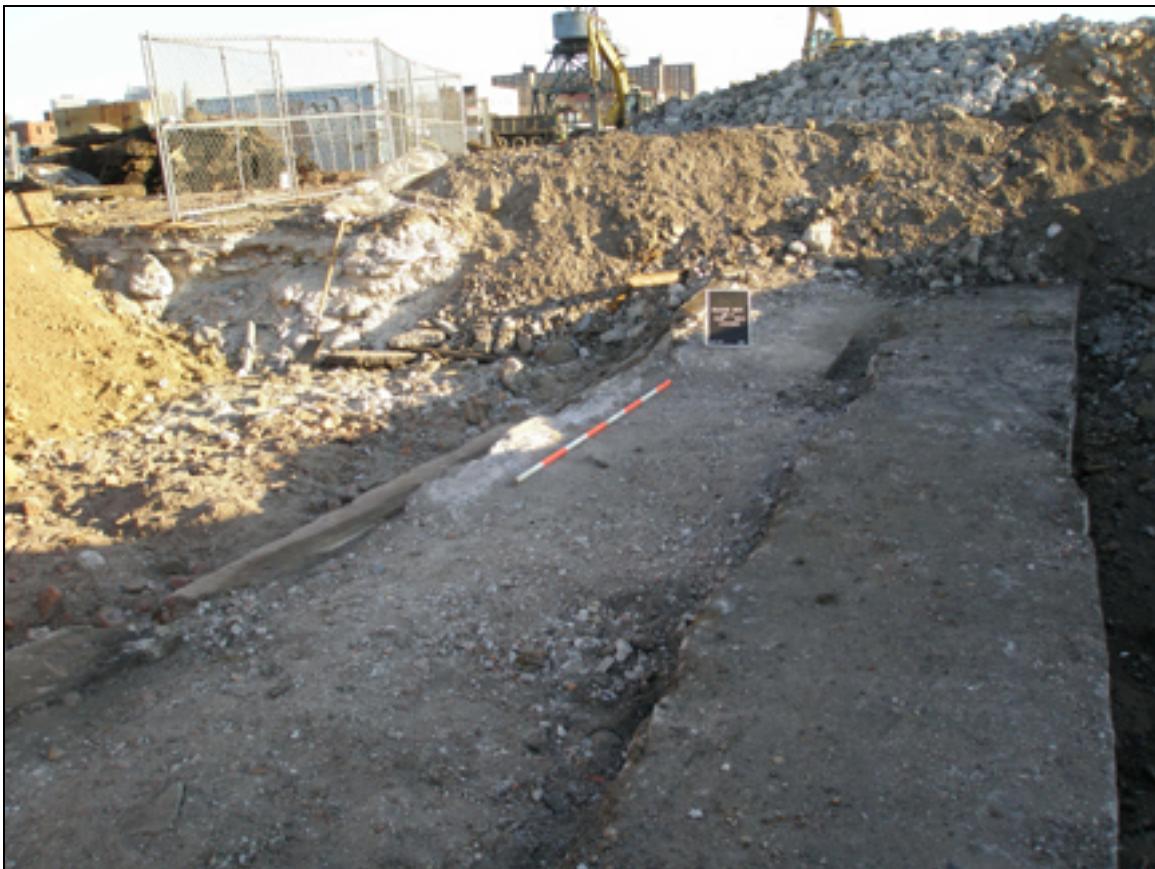
**Photo 3.6.** Looking northeast along the East Wall of Graving Dock No. 2 and electrical conduit within Bulkhead Trench/15-Foot Apron. The east wall was likely compromised during filling in the 1970s and further altered during monitoring/soil remediation. The electrical conduit is located on the right hand side of the photo and the East Wall on the left. Eight-inch pipe removed prior to photo.

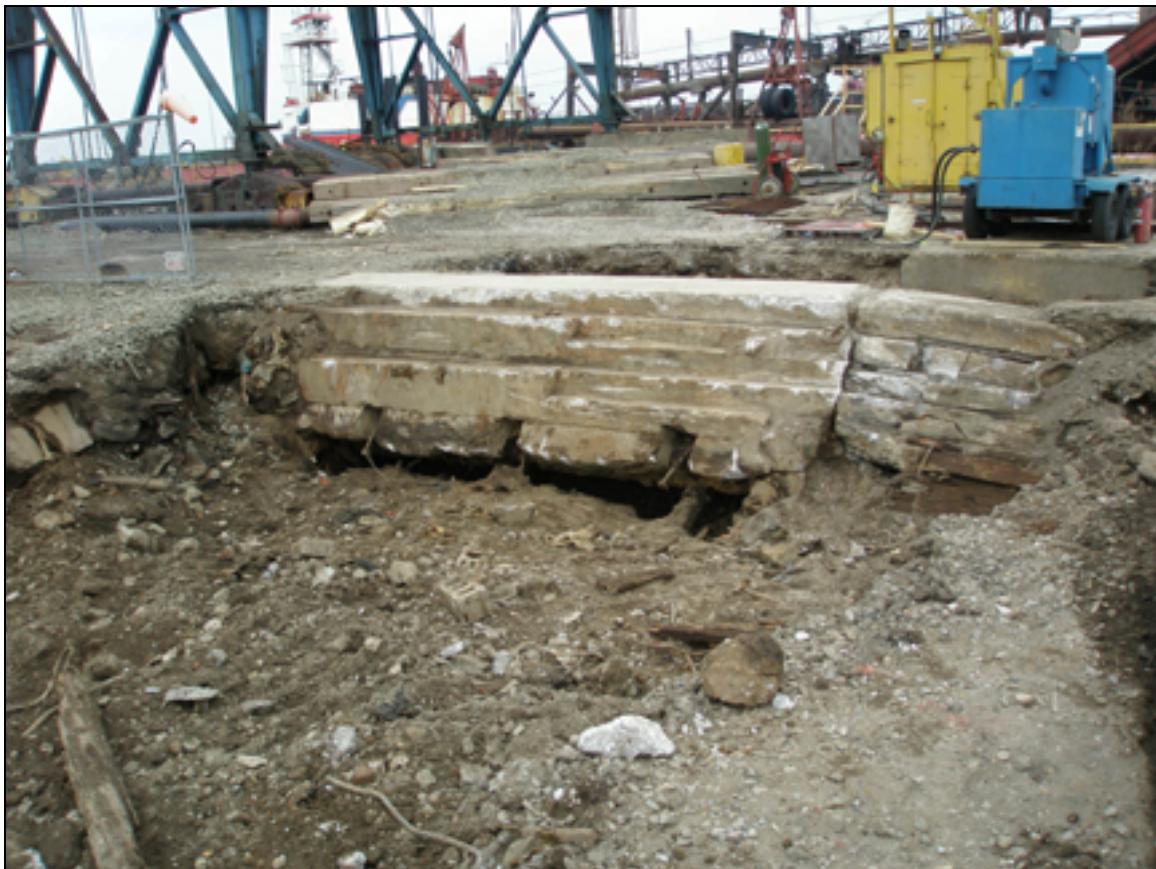
**Photo 3.7.** West Wall of Graving Dock No. 2 within Bulkhead Trench/15-Foot Apron looking southwest. The West Wall is composed of poured concrete Stepped Altars overlying and supported by wooden piles. Wooden sheeting is visible on the right hand side of the photo, attached to the concrete cap by iron ties. The wooden elements of the dock had largely been destroyed or were in the process of rotting away.

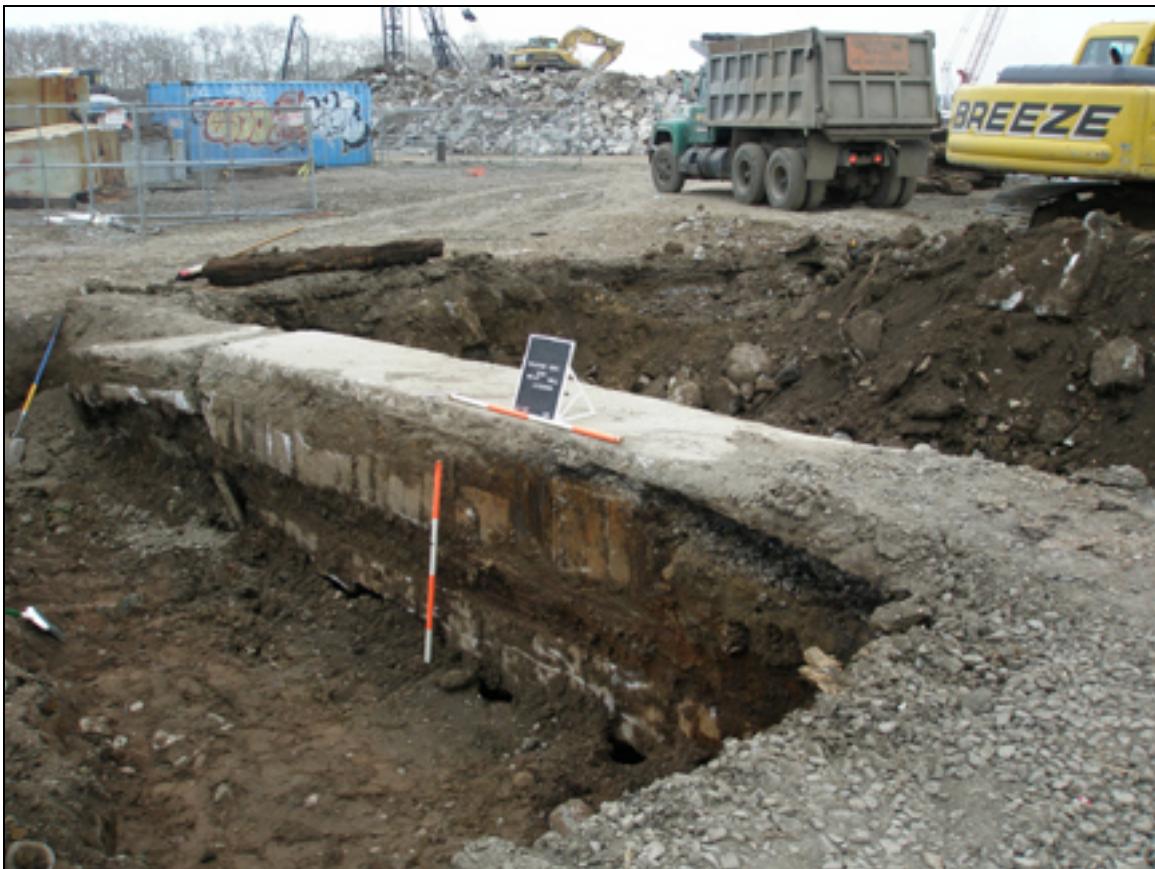
**Photo 3.8.** Exterior View/East Profile of West Wall of Graving Dock No.2 looking northeast. Wooden forms are visible on the exterior of the wall from the construction of the concrete cap.

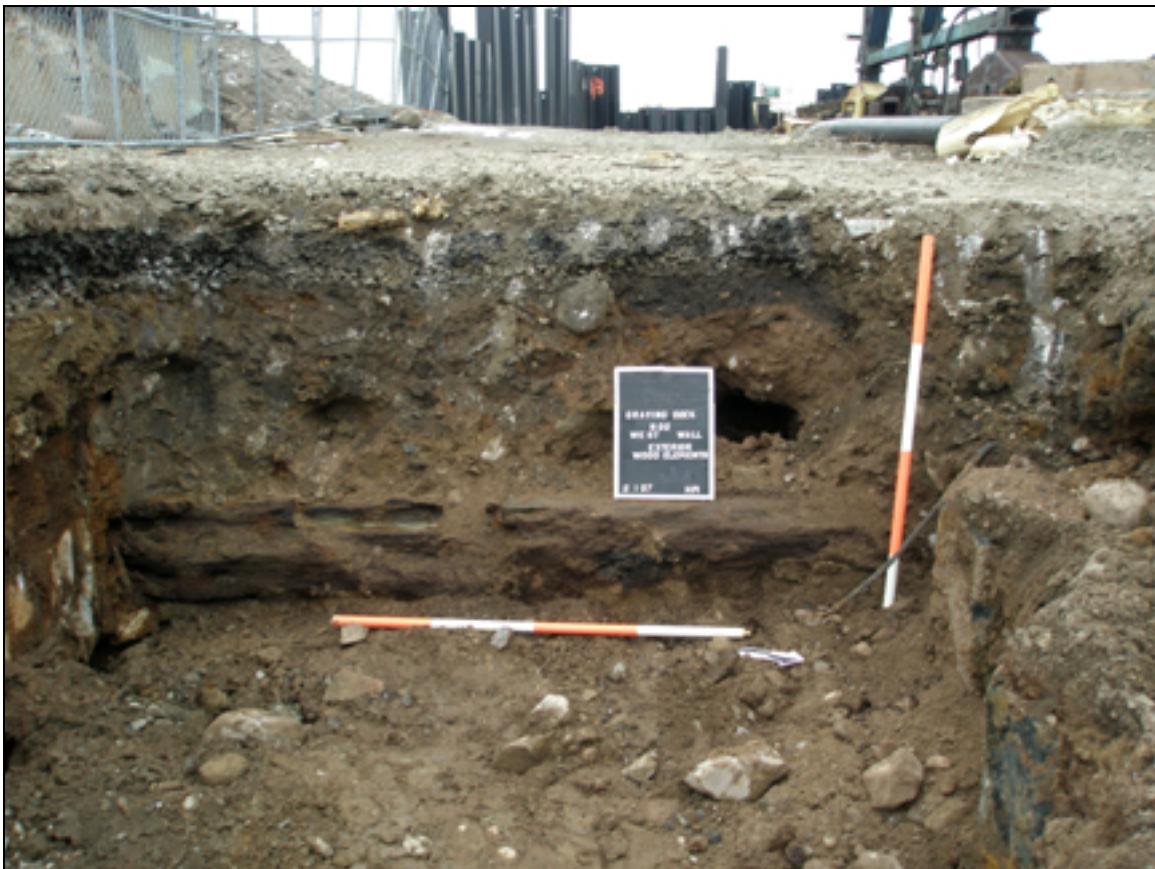
**Photo 3.9.** South profile of 15-Foot Apron along the western side of the West Wall of Graving Dock No. 2. Horizontal wooden element running from the graving dock (left of photo) northwest. A perpendicular wooden element was located above the visible horizontal wooden element within the void partially obscured by the photo board. The perpendicular wooden element was located within the fill episode overlying the visible wooden element.

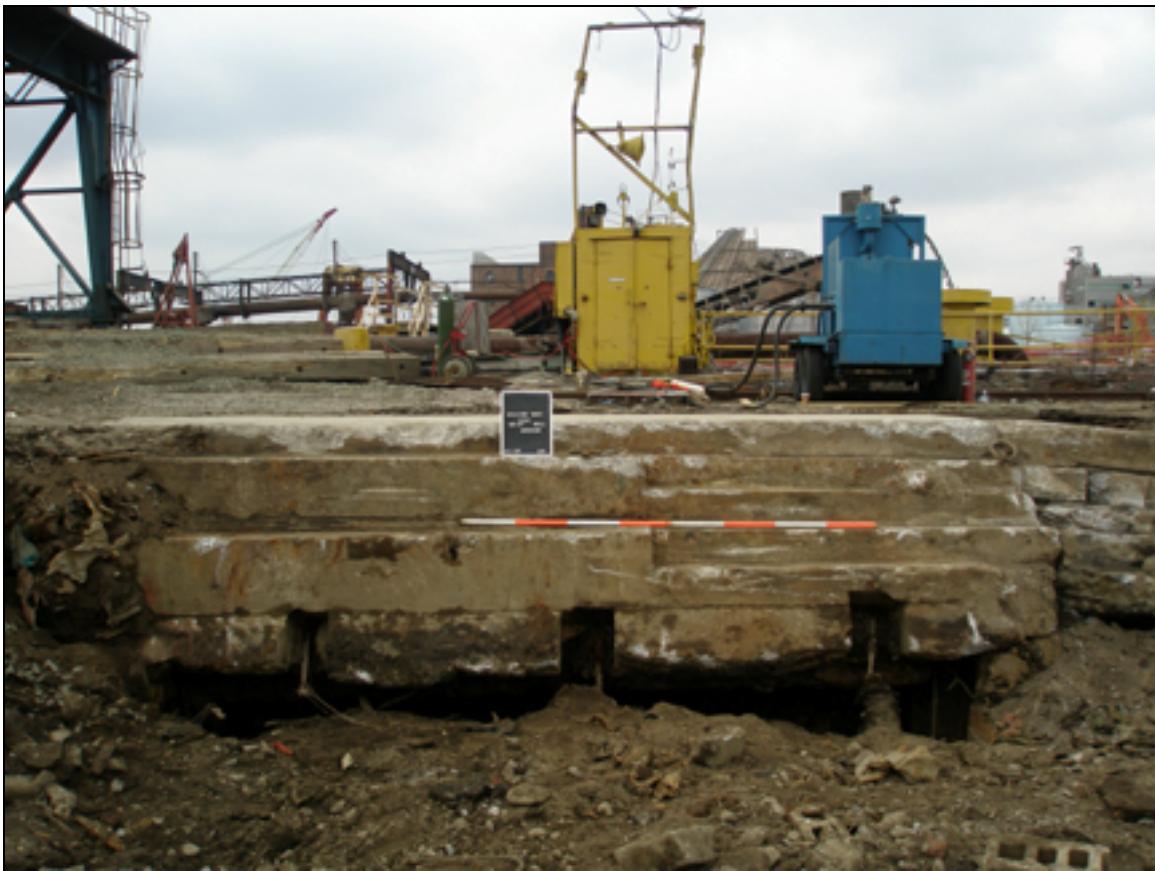
**Photo 3.10.** Interior View/West Profile of West Wall of Graving Dock No. 2 within Bulkhead Trench. West Wall of Graving Dock No. 2 is composed of poured concrete overlying and supported by wooden piles. The piles are connected to the concrete cap by iron ties. Much of the wood is rotting away. The concrete cap is slumping towards the north. Iron rings are located along the second altar on the dock, visible on the right hand side of the photo and to the right of the photo board.

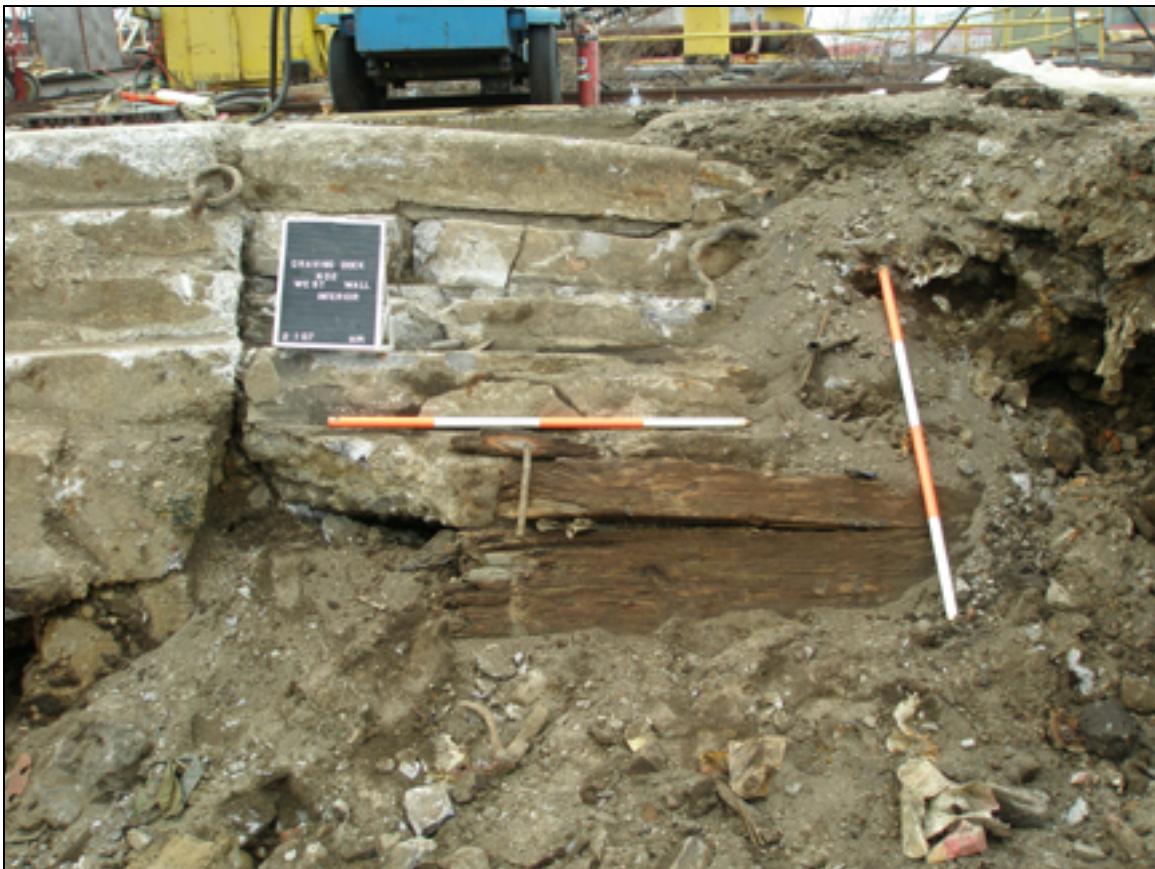
**Photo 3.11.** Interior View/West Profile of West Wall of Graving Dock No. 2 within Bulkhead Trench. Wooden sheeting connected to concrete cap by iron ties. The concrete cap is cracked and slumping towards the north. Iron ring located on second Stepped Altar on left side of photo.

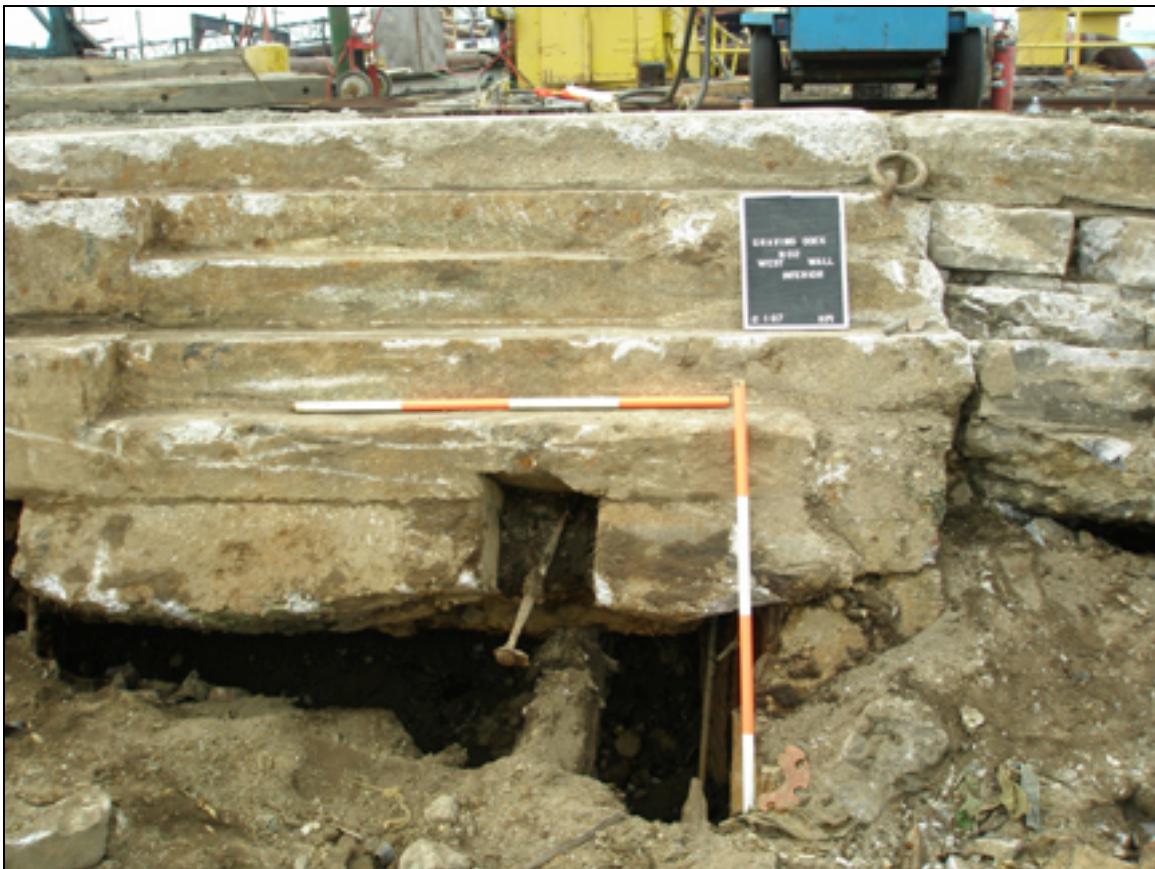
**Photo 3.12.** Interior View/West Profile of West Wall of Graving Dock No. 2 within Bulkhead Trench. Note iron tie protruding from the cut on the lower Stepped Altar of the concrete cap. The tie once intersected the rotting wooden pile behind. Metal sheeting is running into the fill and supporting the concrete cap just to the right of the pile, and left of the vertical range pole.

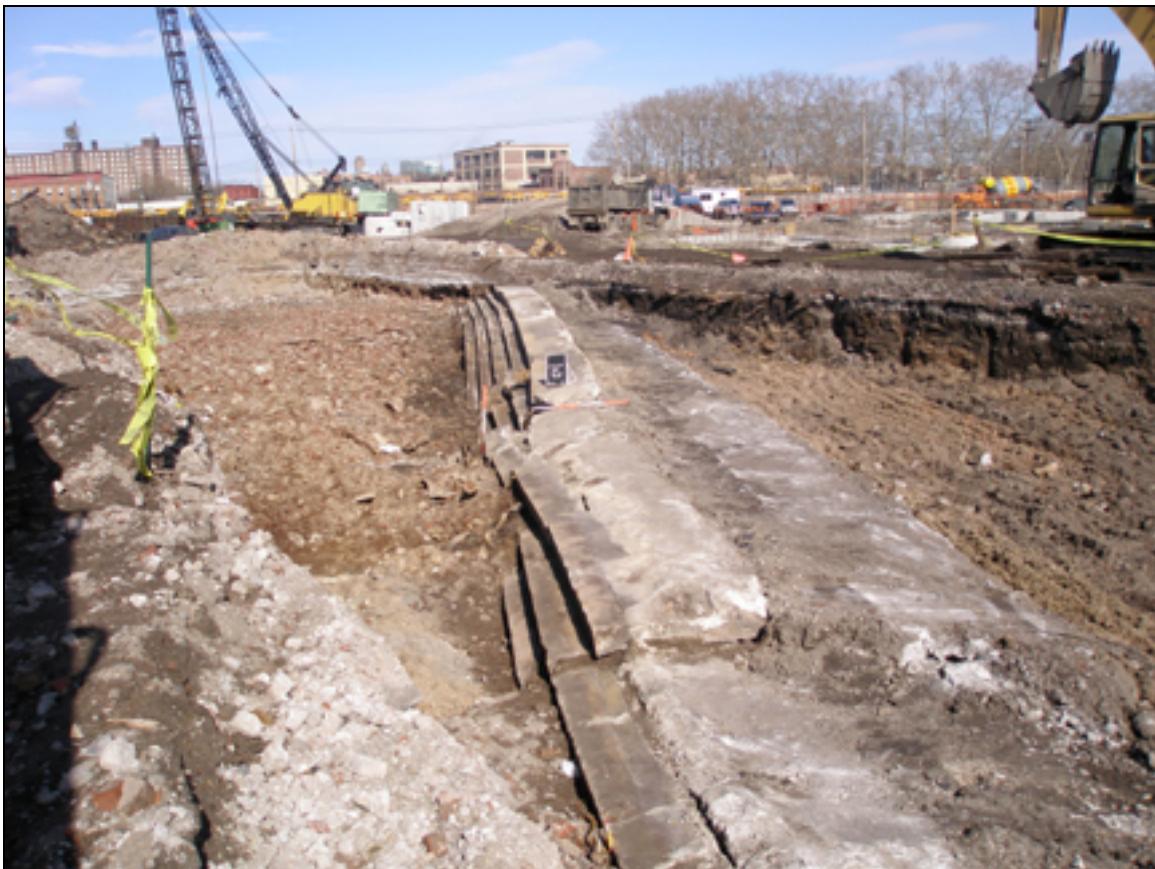
**Photo 3.13.** Trench 1 Looking Northeast towards East Wall of Graving Dock No. 2. Interior/Eastern Face of East Wall of Graving Dock No. 2 was characterized by Stepped Altars. A circa 1940 electrical conduit runs parallel with the wall along the exterior side.

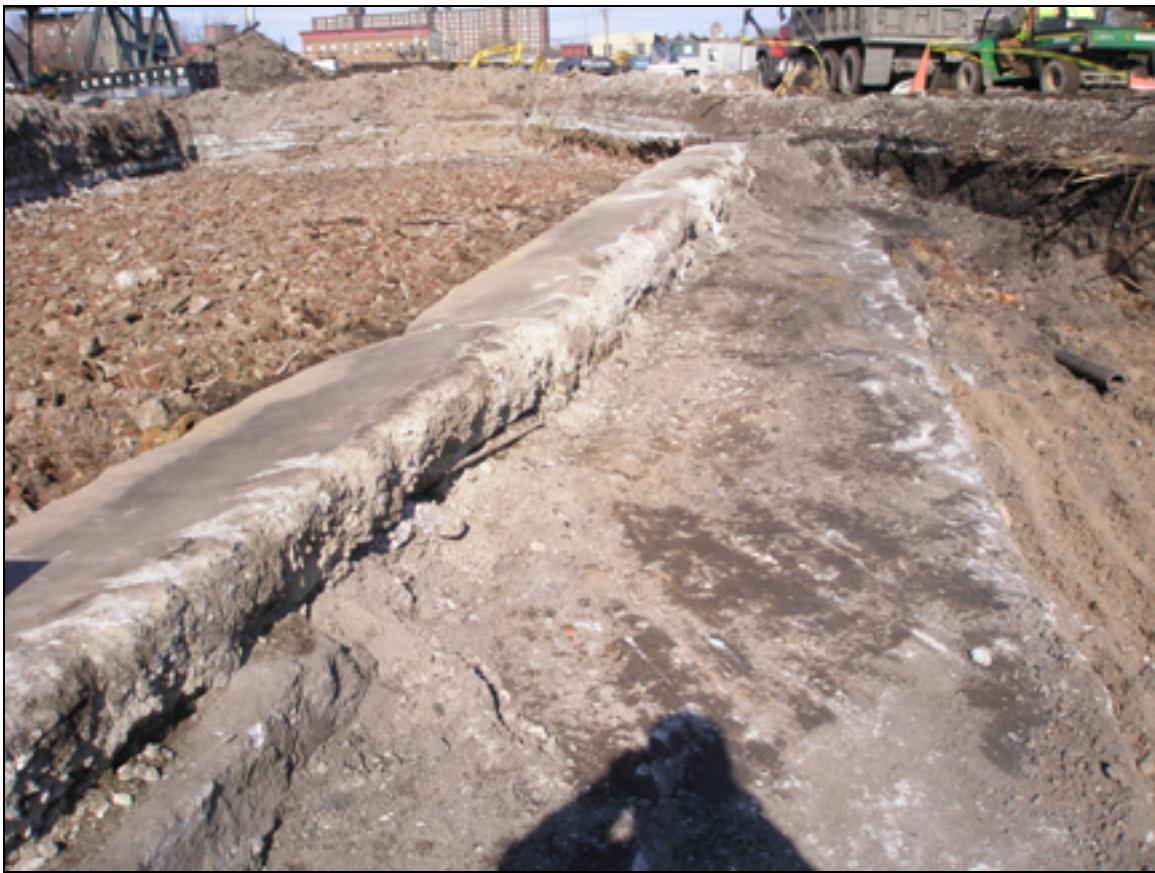
**Photo 3.14.** Trench 1, Looking North. Exterior/western face of East Wall of Graving Dock No. 2 exposed, though with little detail. A small pipe is visible in the middle ground running out of the wall. A Circa 1940 electrical conduit runs parallel with the wall along its exterior side, separated by a compact clay.

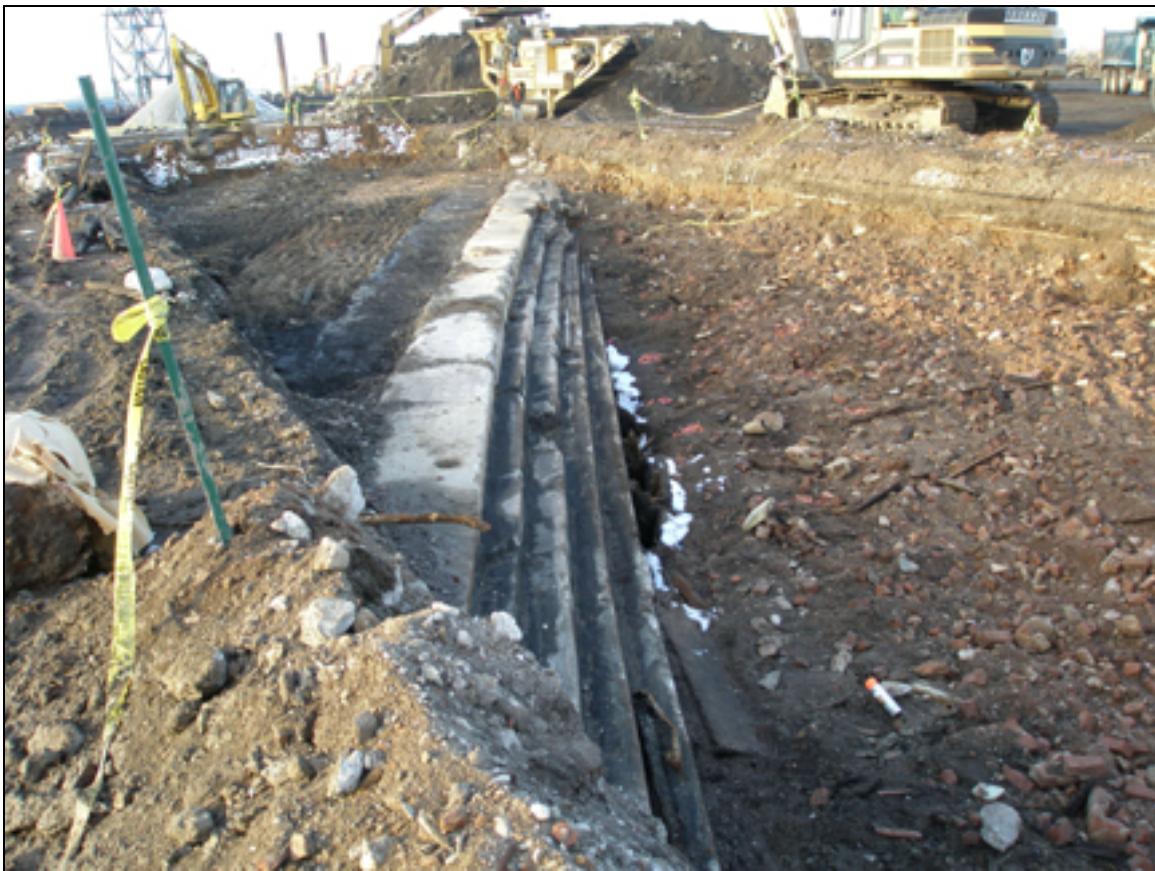
**Photo 3.15.** Trench 1 Looking North at the East Wall of Graving Dock No. 2. Interior/Eastern Face of East Wall of Graving Dock No. 2 was characterized by Stepped Altars. A circa 1940 electrical conduit runs parallel with the wall along the exterior side.

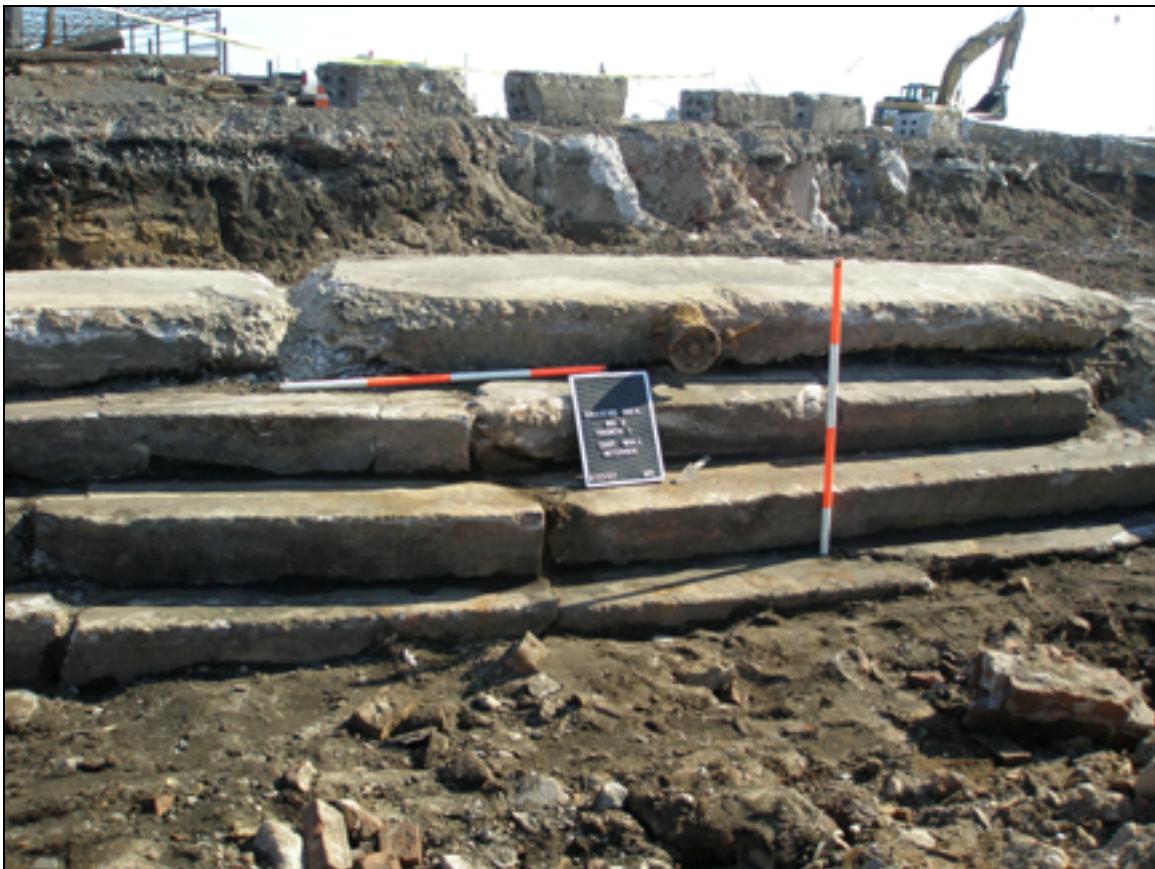
Two vertical 4-inch iron pipe valves were located on the top step altar facing into the interior of the graving dock (Photograph 3.16). The inverse ends, located on the exterior side of the dock, had been smashed or flattened. These valves appeared to be horizontal and level. The valves may have been part of the dewatering process associated with the graving dock, but their orientation (prior to monitoring) and function is unclear. Another horizontal 4-inch pipe was located atop the lowest step altar, similar to the pipe found in the Bulkhead Trench/15-foot buffer (Photograph 3.18).

**Photo 3.16.** Trench 1 Looking Southeast towards East Wall of Graving Dock No. 2. East Wall of Graving Dock No. 2 was exposed during monitoring. Visible in the photo is a pulley and wench.

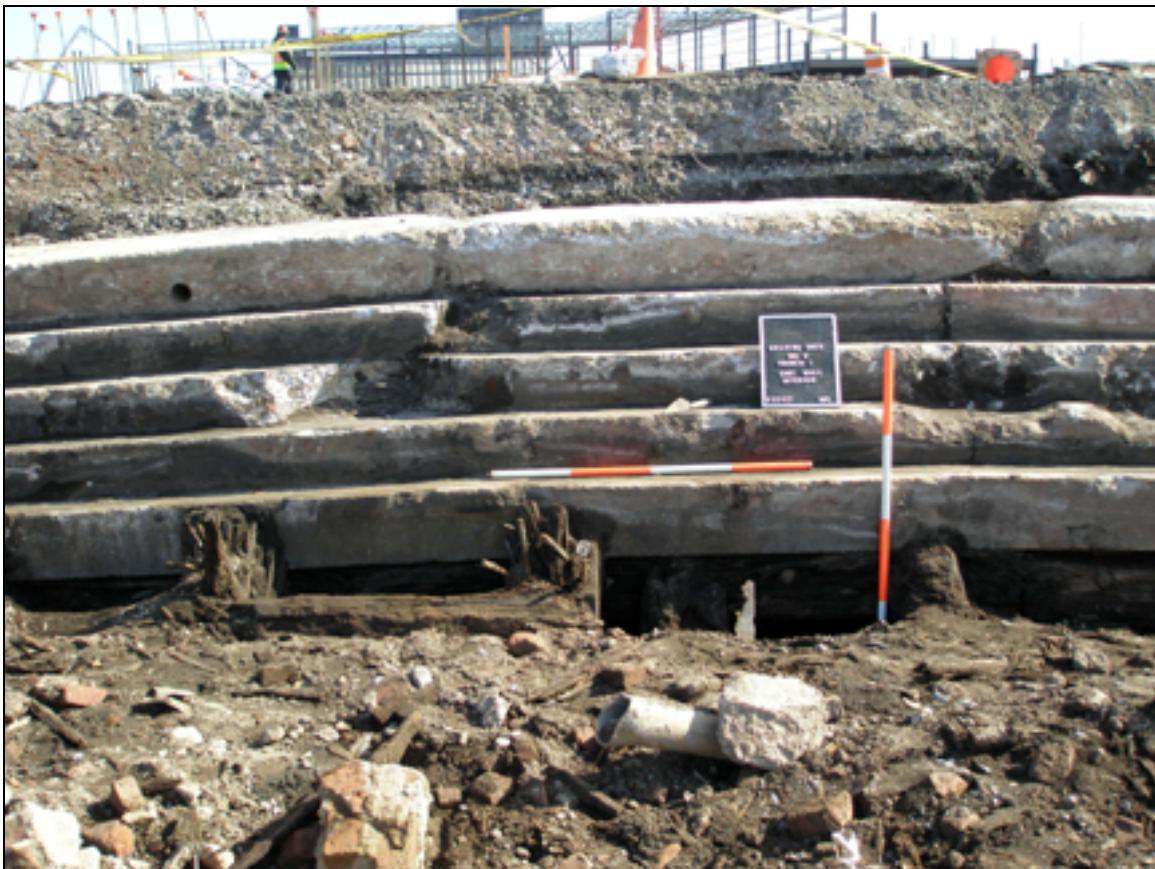
**Photo 3.17.** Trench 1 Looking Southeast towards East Wall of Graving Dock No. 2. Interior/Eastern Face of East Wall of Graving Dock No. 2 overlaid horizontal wooden elements with “pulled” iron ties. The horizontal wooden elements and concrete cap were attached to vertical wooden elements with additional “pulled” iron ties.

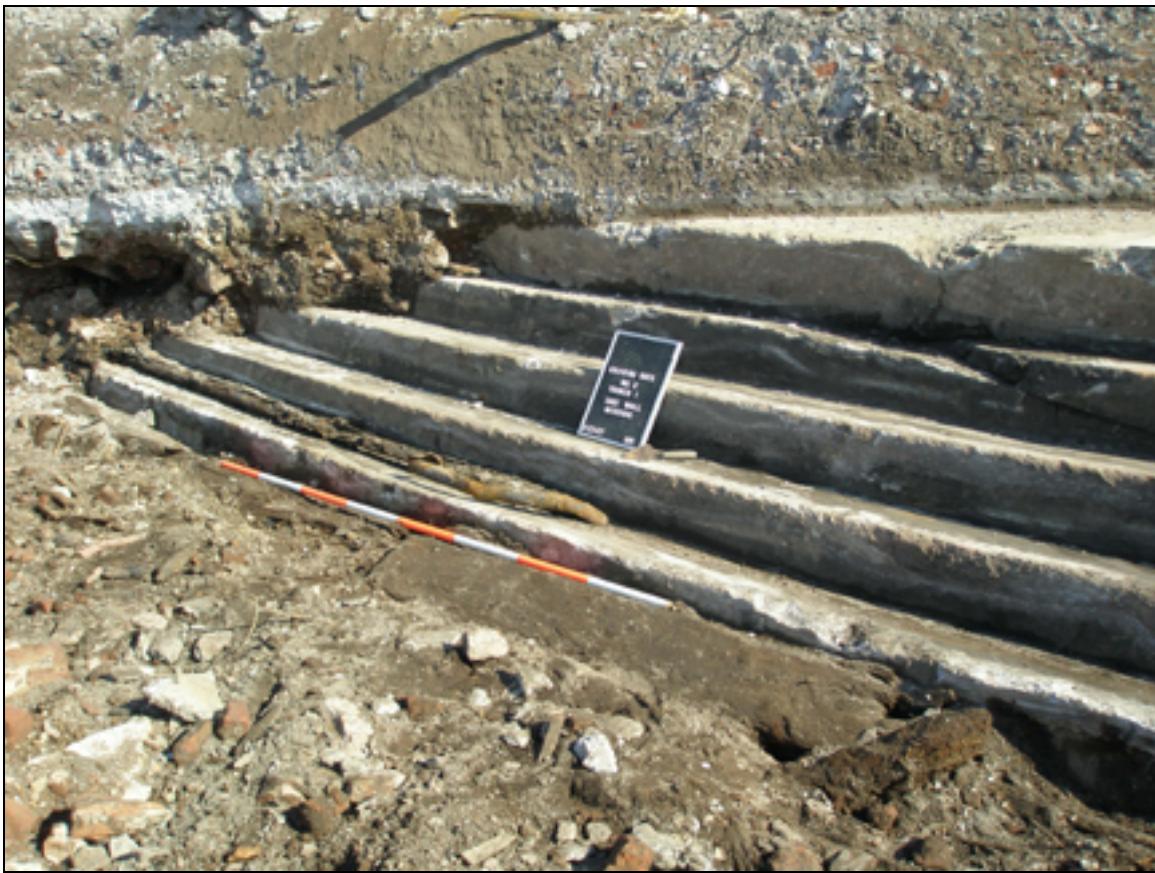
**Photo 3.18.** Trench 1 Looking Northeast towards East Wall of Graving Dock No. 2. Interior/Eastern Face of East Wall of Graving Dock No. 2 showing remnants of 4-inch pipe located atop Stepped Altar.

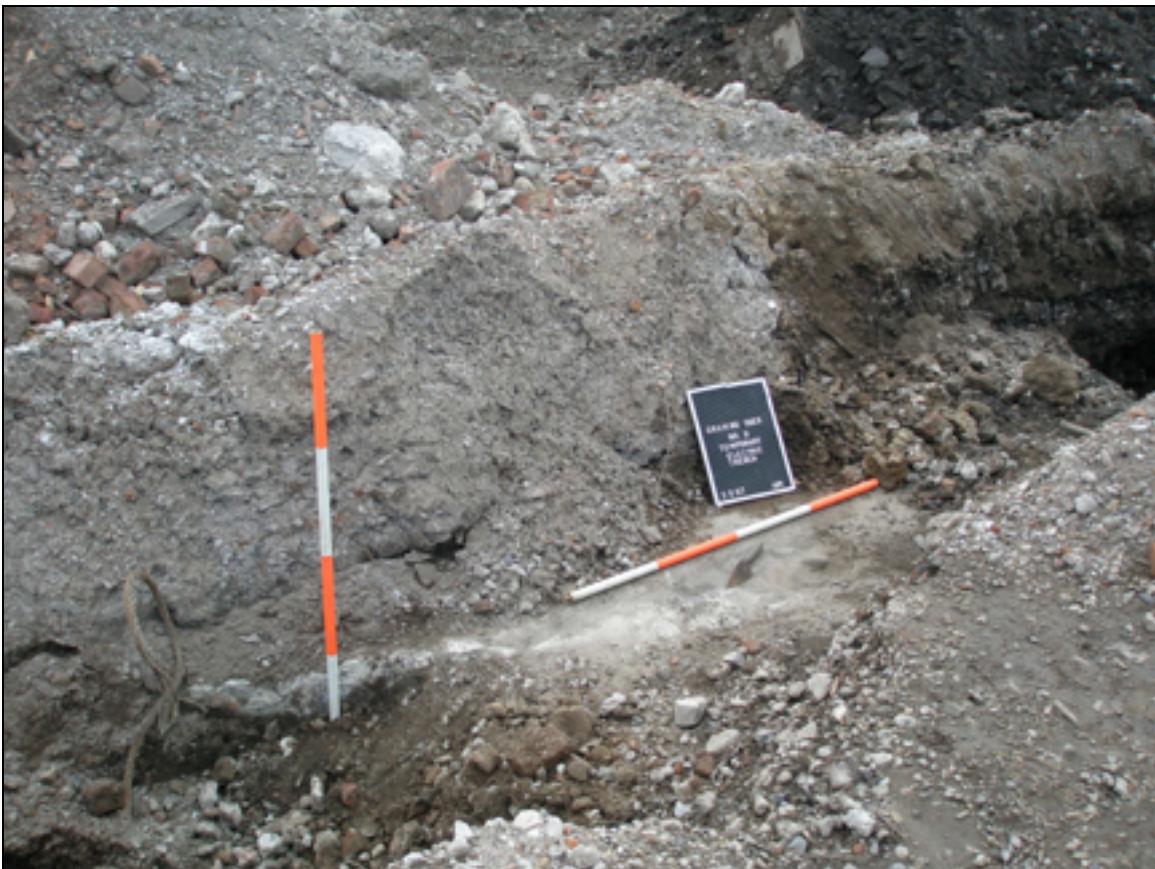
Photo 3.19. Temporary Utility Trench looking southeast. Note uncovered interior edge of Eastern Wall of Graving Dock No 2 (poured concrete). Top of dock was approximately 2.5 feet below grade.

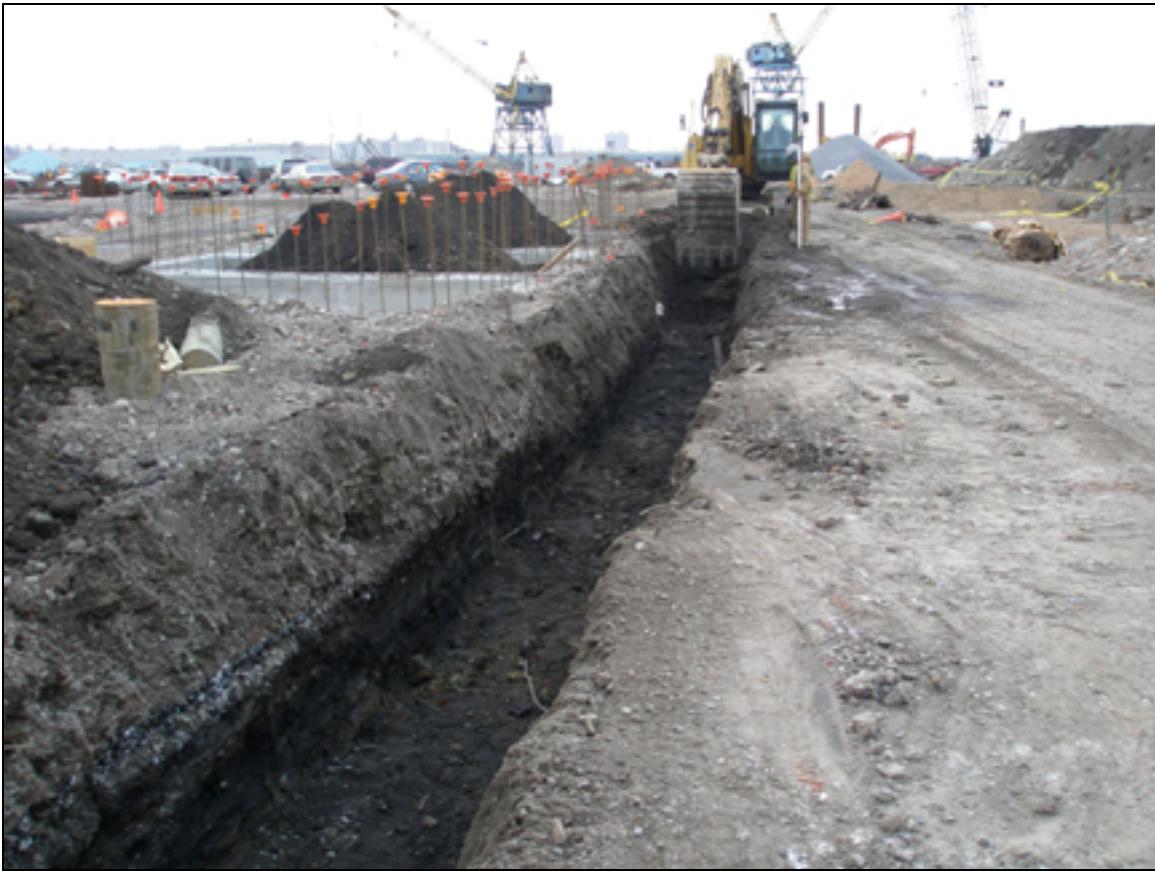
Photo 3.20. Temporary Utility Trench looking south from Eastern Wall of Graving Dock No. 2. Trench depth in this section was approximately 4 feet below grade, later taken to 5 feet below grade.
