# **ARCHAEOLOGICAL FIELD MONITORING**

**IKEA RETAIL SITE  
RED HOOK, BROOKLYN,  
NEW YORK**

**GRAVING DOCK No. 2**

April 2008

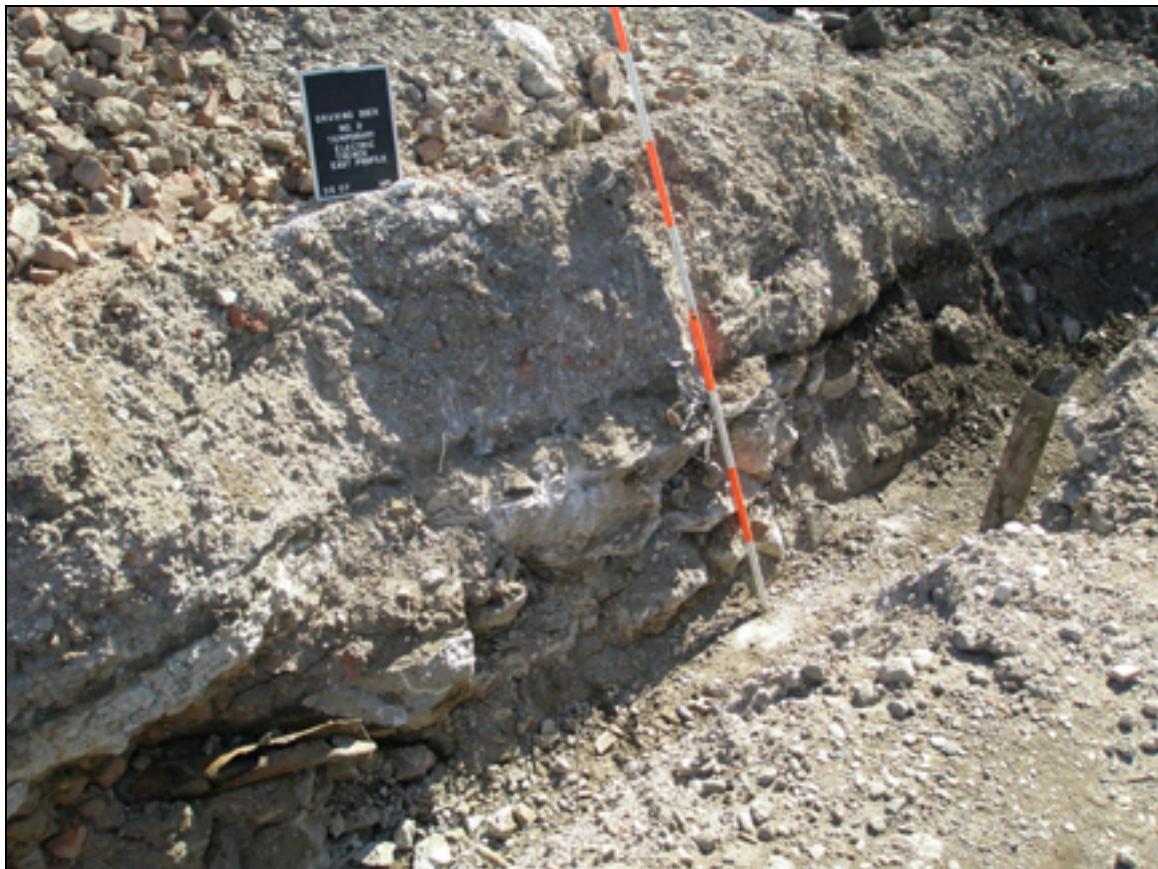
Photo 3.21. Temporary Utility Trench, east profile, after removal of Eastern Wall of Graving Dock No. 2. Note cross section of Eastern Wall of Graving Dock No. 2. The pipe in the foreground is likely located on one of the steps of the dock, as depicted on the 1969 map. The pipe is also seen in the right of the photo, turned upright. Once the wall was removed the trench depth was approximately 5-6 feet deep in this section.

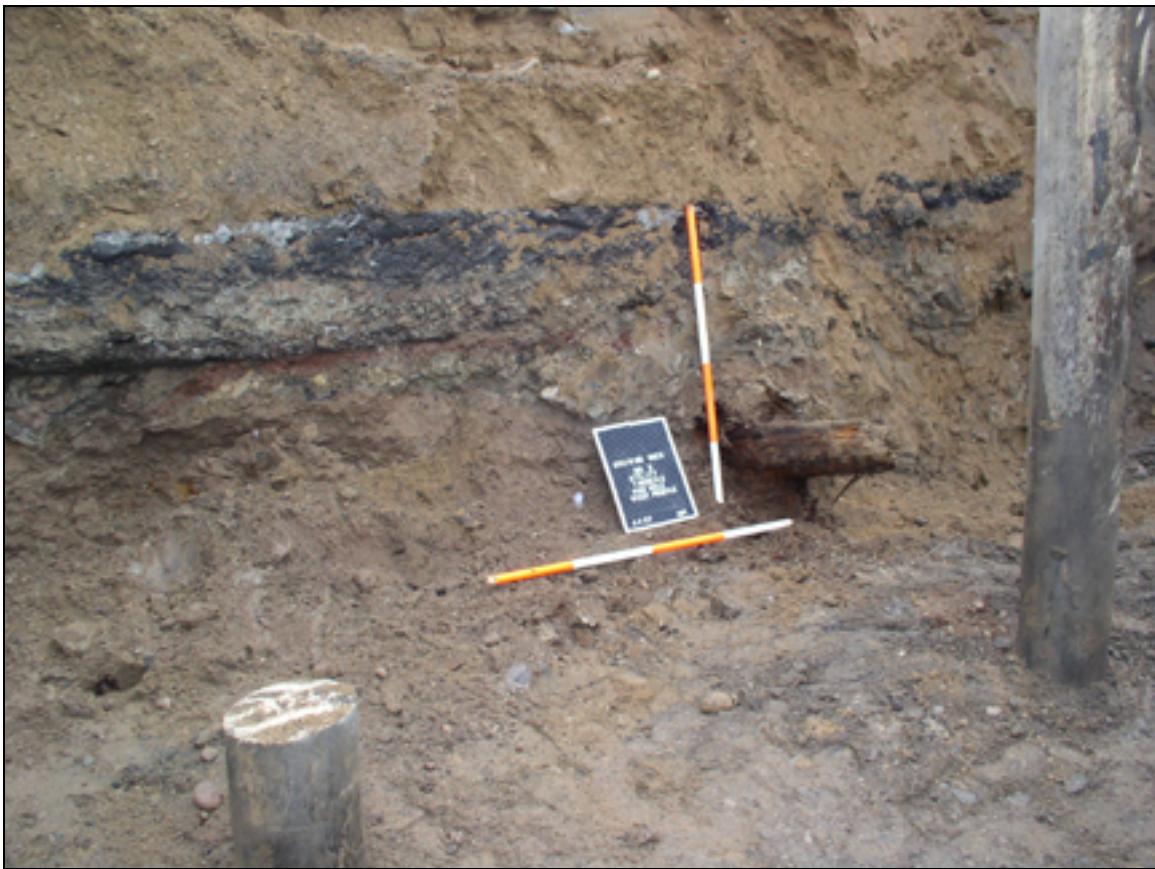
**Photo 3.22.** Utility Trench 2, Manhole Box western profile, looking northwest. Note wooden element protruding east out of wall. Concrete above the wooden element, appearing black in the photo, was the circa 1940 utility duct running parallel with the eastern wall of the graving dock.

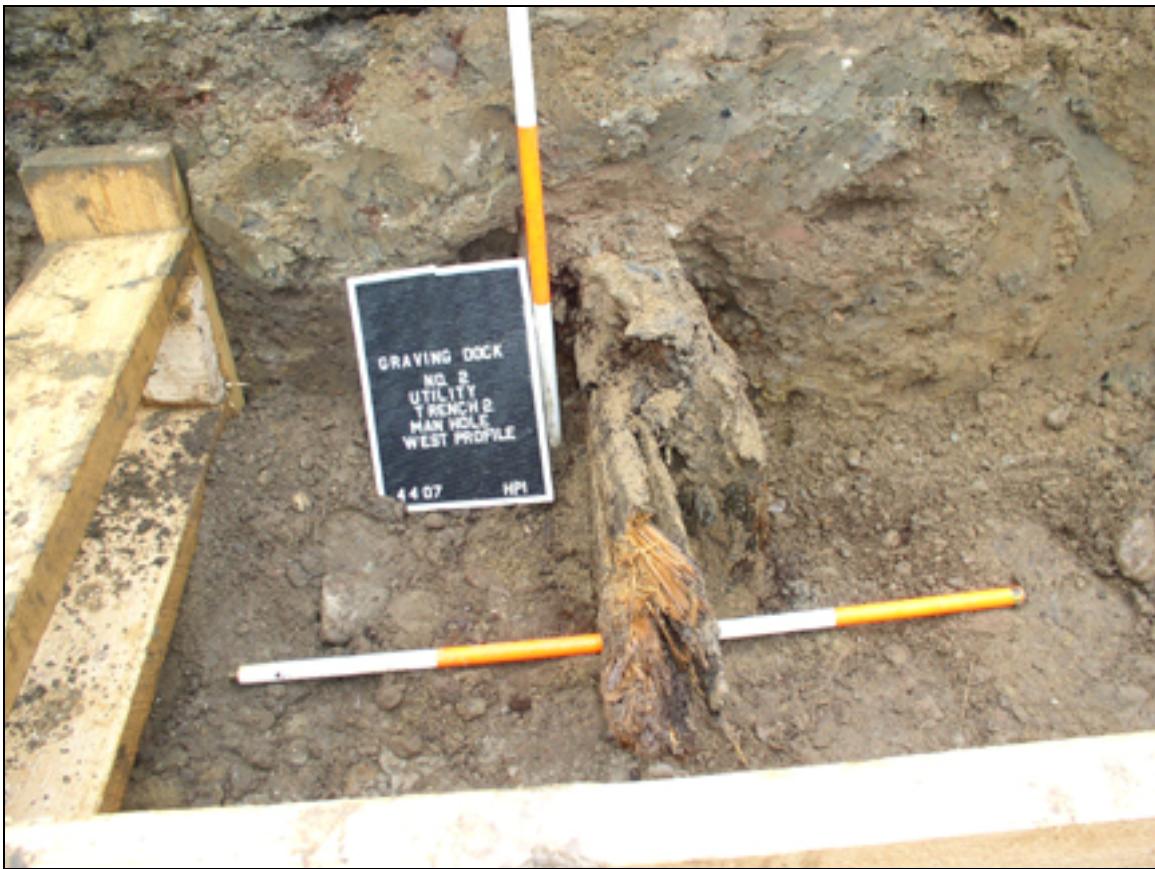
**Photo 3.23.** Photo looking west towards wooden element protruding from western wall of Utility Trench 2, Manhole Box. Note: new 2x4s are part of a form built for the manhole box. Also, there does not appear to be a cut or fill episode for the wooden element.

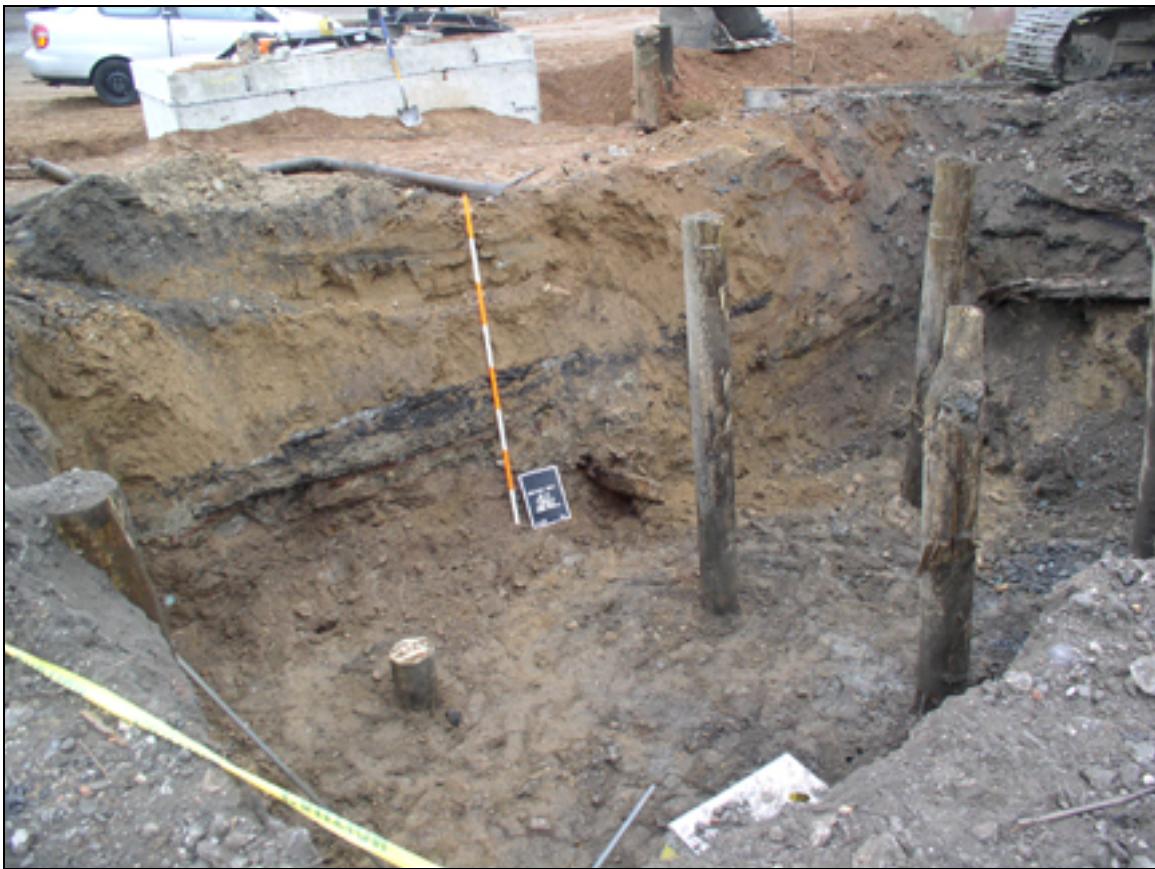
**Photo 3.24.** Western Profile of Manhole Box cut within Utility Trench 2 looking northwest. Note: Circa 1940s electric duct is located above wooden element. No visible cuts or associated features were identified with the wooden element. Vertical piles in the foreground were driven to support the manhole box.

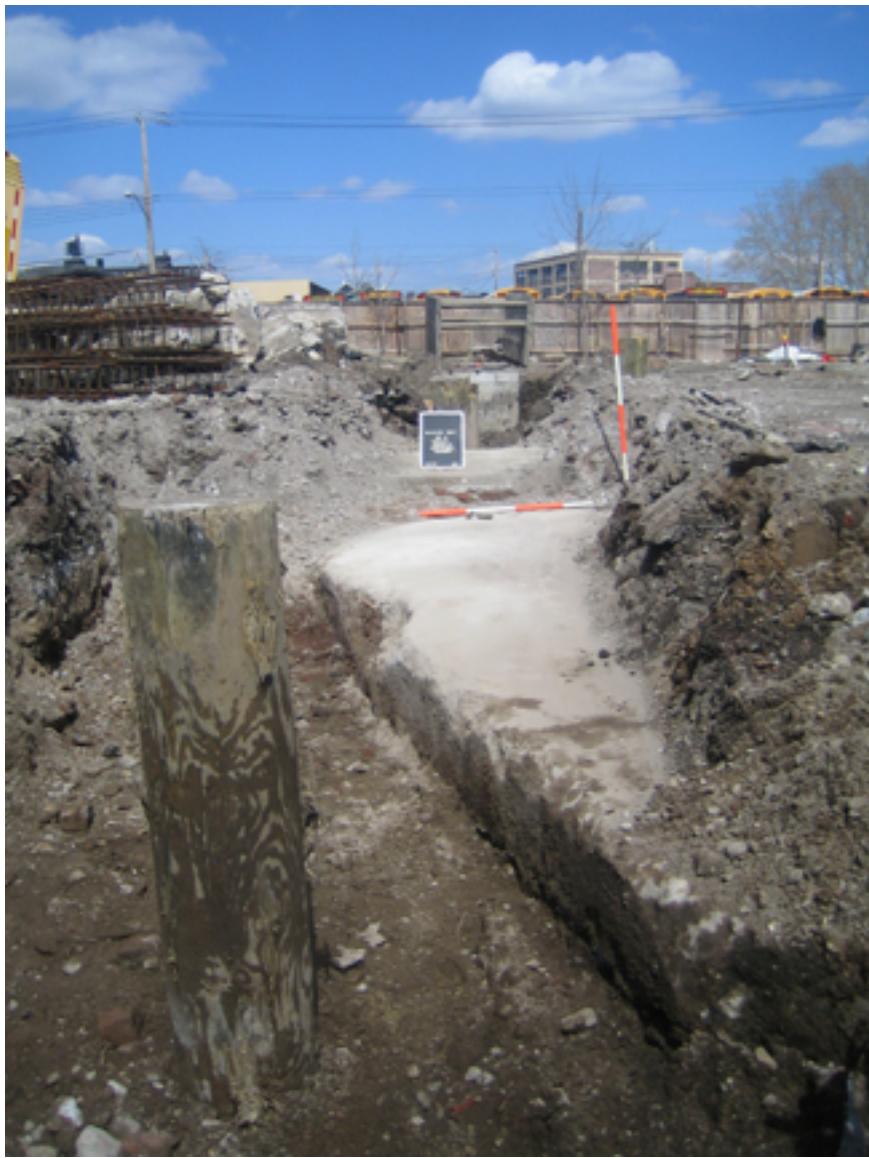
**Photo 3.26.** Headwall of Graving Dock No. 2 within Utility Trench 3, looking northeast.

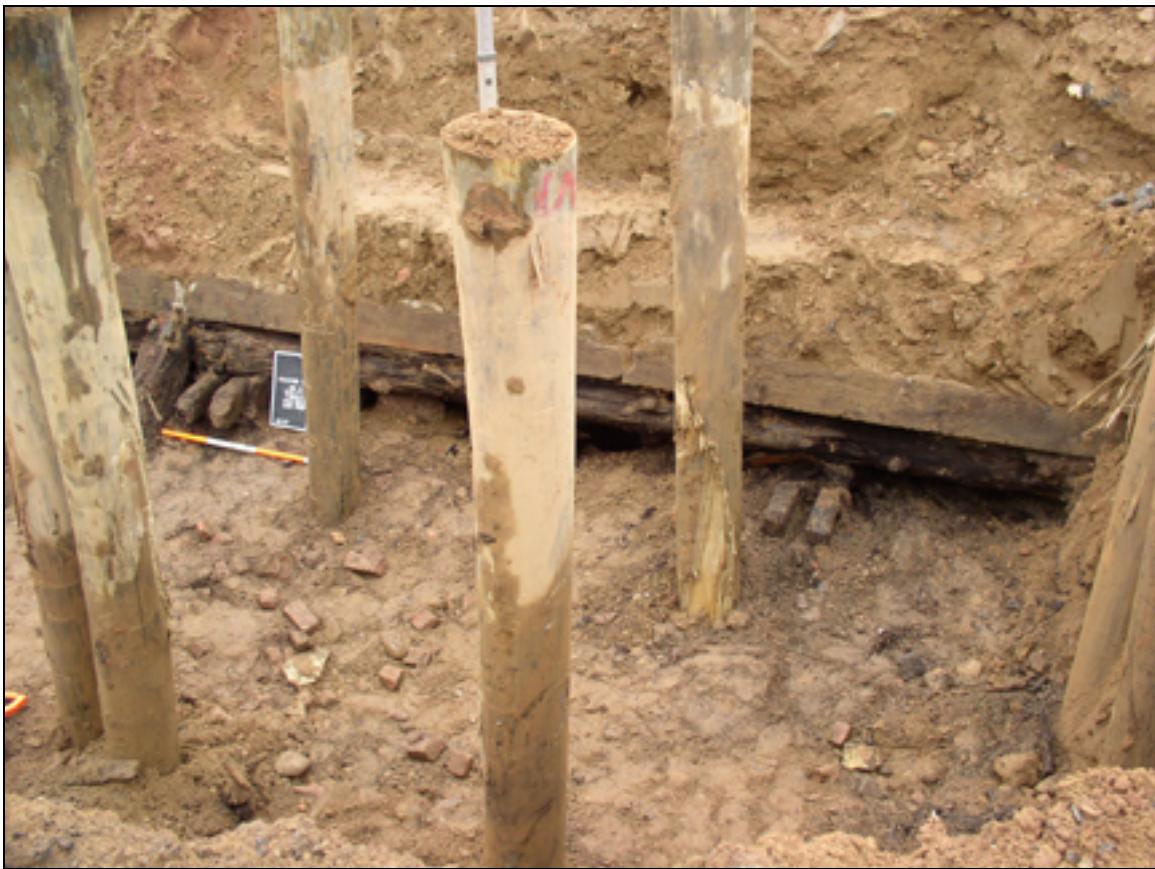
**Photo 3.27.** East Profile of Utility Trench 3, Manhole Box, showing exposed wooden elements of East Wall of Graving Dock No. 2.

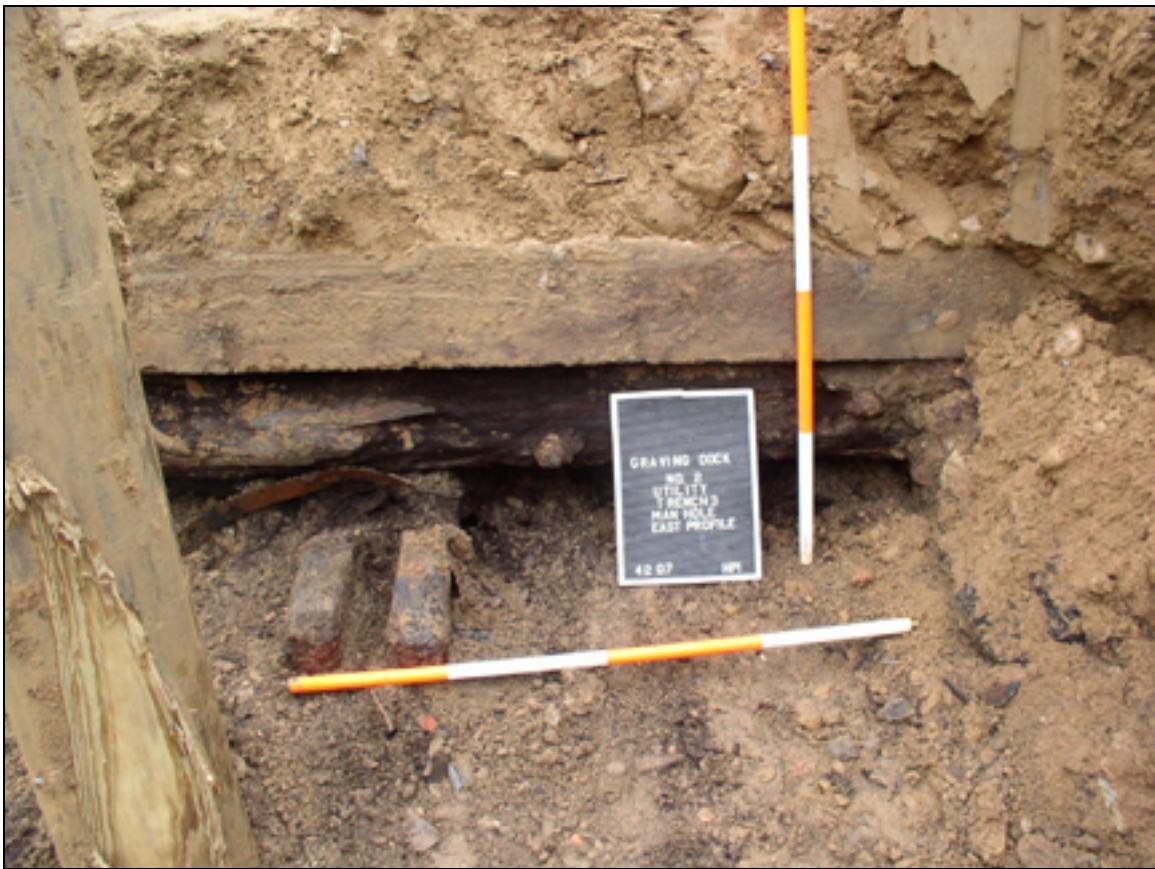
**Photo 3.28.** Close up of southernmost portion of Manhole Box, East Profile of Utility Trench 3, showing exposed wooden elements of East Wall of Graving Dock No. 2.

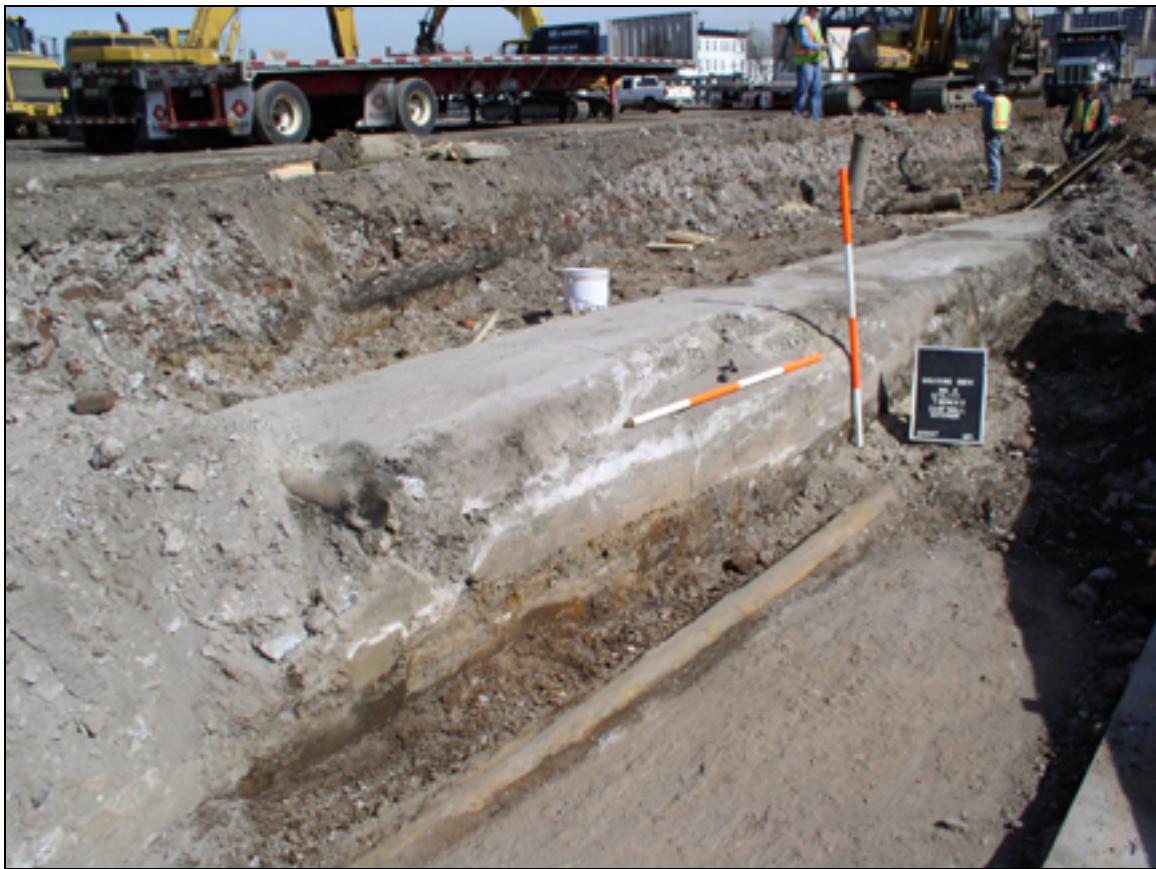
**Photo 3.32.** West Profile/Exterior of Graving Dock No. 2 within Utility Trench 3, Southern Exposure, looking north.

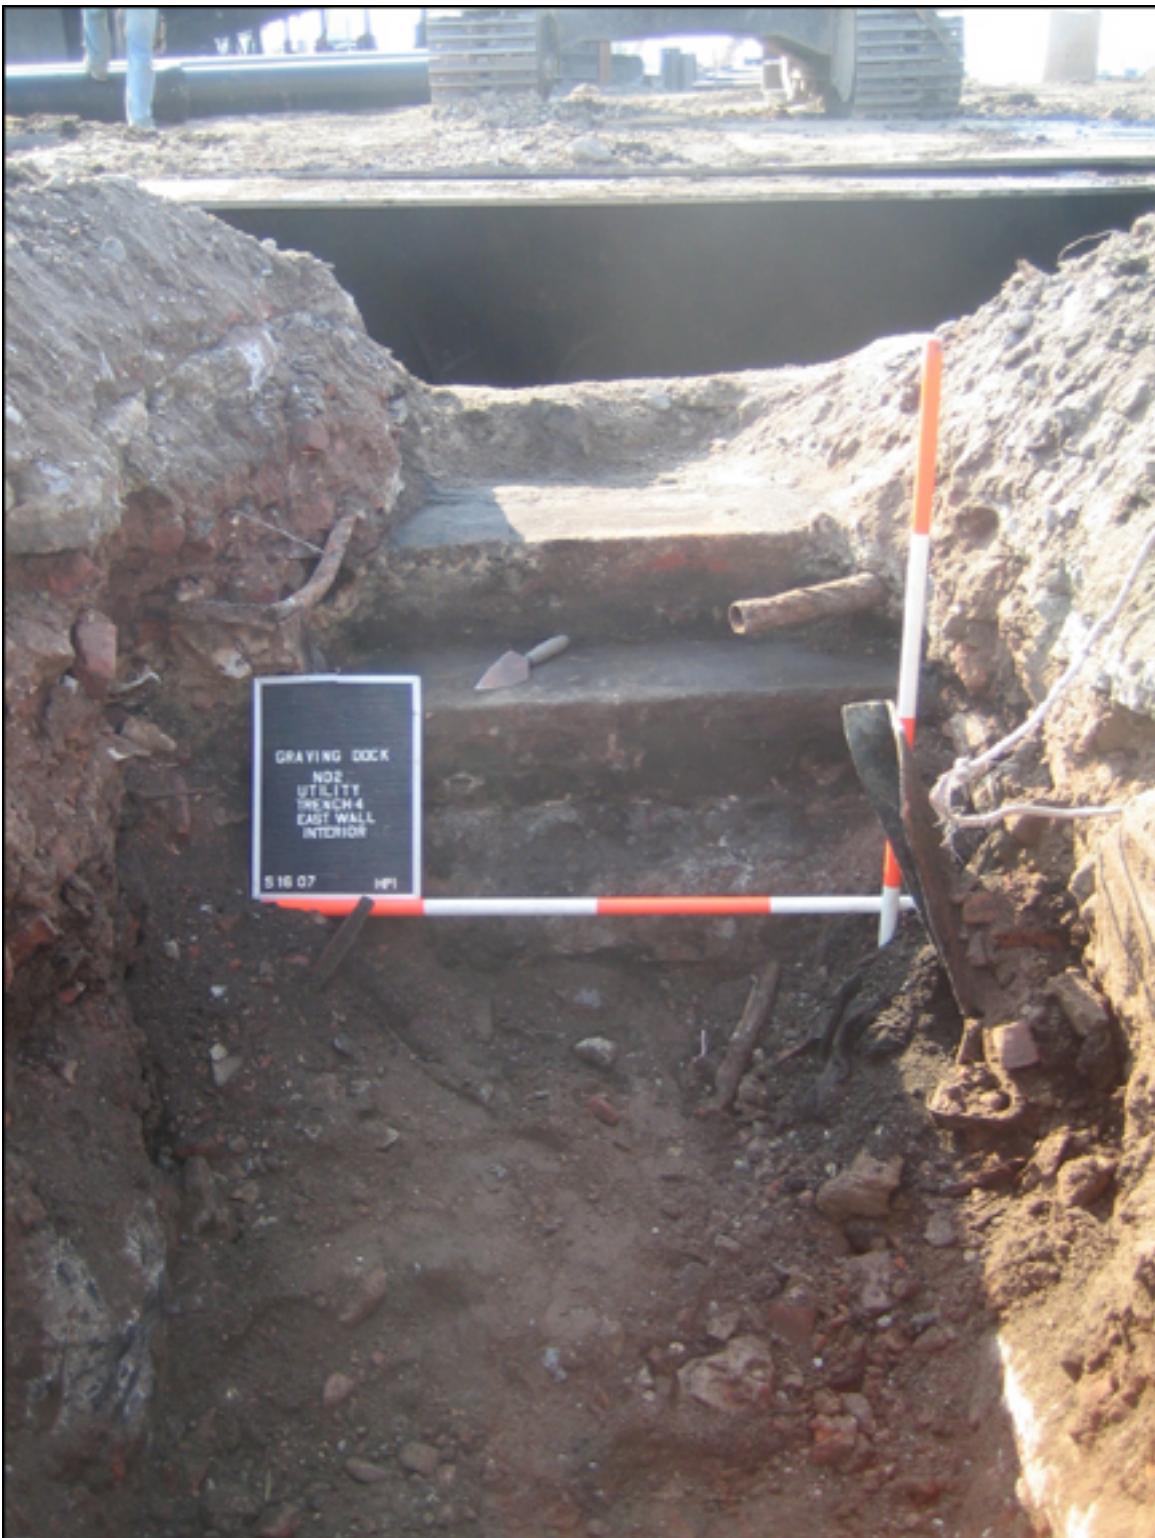
**Photo 3.34.** Looking southeast toward East Wall of Graving Dock No. 2 Interior (East Profile). Note: Pipe in foreground is within fill. Four stepped altars exposed.

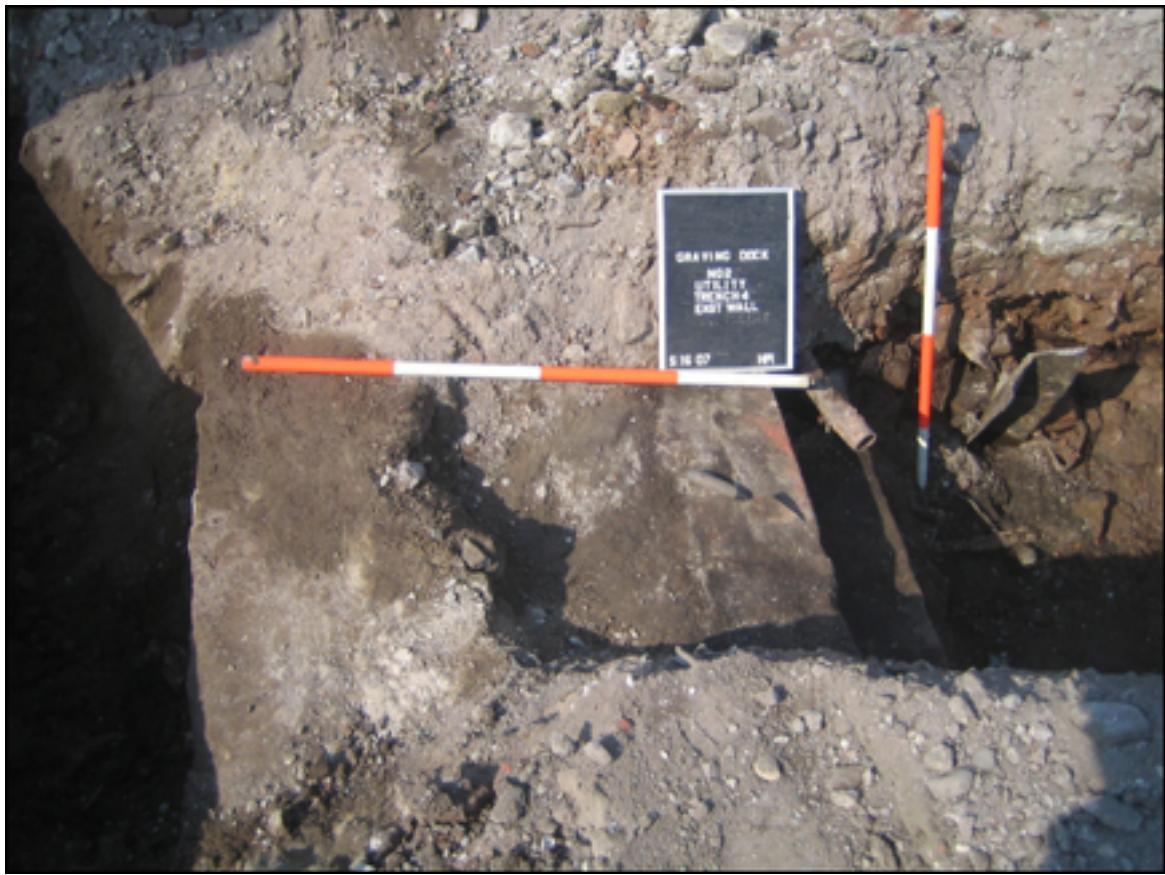
**Photo 3.35.** Looking Southwest toward East Wall of Graving Dock No. 2 - Plan View.
