**MITIGATION REPORT
FULTON STREET TRANSIT CENTER PROJECT**

**UNANTICIPATED DISCOVERY OF BRICK FEATURE BENEATH
THE CORBIN BUILDING**

**192 JOHN STREET
NEW YORK, NY**

March 18, 2010

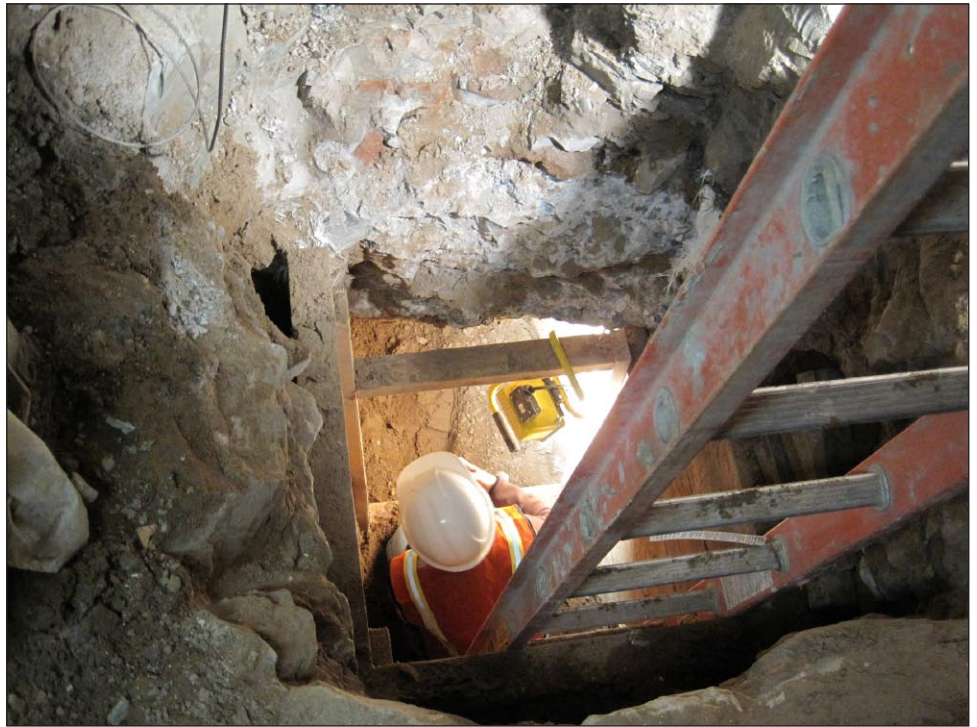
1

Initial test pit excavated for inspection of the feature. Note that the feature is recessed approximately 2' beneath the foundation and footer

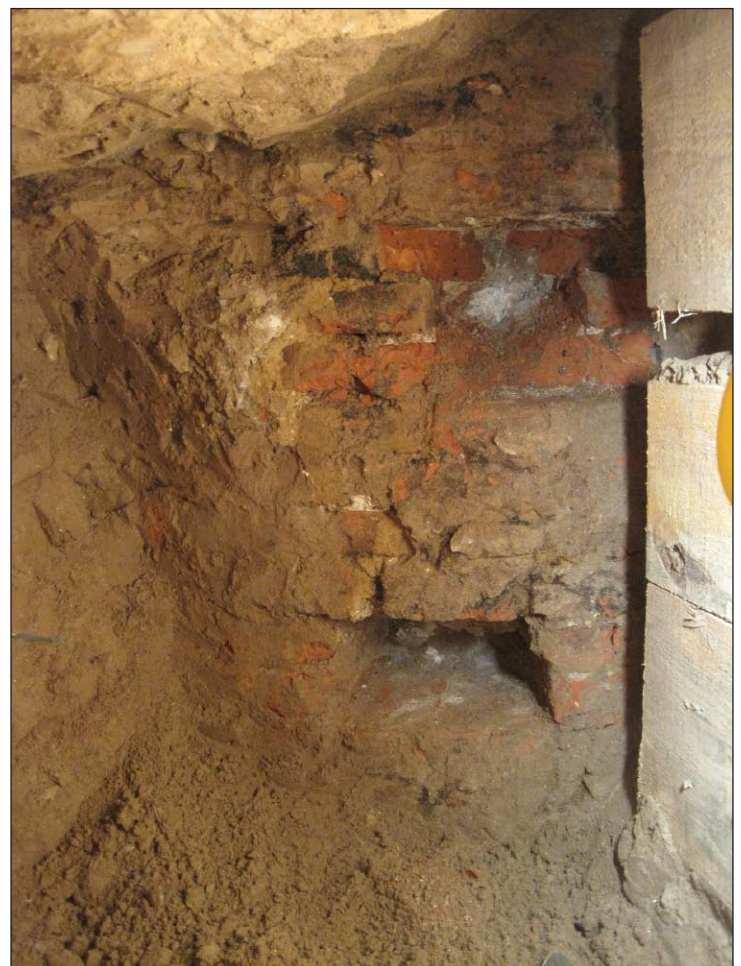
The feature is located immediately beneath the C-4 brick support column and associated inverted arch support (to the east of the column) along the southern wall of the Corbin building (see Figures 2 and 3). As described above, this area had been excavated to explore a problem during the jet grouting operation which in turn had led to the discovery of the feature. The area was then backfilled by the contractor for safety and structural concerns. The contractor subsequently re-excavated the area for inspection by the CRM Team. The initial area excavated for investigation measured approximately 3' by 3' (.91 x .91 meters) and extended 2' (.6 meters) below the column footer (see Photo 1 of Figure 4). This was expanded to a 6' by 4' (1.6 x 1.2 meters) area, and an additional 3' (.91 meters) of depth, that exposed an approximate 55" by 50" (1.39 x 1.27 meters) section of the circular mortared brick feature (see Photo 2 of Figure 4).

North facade of the well, facing south.
Photograph taken from within the initial test pit

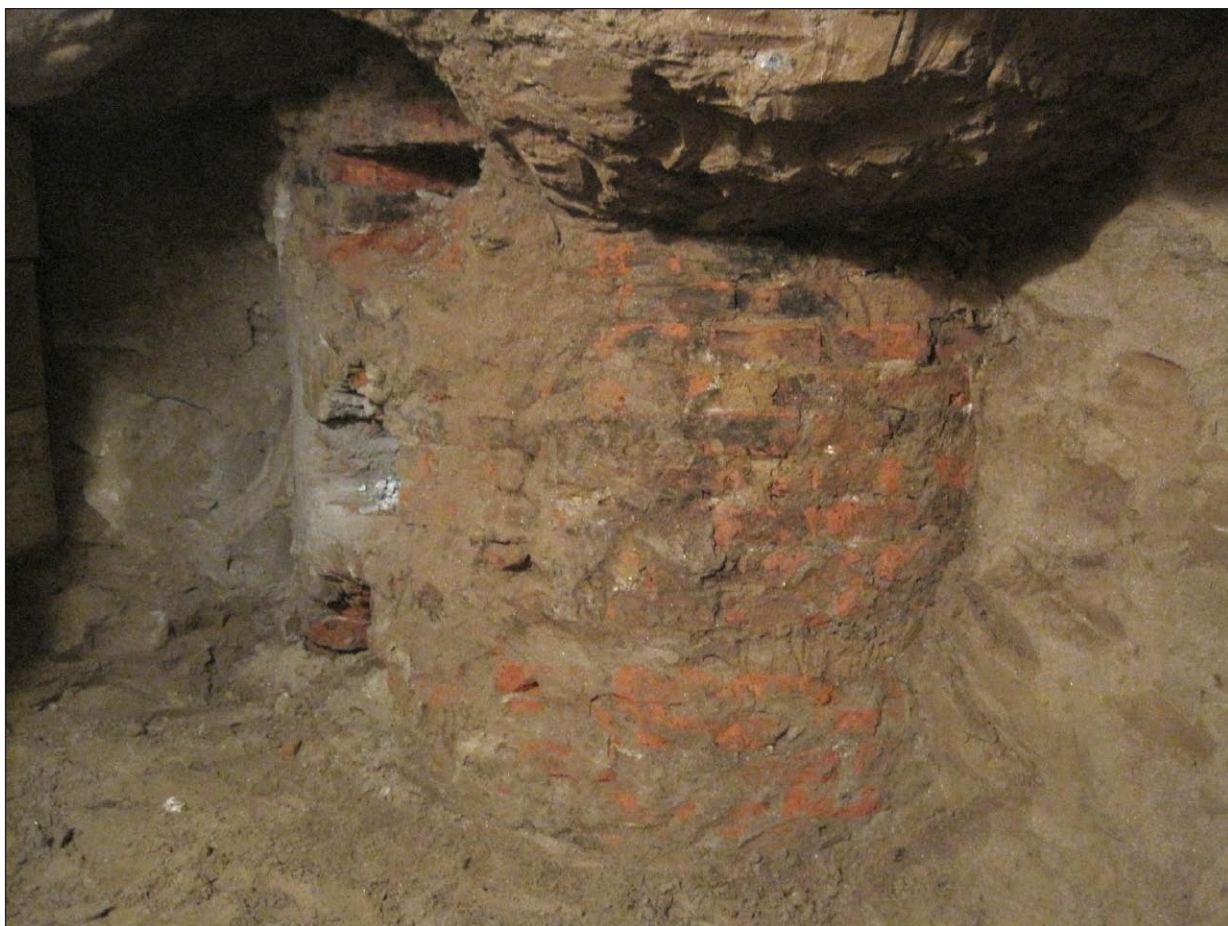
Figure 6

As opposed to what was discussed during the December 2009 conference call, the project engineers subsequently determined that the excavation for the support column would not impact the majority of the feature as originally anticipated. Instead, the underpinning pit was required to extend 10' (3 meters) below the foundation slab (i.e. concrete floor) and 8' (2.4 meters) below the 2' (.6 meters) thick concrete aggregate footing beneath the column (See Figure 5, which shows the area of the feature as originally exposed and the section of the feature removed to excavate the succeeding underpinning pit). During the excavation of the underpinning pit, another portion of the exterior of the brick feature, consisting of an additional 40" (1 meter) of the feature's circumference, was exposed (see Photo 3 of Figure 6).

North facade of the well, facing west within the underpinning pit **3**

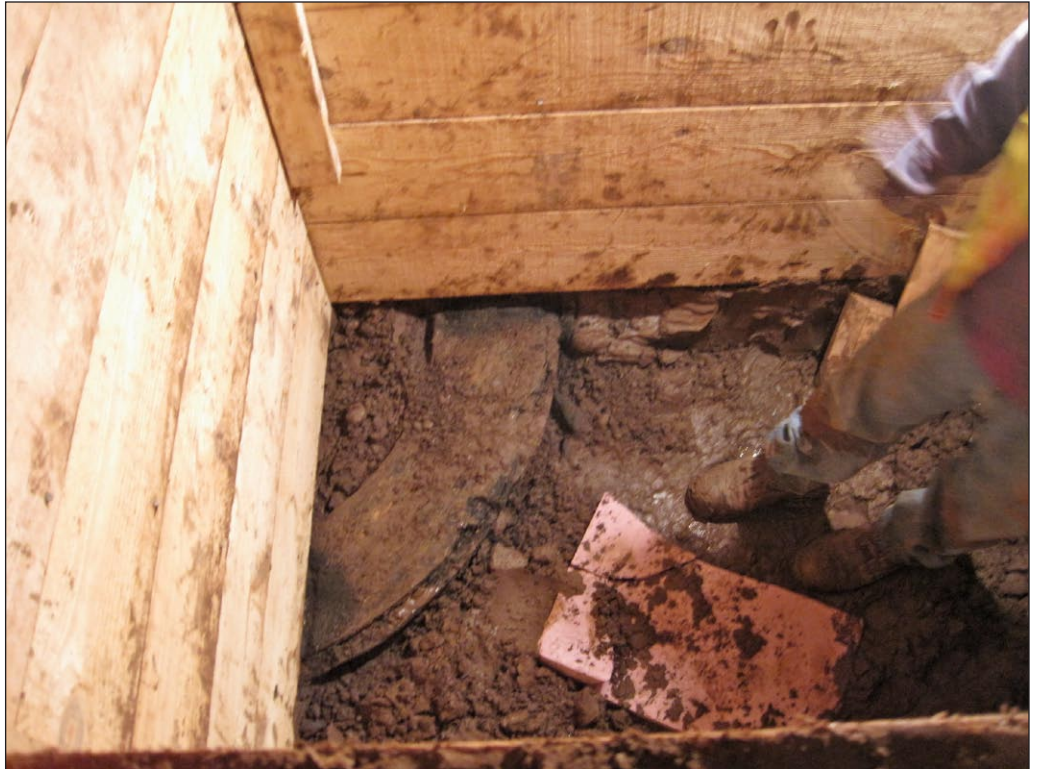
The bottom of the brick feature was reached at a depth of 98" (2.48 meters) below the existing footing. A circular wooden base, known as a curb, which served as a platform on which to lay the bricks, was exposed at the bottom of the excavation (see Photo 4 of Figure 8). This base was constructed of two layers of overlapping sections of wood that were nailed together with square cut nails (see Photo 5 of Figure 8). Similar circular wooden curbs have been found associated with well features at other sites in the city and are discussed further below in Section V. "History." At the bottom of the feature, the same fine, silty sand that surrounded the exterior of the feature was observed. Unlike the majority of the feature which was composed of mortared bricks, the bricks in the lower 30" - 36" (.76 - .91 meters) of the feature were un-mortared.

Wooden curb of the well, *in situ* 4

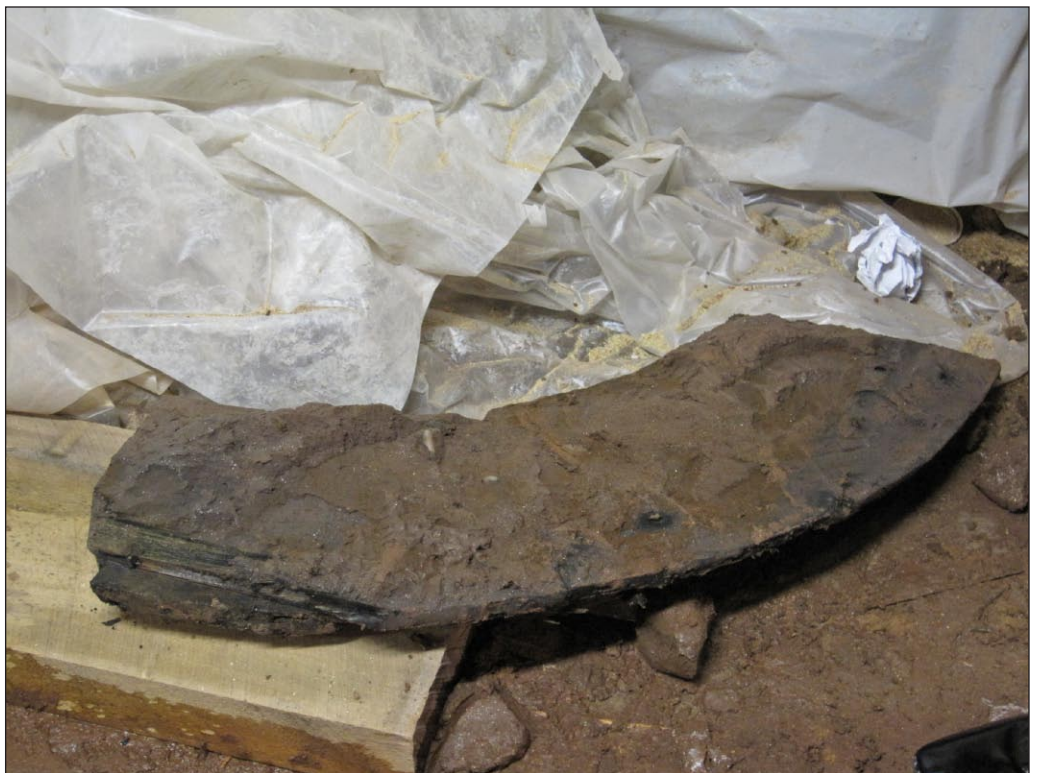
Section of wooden curb after removal 5

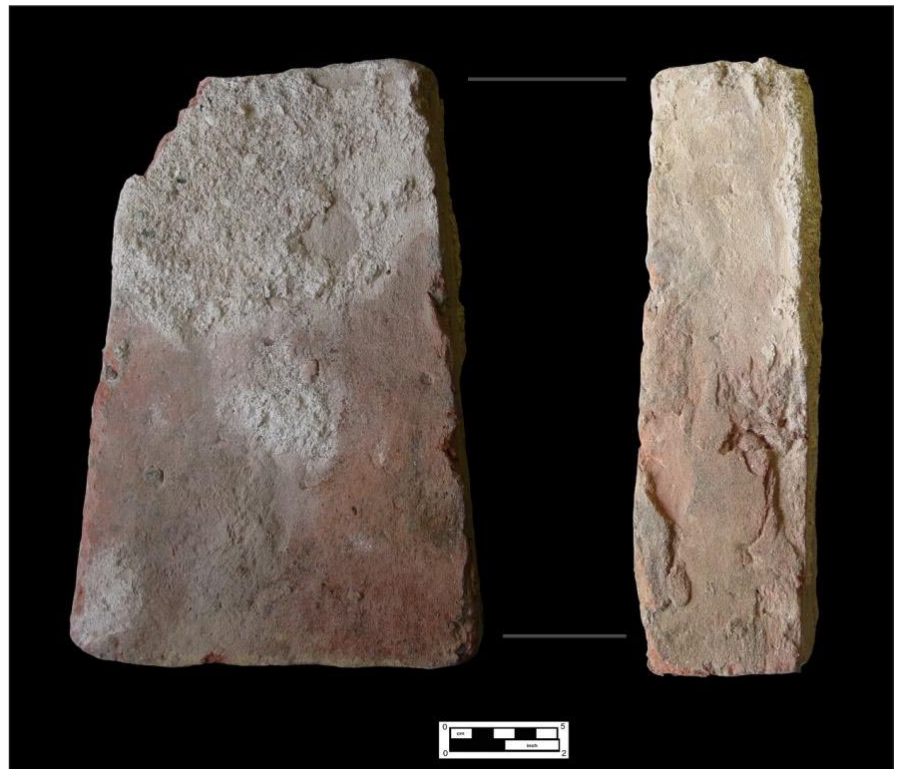
The bricks of the feature are known as compass or key bricks, purposefully tapered to form a circular structure (see Table 1 below and Photo 6 of Figure 9). The bricks of the feature are fairly large and are soft. They measure 2 ¼" (6cm) thick, 8 ½" (22cm) long, and taper in width measuring 6" (15cm) at the wide end and 4 ¼" (11cm) at the narrow end. They range in color from orange to dark red with pebble inclusions. They are notably different from the bricks used for the construction of the Corbin Building which are smaller and have a more uniform appearance.

Plan and section view of brick from well 6

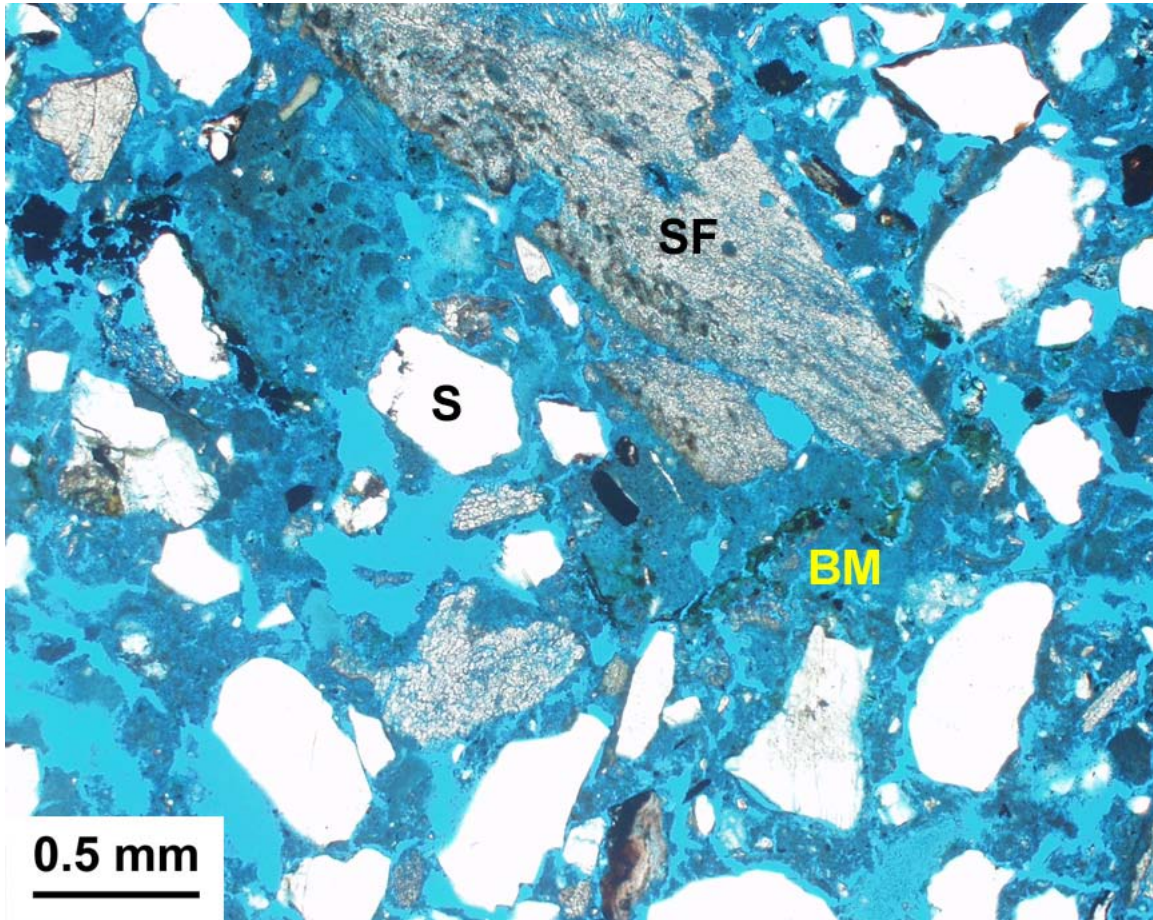
The lime matrix has a high capillary porosity and is virtually all carbonated. Microscopic shrinkage cracks are relatively common and these are typical of lime mortars particularly those with a low sand content. Aside from the typical matrix characteristics, the lime is identified based on the presence of undispersed lime grains. Some of the lime grains contain microtextures that have survived the calcination process. These are consistent with textures found in marine shells. Furthermore, unburned and partially burned shells are dispersed throughout the matrix. The lime is therefore interpreted to have been burned from a shell rather than rock source.

Figure 2: PPL photomicrograph illustrating the overall microstructure of the mortar sample. The binder matrix (BM) has a high capillary porosity as indicated by the absorption of low-viscosity, blue-dyed epoxy used in the sample preparation. Sand grains (S) are well coated with binder and are sparsely distributed throughout the matrix. Shell fragments (SF) represent unburned portions of the lime binder but may be practically considered as an aggregate component.

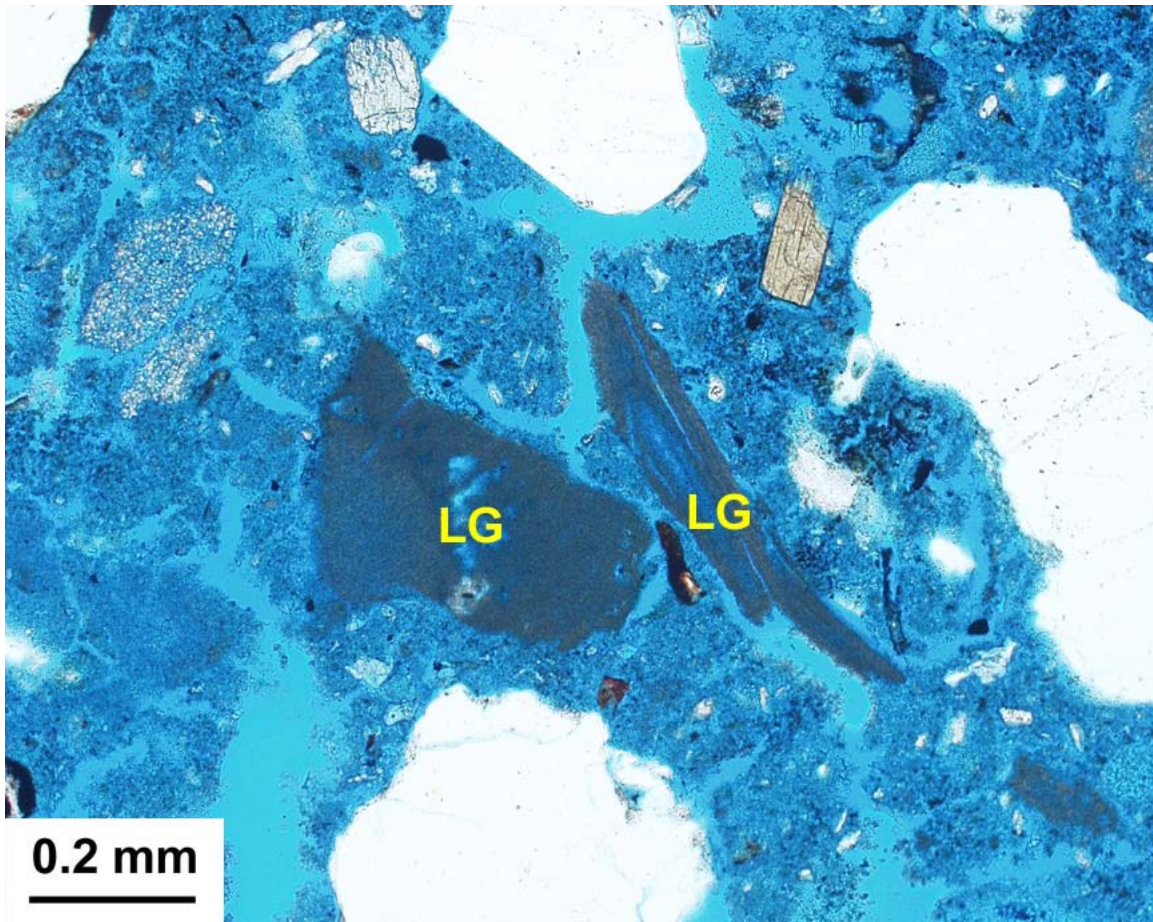
Figure 3: PPL photomicrograph exhibiting undispersed lime grains (LG). The one at right preserves a shape and internal texture consistent with the shell source used for the lime manufacture. Shell limes are generally high calcium and non-hydraulic in character.

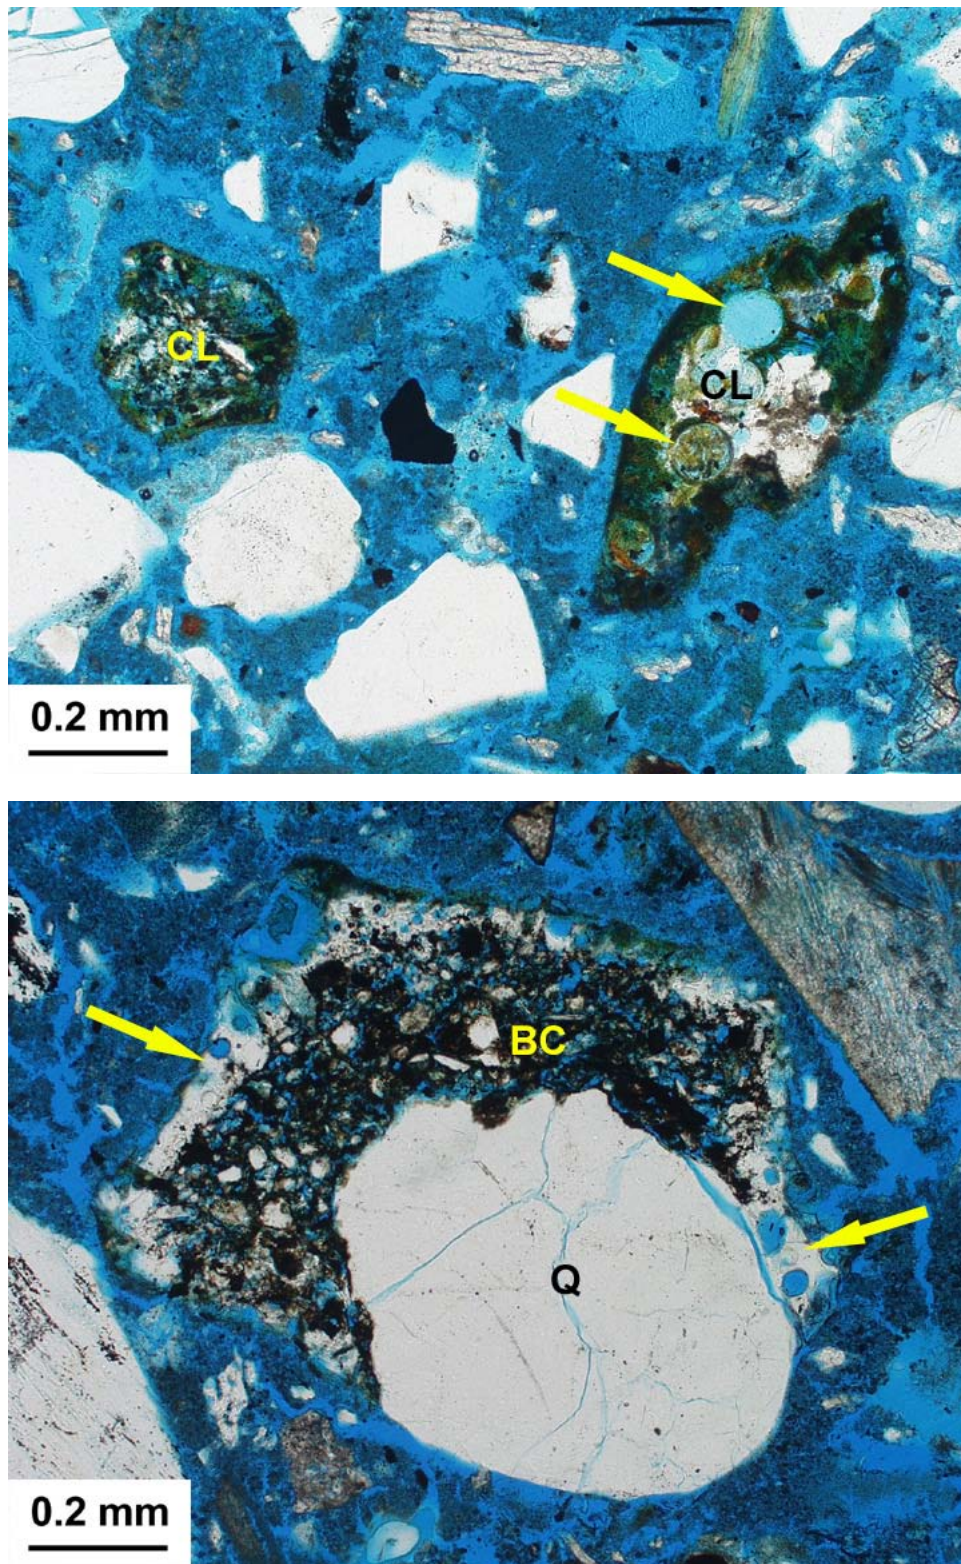
Fine-grained particles consisting of silty clay are detected as well. However, these are not interpreted to be part of the sand. Clay was sometimes added to lime mortars for economy but this does not appear to be the case here either. Some of the clay particles are associated with a vesicular glass suggesting that the clay was calcined. Calcined clay may have been used here as a pozzolan or hydraulic addition.

Figure 4: PPL photomicrographs. (Top) Silty clay lumps (CL) are dispersed throughout the matrix. The arrows indicate vesicles or air bubbles that may have been produced during firing of the clay. (Bottom) A quartz grain (Q) is surrounded by a partially amorphous mass consistent with burned clay (BC). The arrows indicate a layer of vesicular glass surrounding the clay. These features suggest that the clay is not added as a fine portion of the sand or as a separate inert filler.

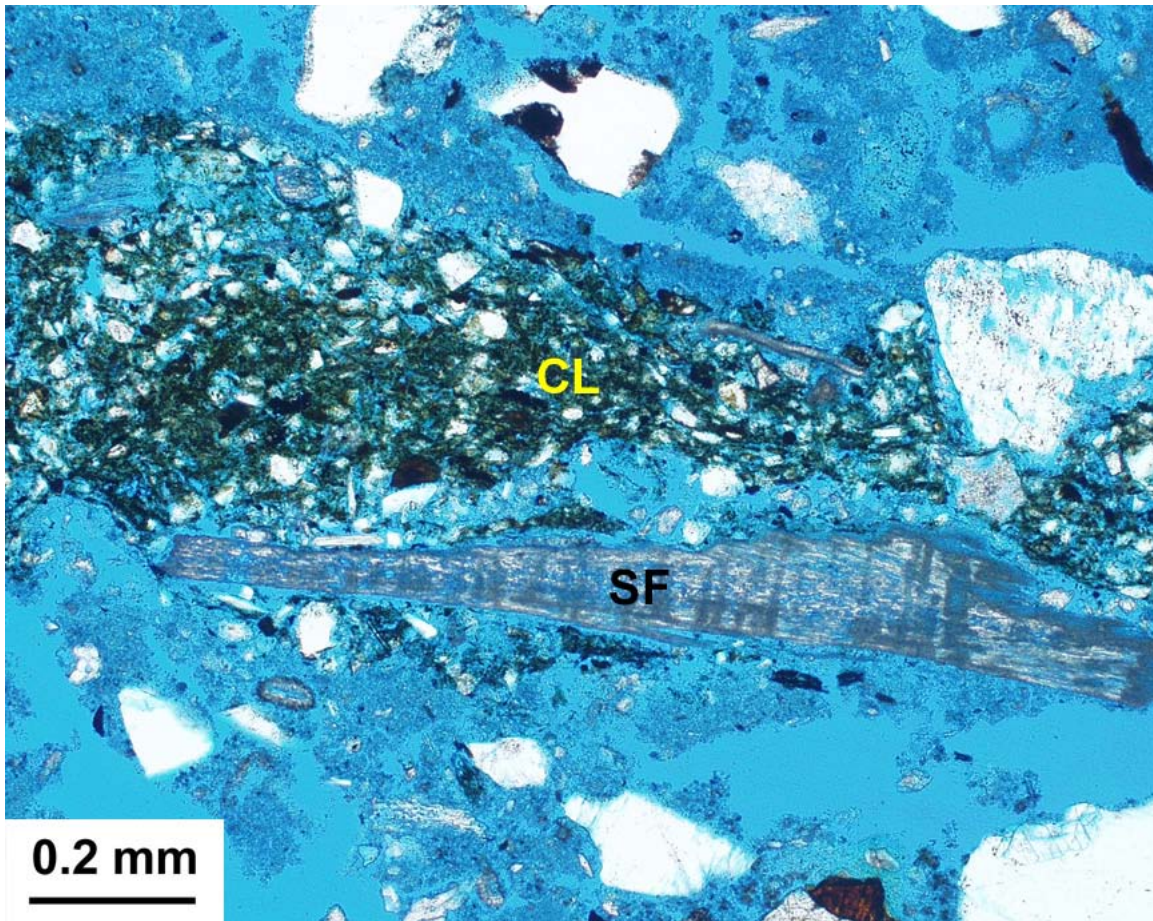
In some cases, the clay is found adherent to unburned or partially burned shell fragments suggesting that the clay and lime had been mixed prior to incorporation in the mortar. There are two ways this might have been performed. The first is that the clay and lime had been mixed prior to calcination in order to produce an artificial hydraulic lime. The second possibility is that the clay was calcined separately and added to the lime to produce a pozzolanic reaction during curing. This latter possibility is favored by the author.

Figure 5: PPL photomicrograph. There is an association between the clay lumps (CL) and the shell fragments (SF). In some cases as shown here, the clay is adherent to the unburned lime (here partially burned) and this suggests the two were mixed prior to incorporation in the mortar. However, if the clay were calcined, it is likely the two were mixed after rather than before calcination.

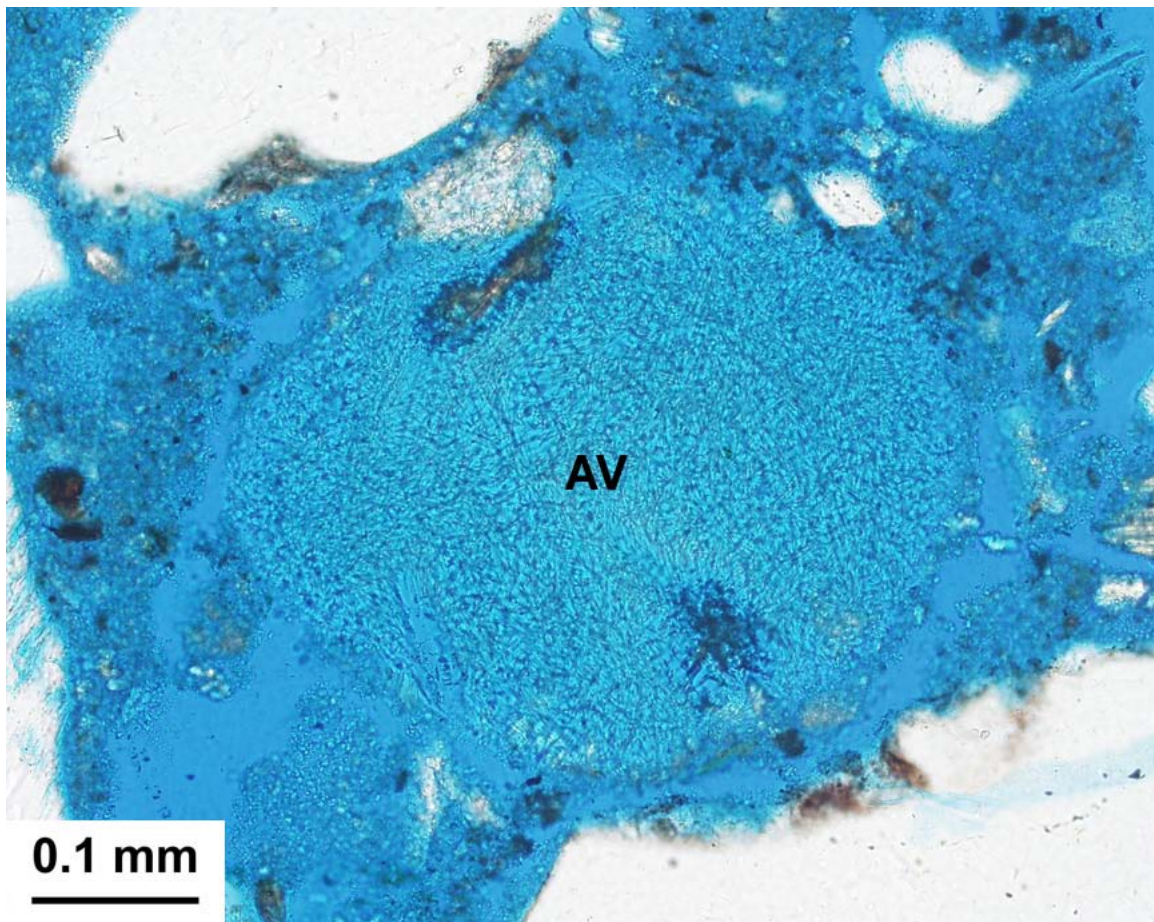
The mortar is virtually all carbonated. Thin "fronts" of denser carbonation are also interspersed throughout the matrix. Sparry calcium carbonate deposits are found along one of the bed surfaces. Ettringite is found in some air-voids but is not present within microcracks.

Figure 6: PPL photomicrograph. Some air-voids (AV) are filled with ettringite, a secondary sulfate mineral. The sulfate is not a common product in lime mortars and may indicate that some sulfate was present in the calcined clay.
