**Replacement of Willis Avenue Bridge over the Harlem River  
BIN No. 2-24005-9/A/B Total Design; Contract No. HBM 1124**

**Final Summary of Archaeological Monitoring**

**February and October 2008**

October 2012

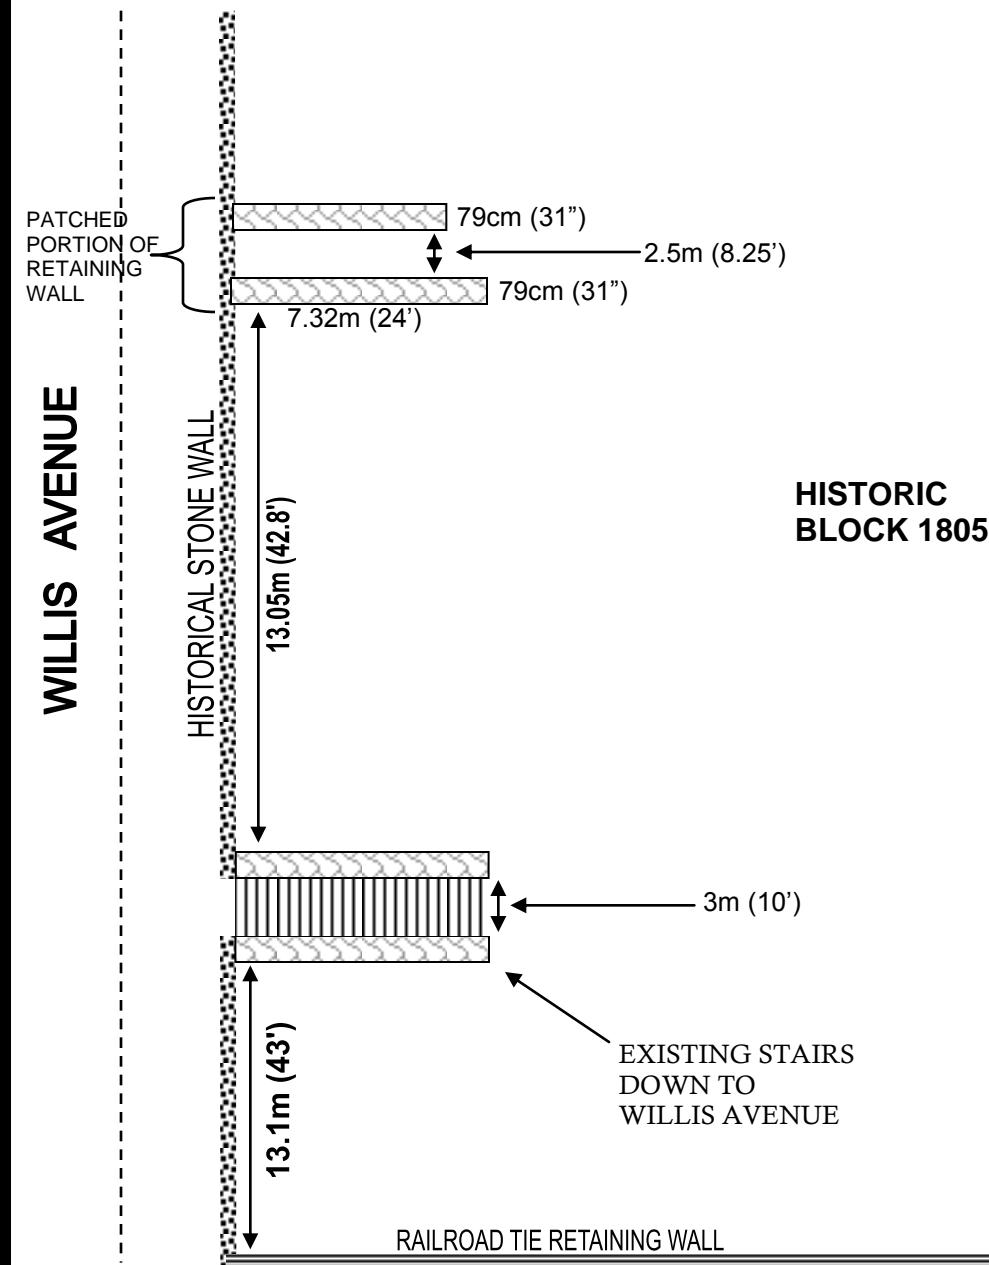
Figure 7: Field recordation of coursed ashlar wall, Pier BI, historic Block 1805.

Measurements were taken of the exposed stairwell wall and the existing retaining wall (see Figure 7). Both walls were photorecorded, and the stairwell was found to lack archaeological significance due to its relatively recent date of construction, the presence of an identical stairwell immediately to the west, and its lack of potential to contribute significant information about historical life ways. Construction at the pier location resumed upon completion of the recordation of the wall. No additional investigation or further documentation was warranted for the Pier B1 wall.

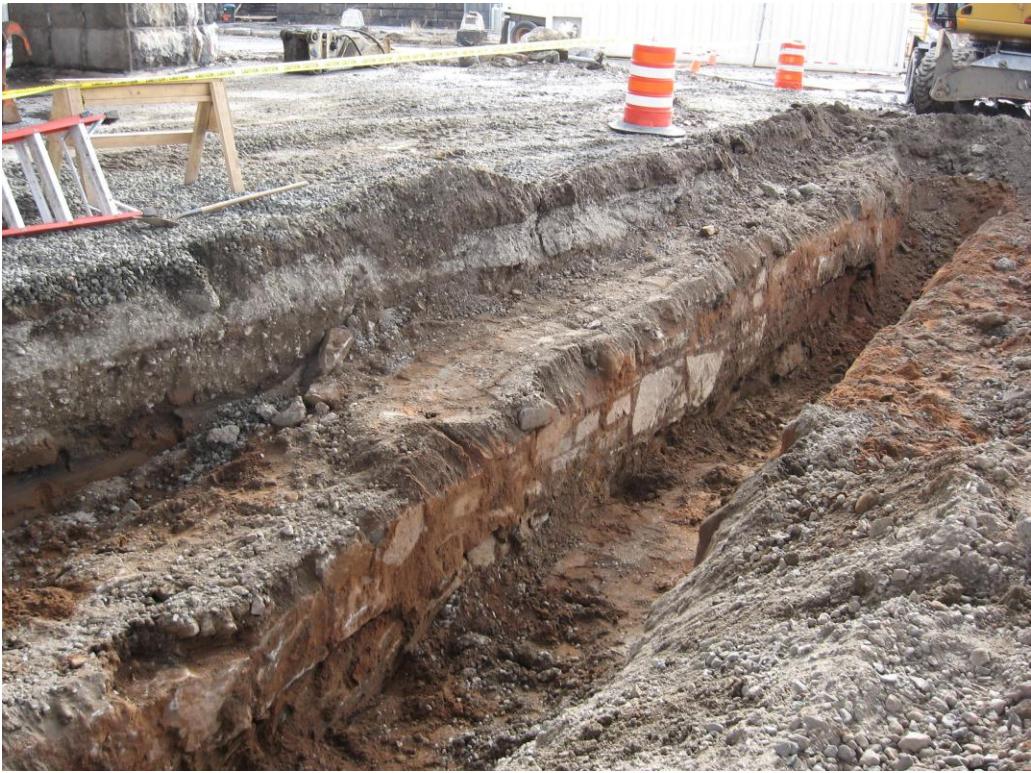
Under the direction of Sara Mascia, archaeological monitoring of the Pier 11 location was initiated on 2/27/08. The Pier 11 foundation trench, approximately 15.7m long (51.5') and 1.2m wide (4'), revealed the severely truncated remains of the exterior edge of the late nineteenth century railroad roundhouse (Figure 4, Photographs 1-3). Typically, the foundations of early engine houses were usually brick or stone. The interior floors were typically made of cinders, cement, stone, asphalt, or timber, with the floor level flush with the top of the rails.

The remaining foundation was represented by one to three courses of large, irregular, cut granite stones. There was no obvious mortar at the west end of the wall. Instead, stone shims were used for stabilization. At the east end, where the corner of the former building was observed, remnants of a sandy mortar were noted. The foundation width varied between 68 and 85 cm (26.8” and 33.5”).

Photograph 1: Exterior edge of the 1870s railroad roundhouse wall, shown within Pier 11 trench. View looking southeast.

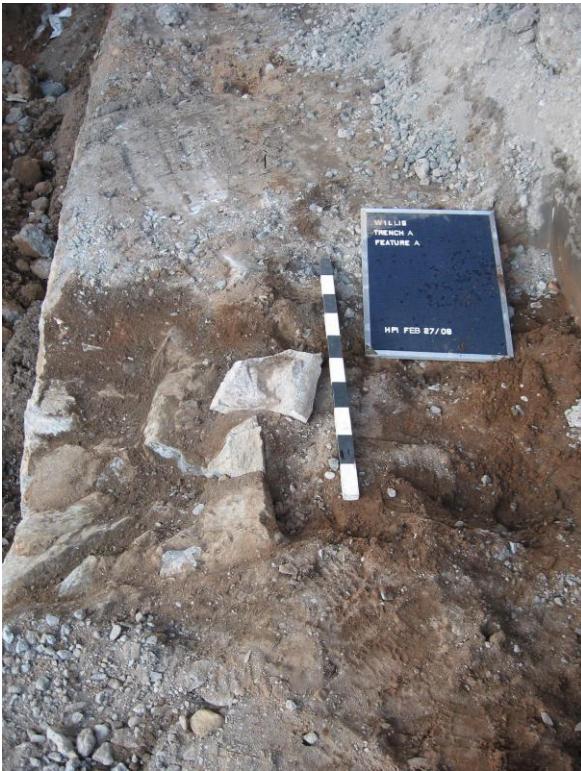
Photograph 2: Top of 1870s railroad roundhouse wall within Pier 11 trench, showing its width. View looking northwest.

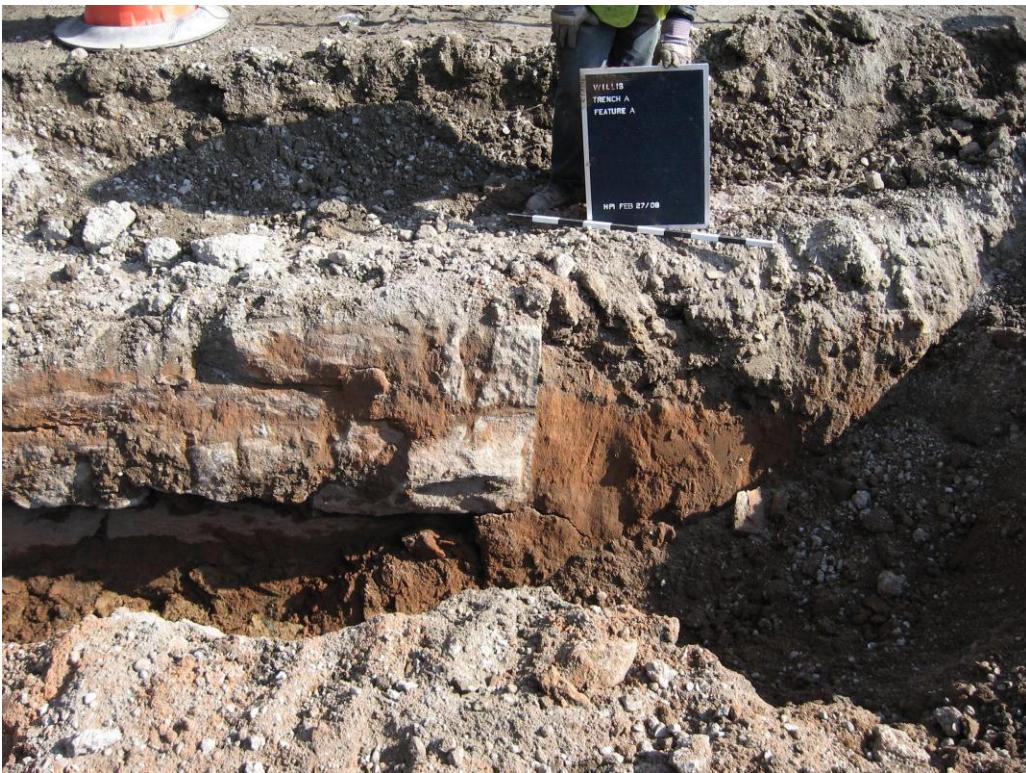
Photograph 3: Outside edge of roundhouse wall in Pier 11 trench. View looking northeast.

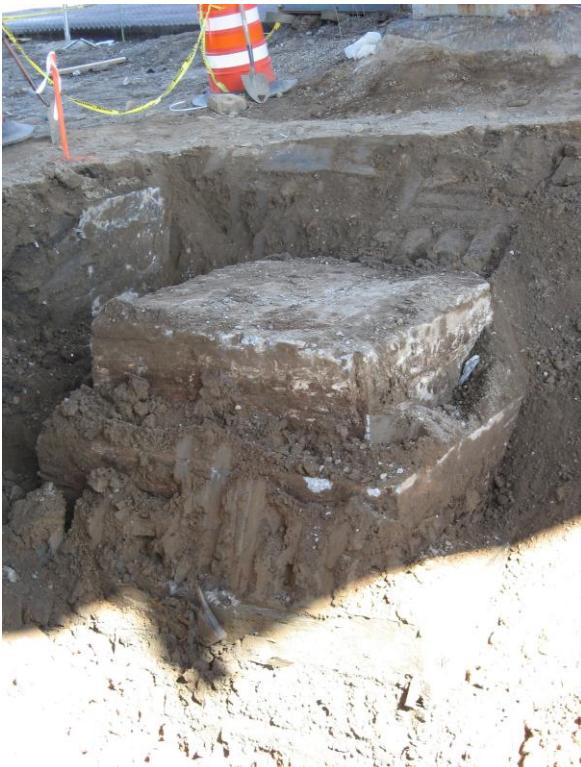
Archaeological monitoring of the Pier 12A location was initiated on 3/17/08 (Figure 4). The Pier 12A trench measured approximately 5.5 m (18 feet) north-south and 6.7 m (22 feet) east-west. Excavation almost immediately exposed a large concrete platform or support footing at 65 cmbs (Photograph 4). The feature was found to have four levels, each slightly larger resulting in the appearance of a step pyramid. The initial layer, closest to the surface was 1.52 m square (5 feet). Each successive concrete layer was approximately 70 cm (2.4 feet) larger on each side than the one above it. Each level was approximately 48-55 cm deep (1.57-1.8 feet). When fully exposed, the entire platform was approximately 2.13 m (7 feet) deep. Excavation halted when the feature was fully exposed. There were no other observable features in the remaining portion of Trench 12A.

The feature was not related to the former roundhouse located within this block and the original purpose of the platform was not immediately apparent. It is possible that it was a temporary support or staging platform that was constructed when the Willis Avenue Bridge was built.

Photograph 4: Concrete platform or support footing in Pier 12A trench. View looking northeast.

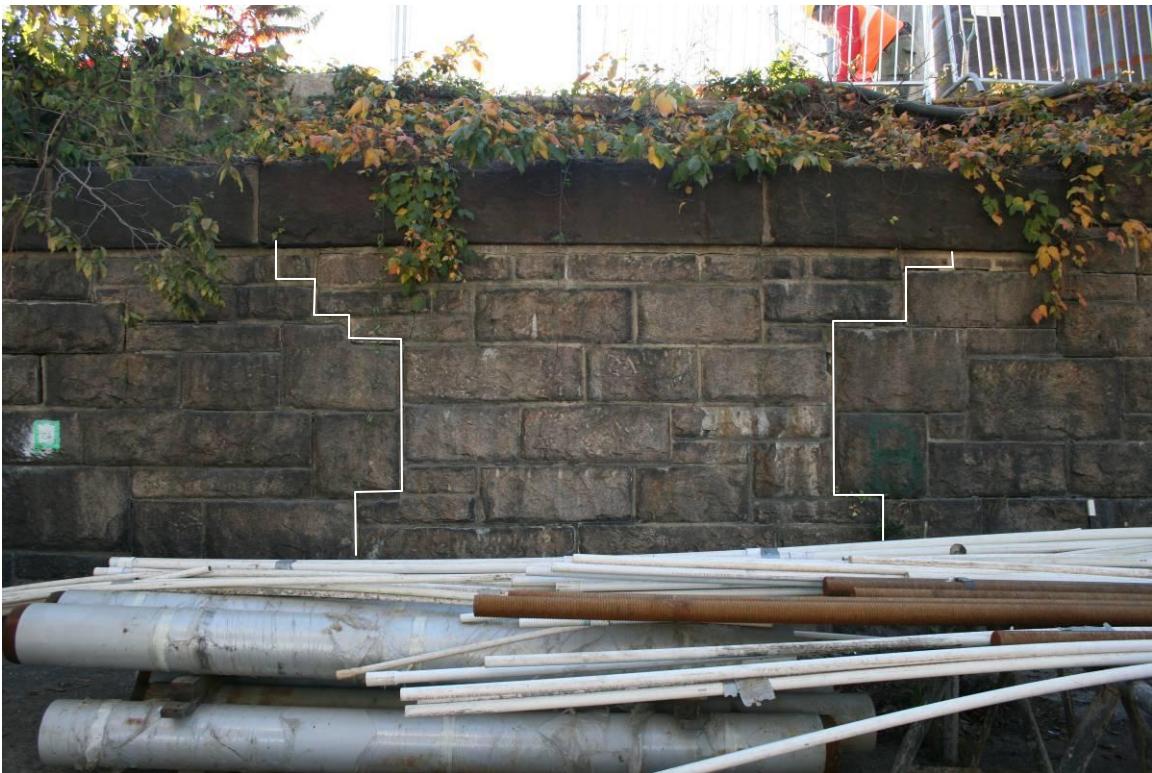
The coursed-ashlar wall encountered at Pier B1 was cleared of dirt and debris and was visually and structurally found to match the existing stairwell wall located 13.05m (42.81') to the southwest (Photographs 7-8). A visual inspection of the retaining wall along Willis Avenue found that it had been modified to hide the former location of the stairwell opening (Photographs 5-6). Ashlar stones had been removed from the corner formed by the intersection of the stairwell wall and the retaining wall, and the opening was closed off to match the remainder of the retaining wall. Variations in the color of the masonry defined the outline of the “patched” area.

Photograph 5: Historical stone wall at northern end of historic Block 1805 on Willis Avenue, facing southwest. Note the location of the patched portion of the retaining wall, outlined in white, which was formerly the access for a staircase up to a train platform. Man in orange vest at top of picture marks the location of the perpendicular coursed ashlar wall found in the excavation pit for Pier BI.

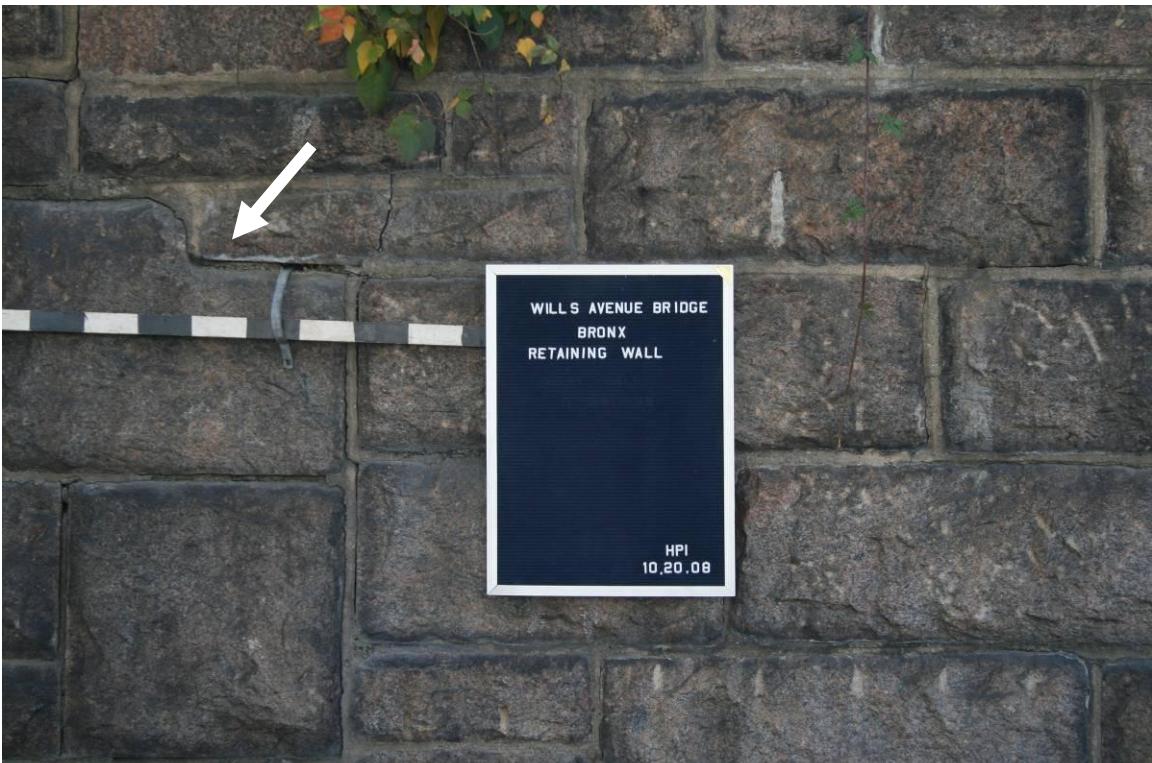
Photograph 6: Close up of historical stone retaining wall on Willis Avenue, facing southwest. Note the cracked joints that demarcate where the wall was patched after the stairwell was abandoned and sealed up.

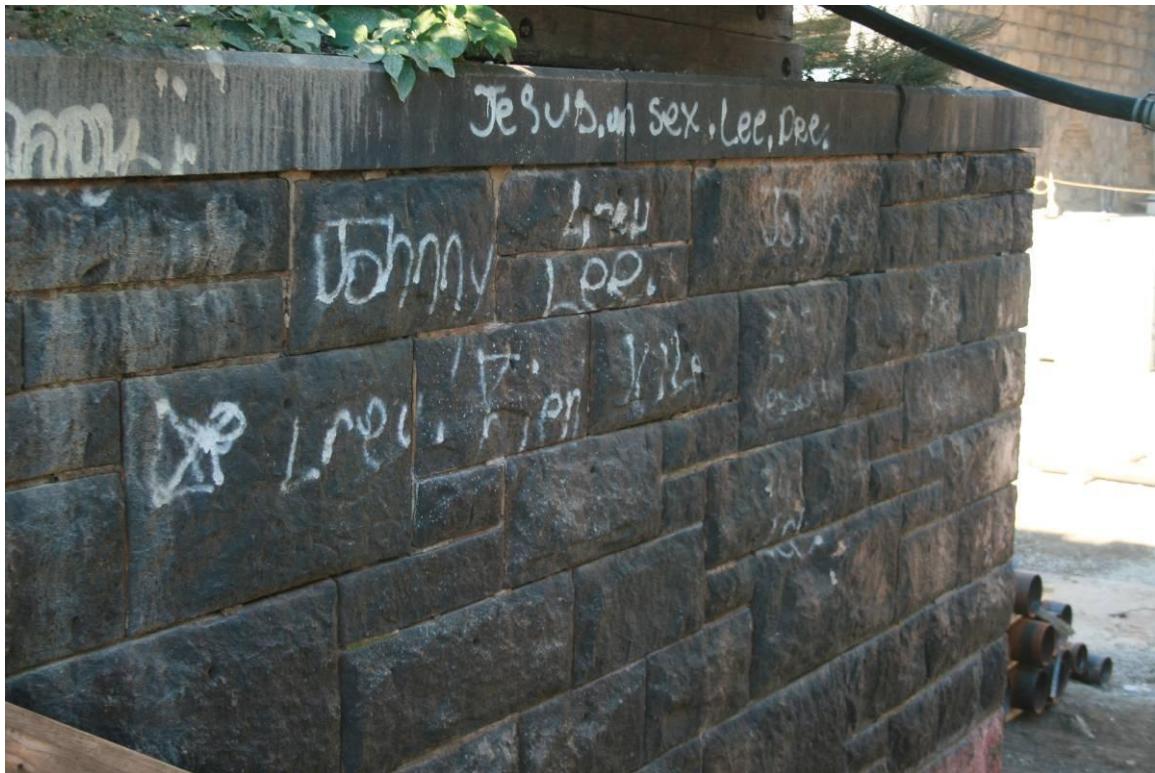
vacant until 1891 (Figure 5) when there was a stairwell shown leading from Willis Avenue up to a train platform in this approximate location (Robinson 1885, 1887; Sanborn 1891). Two other platform-access stairwells were also present; one to the east and the other to the west. The westernmost stairwell was extant (Photograph 7).

Photograph 7: Extant stairwell at northern end of historic Block 1805 that descends to Willis Avenue, facing northwest.

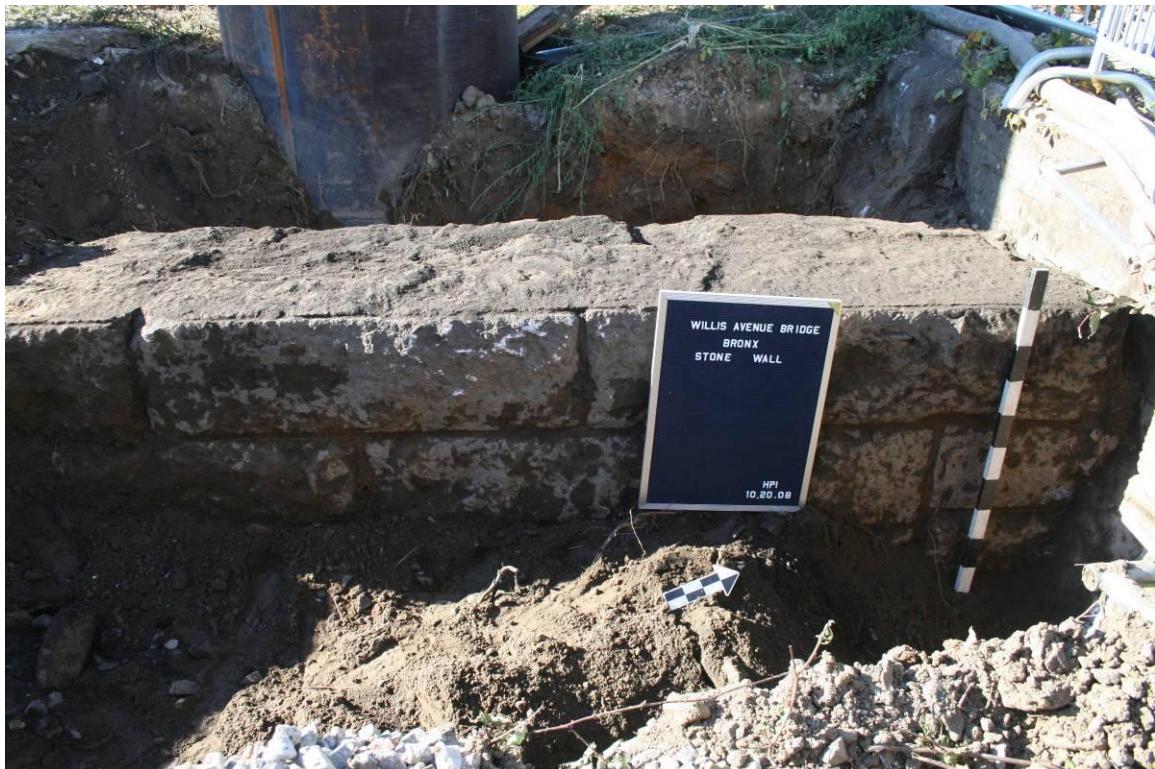
Photograph 8: Stone wall encountered in excavation pit for Pier BI, facing west. Note that the material and design match both the extant stairwell and the historical retaining wall, and that the northern end of the wall abuts the historical retaining wall, at the right.

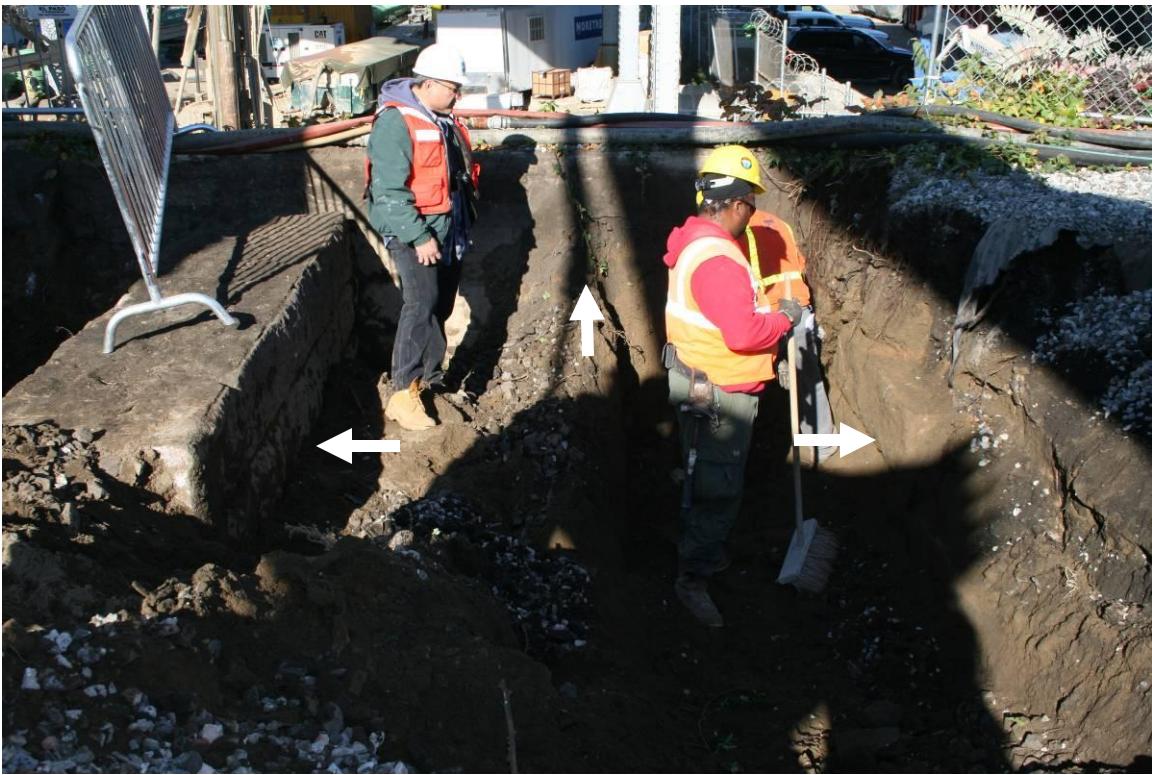
Additional exploratory excavations found that a second parallel wall was buried about 2.51m (8.3') to the northeast of the exposed wall, confirming that this was indeed the location of a former stairwell (Photograph 9).

Photograph 9: First stone wall encountered in Pier BI on left, and second stone wall encountered at right. Note that the men are standing in what would have been the stairwell before it was filled. The patched historical stone retaining wall that fronts onto Willis Avenue is between the two stairwell walls in the rear of the photograph.
