Fort Greene Park, Brooklyn Dry Well Locations Near Willoughby Gate Archaeological Testing Memo Report

Project No. B032 - 110M

Prepared for the New York City Department of Parks & Recreation
through Nancy Owens Studio, LLC
by Joan H. Geismar, Ph.D., LLC
May 19, 2014

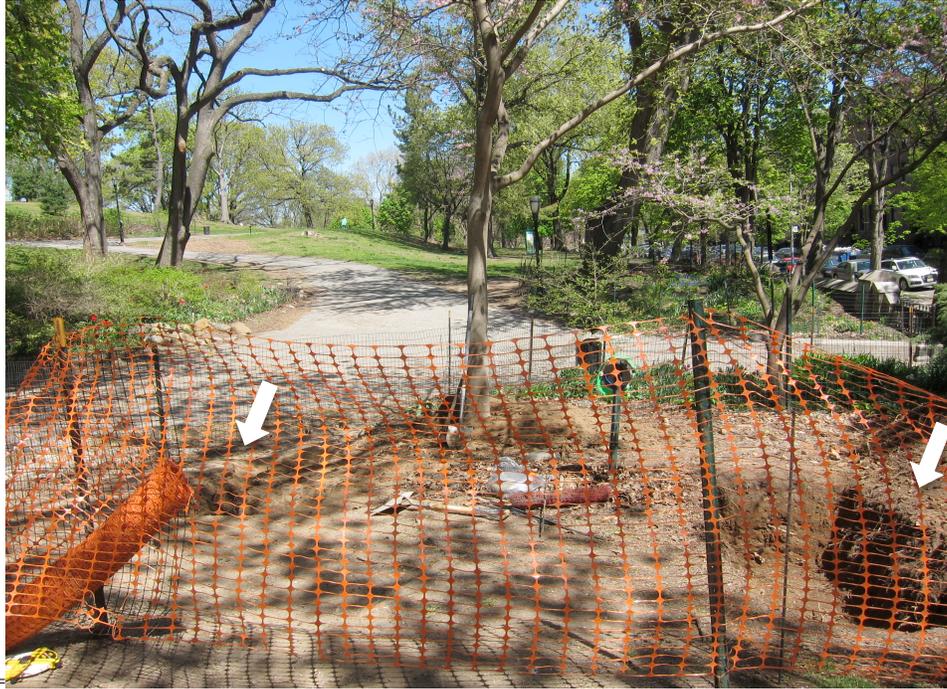
Photo 1. Looking north with plastic protective fencing in the foreground during hand excavated testing. TR1 is to the left (left arrow) and TR2 to the right (right arrow). The Redbud trees in the center of the photo and to the right were to be removed and both were cut down. However, with Parks' approval, only the stump of the tree in the center was removed during this testing phase. (Geismar 5-5-14)

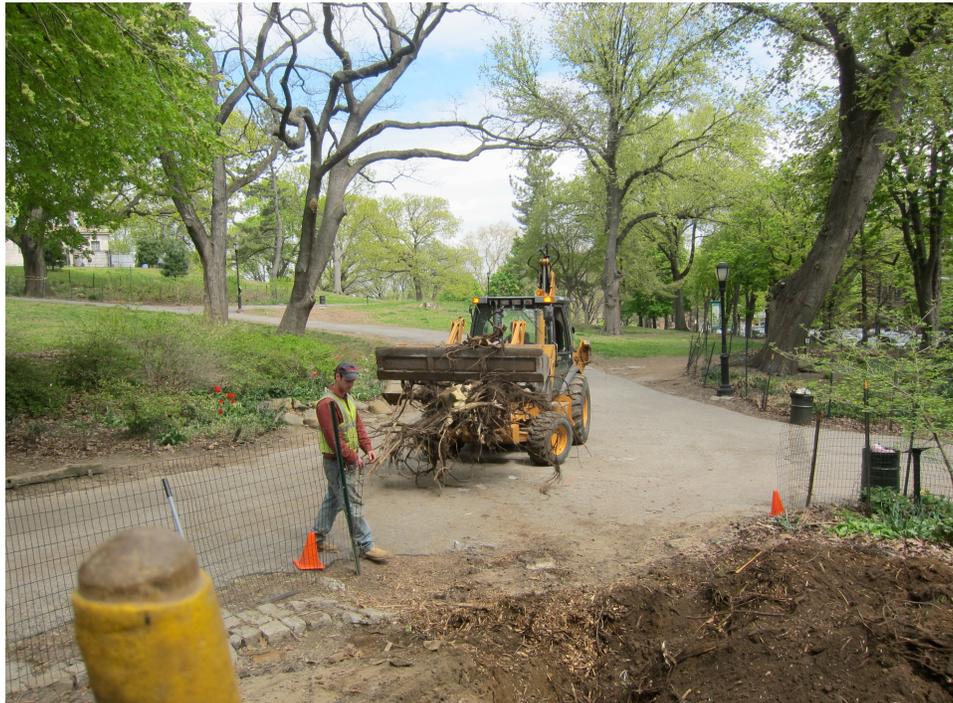
removed (see Photo 2) after it was determined that archaeological features were not an issue (with Parks' approval, the other tree stump was left in place for removal when its garden setting was eliminated). Plastic fencing was then reinstalled to delineate and secure the test area (which included part of a vernacular jogging path), and the backhoe excavation of TR1 began.

Photo 2. Stump of Redbud being removed from the site after it was extracted from its location just east of TR1 and protective fencing is being restored. (Geismar 5-6-14)

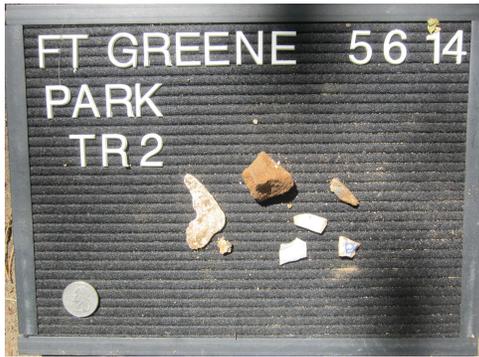
TR2, located upslope from TR1, and therefore higher above street level, contained the same mottled soil found in TR1 to a depth of ca. 7.5 feet (2.3 m) where it became siltier and darker with depth but with inclusions of small ceramic fragments, clinkers, and decomposed oyster shell to the bottom of the trench (9.2 feet [2.8 m] below grade; see Photo 3 for examples of the cultural material). Given the nature of the soil, only the east side of TR2 was taken to a depth of 9.2 feet (2.8 m); excavation on the west side of the trench was halted at 3 feet (0.91 m) below grade. Again, after a plan and schematic profile were drawn and photographs taken (Figure 5), the trench was backfilled.

Photo 3. Fill artifacts (selected) from TR2 (quarter is for scale). (Geismar 5-6-14)

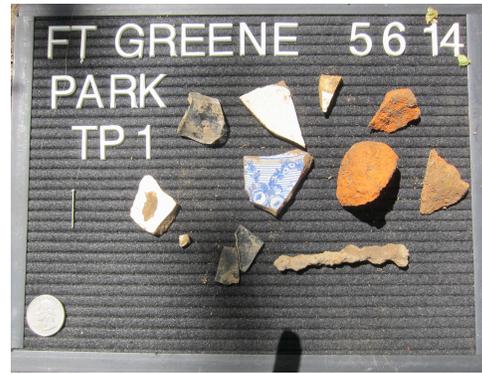
TP1 ultimately was also tested. Since it was backhoe excavated, it became a small trench rather than a true pit. Considerably more debris was found at this location (a broken but worked building stone was found below the surface, as was a sizeable concrete fragment at 3 feet [0.92 m], a piece of wire at 7 feet [2.1 m], and a small ceramic fragment at 8 feet [2.4 m]). What appeared to be a brick concentration at 7 feet (2.1 m) was explored by widening the pit slightly, but it proved to be debris. A broken, earth-filled but perhaps *in situ* terra-cotta drainpipe was encountered 7 feet (2.1 m) below grade in the southern part of the pit and window glass fragments were found at 9.6 feet (2.9 m). The excavation was taken to a depth of 10.3 feet (3.1 m) in the southern portion of the pit/trench (a straight pin (?) was found in the backdirt at approximately this depth; see Photo 4 for an example of the cultural material from TP1). Again, measurements and photographs were taken and a schematic profile drawn (Figure 7) before the pit was backfilled. The archaeologists then left the site with the assurance of the backhoe contractor that all would be restored to its pre-testing condition. A site visit on May 12, 2014, indicated that this was, indeed, the case (Photo 5).

Photo 4. Fill artifacts (selected) from TP1 (quarter is for scale). (Geismar 5-6-14)

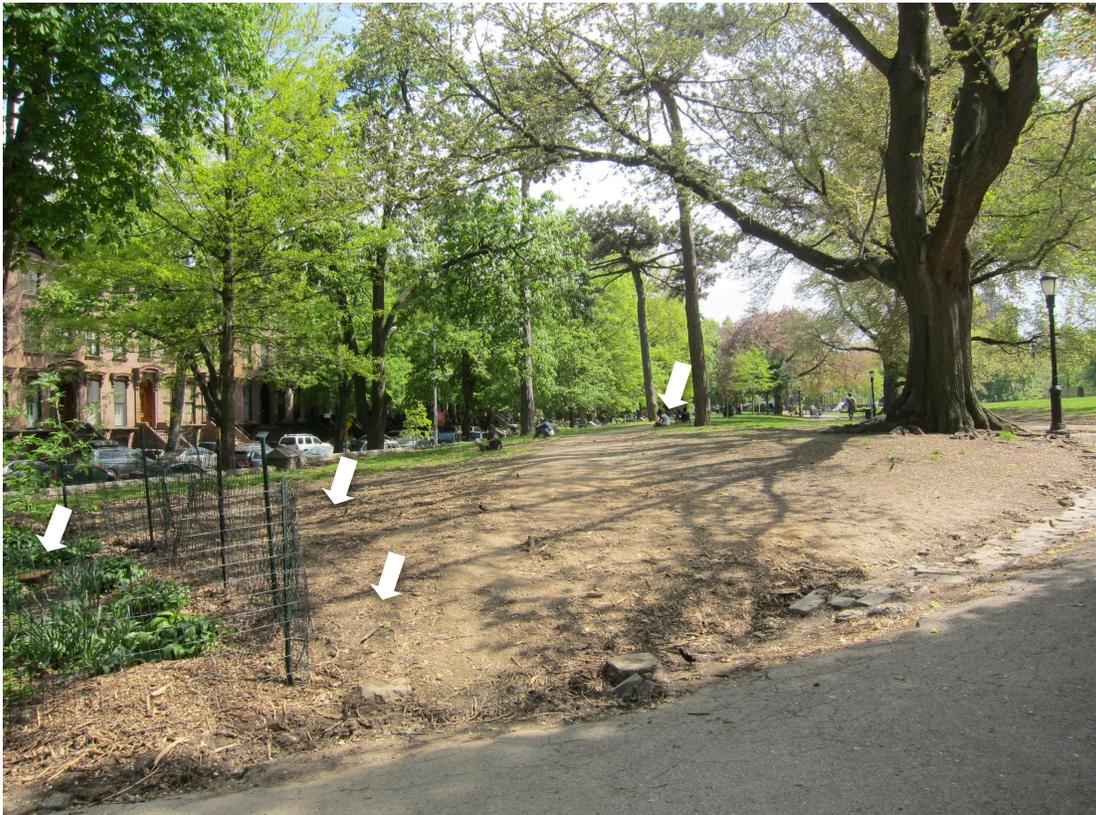
Photo 5. Looking south across the test area six days after it was restored. The Redbud tree stump (far left arrow) is to be removed when the garden becomes a work area. TR1 was to the right of the fence, just off the asphalt walkway (lower center arrow); TR2 was up slope and left of TR1 (upper left arrow), and TP1 was further up slope (right arrow), east of the elm and north of the pine tree. (Geismar 5-12-14).

Testing the potentially archaeologically sensitive locations where three dry wells will be introduced determined that deep fill was present throughout. Consequently, no further archaeological investigation is required. However, it is recommended that an archaeologist be on call (not on site) during excavation for the drywells at these three locations in the unlikely event of an unanticipated discovery.

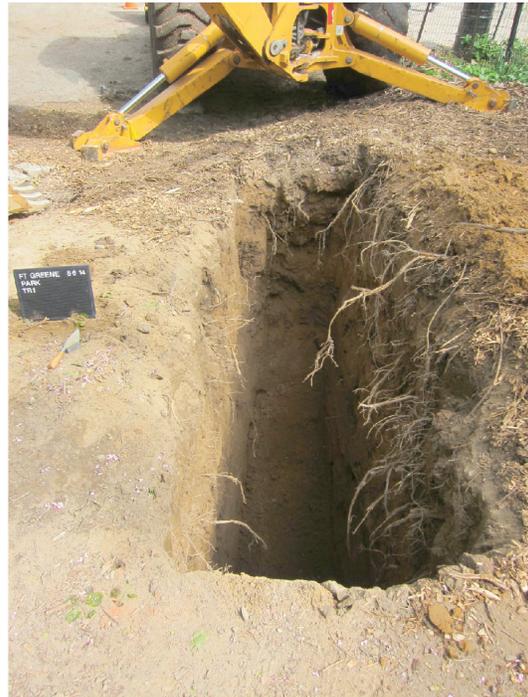
4b

TR1, situated at the lowest point of excavation but still well above street level, was taken to 9.8 feet (3.0 m) in the center of the trench with relatively clean fill indicated throughout (roots from a Redbud tree scheduled for removal were present on the east side of the trench [see Figure 4b]. Metal tubing and oyster shells found at 6.0 feet (1.8 m) below grade and oyster shell noted at 8 feet (2.4 m) determined that the soil comprised fill. Perhaps most telling was the mottled soil, devoid of strata, that was found throughout. An electric conduit pipe was noted just beyond the southeast corner of the trench, and park drawings indicate there were water pipes and other electric lines nearby. TR1 was measured, a schematic profile was drawn, and it was photographed (Figure 4) and backfilled.

Note: roots on east side of trench (right) are from a Redbud tree, subsequently removed.
