Fairview Park

Phase 2 Archaeological Survey Report

NYCDPR Contract No. CNYG-311MR

Prepared for New York City Department of Parks and Recreation
Through Hargreaves Jones Landscape Architecture DPC (Hargreaves Associates NY)
Prepared by Joan H. Geismar, Ph.D., LLC
May 2016

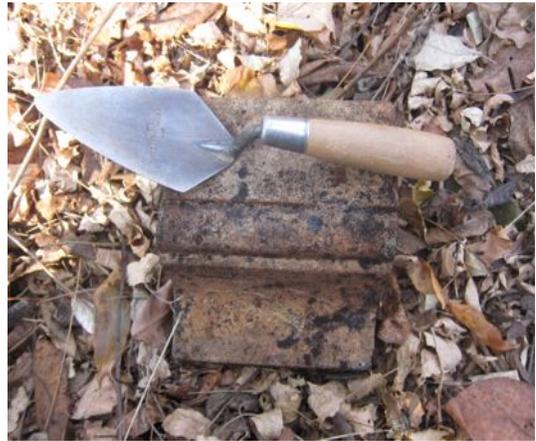
Photo 6. A decorative terra-cotta fragment noted in Fairview's cellar hole (C2). The trowel is for scale. (Photo: J. Geismar 12-10-2016)

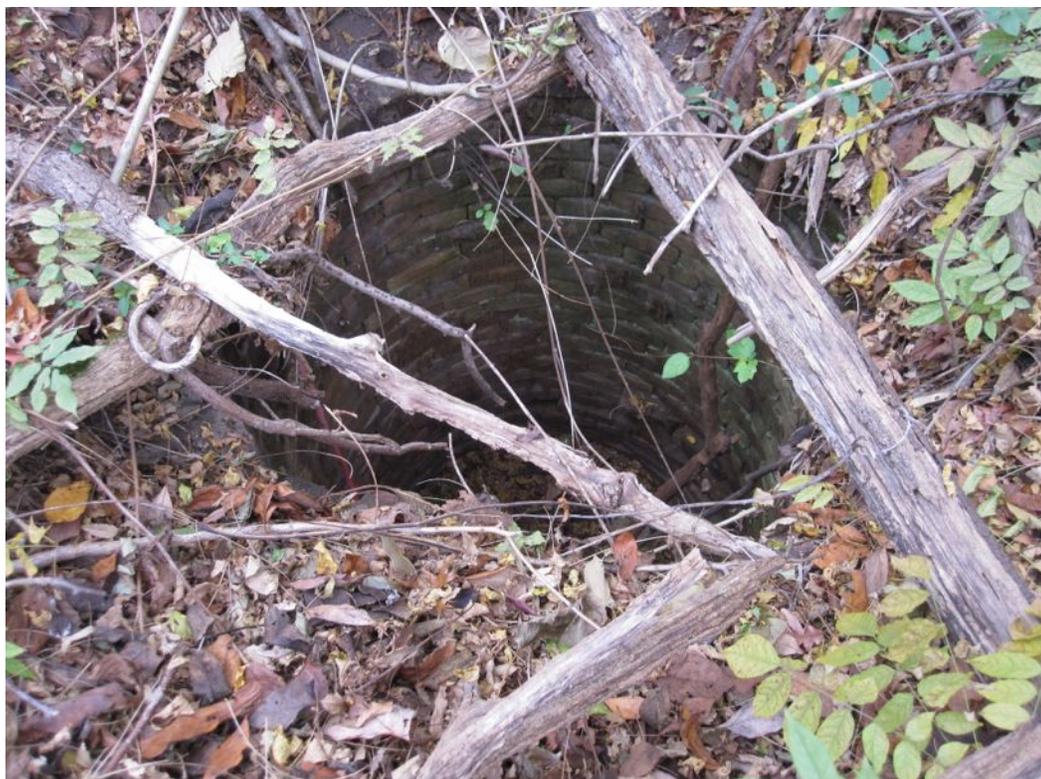
To identify the function of B2, one of the shaft features found too unstable to investigate by traditional excavation methods (JMA 2000:29), a soil boring was drilled to sample the fill and determine its depth. This approximately 5-foot (1.5 m) diameter brick shaft feature is located

about 10 feet (3.0 m) southeast of what has now been confirmed as the base of Fairview’s former water tower (B5; see below). The function of a small, nearby shaft feature, approximately 1.5 to 2.0 feet (0.46 to 0.61 m) in diameter, was partially tested in 2000 but remains unidentified.

Feature No.	2000 Identification	2016 Identification	Method/Criteria
B2	Brick lined circular shaft feature c. 5 ft. (1.5 m) in diameter. Identified as a cistern, it was filled with leaves and other natural debris to approximately 6 ft (1.9 m) below the ground surface (BGS). Safety was an issue and it was not tested. Identified as a cistern possibly associated with the nearby water tower (B5, see below). Machine-aided excavation was recommended to determine the content of the feature's fill, its depth, and possibly its function.	Brick well (Photo 7) more than 31 ft. (9.5 m) deep, apparently associated with the former Kreisler water tower (B5) located ca. 8 ft. (2.4 m) to the NE (see B5 below).	A soil boring was drilled into the fill and continuous samples collected to 30 ft. (9.1 m) BGS revealed a redeposited fill (ash, clinkers, some small ceramic, glass, and fragments, stones, etc.) rather than “natural” debris; see Photo 13). The deposit continued to an undetermined depth but undoubtedly to the deeply buried water table. Trapped water was observed in several samples but ground water was not reached. The homogeneity of the fill indicated it, or at least the upper 21 ft. (6.4 m), had probably been introduced in a single episode. Two terra-cotta fragments cut and extracted by the sampling spoon 19 -21 ft. (5.8 - 6.4 m) BGS may have been a trashed drainpipe or possibly piping to conduct water from the well to the adjacent water tower (B5), but this is speculation.

Photo 7. A brick well (B2), approximately 5 feet (1.5 m) in diameter, was originally identified as a cistern (JMA 2000, 2005). However a soil boring revealed that it extended down more than 31 feet (9.5 m) BGS to an unknown depth and was instead a well. (Photo: B. Seamans 11-19-2015).

Protection of the located archaeological features is a concern as is the safety of those who may venture off designated paths. At this writing, it is expected the shaft features will be filled to the brim with aggregate. This will eliminate the potential danger presented by these somewhat hidden hazards while protecting but not obscuring the resources. In addition, construction documents will alert the contractor to these concerns and dangers. That said, no further archaeological work is recommended although park staff and any future plans should consider the continued protection of these archaeological features and be aware of the potential for prehistoric material. Should presently unknown features or archaeological deposits be encountered in the future, archaeological input should be provided.

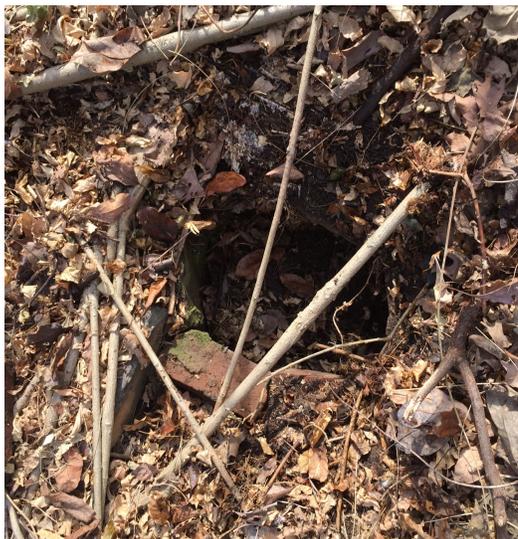
B3	Unidentified circular, leaf-filled brick shaft feature, ca. 2 ft. (0.6 m) in diameter with a ca. 1 ft (0.31 m) aperture.	Unidentified circular, leaf-filled brick shaft feature, ca. 2 ft. (0.6 m) in diameter with a ca. 1 ft (0.31 m) aperture.	The feature was excavated to 1 ft. (0.31 m) BGS in 2000 but its depth and function remain undetermined. It may be associated with former farm structures.
B5	Kreisler Water Tower base.	Kreisler Water Tower base.	This ca. 5-ft (1.5-m) diameter stone and brick base is a remnant of the water tower depicted somewhat fancifully in the 1887 engraving of Fairview (see Figure 7). The tower is not indicated on the 1913 topographical survey (see Figures 4 and 8).
C2	Fairview mansion cellar hole and stone foundation.	Fairview mansion cellar hole and stone foundation.	The feature’s measurements correspond with those on the 1913 topographical survey.
C3	Circular brick-lined shaft or vault feature adjacent to the SE corner of C2. Ca. 8 ft. (2.4 m) in diameter and at least 7 ft. (2.1 m) deep. Observed within the feature's interior were architectural debris such as brick, stone, and mortar.	Rectangular Foundation/cellar hole of a structural appendage on the S side of the extension ending in the brick wall now identified as C4; this is depicted in the 1887 engraving, the 1913 topographical survey, and in Photo 14.	The feature’s measurements correspond with those of an appendage to the main Fairview structure documented on the 1913 topographical survey (see Figure 8). Also, remnants of the feature’s west stone wall appear to be straight rather than circular, suggesting a square foundation rather than a circular shaft feature.

Photo 8. This small, unidentified shaft feature (B3) was partially excavated in 1999 or 2000 (JMA 2000) but remains unidentified. (Photo: J. Geismar 1-8-2016)

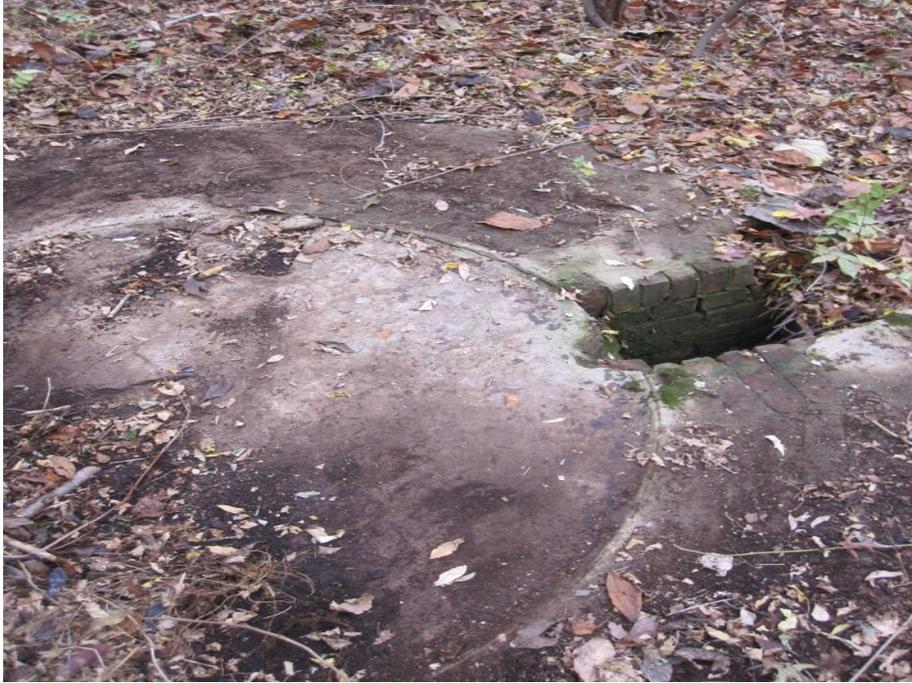
Photo 9. Water tower foundation (B5) looking northeast. B5 and B2 are probably features associated with Balthazar Kreisler's water system. (Photo: B. Seamans 11-19-2015).

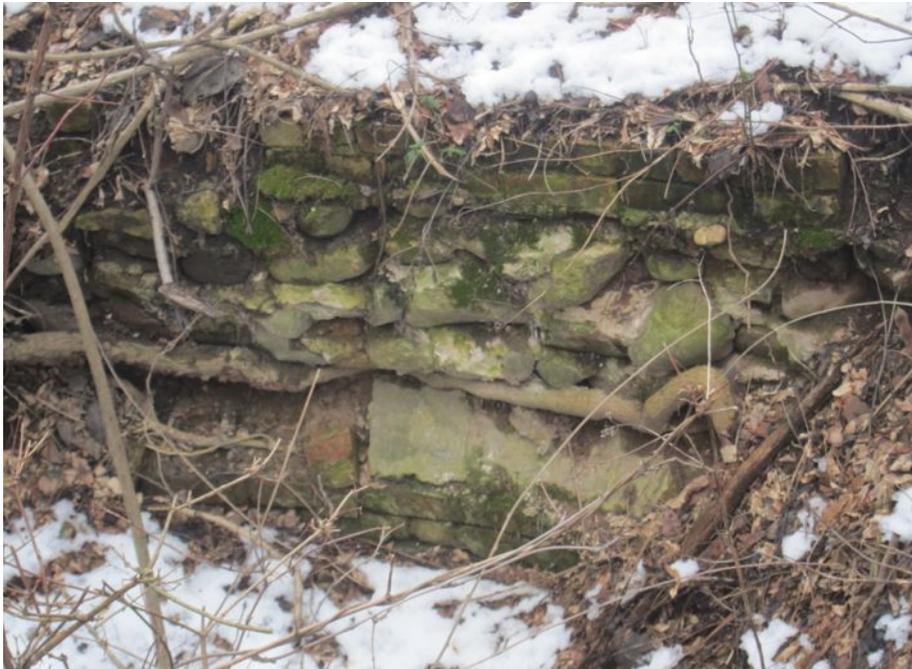
Photo 10. Remnant of Fairview's western foundation wall (C2). The building was destroyed by fire in 1931 and little of the foundation remains. (Photo: J. Geismar 2-8-2016)

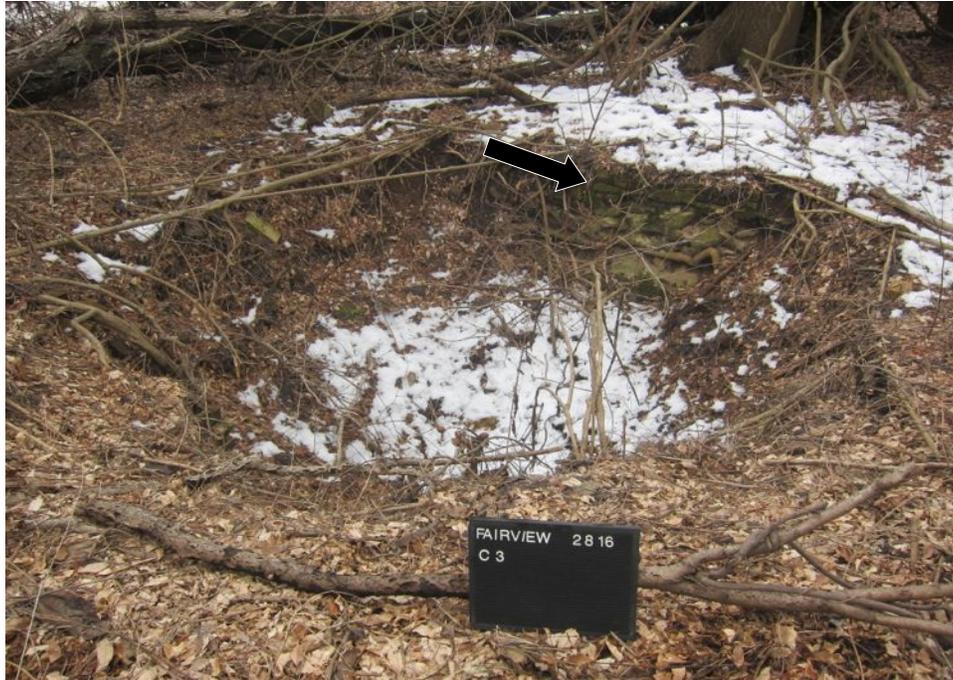
Photo 11. The cellar hole of an appendage (C3) on the south side of Fairview's eastern extension. A remnant of a straight line of foundation stones (arrow) contradicts what appears to be a circular feature when it is actually rectangular. (Photo: J. Geismar 2-8-2016)

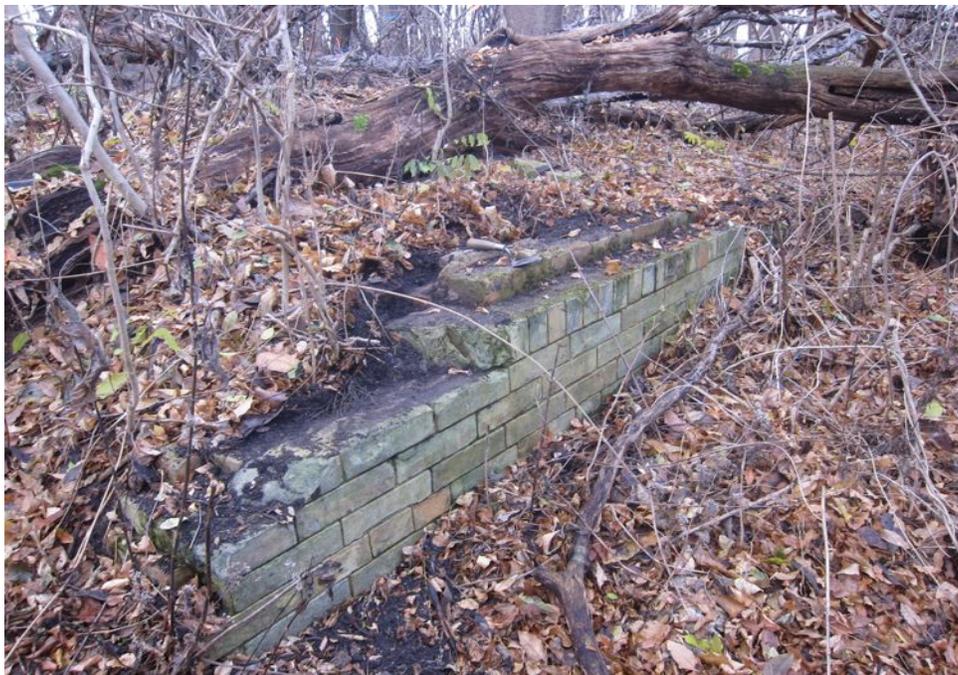
C4	Possible foundation wall of porch depicted in the 1887 engraving of Fairview (Figure 7).	East brick foundation wall of the extension on the east side of the mansion indicated on the 1887 engraving (Figure 7) and 1913 topographical survey (Figures 4 and 8).	The 1913 topographical survey documents an extension running east from the house and its eastern end wall corresponds to the location of C4 (see Figure 8). The porch, indicated on the survey and in the 1887 engraving, is on the west side of the building (see Figure 8).

Photo 12. The remnant of the brick foundation wall (C4) that marks the end of Fairview's east extension. (Photo: J. Geismar 12-3-2015)

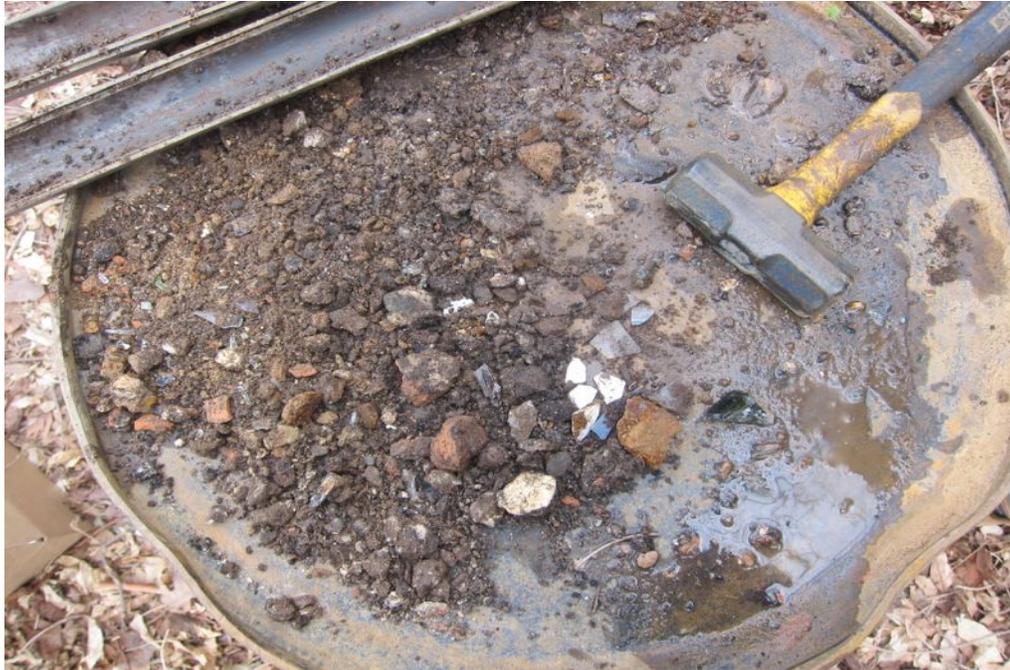
Photo 13. Sample of the fill in B2 recovered from a soil boring intended to determine the function of this circular feature originally identified as cistern. The depth of the fill, which proved to extend beyond 31 feet (9.5 m) below the feature surface, established that it was a well. The sampling spoon is in the upper left corner. (Photo: J. Geismar 4-8-2016)
