REPORT ON  
ARCHAEOLOGICAL WORK CONDUCTED FOR  
THE GOVERNORS ISLAND  
FULL SEAWALL REHABILITATION PROJECT  
GOVERNORS ISLAND  
NEW YORK, NEW YORK  
OPRHP Project Review No. 11PR07543

Prepared for: The Trust for Governors Island  
10 South Street, Slip 7  
New York, New York 10004

Prepared by: Linda Stone, MA, RPA  
249 E. 48 Street, #12B  
New York, New York 10017

March 19, 2015

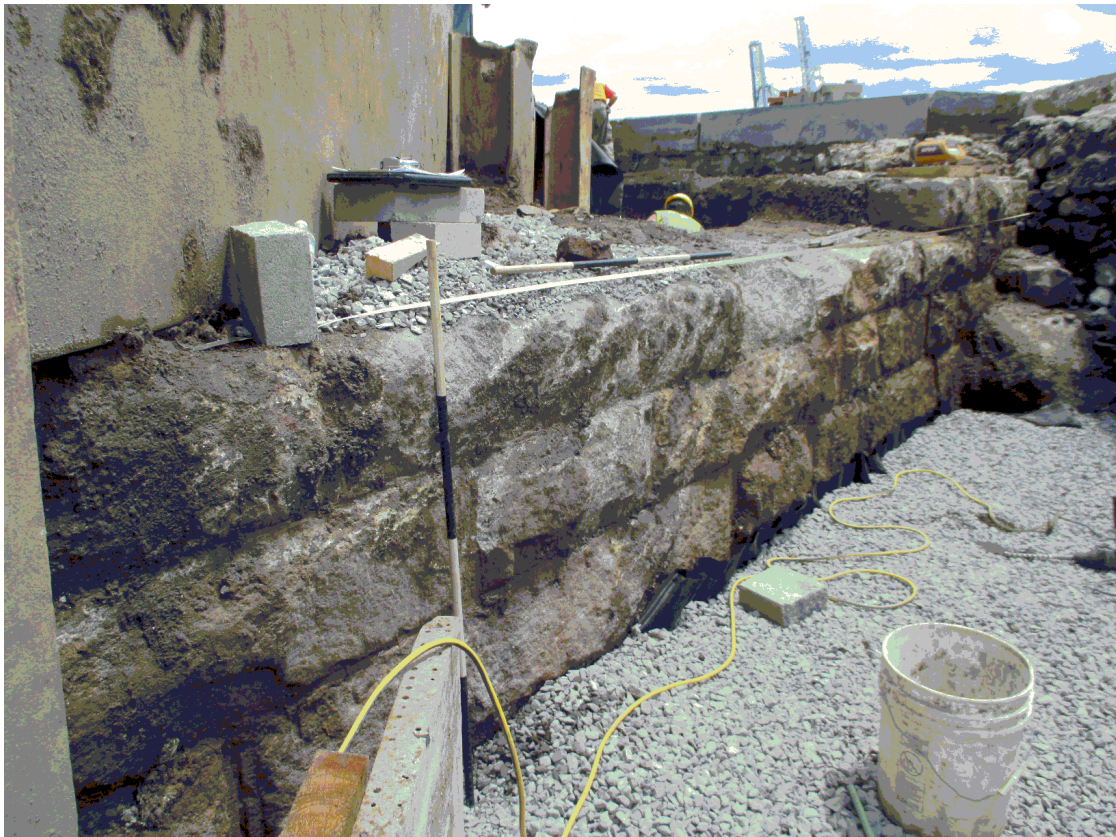
Section of historic 1883 seawall as it has been preserved, facing east (Image 4522: June 26, 2014)

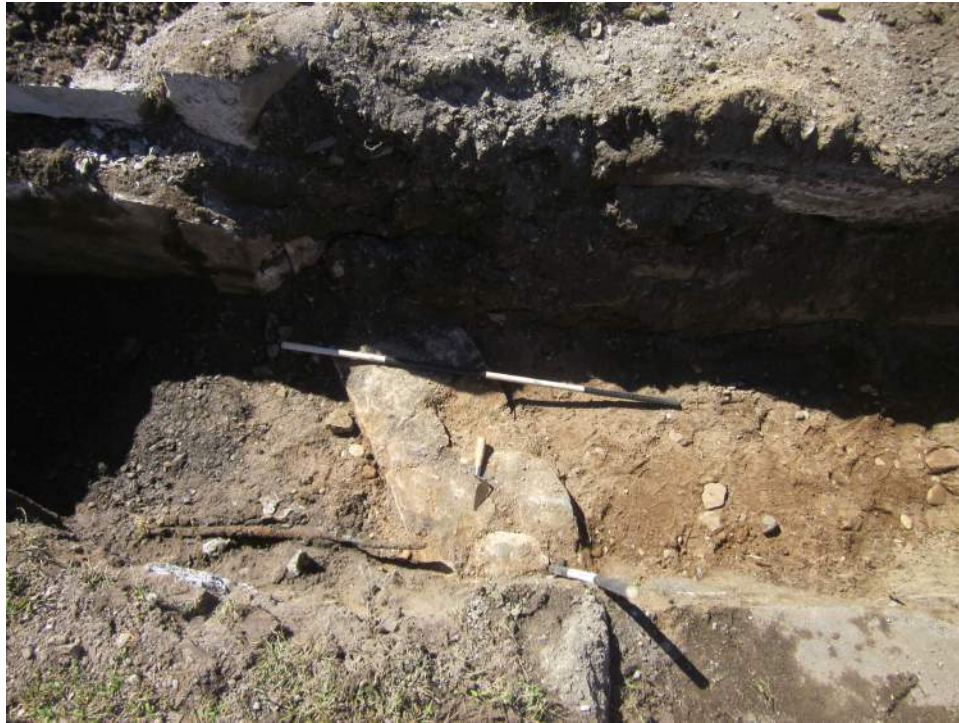
Feature 2 is a portion of the original stone seawall around Castle Williams. It was found during excavation of an archaeological test trench (TT 01) done in advance of storm drainage work for OF 6. This segment of the original stone seawall was found buried approximately 2.2 feet below ground surface (see Photo 1). It measured 1.6 feet (49 cm) wide and ran diagonally through TT 01.

Photo 1 The top of Feature 2, part of the 1866 seawall, found in TT 01 near Castle Williams, with defunct concrete utility encasement to the east (upper left), facing south (Image 3419: September 18, 2013).

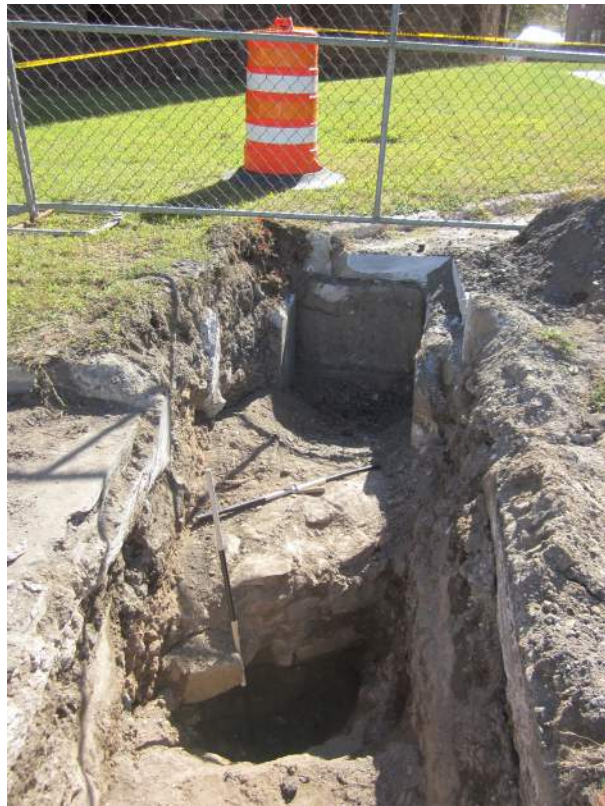
Photo 2 Feature 2 upon completion of excavation showing the waterside (western) stone face of the former 1866 seawall and the defunct concrete utility encasement at the top of the image, facing east (Image 3430: September 18, 2013).

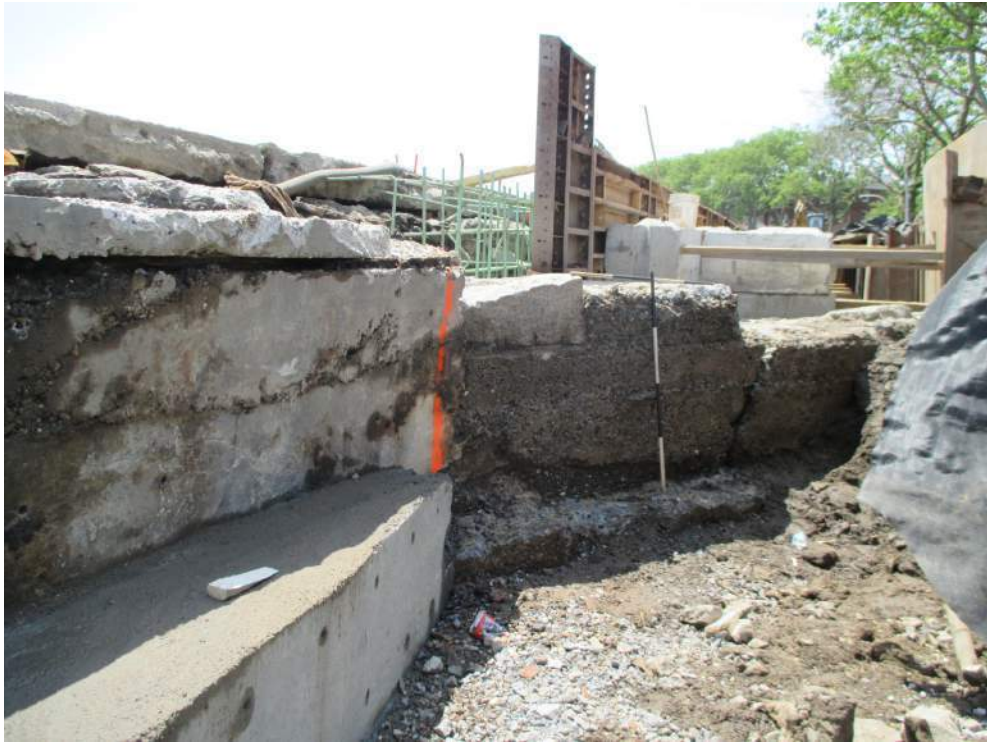
The landward side face was covered with concrete within the seawall repair excavation, likely from an earlier repair <sup>5</sup>. Photo 3 depicts large-aggregate concrete on the landward face of Feature 3. It is not possible to assess whether the concrete covered stones are similar to those on the waterside face or if what looks like the shape of possible stones behind the concrete is a ghost of a wooden form used to pour that concrete (see right/west side of Photo 3). The left/east side of the photo depicts more recent concrete on the upper half of the wall, likely from a previous repair (painted with an orange vertical stripe and to its left) and fresh concrete at the bottom was poured to plug a leak as the contractor was dewatering. Wood was found along the upper course of the earlier concrete repair (at the top of the orange vertical stripe in Photo 3). The presence of a leak that was plugged during the current work leads one to speculate that the corner of the seawall in that location may have historically suffered some of the same wave action that caused similar damage which resulted in the historic repair. It is also interesting to note the configuration of the wall as depicted in the plan view is suggestive of reinforcement of that corner of the seawall because there are two angles there on the landward side; one where the historic wall meets the existing seawall and the other just to the west of that (see Figure 10).

by the trench box on the south side of the storm pipe trench. The presence of concrete may indicate that section of the historic seawall was repaired at some point in time when the concrete was added to the landward face. If a repair was completed there, it would have been sometime after the construction of that section of seawall in 1883 and prior to the creation of the south Island with the addition of landfill in 1911, a time span of less than 30 years. It is unlikely the concrete was used in the 1883 construction based on the Corp of Engineers Chart (Figure 12).

Photo 3 The landward side face of Feature 3, the 1883 seawall, within the seawall repair excavation showing more recent repairs to the left (east), facing southeast (Image 4558: June 30, 2014).

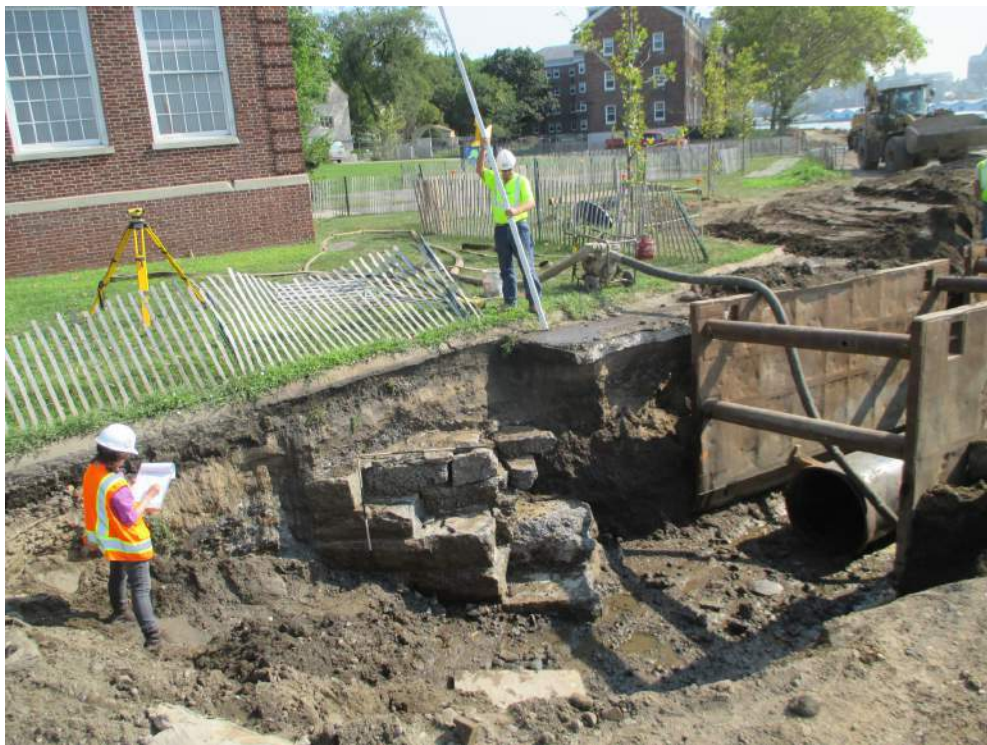
The portion of the 1883 seawall that was present in the storm drainage trench was similar to that documented in the seawall repair excavation, but that location also afforded the opportunity to examine the interior fill of the wall. The orientation of the wall within the storm drainage trench and the contractor's excavation from east to west provided better viewing of the waterside and interior fill of the trench, rather than the landward side (see Photo 4). The former waterside of the historic seawall found within the storm drainage trench was identical to that documented in the seawall repair excavation, as seen to the northwest of the new pipe, to the left on Photo 4.

The interior of the storm drainage trench portion of the historic seawall contained deteriorated concrete blocks. One of these blocks is visible in Photo 4 inside the intersection of the two photo sticks at the upper left of the wall segment in the image. The part of the excavation adjacent to the pipe was cut back to accommodate the trench box, exposing the interior of the historic seawall, but not the landward face which remains unexcavated beneath the existing Kimmel Road curb on the north side and was obscured

Photo 4 The portion of the storm drainage trench between CB 10.01 and MH 10.05 showing part of the waterside face of Feature 3, the 1883 seawall, facing northeast (Image 5185: August 8, 2014).

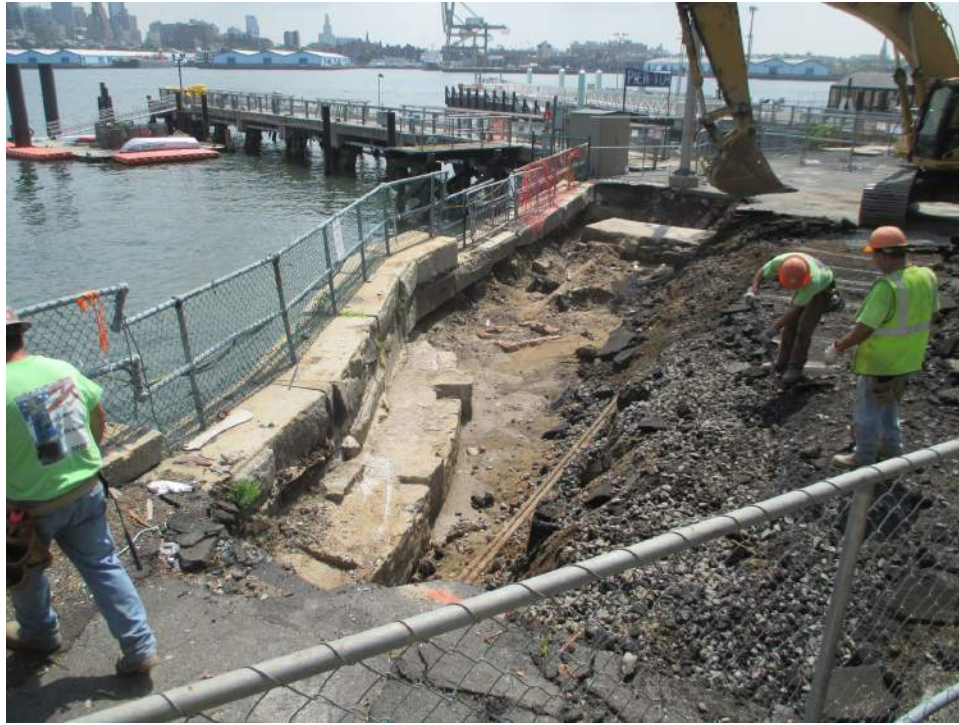
Feature 4 was part of a historic pier (see Photo 5). It was identified during preconstruction testing when a portion of concrete covered stone and a square cut timber were exposed in TT 03. These elements were reburied until a data recovery plan could be prepared and implemented. During data recovery, an additional portion of Feature 4 was identified within the seawall repair excavation footprint and, during later excavation for one of the catch basins, yet another piece of the feature was found (see Figure 13). Ultimately, the wooden element was determined to be part of a form used in the construction of the more recent/current seawall. The earlier, stone, elements were preserved in their entirety rather than removing them as anticipated in the data recovery plan.

Photo 5 Feature 4, part of the 1857 – 1906 pier, shown within the seawall repair from Stations 104+36 to 105+00 as excavation progressed, with the stone edges of the pier at the top (southeast) and bottom of the photo (northwest), a defunct brick catch basin in the center of the excavation and a wooden member and two excavation units between the catch basin and southeastern stone wall segment above in the image, facing southeast (Image 5108: August 4, 2014).

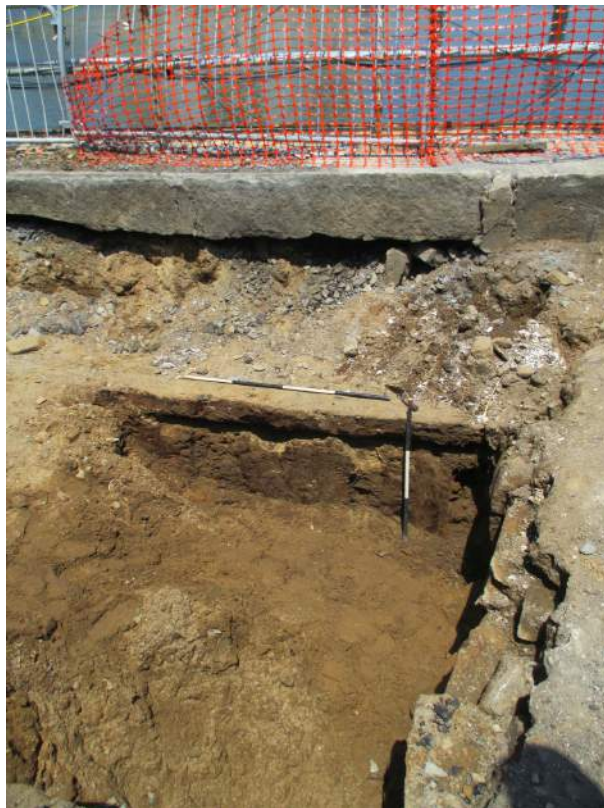
Photo 6 The wooden beam in Feature 4 after excavation that exposed part of vertical wooden planks beneath it, also showing part of the southeastern segment of the stone wall on the right of the image (southeast), facing northeast (Image 4686: July 7, 2014).

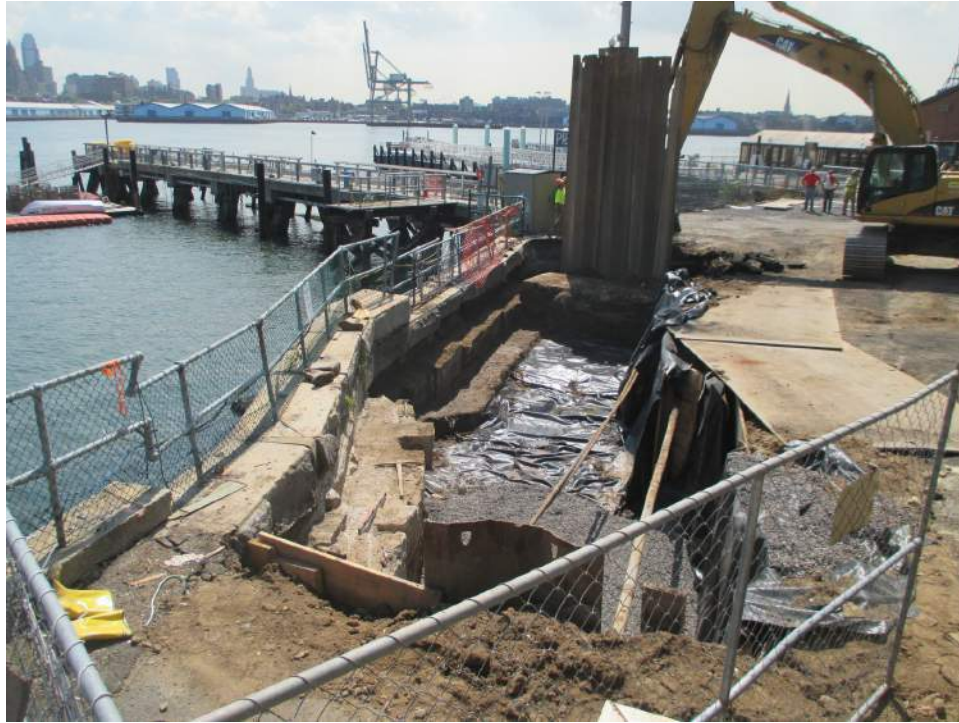
Photo 7 Feature 4 at the completion of excavation for the seawall repair from Stations 104+36 to 105+00, depicting the lower courses of existing seawall extending inland with excavation depth, facing southeast (Image 5131: August 5, 2014).

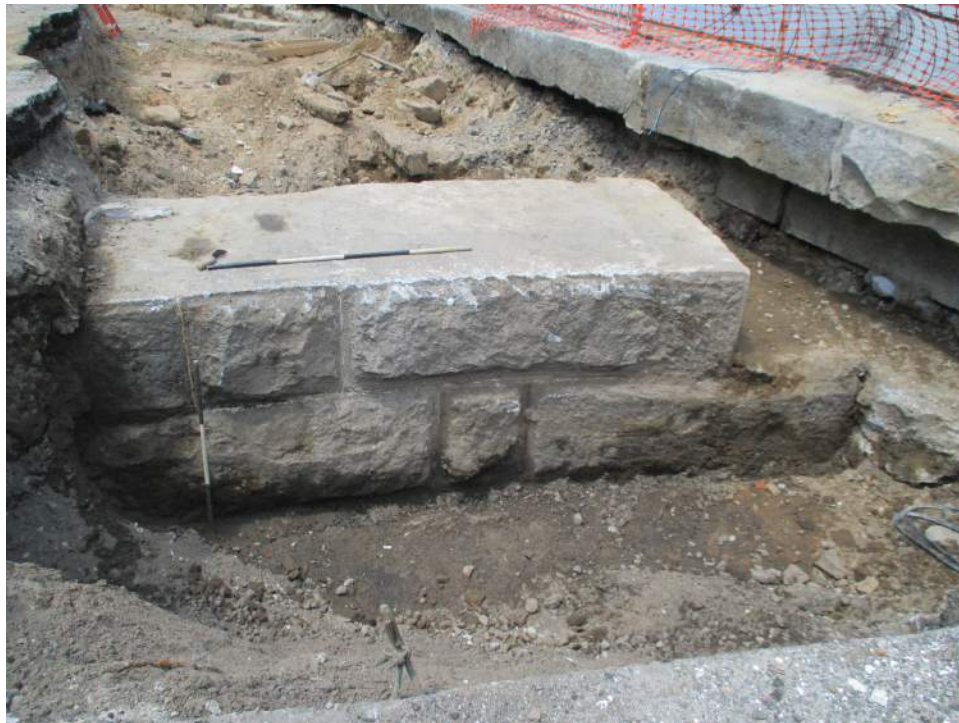
Photo 8 The waterside face of the southeastern portion of Feature 4, facing northwest (Image 4779: July 9, 2014).

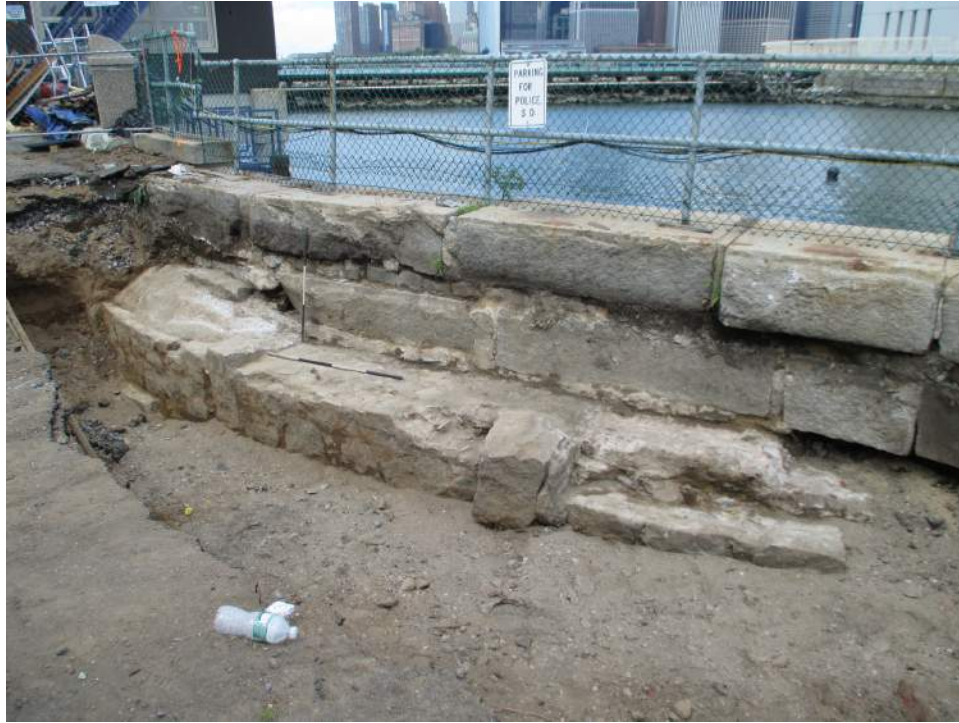
Photo 9 The landward side face of northwestern portion of Feature 4, facing north (Image 4804: July 9, 2014).

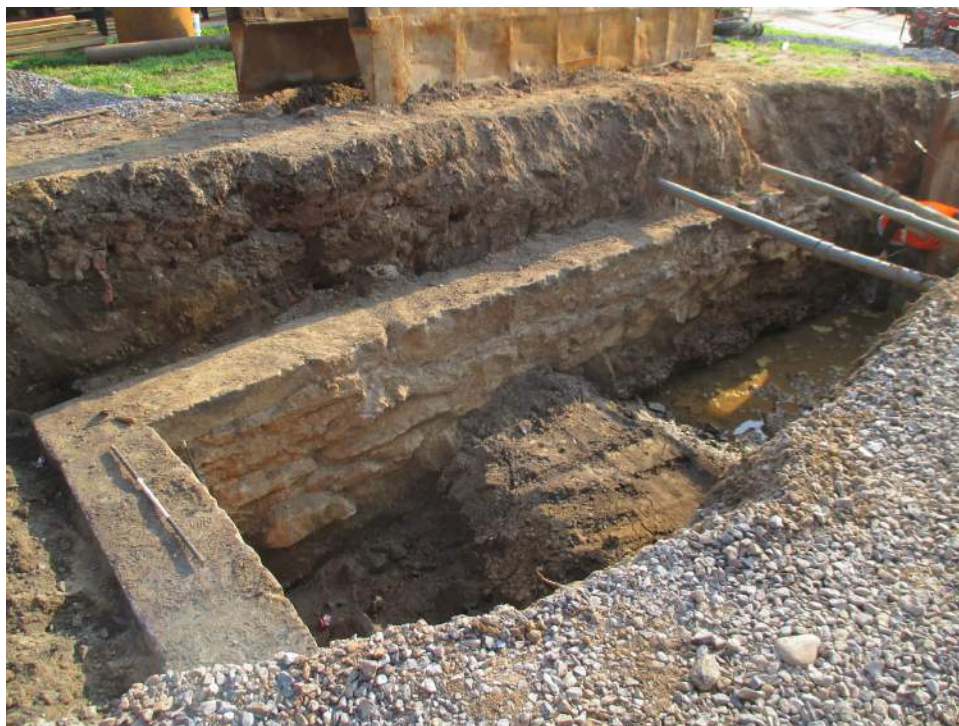
Photo 10 Feature 5, part of the 1902 coal shed foundation, found in the storm drainage excavation between Outfall 13 and MH 13.01, facing northeast (Image 4931: July 22, 2014).

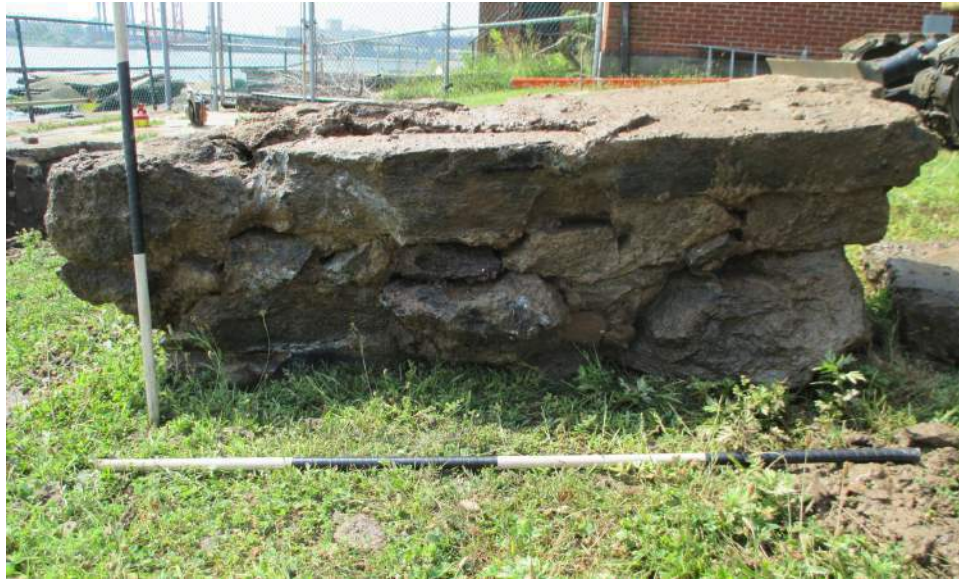
Photo 11 A large section of previously displaced mortared stone wall, found in the feature fill, that may once have been part of Feature 5 (Image 4611: July 3, 2014).

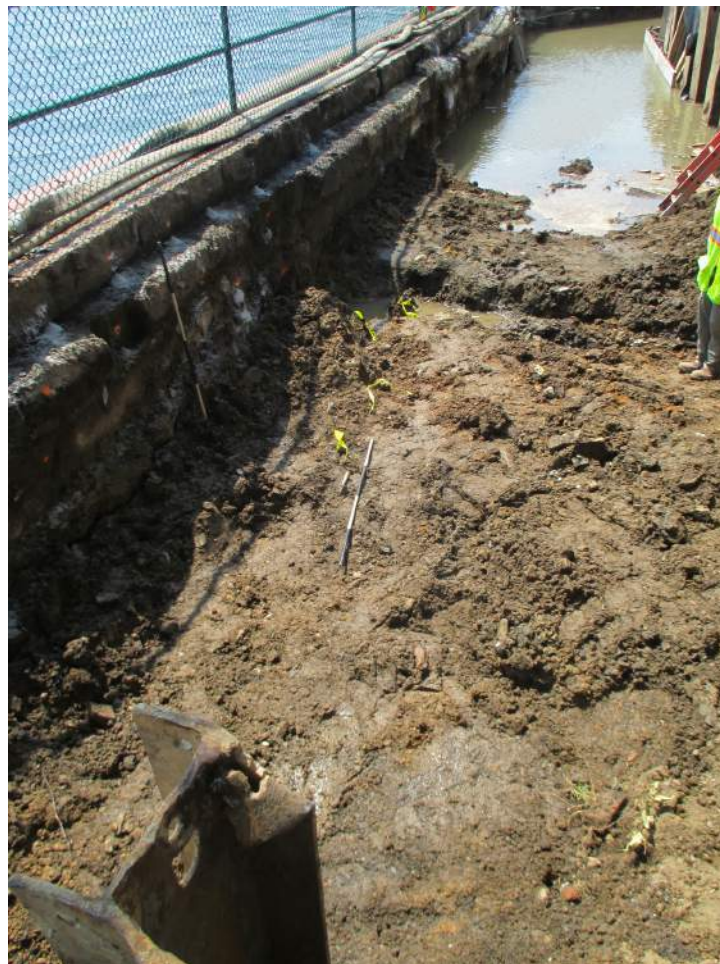
Photo 12 The top of Feature 6, wooden landfill retaining structure, identified within TT 07 and shown within the seawall repair excavation from Stations 96+14 to 96+42 with yellow caution tape tied to the exposed elements, facing south (Image 5058: August 1, 2014).

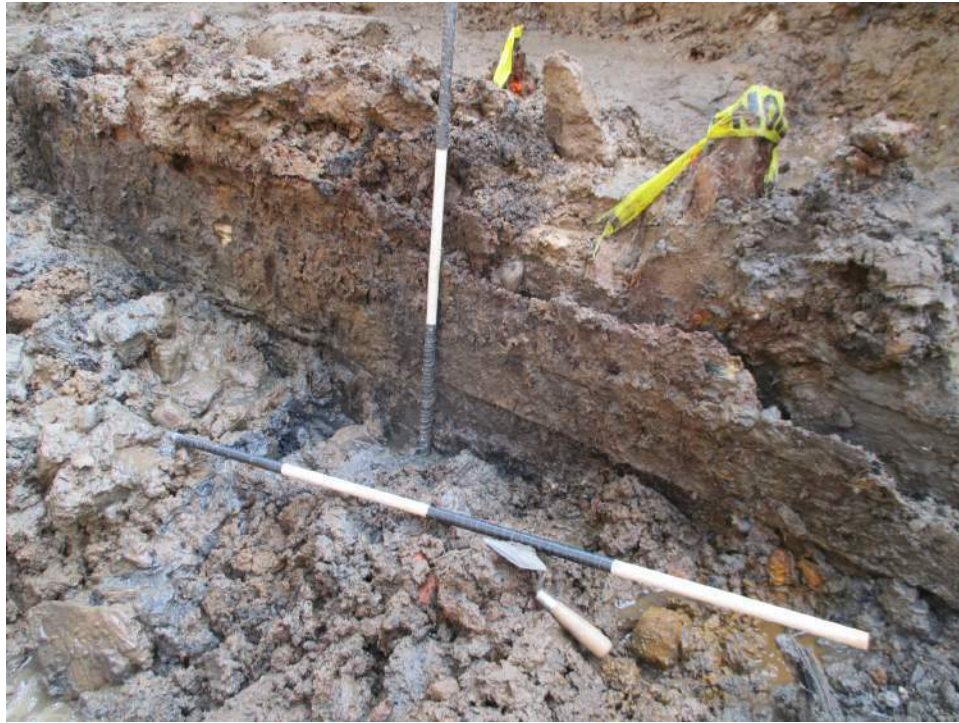
Photo 13 Close-up view of a section of the planks that were part of Feature 6, facing northeast (Image 5071: August 1, 2014).

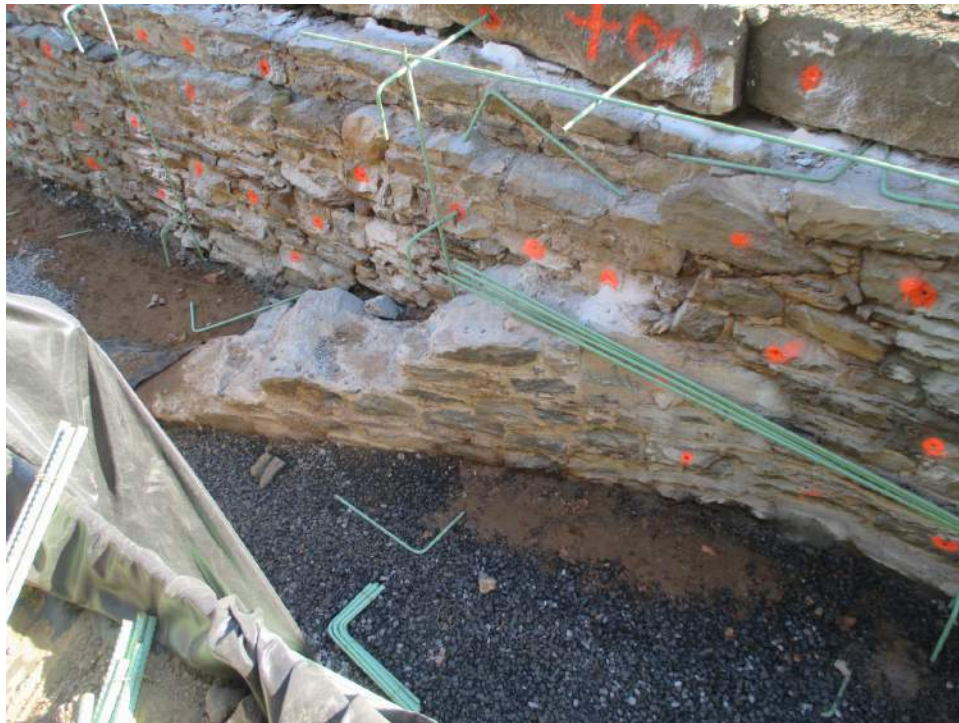
Photo 14 Feature 7, part of a possible historic seawall found at Station 110+00, at the completion of excavation, facing northeast (Image 5466: August 29, 2014).

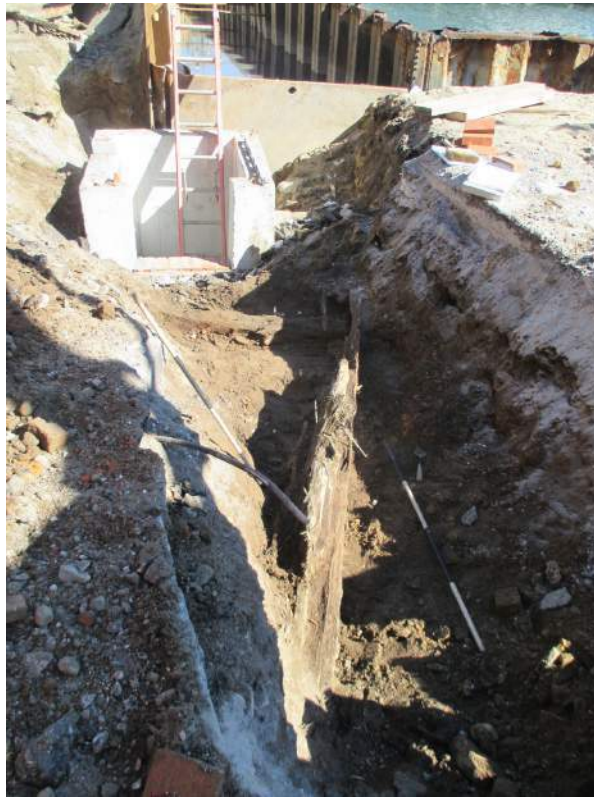
Photo 15 Two of the wooden elements comprising Feature 8, possible interior cribbing of Pier 102, found in the storm drainage trench excavation between CB 13.04 and CB 13.12, facing north (Image 5483: August 29, 2014).

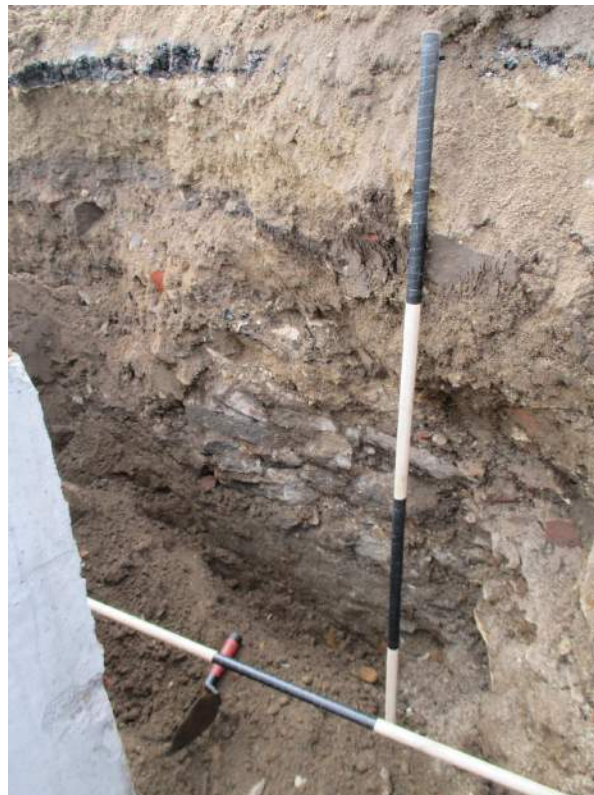
Photo 16 Feature 9, part of a flagstone foundation wall of the pre-1867 stable, shown in the profile after the installation of CB 29.01 (concrete at the lower left side of photo), facing south (Image 5551: September 5, 2014).

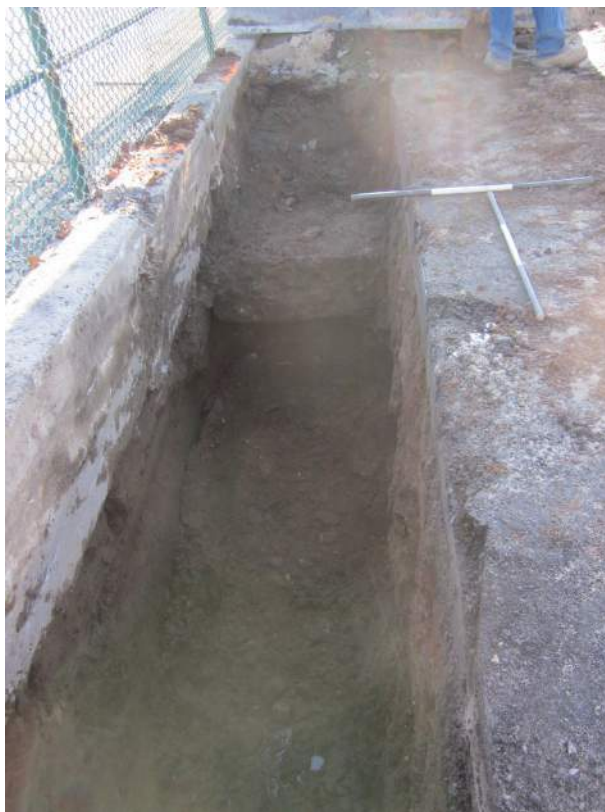
Photo 17 TT 02 at the base of excavation showing buried concrete, facing east (Image 2523: March 20, 2013).

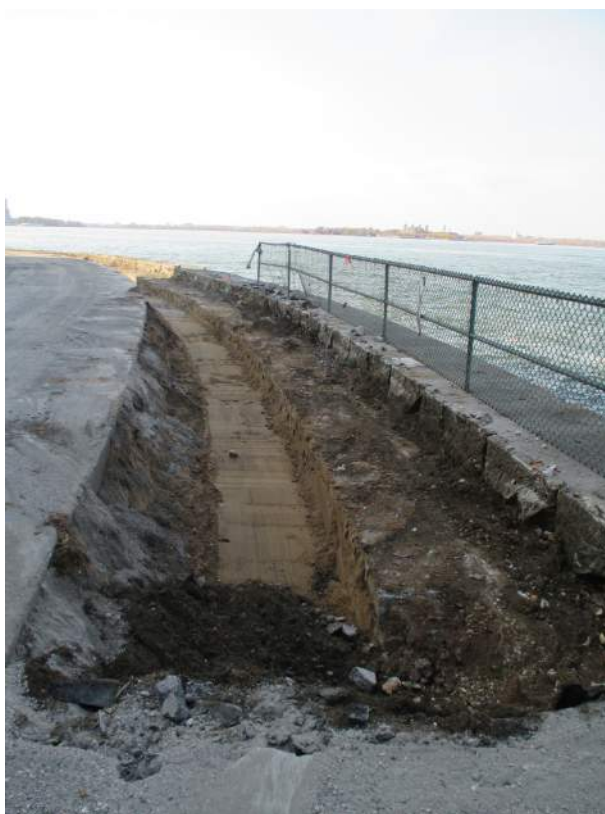
Photo 18 The completed seawall repair excavation from Stations 10+23 to 10+88 showing the concrete seawall buttress, facing south (Image 3639: October 29, 2013).

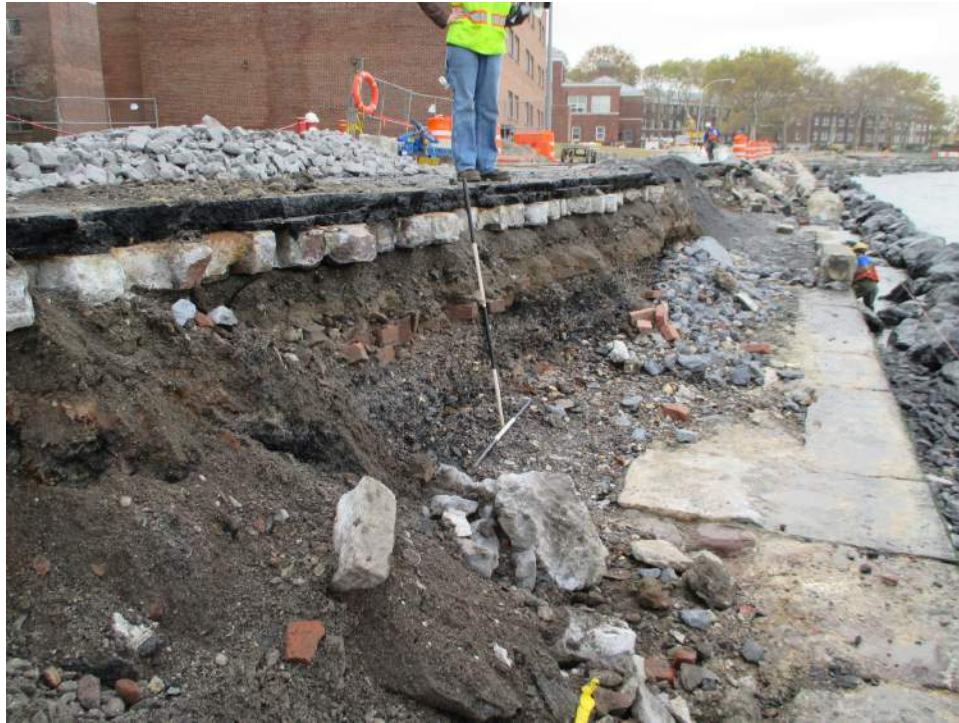
Photo 19 Excavation for the seawall repair around Castle Williams showing the stratigraphy beneath Carder Road, from near Station 13+20, facing south (Image 3522: October 16, 2013).

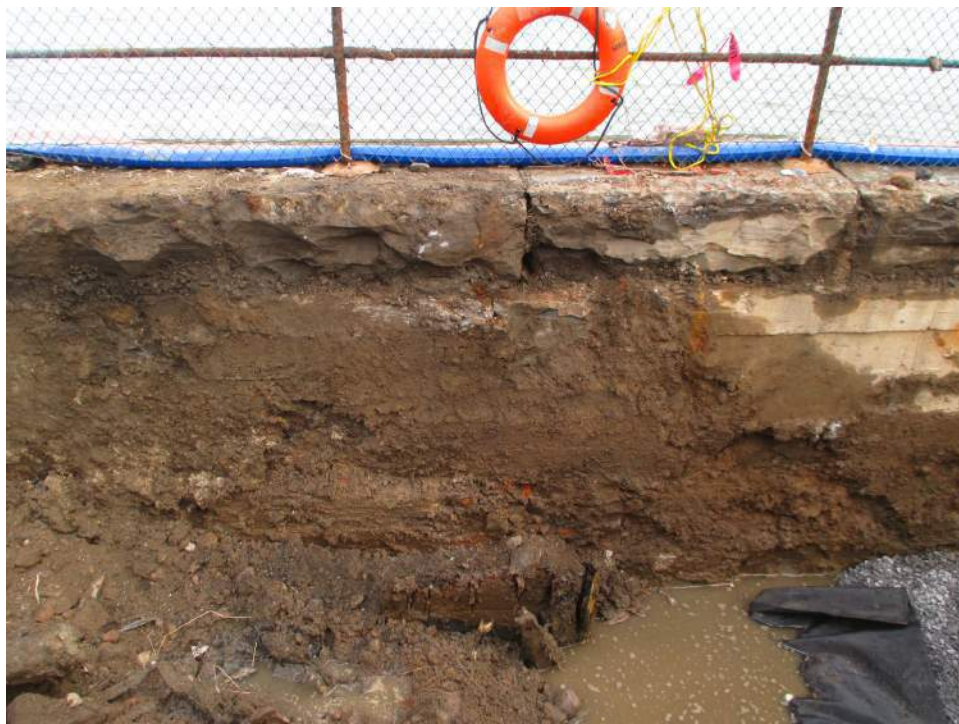
Photo 20 Seawall repair excavation in progress from Stations 9+50 to 9+60 showing remnants of the wooden forms used during seawall construction at the base of excavation, facing north (Image 4204: April 17, 2014).

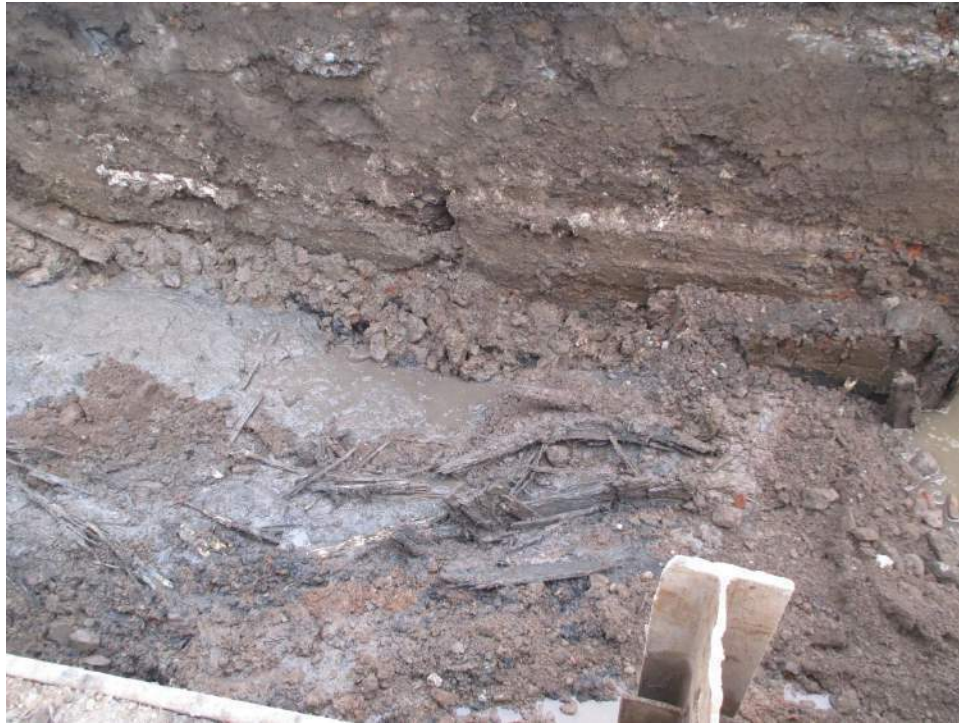
Photo 21 Frayed wood found in the base of seawall repair excavations at approximately Station 9+50, facing northwest (Image 4224: April 7, 2014).
