STAGE 1b ARCHAEOLOGICAL INVESTIGATIONS
AMBOY/BEDELL SHOPPING PLAZA
PLEASANT PLAINS, STATEN ISLAND, NEW YORK
CEQR #90-175R

by
ARNOLD PICKMAN
and
EUGENE BOESCH

Submitted To
CALVANICO ASSOCIATES

October, 1990

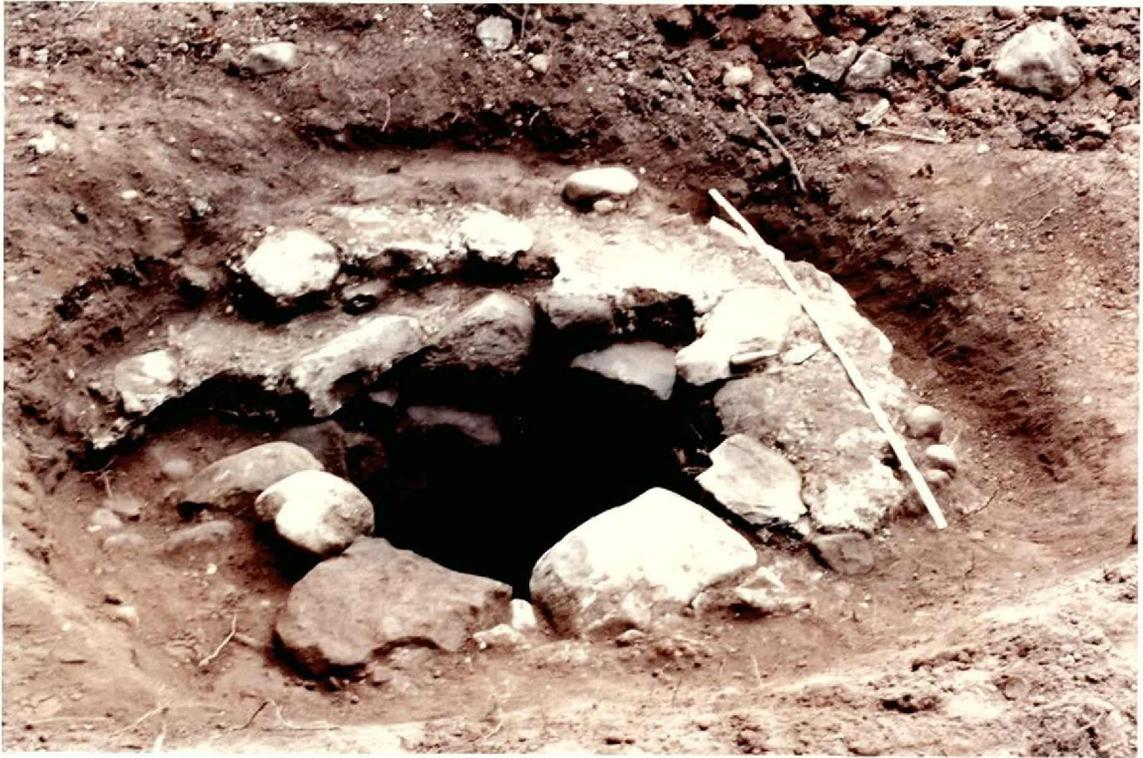
brick well-head had been demolished and the remains deposited in the well. This debris (see Figure 2) was hoisted out of the well so that the feature could be examined further. The well was ovoid in shape and its inner diameter measured some 30 by 38 inches (see Figures 3-4). Soil, which apparently represents fill material deposited in the feature during demolition of #45 Bedell Street, began at a depth of 39 - 51 inches beneath the top of the feature. A space was visible between this deposit and the southern portion of the feature wall (see Figures 5-6). Probing in this space indicated that the fill deposit reached a depth of some seven feet below the top of the feature. Prior to demolition, therefore, the topmost seven feet of the well had been devoid of archaeological deposits.

Figure 2
Portion of Brick Well-Head
After Removal From Feature 1

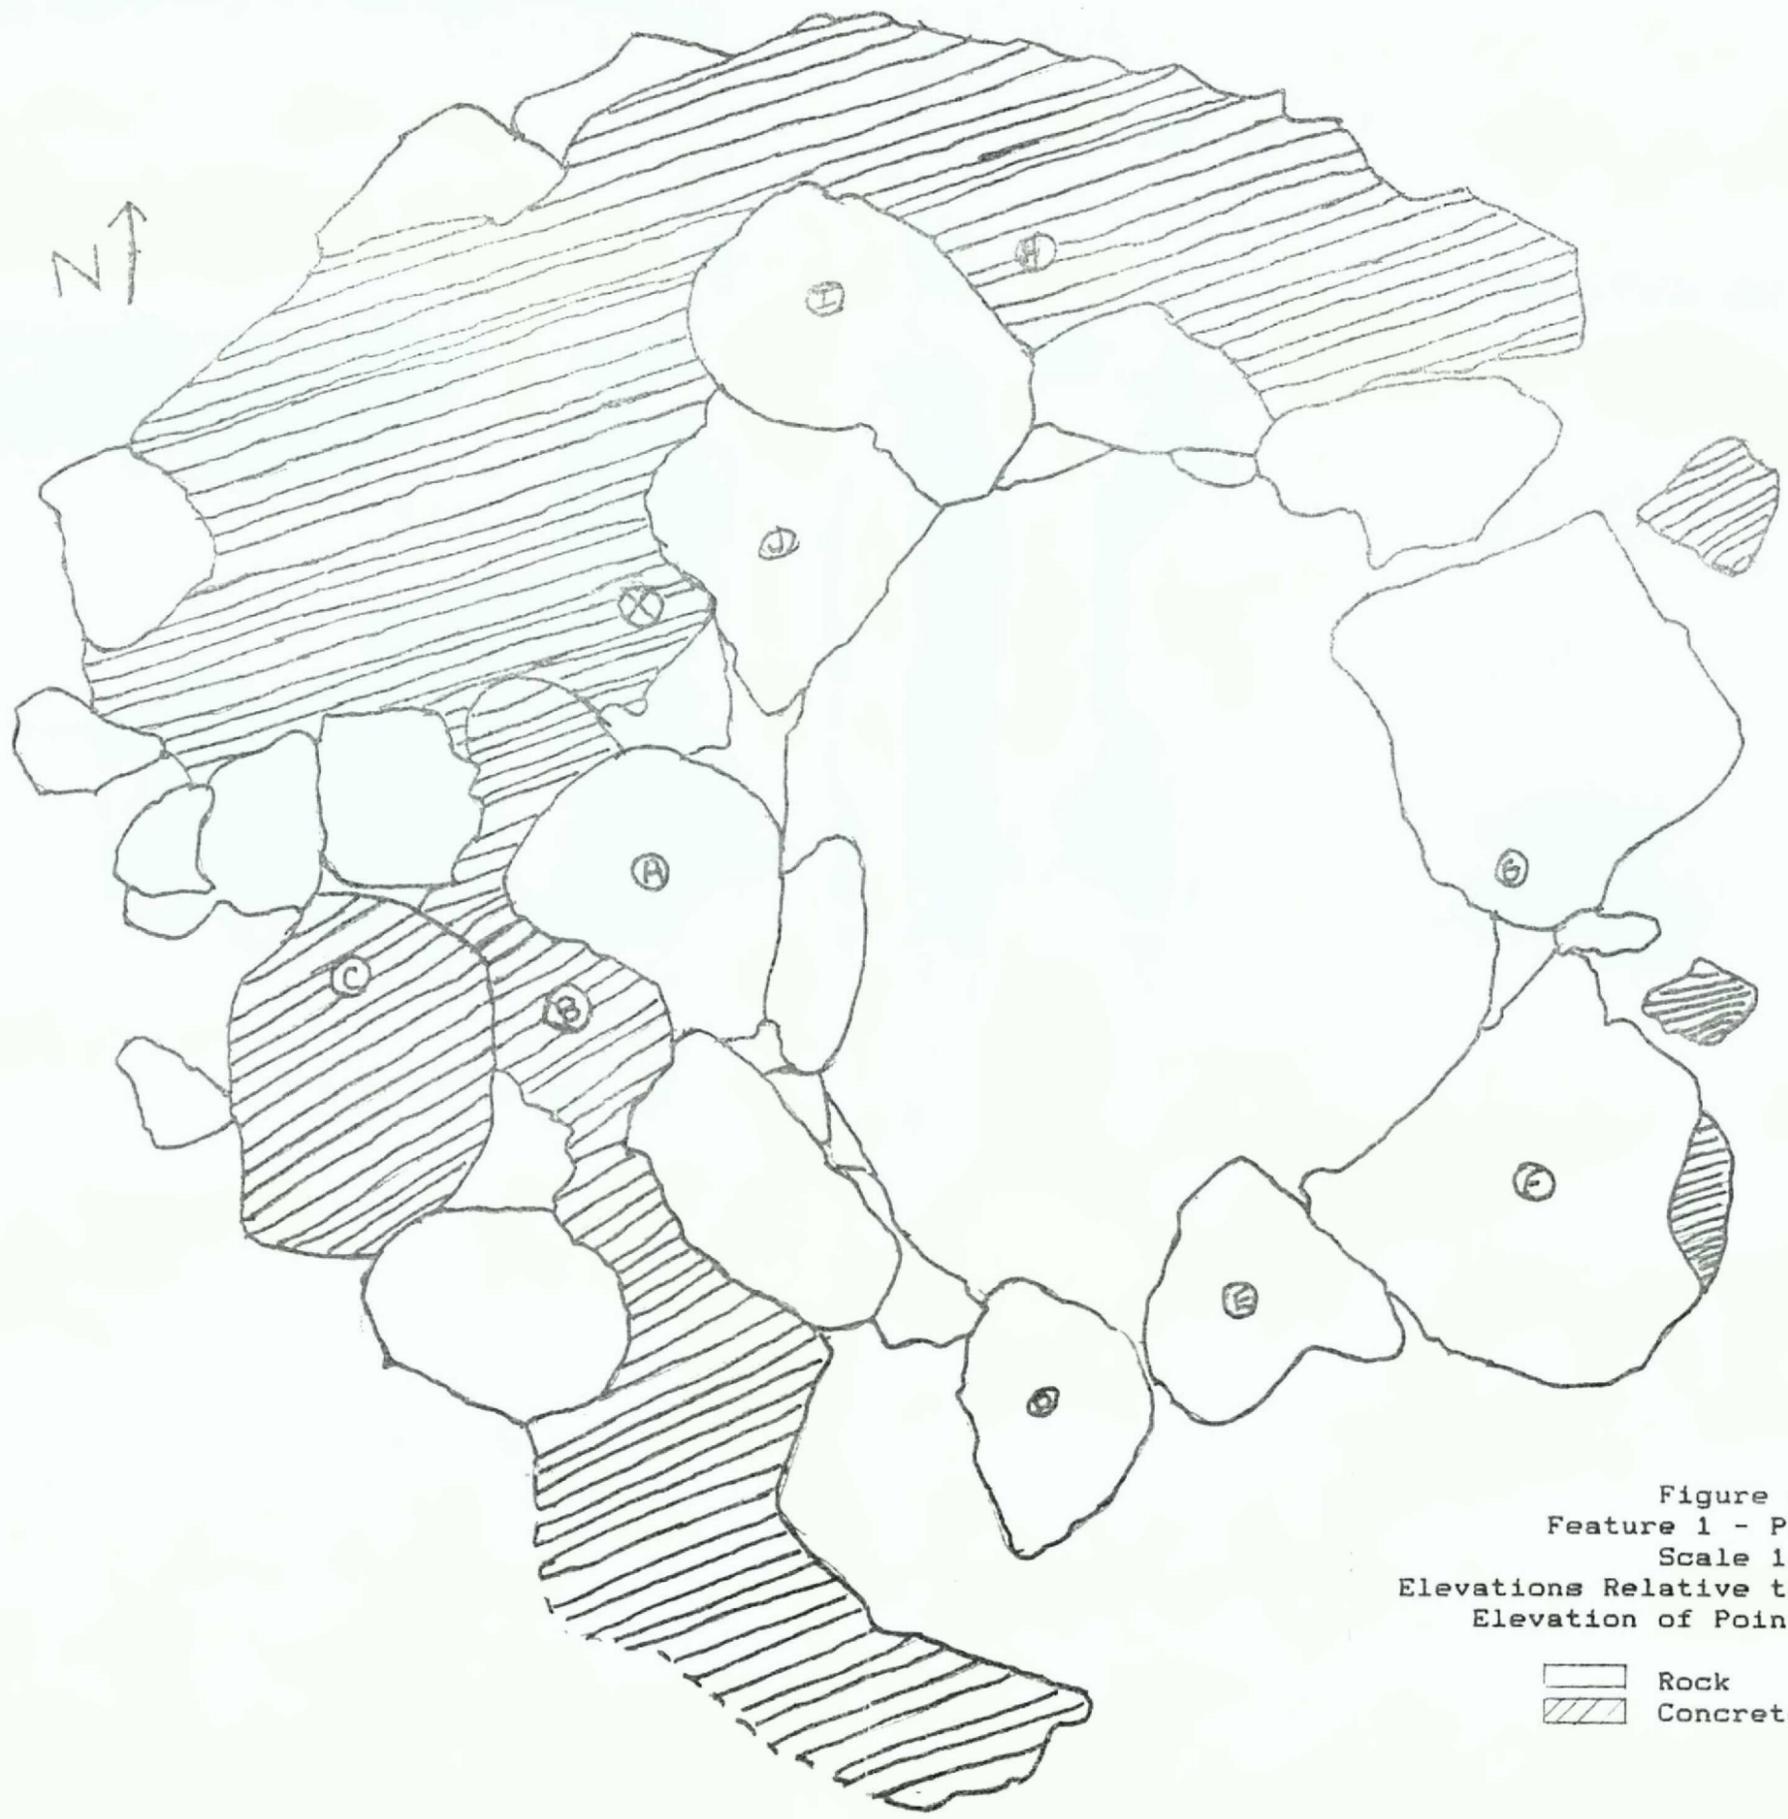
The site topographic map (see Figure 1) shows a square symbol west of #45 Bedell Street. This feature is labelled "well" on the copy of the site topographic map included as Figure 1. It was not labelled on the version of the map which was examined prior to the beginning of field work. However, a local informant indicated that a well had been present at this location prior to the demolition of #45 Bedell Street and had been covered by fill during the demolition activities. We used the backhoe to remove the fill and expose the top of the well. The dry-laid stone walls of the well were completely intact. The well had been topped with a ring of concrete and a brick well-head had been constructed atop the concrete. During the demolition of the structure the

Figure 3
Feature 1 - View West

No attempt was made to excavate this feature. It was photographed and a plan view of the top of the feature was drawn (see Figure 4). After the completion of recording, the feature was backfilled with clean sand.

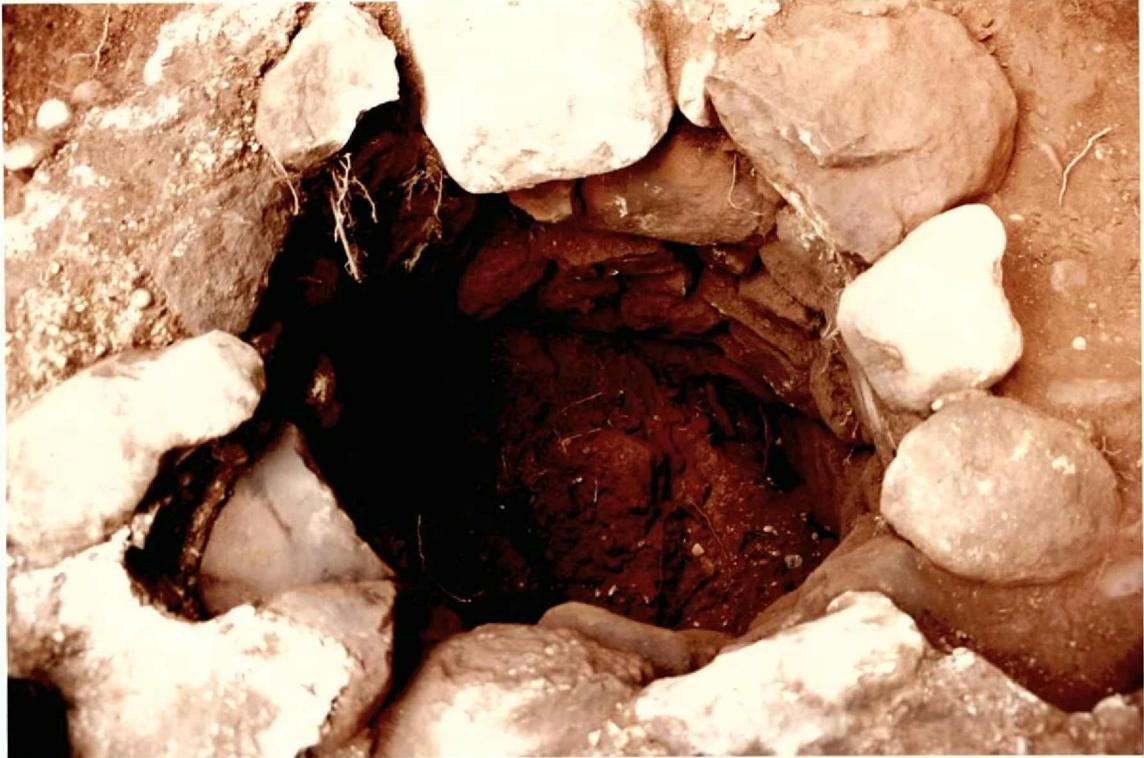
Figure 5
Interior of Feature 1 Showing Surface of Fill Deposit
Note Space Adjacent to Wall at Right
View East

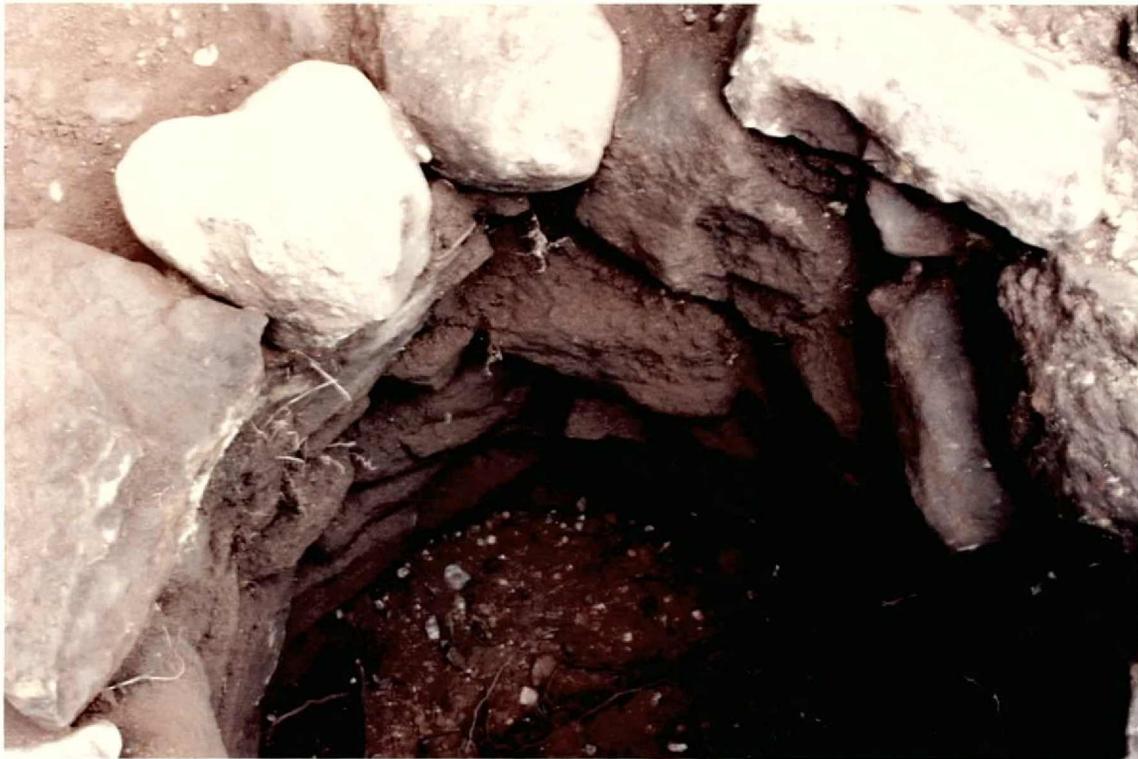
Figure 6
Interior of Feature 1 - Detail
Note Space Adjacent to Wall at Left
View West

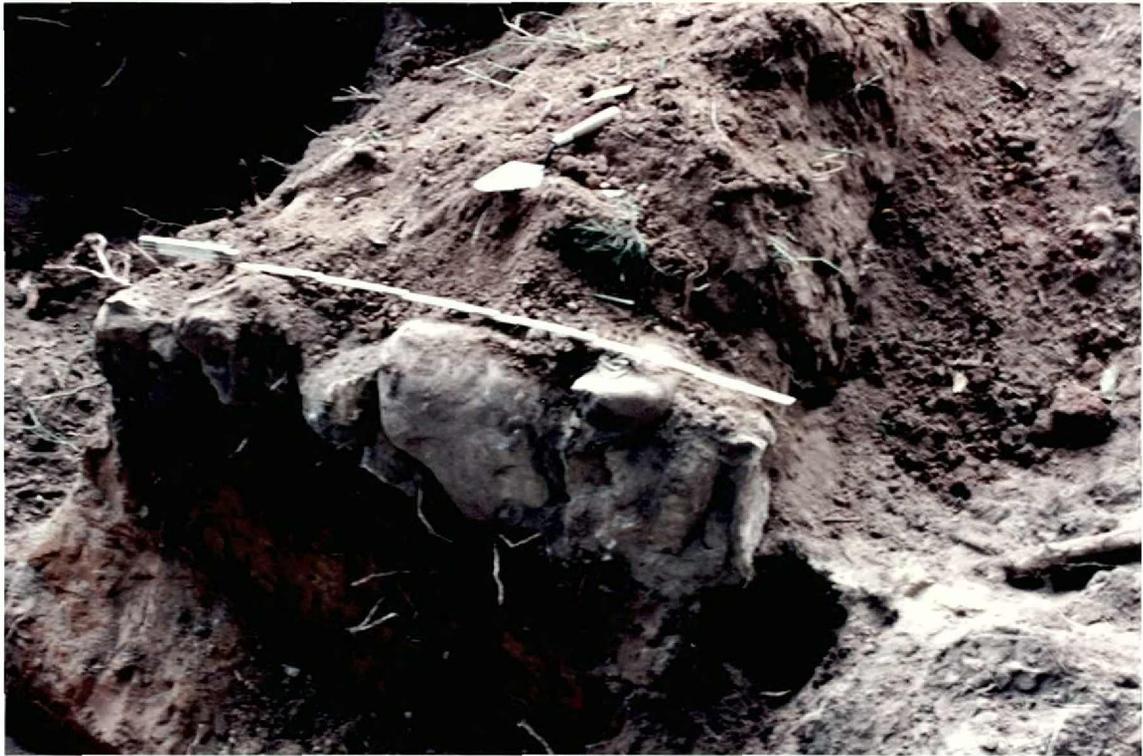
As noted in the Stage Ia report, a portion of a stone wall immediately east of #45 Bedell Street was noted during pedestrian reconnaissance. The location would place this feature in the northwest portion of the #37 Bedell Street property. A small outbuilding is shown at this approximate location on the 1911 Borough of Richmond topographic sheet (see Stage Ia report, Figure 17). Prior to the beginning of this project, New York City inspectors required debris to be removed from the #45 Bedell Street foundation and replaced with clean fill. This resulted in soil being deposited at the feature location. This overburden was removed with the backhoe. It appears that only a small portion of the stone wall remained intact. The results confirmed the preliminary probing during the Stage Ia reconnaissance which indicated that the wall was probably only a few courses thick. The portion of the wall remaining at the time of the backhoe investigation was only one course thick (see Figure 7). This wall apparently supported a small shed or other outbuilding, rather than representing a privy, well, or other sub-surface feature.

Figure 7
Feature 3 - View Southeast

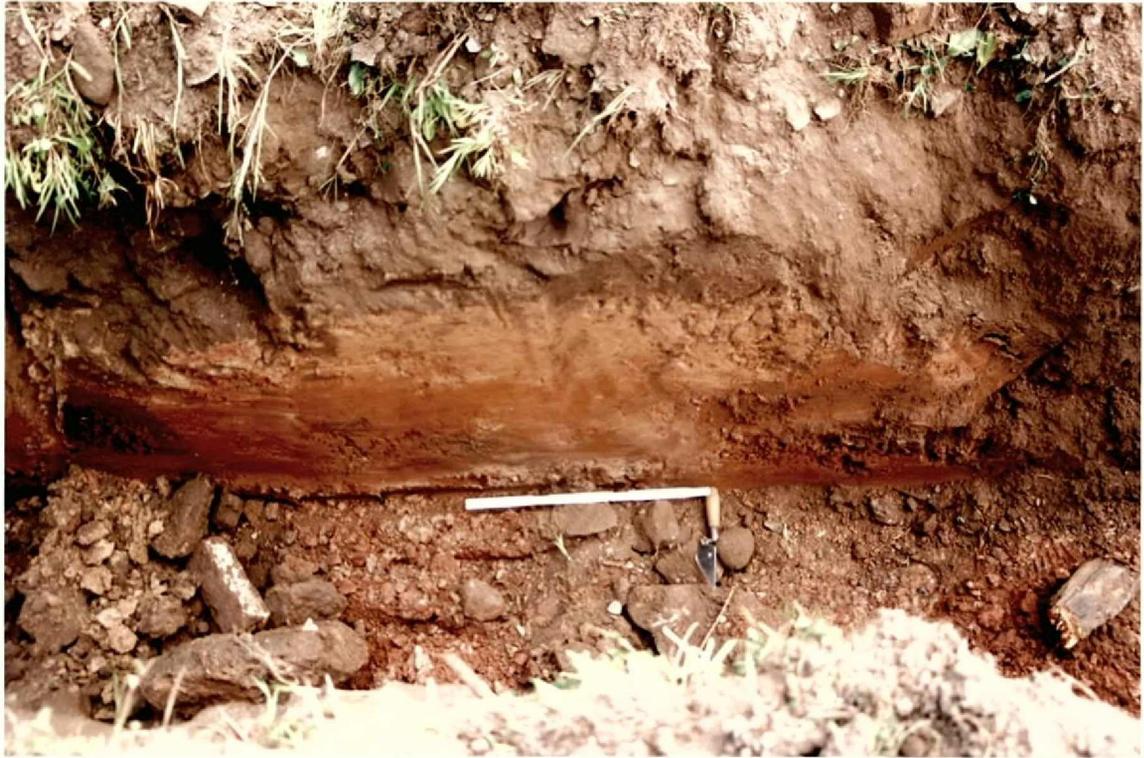
This trench extended some 20 feet eastward from the rear of #6420 Bedell Street, with a connecting trench extending 15 feet to the north. Most of the area east of the structure would have been disturbed by the construction of the three houses fronting on Bedell Street and a garage located to the rear of the house, as shown on the site topographic map. The backhoe trench was placed in the area southeast of the structure, which would have been least affected by the latter construction. The backhoe trench profile (see Figure 8), suggests that the original ground surface had been removed from this location, with more recent fill overlying the reddish clayey subsoil. The east-west trench also encountered concrete slab which apparently represents a walkway.

Figure 8
Backhoe Trench 1 - South Profile

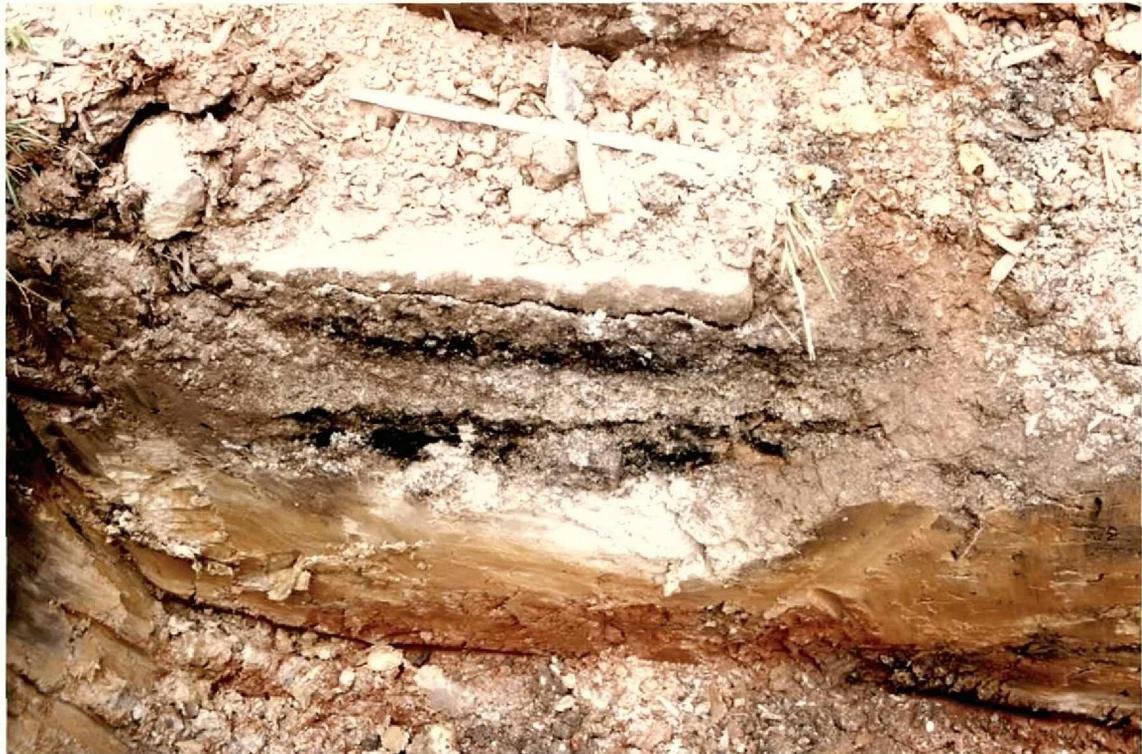
An excavation had been made into the underlying subsoil for the installation of bedding material for the walkway (see Figure 9).

Figure 9
Backhoe Trench 1
North Profile Showing Walkway Disturbance

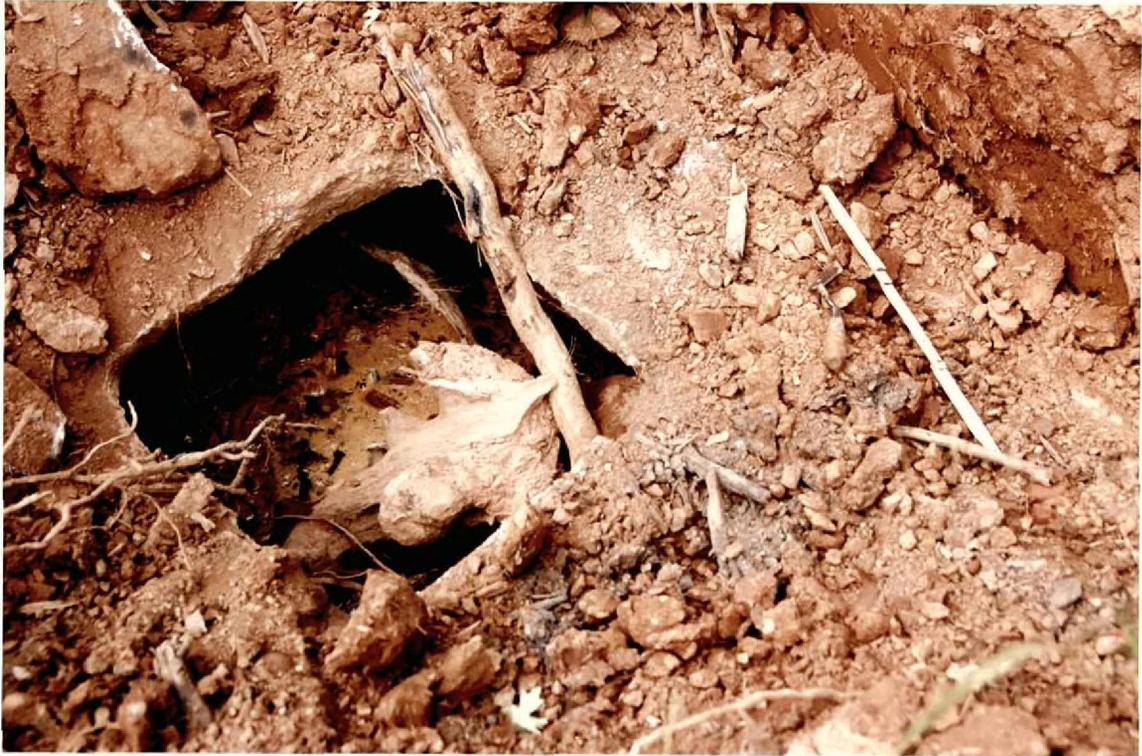
In the Stage Ia report, the presence of a depression containing standing water was noted somewhat west of the #6420 Amboy Road property, and it was speculated that this could be the site of a cistern or other archaeological feature. This area was exposed with the backhoe. The feature turned out to be a relatively modern concrete septic tank (see Figure 10). This septic tank was probably associated with the house which was constructed at #6414 - #6416 Amboy Road after 1917.

Figure 10
Septic Tank (Feature 4)

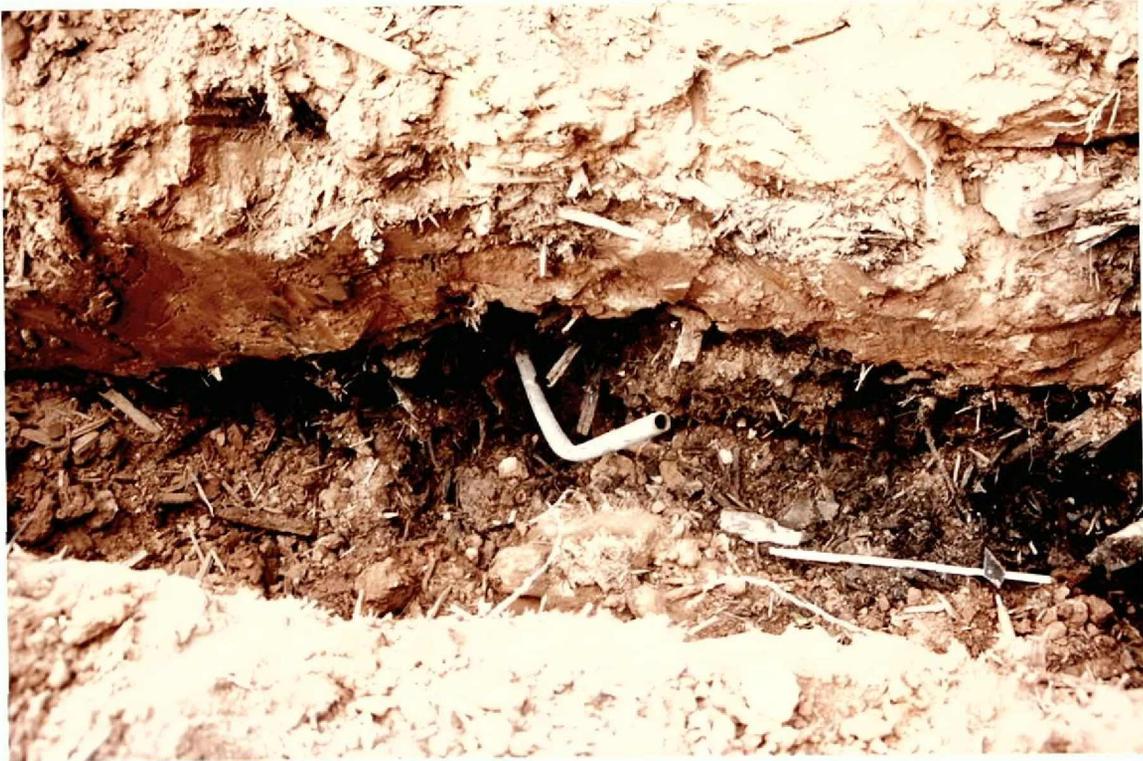
This trench extended approximately 30 feet eastward from the location of the rear of #6408 Amboy Road. It encountered a large disturbed area filled with wood and other debris which was stained black (see Figure 11) and had a strong odor of oil. This may have been the location of a buried oil tank which was subsequently removed, possibly when the house was demolished, and the pit filled in with debris. What appeared to be several metal oil tanks were noted in a disturbed wooded area near the stream in the northern portion of the project area.

Figure 11
Backhoe Trench 2
North Profile Showing Portion of Disturbed Area

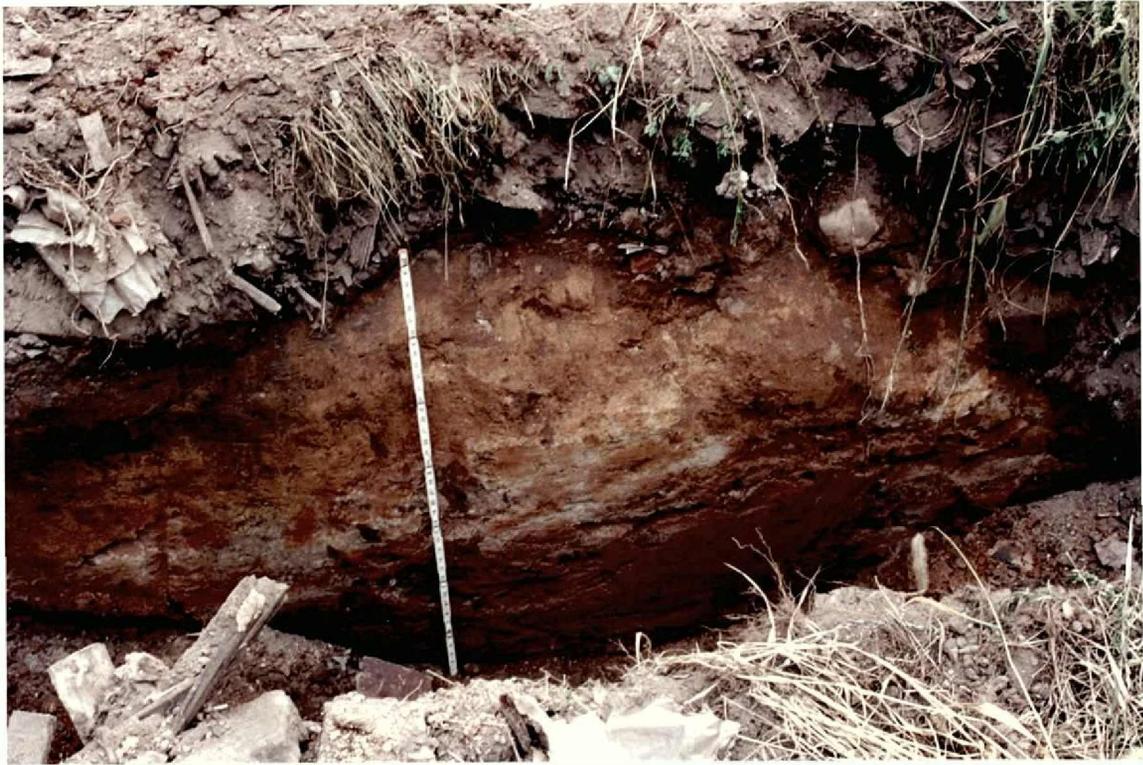
Backhoe trench 4 extended some 90 feet eastward from the rear of #6388 Amboy Road. Immediately adjacent to the structure, the trench stratigraphy indicated a disturbance apparently associated with construction of its rear wall (see Figure 12). Beginning east of this disturbed area a thin, (ca. six inch thick) band of light brown soil with orange mottling underlay the debris deposited during demolition. This stratum did not appear to represent a well developed ground surface or plow zone, or a refuse deposit, such as were noted at some of the shovel test locations further to the east.

Figure 12
Backhoe Trench 4
South Profile - West End of Trench

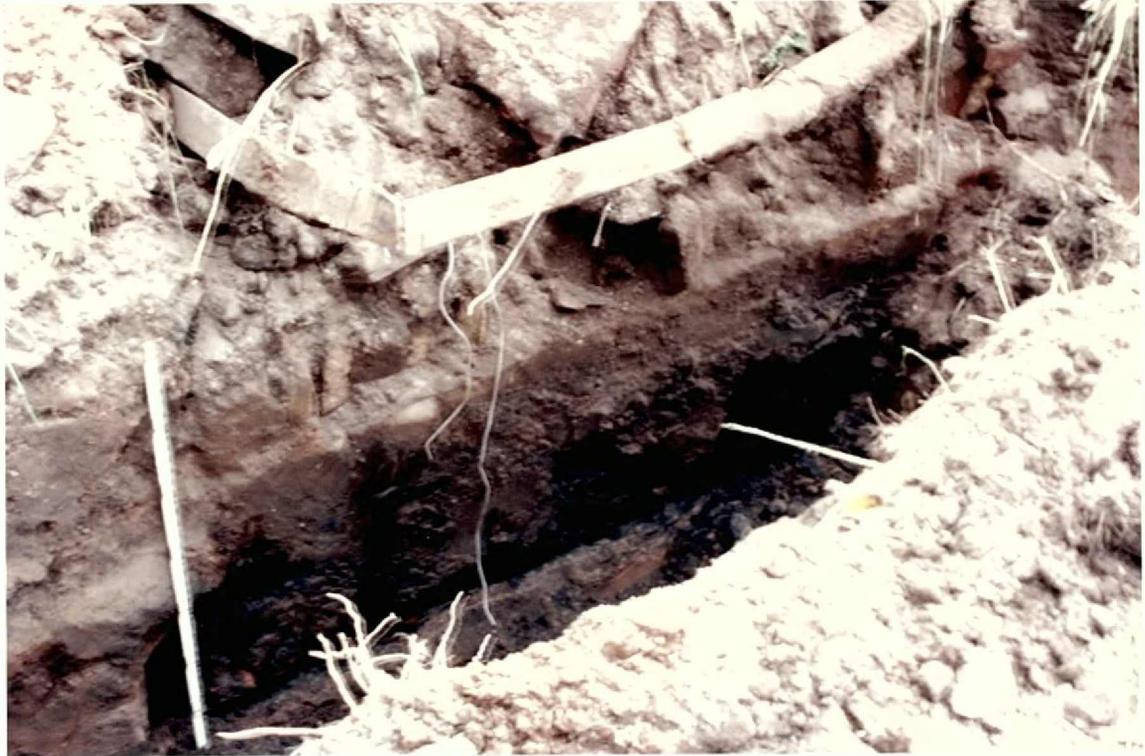
Additional sources of disturbance were also noted in this trench. These include the cinder block foundation (see Figure 13) of the structure labelled "screen house" on the Figure 1. Approximately 10 - 15 feet east of this foundation, another disturbed area was

Figure 13
Cinder Block Foundation of Structure Labelled "Screen House" on Figure 1
Backhoe Trench 4 - South Profile

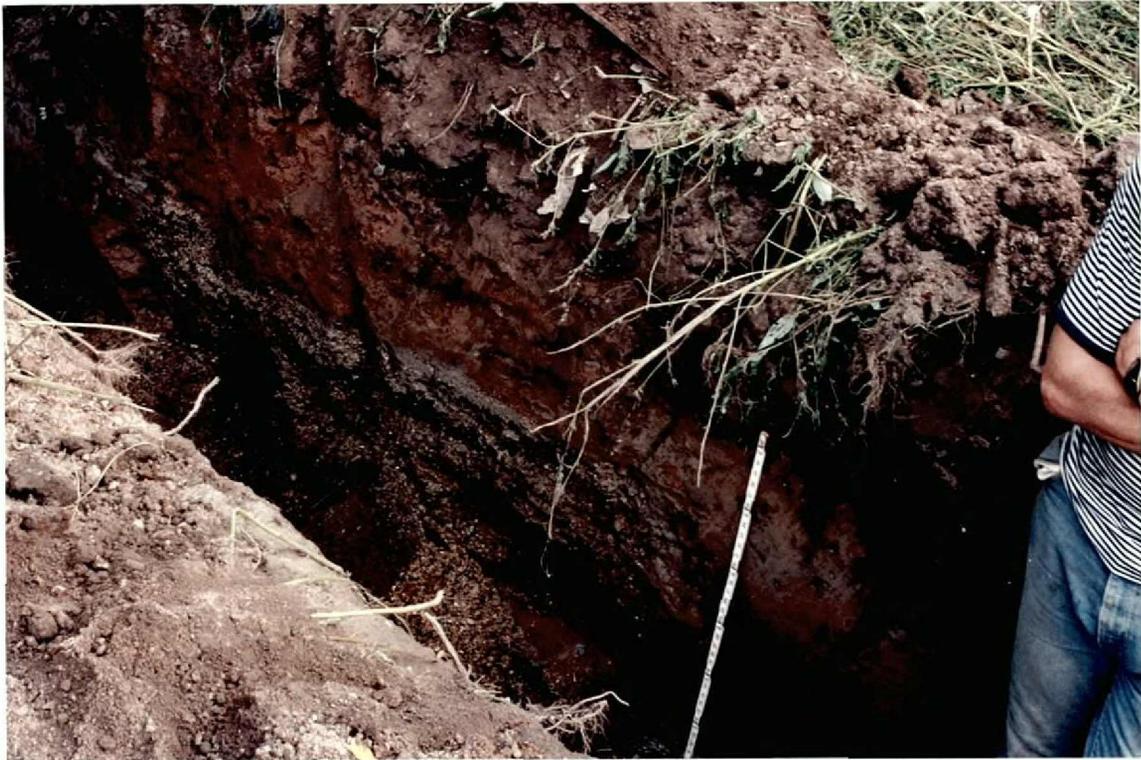
encountered. This area appeared to have been excavated and the lower portion of the excavated area filled with cinders (see Figure 14). The backhoe trench was not excavated to the base of this disturbance. However, it most likely represents an area excavated for the installation of a pipe.

Figure 14
Backhoe Trench 4
South Profile Showing Cinder-Filled Trench

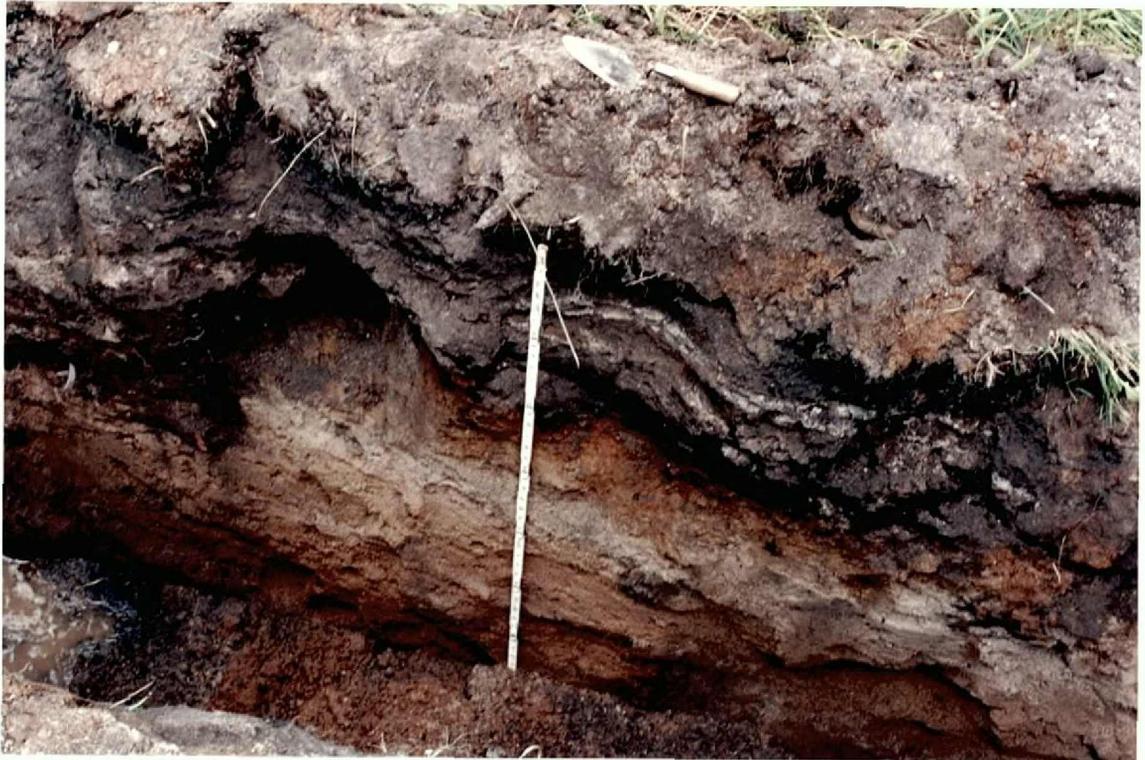
East of #6388 Amboy Road, the stratigraphy noted in the backhoe trench profiles also corresponded with that encountered in several shovel tests placed in this area: a layer of cinder and ash overlying dark brown sandy silt which appears to represent a former plow zone (see Figure 17 - The material shown above the cinder layer represents both the recent soil development noted in the shovel tests and backdirt from the backhoe trench).

Figure 15
Backhoe Trench 5
East Profile - Area East of #6388 Amboy Road

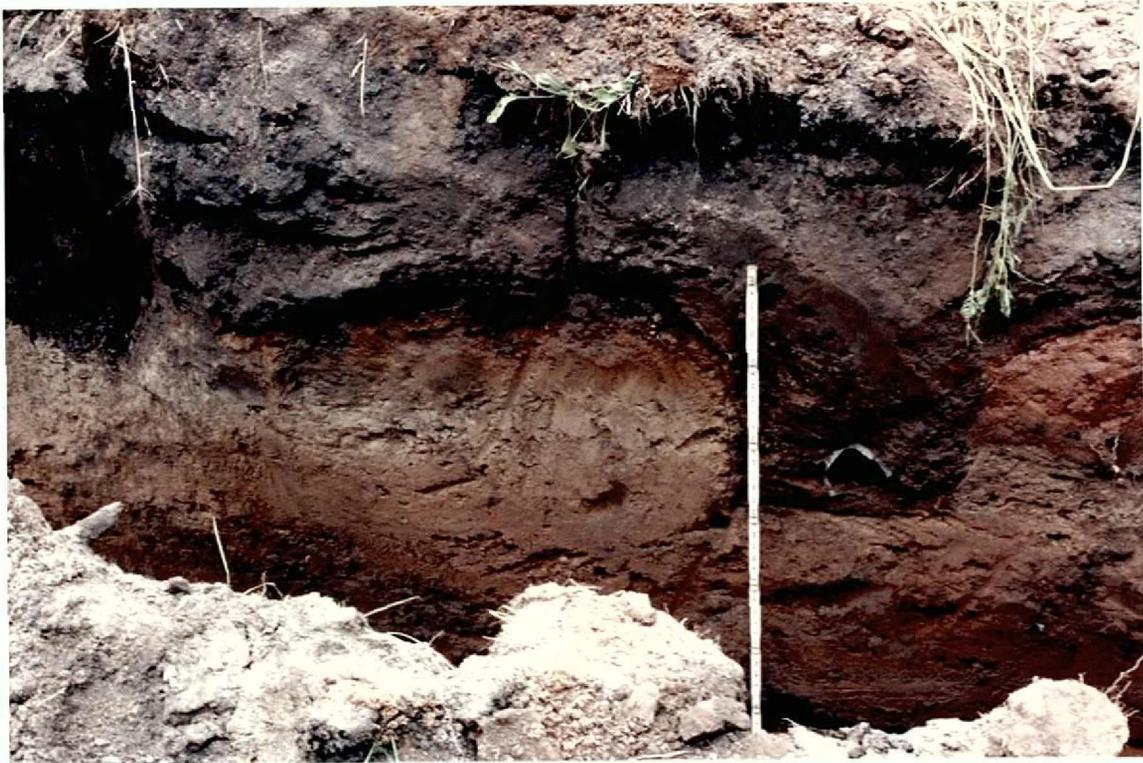
A backhoe trench was extended southward across the site beginning at the location of backhoe trench 4. This trench was excavated to further examine the stratigraphy encountered in the shovel tests and to detect any features which may have been present in the area. Figure 15 indicates the stratigraphy present in the area east of #6388 Amboy Road. As noted in the shovel tests descriptions, the cinder and ash layer directly overlay the subsoil in this area. Several pipe trenches were also noted (e.g. see Figure 16).

Figure 16
Backhoe Trench 5
West Profile Showing Pipe Trench

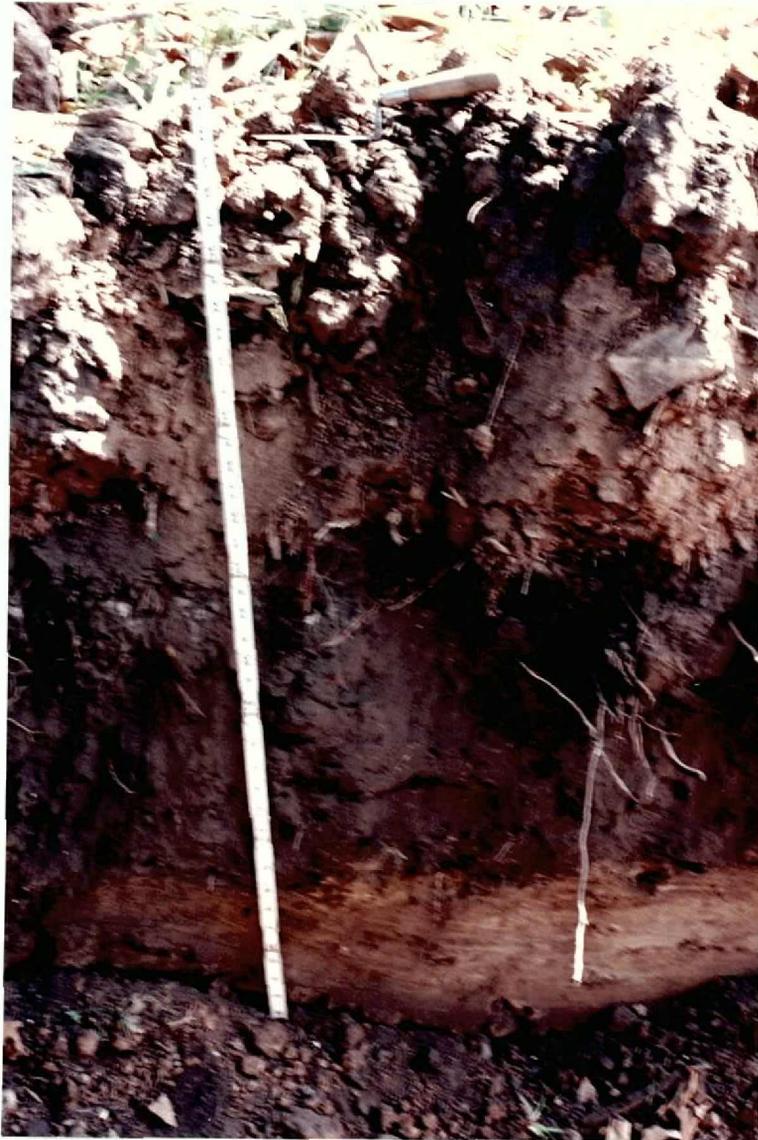
Figure 17
Backhoe Trench 5
East Profile - Vicinity of Shovel Tests C-10 and C-11

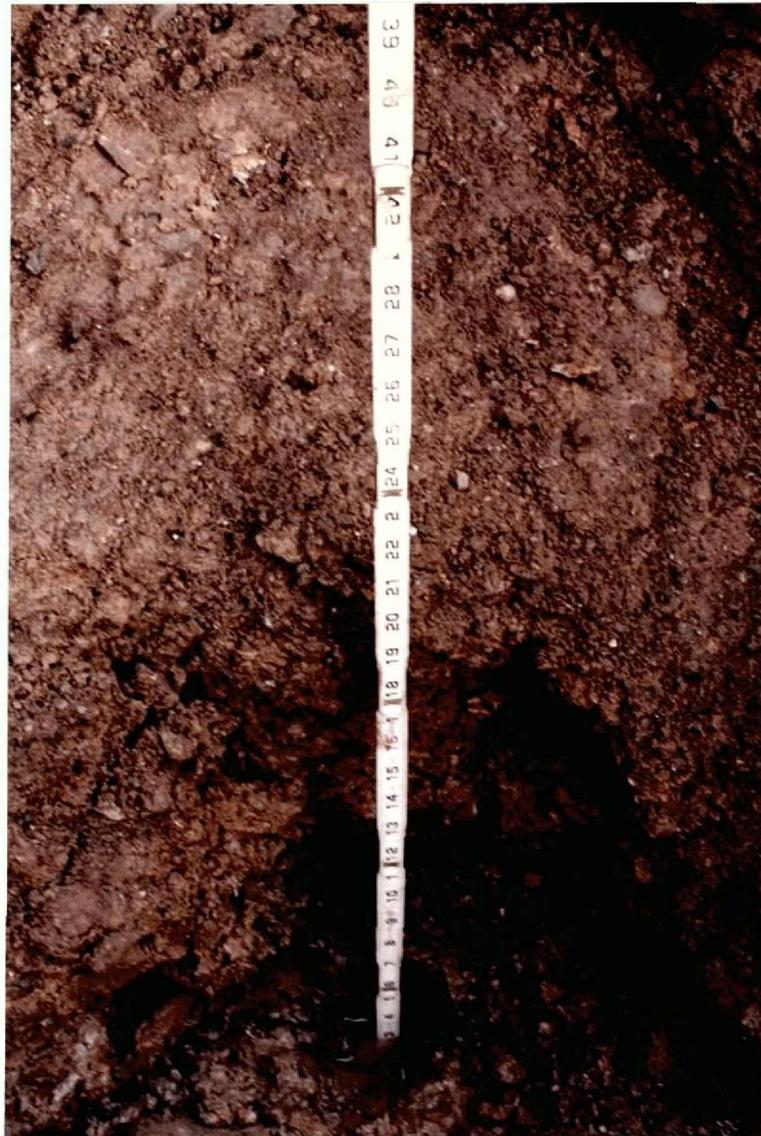
To determine whether artifact deposits were present we excavated a small shovel test which sampled the black sandy silt and the underlying gray/brown clayey silt to a depth of 13 inches below the top of the former stratum (76.5 inches below the ground surface). Cobbles at the base of the shovel test prevented further excavation. Approximately one large plastic bucket full of soil was screened. This material also included some of the disturbed soil overlying and adjacent to the undisturbed strata. The material recovered from the shovel test consisted mainly of small fragments of cinder and shell. Two pieces of cut wood were manually removed from the gray/brown silty clay deposit, near the base of the shovel test. The only other artifacts recovered were a small piece of clear glass and a milk glass chip. It is possible that these artifacts derived from the disturbed soil. The feature was covered over with a sheets of plywood and tin and the excavation backfilled.

Figure 23
Profile of East Wall of Shovel Test at Base of Feature 2
Location of Profile shown at Center of Figure 21

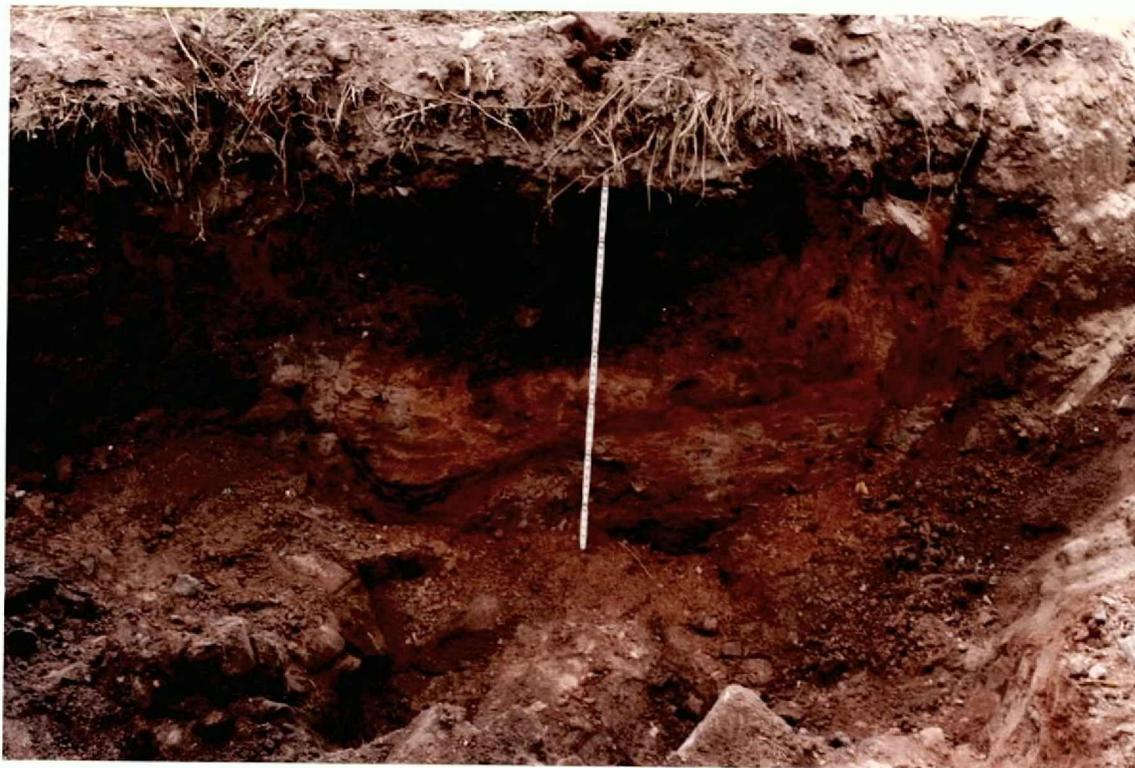
On the north side of the feature, the curved wall was not visible in the western profile of the backhoe trench (see Figure 22). The stratigraphy indicated by this profile, suggests that the western portion of the feature had been removed at some time prior to the present investigation, and the resulting trench or pit backfilled. The large boulder was probably deposited with the backfill of the trench. The site map indicates that the location of the feature was near the large addition which was constructed on the south side of #6388 after 1917 (see Stage Ia report). The feature may have been disturbed during construction of this extension.

Figure 22
West Profile of Backhoe Trench 6
Showing Disturbed Stratigraphy Immediately West of Feature 2
View West From Ground Surface Immediately Above Feature 2 Wall

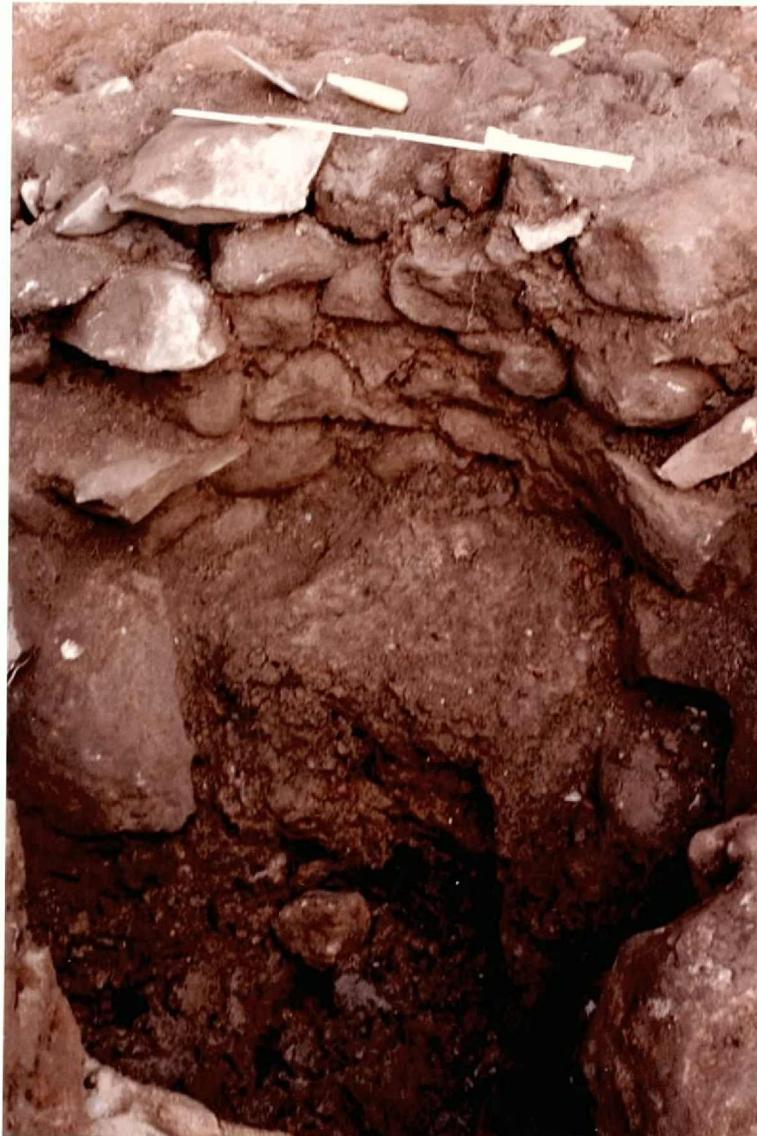
On its south side, the remaining stones of the feature wall, at a depth of some 42 - 54 inches below the ground surface, appeared to abut a large boulder which was encountered in the backhoe trench (see Figures 20 - 21). The top of this boulder is some 44 inches below the surrounding ground elevation. This boulder was too large to be moved by the backhoe without disturbing the surrounding area.

Figure 21
Feature 2 Showing Disturbed Portion of Southern Wall Adjacent to
Boulder (in right foreground of photo)
View Northeast

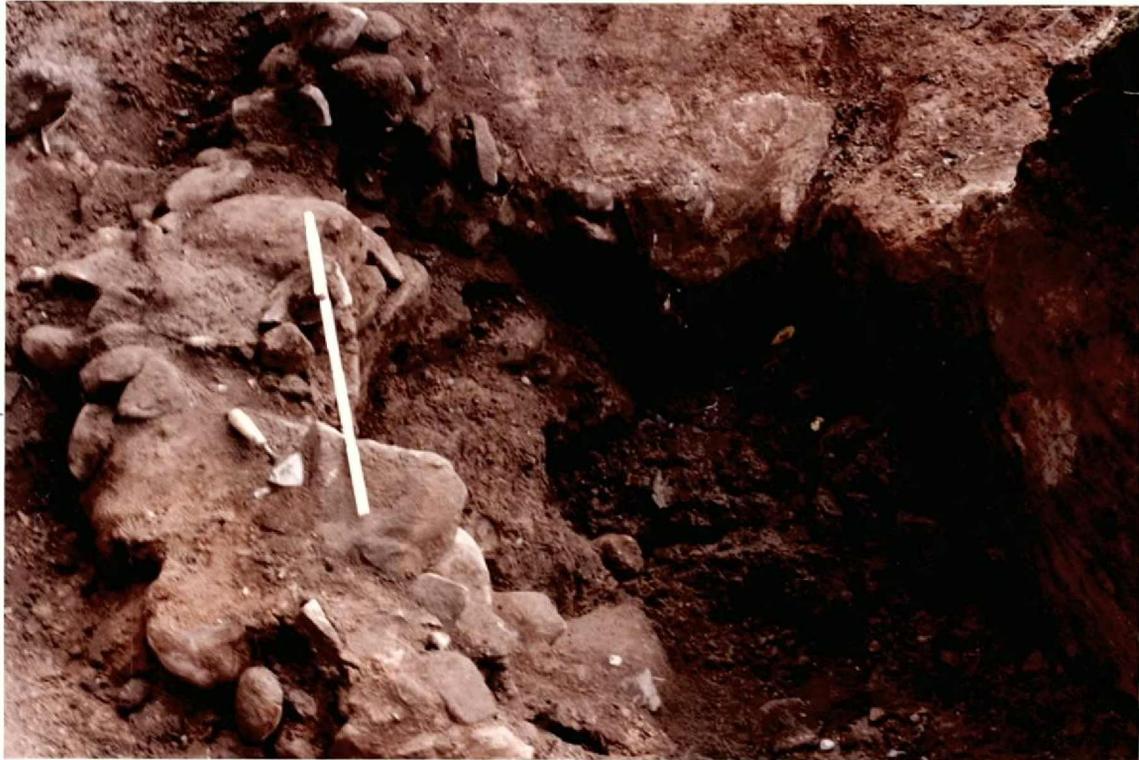
Figure 20
Feature 2 and Backhoe Trench 6
Showing Large Boulder Adjacent to Feature
View Southeast

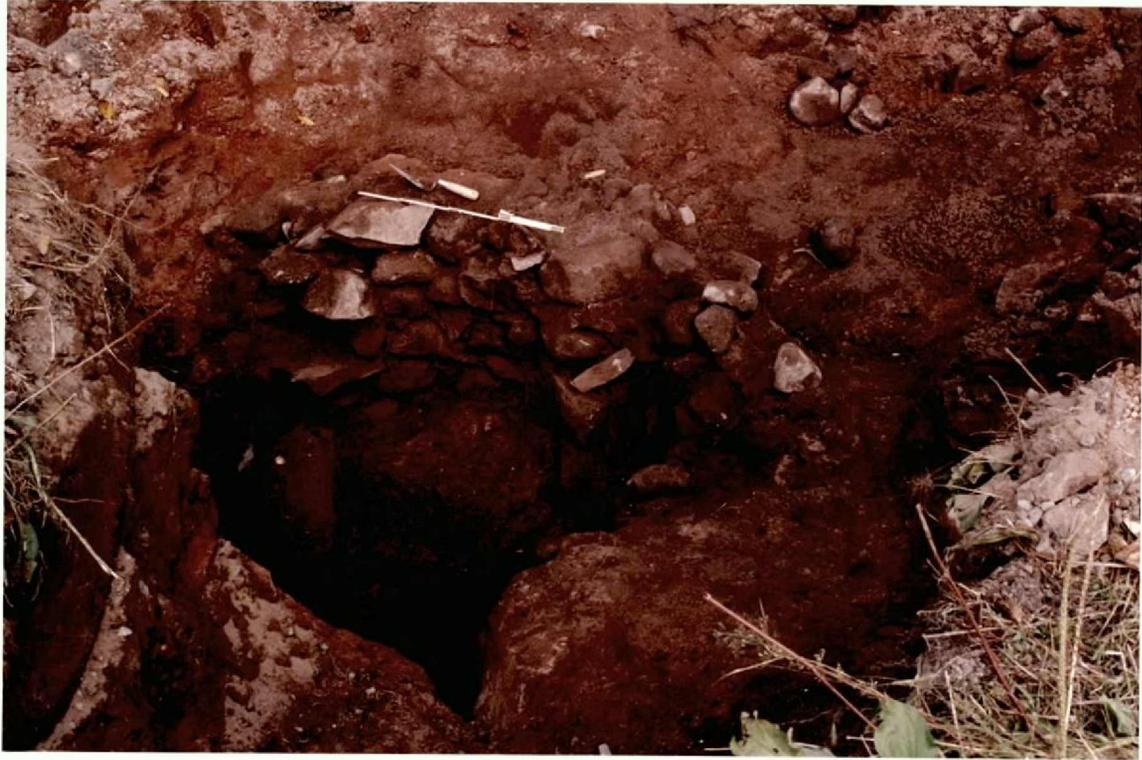
This disturbed feature was encountered in backhoe trench #6 at the rear of #6388 Amboy Road. The backhoe trench encountered a deposit of cobbles which began ca. 6 inches inches beneath the surface, underlying the surface debris deposited during structural demolition. At the location of the backhoe trench the deposit of loose cobbles continued to a depth of some 52 inches below the existing ground surface. A wall did not appear to be present at the location of the trench. However, several artifacts, including a late 19th century medicine bottle, and a fragment of a blown-in-mold bottle which probably dates to the mid-19th century were noted among the cobbles. Closer examination of the eastern profile of the backhoe trench indicated what appeared to be the remains of a curved, dry-laid stone wall underlying and surrounded by cobbles. The cobbles were removed by the backhoe from above the dry laid stones. The remaining cobbles between the interior of the curved wall and the backhoe trench were manually removed and the feature wall was cleared. The top of this wall on the eastern side of the feature (see Figure 19) was some 34 inches below the ground surface.

Figure 19
Feature 2
View Northeast
