STAGE 1b ARCHAEOLOGICAL INVESTIGATIONS
AMBOY/BEDELL SHOPPING PLAZA
PLEASANT PLAINS, STATEN ISLAND, NEW YORK
CEQR #90-175R

by
ARNOLD PICKMAN
and
EUGENE BOESCH

Submitted To
CALVANICO ASSOCIATES

October, 1990

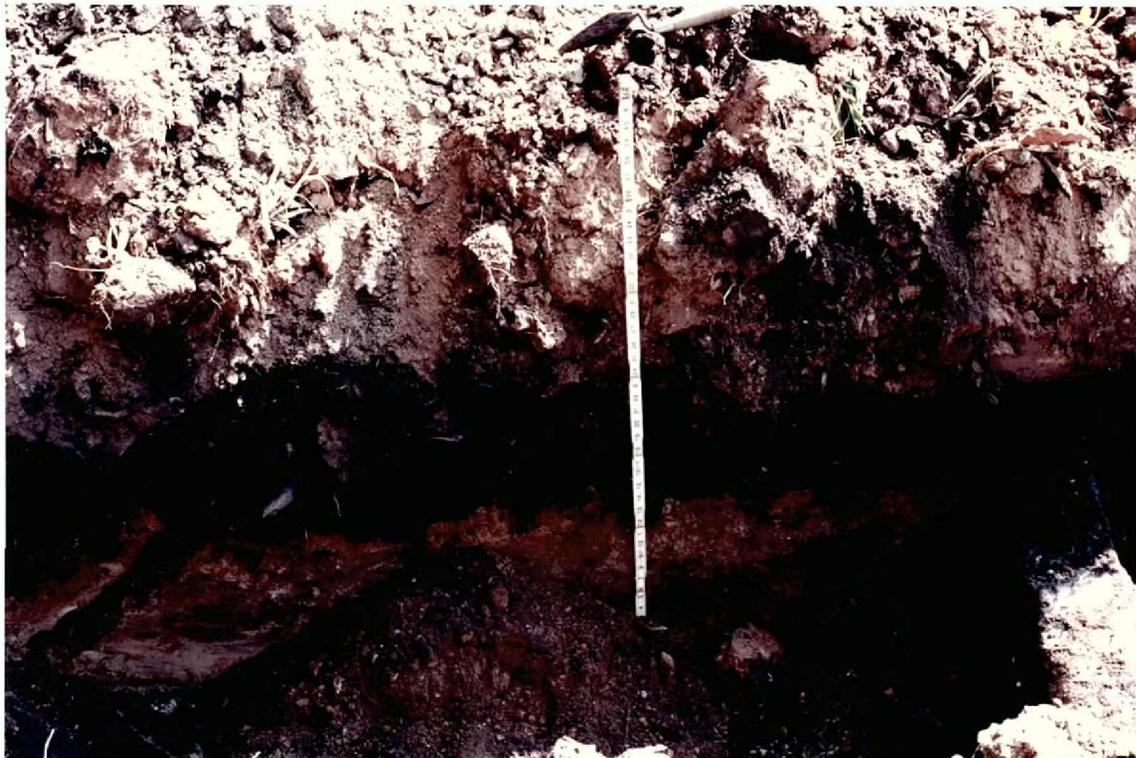
This stratigraphic sequence was present in most portions of the backhoe trench, which traversed the properties at #6398, #6408 and #6414 - #6416 Amboy Road. The southernmost portion of backhoe trench 5 encountered an area of disturbed stratigraphy associated with the 20th century structure fronting on Bedell Street. The construction and/or demolition of this structure had resulted in disturbance of the previous stratigraphy in this area. Figure 18 shows a portion of the northern wall of the garage shown on the site map, which was encountered in the southern end of backhoe trench 5. The plow zone and cinder deposit are not present in this area. The black layer overlying the subsoil is most likely associated with the construction or demolition of the structure.

Figure 18
Backhoe Trench 5
East Profile - South End of Trench Showing North Wall of 20th
Century Garage and Disturbed Stratigraphy
