Stage 1b Field Testing
The Harlem River Yard Transportation
and Distribution Center Site
(Block 2260 Lot 62 and Block 3543 Lots 1 and 2)
Bronx, New York

Prepared for TAMS Consultants, Inc.

Prepared by Joan H. Geismar, Ph.D.

April 1993

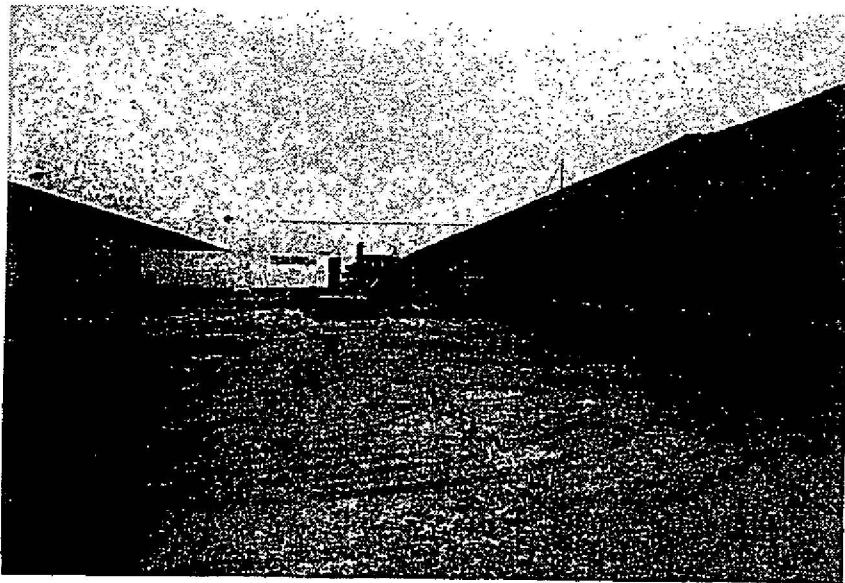
2 View looking west across Test Area G1 where the backhoe used for testing is visible in the center rear. A trailer truck is parked nearby; truck access made it necessary to limit the test area. (photo Geismar 2/11/93)

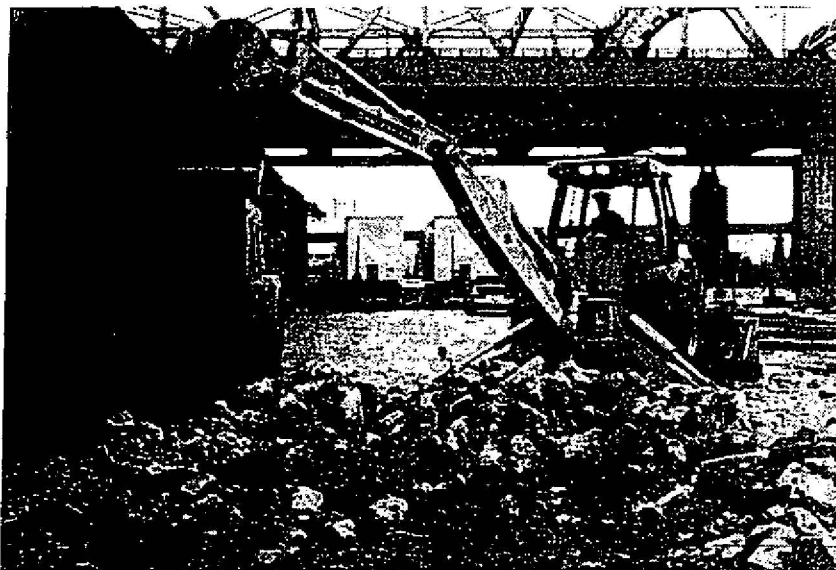
3 Removing broken concrete in Test Area G1. View is looking east toward the Triborough (near background) and the Little Hellgate (far background) bridges. (photo Geismar 2/11/93)

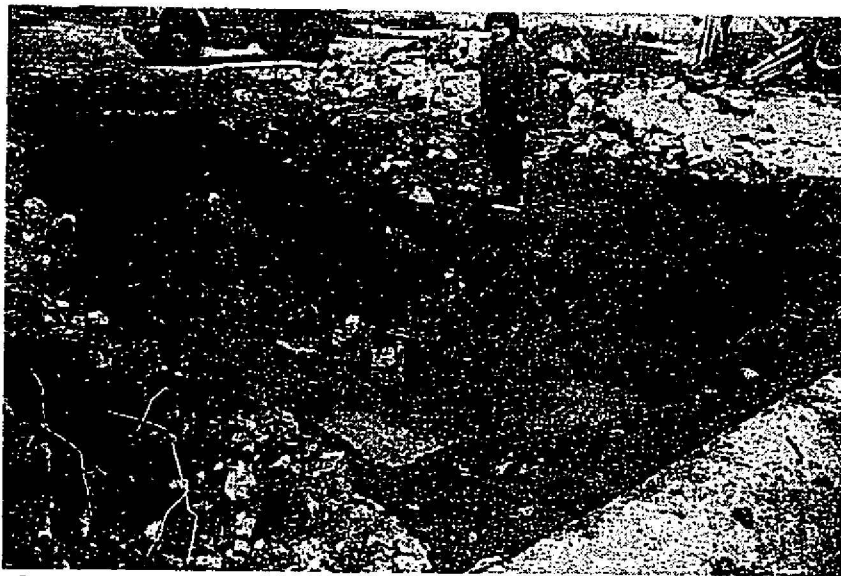
G1 TT 1/G1 Pit 1. On February 11, after clearing concrete pavement previously broken up to facilitate removal, a backhoe was used to open a test trench (G1 TT 1). This was located in the north-west corner of a rectangle of approximately 62 by 48 ft. that initially comprised Test Area G1 after it was modified to accommodate the activities of a commercial tenant. Rock and boulder-laden fill was found under the concrete paving to a depth of about 5 1/2 ft. (5.66 ft.) when a rock outcrop or bedrock was reached. Since a boring mapped in this vicinity (see footnote 1 and Exhibit 5) had suggested a series of boulders separated by soil to a depth of 7 1/2 ft., this rock outcrop was completely unexpected. It was in this trench that the first foundation-like feature mentioned above was found cut into the rock. An attempt was made to determine the areal extent of the rock outcrop, and the trench became an irregularly shaped pit (G1 Pit 1) that was approximately 16 by 20 ft. and covered the entire north-western corner of the test area (Exhibits 5 and 6). Further testing determined that the rock outcrop dipped from approximately 3 ft. to just over 5 1/2 ft. in a southerly direction.

6 Test Area G1 Pit 1 at the end of excavation; the view is to the southeast. Note water in the bottom of the pit and tumbled boulders. Bedrock and outcrops seen in the excavation are now obscured by the water. (photo Geismar 2/11/93)

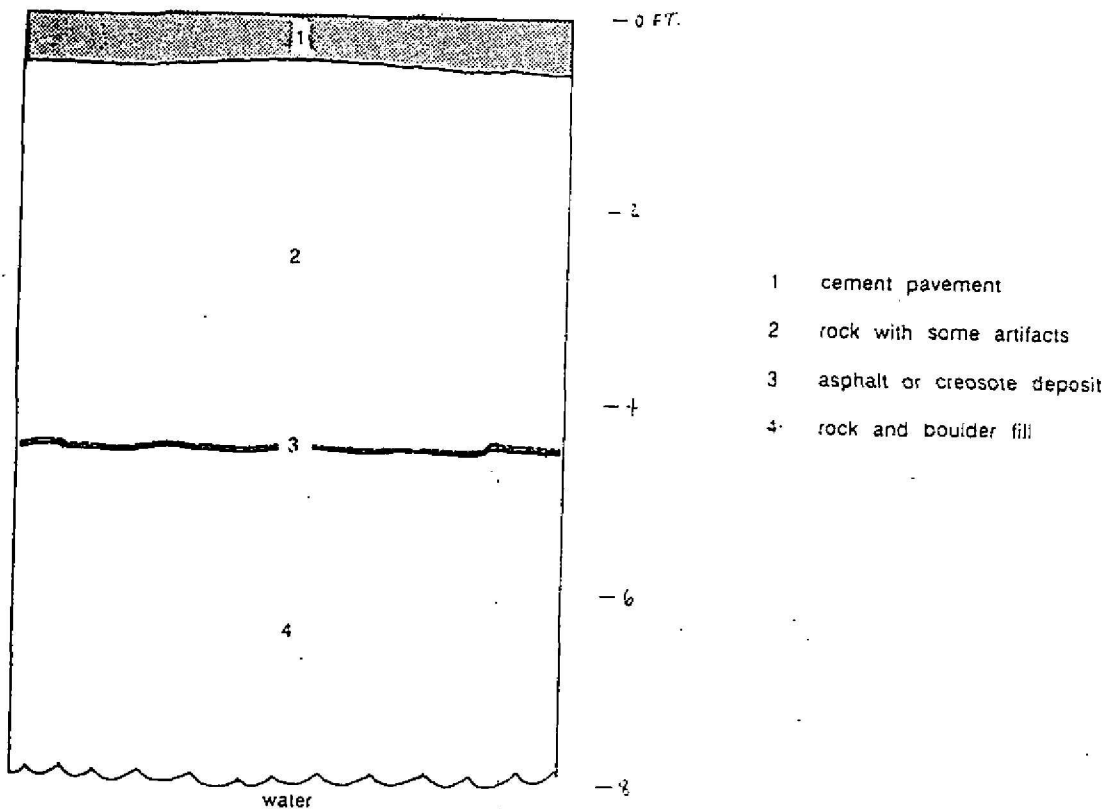
G1 Pit 2 and Extension. Testing then moved to the southeast corner of the test area where backhoe excavation revealed very different subsurface conditions. Here rock and soil were found above a layer of asphalt or creosote lying approximately 4 1/2 ft. below the surface (Exhibit 7). This fill level also contained a few embossed brick fragments (one of them appeared to be a "ROSE" brick), the fragmented top of a ceramic bottle, and an animal bone later identified as the femur of a small but mature sheep (Ovis/Capra) by Barbara Davis--probably a remnant of someone's lunch or dinner. This pit, designated G1 Pit 2, was excavated to about 9 1/2 ft. It was then extended northward (G1 Pit 2 ext.) to define the extent of the asphalt or creosote layer and to determine if it could be a former surface or roadway, but it appeared to be only a random deposit. Beneath this, some isolated rocks and several flat boulders were encountered, seemingly yet again a fill. In addition, several worked stones were observed, one from the G1 Pit 2 extension identified as a curbing stone; another recovered from about 2 1/2 to 3 ft. below the surface was a window lintel, but both came from the level above the asphalt or creosote and were also apparently part of the fill. None of the rocks and boulders found below the asphalt appeared to be cut or worked. As testing proceeded, water became a problem (Exhibit 8), but excavation resulted in a pit of approximately 10 by 15 ft.

8 Test Area G1 Pit 2, south wall. A layer of asphalt or creosote is visible about 4 1/2 ft. below the surface (arrow) and the water that ultimately inundated much of the excavation can be seen at the bottom of the pit. (photo Geismar 2/11/93)

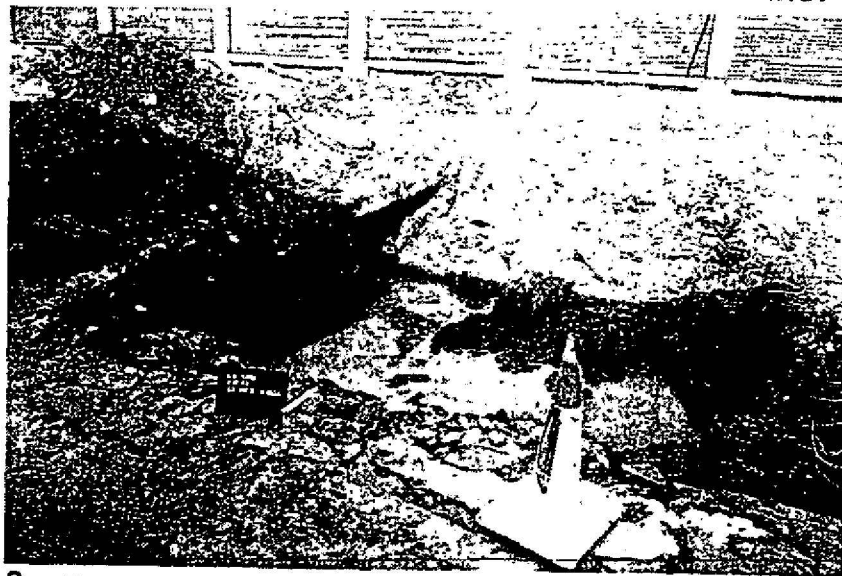
Subsurface conditions in this pit were different from those found in either Pits 1 or 2. Many large boulders were encountered immediately under the concrete, but only one appeared to be worked or cut or could possibly have been a foundation stone. This large, flat rock protruded from the western edge of the test area, about 3 ft. below the concrete, but most of it was situated beyond the test area under unbroken pavement. Since this part of the test area could not be expanded westward without interfering with the operation of the aforementioned tenant still on the site, the possible function of this stone has not been identified.

9 Pit 3 in the southwest corner of Test Area G1, looking northwest across the excavation and test area. A large, flat boulder that appears to be cut on its east face, its only visible surface, is located in the west wall of the excavation (arrow). Note water at the bottom of the pit. (photo Geismar 2/17/93)

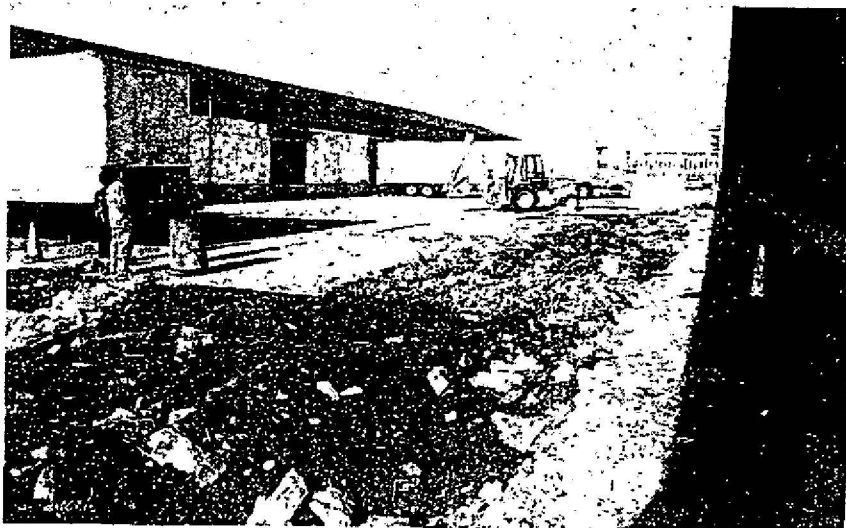
10 Western side of Test Area G1 with pavement in the extended test corridor broken for removal. The large trailer trucks that were a concern during testing are clearly visible. The view is to the west. (photo Geismar 3/10/93)

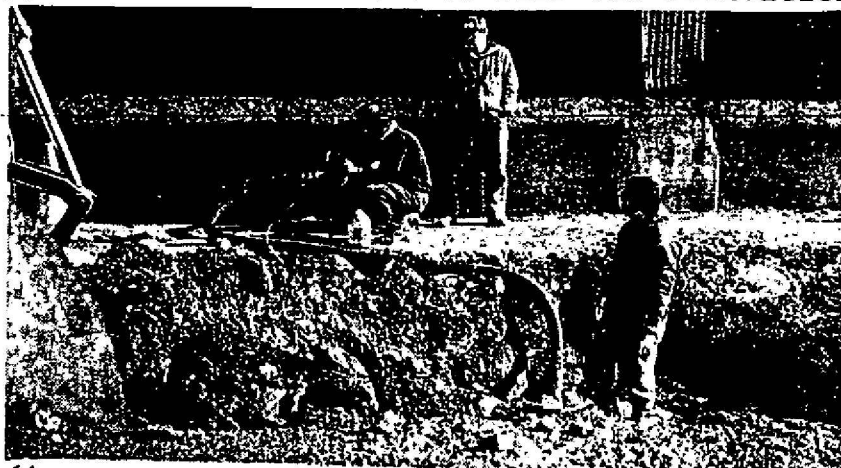
G1 Pit 1 was reopened, and water was immediately encountered. A sump hole was dug in the eastern part of the pit, but unfortunately the larger pump used to attempt dewatering did not function properly (Exhibit 11), and water continued to fill the excavation. Another

11 Attempting to create a sump in Test Area G1 where Pit 1 was originally excavated. Unfortunately, the pump did not function properly and could not draw water from the rest of the test area as intended. The large hose is an water outtake hose from the pump. (photo Geismar 3/10/93)

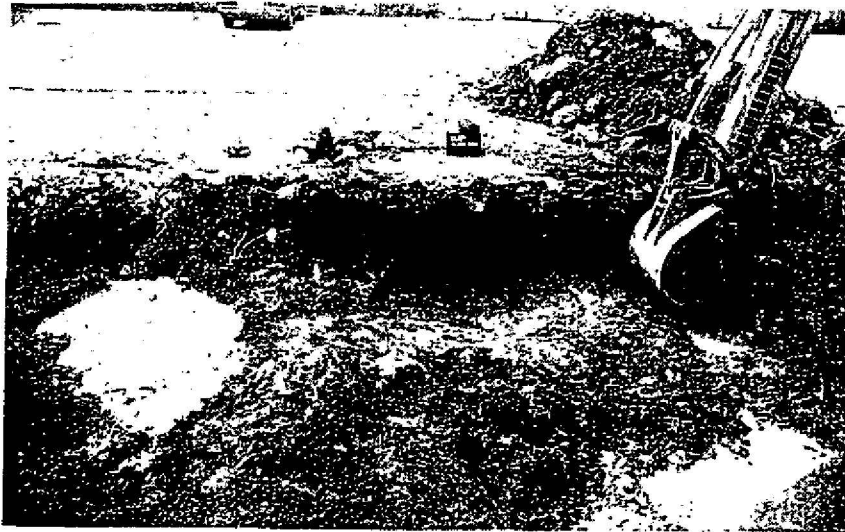
G1 Pit 4. This 15 by 18-ft. pit was located at the extreme western end of the 60 by 15-ft. test corridor. While this excavation was initially dry, water was anticipated to be a problem. A rock outcrop was encountered about 2 1/2 ft. below grade, and once again part of it had been cut to create a strip of rock with an east and west face and a flattened surface similar to the cut rock seen in G1 Pit 1. This feature appeared to be smaller than the one found earlier, but, since it continued under the pavement to the south (Exhibit 12), its extent is unknown.

12 Test Area G1 Pit 4. View is looking south across the pit. A small section of stone (arrow) that may be a foundation of some sort is cut into the shallow rock outcrop or bedrock and apparently extends under the pavement to the south. Note water on the left seeping into the excavation. (photo Geismar 3/10/93)

It was a question whether this foundation-like feature was natural or something accidentally fashioned by the backhoe, but neither seemed likely. An attempt was made to consult with a geologist to explain what this cut rock represented, but the two who were contacted, Dr. Sidney Hornstein of the American Museum of Natural History and a staff geologist from TAMS Consultants, Inc., were both unavailable. Based on photographs and a verbal description, it was later determined by Dr. Hornstein that this cut rock it was definitely not a natural occurrence nor could it be an effect of the backhoe, but that it was a man-made feature.

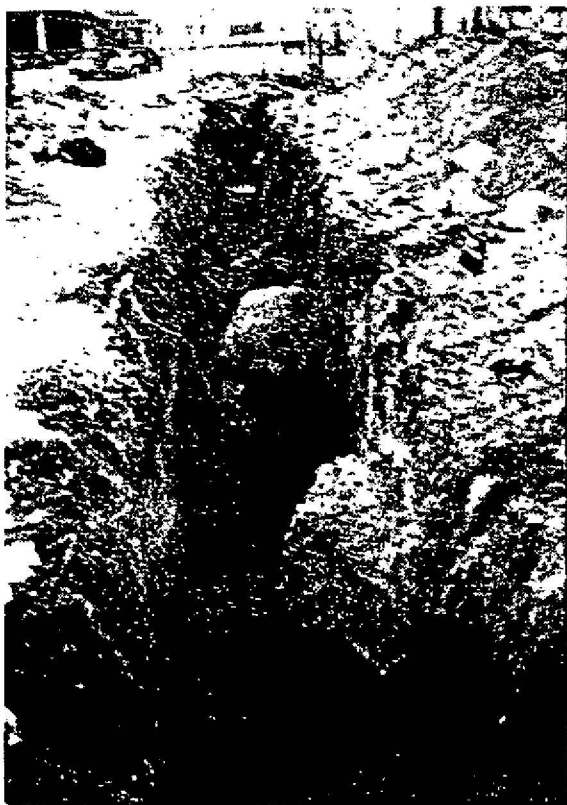
long and its depth ranged from 5 1/2 to 9 1/2 ft., most of between 6 1/2 to 7 ft. As noted previously by the backhoe operator, an unstable sand was found in the western part of the trench, and water seeped in. Rock outcrops were, or bedrock was, found at about 9 ft. below the surface in this end of the trench. As excavation proceeded eastward, various stones, rocks, and small boulders were encountered, with their frequency increasing as the excavation moved eastward. At a point 70 ft. east of the western end, a concentration of rocks was noted at a depth of 2.8 to 3 ft. below the surface, and a large glacial boulder was encountered 24 ft. further east. A second boulder was exposed 11 ft. further east, and dense silt was noted between the two (the more westerly boulder was 2 ft. below the ground surface, the more easterly 1 1/2 ft. below it). The trench extended 10 ft. beyond this second boulder, and here the excavation was only taken to 5 1/2 ft., the shallowest point in the trench. A surface soil horizon was missing throughout the trench (Exhibit 13).

13 Test Area G2 TT 1 looking west. A sandy soil with some stones, rocks, and the two large glacial boulders shown here was uncovered in this 115-ft. trench located where the home of Gouverneur Morris II stood until 1905. (photo Geismar 3/10/93)
