REPORT ON
ARCHAEOLOGICAL TRENCHING
AT TWO LOCATIONS IN THE GOLF COURSE/
FORMER PARADE GROUND
ON GOVERNORS ISLAND
NEW YORK, NEW YORK

Prepared for: Governors Island Preservation and
Education Corporation
10 South Street, Slip 7
New York, New York 10004

Submitted by: Linda Stone, MA, RPA
249 East 48th Street, #12B
New York, New York 10017

February 19, 2007

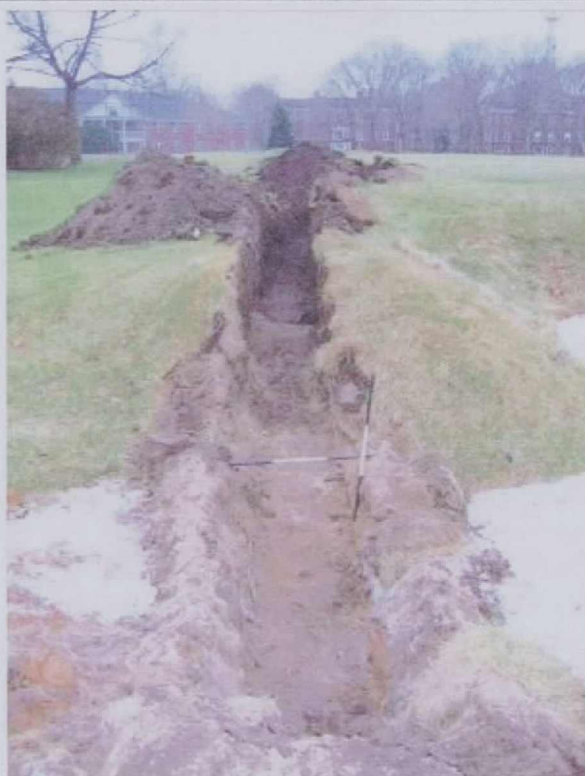
Trench B facing west southwest after completion.

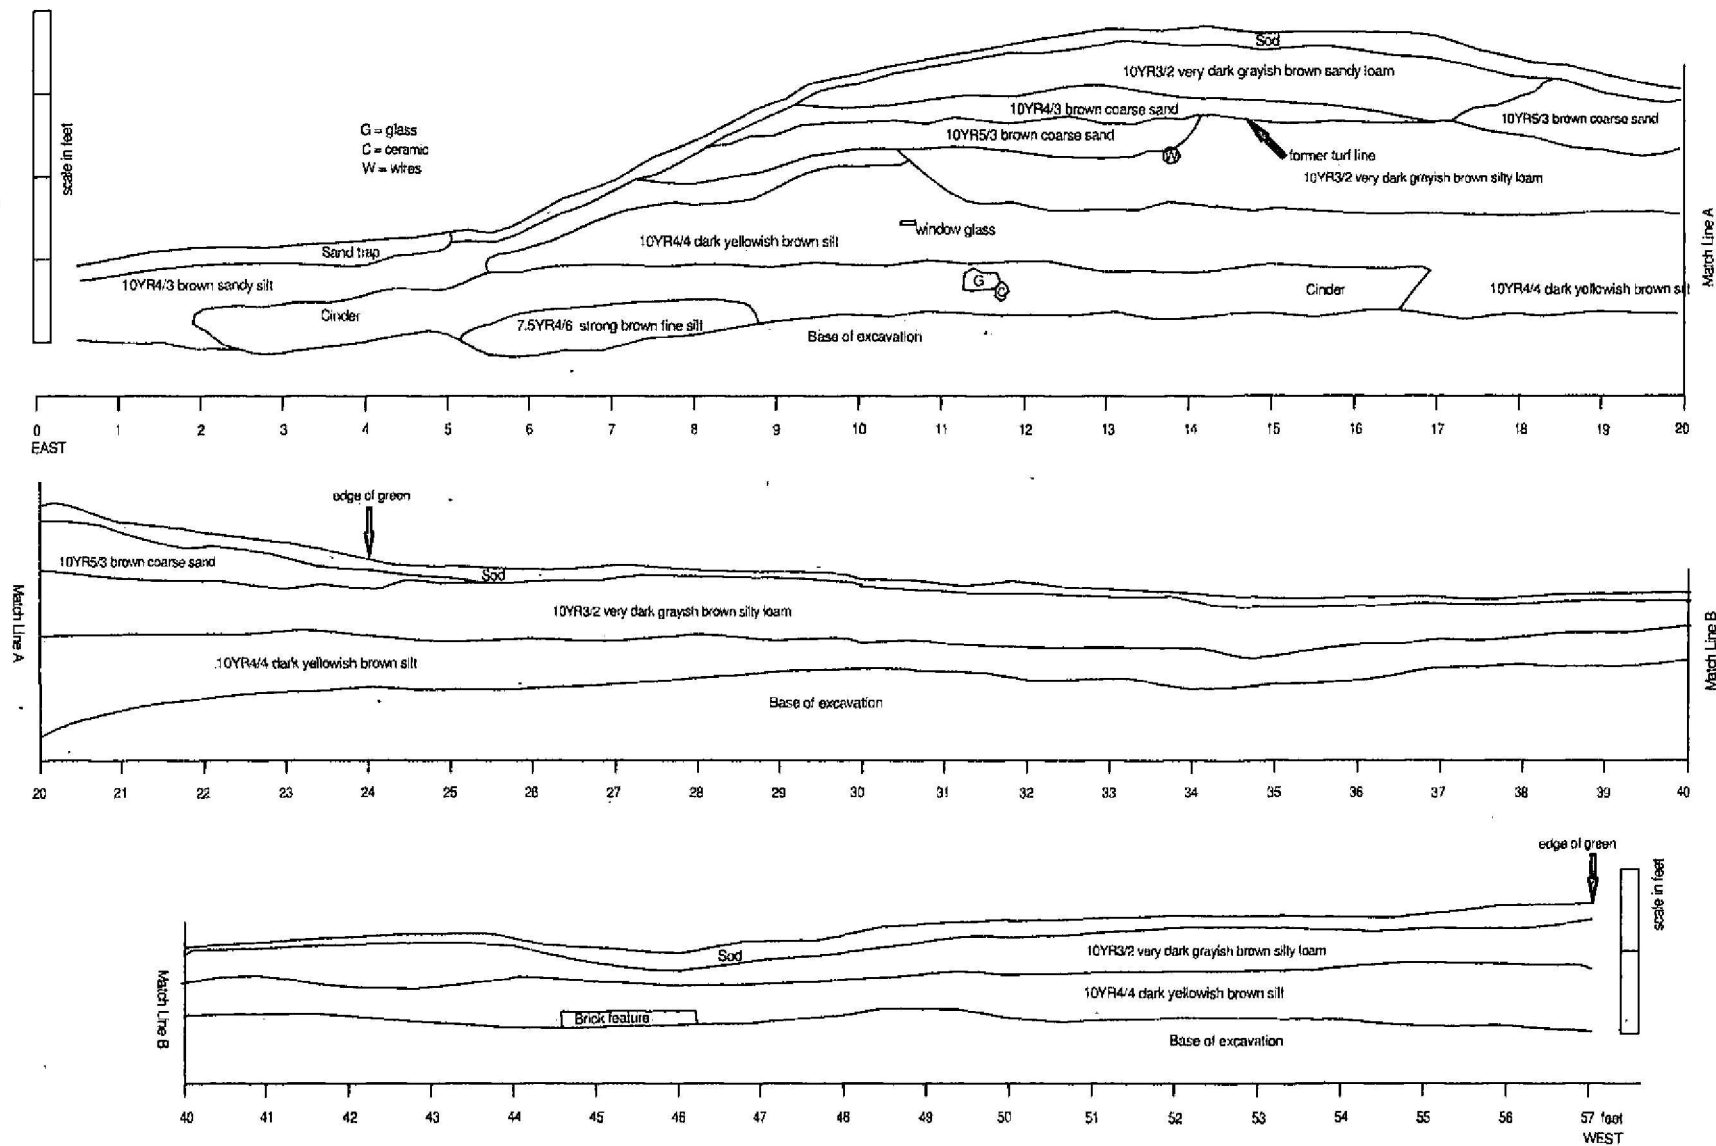
Figure 2 South profile of Trench A.

The stratigraphy within the green, depicted on Figure 2 between 24 – 57 feet, consists of only two strata beneath the level of the new sod. Directly below the sod is very dark grayish brown silty loam. The basal stratum was dark yellowish brown silt. These two strata were also observed in the berm, seen from 11 – 24 feet on Figure 2. The berm appears to have been built up on this base. The very dark grayish brown silty loam was overlaid by brown coarse sand and very dark grayish brown sandy loam and then covered with new sod during the recent golf course reconstruction. The exposed wires noted at 14 feet on the profile lacked evidence of a trench which would have resulted from the excavations associated with their original installation. The wires are at the interface of the very dark grayish brown silty loam that extended throughout most of Trench A and the overlying course sand. This indicates these overlying soils were added at some point in time after the initial wire installation. However their shallow depth at about 1.5 feet (46 cm) bgs would indicate the pre-July golf course surface was either at or above this level since no new utilities are known to have been installed during the reconstruction and the wires pre-date the July 2006 work. Therefore the disturbance from the recent reconstruction did not extend very deeply as demonstrated in Trench A, no more than 1.5 feet (46 cm) on the berm and less, if at all, on the green.

The excavation of the sand trap and the most of the berm exposed part of a large deposit of cinders. This can be seen on the profile drawing between 2 – 17 feet on Figure 2. Because the excavations began within the sand trap and extended westward, the initial interpretation of the cinder deposit was that it was used as a base for the sand trap and golf course since it would have enabled good drainage. It contained only a few artifacts. The location of recovered ceramic and glass sherds is depicted on Figure 2 at 11.5 feet. An additional glass sherd was recovered from 3.2 feet (31 cm) along the trench. These artifacts indicate the cinder deposit could date from as early as the mid- to late-nineteenth century, based on multiple sherds from a torpedo-type bottle (see Photo 3) and a finish from another bottle. The one section of Trench A where the base of the cinders was exposed shows it was underlain with subsoil. No buried pre-July 2006 ground surface was identified.

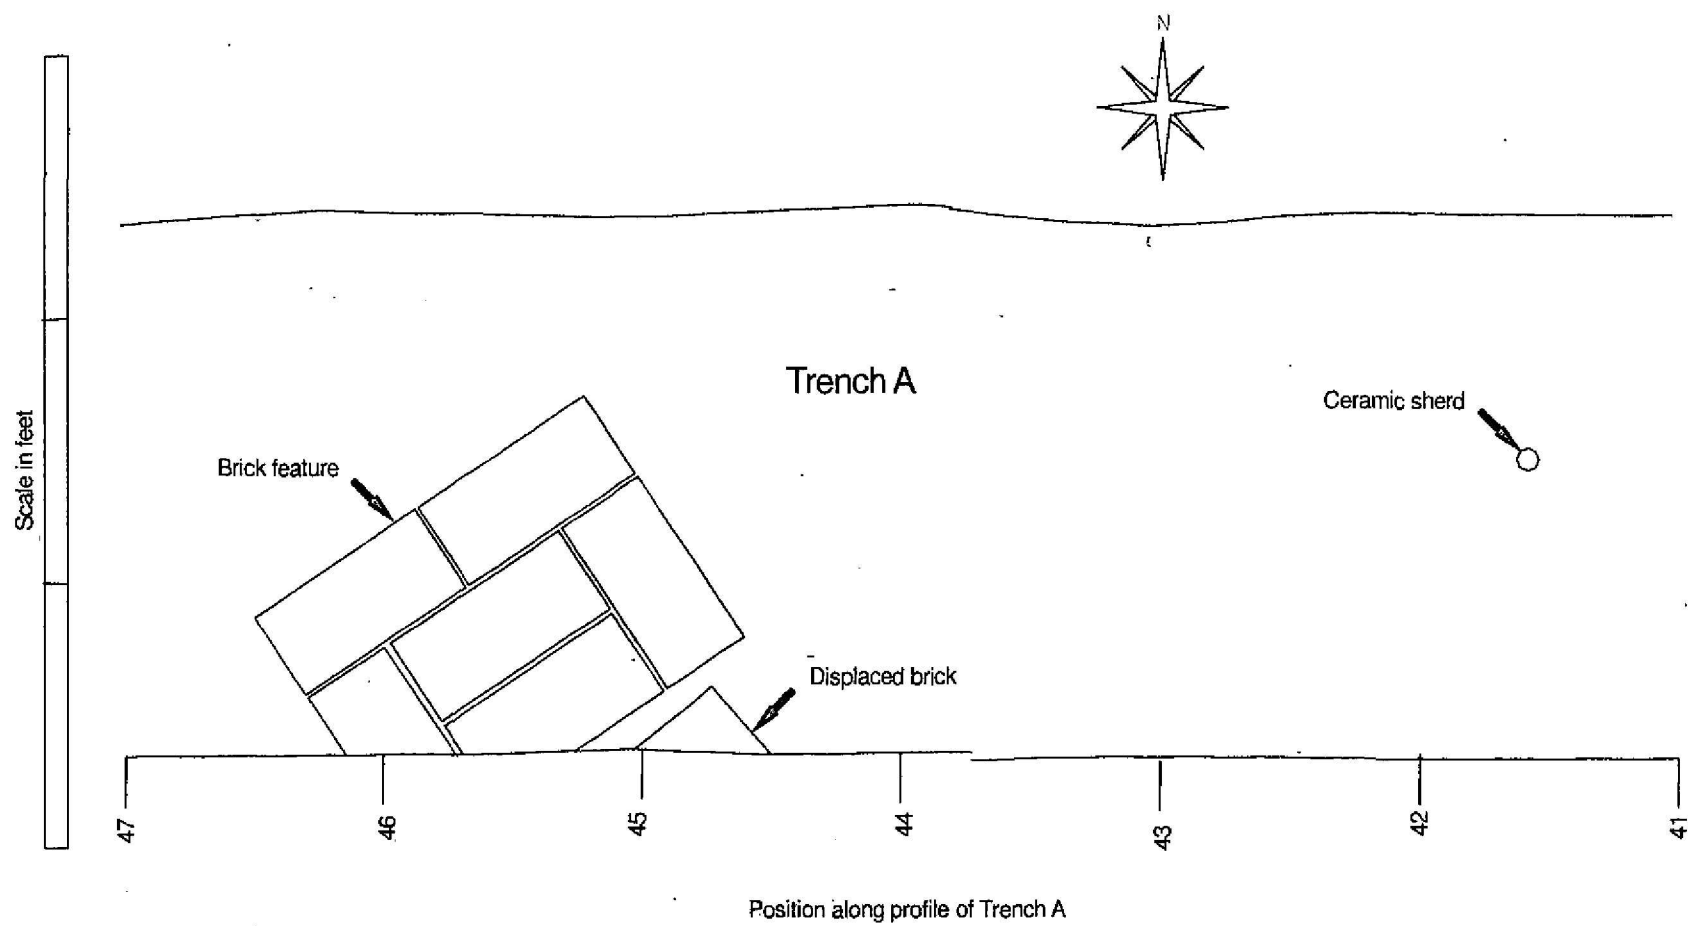
Figure 3 Plan view of brick feature found in Trench A.

The brick feature was found in the base of excavation, about 0.8 feet (24 cm) bgs from 44.5 – 46.5 feet along the trench, as seen in the profile (Figure 2). The feature is also shown on Figure 3 in plan view and in Photo 2. Only five whole and three partial bricks were exposed, therefore the pattern is not entirely discernable. However, the bricks appear to be laid in a modified basket weave pattern, possibly with a border of bricks. The exposed portion represents one end of the brick feature. It is possible the feature is a square of brick, as in a footing, or it could be the end of a narrow and longer brick feature, such as a border or walkway. No artifacts were found in the immediate vicinity of the feature, however a sherd of whiteware was found in the base of Trench A about three feet away (see Figure 3). The bricks themselves measure $8 \frac{1}{4} \times 3 \frac{1}{2} \times 2 \frac{1}{4}$ inches with slight variation in size. As stated above, there was no mortar associated with the brick feature and the bricks were not marked. However, during trowel scraping of the feature and soil matrix, it seemed the soil was more compacted on top of and around the feature than it was just a few inches away. Nevertheless, the feature soil matrix was the same Munsell color and texture at the entire basal stratum of Trench A from 17 feet onward, dark yellowish brown silt. Once photographed, measured and drawn, the brick feature was left in place and later buried when Trench A was backfilled.

The July 2006 golf course reconstruction did not disturb any buried surfaces. However the identification of the brick feature in Trench A constitutes a potentially significant finding which would require further exploration and research should this area of the golf course require additional ground disturbing actions. Furthermore, archaeological oversight of additional redistribution of soil in this part of the golf course is recommended so that such below ground work does not extend to depths below the earlier incarnations of the golf course and destroy potential archaeological resources.

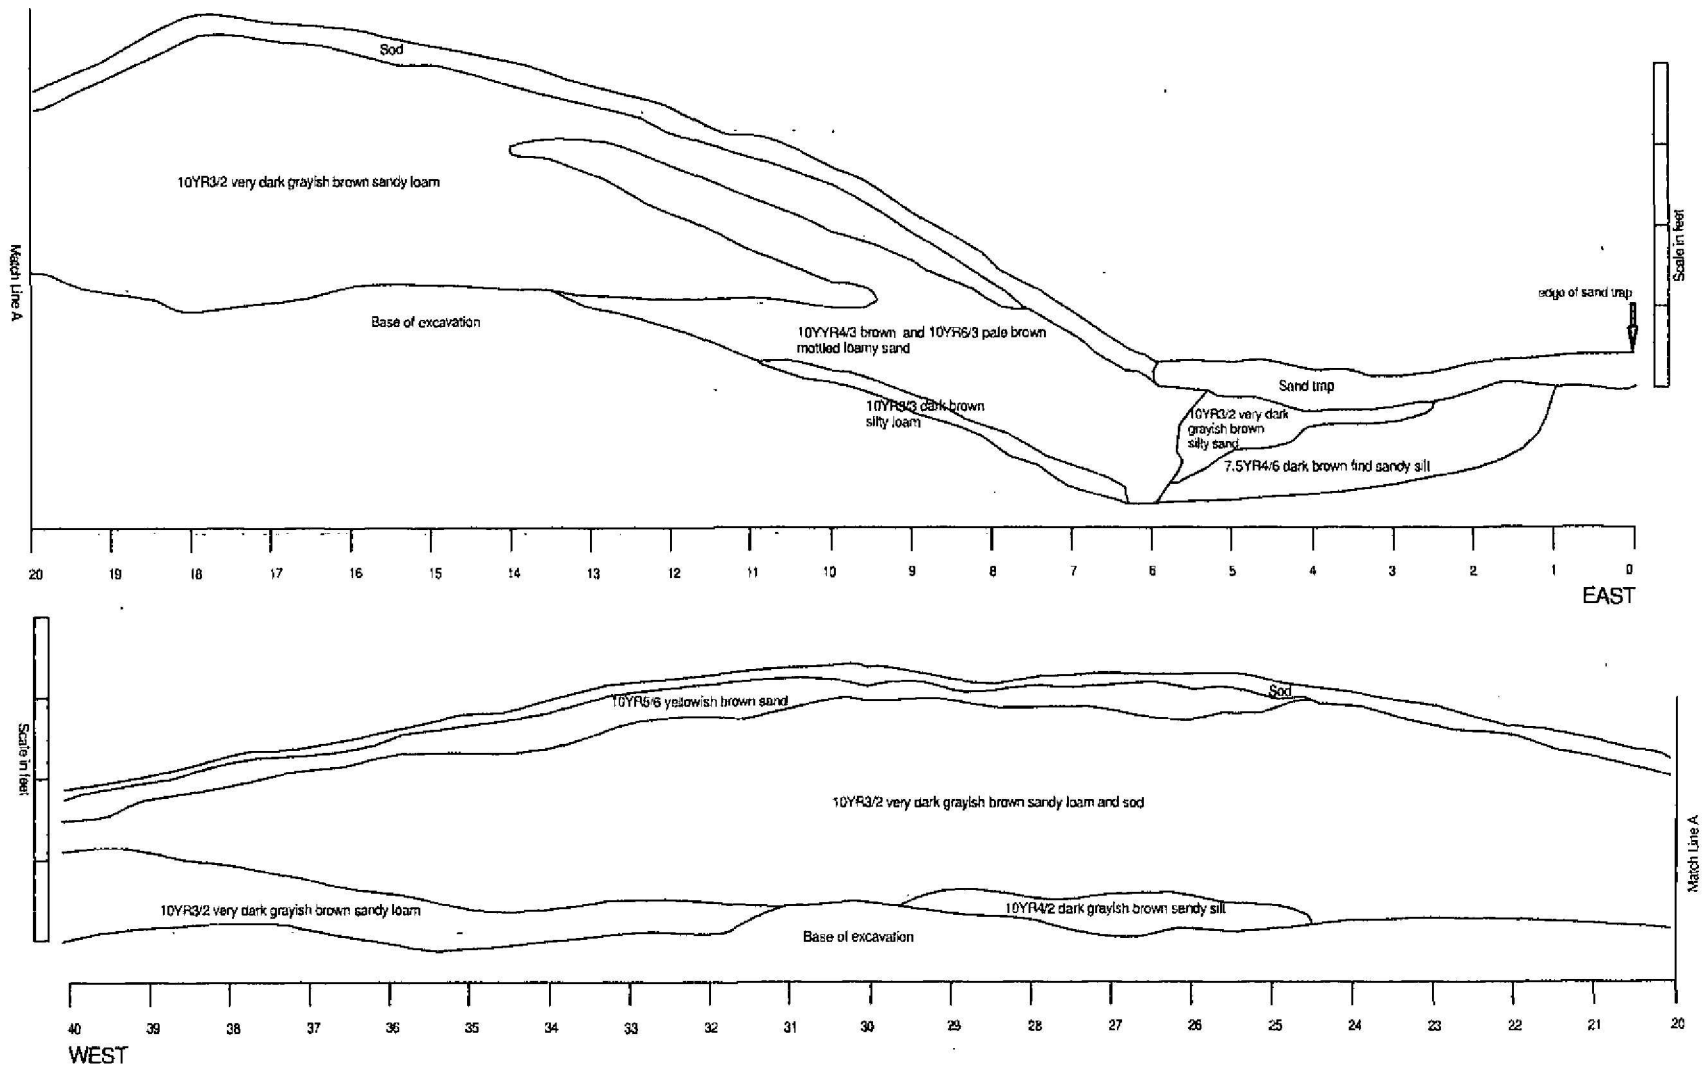
Figure 4 North profile of Trench B, eastern half.

The stratigraphy in Trench B was quite a bit more straightforward because of the identification of the stratum that was disturbed by the July 2006 golf course reconstruction. This stratum was a very dark grayish brown sandy loam with pieces of sod mixed in. The sod was obviously the pre-July ground surface and was mixed into the underlying matrix when the earth was redistributed to recreate the golf course. Within Trench B, this stratum was generally underlain with very dark grayish brown sandy loam that had no pieces of sod mixed in (see Figures 4 and 5 and Photo 4). In a couple of places, including a section of Photo 4, the brown fine sandy silt subsoil was exposed. Of note was a strong odor of possible fertilizer in the eastern half of Trench B.

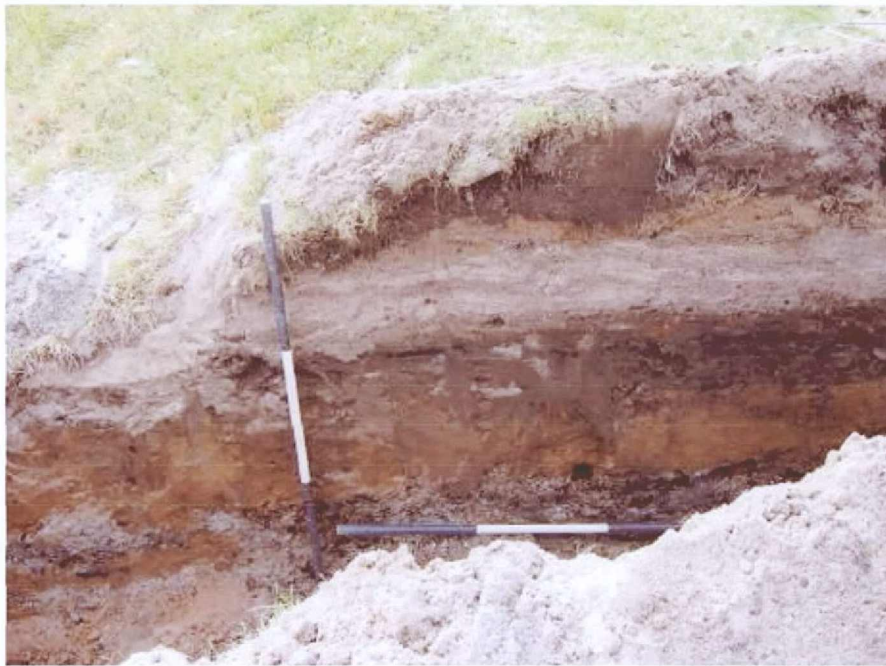
Photo 1 Trench A from 7 to 13 feet on the profile drawing.

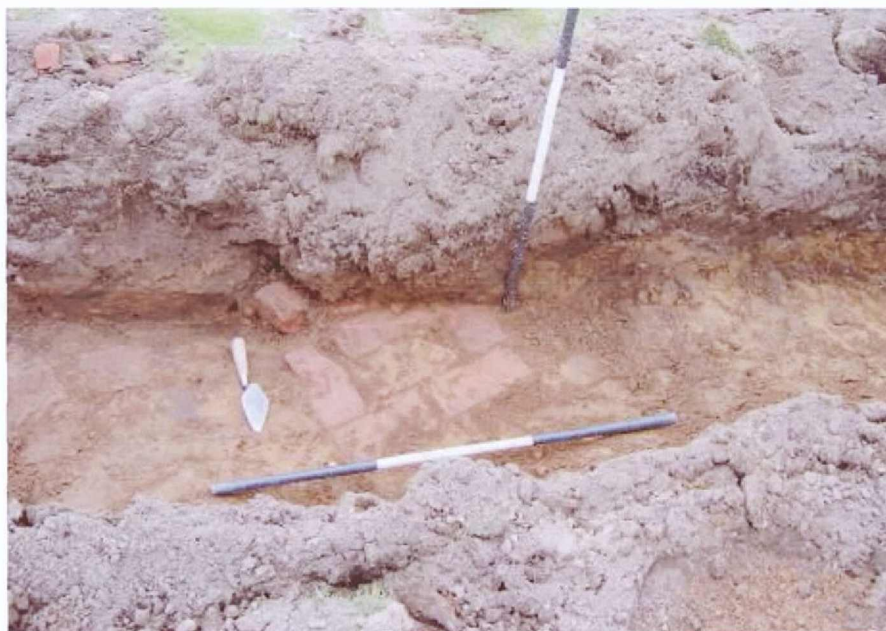
Photo 2 Brick feature found at the base of excavation in Trench A from 44.5 to 46.5 on the profile drawing.

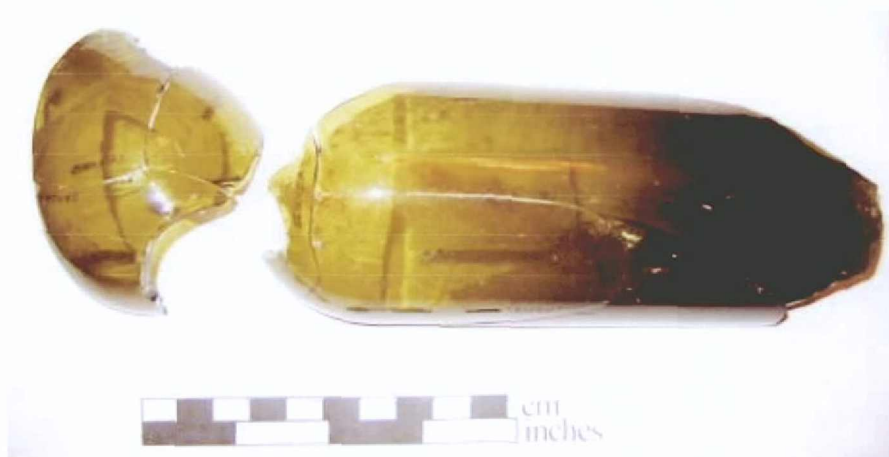
Photo 3 Possible torpedo bottle recovered as from Trench A.

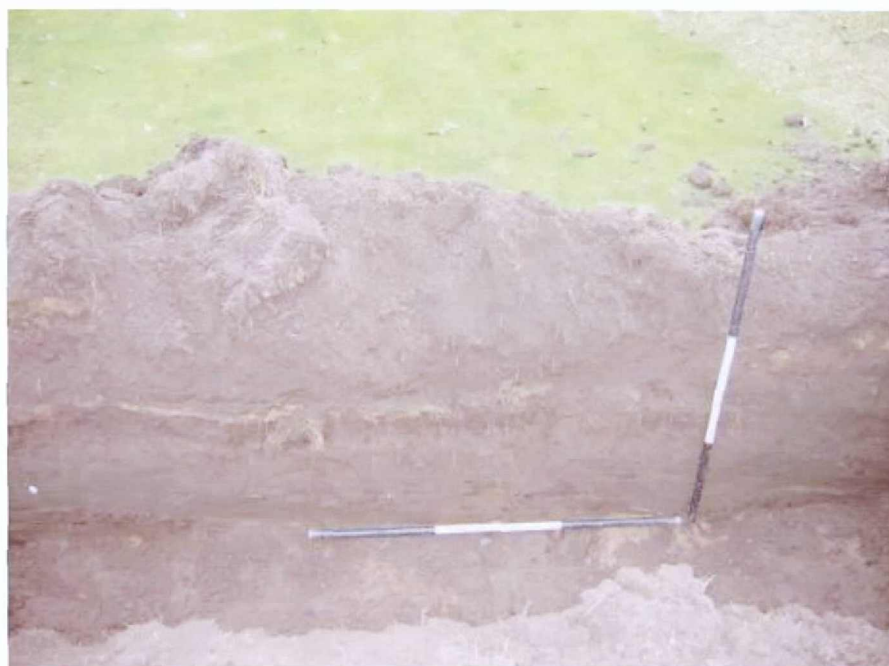
Photo 4 Trench B from 42 to 49 feet on the profile drawing.

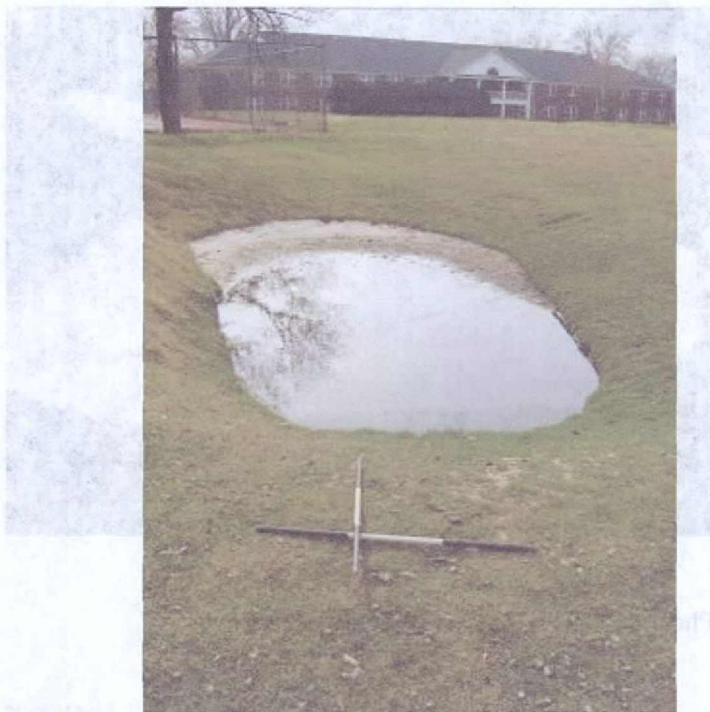
The western berm is at a substantially higher elevation than the western sand trap (see Photo 7 in Appendix B). This, coupled with the standing water in the trap, prevented the backhoe from excavating the trench continuously from east to west. The trench was excavated as far west as 68 feet (20.7 m) before the backhoe needed to reposition on the western side of the sand trap. The arm of the backhoe could not reach as far as the 68 foot point along the trench and therefore there is an unexcavated gap in Trench B from 68 – 72 feet along the profile (see Figures 4 and 5). Trench B was ultimately excavated to 88 feet (26.8 m). At that point a piece of buried PVC pipe was exposed and excavations stopped. No features were identified during excavation of Trench B. The profile was documented and the trench was backfilled.

Photo 7 Area B West Trap facing south.
