THE CEDARS - 745 FOX STREET

Block 2707, lot 11

BOROUGH OF THE BRONX, NEW YORK

PHASE IB ARCHAEOLOGICAL TESTING

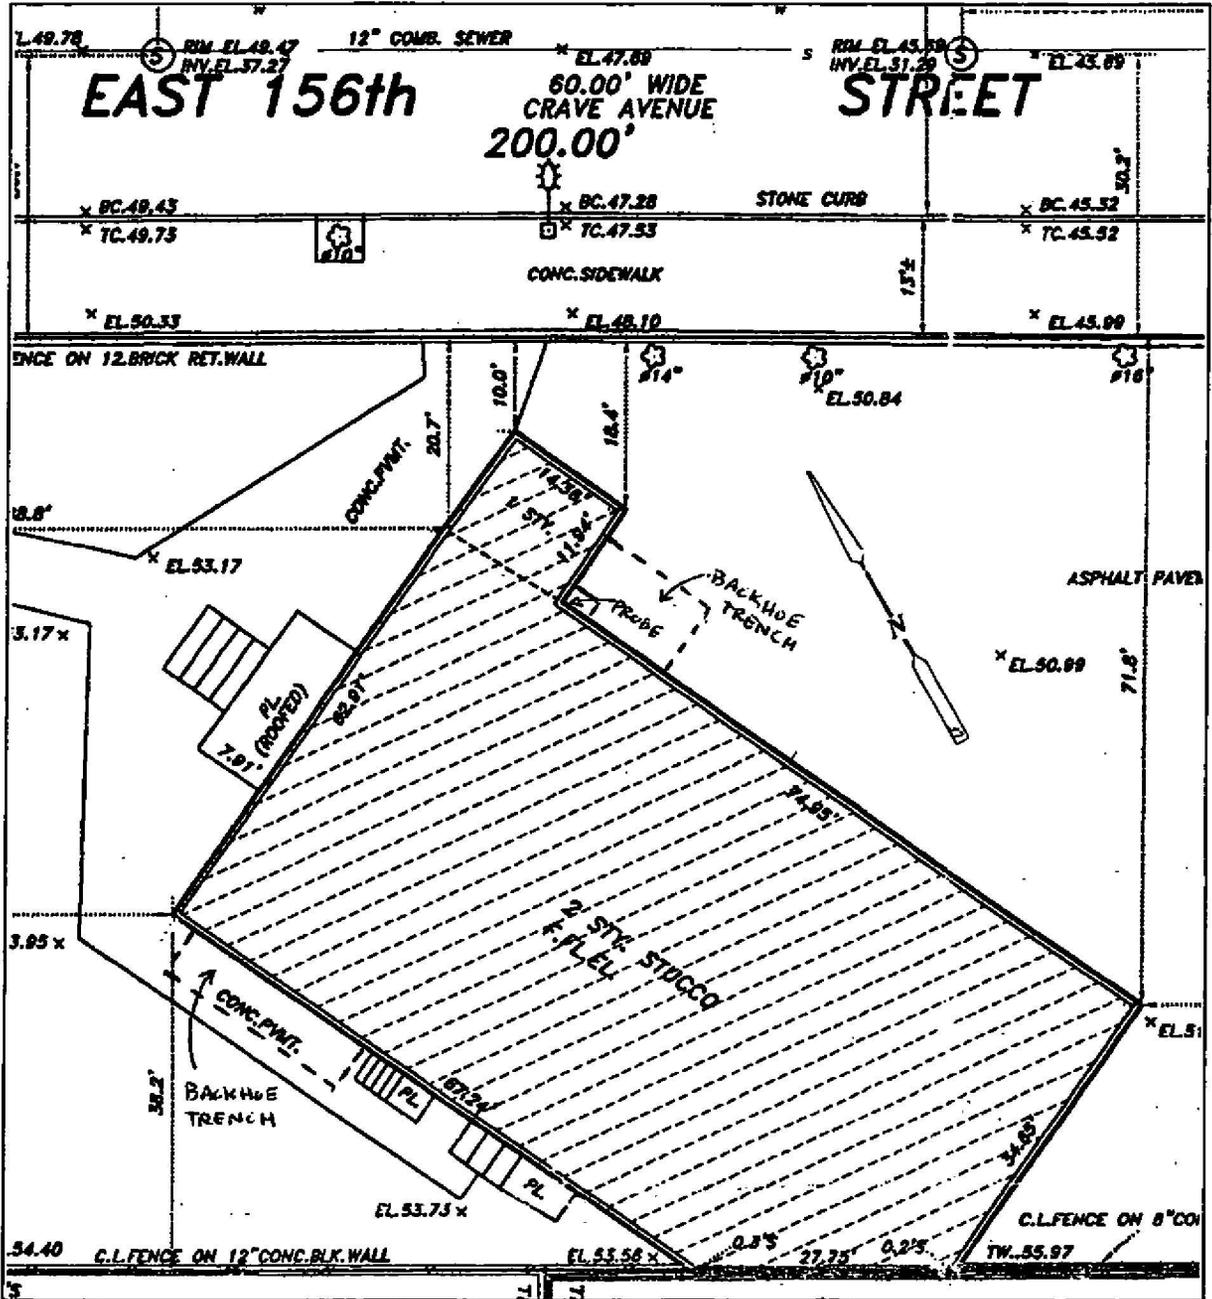
Fig. 1. Plan of the building at 745 Fox Street showing the location of the backhoe trenches and the probe.

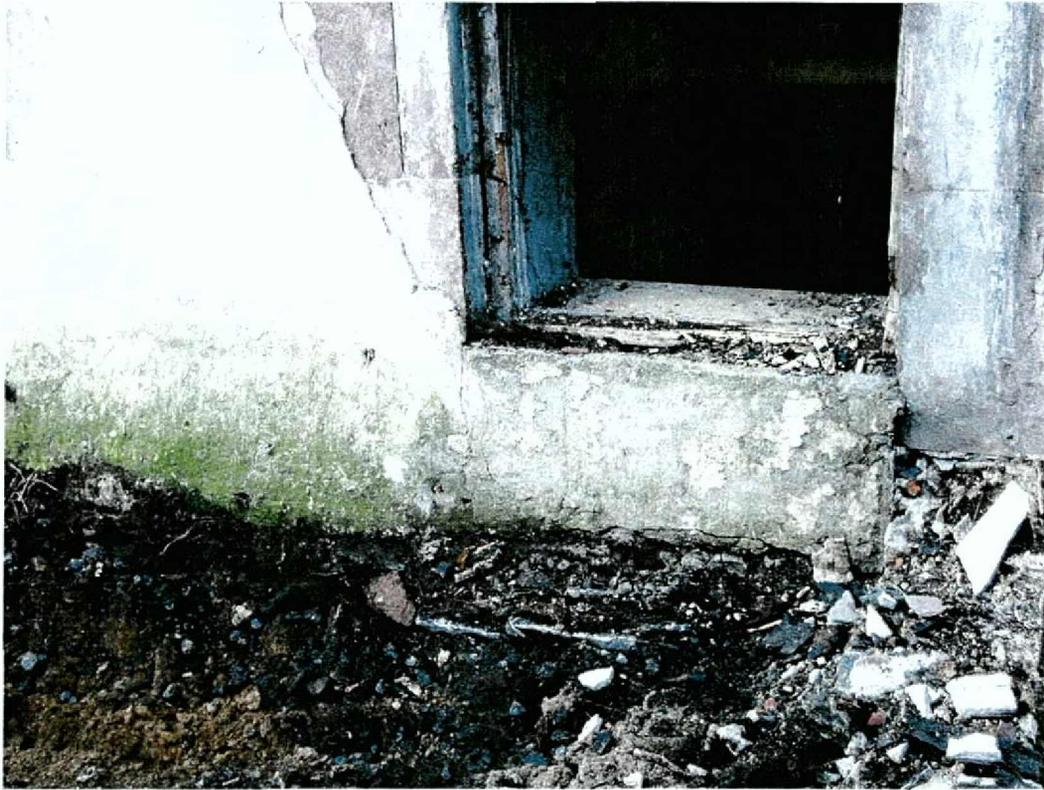
Fig. 2. View of the building's east side showing the paving stones above the foundations in situ

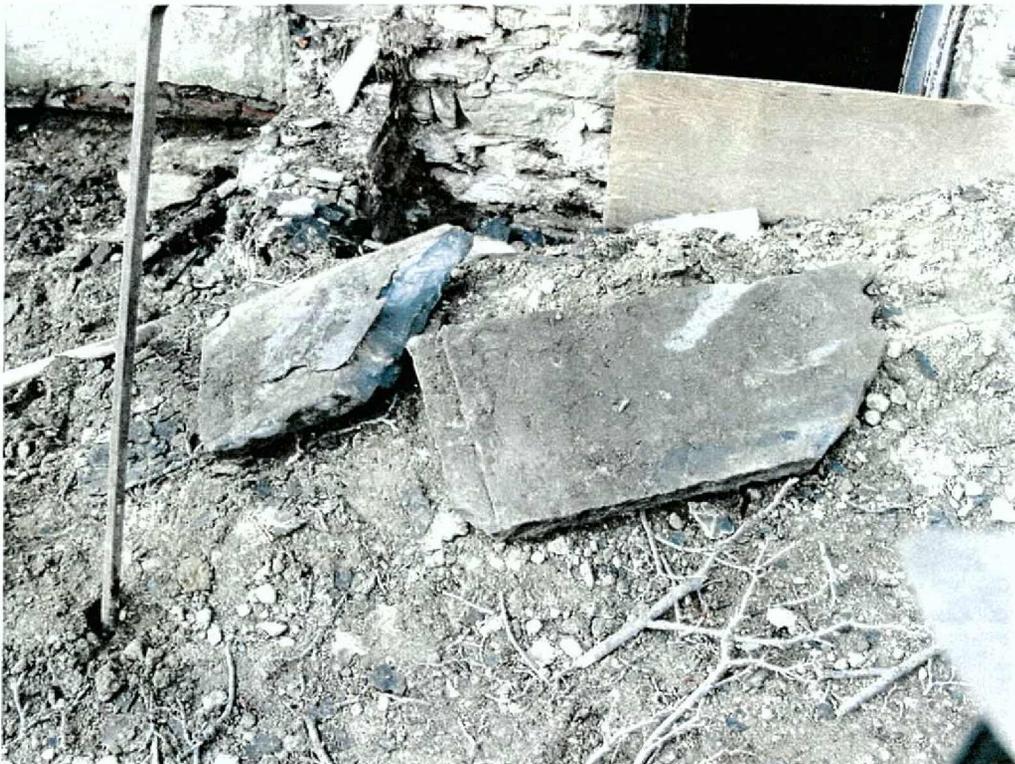
Fig. 3. Paving stones from above the rubble foundation, east side of the building

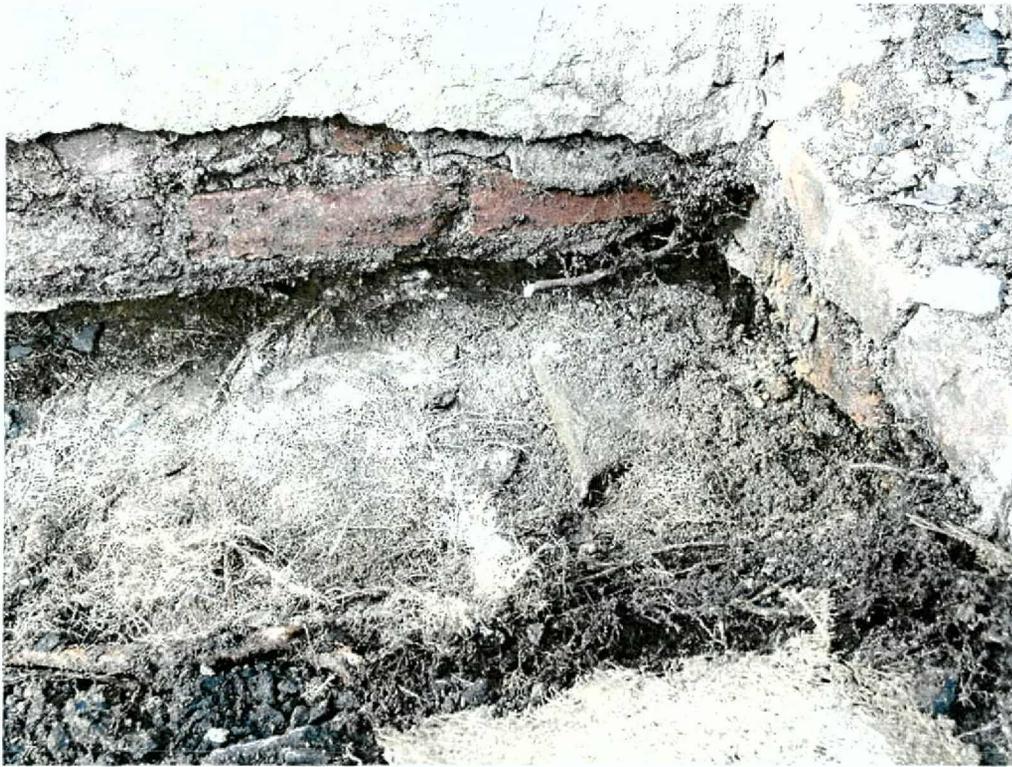
Following the completion of the backhoe trench, a small probe was excavated by hand at the north end of the trench, against the rubble foundation of the building, immediately south of the concrete wall of the stairwell for the basement entrance (Figs. 4, 5 and 6). The probe was excavated beginning just above the building's rubble foundation but below two large slate paving stone, originally lying at ground level and slotted under the lowest course of the wall (Figs. 2 and 3). When these were removed, an earlier ground surface, marked by a layer of organic material, came to light (Fig. 4). The probe was 2 feet wide and 3 feet 4 inches long and was excavated to a depth of 2 feet below the bottom of the brickwork and 18 inches from the top of the rubble. Three bags of the artifacts were collected from the probe. The brickwork and rubble foundation of the small spur wall that once enclosed stairs leading to a basement entrance is surely not much later than the original construction, if not contemporary (Fig. 6).

Fig. 4. View of the probe and dried grass below the paving stones, east side of the building

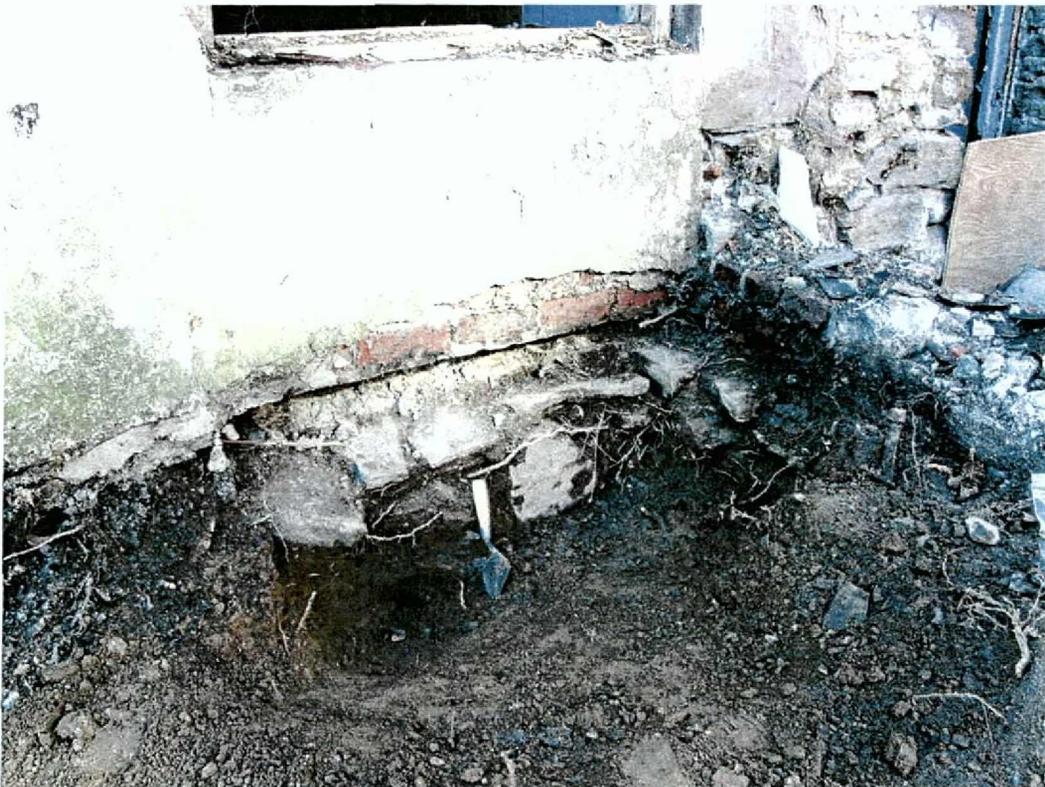
Fig. 5. View of the probe on the building's east side

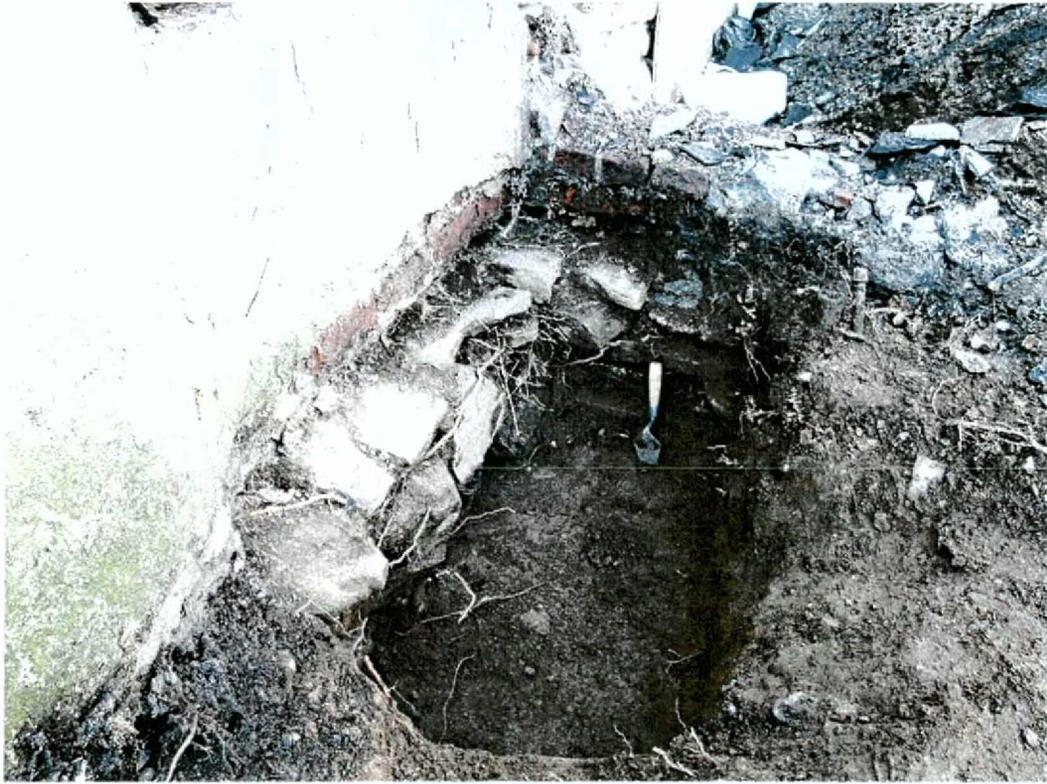
Fig. 6. View of the probe at the end of excavation looking north

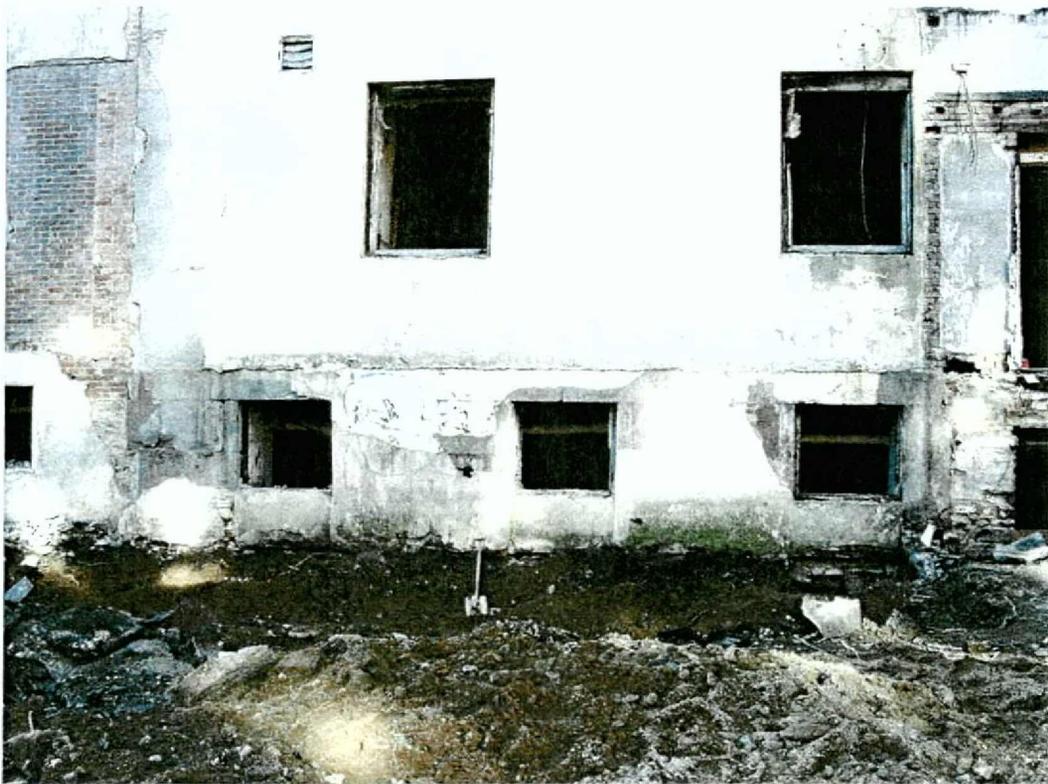
On January 3, testing was conducted on the east side of the building. A backhoe trench approximately 8 feet wide was excavated for a distance of 13 feet along the east side of the building (Figs. 7 and 9). The writer observed the excavation and collected three bags of artifacts by shoveling through the backhoe dirt. These included fragments of building materials such as a door plate (Fig. 20); marble veneer; square, light blue glazed ceramic tile, and small hexagonal tiles. There were also fragments of stoneware jars (see below). The soil was brown sandy silt with a great deal of the dark grey, sparkling gneiss characteristic of the Bronx. This material was extensively used in the house's foundation. At the bottom of the trench, approximately 32 inches below surface, we encountered a ceramic pipe twelve inches in diameter (Figs. 8 and 21). It ran diagonally towards the basement opening at the north end of the building's east side.

Fig. 7. View of the backhoe trench on the building's east side

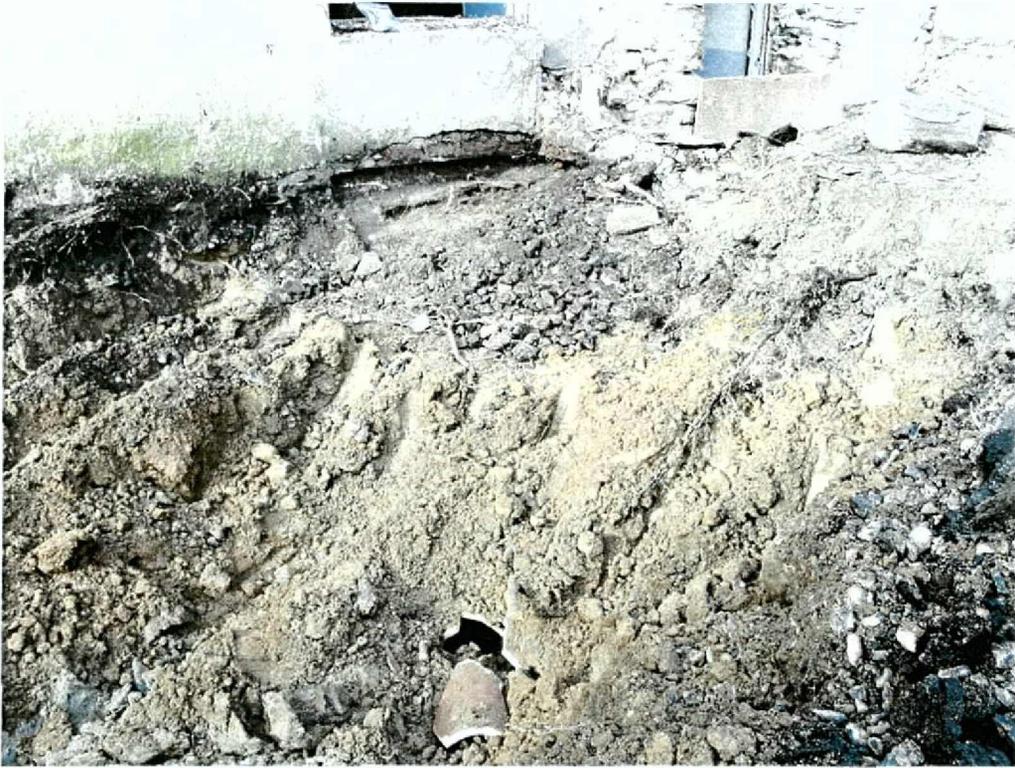
Fig. 8. View of the ceramic pipe in the bottom of the backhoe trench, north end

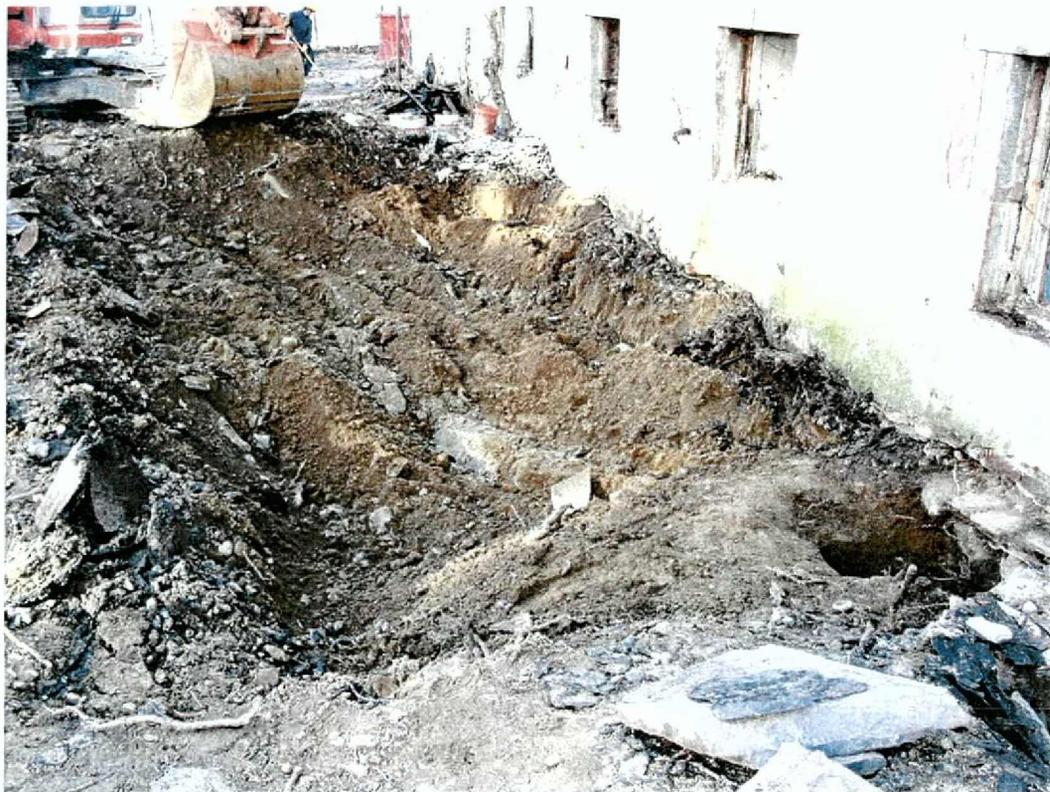
Fig. 9. View of the backhoe trench on the building's east side looking south

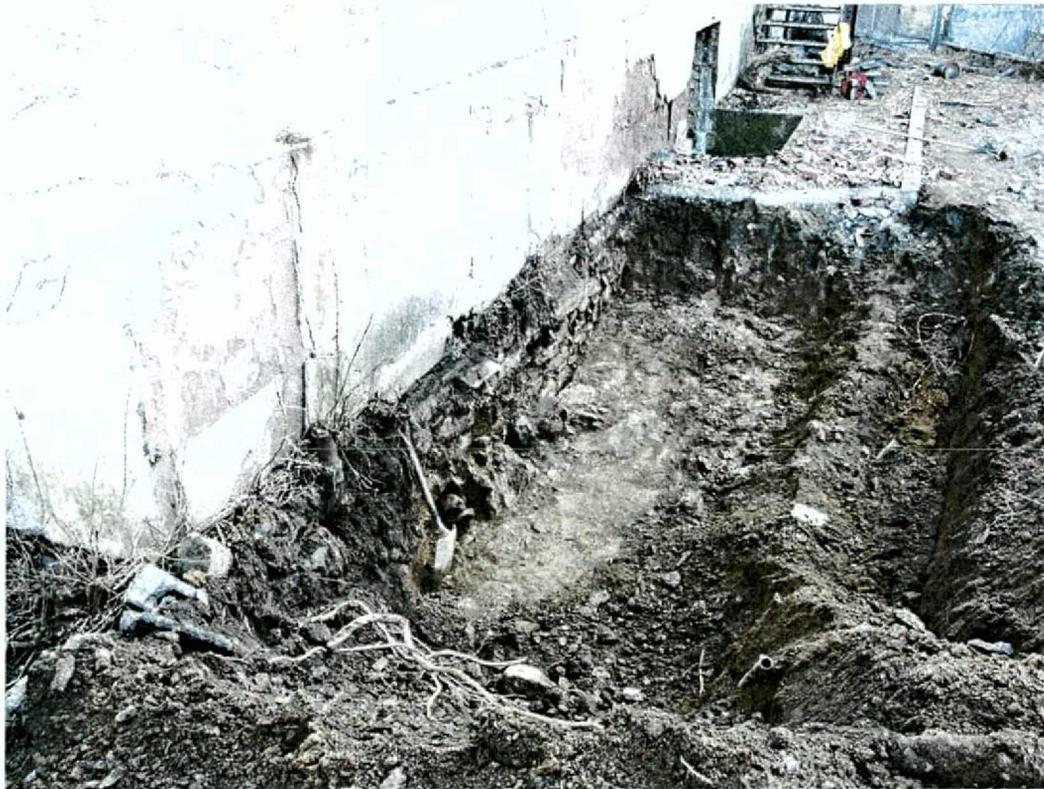
At a distance of approximately 3 feet south of the northwest corner there was a short section of vertical metal pipe against the wall with a bend at the bottom that ran into the building (Fig. 10, to the left of the shovel). Neither the backhoe trench nor the hand excavation was continued to the northwest corner because the area around this pipe had evidently been disturbed during its insertion -- the south outline of the pit, extending approximately 6 feet from the corner of the building, was clearly visible (Figs. 10 and 11). Its depth was traced to ca. 31 inches below the bottom of the wall.

Fig. 10. View of the backhoe trench on the building's west side looking south.

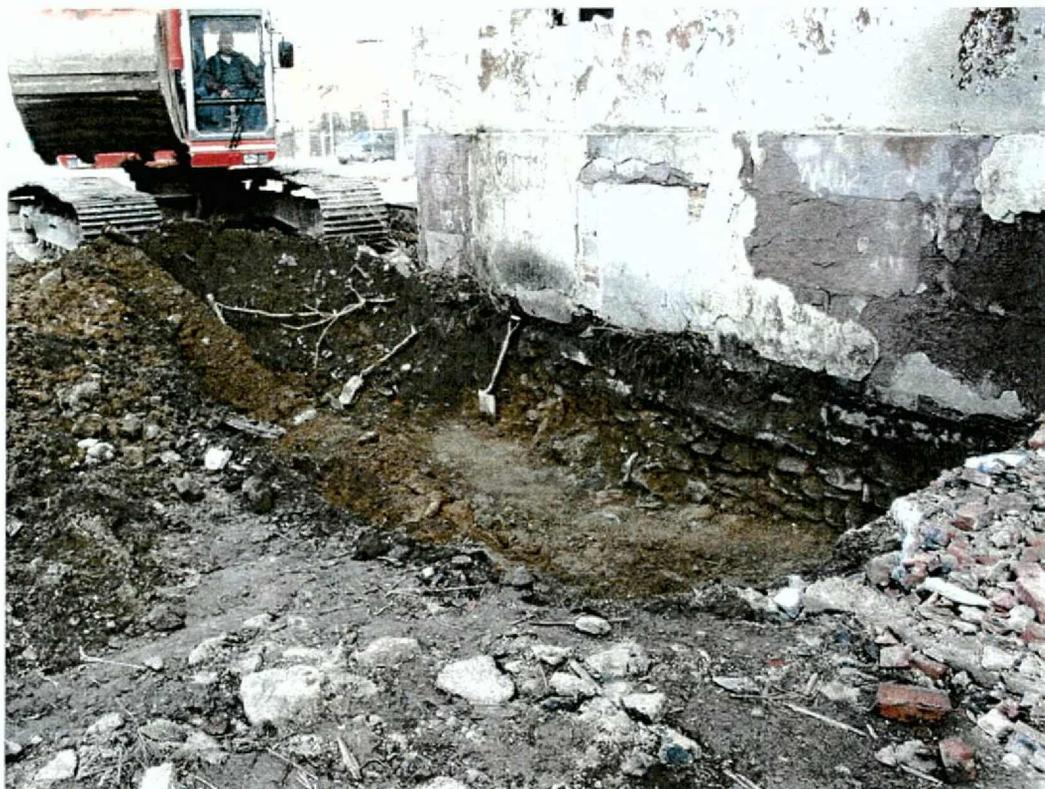
A backhoe trench approximately 22 feet long and 6 feet wide was excavated to an average depth of 38 inches and a maximum depth of 44 inches below the bottom of the wall. The trench extended to within approximately three feet of the northwest corner of the building and stopped at the concrete wall, dug into the ground, which enclosed a flight of concrete steps, cast in one piece and leading to a basement (figs. 10 and 11).

Fig. 11. View of the backhoe trench on the building's west side.

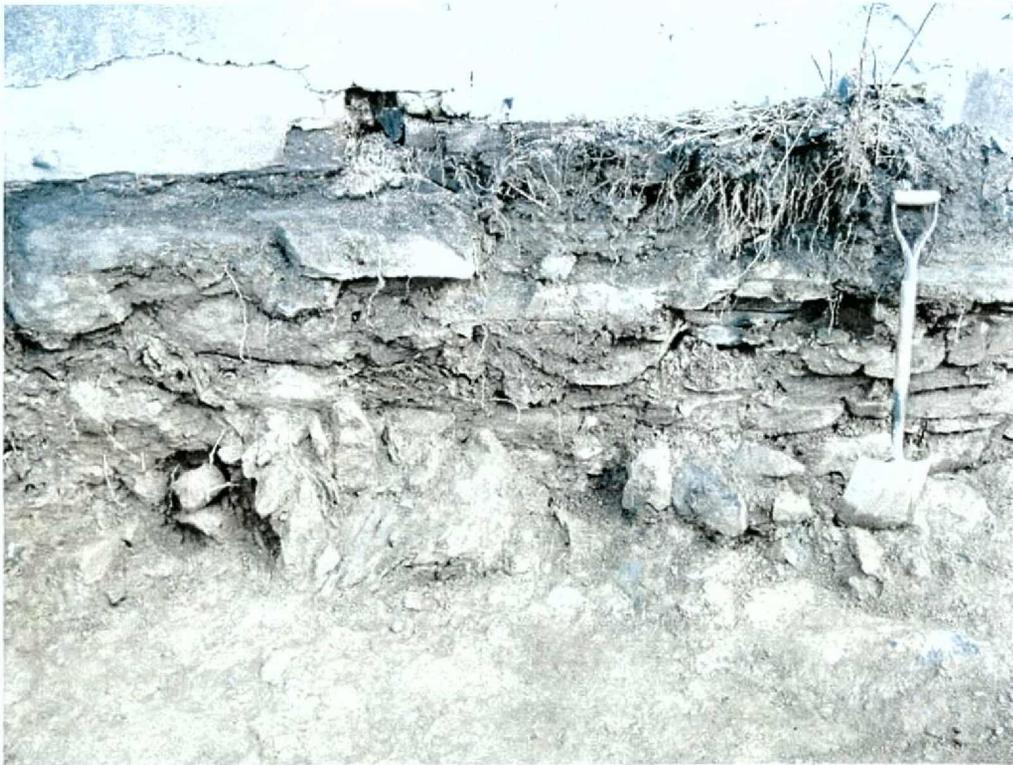
Fig. 12. View of the middle of the backhoe trench on the building's west side.

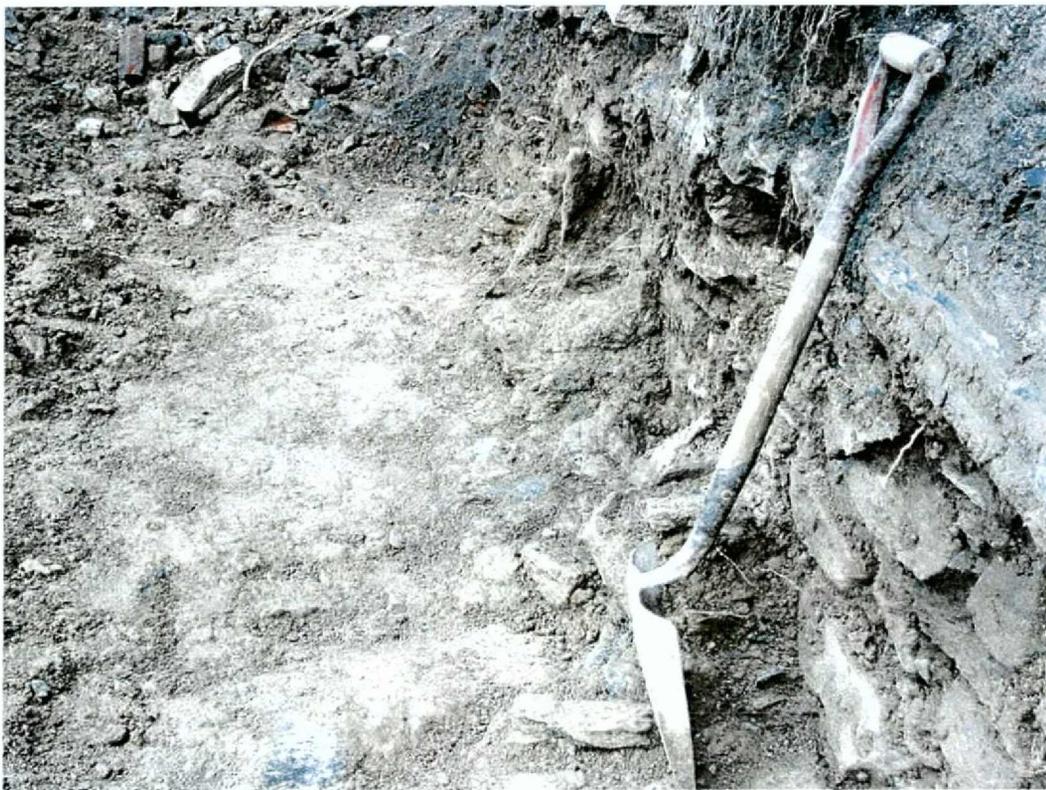
Fig. 13. View of the north end of backhoe trench on the building's west side looking north.

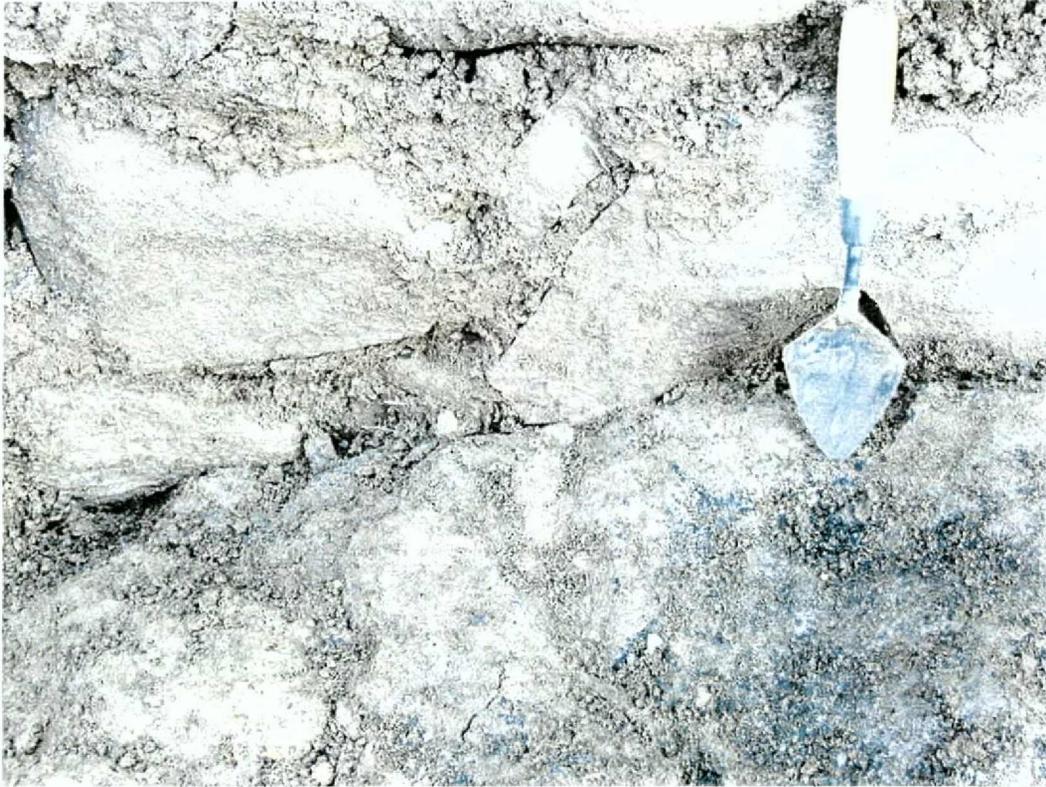
The rubble foundation course on this side of the building was exposed to a depth of 32 inches below the base of the wall at the south end of the trench and 45 inches at its deepest point, approximately in the center of the trench, where it was possible to verify that the wall rested on bedrock (Fig. 14). The only finds from between or adhering to the stones of the foundation were a few fragments of window glass that was mold-made and therefore dated to the later 19th or 20th centuries. The natural rock slopes up from north to south, which accounts for the different depths of the foundation course. It appeared that on this side of the building, the foundation trench had been partially filled with rubble (Figs. 12 and 13). This filling was traced in a small area only -- where it was not removed by the backhoe -- beginning approximately 22 inches below the bottom of the base of the brownstone wall and about 9 feet north of the south end of the trench. Below the packing, the bottom of the foundation was reached at 45 inches below the base of the brownstone wall. The deepest point of the trench was 52 inches below the bottom of the brownstones. The contrast between the finely dressed brownstone blocks and the uneven layers of gneiss slabs and chips of the foundation was noteworthy.

Fig. 14. View of the base of the rubble foundation in the middle of the west side of the building standing on the natural rock.

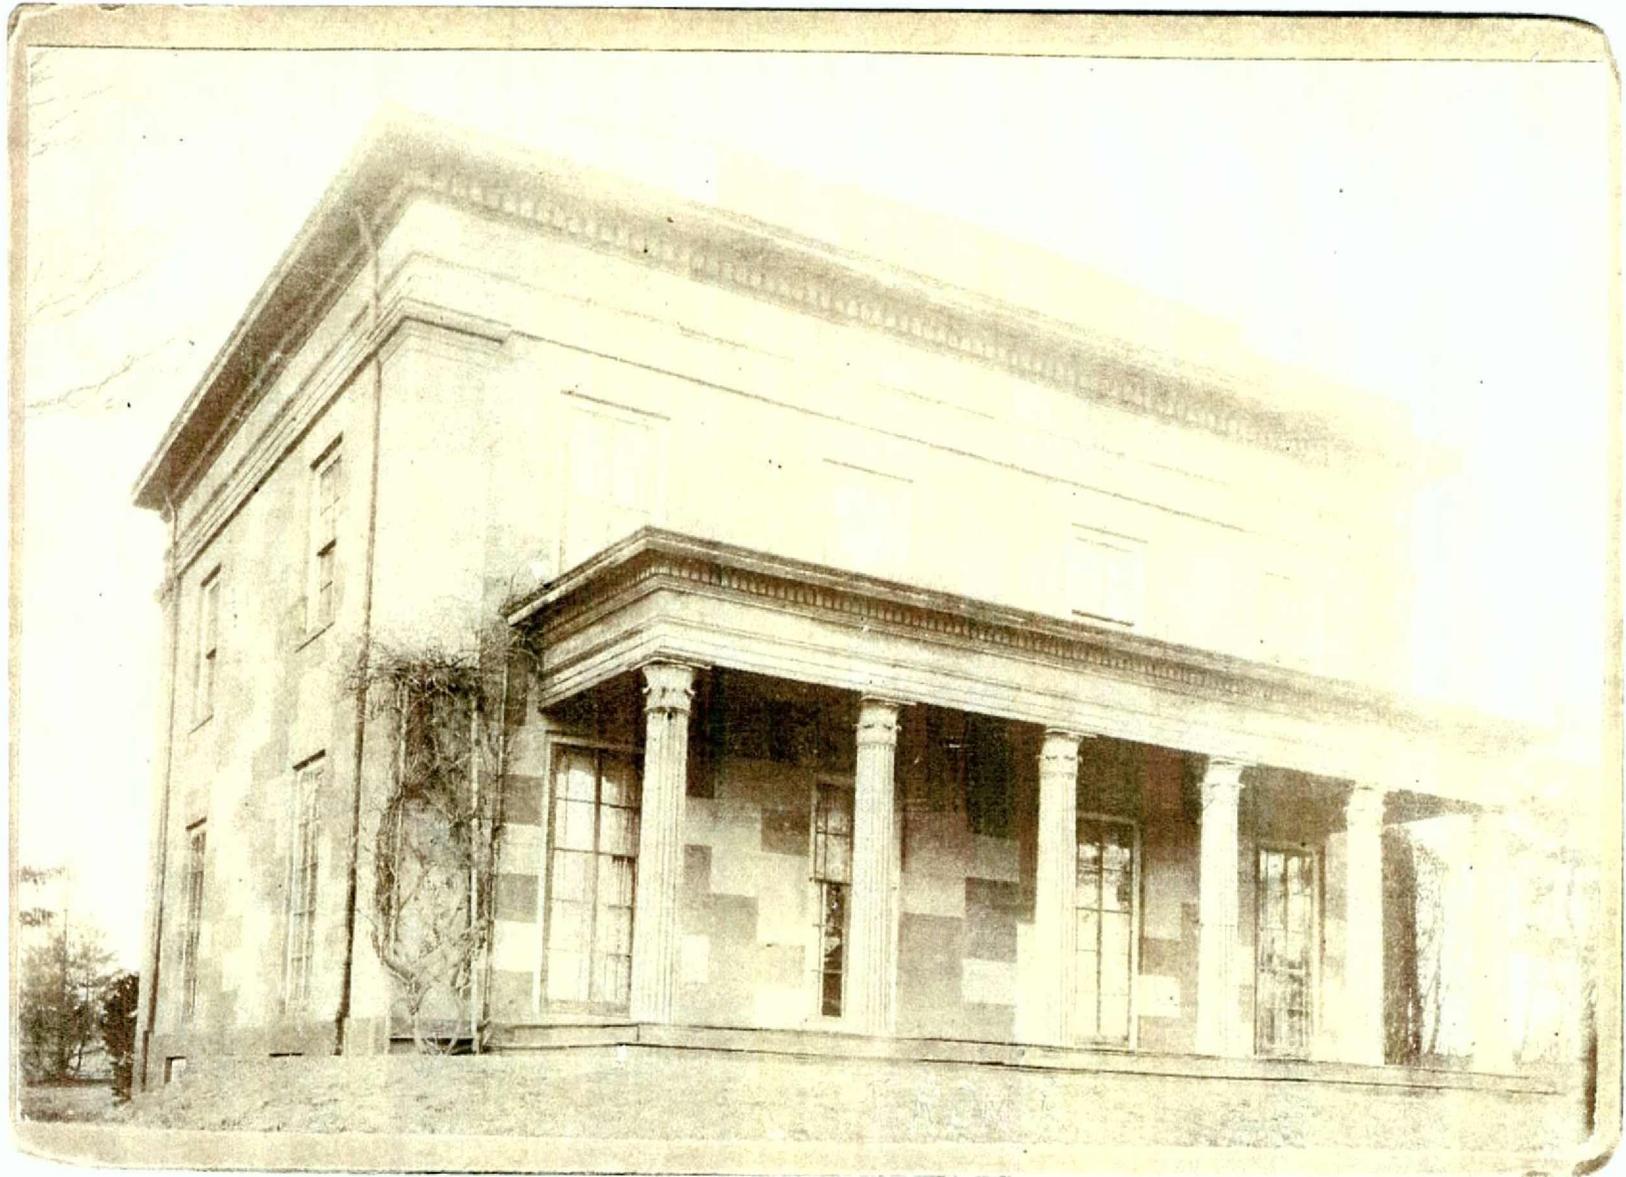
Fig. 15. Undated view of the rear of the Charles Denison Mansion showing the porch [Reproduced from Greenhouse Consultants 2006, Pl. 4].

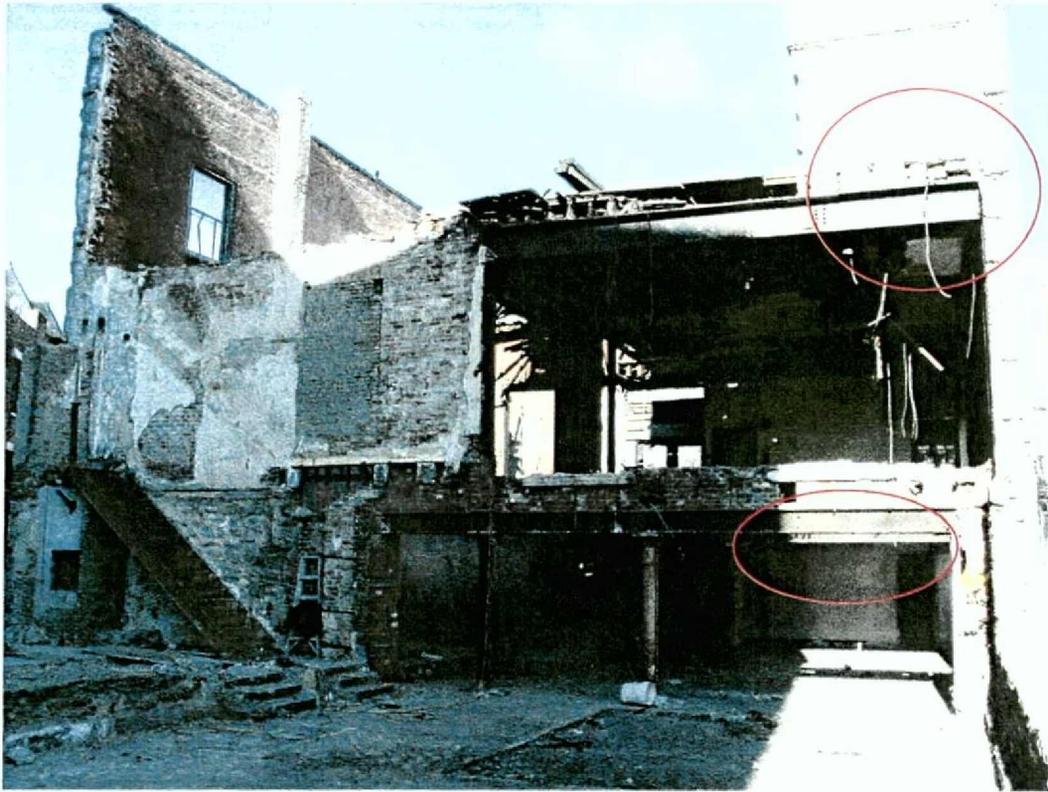
Fig. 16. View of the facade of the Charles Denison Mansion after demolition of the turn-of-the-century addition, showing the area of the details in Figs. 18 and 19.

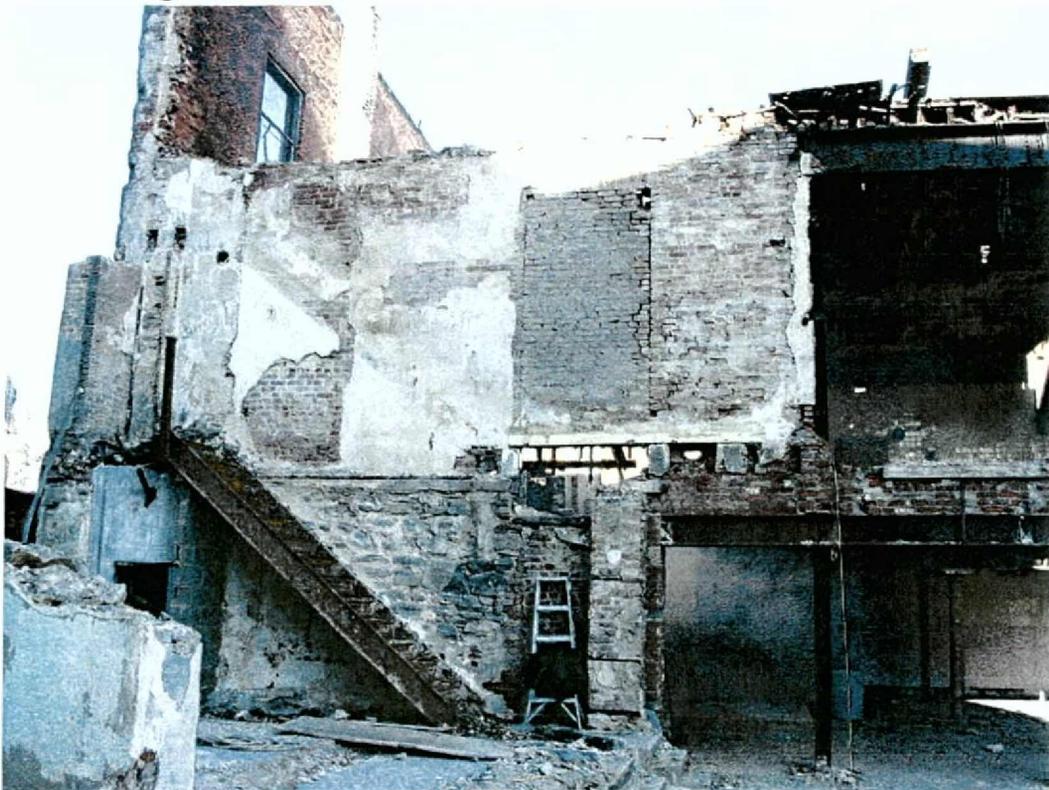
Fig. 17. View of the facade of the Charles Denison Mansion after demolition of the turn-of-the-century addition (detail).

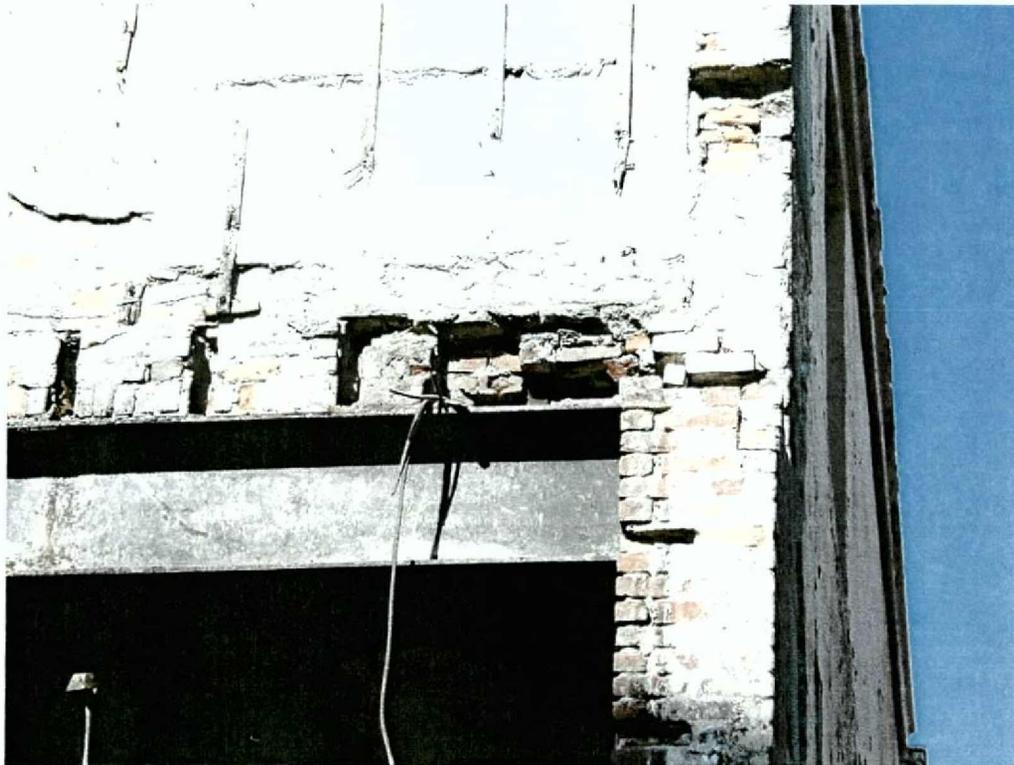
be noted that what now serves as the main entrance to the building, on its north side, was originally the rear, and that the addition was attached to the former facade. An undated photograph of the front of the building (Fig. 15) shows that it was equipped with a verandah whose roof was supported on six pseudo-corinthian-style columns. Judging by the photograph, the floor of the verandah was reached by two steps. The entablature is decorated with three fasciae and an undecorated frieze zone surmounted by a row of dentils below the heavy, projecting cornice. The facade was framed by pilasters, as on the rear of the building, but these did not survive the construction of the addition. The outline of the southeast corner pilaster is however visible on the east side of the building (Fig. 7). On the south side of the building, the east edge was cut out by the large opening cut at the second story level to permit access to the addition. Originally, there were four windows of double height or French doors on the ground floor, framed by the verandah, and four windows directly above the verandah roof on the second story. The two ground-floor windows on the west side of the building, filled with brick and visible only in outline, were revealed after most of the plaster that was applied to the wall in its later periods of use fell off (Figs. 16 and 17). The two eastern windows were destroyed by the above-mentioned opening but their sills are still preserved in situ (Figs. 16; Fig. 17, the western of the two only). Fig. 15 shows that the ground level on this side of the building was originally considerable higher than at the rear, because of the natural upward slope of the bedrock from north to south, as observed in the excavation of the trench on the west side of the building. The original ground surface would have been approximately at the height of the iron I-beam of the basement ceiling (Figs. 16, 17 and 19). The floor of the verandah would have been attached to the facade below the level of the window sill, Fig. 19. Perhaps the slot seen in that view was used for one of the verandah's floor beams. Regarding the attachment of the veranda roof, the photograph shows that it was several feet above the top of the ground floor windows. Only a small section of the facade at that level, on the east side above the I-beam, has possibly been preserved (Fig. 18). A series of vertical slots seen there may have held the ends of the verandah's roof beams.

Fig. 18. View of the facade of the Charles Denison Mansion (detail)

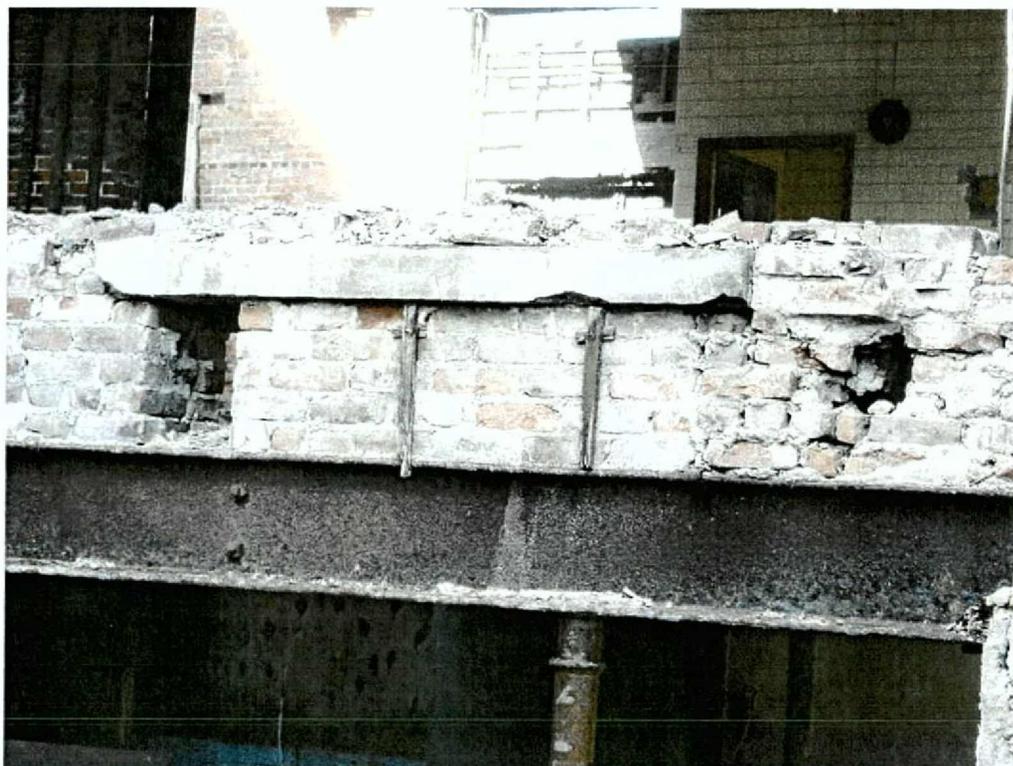
Fig. 19. View of the facade of the Charles Denison Mansion (detail).

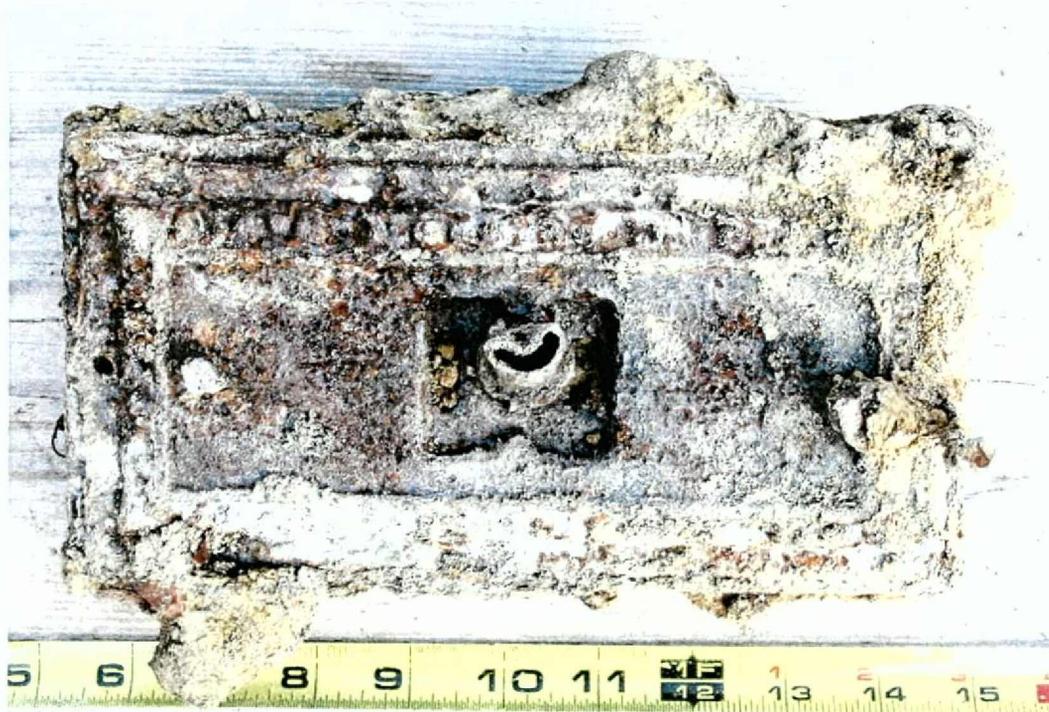
Fig. 20. Metal door plate found in the backhoe dirt, trench on the east side of the building.

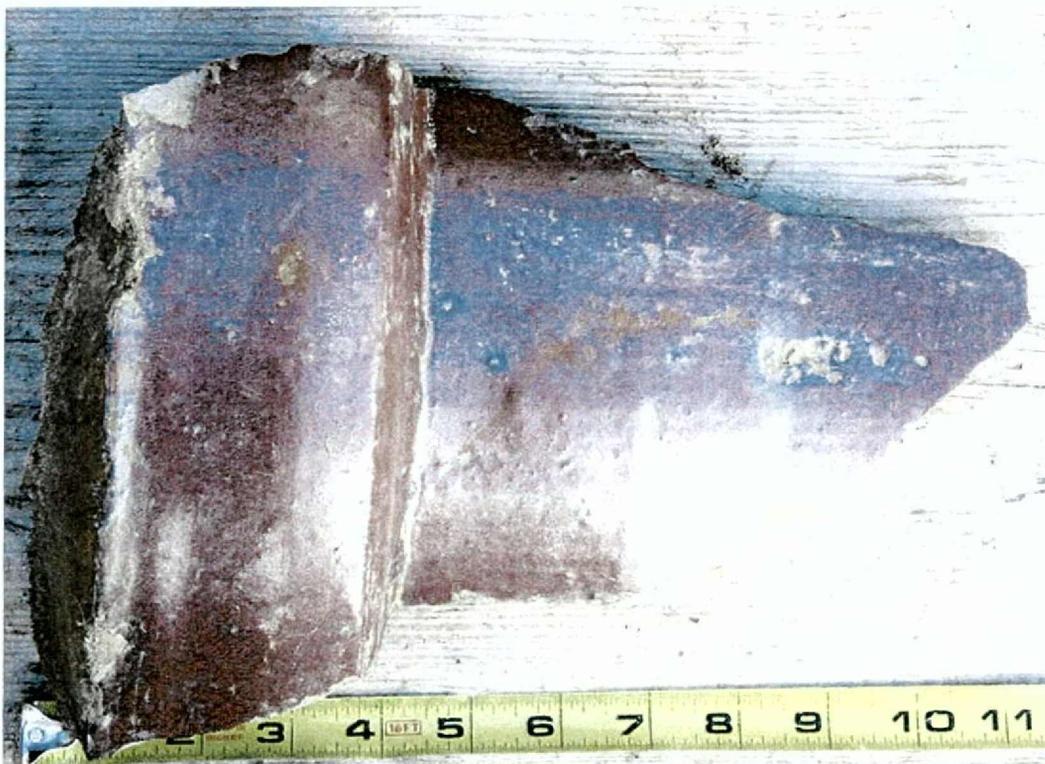
Fig. 21. Ceramic pipe found in the trench on the east side of the building.

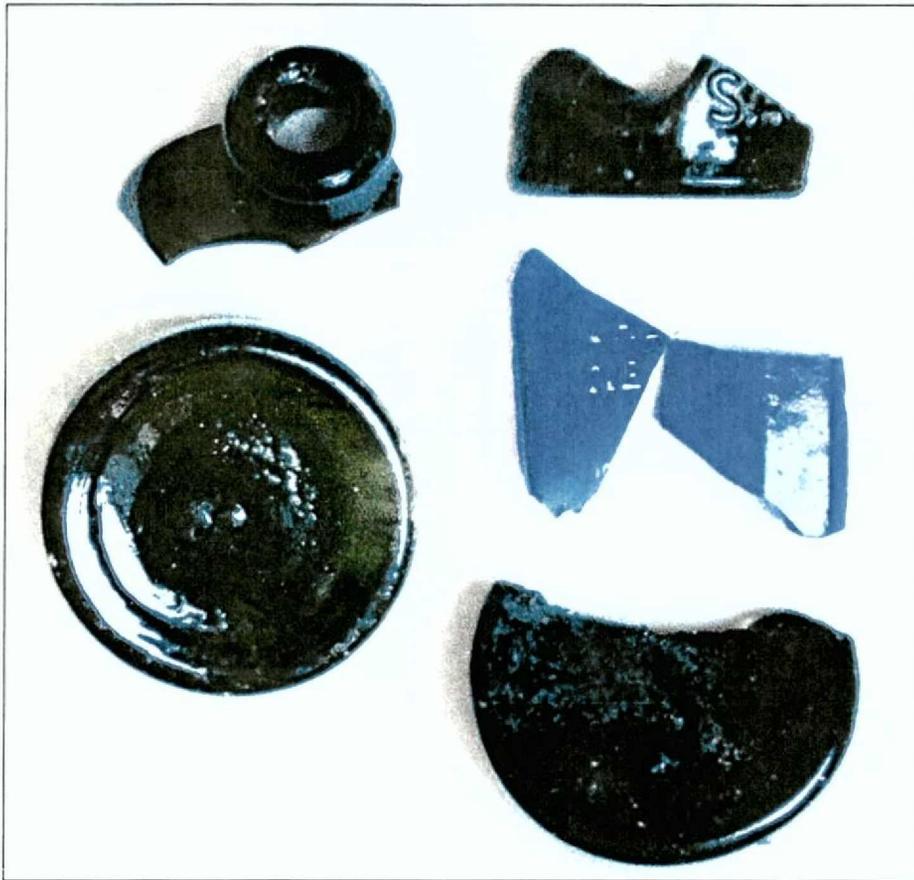
Two bags of artifacts of glass and ceramic fragments were collected from this operation (Figs. 22 and 23). None of this material appeared to be earlier than the late 19th century, dating either ca. 1890-1910 or early 20th century. When identifiable, the glass was all blown in molds, rather than pontiled, indicating a date in the second half of the 19th century at the earliest.

Fig. 22. Glass fragments from the probe on the east side of the building.

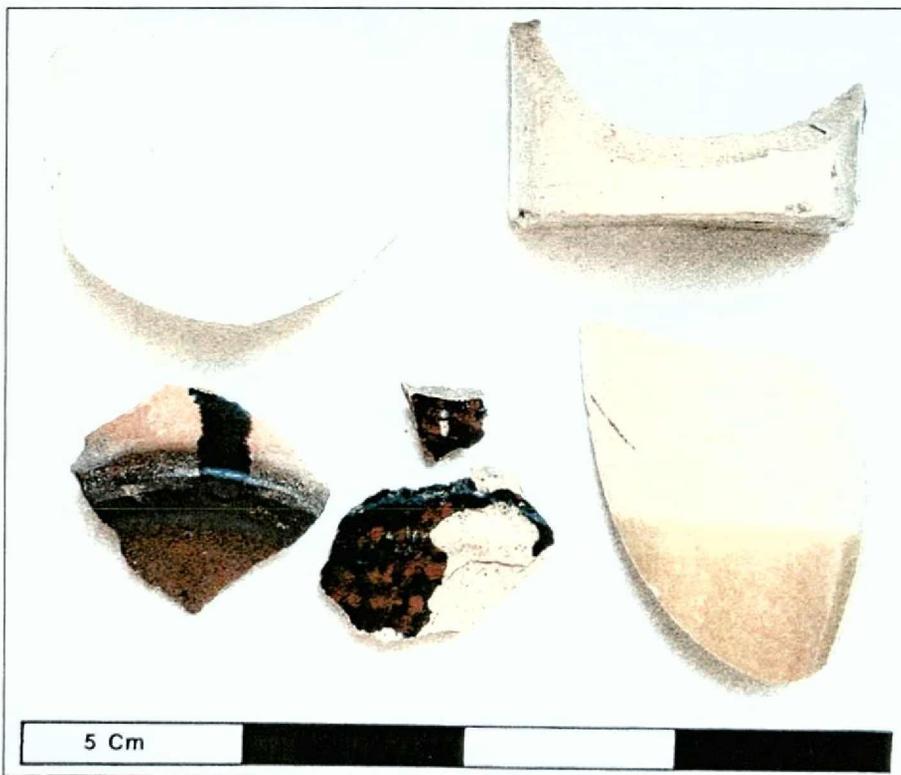
Fig. 23. Pottery fragments from the probe on the east side of the building.
