Removal of Intrusions from the Burial Ground of the Flushing Meeting House of the Religious Society of Friends, 137-16 Northern Boulevard (Block 4977, Lot 26), Flushing, Queens

May 28, 2013

- To: Brian Doherty, as the Representative of the Flushing Meeting House of the Religious Society of Friends
- From: Joan H. Geismar, Ph.D., LLC
- Date: May 28, 2013
- *Re*: Removal of Intrusions from the Burial Ground of the Flushing Meeting House of the Religious Society of Friends: End of Field Memo Report

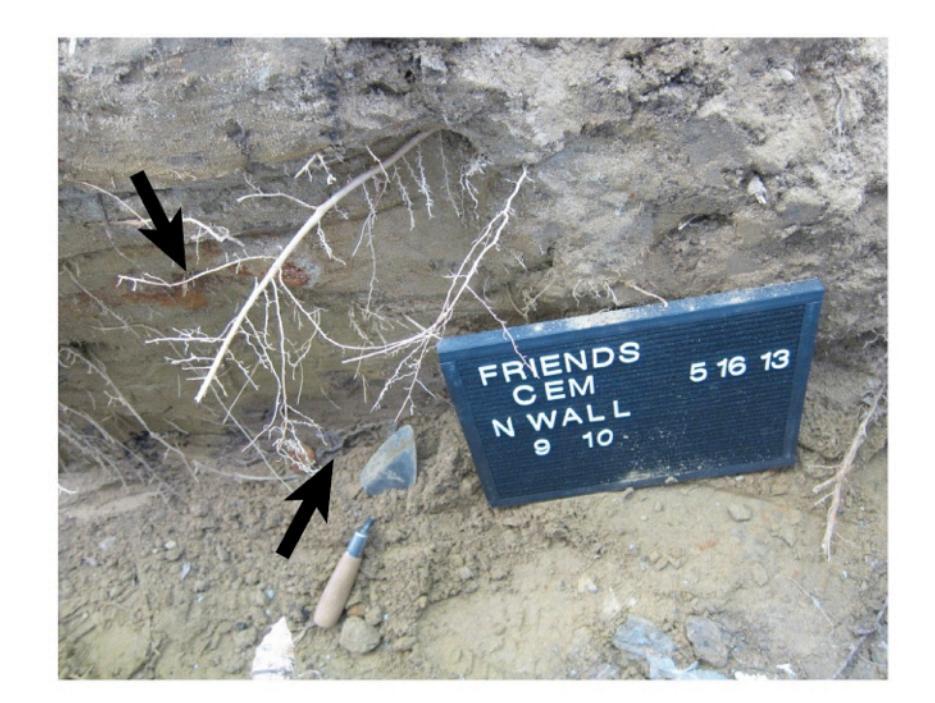
Approximate location of 2- x 2-foot (0.61 x 0.61 m) section of the north "wall" profiled near the eastern end of the trench. Note the patch of orange (corrosion?) sand (upper arrow) and a fragment of old black plastic sheeting (bottom arrow) in the trench wall. Both indicate fill. (Geismar 5/16/13)

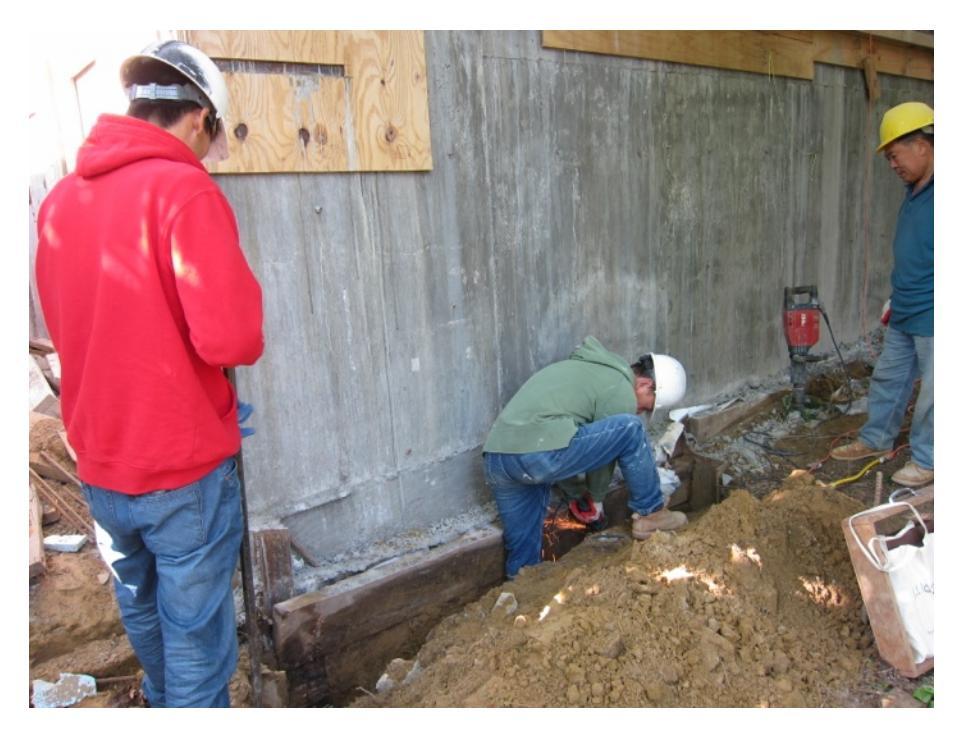
Photo 1. Pinnacle personnel during removal of the second of three lagging planks removed between SB10 and SB9. A blowtorch is being used to eliminate a support. Note the narrow trench in front of the lagging. The trench width never exceeded 2 feet (0.61 m) and was considerably narrower for much of its length.

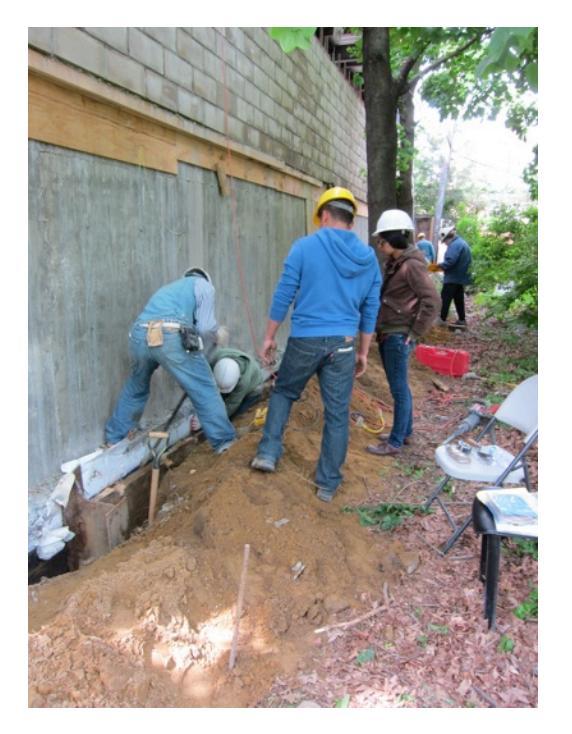
Photo 2. Lagging removal between SB9 and SB8, a typical lagging removal. While two planks were the norm, in some sections, such as SB10 - SB9 noted in Photo 1, three planks were removed to meet the 2-foot (0.61 m) requirement.

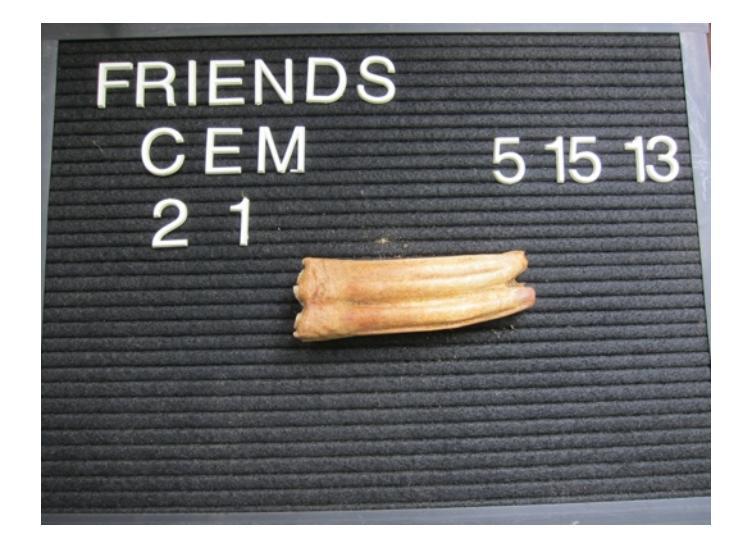
the established protocol, all were returned to the soil. Of interest was the tooth (molar?) of a large animal (see Photo 3), the enamel almost totally worn down by use and indicative of age. This isolated specimen (there were no other associated bones) was collected for identification purposes and its preliminary identification of a horse tooth was confirmed (Brown 2013:personal communication). Following the established protocol (any bone material was to be returned to the soil), the tooth will be reburied at the Friends' direction.

Photo 3. The only collected "artifact," this large tooth, its enamel extremely worn, was recovered from soil excavated between SB2 and SB1. Its field identification as the tooth of an aged horse has been confirmed (see text).

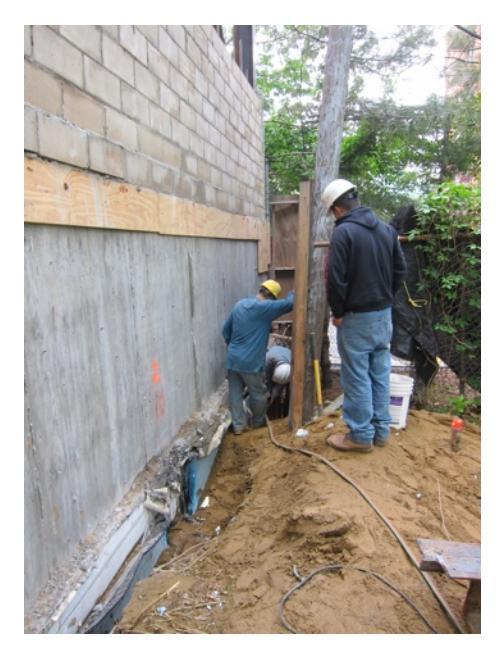
Photo 4. Lagging removal west of SB1, adjacent to a wood partition and extending to the line of an east - west running chain-link fence that protrudes through the wood partition (see Photo 5).

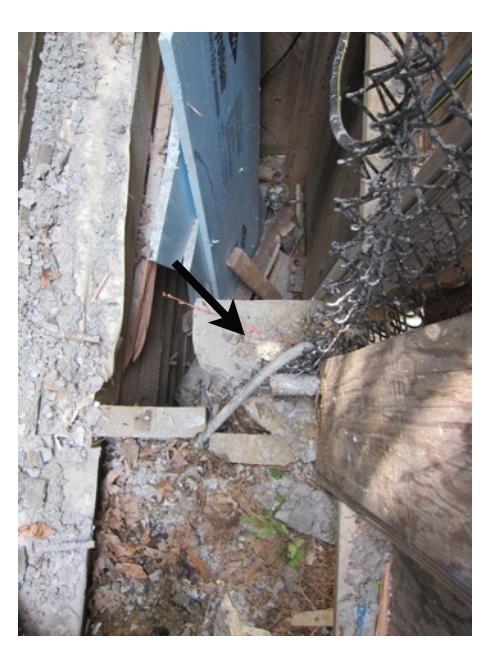
Photo 5. View of the void beyond the line of the chain-link fence that intrudes between SB1 and an 11th Soldier-Beam. The wood partition, the fence post, and its concrete support (arrow) are to the right.

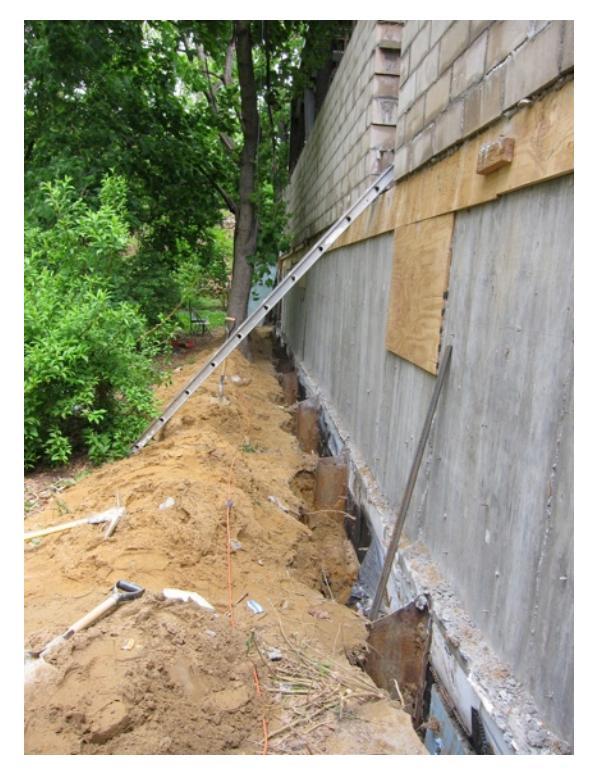
Photo 6. View east from SB4 - SB3 along the narrow trench excavated to provide access to the lagging and Soldier-Beams. The lagging has been removed and the Soldier-Beams exposed.

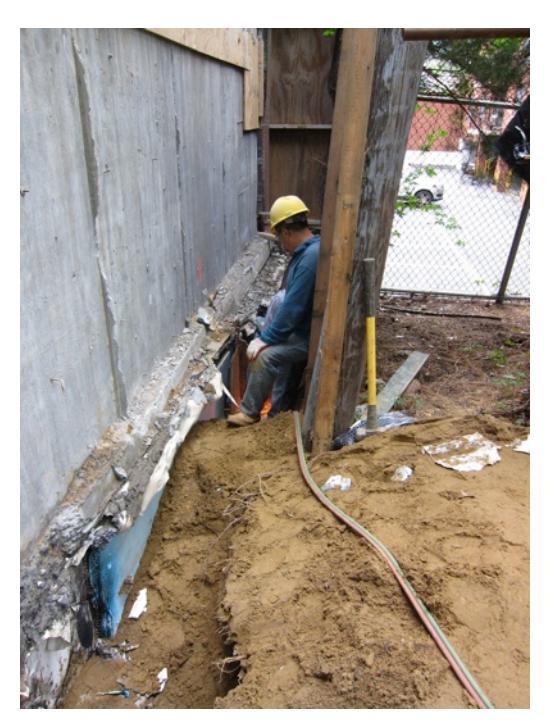
Photo 7. SB1 being torched for removal. The cramped location and styrofoam on the wall made removal difficult. The east end of a neighboring parking lot can be seen to the far right, behind the chain-link fence.

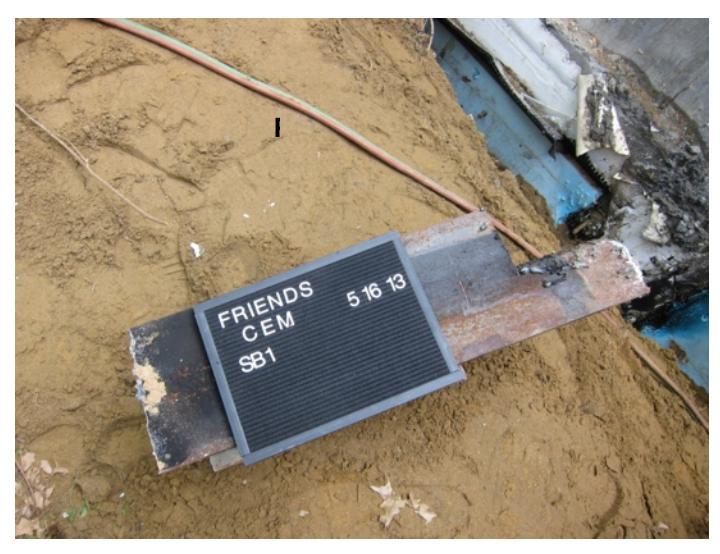
Photo 8. The upper 2.4 feet (0.73 m) of SB1 after removal.

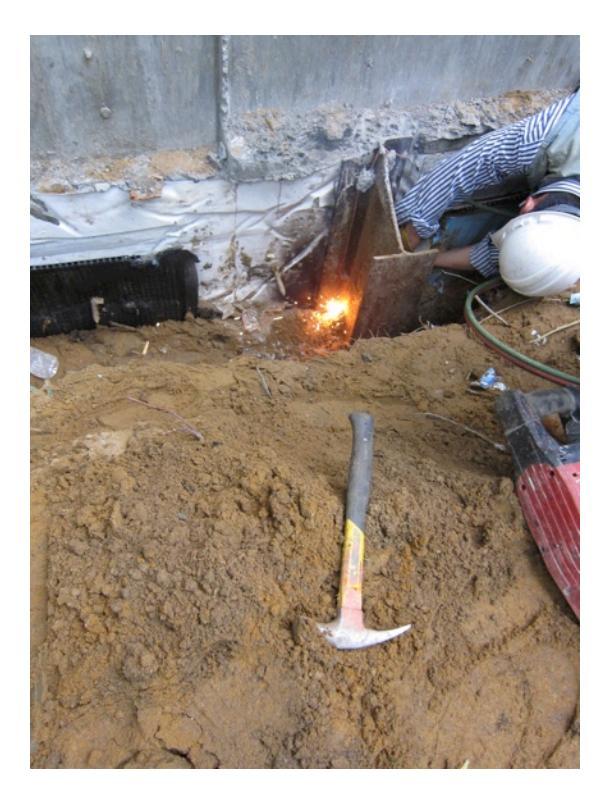
Photo 9. The removal of the upper part of SB3 shown here was typical of the torchand-hammer removal procedure.

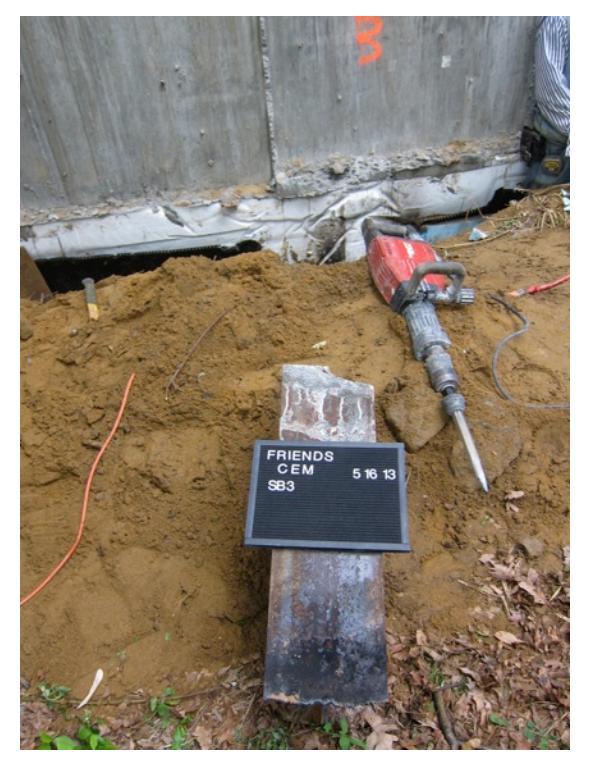
Photo 10. The upper 2.3 feet (0.7 m) of SB3 after removal.

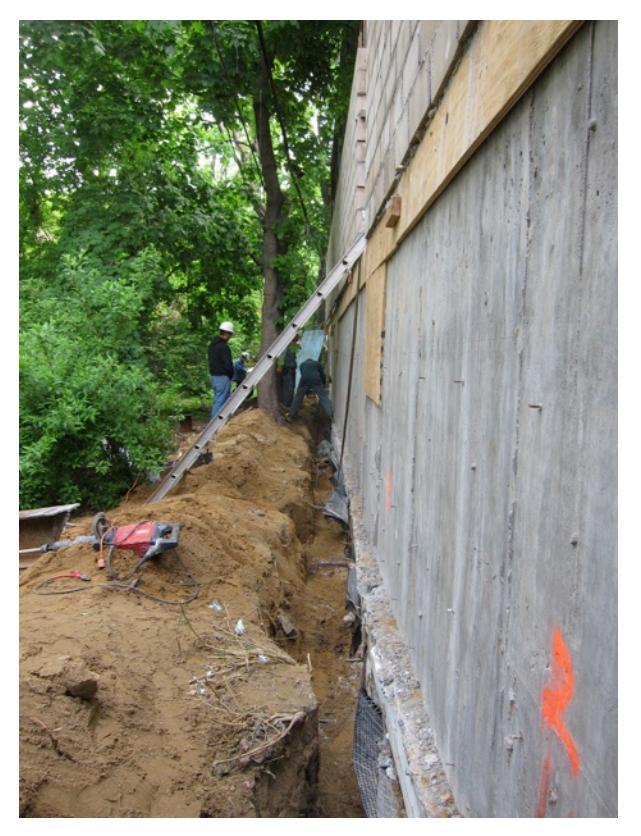
Photo 11. View east from the location of SB2 after all but SB10 at the western end of the trench had been removed.

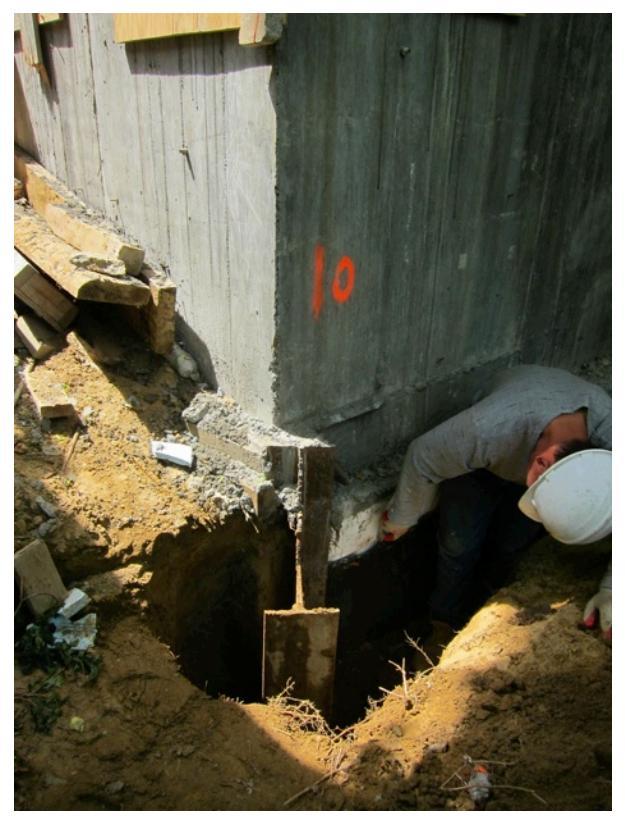
Photo 12. Clearing to remove SB10 at the southeast corner of the new building. Removal of this corner element required greater effort and excavation than was typically necessary.

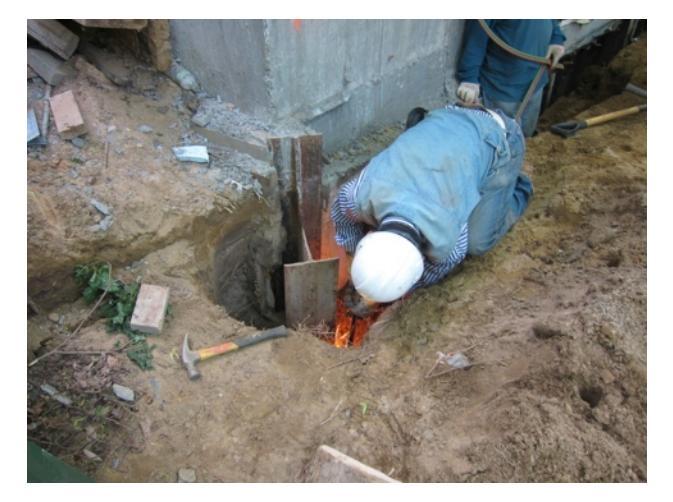
Photo 13. Torching SB10 to remove the upper portion. The height of the ground surface in this area made removal of this last remaining SB within the project area more difficult than elsewhere.

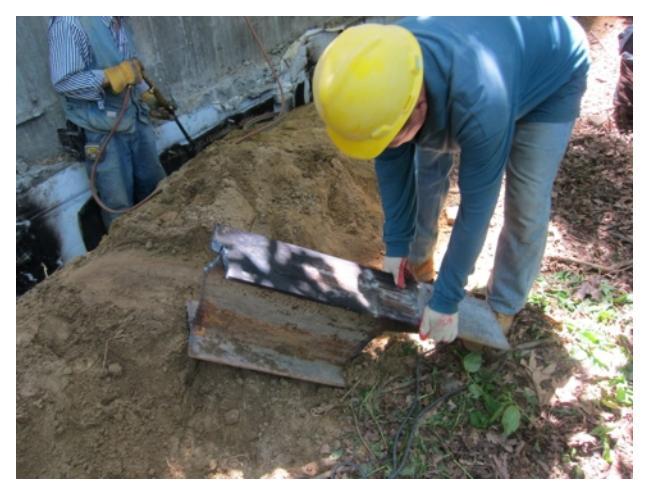
Photo 14. SB10. This was the largest of the ten SB segments (3.0 feet [0.9 m]) that were removed.

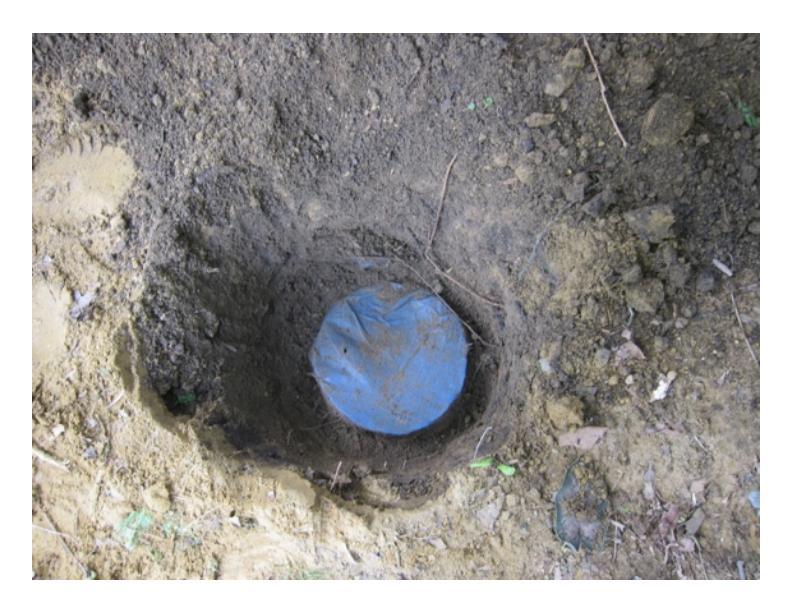
Photo 15. The exposed top of the truncated utility pole located about 1 foot (0.31 m) below the current ground surface. The blue plastic sheeting tied with cord that covered the upper 2 feet (0.61 m) was evidence of the previously reported excavation around the pole (Mascia 2012:10).

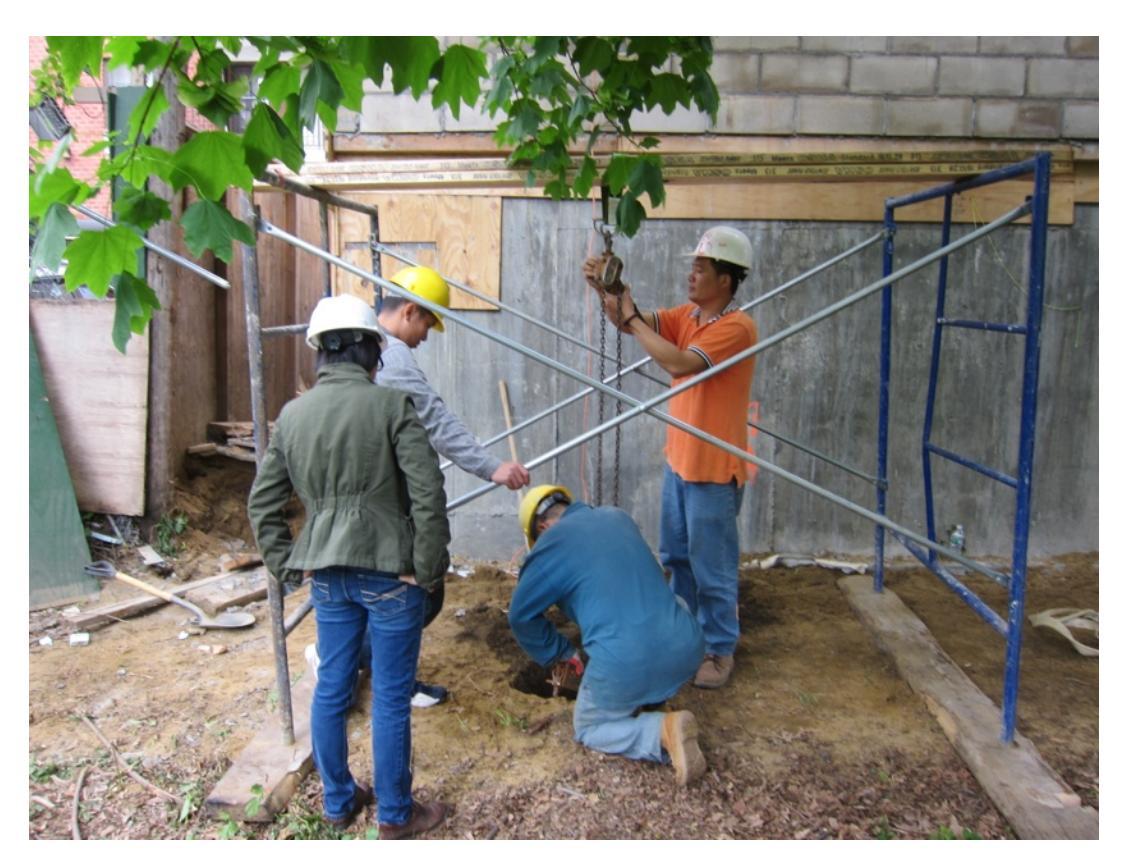
Photo 16. Surface-supported scaffolding being introduced to allow the use of a winch and chain to extract the truncated utility pole without involving excavation other than what was needed to uncover it. On a previous site visit, in anticipation of the pole's removal, Ms. Yan Huang of Pinnacle (standing in the foreground) had determined and marked the pole's location based on a ground penetrating radar survey.

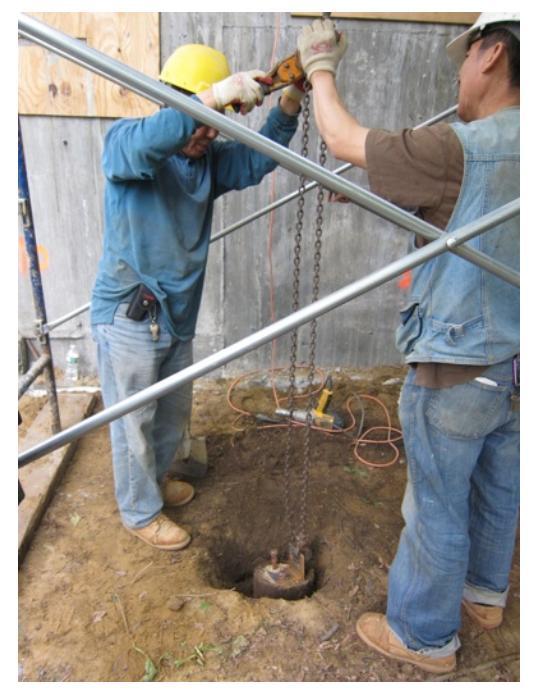
Photo 17. Hoisting the pole, its length as yet unknown.

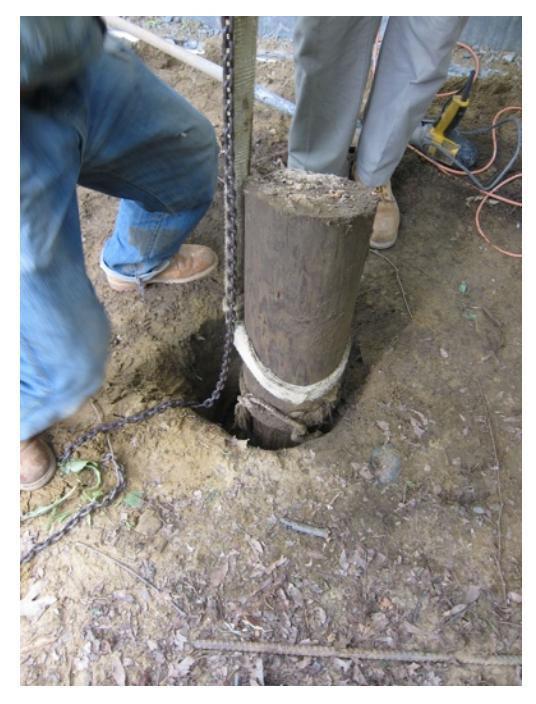
Photo 18. The pole's extraction in progress.

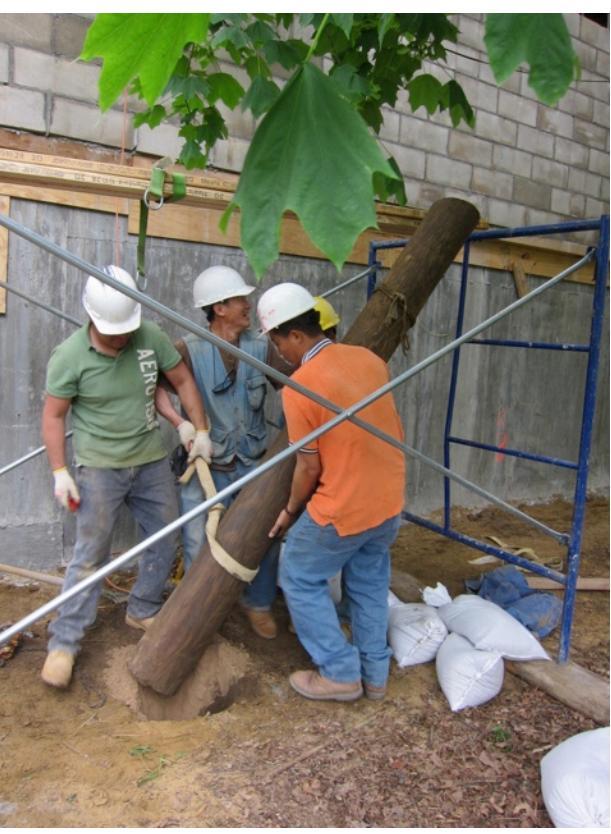
Photo 19. What proved to be an 8-foot (2.6 m), pole remnant being lifted from the hole. Note that sand has been introduced during the extraction to prevent hole's collapse.

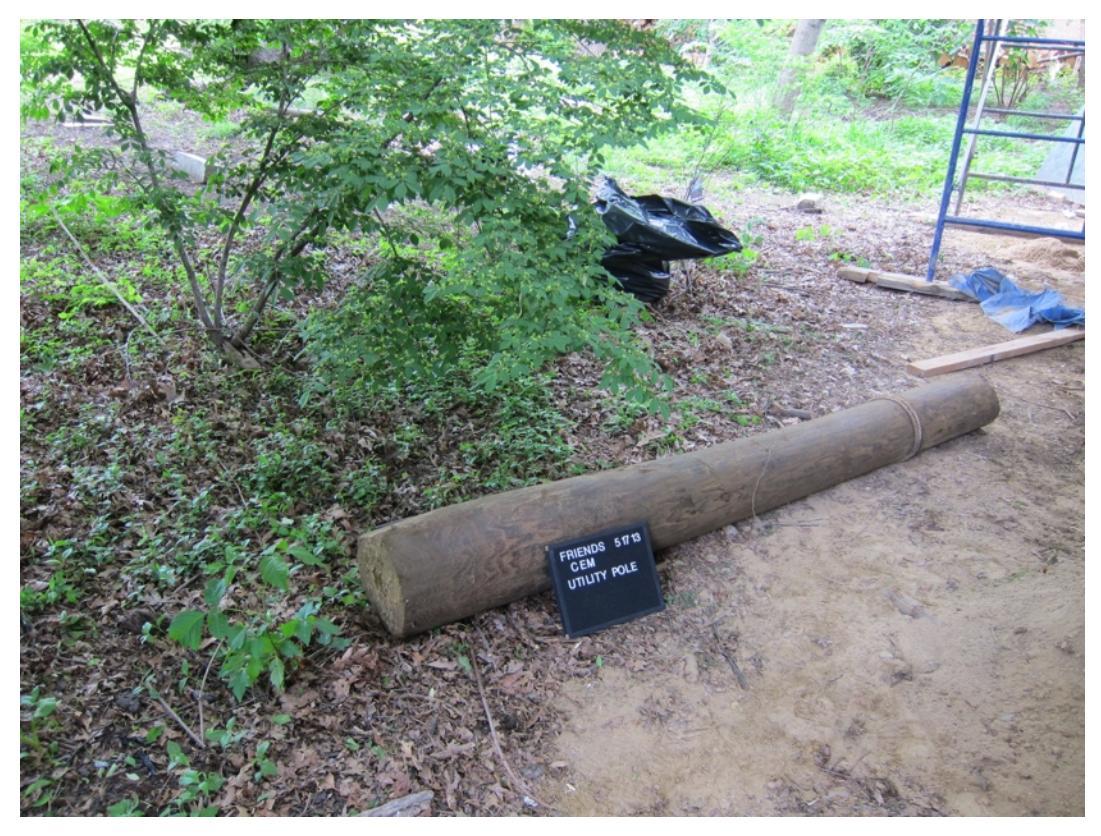
Photo 20. The 8-foot (2.6-m) utility pole remnant. The successful effort by Pinnacle personnel took less than one hour. Filling the hole required eleven 10-lb bags of sand.

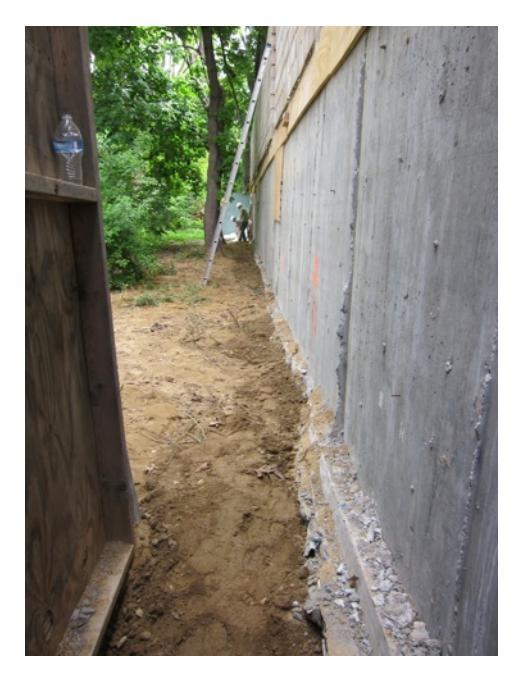
Photo 21. Looking east from SB1 about one hour after the pole's removal. The trench has been backfilled and the site cleared.

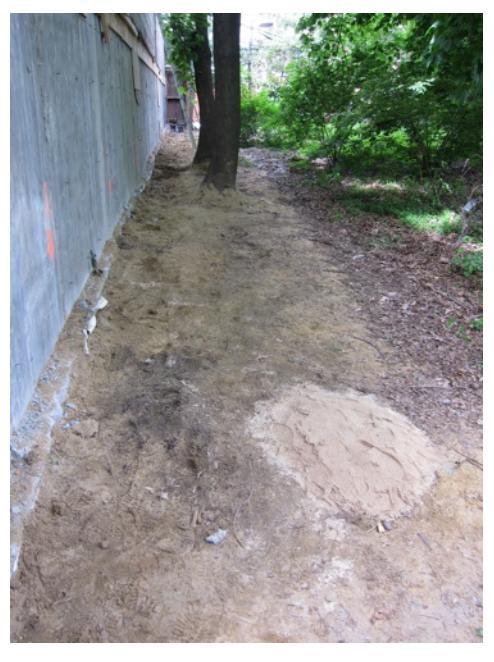
Photo 22. Looking west, the patch of sand in the right foreground marks the former location of the utility pole.
