Archaeological Field Testing of the Wallabout Urban Renewal Area, Block 2027, Brooklyn, July 20 and 21, 1993

CEQR No. 88-232K

Prepared for the New York City Department
of Housing Preservation and Development (HPD)

Prepared by Joan H. Geismar, Ph.D.

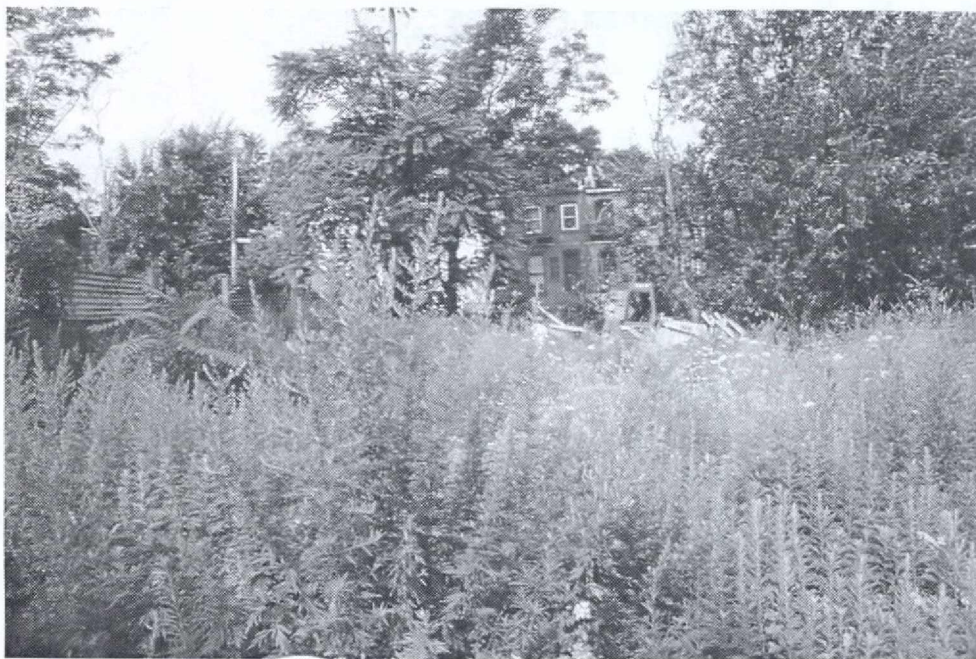
2 Vegetation covered a great deal of the project site during field testing. View is looking southwest toward backs of houses on North Elliot Place seen through the trees. (7/20/93)

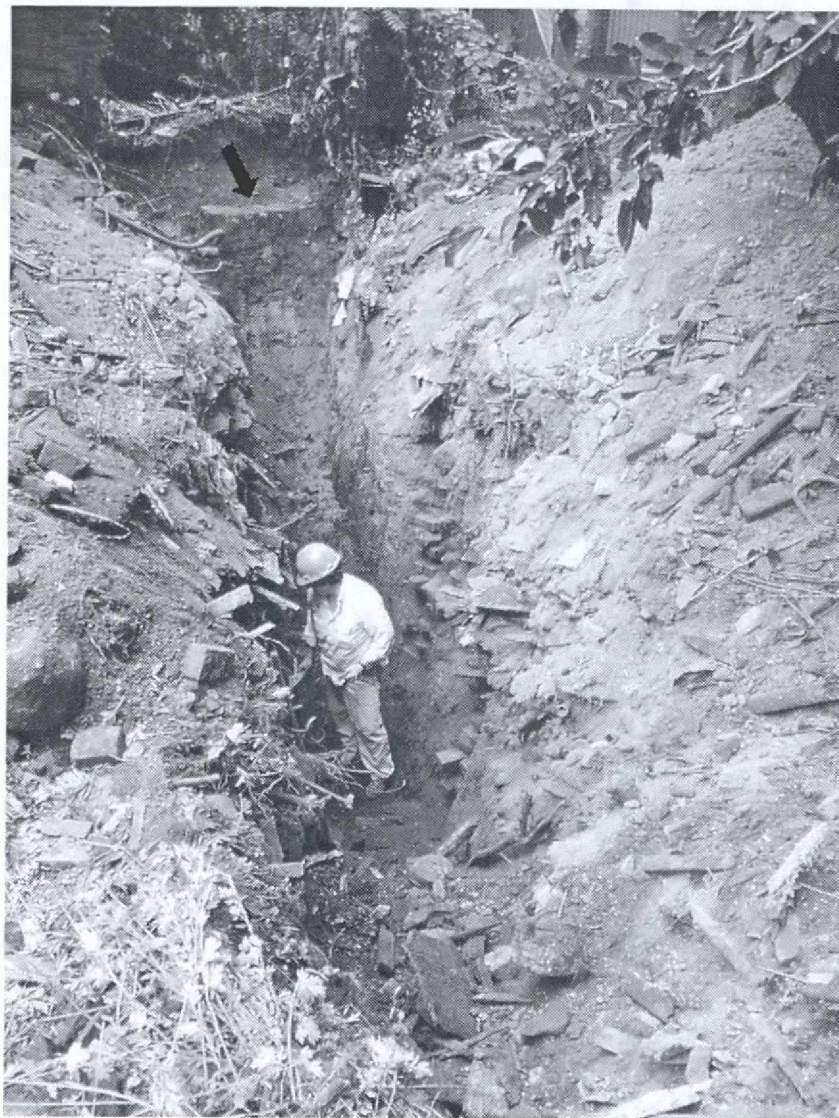
4 Shelly Spritzer in TT1, view looking south. Note trashed stone lintel or step (arrow) at the southern end of the trench. (7/20/93)

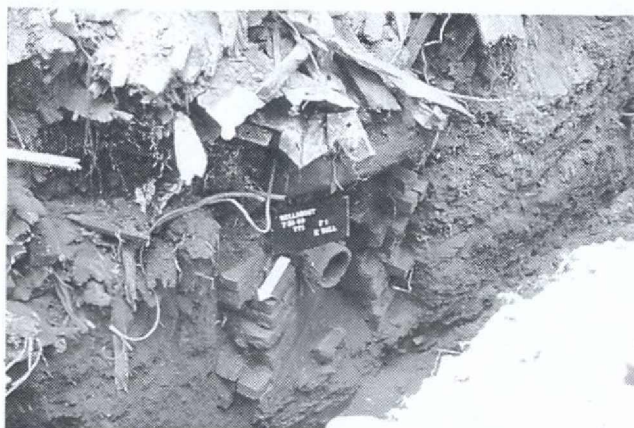
Test Trench 1 (TT1) was run diagonally from southwest to northeast, across the rear portion of the two yards, a configuration that followed the rear property line of the Division Street houses. Building rubble was found throughout the first 5 ft. of excavation, and the underlying soil was a sandy fill interlaced with ash. The trench, which was 36.5 ft. long, 9.5 ft. deep, and approximately 3 ft. wide but wider at its southern end, was taken to and into ground water (see Exhibit 4), but the only feature of note was the aforementioned brick cesspool, designated Feature 1 (F1). This round construction behind 18 North Portland Avenue was inadvertently bisected by the backhoe (see Exhibits 5 and 6). It was encountered immediately below building rubble, and the interior of the feature was about 4 ft. in diameter, with remnants of a metal pipe entering it at its center from the east (see Exhibit 5). The feature was located near

the north property line of the 18 North Portland Avenue lot. It is possible that this was one of the looted features, but this remains unknown. No artifactual material was noted. *any fill?*

5 Brick cesspool in east wall of TT1. Note metal pipe (center) entering from the west where the house formerly stood, and the building rubble just above the feature. (7/20/93)

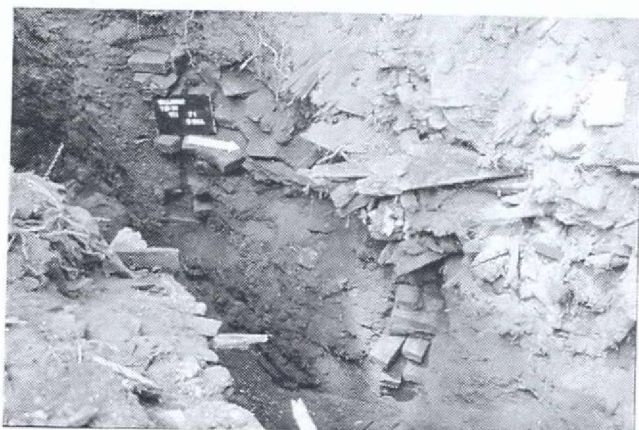
6 Western portion of brick cesspool feature (F1) in TT1. Note brick wall of the feature damaged by the backhoe. (7/20/93)

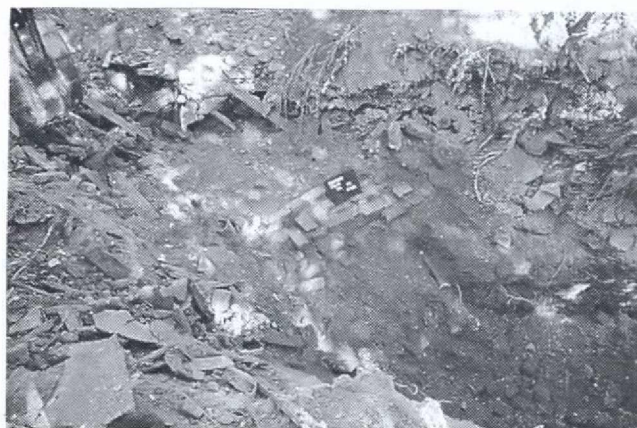
During the course of excavation, a corner of the building that had stood at 16 North Portland Avenue, a brick structure built between 1852 and 1879, was also found where it is indicated on nineteenth- and early-twentieth-century atlases. Designated Feature 2 (F2), this was the only other construction uncovered during excavation of TT1 (see Exhibit 7).

7 Exposed brick wall (F2) (below story board) of demolished house formerly standing at 16 North Portland Avenue. Segment exposed in TT1. (7/20/93)

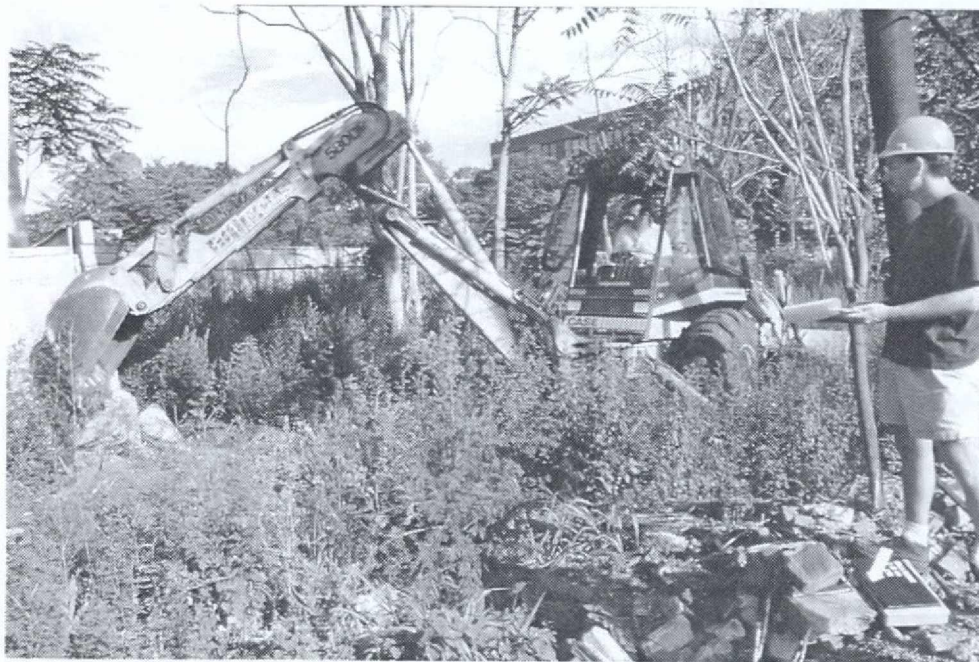
8 Bob Wogish running backhoe during excavation of TT2 with Cas Stachelberg monitoring in foreground. Note vegetation and trees that ultimately limited excavation of the trench. (7/21/93)

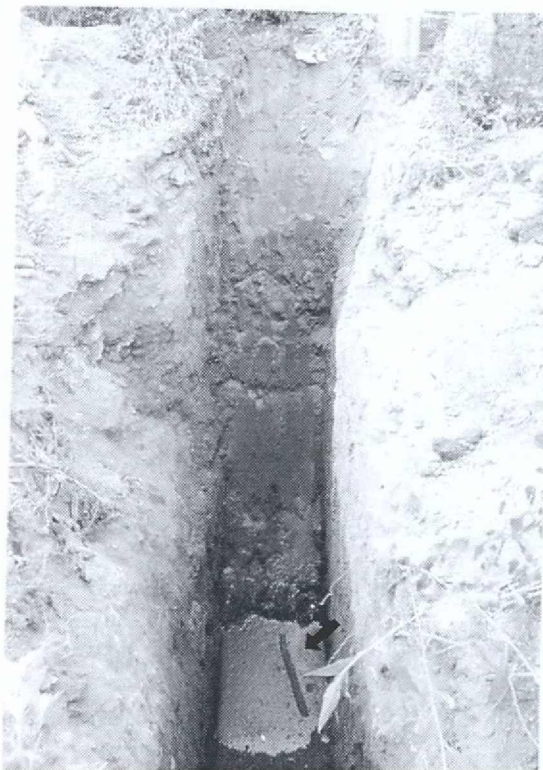
Test Trench 2 (TT2) was opened in the northeastern corner of the project site, formerly 26 and 24 Flushing Avenue in the vicinity of the old Wallabout Bridge Road. The trench was run diagonally from the northeast corner of the lot at 9 North Elliot Avenue toward the corner of North Portland and Flushing Avenues (see Exhibit 3). Although standing trees ultimately limited the length of the trench (Exhibit 8), it crossed the area considered potentially sensitive. This (14-) by 3-ft. trench was dug to 10.5 ft. where water was reached (see Exhibit 9), but no evidence of the roadway was found. Moreover, artifacts were neither profuse nor of an age that suggested a primary landfill material. Instead it appeared to be a later, relatively clean fill.

9 TT2 looking south. Ground water (arrow) at the bottom of the excavation was 10.5 ft. below the surface. (7/21/93)

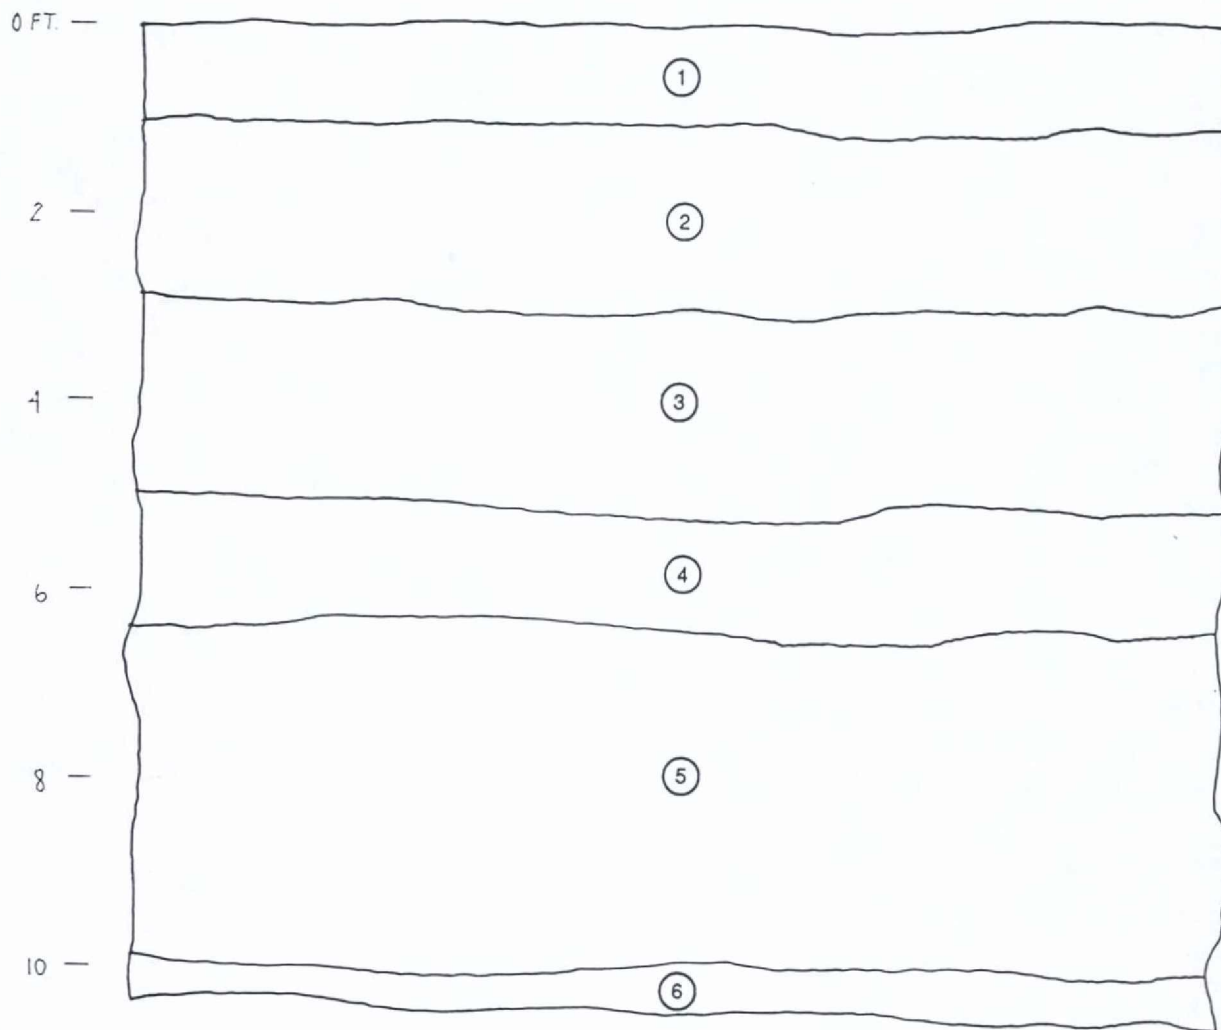
- ① surface (dark brown)
- ② grey ashy light brown/tan (fill)
- ③ reddish brown (fill)
- ④ ash layer (fill)
- ⑤ reddish brown (fill)
- ⑥ reddish brown (wet) with clinkers (fill) (water at bottom)

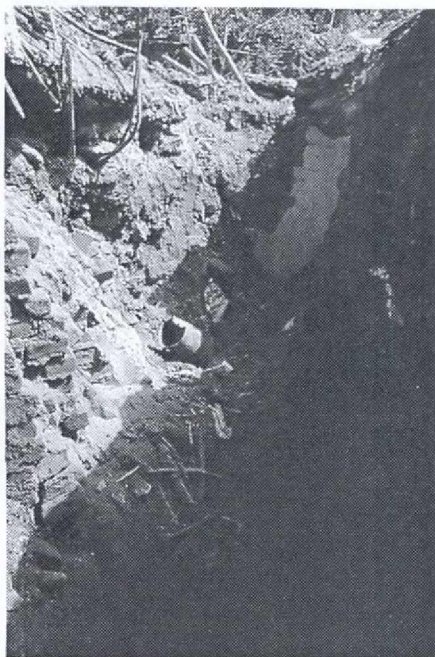
As noted above, this corner, like the one at North Elliott Place, was the site of a gas station by 1932. The brick walls found just below the asphalt confirmed the presence of a former building that predated the gas station structure, one that is shown on late nineteenth-century atlases. The soil beyond (south of) these walls was a fill with ash and clinkers that did not emit the petroleum odor. This, more than any other excavated fill, contained fragmented domestic artifacts such as small ceramic and glass fragments and some butchered animal bones (see Exhibit 13), but it did not appear to be archaeologically significant. No evidence of the tannery structure, the road, or early landfill was found. Nor was there any indication that further exploration would offer any significant findings.

11 Brick building walls (left foreground and right rear) in TT3. View is looking south. Note the pipe and other debris lying in the trench. (7/21/93)

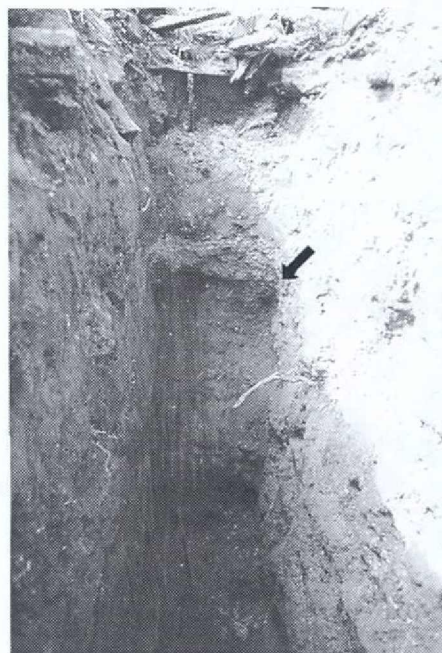
encountered that could not be removed with the backhoe. The trench was relocated a few feet to the northeast where asphalt rather than concrete was found, and excavation proceeded diagonally across much of the area believed to be the site of the 1841 tannery. This trench ran 26 ft. with a curve to the northeast, and was 3.5 ft. wide. It, too, was taken to water. The soil in the northeastern part, which lay within the brick walls of a former building, appeared to be oil or petroleum soaked (see Exhibits 11 and 12) and emitted a strong petroleum odor.

12 Oil or petroleum soaked deposit (arrow) in TT3. The deposit exuded a strong petroleum odor, but was limited in extent, probably lying under or near the pumps of a gas station built by 1932. (7/21/93)

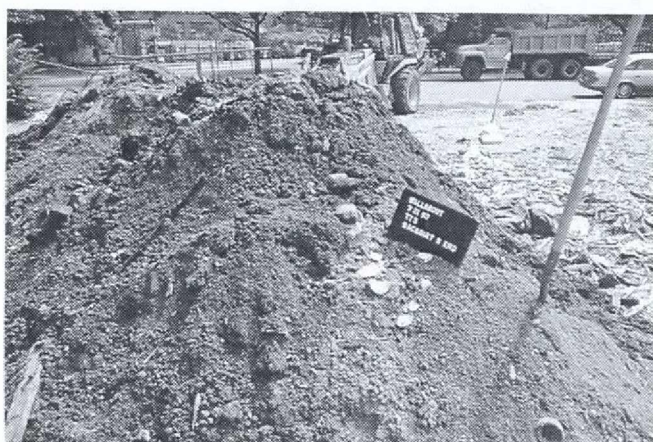
Again, photos were taken (Exhibits 11-13) and the east wall of the trench profiled (Exhibit 14) before backfilling. One of the photos was of the backdirt pile where domestic artifacts, most of them--like soda and beer bottle fragments--of relatively recent origin, are in evidence (see Exhibit 13).

13 Backdirt pile from TT3. North Portland Avenue is in the background. Note fragmented artifacts near story board. (7/21/93)

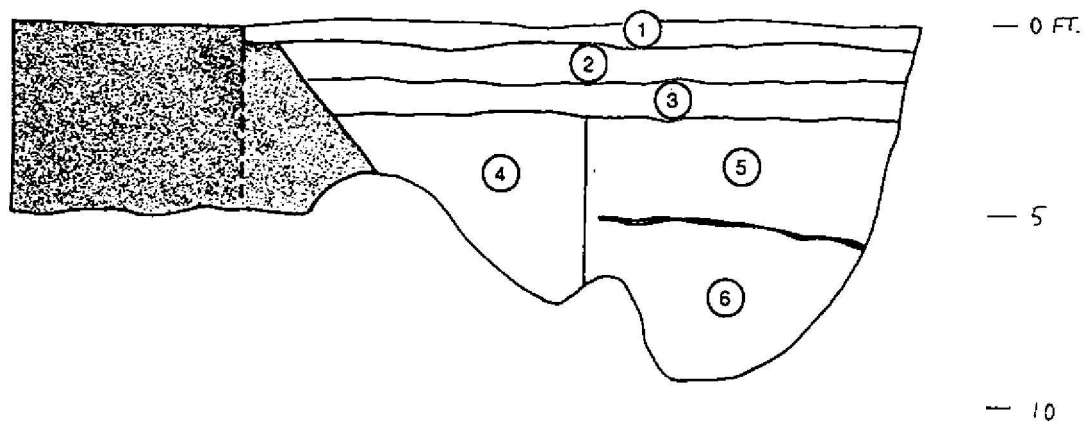
- ① asphalt layer/light brown soil (mixed)
- ② grey
- ③ reddish
- ④ oil/petroleum-soaked fill (strong petroleum odor)
- ⑤ reddish mottled with cinders
- ⑥ brown with wet ash and cinders (water at bottom)
-

brick wall
-

dense layer of coal, ash, and cinder
-

angle in brick wall (schematic)

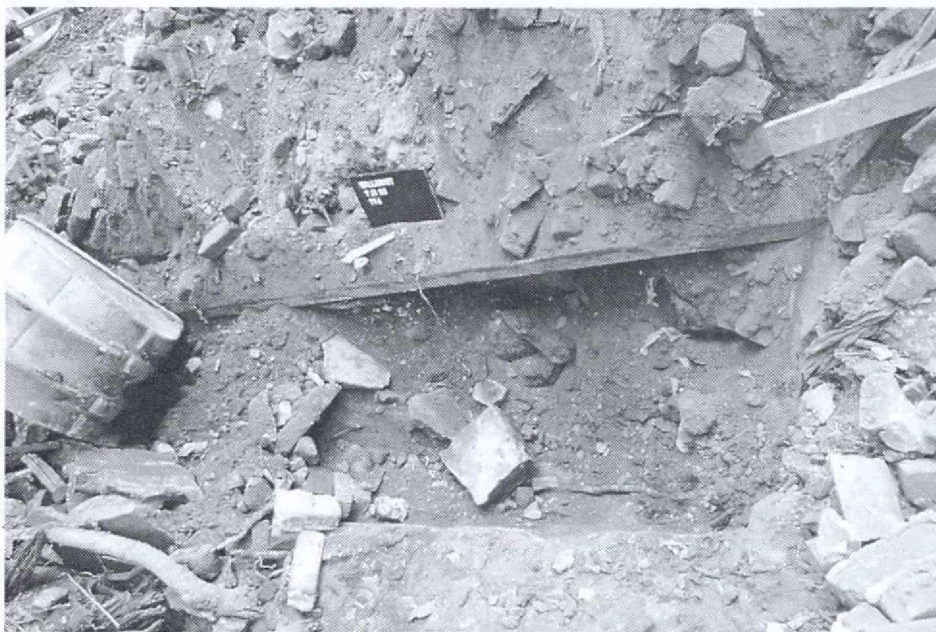
Test Trench 4 (TT4) was opened in the 8 North Portland Avenue lot, but a concrete layer adjacent to what appeared to be an extensive 2 1/2-in. thick metal plate or floor found just below the ground surface made excavation impossible (see Exhibit 15). It is assumed that both the concrete and the large metal plate are remnants of the auto repair shop that until recently stood on this lot. This shallow trench, which was 6 ft. long, 2.5 ft. wide, but only 1 ft. deep, was photographed (Exhibit 15) and backfilled.

15 Cement slab (bottom) and metal plate (top) in TT4, apparently the remnants of an auto body shop that stood on this part of the site until recently. The backhoe is attempting to excavate between the two, but with no success. (7/21/93)

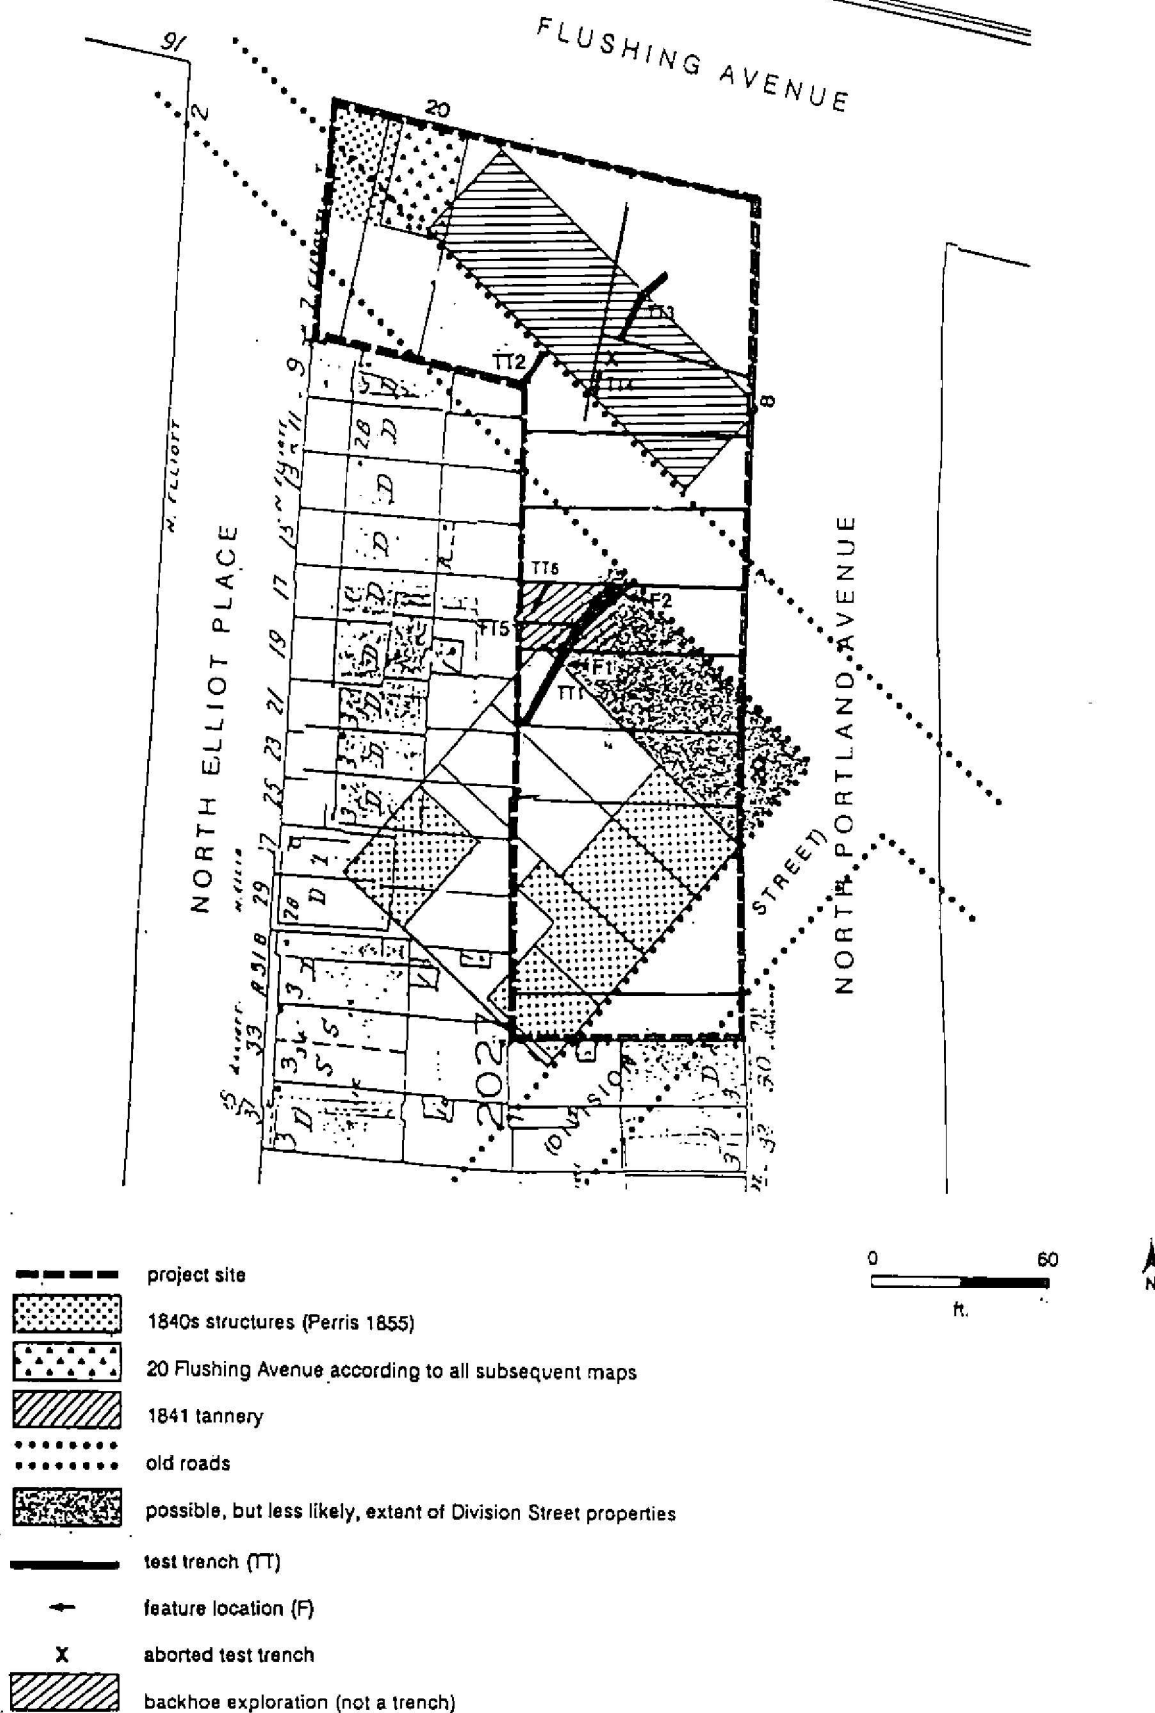
nor was primary landfill documented. In general, a relatively modern fill was found throughout the tested areas. (Exhibit 16 correlates historical considerations with test trenches and other excavations.)

The July archaeological field work documented a greatly disturbed site with no obvious archaeological potential, but these findings do not negate the necessity of testing for the privy that might be associated with the structure that once stood at 20 Flushing Avenue. Although privies said to be located in the yards of North Portland Avenue properties may have been looted in the late 1980s, there is no evidence that this occurred in the 20 Flushing Avenue lot. Unfortunately, this lot was not available for testing during the July 1993 field program. While no evidence of the old Wallabout Bridge Road was found in July, it is conceivable that it may also survive in the lot at 20 Flushing Avenue or neighboring lots that may have less disturbance than the areas tested to date. Therefore, testing of the 20 Flushing Avenue backyard is still recommended.
