Clinton Broome Apartments

165 BROOME STREET; BLOCK 341, LOTS 60 AND 158

Phase 1B Archaeological Investigation

MAY 2022

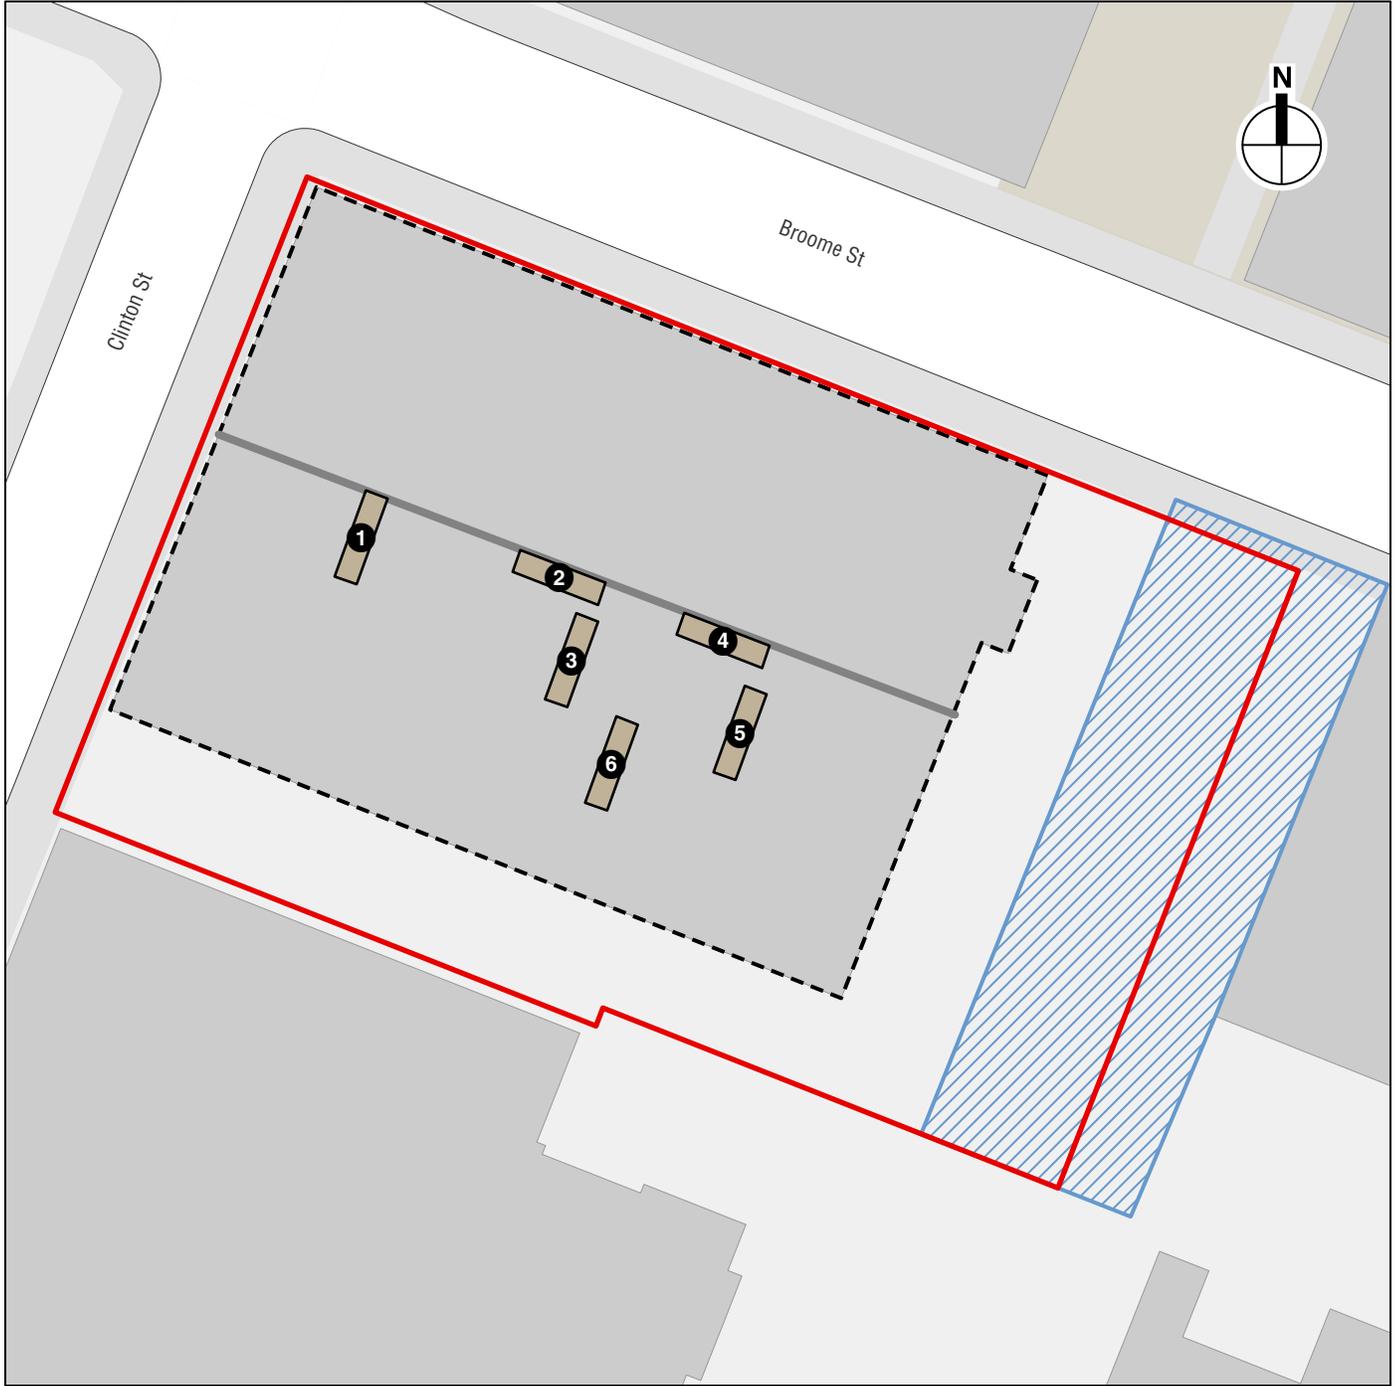
Location of Archaeological Test Trenches
Figure 4

Approximate location of foundation wall/grade change

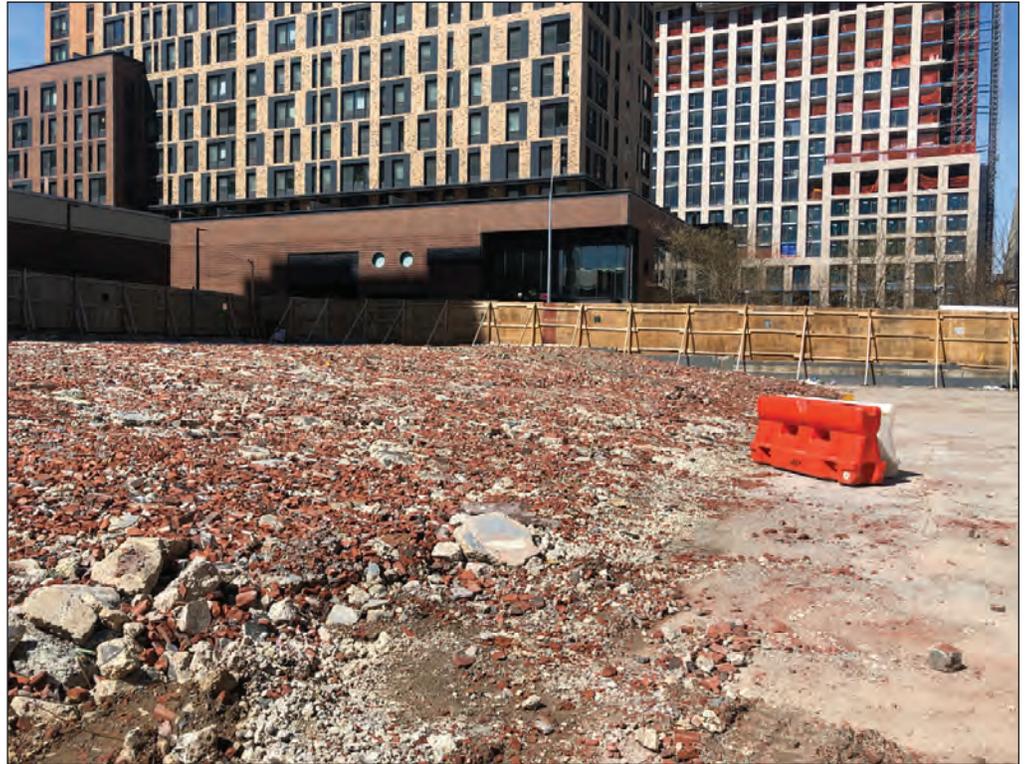
Looking southwest across the project site from Broome Street, showing the 4-foot difference in the grade of the floor slab and the mound of brick rubble 1

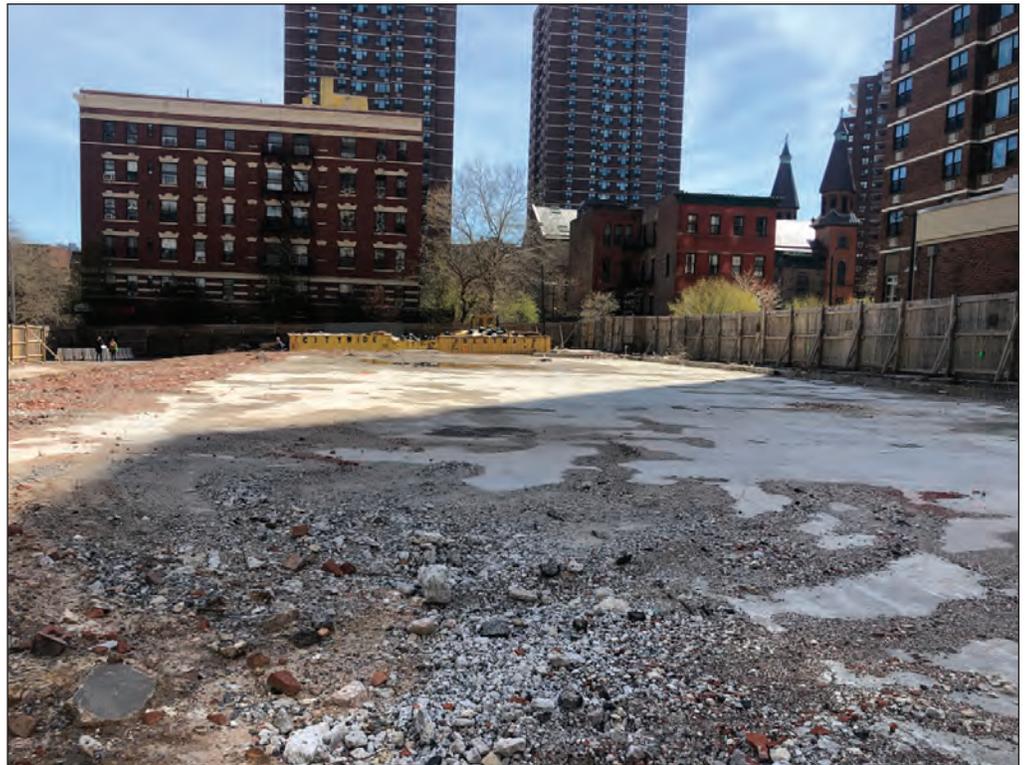
View east across the area of higher elevation, showing the part of the slab where the test trenches were excavated. The fence at right is near the southern wall of the parking garage foundation 2

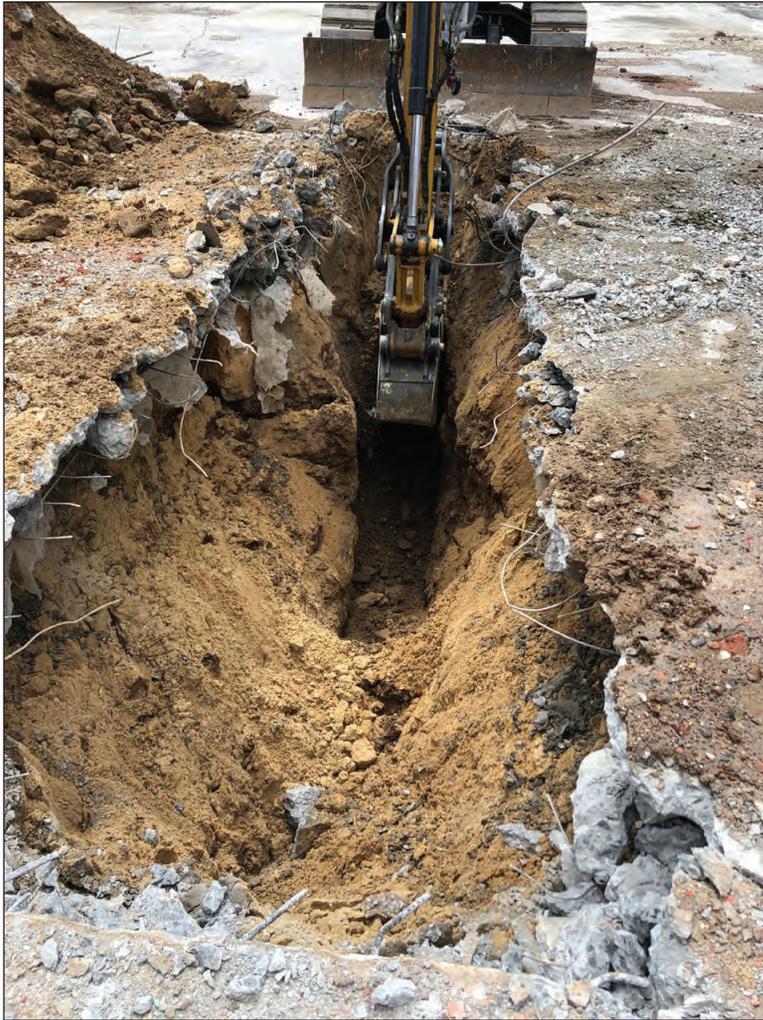
Trench 1 was oriented north–south and was 5 feet in width by 20 feet in length. The trench located as mapped in the approved Work Plan was slightly further north and would have been fully situated within the rear yard of the building formerly known as 144 Clinton Street. However, given the placement of the foundation wall that bisected the former parking garage east–west, the trench was opened in the southern portion of the 144 Clinton Street rear yard and extended to the south into the property formerly known as 146 Clinton Street. The property at 146 Clinton Street was formerly developed with a building with a basement. The northern half of the trench was excavated first, followed by the southern half. During all parts of the excavation, the soils within the trench walls were observed to be extremely loose and continued to collapse into the trench throughout the excavation. The trench was excavated to a depth of approximately 10 feet before excavation was terminated due to the consistent collapse of the surrounding trench walls.

View of excavation of Trench 1; the lighter colored soils in the foreground were the result of the collapse of the trench walls following excavation to greater depths **3**

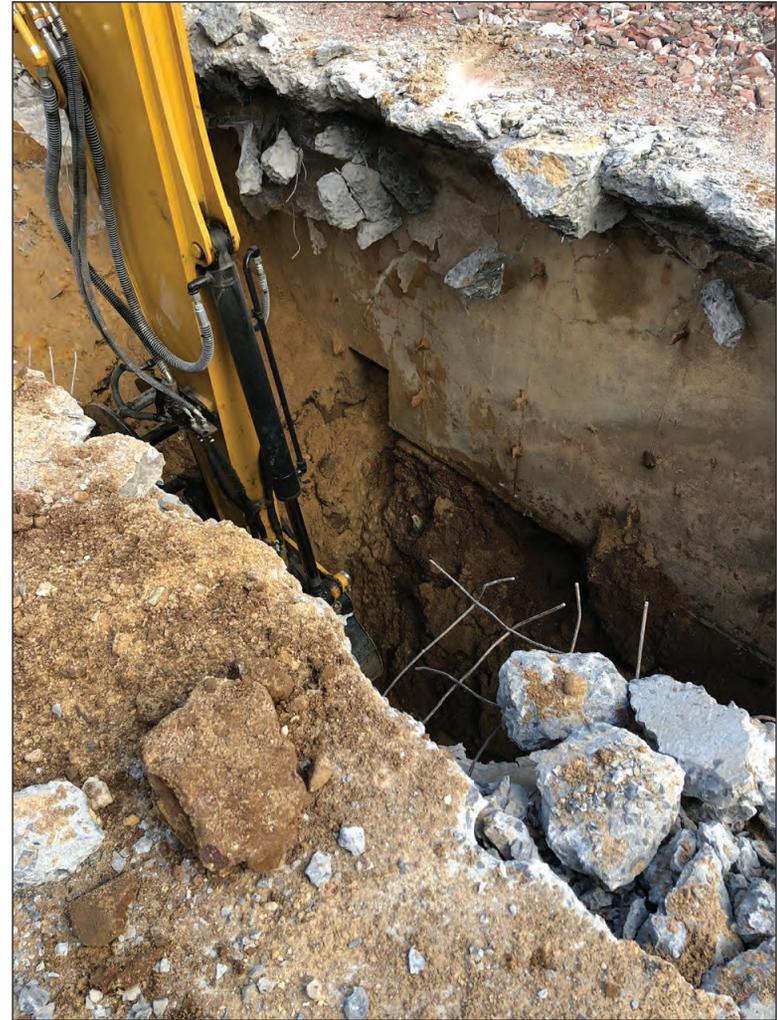
Trench 2 was a 5- by 20-foot trench situated east–west and was located in the rear yards of the buildings formerly known as 169 and 171 Broome Street. The trench was opened to the south of the foundation wall that bisected the parking garage, which was used as the north wall of the trench and prevented soil collapses similar to those seen during the excavation of Trench 1. The same two soil layers were observed beneath the slab: a layer of very clean sand underlain by a brown fill layer containing low concentrations of brick rubble and modern refuse (e.g., Styrofoam and architectural debris). The foundation wall in the north wall of the trench extended to a depth of approximately six feet below the ground surface and was associated with a series of pipes, one of which began to drain water into the trench during excavation. Massive boulders and segments of mortared brick walls were observed during excavation of the western half of the trench. Light-colored subsoil appeared to be observed at the base of the trench at a depth of approximately 9 to 10 feet. The subsoil layer could not be fully explored due to the collapsing soils from the southern trench wall and the flooding associated with the pipes in the foundation wall. No evidence of shaft features was observed and no artifacts were collected from Trench 2.

The bottom of the foundation wall observed in the north wall of Trench 2 **4**

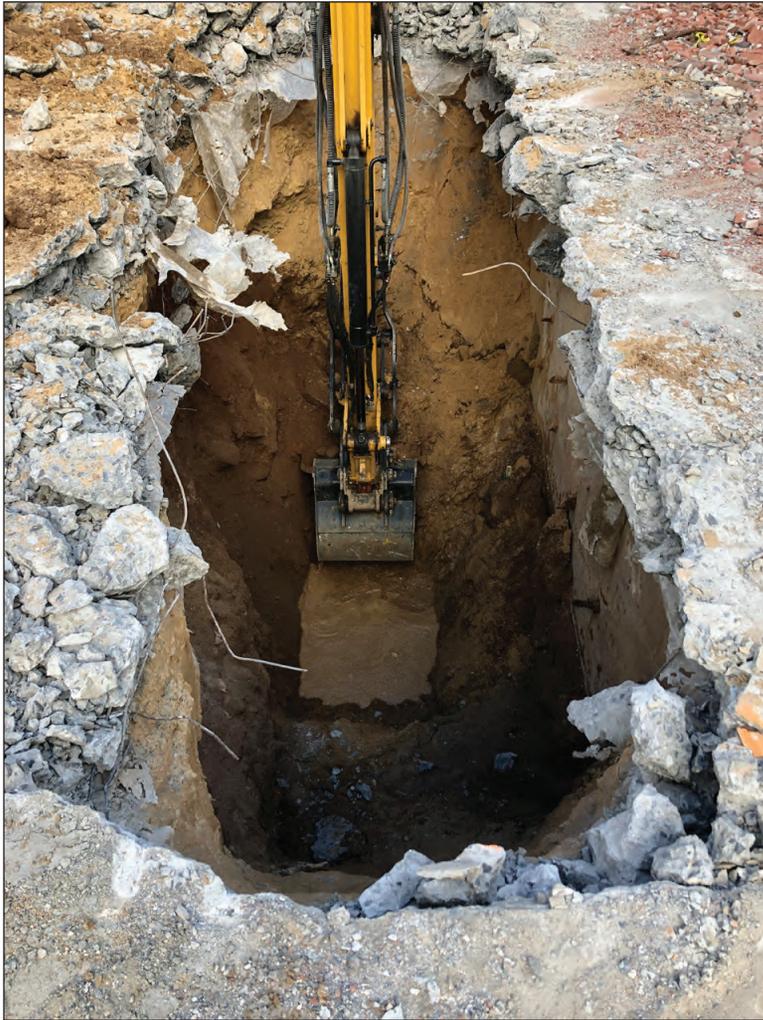
The lowest point of the excavation of Trench 2 where the archaeologists observed what appeared to be subsoil beneath the fill deposit; the backhoe is being used to hold back the soils to prevent collapse **5**

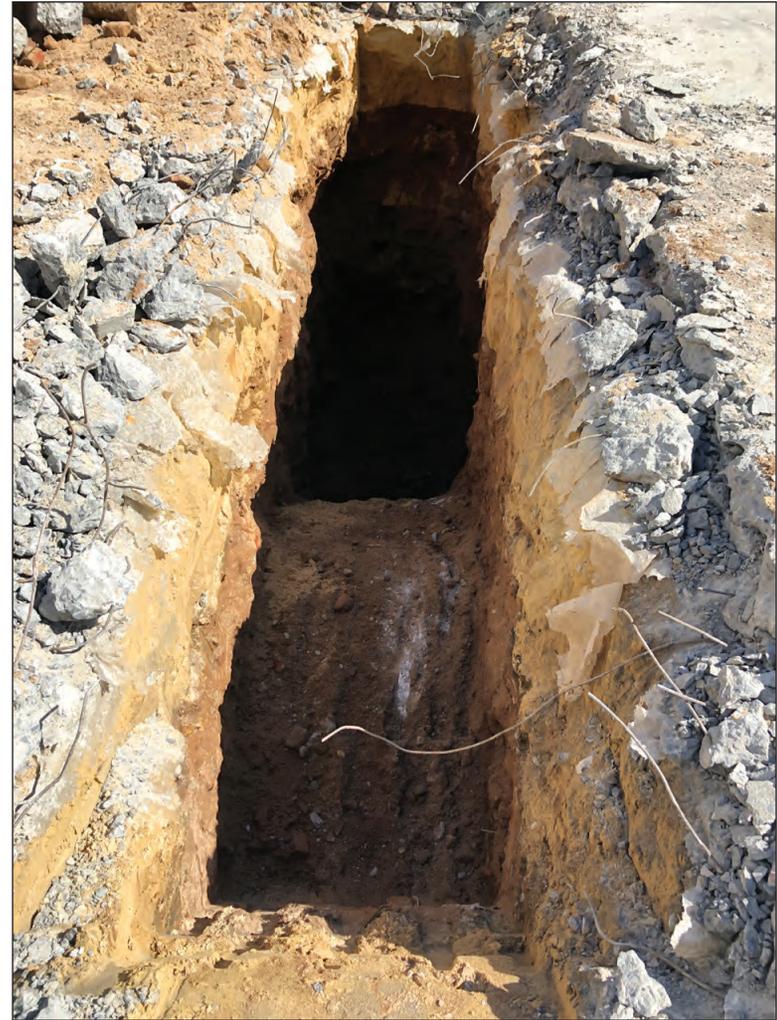
Trench 3 was a north–south-oriented, 5- by 20-foot trench situated in portions of the historical rear yards of the buildings formerly located at 169 Broome and 146 Clinton Streets. The sandy foundation layer beneath the concrete slab was slightly thinner than that seen in Trenches 1 and 2, measuring approximately 2 to 3 feet in thickness, with the depth increasing to the north. The underlying brown fill layer was also significantly thicker and denser. The fill extended to a depth of at least 12 feet below the ground surface and contained denser deposits of demolition debris, including iron girders and pipes. A massive boulder obstructed excavation in the south half of the trench beginning at a depth of 5.5 feet below the slab. Lighter soils presumed to be the subsoil were observed at a depth of approximately 12 feet below the ground surface. No shaft features were observed within the trench.

A massive boulder observed in the southern half of Trench 3 **6**

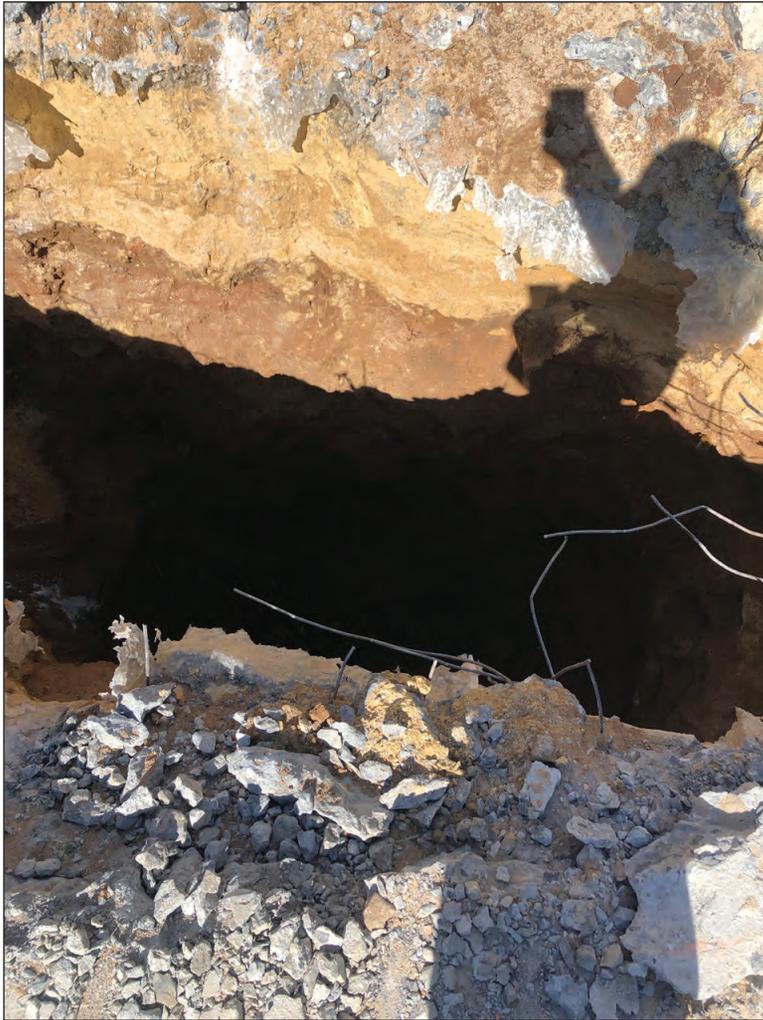
Stratigraphy in the wall of Trench 3, showing the concrete slab, the underlying slab, and the brown fill 7

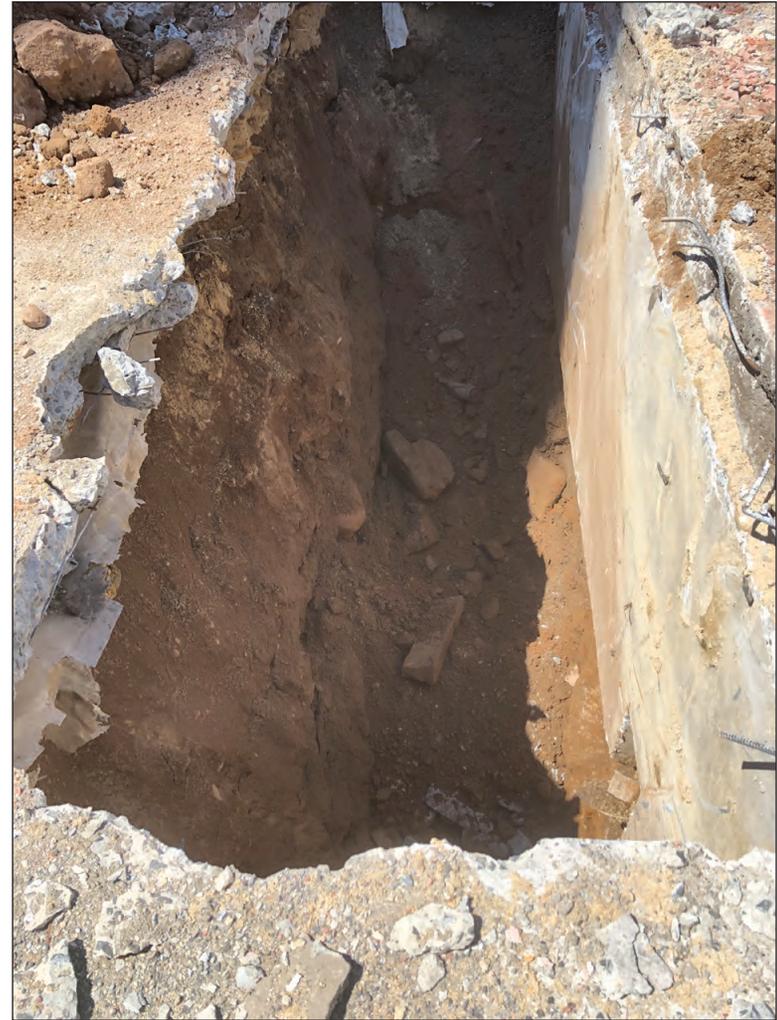
Trench 4 was excavated east–west to the south of the parking garage foundation wall along the same line as Trench 2. The trench was located in what was historically the rear yard of the buildings formerly at 165 and 167 Broome Street. The brown fill layer in this trench contained few artifacts in addition to modern demolition debris. Very large pipes were observed in those soils in the western part of the trench that were in association with the parking garage foundation wall lining the trench's northern side. Unlike Trench 2, however, a difference in soil texture and color was visible beneath the foundation wall. The soils there were slightly darker, damper, and contained limited amounts of rubble and demolition debris.

Brown fill material and the foundation wall in the northern wall of Trench 4 8

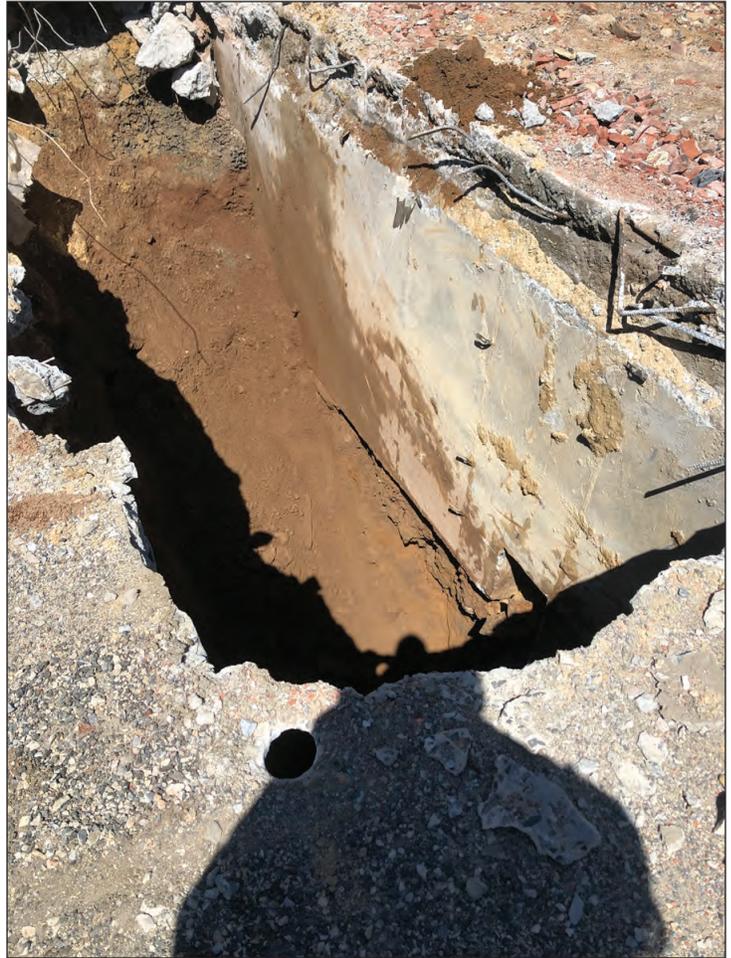
Seemingly cleaner soil beneath the foundation wall in Trench 4 9

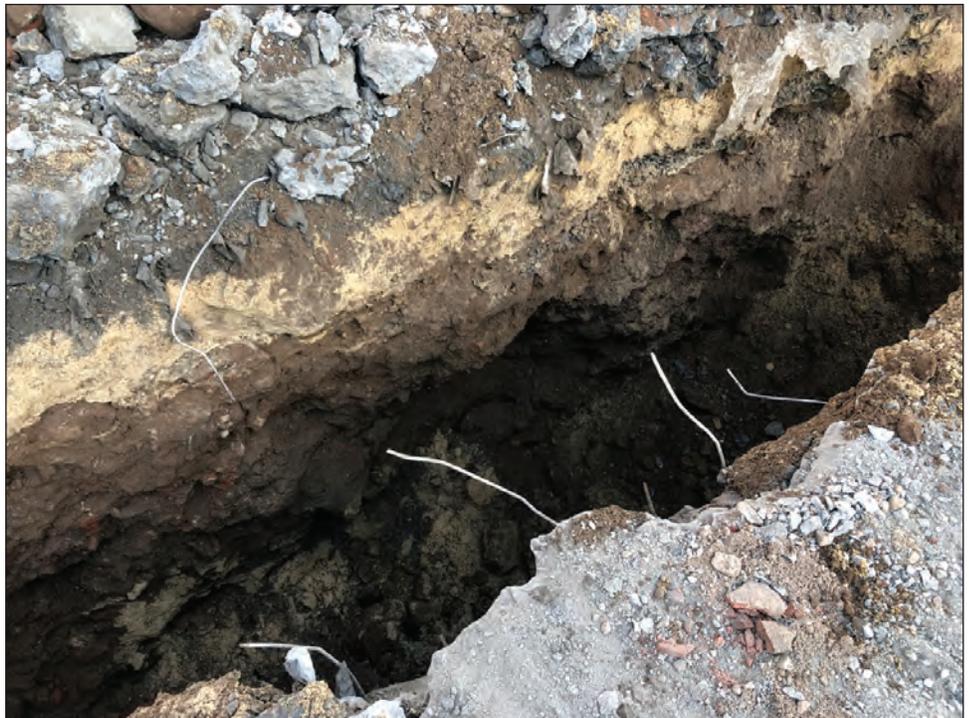
Trench 5 was situated north–south in the vicinity of the former rear yards of the buildings formerly known as 165 Broome and 39 Attorney Streets. The trench contained denser brick rubble than that seen in previous trenches, particularly in the western wall. A former brick rear dwelling stood at the western end of the property at 39 Attorney Street west of Trench 5. While the research completed for the Phase 1A Study did not suggest that the rear building had a basement, the denser concentrations of rubble to the west of Trench 5 may suggest that it either had a basement level or a substantial foundation. The denser rubble extended to a depth of approximately 7 feet below grade, below which was a layer of slightly cleaner, lighter soils. These soils continued to a depth of 12 feet, the maximum possible reach for the backhoe being used for the excavation. Lighter soils similar to the potential subsoil observed in Trenches 2 and 3 was observed towards the bottom of the excavation; however, the collapse of the loose soils in the trench walls prevented further examination of these deposits. A support column associated with the former parking garage was observed within the northeast corner of the trench. No evidence of shaft features was observed and no artifacts were collected within Trench 5.

Stratigraphy visible in the wall of Trench 5 10

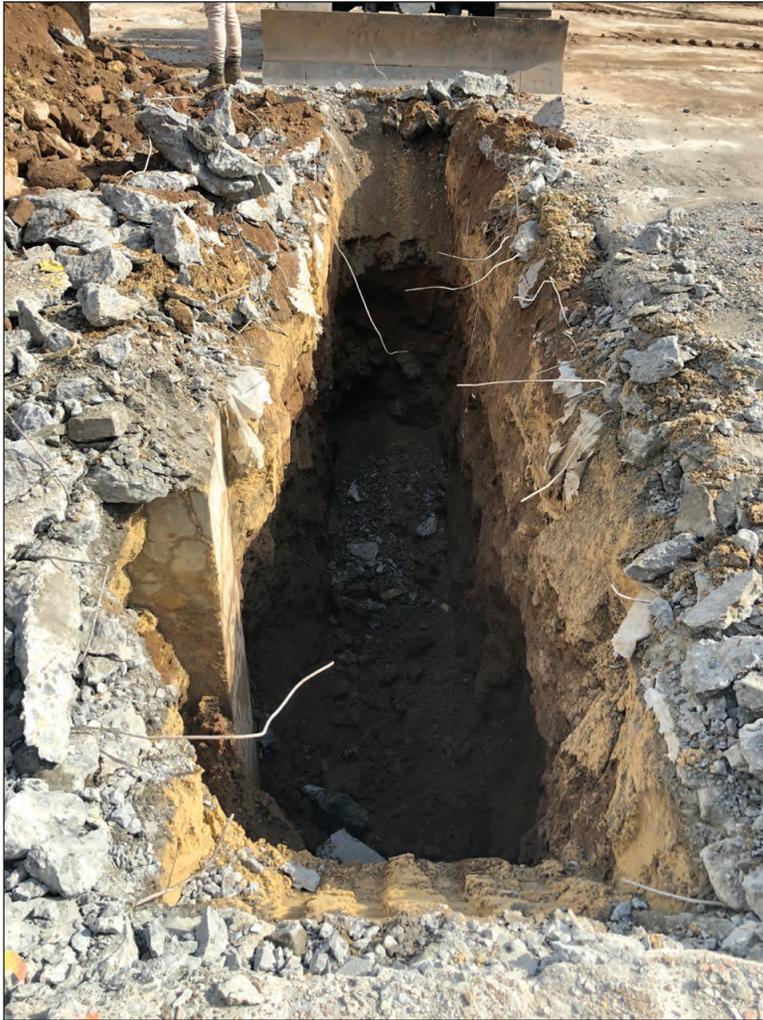
Trench 6 was oriented north–south within the former rear yards of 37 to 39 Attorney Street. As per the 2019 Work Plan, the trench was originally to be located within the rear yard of 35 Attorney Street; however, that part of the site was inaccessible due to its proximity to the public pedestrian plaza. Trench 6 as actually excavated was also situated within the footprints of the rear dwellings of 37 to 39 Attorney Street as noted previously. The soils in the trench were noticeably cleaner and contained less brick rubble than those observed in Trench 5 to the north, despite being partially within the same historical property. A large concrete support column associated with the former parking garage was observed within the west wall of Trench 6 near its southwestern corner. The column extended past a depth of 12 feet, which was the maximum depth that could be reached by the backhoe used for the excavation and it is presumed to continue to a greater depth. A total of four artifacts was recovered from the trench, including floor tiles and porcelain plumbing fixture fragments. No evidence of shaft features was observed.

Fill material observed within Trench 6; note column at left 11

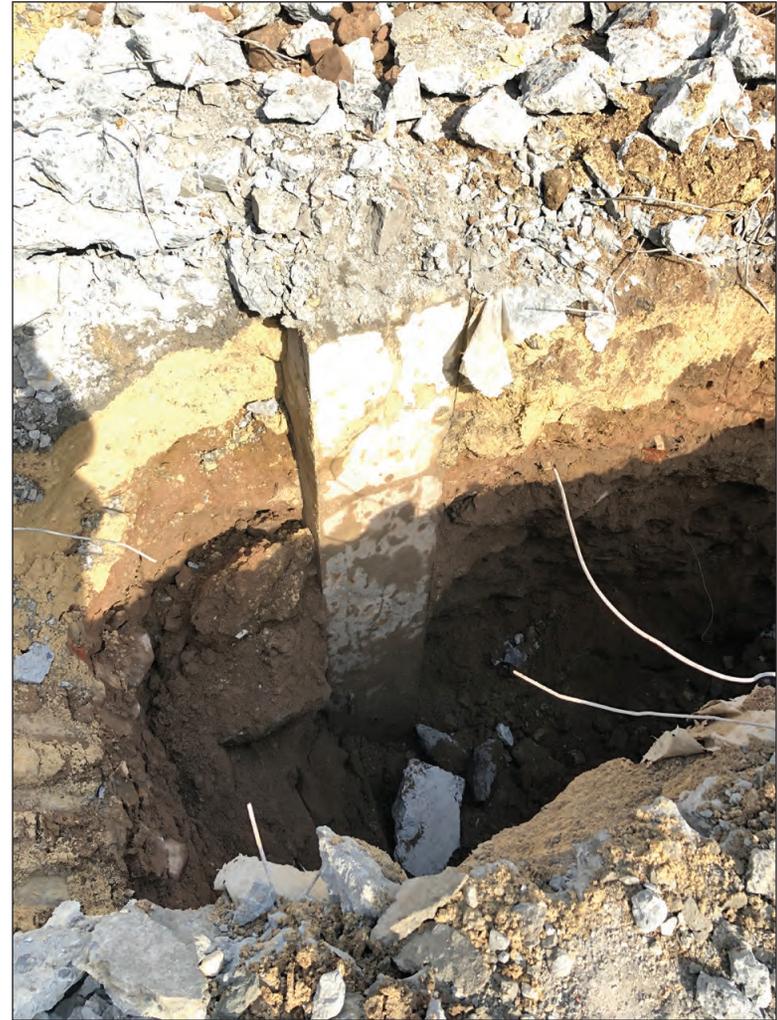
The support column observed within Trench 6 that extended beyond the excavator's maximum reach 12
