## Jennings Hall Expansion/819 Grand Street Redevelopment

**BLOCK 2922, LOT 3**

## Phase 1B Archaeological Investigation

SHPO PROJECT NUMBER: 24PR03570 LPC PUID: 36603

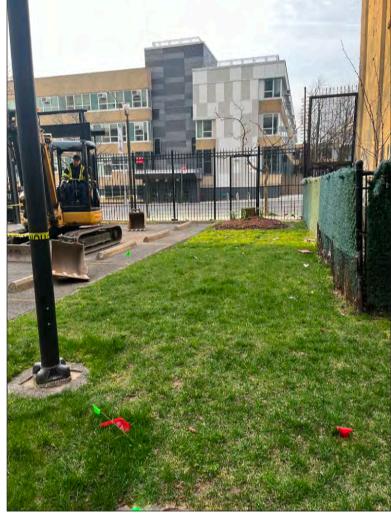
**Photograph 1:** Looking south at the location of Trench 1; the red and green pin flags mark the locations of existing gas and drainage utility lines, respectively.

Looking south at the location of Trench 1; the red and green pin flags mark the locations of existing gas and drainage utility lines, respectively.

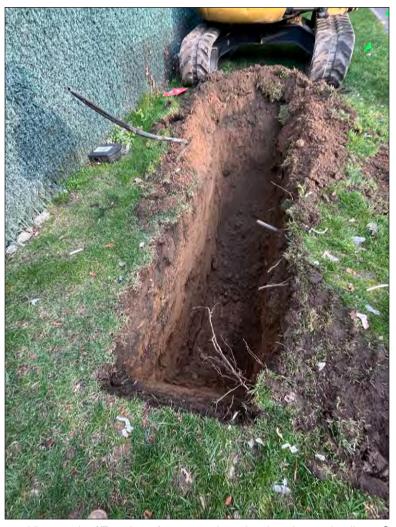
**Photograph 2:** View north of Trench 1 after excavation, showing clean subsoil below the depth of the existing sod layer; a damaged sprinkler line is visible on the left side of the photograph.

facility's sprinkler system was well as traces of demolition debris and asphalt. The topsoil was underlain by yellowish brown (10YR 5/6) slightly silty/clayey sand that appeared to be sterile subsoil. The subsoil was rocky and contained large cobbles. Increased disturbance was observed in the northern and eastern walls of the trench, likely associated with the construction of the adjacent drainage line. One very thick porcelain fragment—likely related to a plumbing fixture—and one piece of modern-looking brown beer bottle glass were collected from the disturbed subsoil within this trench. No intact historical artifact deposits, a buried ground surface, or shaft features were observed in this trench nor was any evidence observed that would suggest that archaeologically sensitive soils are present.

View north of Trench 1 after excavation, showing clean subsoil below the depth of the existing sod layer; a damaged sprinkler line is visible on the left side of the photograph.

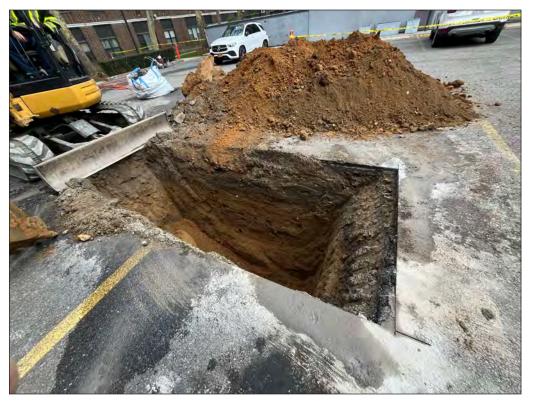
**Photograph 3:** View of the eastern wall of Trench 2, showing the layers of disturbed fill between the pavement/bedding and the clean subsoil

The ground surface in this location was underlain by two layers of asphalt measuring a total of 3 inches in thickness followed by a 3-inch-thick layer of light gray ashy bedding material. Directly beneath the bedding material was a layer of black (10YR2/1) compact mixed fill with demolition debris that extended to a depth of 2.5 feet below grade in the west wall of the trench and 3 feet below grade in the east wall. The fill layer was underlain by a layer of what appeared to be disturbed and redeposited subsoil or fill. This layer included dark yellowish brown (10YR3/4) silty sand with low concentrations of historic period artifacts. The layer appeared to slope down to the east and extended to a maximum depth of 4.5 feet in the west wall of the trench and 5 feet in the east wall of the trench. Beneath the disturbed layer was what appeared to be sterile subsoil made up of yellowish brown (10YR 5/6) slightly silty sand with clay inclusions. This layer contained large cobbles/small boulders and no artifacts were collected from that level.

View of the eastern wall of Trench 2, showing the layers of disturbed fill between the pavement/bedding and the clean subsoil.

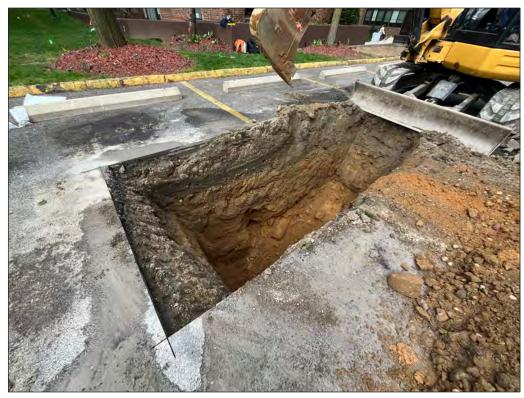
Photograph 4: View of the western wall of Trench 2, where the disturbed fill layers were slightly shallower; note: the indentation in the wall is situated near the interface between the disturbed soils and the subsoil and was formed by the removal of a large cobble, seen in the trench to the right of the photograph.

View of the western wall of Trench 2, where the disturbed fill layers were slightly shallower; note: the indentation in the wall is situated near the interface between the disturbed soils and the subsoil and was formed by the removal of a large cobble, seen in the trench to the right of the photograph.

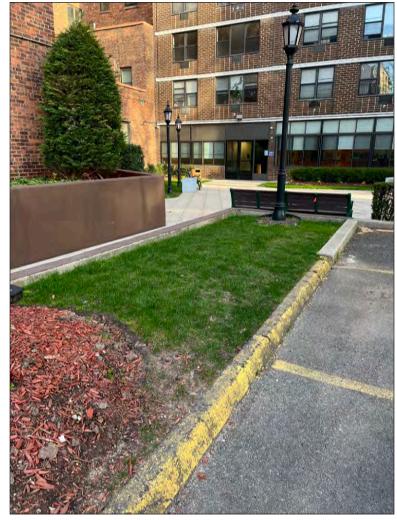
**Photograph 5:** Looking northwest at the location of Trench 3showing the grade change to the north and west; electrical lines extend in the walkway west of the grassy area and in the vicinity of the lamppost along the northern side of the parking lot.

Looking northwest at the location of Trench 3 showing the grade change to the north and west; electrical lines extend in the walkway west of the grassy area and in the vicinity of the lamppost along the northern side of the parking lot.

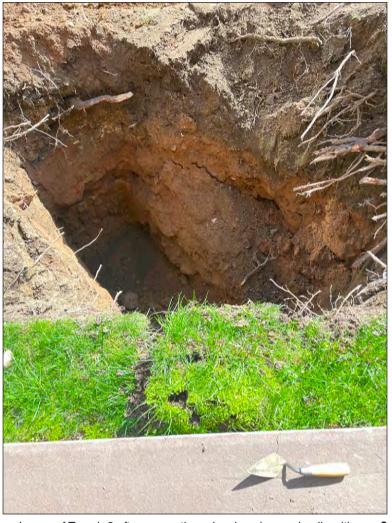
**Photograph 6:** Image of Trench 3 after excavation, showing clean subsoils with disturbed soils in the western end (bottom of photograph)

The ground surface was underlain by a layer of black (10YR 2/1) sandy silty loam topsoil with roots and evidence of sprinkler-related infrastructure that extended to a depth of 2 feet. Underneath the topsoil was a layer of disturbed and redeposited subsoil that extended to a depth of 5 feet below ground surface. Within this layer, a buried asphalt surface was encountered at a depth of approximately 3 feet, seemingly in associated with the foundation wall of the adjacent walkway that was encountered at the same depth in the west wall of the trench. As a result of the construction of the adjacent walkway, there was greater soil disturbance observed in the west wall. In the east half of the trench, where soils appeared to be less disturbed, the soil was a dark yellowish brown (10YR3/4) damp silty sand with occasional large cobbles/small boulders. The disturbed soils included fragments from porcelain plumbing fixtures, bricks, and other demolition debris that was not collected or analyzed. Between depths of 5 and 7.5 feet below the ground surface was a sterile subsoil comprised of dark yellowish brown (10YR 3/6) slightly silty sand with gravel, small rocks, and clay inclusions. Low concentrations of demolition debris observed within these soils appears to have fallen in from upper levels during excavation. No buried ground surfaces or shaft features were observed in this trench nor was any evidence observed that would suggest that archaeologically sensitive soils are present.

Image of Trench 3 after excavation, showing clean subsoils with disturbed soils in the western end (bottom of photograph)

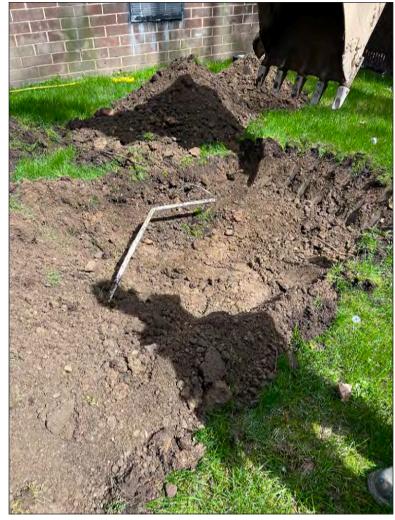
**Photograph 7:** Looking north at an undocumented utility line at a shallow depth within the abandoned Trench 5.

Looking north at an undocumented utility line at a shallow depth within the abandoned Trench 5.

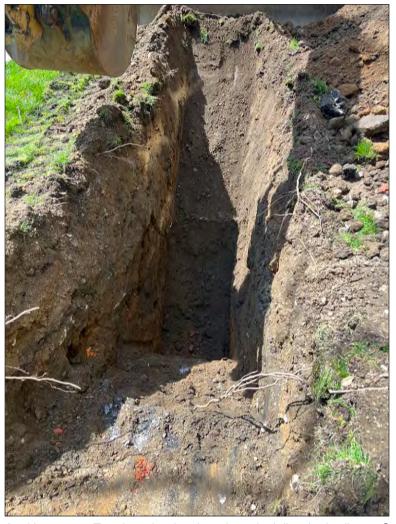
**Photograph 8:** Looking west at Trench 4, showing densely packed disturbed soils throughout the entire depth of the trench; project-related impacts in this area will not exceed the depth of disturbed soils.

area in this general vicinity. Beneath the very disturbed and compacted material, subsoil was encountered at a depth of 6 feet. The subsoil was composed of dark yellowish brown (10YR 4/6) damp slightly silty sand. No buried ground surfaces or shaft features were observed in this trench nor was any evidence observed that would suggest that archaeologically sensitive soils are present. It is believed that this portion of the project site was extensively disturbed during the construction of the adjacent Jennings Hall.

Looking west at Trench 4, showing densely packed disturbed soils throughout the entire depth of the trench; project-related impacts in this area will not exceed the depth of disturbed soils.

The results of the testing appear to suggest that the disturbance from the construction of Jennings Hall and the surrounding buildings has removed traces of historical building foundations and backyard deposits, including any potential shaft features. Given the extent and depth of this disturbance, it is unlikely that the construction of the proposed project would result in the disturbance of archaeological resources, including domestic shaft features. No further archaeological analysis is recommended.
