Phase IB Archaeological Investigation 236 Gold Street Development Project

236, 242, 244, 246 Gold Street, Brooklyn, NY 11201 (Brooklyn Block 121; Lots 33, 35, 36, 37)

LPC Project Number: 78DCP057K (Department of City Planning)

August 2024

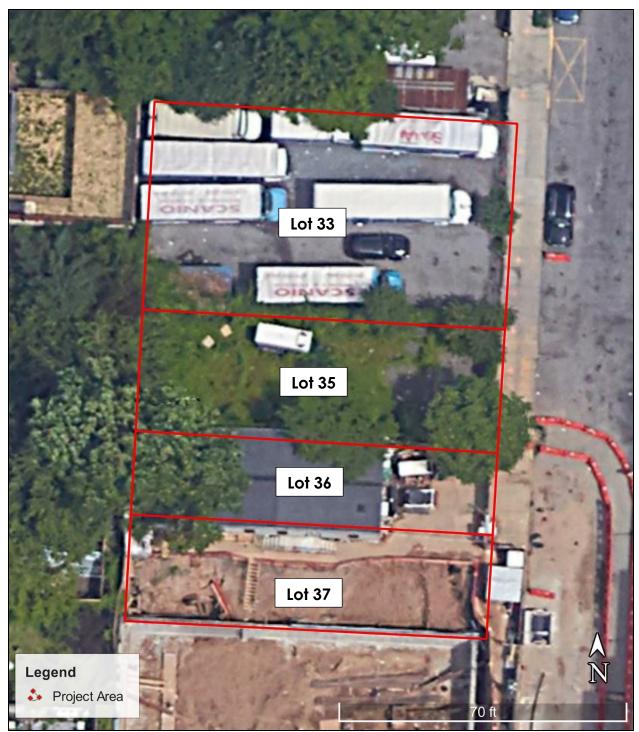
The disturbance identified in Lot 37 in both Trench 1B, along the rear property line, and in Trench 5, to the rear of the structure, is consistent with the 2018–2019 construction of the building to the south 260 Gold Street (Figure 6). During that construction Lot 36 was used to house construction trailers and Lot 37 was partially excavated to provide access to the building foundation level. This excavation extended approximately 16' into the 25' wide lot, and provided access to the foundation of the structure via a temporary wooden staircase. This deep excavation explains the deep destruction of the rectangular brick privy at the rear of the lot and the lack of any preserved features or ground surfaces behind the dwelling.

Figure 6. Aerial photograph from May 2019 (Google Earth Pro), note excavation within Lot 37 associated with the construction of 260 Gold Street to the south.

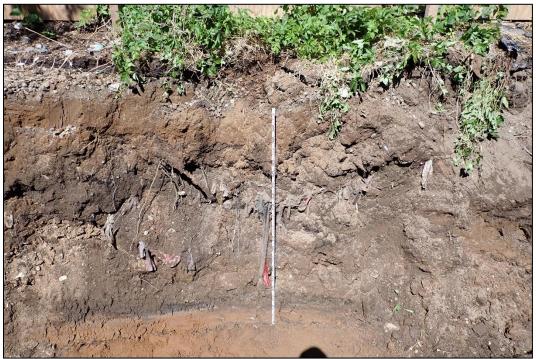
Photograph 8. Trench 1A along the rear of former Lot 34, facing west. Note dense fill of fabric scraps.

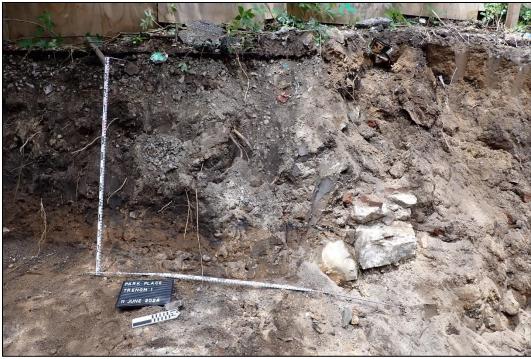
Photograph 9. Trench 1A along the rear of Lot 35, facing west. Note foundation wall of light industrial structure.

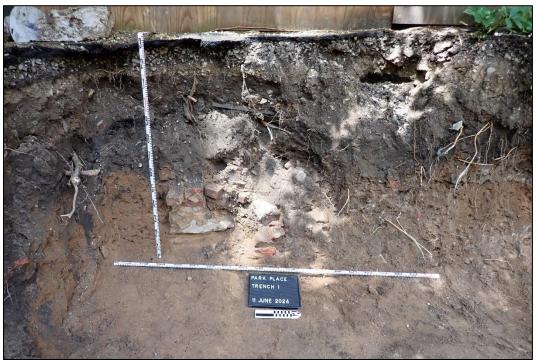
Photograph 10. Trench 1A along the rear of Lot 35, facing west. Note foundation wall of light industrial structure.

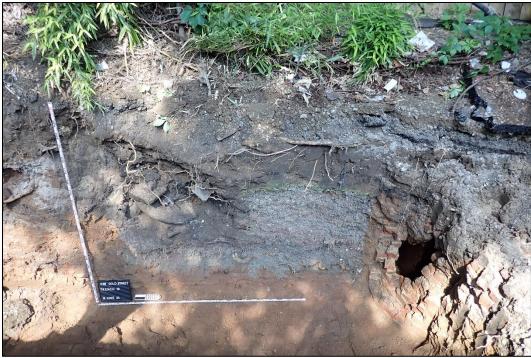
Trench 1B also identified a circular brick shaft feature in the northwest corner of Lot 36 (Photograph 11). This feature was partially cut by the excavator bucket, revealing that the interior was unlined. Due to its location on the rear lot line and the lack of cement lining it is interpreted as a privy. The interior of the feature was largely empty except for a large piece of rusted metal equipment that had been dumped in upside down (Photographs 12–13). This equipment is potentially a furnace, presumably deposited in the shaft feature when the associated building was upgraded or demolished in the 20th century. The base of the trench was 1.8m below ground level (bgl), with the equipment continuing further to approximately 2.5m bgl. The space around the piece of equipment was notably free of debris. The depth of the feature and lack of debris suggests that the privy was cleaned and potentially used as a drywell during the 20th century, prior to its abandonment. The full plan of the feature was not exposed as it extended under several layers of fencing to the north (Photograph 14) and an active utility pole to the west (Photograph 2). The surface elevation of Trench 1B in Lot 36 was 40.6' (NAVD88) and excavation reached a depth of 32.7' (NAVD88), though the privy feature extended lower.

Photograph 11. Trench 1B along the rear of Lot 36, facing west. Note trash pit filled with ash and 20th century trash, and circular shaft feature extending to the north and west.

The circular brick privy identified in Lot 36 is notably empty, save for a large piece of metal equipment dumped in it. Excavation of this feature is unlikely to yield significant information on the lives of the past inhabitants of the Lot 36 residence. The rectangular brick privy identified in Lot 37 is badly disturbed by modern construction activities and what intact feature fill remains is largely composed of 20th century trash. Excavation of this limited intact material is therefore also unlikely to yield significant information on the lives of the past inhabitants of the Lot 37 residence. Additionally, trash pits were identified in Lots 36 and 37, however, they were filled with 20th century trash, ash, and/or shell, all of which are classes of material with limited to no research potential. Based on these results no significant archaeological sites or features were identified by this field effort and no further archaeological investigations are recommended for this undertaking.

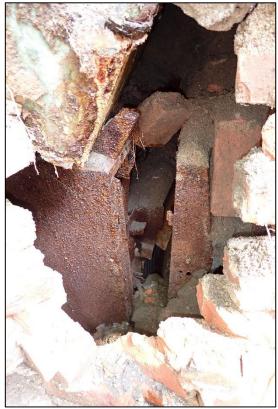
Photograph 12. View into the interior of circular shaft feature, note large upside-down rusted equipment.

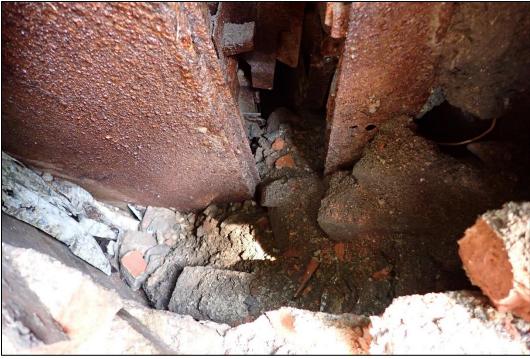
Photograph 13. View down the circular saft feature, note limited fill.

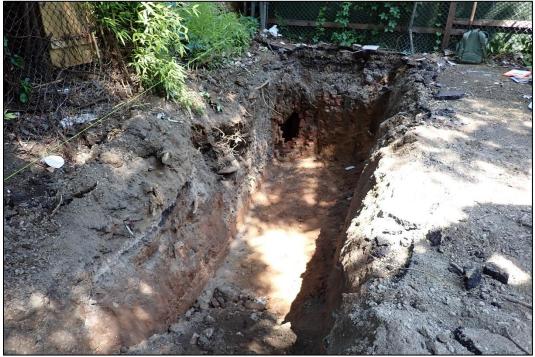
Excavations in Lots 36 and 37 found a pair of brick structures along their rear property lines, interpreted as privies due to their placement and lack of cement lining. In the northwest corner of Lot 36 a circular brick feature was found and partially cut by the current excavation. The interior was notably empty except for a large and rusted piece of metal equipment that was previously discarded into the feature. This piece of equipment may have been a residential furnace or boiler. The otherwise empty feature and discarded residential equipment suggest that the privy was cleaned out and used as a drywell, until the 20th century demolition of the associated structure. The plan of the feature was not exposed as it extended to the north beneath the fence separating Lots 35 and 36 and to the west towards an active utility pole.

Photograph 14. Overview of Trench 1B, facing north. Note the extension of the feature below the fence to the north and into the property to the west.

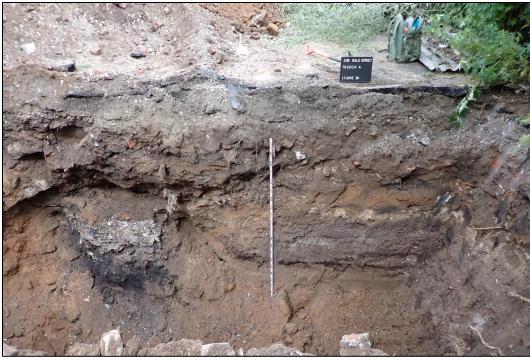
Trench 4 was also excavated within Lot 36, located to the rear of the brick residence noted on the 1855 map. The rear wall of the structure was identified through superficial excavation and the trench positioned along its exterior. An opening into the structure was identified, filled with demolition debris. A buried surface associated with the former yard of the structure was also identified and a trash pit was identified extending into the western profile (Photograph 15). The pit appeared circular but without a built structure. It contained a lower layer of dark black ash and an upper layer of oyster and clam shells. Above both the pit and the surface were a fill of demolition debris, which included fragments of cloth similar to those identified in Lot 33. The surface elevation of Trench 4 was 38.2' (NAVD88) and excavation reached a depth of approximately 30' (NAVD88).

Photograph 15. Trench 4 to the rear of the residence in Lot 36, facing west. Note trash pit containing shell and ash, note 20th century fill above.

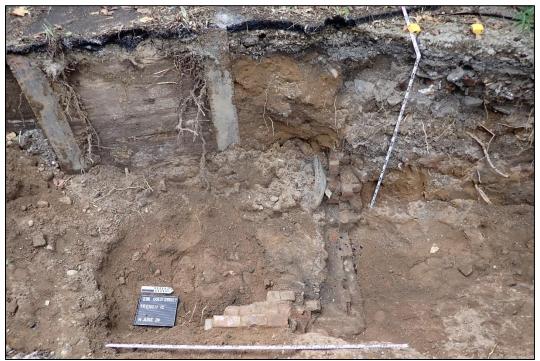
The feature was, however, disturbed ca. 2018 (Figure 6) by a series of H beam piles driven into the ground along the property line and linked together with wooden boards. This shoring extended into the feature, with an additional section having been excavated and filled with clean, silty sediment (Photograph 16). The feature was further disturbed to the south by deep excavation that removed the entire southern portion of the feature, replacing it with mixed fill containing few artifacts. There is therefore little of the feature left intact and it too appears to have been cleaned out and used as a drywell prior to being fill with mid-20th century debris. The surface elevation of Trench 1C in Lot 37 was also 40.6' (NAVD88) and excavation reached a depth of 34' (NAVD88), though remnants of the disturbed privy feature extended lower.

Along the rear property line of Lot 37 a square brick feature was identified, also unlined and also interpreted as a privy. The feature was badly disturbed by recently installed shoring and excavation associated with the 2018–2019 construction of the building to the south. The extant feature fill contained abundant 20th century trash, such as automobile tires and domestic refuse. This chronologically late fill, mixed with earlier material, suggests that it too was likely cleaned out and used as dry well during the 20th century, until the late-20th century demolition of the associated structure.

Photograph 16. Trench 1B along the rear property line of Lot 37, facing west. Note rectangular brick feature with rubber tire. Disturbance from temporary retaining wall to the west and previous excavation to the south.

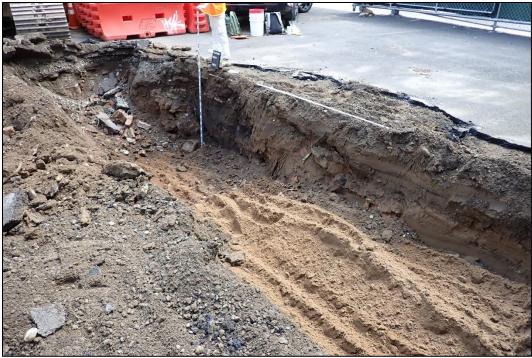
Trench 5, excavated along the rear of the domestic structure, identified the badly disturbed rear foundation wall of the structure, built of stone blocks (Photograph 17). Here too, ca. 2018, the wall had been cut and a deep excavation sloped downward towards the adjacent building to the south (Figure 6). The fill was clean sand with modern construction debris, such as plywood and caution tape. The surface elevation of Trench 5 was also 38.2' (NAVD88) and excavation reached a depth of 33.9' (NAVD88).

Photograph 17. Trench 5 along the rear of the residence in Lot 37, facing northeast. Note sloped cut and clean fill extending to the south.

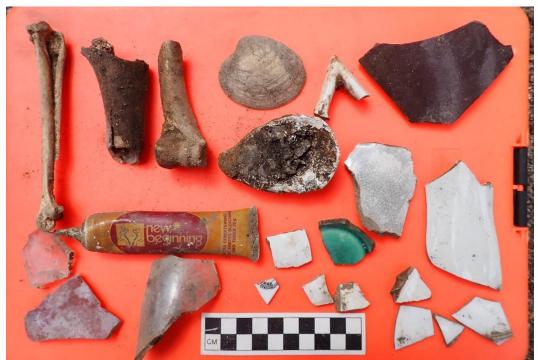
This lot (Figures 2–3) was developed by 1855 with a wood framed residence (Figure 4), which was built in conjunction with an identical house to the south (beyond the current project area). It was tested with Trench 1C along the rear property line and Trench 5 to the rear of the house. Trench 1B found the remains of a badly disturbed square shaft feature constructed of brick (Photograph 16). It is unlined and interpreted as a privy. The fill of the feature that appeared historic contained automobile tires and other 20th century trash, with smaller pieces of 19th century material, such as butchered animal bones, shells, and small pieces of whiteware and stoneware ceramics (Photograph 21).

Photograph 21. Disturbed fill from Lot 37 Privy, Trench 1C.
