Stage 1B Archaeological Examination

527 and 529 East 118th Street

East River Plaza Site

December 1998

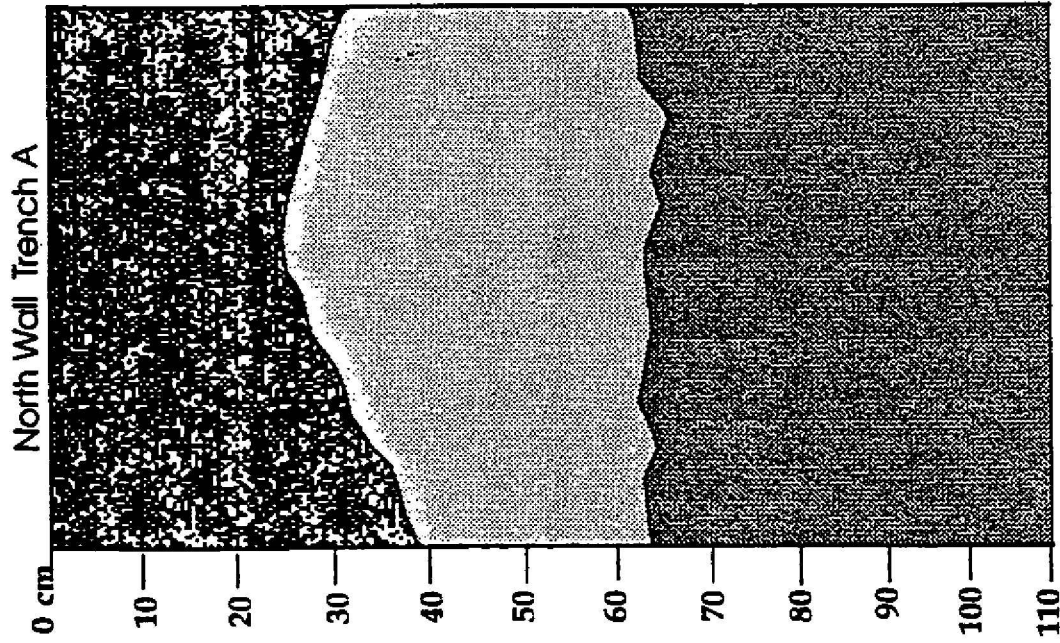
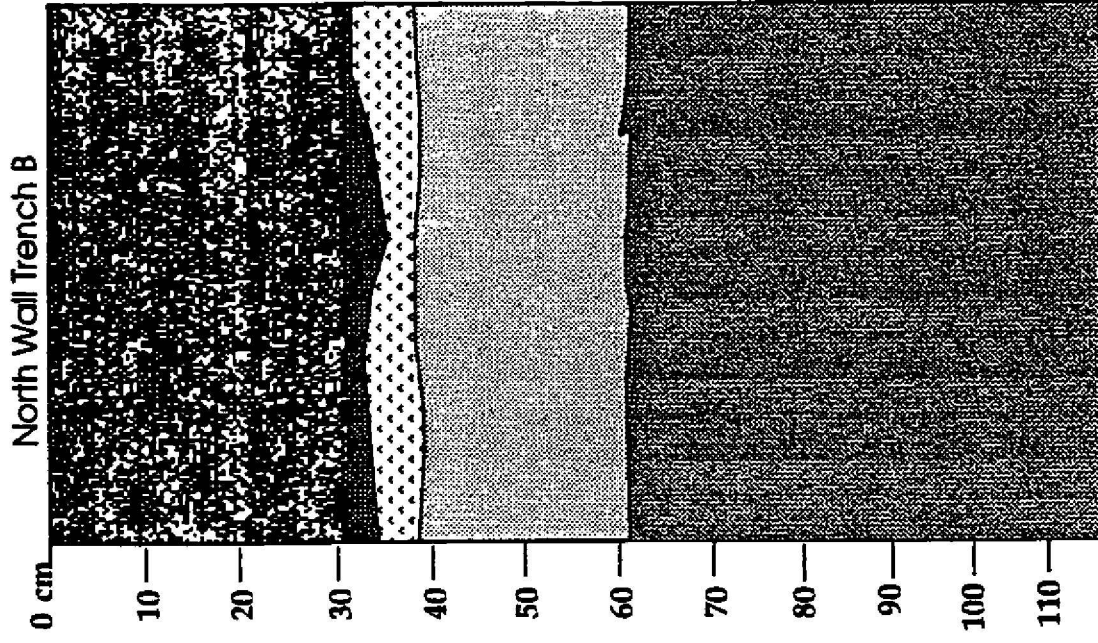
Figure 3. Stratigraphy. East River Plaza.

After the removal of the surface gravel and deposits, a thick fill level was encountered (Figure 3). Continued excavation revealed a significant fill layer that contained a large amount of building debris and twentieth century artifacts (bottles and jars with modern plastic twist tops, Perrier Water bottles, plastic pipe fragments, plastic game pieces, electrical wire, brick fragments, a variety of plastic containers and bottles, and modern whiteware). Only a few nineteenth century ceramic fragments were noted from this mixed context. The soil was a very dark grayish brown silty sand that was very compact. Following the removal of approximately 30-40 centimeters of fill, Level 2 was encountered. A dark yellowish brown silty sand, this stratum contained fewer artifacts. The majority noted, however, also dated to the twentieth century. Modern glass bottles, PVC pipe fragments, a large fragment of a plastic bag, flower pot fragments, and a modern plastic fork were identified.

Following the removal of approximately 35 centimeters of fill in the northern section of the trench a thin soil layer was encountered under Level 1 (Figure 3). This stratum, identified in Trench B as Level 2, was a pale brown sand layer that contained no artifacts. It was only present in the northern eight meters of the trench. Near the northern edge of the trench, approximately two feet below the surface, another series of connecting flagstones was encountered. As in Trench A, a patio, or path terminus was found at the northern end of the lot. Many of these flagstones were no longer in place. Level 3 was encountered at a depth of 40 centimeters below the surface. This level was identical to Level 2 found in Trench A. In the eastern portion of the lot, another path, running north-south was discovered, approximately one meter east of the path discovered in Trench A. Again a large section of these dressed stones was exposed via shovel-shaving (Photograph 6). This pathway, also a little over one-half of a meter wide (1 3/4 feet), was constructed in the same manner as the one in Trench A.

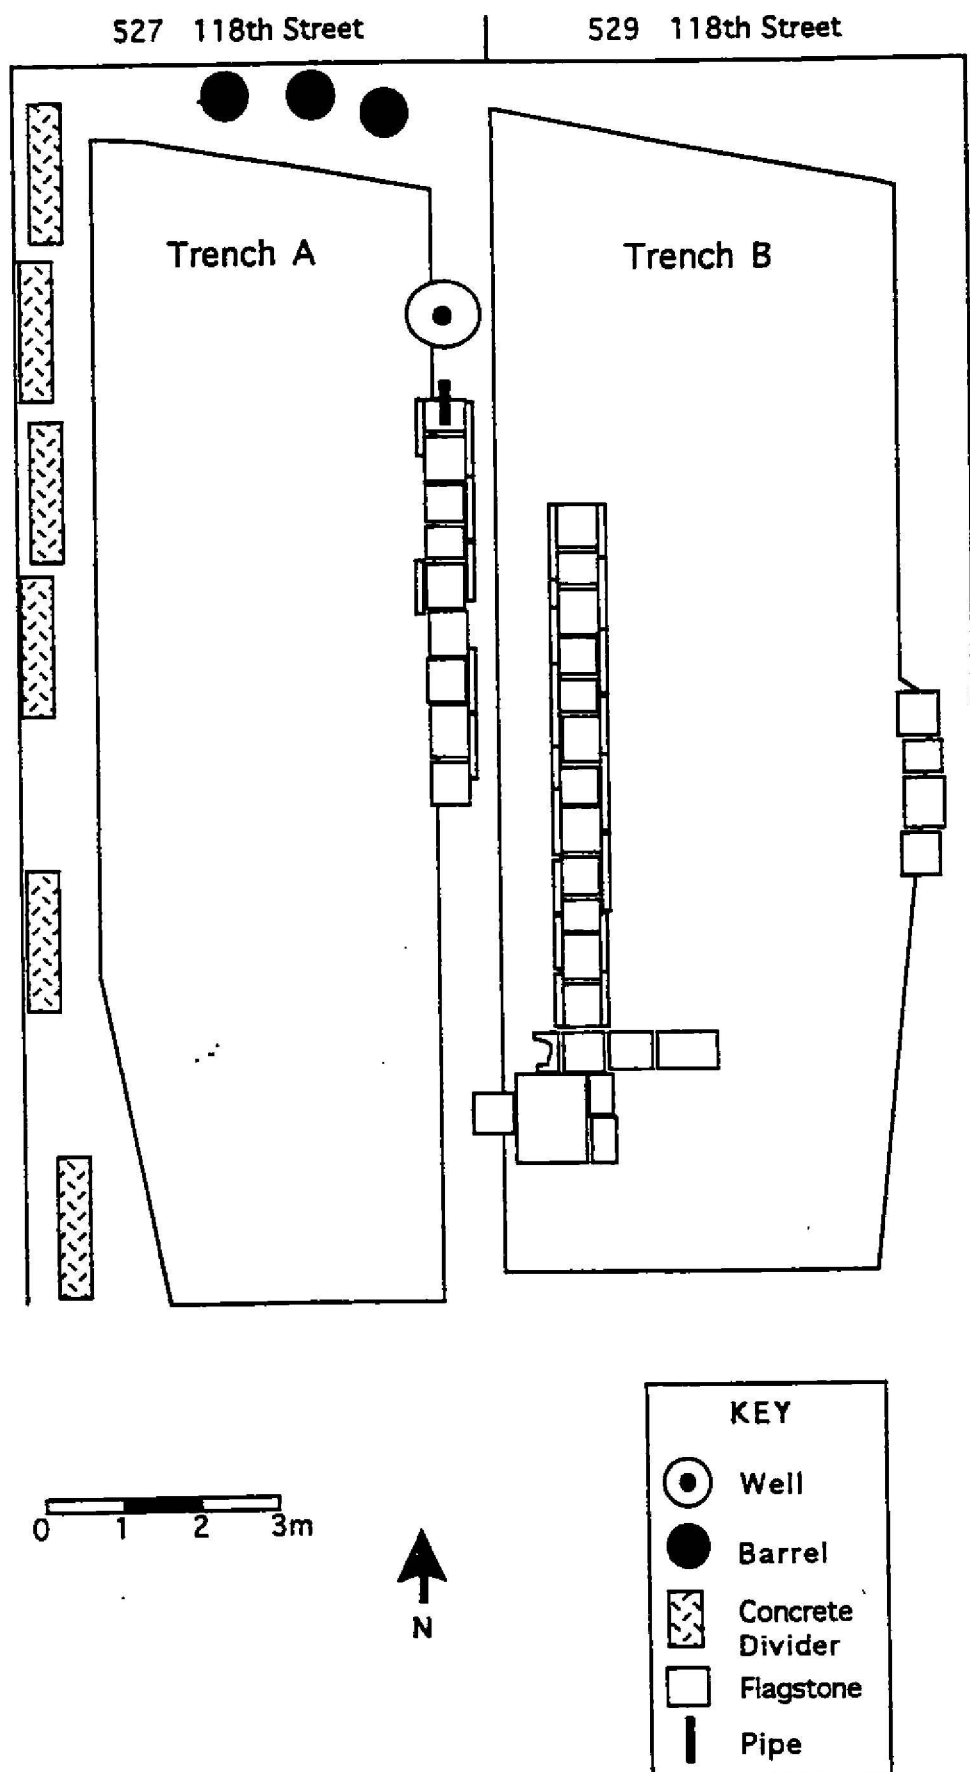
Figure 4

The backhoe was used to expose as much of the flagstone path as possible. It was discovered that another patio was present at the southern end of the path adjacent to the former residence. A large stone, which may have been the bottom step of a rear entry was still in place (Figure 4; Photograph 7). A section of the path discovered in Trench B was also dismantled in order to examine the soils below and compare them with Trench A. After the removal of the flagstones, a small layer of fill, less than three centimeters deep, was encountered. This fill level was identical to Level 3 except that no artifacts were recovered. A portion of a third flagstone pathway, running north-south, was also discovered near the eastern edge of the lot. This path was constructed slightly different, as it only had a single line of flagstones with no border stones. Because of the proximity to the brick building only a small section of this path was exposed. As with the other paths, the stones were found to be placed almost directly on top of the subsoil, identified in this trench as Level 4, a strong brown fine silty sand. No artifacts were recovered from this layer.

When the two residences were standing, it appears that a significant amount of grading took place in order to create a level surface for the flagstone paving. The absence of a clear defined layer of soils containing nineteenth or early twentieth century materials indicates that this grading likely took place during the second quarter of the twentieth century. The residents may have connected the two homes to a patio at the northern edge of the property and were perhaps the ornamental borders to a back yard garden. The stones were dressed and their placement in the yard was likely a labor intensive activity (see Photographs 2, 6, and 7). It is clear that they were constructed in a single episode when both buildings were occupied or owned jointly (Figure 4).

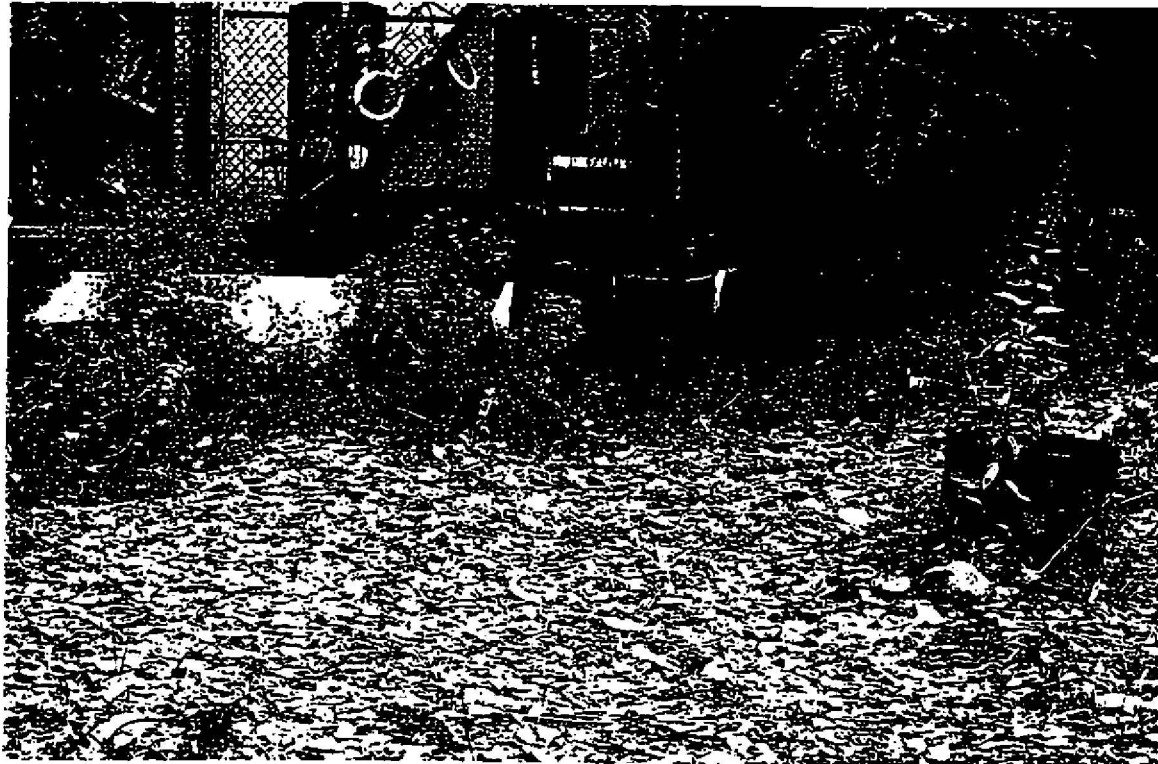
The first area examined was the northern or rear portion of a residential lot that was formerly the backlot of 527 East 118th Street. At the start of the examination, the lot was covered with gravel, architectural debris, and modern trash. At one point in the lot's history it was utilized as a parking facility and signs indicating the parking space numbers were partially visible along the boundary. In addition, several large concrete road dividers were found along the western edge of the lot adjacent to a wire fence. The northernmost portion of the lot was found to be bounded by a cement wall outlining the below ground entry into the building located at 524 East 119th Street. In addition, a modern monitoring well and large metal trash barrels are located in the northern section of this lot (Photograph 1).

Photograph 1. 527 East 118th Street. Location of Trench A.

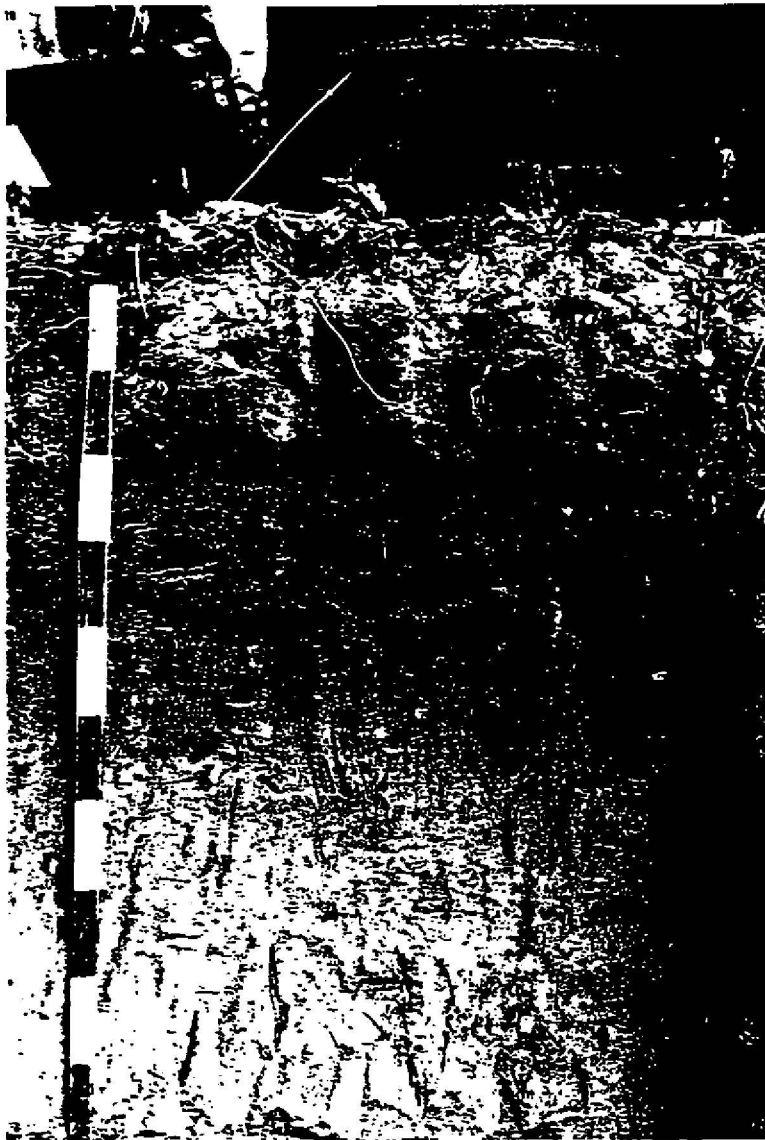
Photograph 3. 527 East 118th Street. North Wall, Trench A.

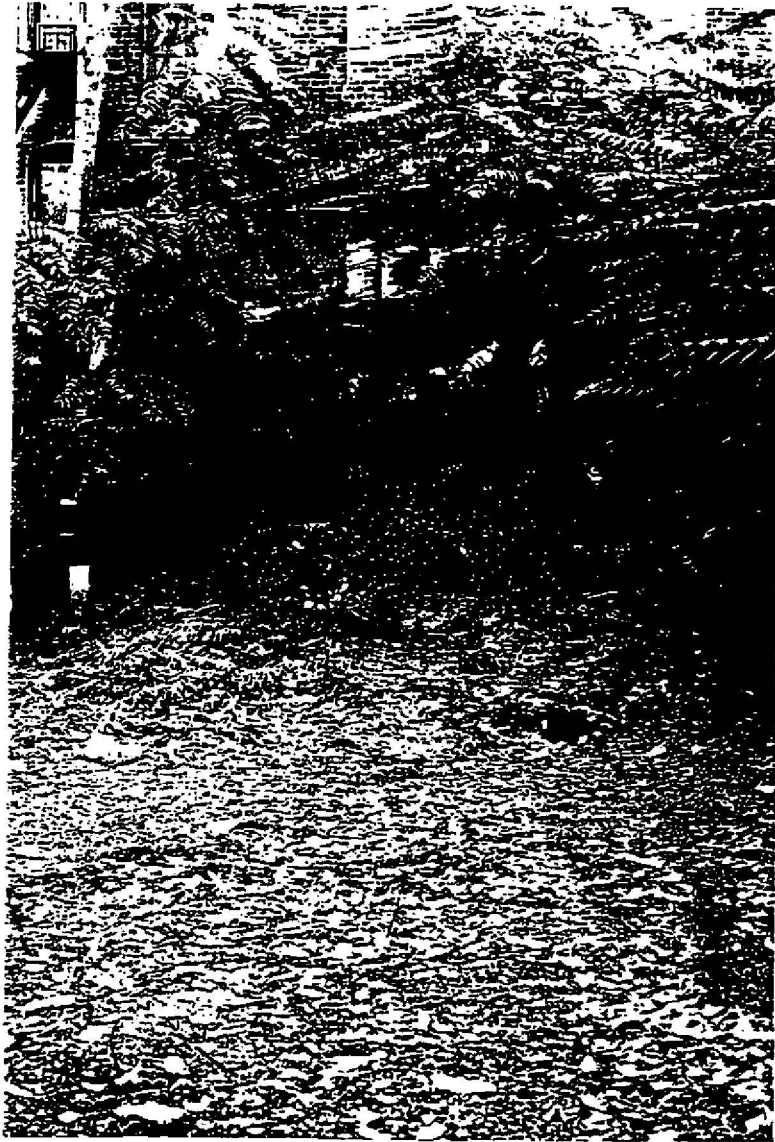
The second area examined was the northern or rear portion of a residential lot that was formerly the backlot of 529 East 118th Street. At the start of the examination, the lot was covered with gravel, architectural debris, a large pile of mixed debris, soils, and gravel, as well as modern trash. This lot had also once been utilized as a parking facility and painted parking space numbers were partially visible on the brick structure located on the east side of the project lot (Photograph 4).

Photograph 4. 529 East 118th Street. Location of Trench B.

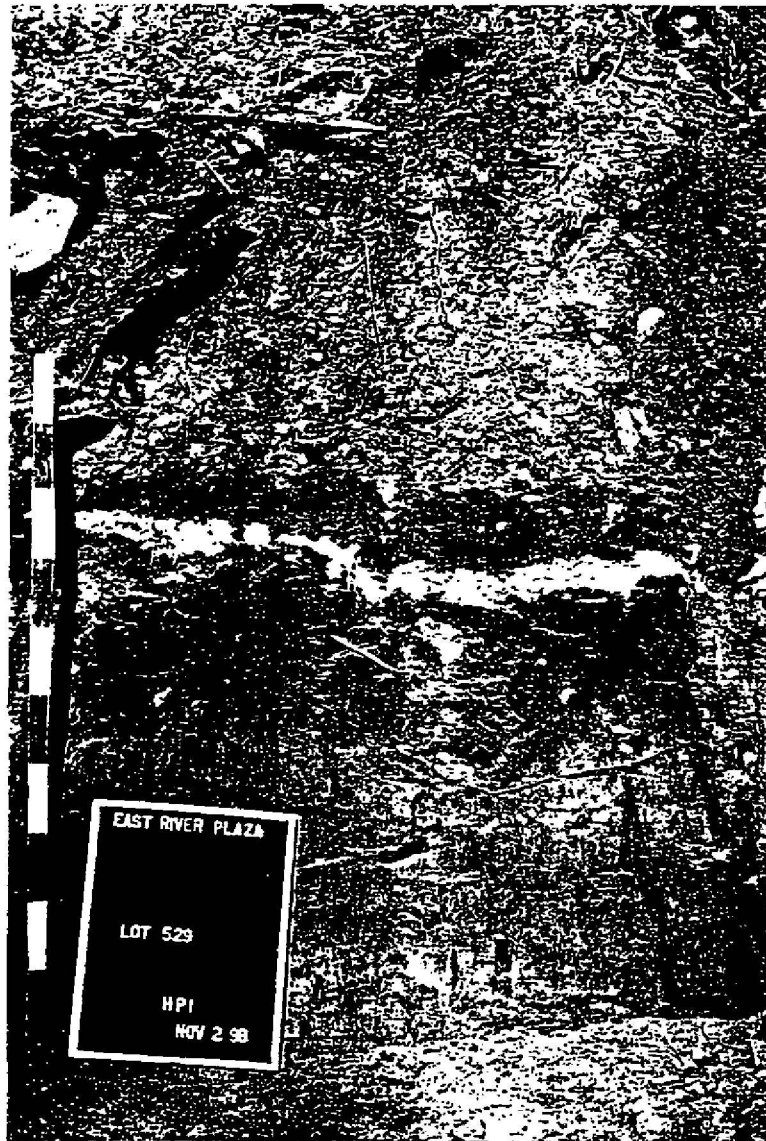
After the removal of the surface gravel and deposits, a thick fill level was encountered (Figure 3, Photograph 5). Continued excavation revealed that the fill layer contained a large amount of building debris and twentieth century artifacts. Only a few nineteenth century ceramic fragments were noted from this mixed context. Although this level was similar to Level 1 in Trench A, there was a significant ash content that had not been present in the adjacent trench. In fact, several ash lenses were found throughout this fill layer. The artifacts noted in the fill included plastic bottles, glass bottles with modern plastic twist tops, PVC pipe fragments, electrical wire, bricks and brick fragments, and large unidentified iron fragments. The soil was a very dark gray coarse sand mottled with ash and very compact. The ash

Photograph 5. 529 East 118th Street. North Wall, Trench B.

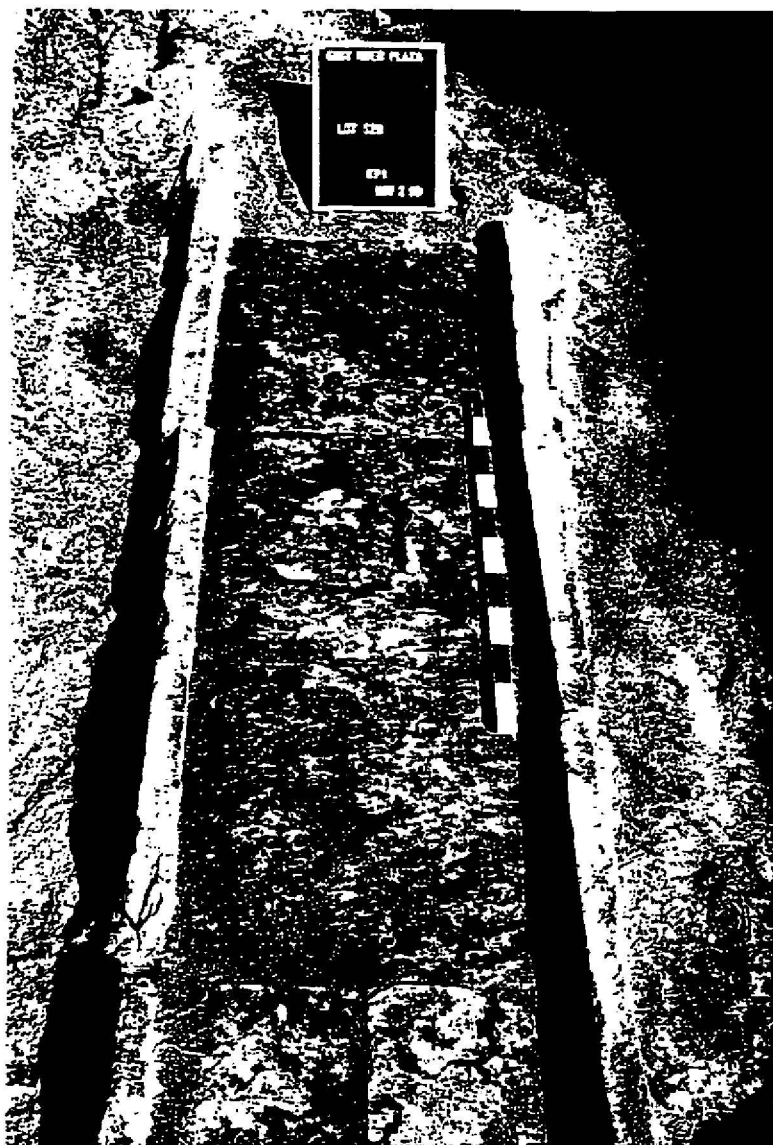
Photograph 6. 529 East 118th Street. Flagstone Path.

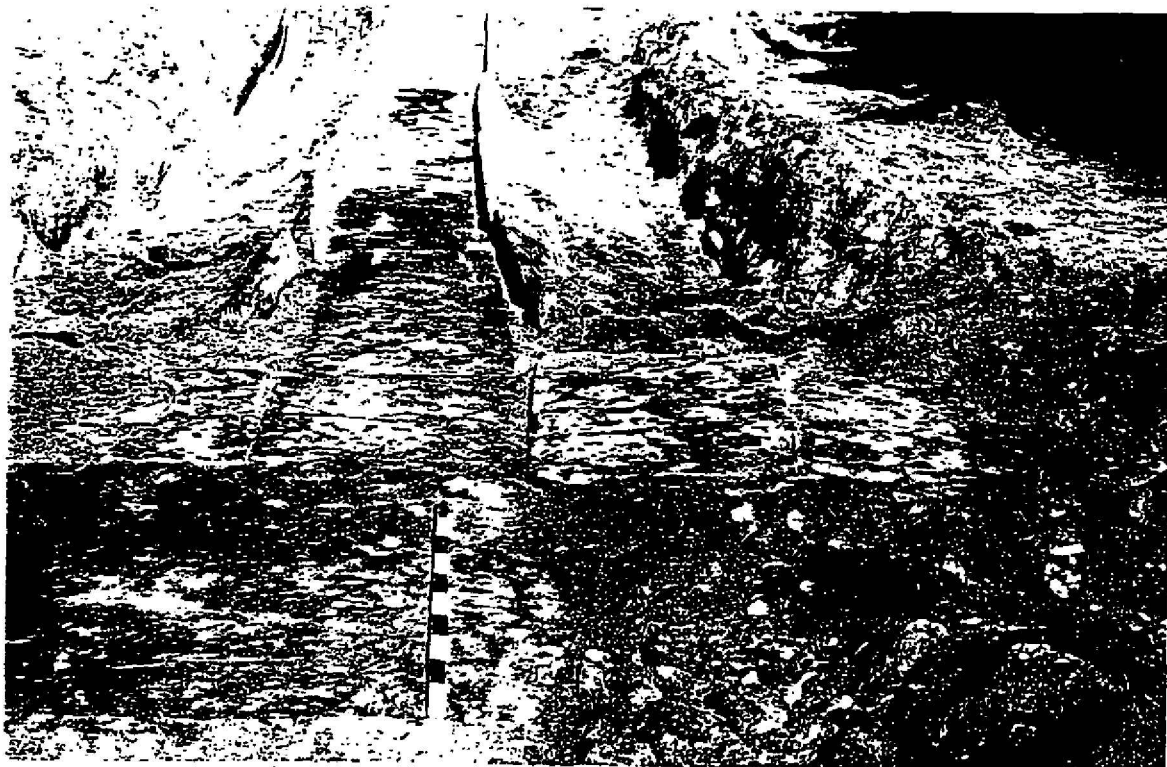
Photograph 7. 529 East 118th Street. South End of Flagstone Path at the Location of the Former Residence.
