5050R  
US DOI

Cultural Resources Report for Fort Wadsworth, Staten Island, New York

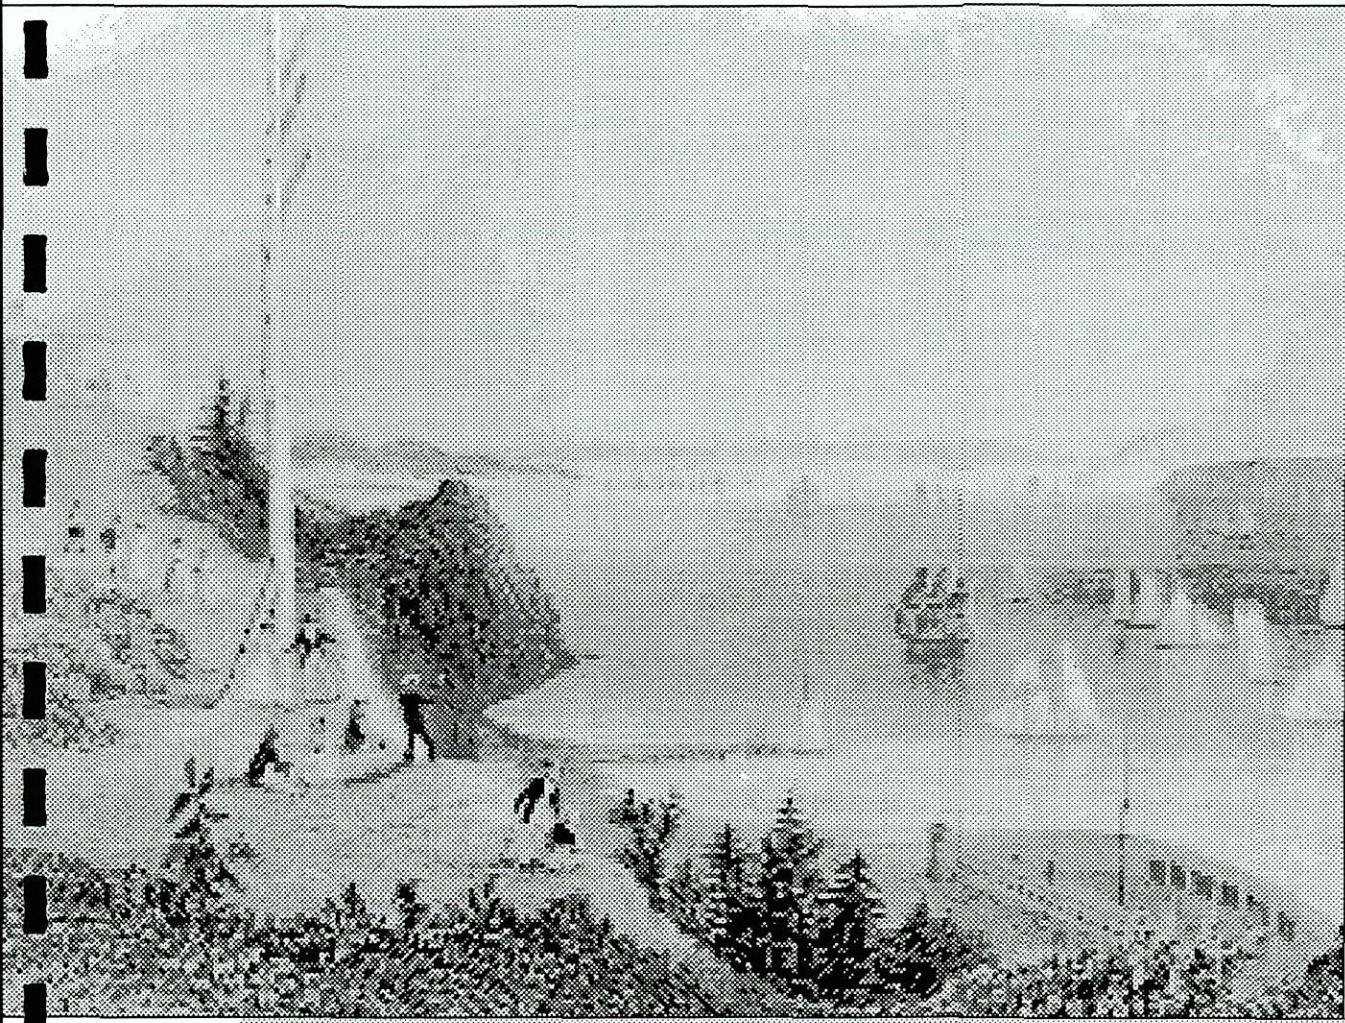
**1.1 Introduction**

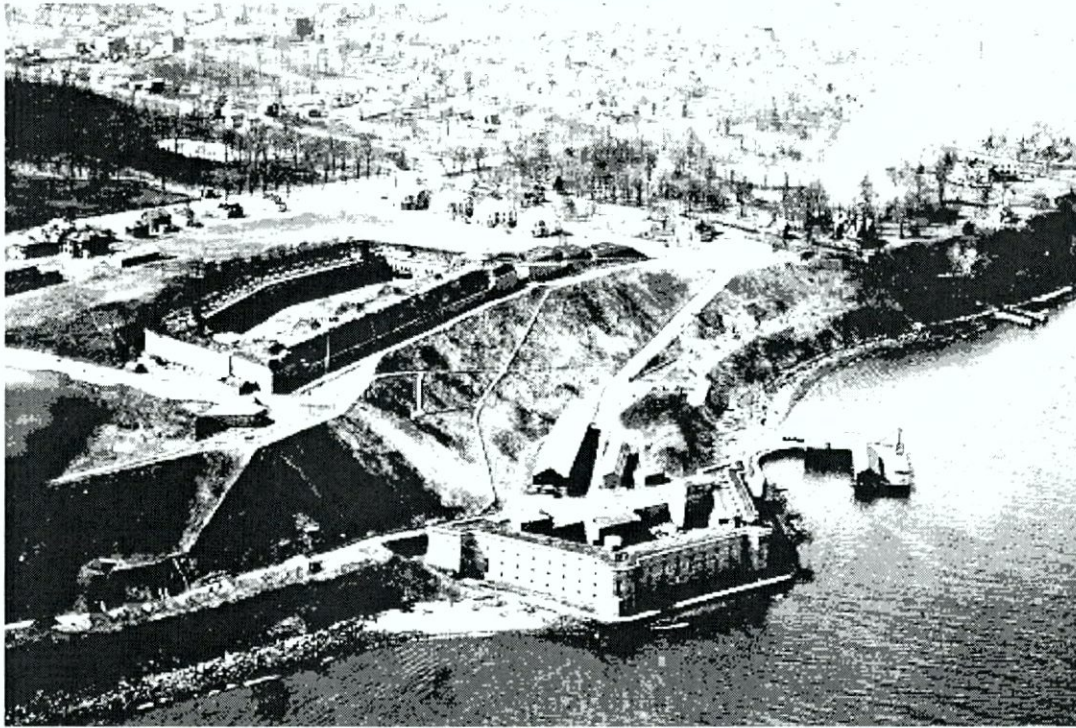
## **1.2 Programmatic and Research Recommendations**

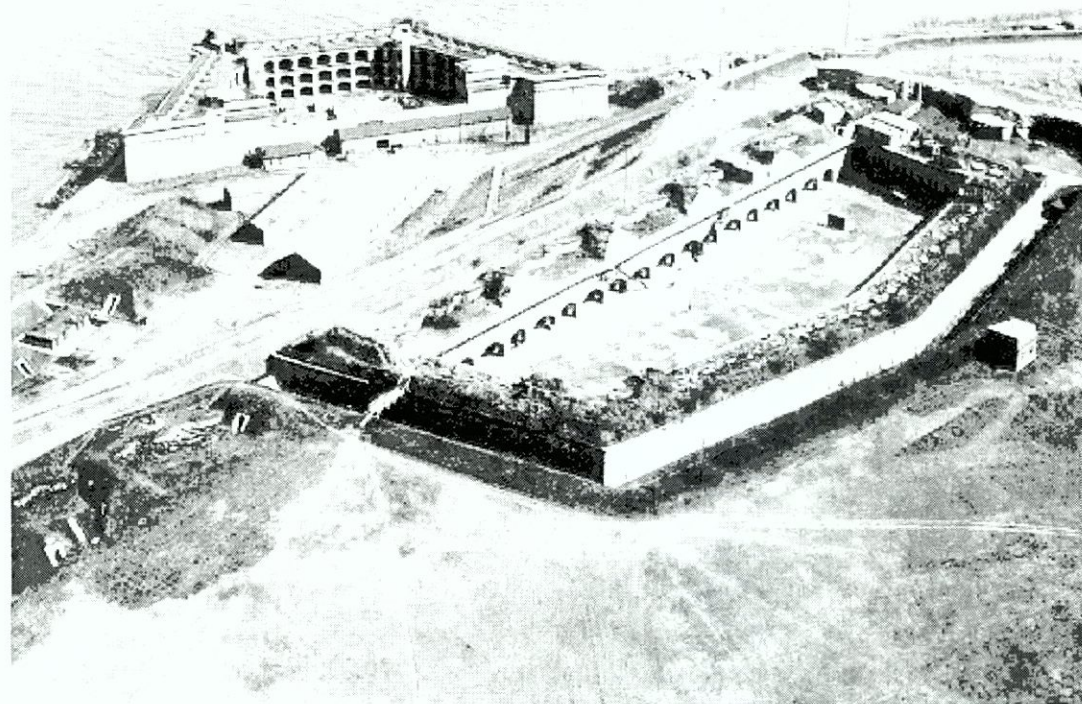
An inventory should be made of hazardous materials at the Fort, including asbestos, lead paint, undetonated ammunition, and underground tanks. If found, each area should be addressed on an individual basis, and the significance of the fabric determined prior to treatment.

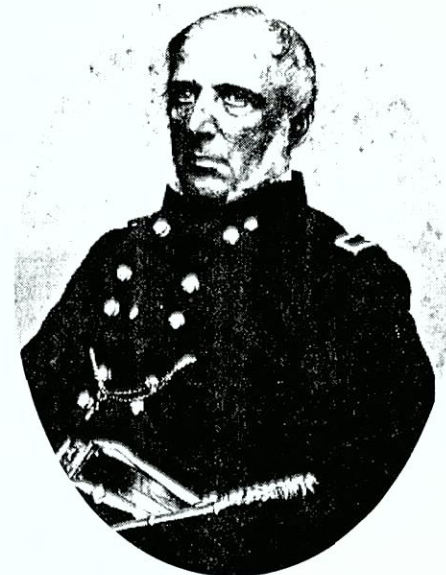
Upgrade and consolidate the storage of all Gateway NRA collections at Fort Wadsworth, adapting a portion of Building 210 to ensure safe, secure, climate-controlled conditions in accordance with the guidelines in Special Directive 80-1 and the NPS Museum Handbook.

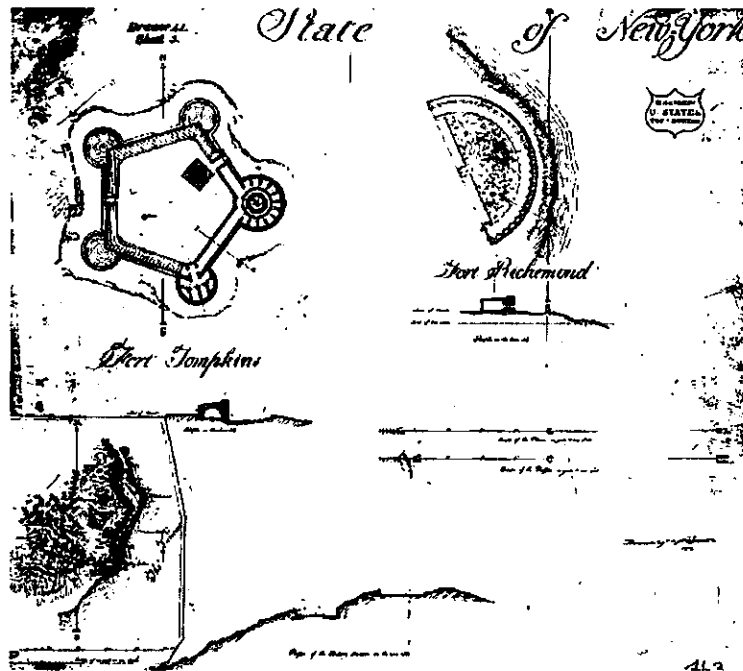
project appeared to wane. Fortunately, Governor Tompkins advised the New York legislature that the Commissioners of Fortifications urged the appropriation of necessary funds since the materials had already been purchased and the half-finished structure was vulnerable to water damage. A year later Tompkins reported that additional monies were required for grading the terrain between the various works, for the purchase of the site of Fort Smith, and for the completion of Fort Richmond. At this request, however, the legislature balked, granting only a portion of the money requested. According to Black, the site had been largely abandoned by 1817.

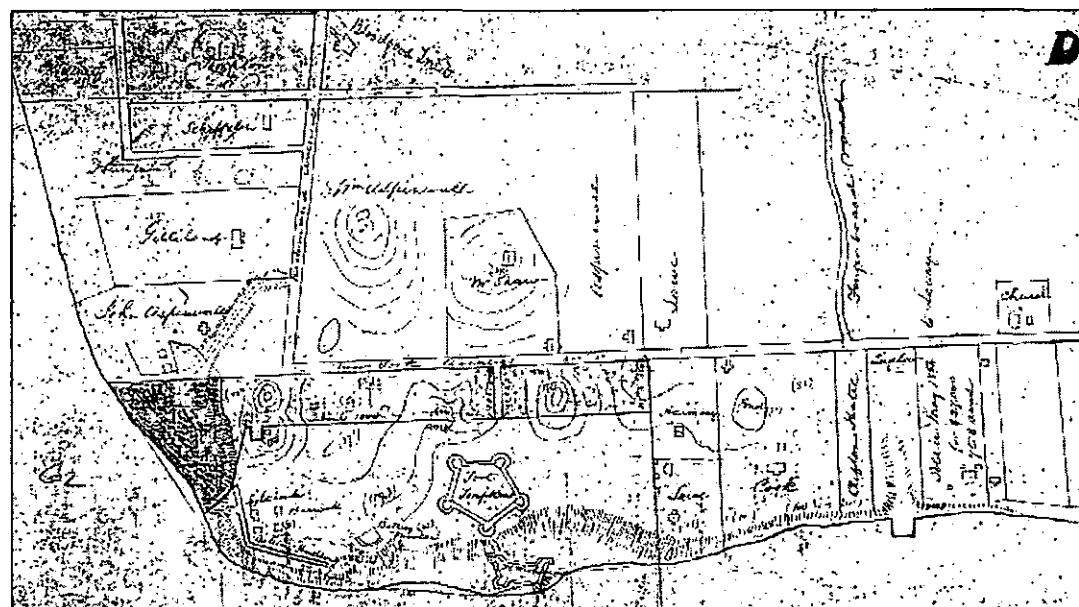
Associated with the construction of the new Fort Richmond and Fort Tompkins was the construction of shops, sheds, dormitories, storehouses, stables, hydraulic equipment, and steam engines, and dormitories for construction workers.

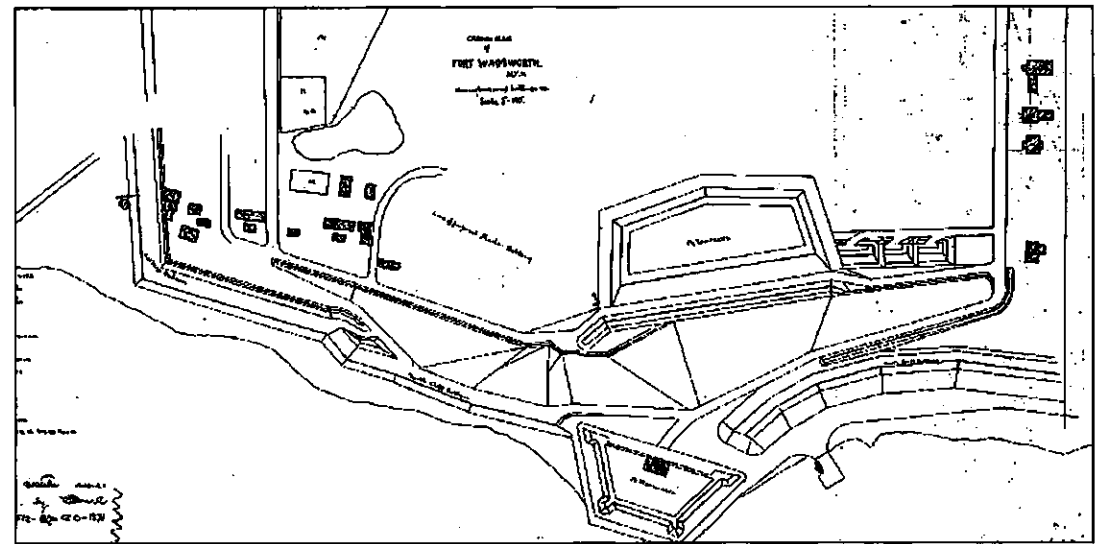
General Sheridan, the post at Fort Wadsworth was established as a regular garrisoned post (before that time it had been under the command of Fort Hamilton). It appears that some soldiers continued to live in Fort Tompkins until World War 1.

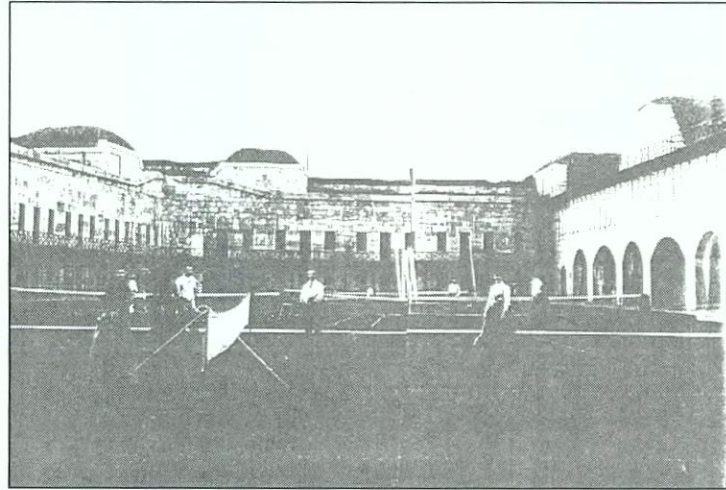
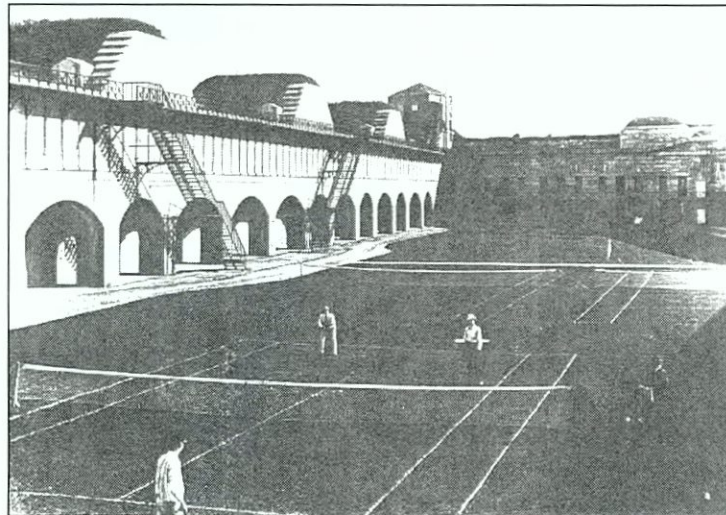
when exposed or denuded of vegetation, is never free from fungi. Having no outlets and receiving the drainage from the surrounding surface, the valleys already mentioned usually contain ponds or swamps, which, during the summer and autumn, emit great quantities of vapor, in connection with diffusible products of organic composition.

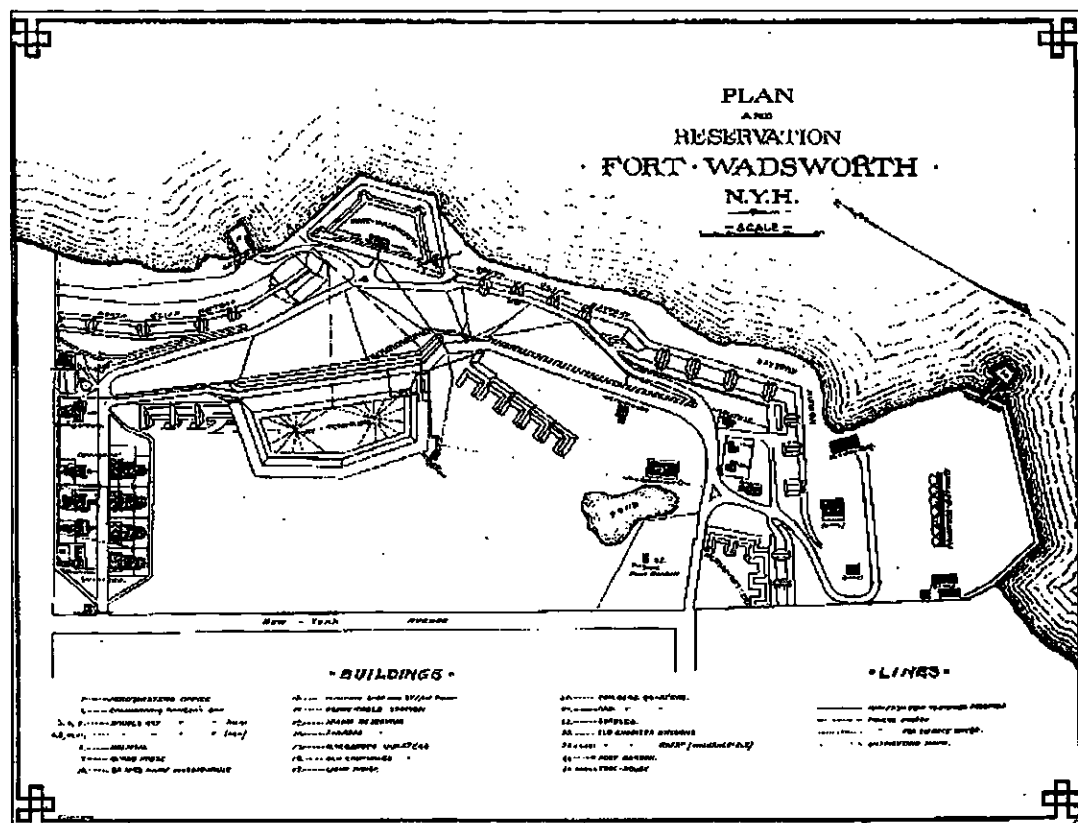
sizable, appear to have stood on most of the parcels acquired by the government.

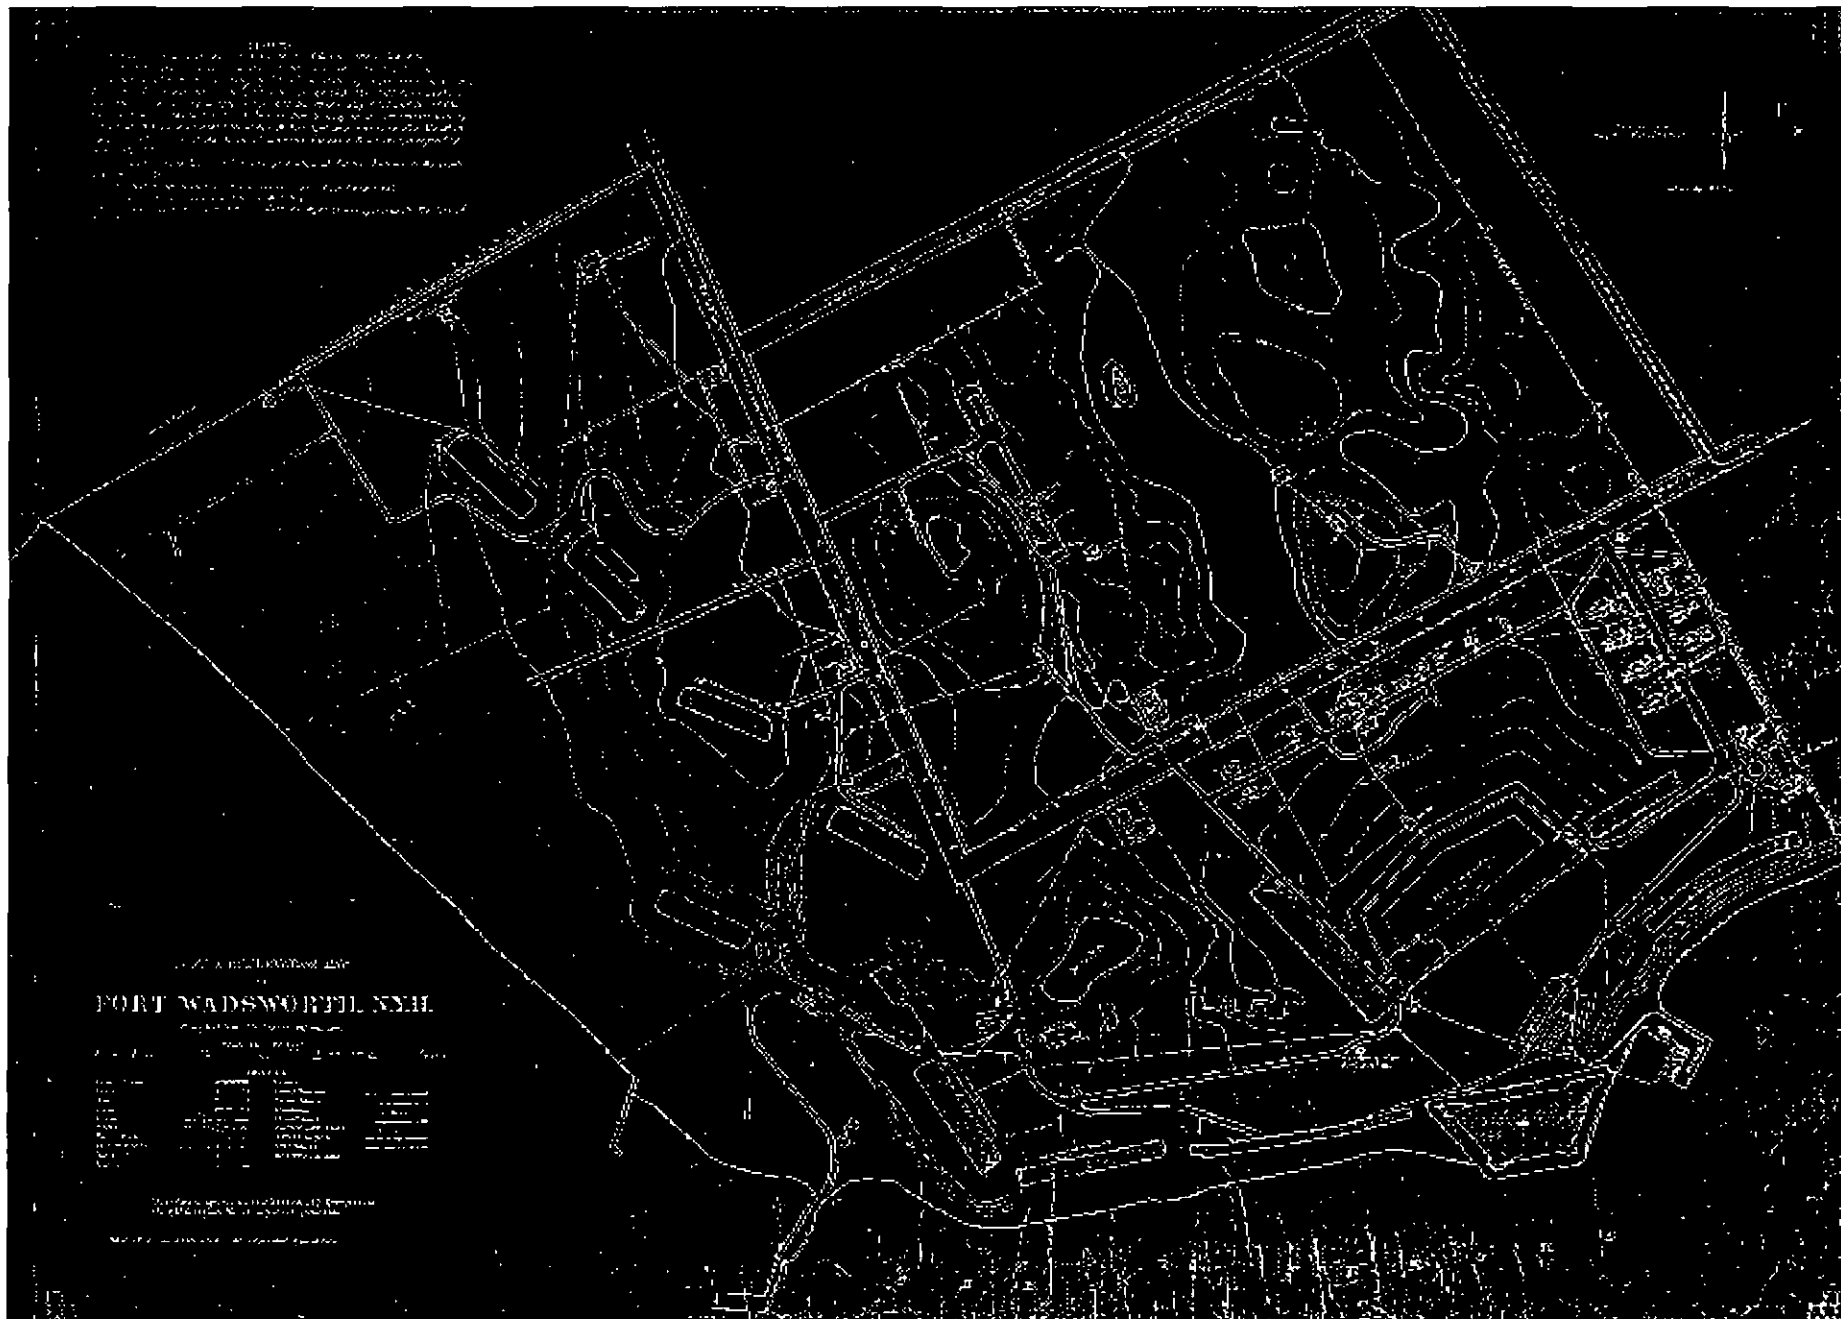
**Figure 3:12** Shows location of Endicott Batteries, and topographic conditions. From "Post and Reservation Map of Fort Wadsworth, NYH, Compiled from the Latest Information." National Archives, Bayonne, RG 77 War Department Collection.

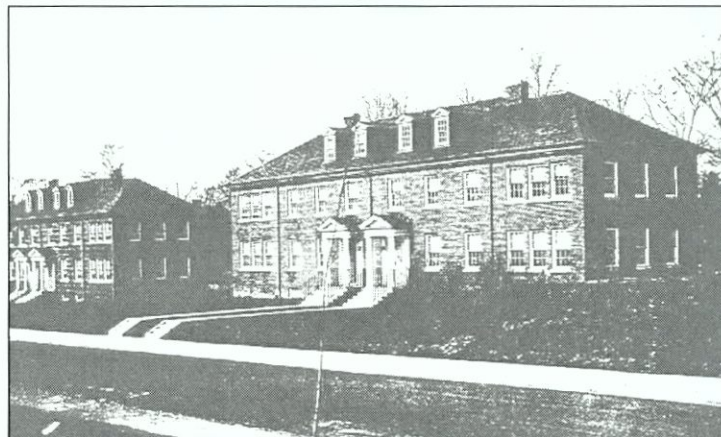
**Figure 3:24** New Officers Quarters on Mont Sec Avenue, c. 1930s. Source? Received from 2nd Coastal Artillery.

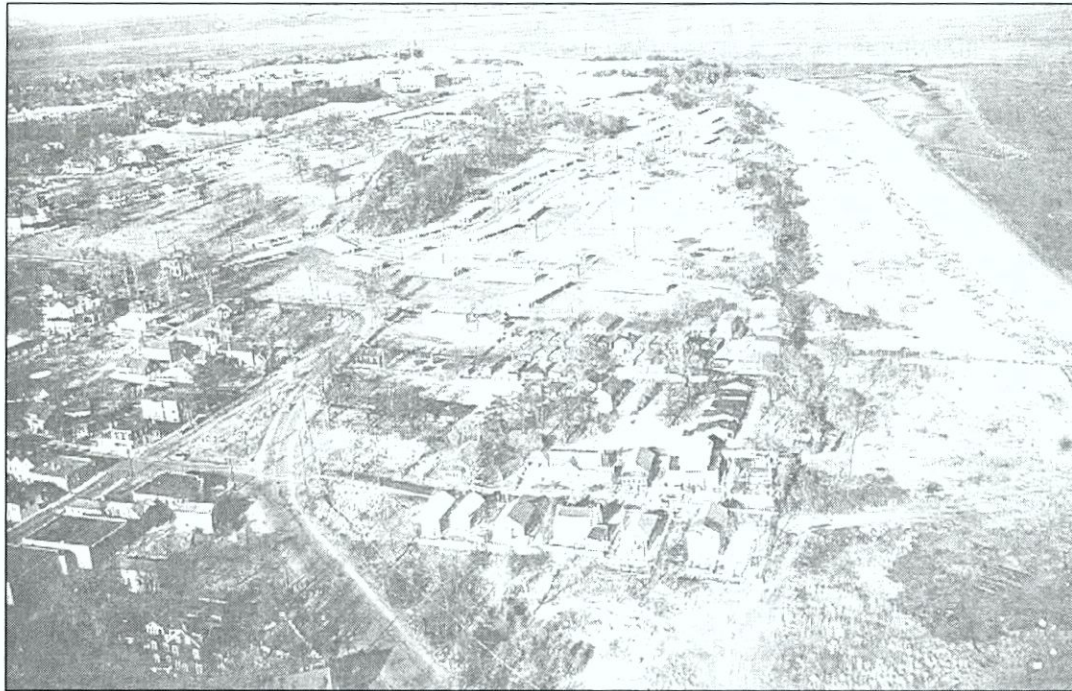
**Figure 3:28** Aerial View of First United States ACAN Transmitter Station Antenna farm at Fort Wadsworth, Staten Island. Photo by Frank Cordeiro, First United States Army Central Photo Lab, Governor Island, New York. Source, Reproduced at the National Archives.

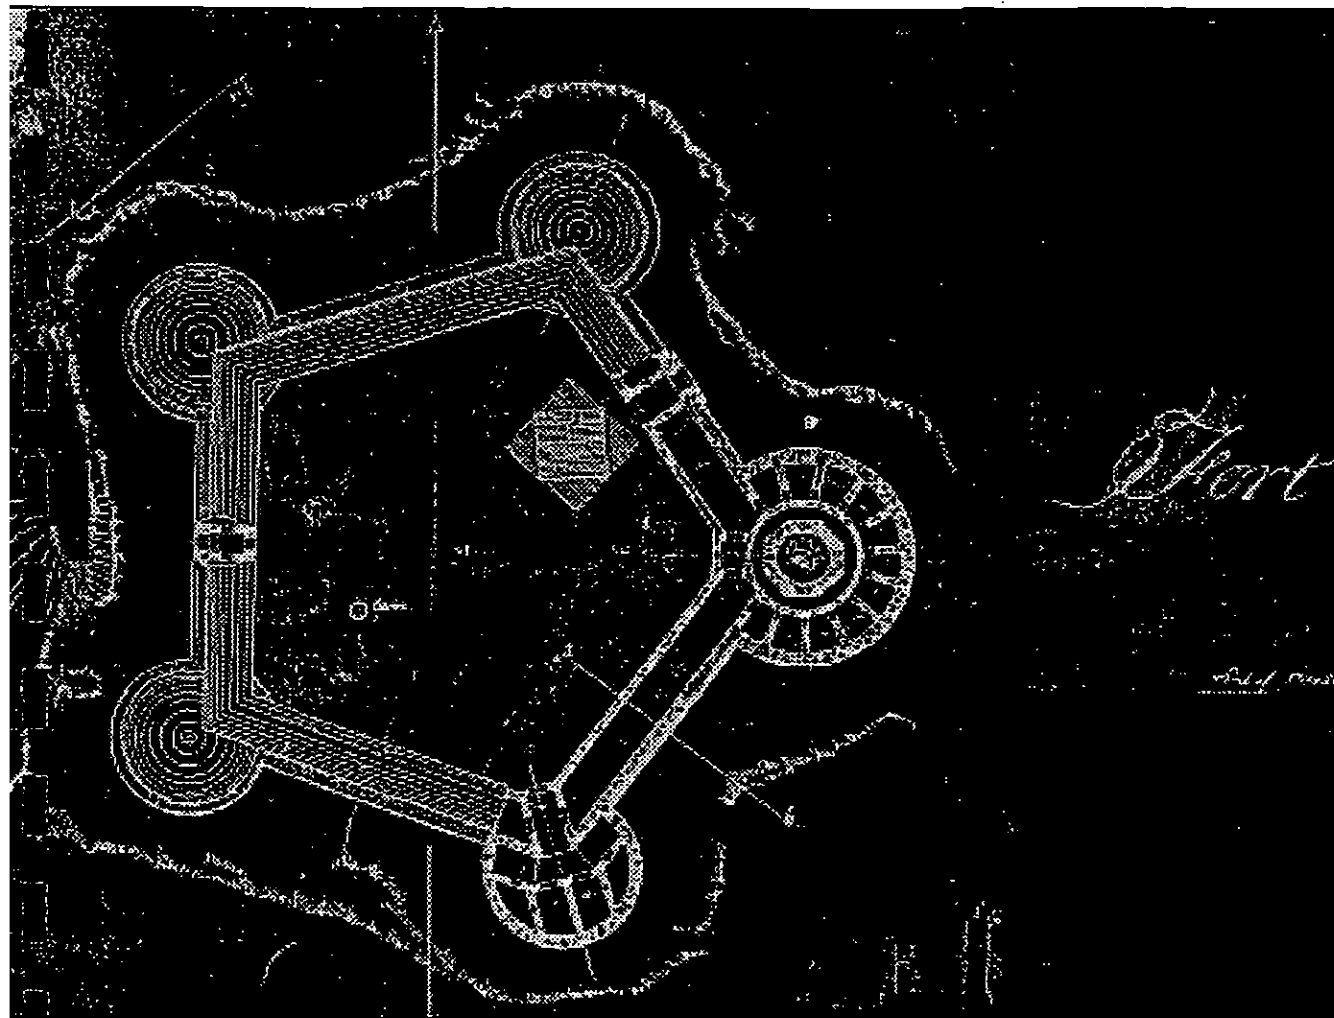
## **4.1 Introduction**

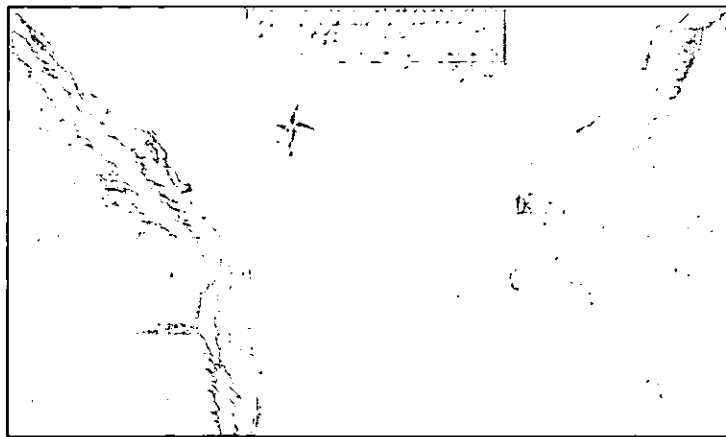
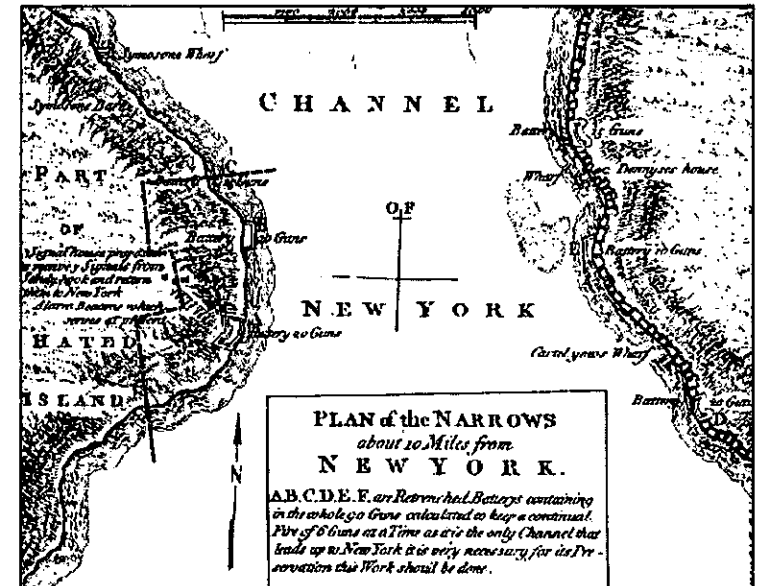
**Figure 4.4** Bellini, S. "Bay & Port of New-York, Capital of New York." 1764. Scale 1 inch:3.5 miles (approx.). Fort Wadsworth vicinity circled.

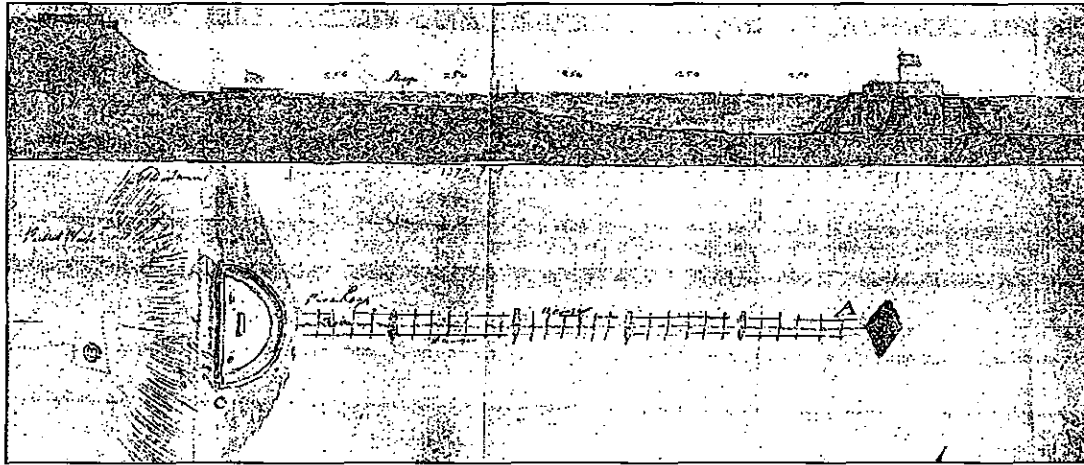
Figure 4.8 Poussin, Capt. W. Tell. "State of New York, Fort Tompkins, Fort Richmond". 1819. Scales as indicated. (National Archives, Record Group 77, Drawer 41, Sheet 3.)

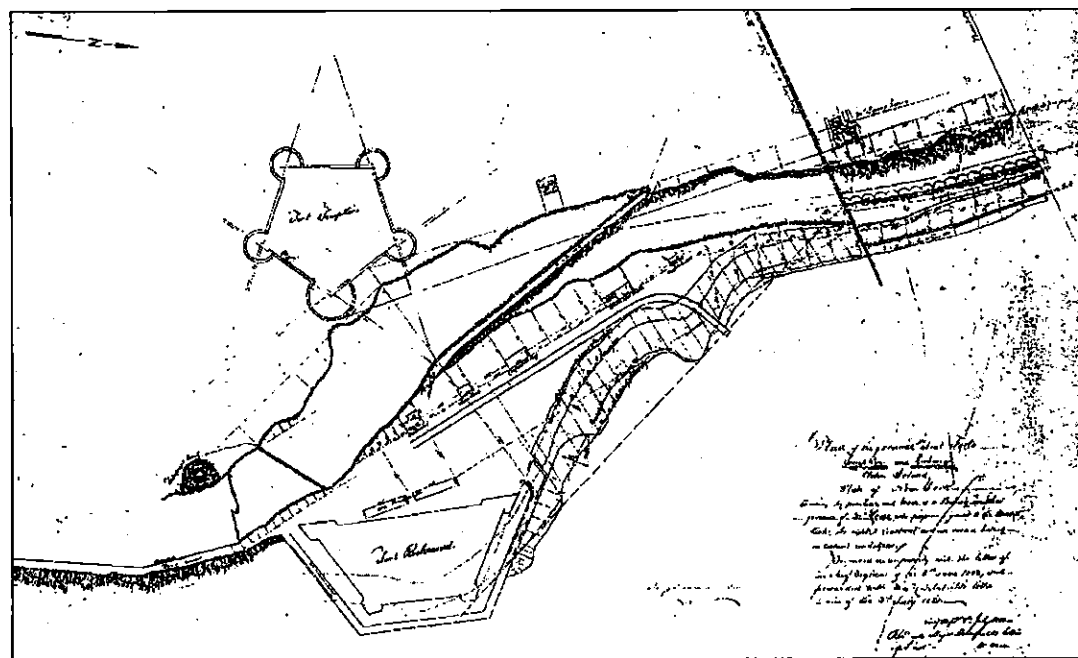
new Fort Richmond was designed by Joseph Totten, Chief Engineer of the U.S. Army, as a replacement for the water battery on the shoreline. It consisted of a much larger trapezoidal-plan, 67-foot high, two-tiered structure capable of mounting 116 heavy channel bearing and 24 light flanking guns, and survives today as one of the most impressive examples of military engineering of its period (figure 4.9).

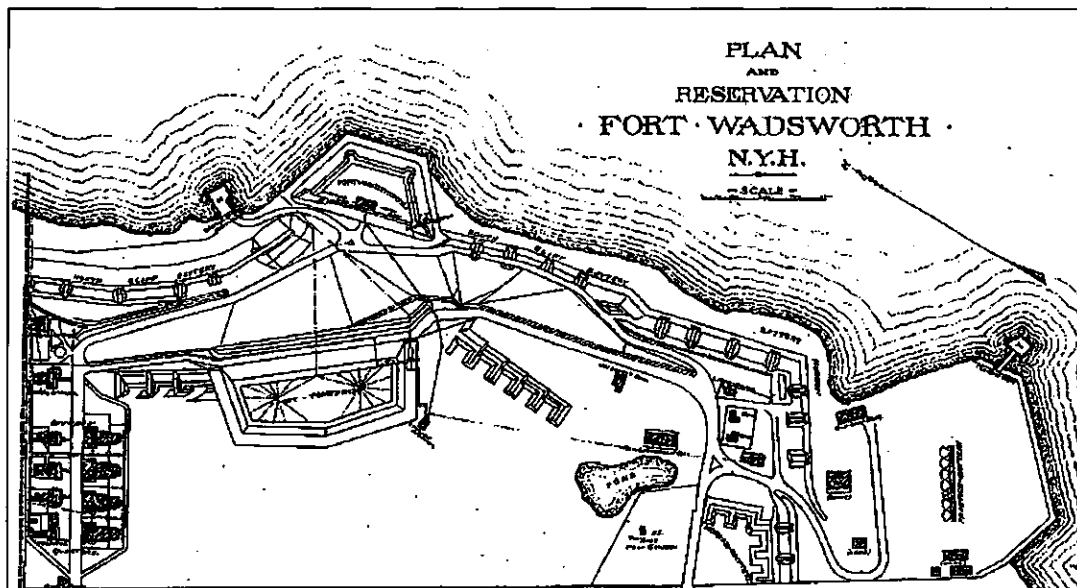
Figure 4.11 "Map of the Vicinity of Fort Wadsworth, Staten Island, N.Y." 1889. Scale as indicated. Limits of Fort Wadsworth Reservation shown with dashed line. (National Archives, Record Group 77, Drawer 43, Sheet 53.)

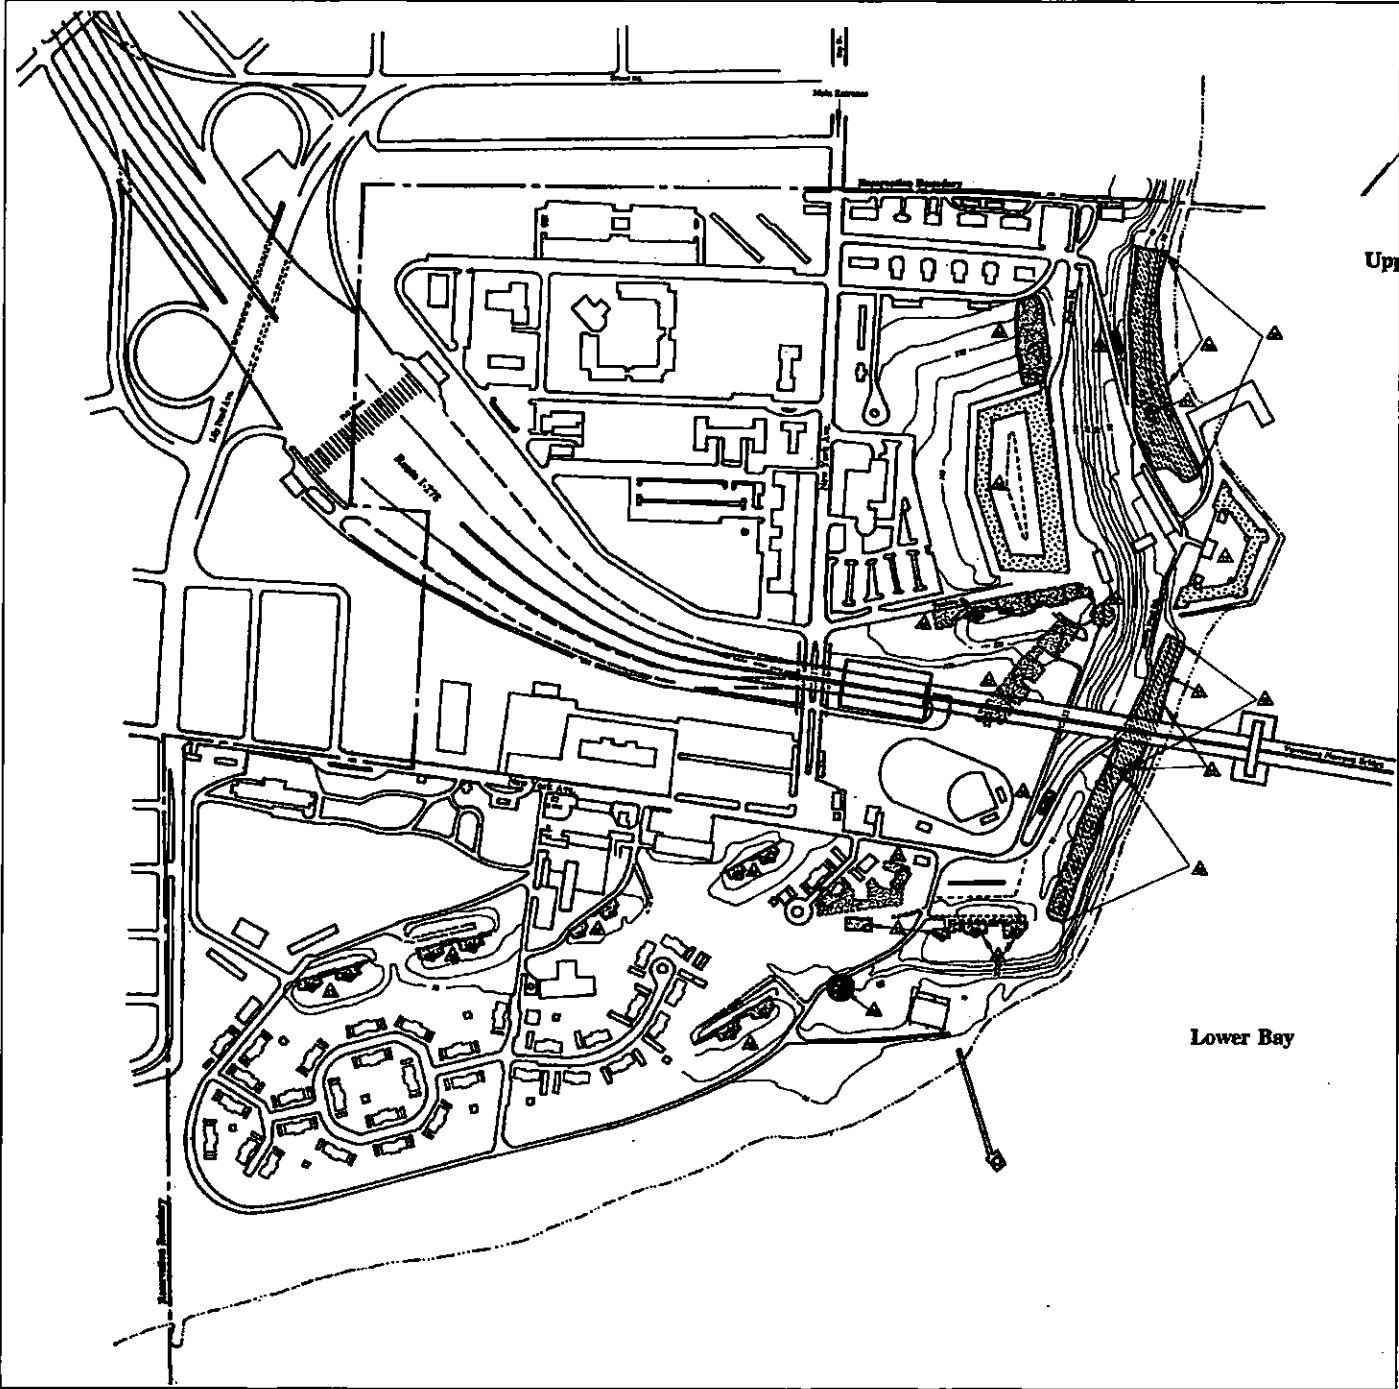
Military records (Black 1983:111) indicate that seven of the Endicott batteries (Ayers, Richmond, Dix, Millis, Hudson Turnbull, and Catlin) remained in service during World War II. Later modifications are evident at least at Catlin; concrete World War II communication/fire control stations [Resources 58 and 59] stand behind Batteries Catlin and Turnbull. A small concrete tower (Building 338) [Resource 60] stands near the shoreline east of Battery Dix. A brick structure (Building 140) [Resource 57] stands within Battery Catlin near the entrance to a North Cliff Battery magazine.

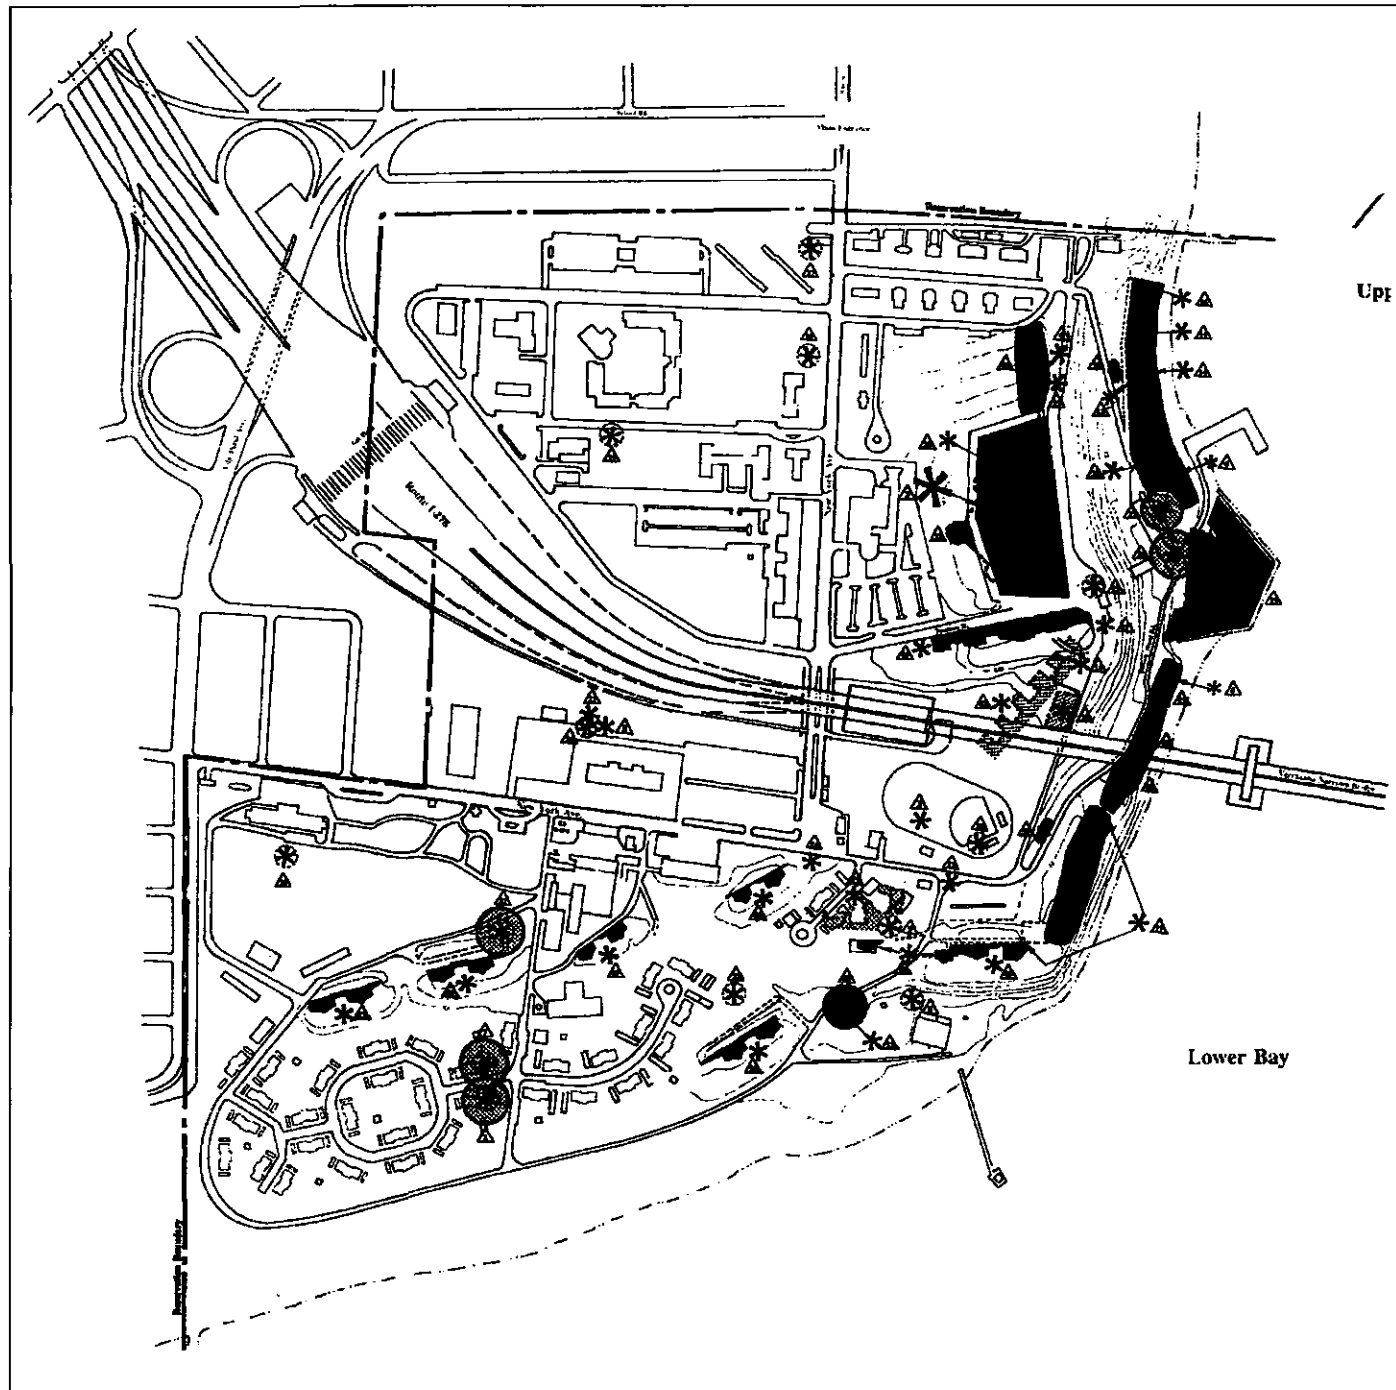
## Conclusions and Recommendations

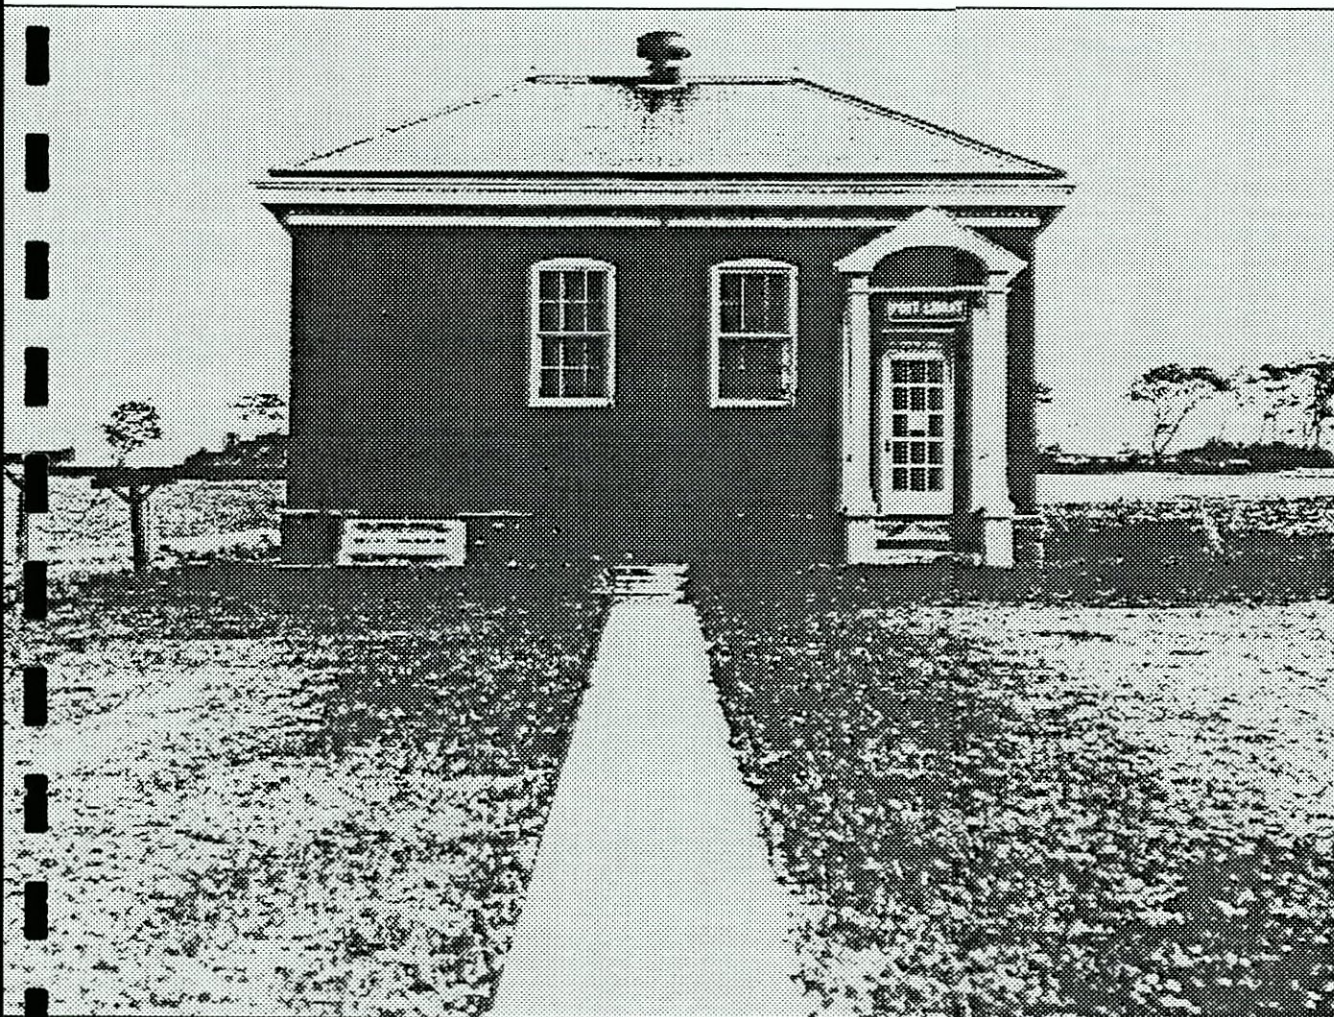
## **5.1 Evaluation of National Register Significance**

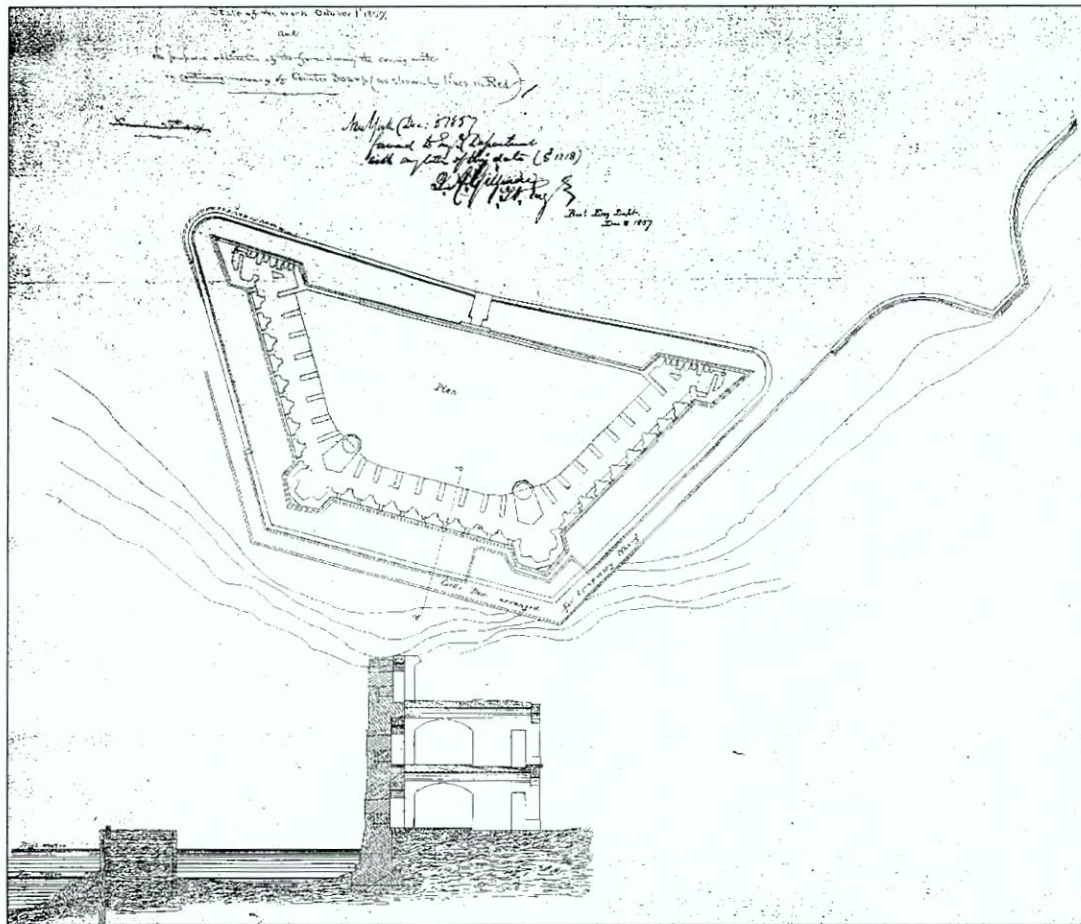
color than the rest of the walls. The blocks are similar in appearance to those used for the guardhouse and the addition on the northeast wall. The infill wall and addition date to 1887 modifications. It is not known when the parapets were constructed.

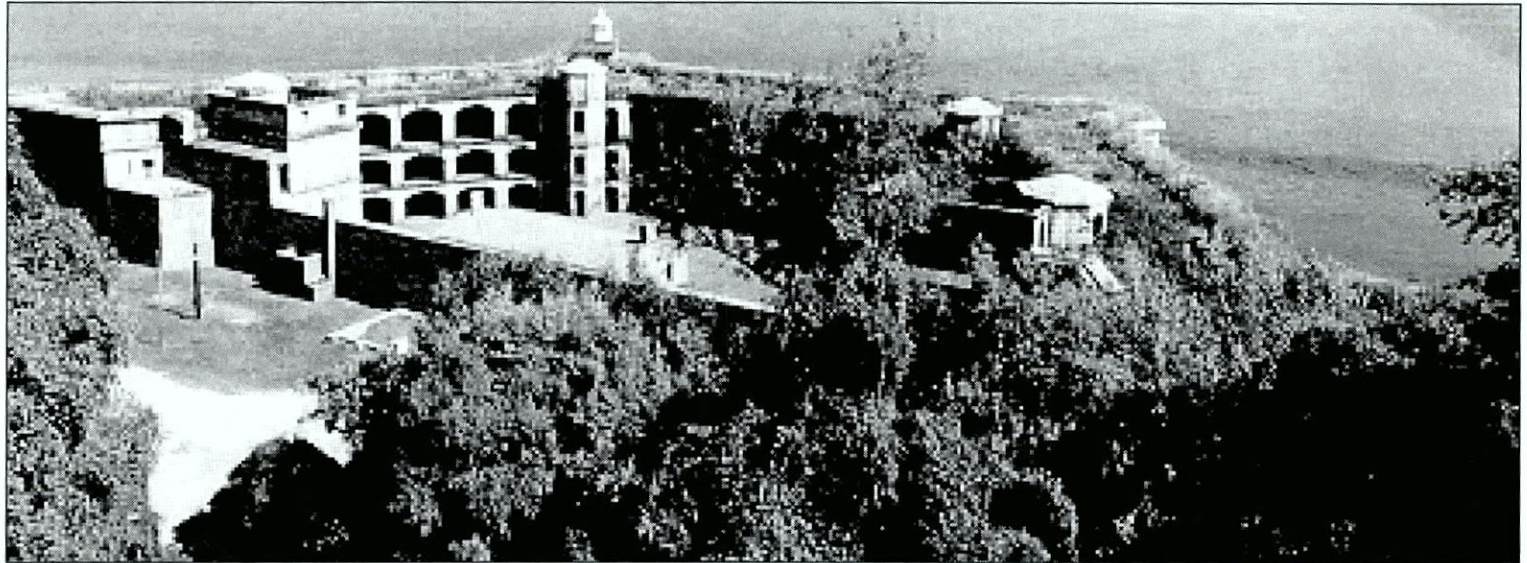
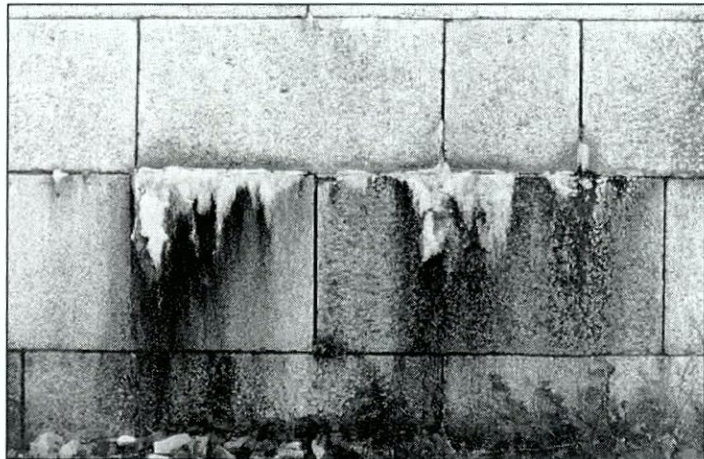
**Figure 6.13** White leaching caused by water-born migration of calcite. Black staining caused by rusting of iron cramps

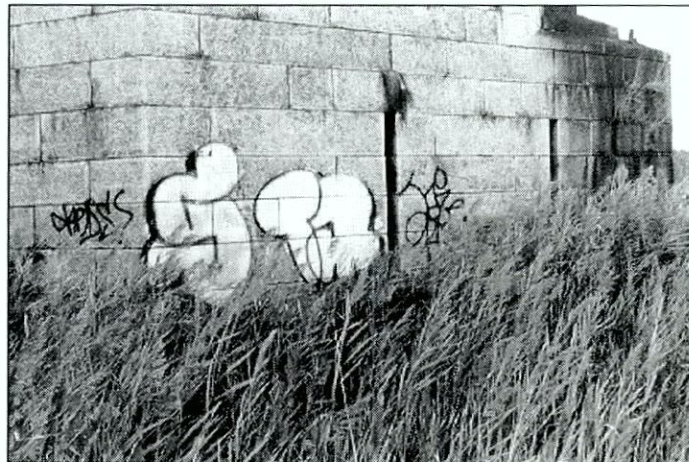
**Figure 6.14** Spray-paint graffiti at southeast corner of Battery Weed
