5050R  
US DOI

Cultural Resources Report for Fort Wadsworth, Staten Island, New York

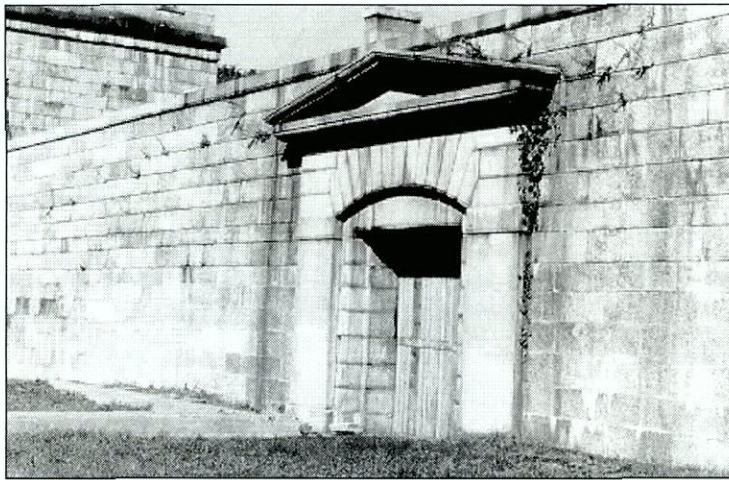
**Figure 6.15** Front wall showing weeds growing out of deteriorated mortar joints. Volunteer ivy working its way into open joints.

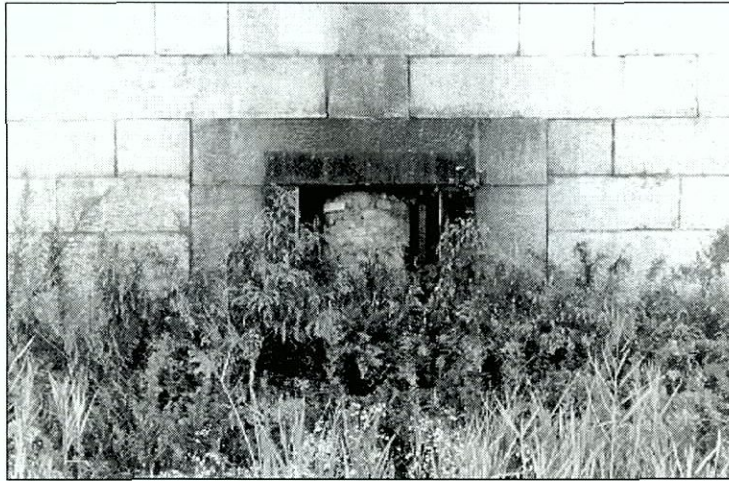
**Figure 6.16** Brick and mortar in-fill of Totten window. Surface corrosion of cast-iron shutters.

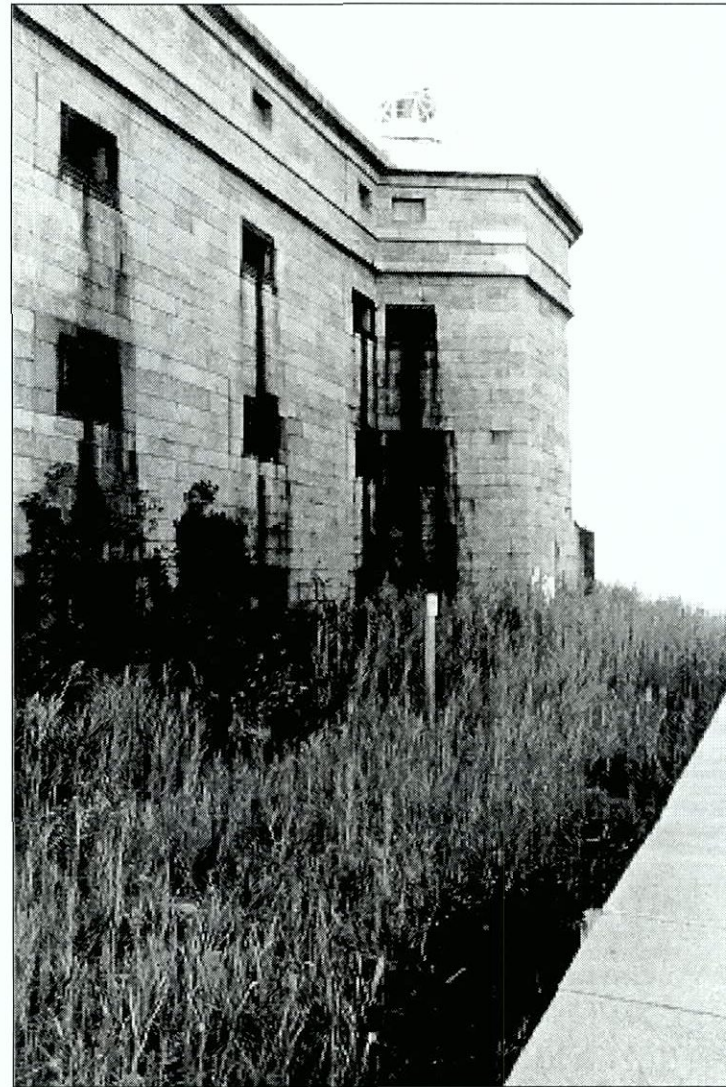
**Figure 6.17** General condition showing black ferrous staining caused by the rusting of the Totten cast-iron shutters. Note ivy at the lower wall and in-fill of the original water moat with vegetation.

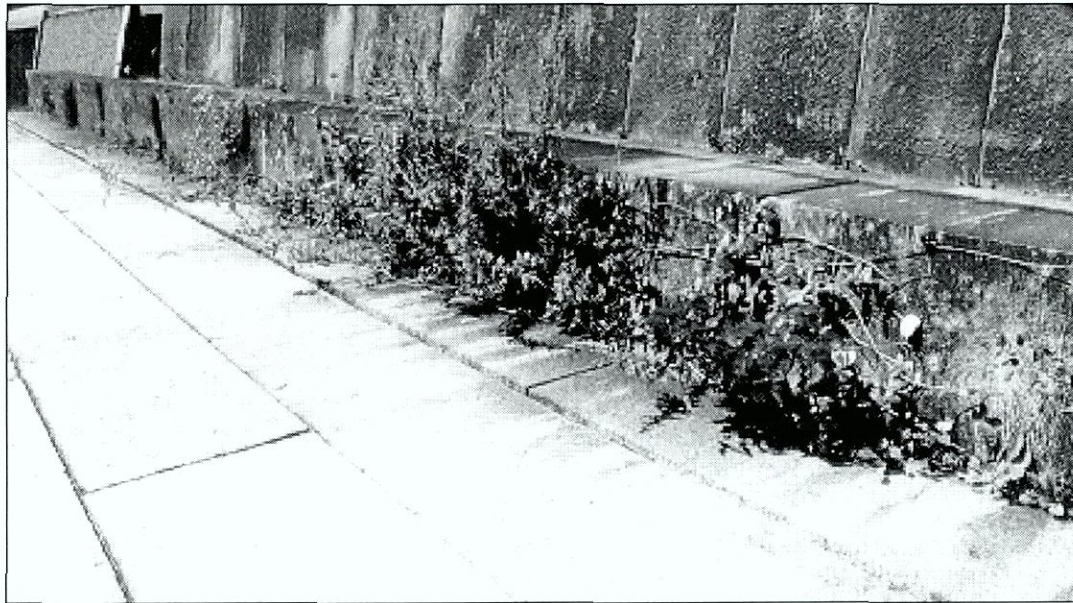
**Figure 6.18** Vegetation growing in the deteriorated mortar joints of the west elevation stringcourse, accelerating erosion of the joints and may lead to the displacement of granite blocks.

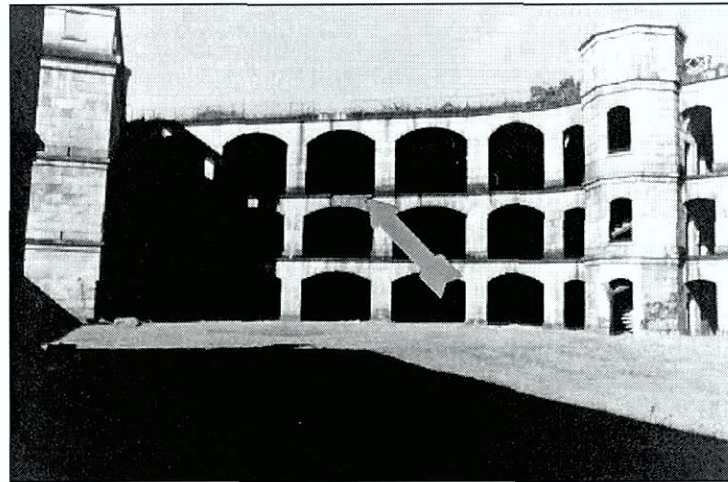
**Figure 6.19** Ivy growing on the north masonry facade of Battery Weed. The ivy can work its way into the cast-iron Totten shutters and interior casements resulting in increased deterioration.

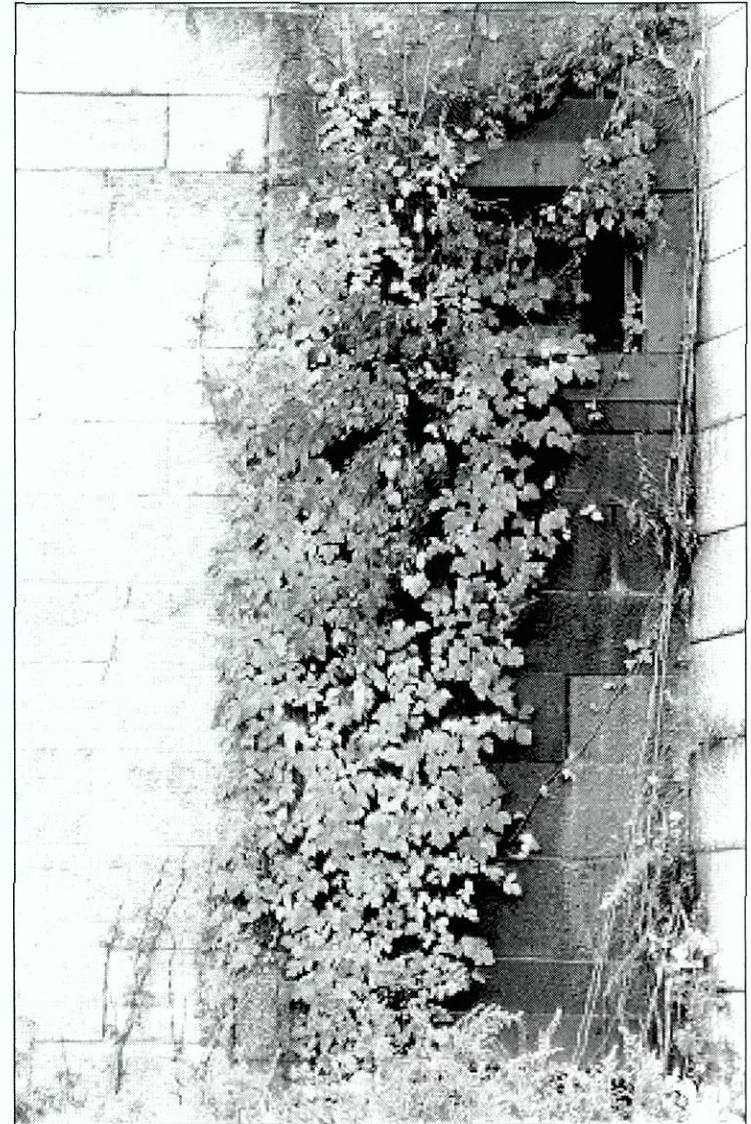
**Figure 6.20** General view of parade elevations with north magazine on the left and stair tower on the right. Arrow identifies missing ledgestone from third tier's central casemate.

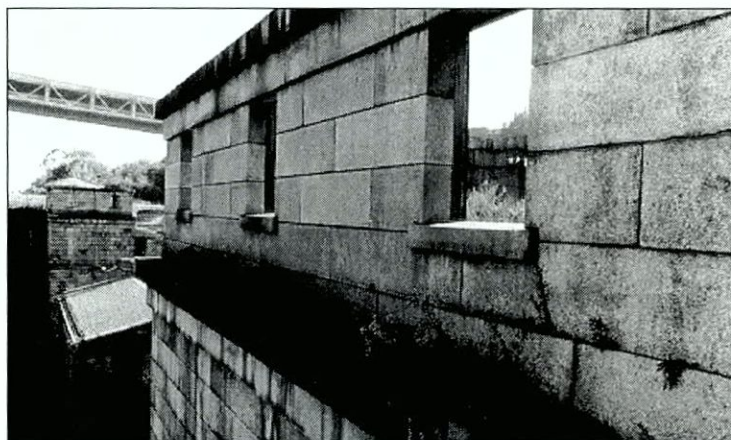
**Figure 6.21** North magazine showing vegetation growing out of deteriorated joints. Magazine interiors exposed to the elements due to lack of roofs or window units.

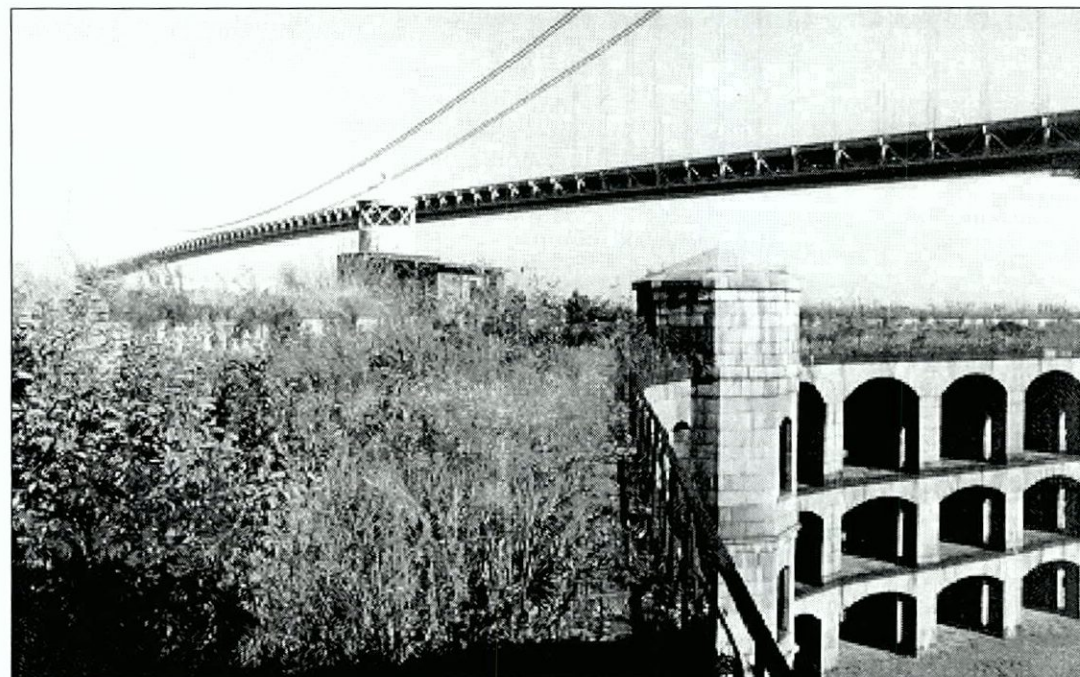
**Figure 6.22** General view of Battery Weed barbette looking southeast. Excessive vegetation consisting of small plants, ivy, shrubs, and saplings encourage deterioration to the masonry below and conceal gunmounts and kneewall.

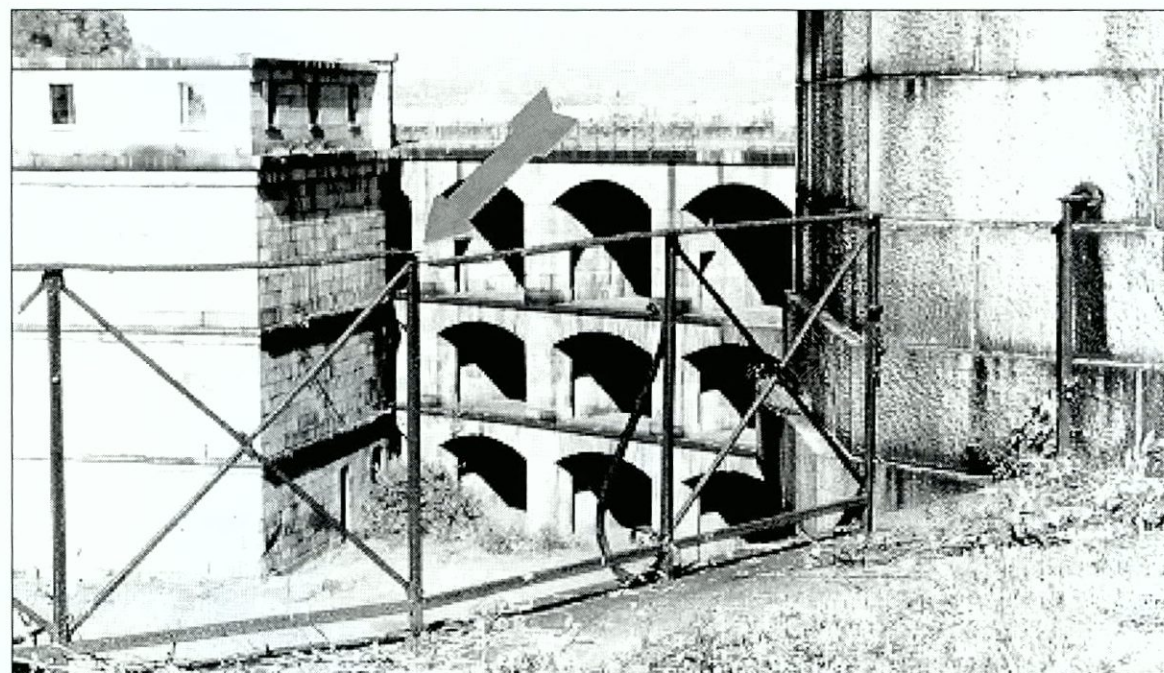
**Figure 6.23** Wrought-iron balustrade at barbette. Note missing cross bracing from middle section. Arrow denotes failure of connections due to ferrous corrosion. Crossings originally exhibited cast-iron rosettes.

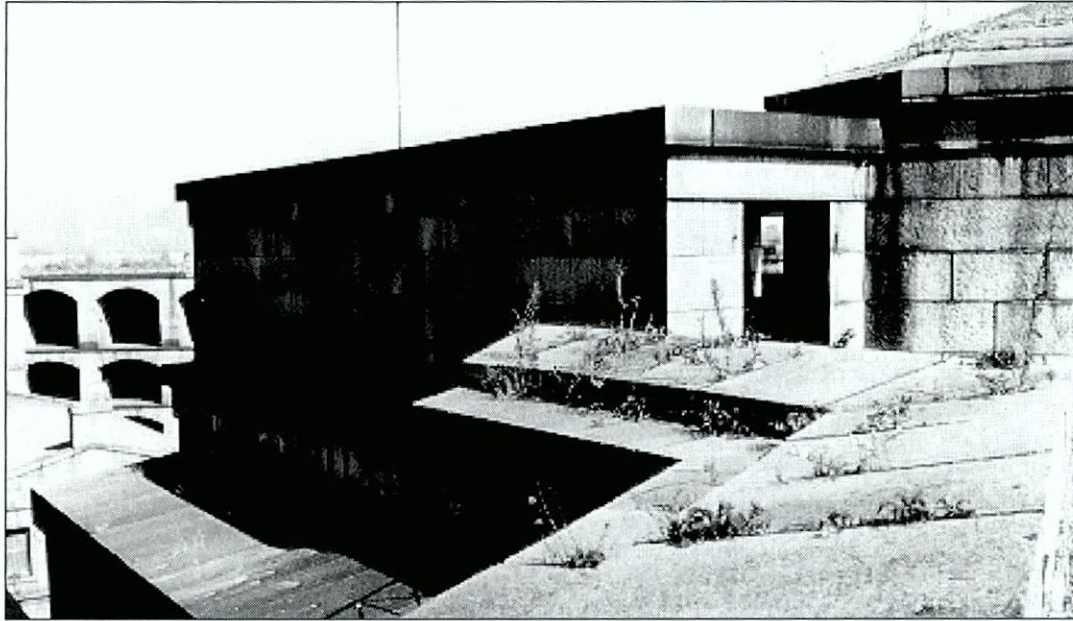
**Figure 6.24** General view of granite copingstone at the southwest corner of Battery Weed. Volunteer vegetation growing out of vulnerable mortar joints throughout the parapet.

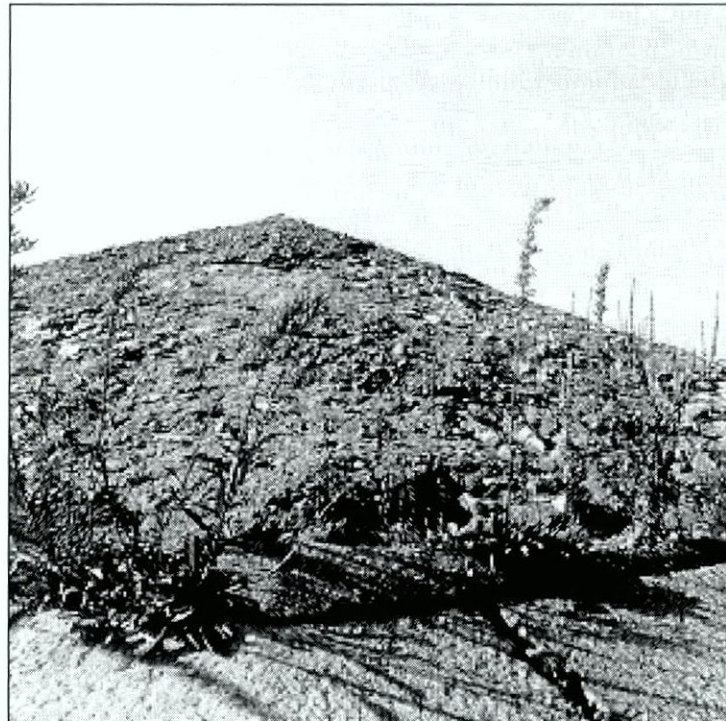
**Figure 6.25** Detail showing general deterioration of cement caps at the stairtowers and the introduction of unwanted vegetation.

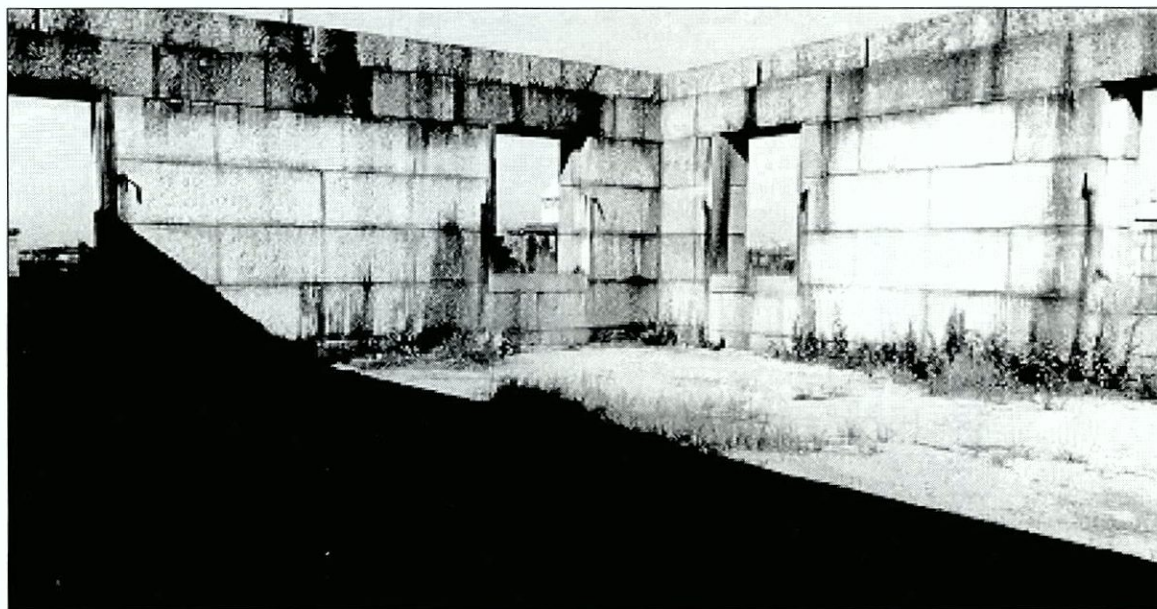
**Figure 6.27** General view of south magazine interior showing deterioration of floor; intrusion of organic growth; missing window units; and missing roof system.

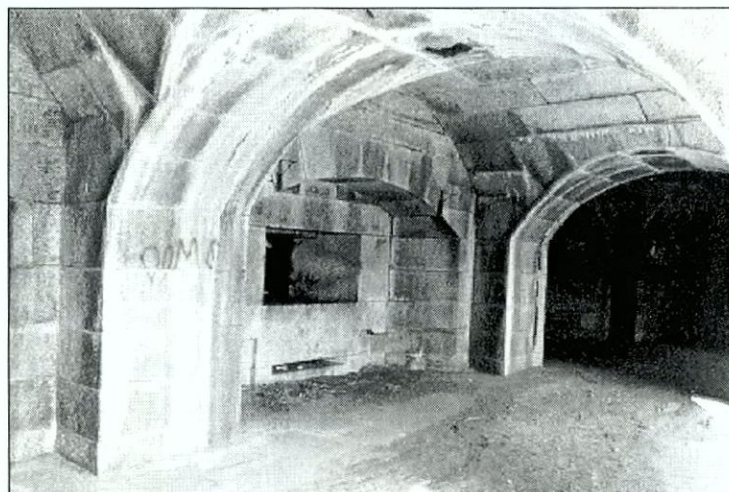
**Figure 6.28** Typical case-mate in Battery Weed showing extensive calcite leaching from joints and deposition onto finish surfaces. Also note green biological staining in the arch.

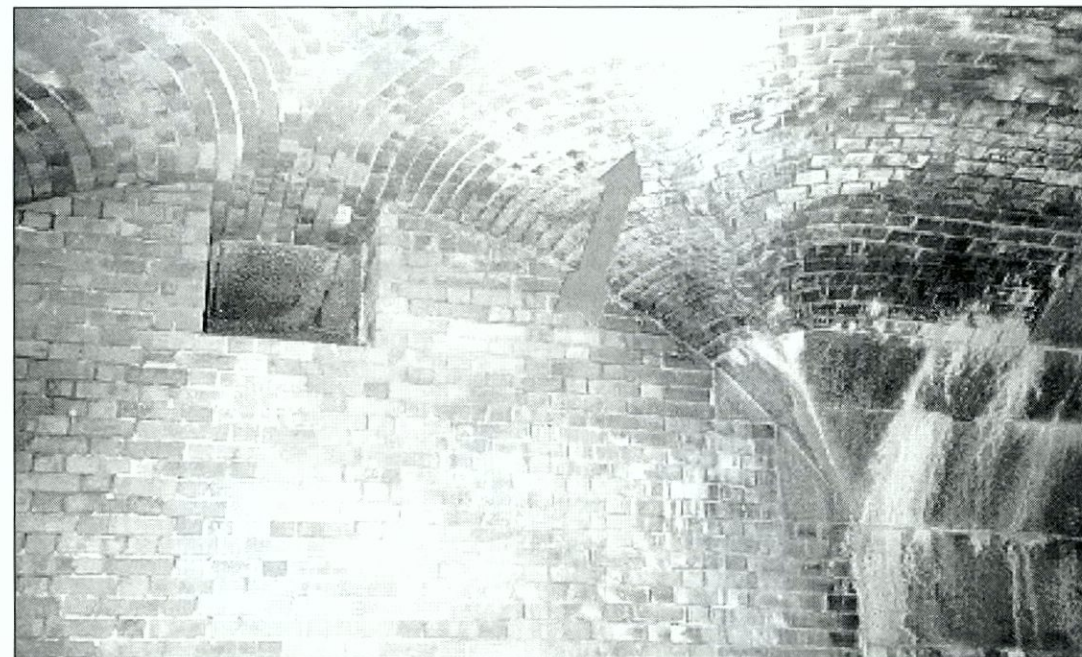
**Figure 6.29** Original brick vault at south magazine showing major efflorescence (arrow) and calcite leaching through granite joints. Extensive loss of mortar from brick joints.

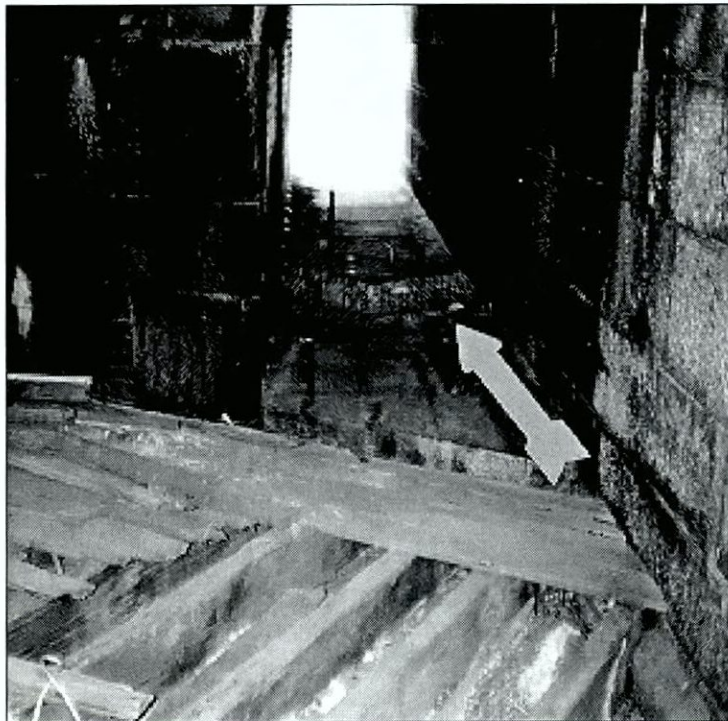
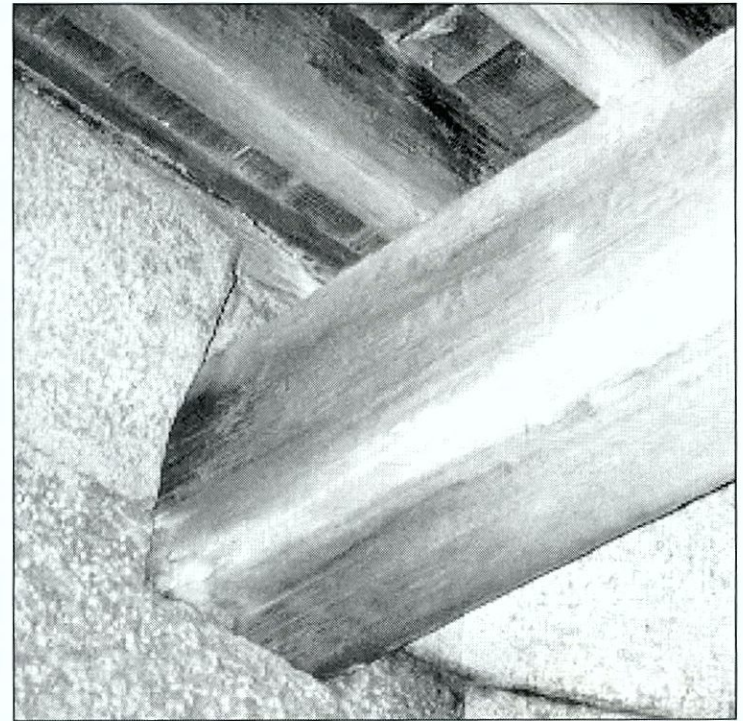
**Figure 6.31** Detail of wood beam and stone pocket located near south magazine; presence of wood rot and formation of water-borne deposits originating from the granite masonry.

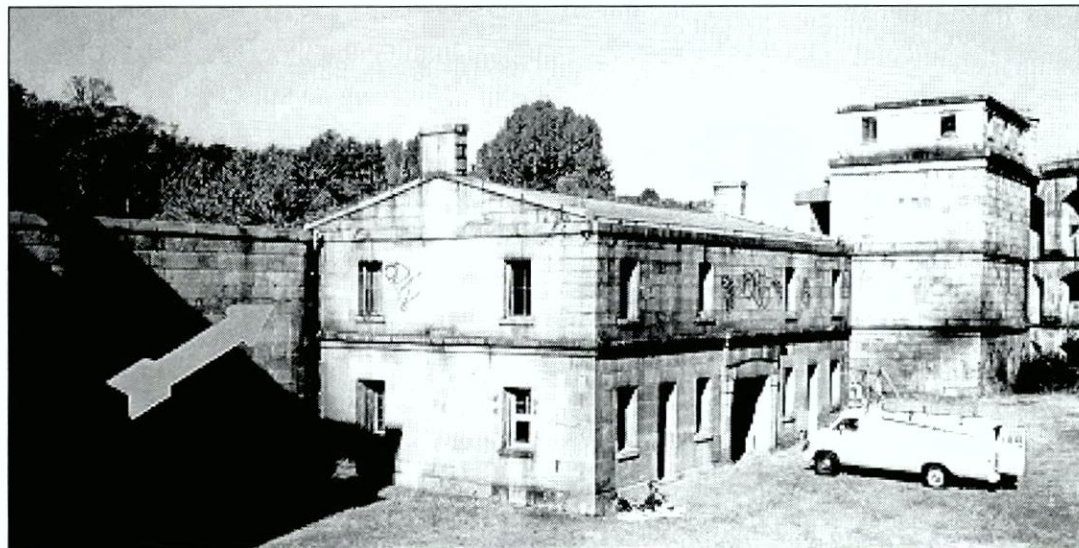
**Figure 6.32** General view of guardhouse showing south and east facades. Note prominence of graffiti at upper levels and poor condition of window units. Arrow identifies dark staining caused by faulty drainage system.

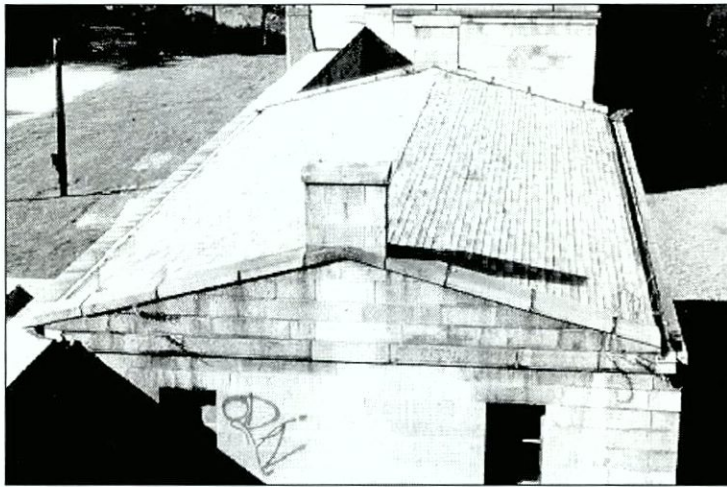
**Figure 6.33** General view of guardhouse roof showing overall poor condition of asphalt shingles. Note poor repair to joints and the presence of vegetation at the southeast corner.

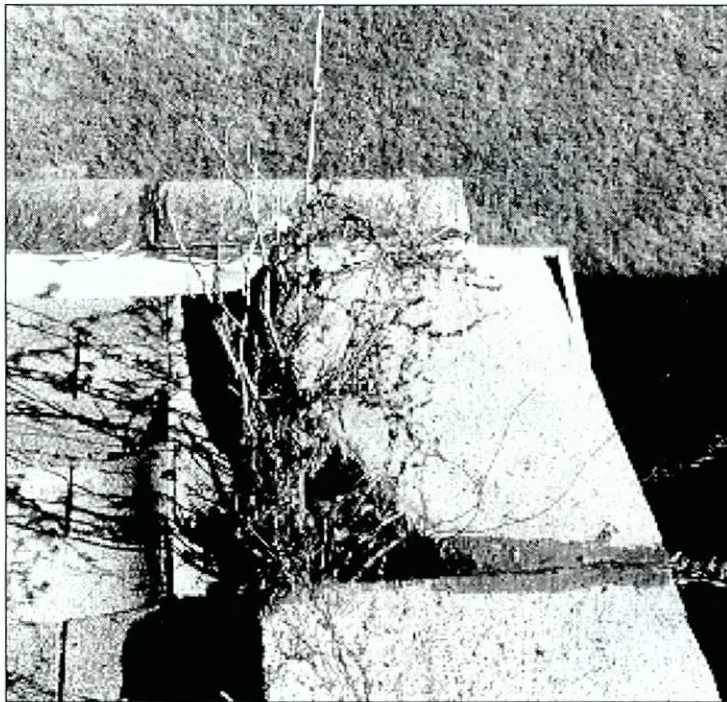
**Figure 6.34** Detail of guardhouse roof showing loss of copingstone corner, failure of mortar, poor repair with bitumastic, and introduction of vegetation.

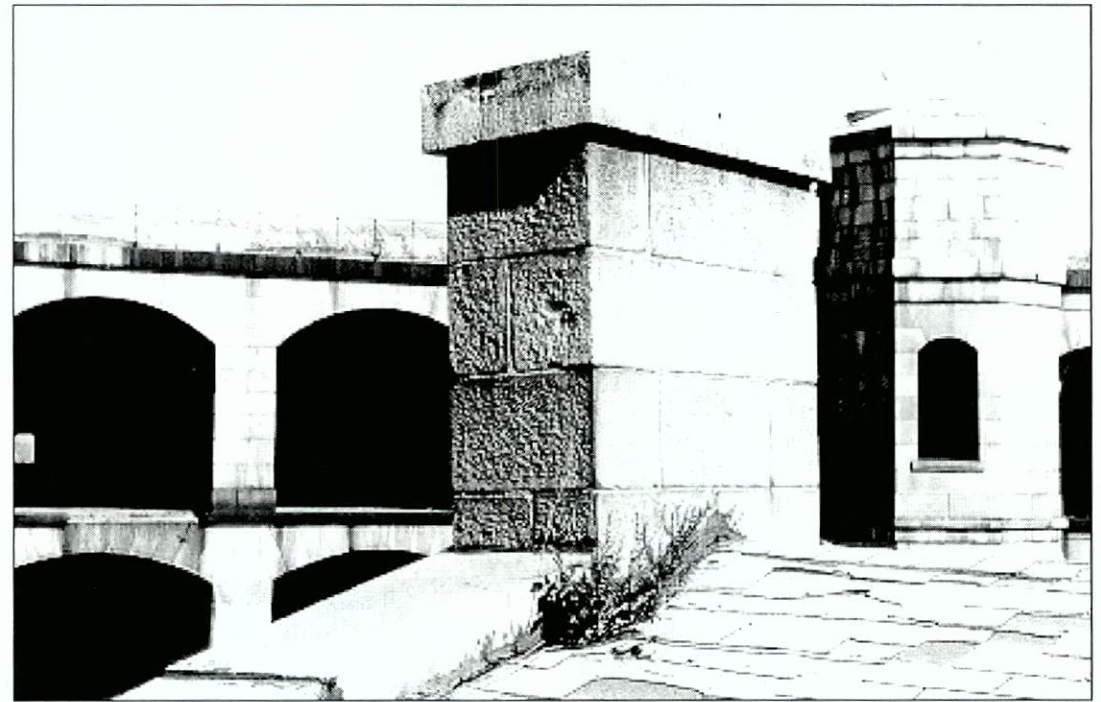
**Figure 6.35** Bowing of guardhouse endwalls has resulted in a gap between the gables and the roof. Note poor repair with mastic and the introduction of vegetation.

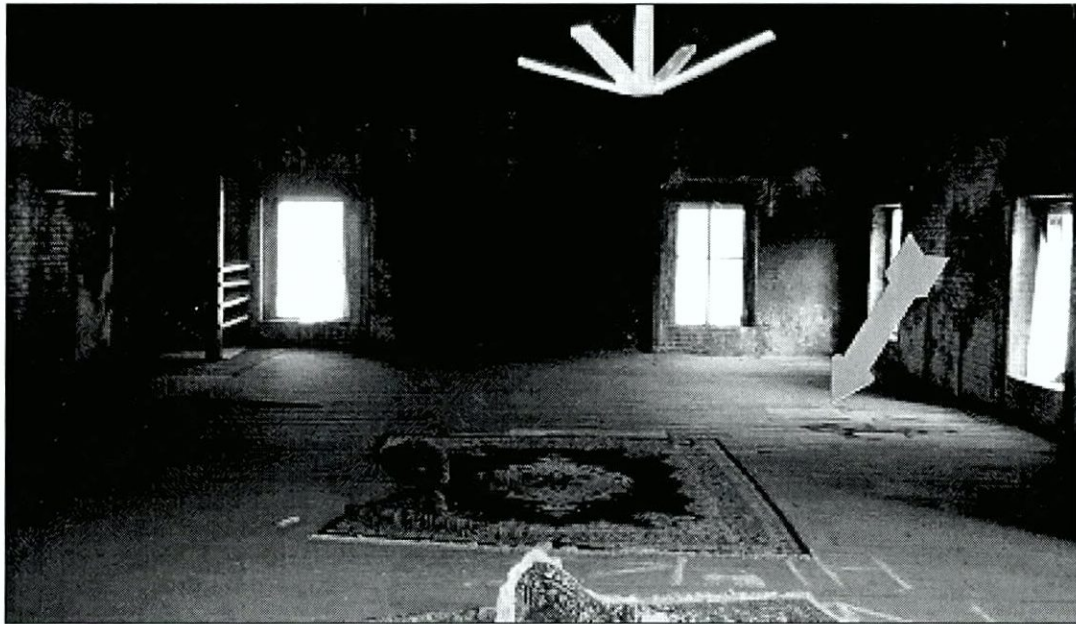
**Figure 6.36** Second floor interior of guardhouse showing general condition. Note poor condition of window units and large patch in the floor (arrow).

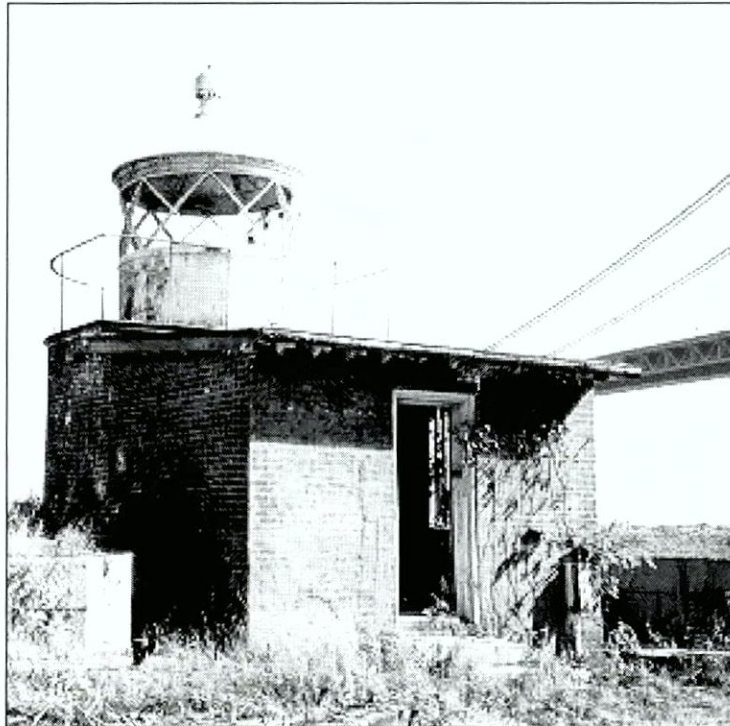
**Figure 6.37** General view of lighthouse on barrette level. Photo taken just after cutting of vegetation.

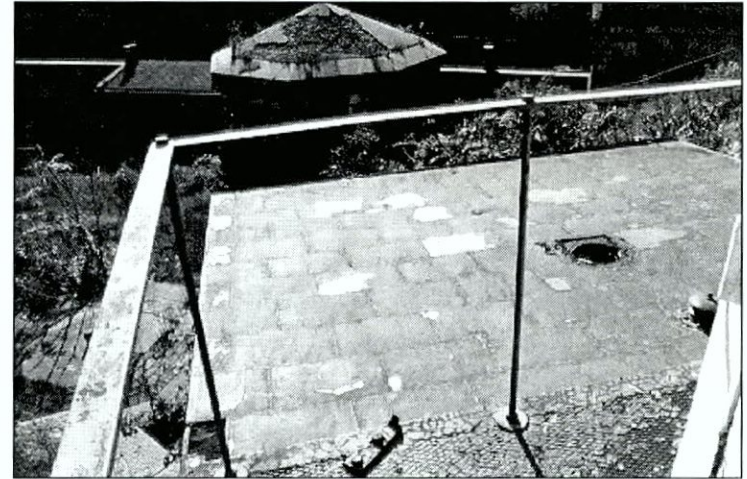
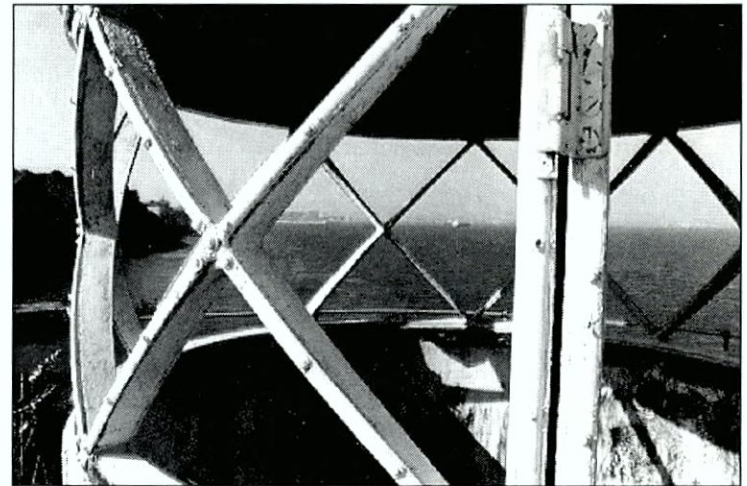
**Figure 6.39** Detail of window muntins at lighthouse lantern. General rusting of ferrous metal and absence of window glass.

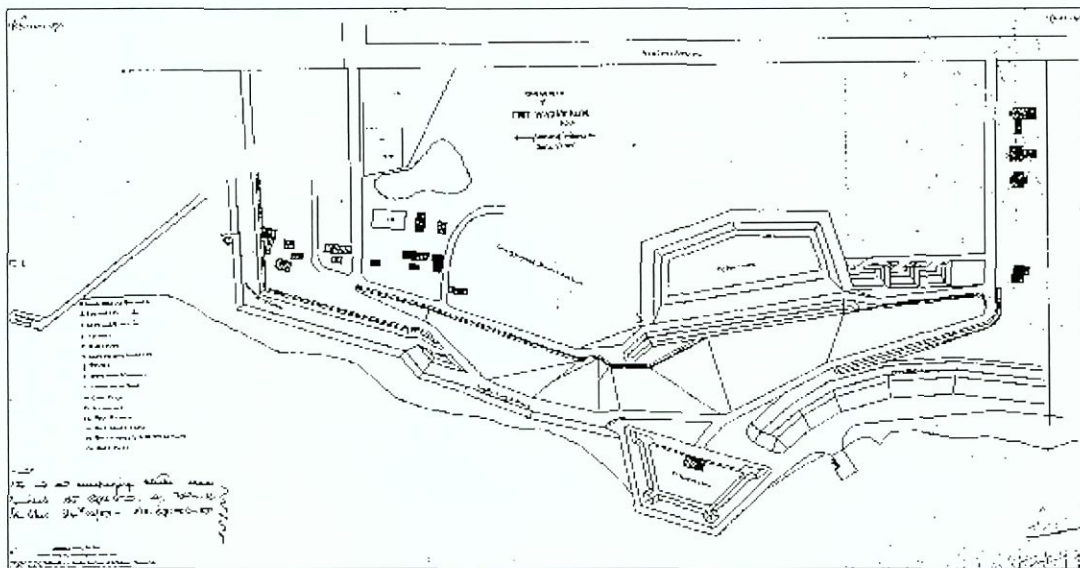
Figure 6.41 Battery Weed, dock, and boathouse (shaded area by dock), 1871.

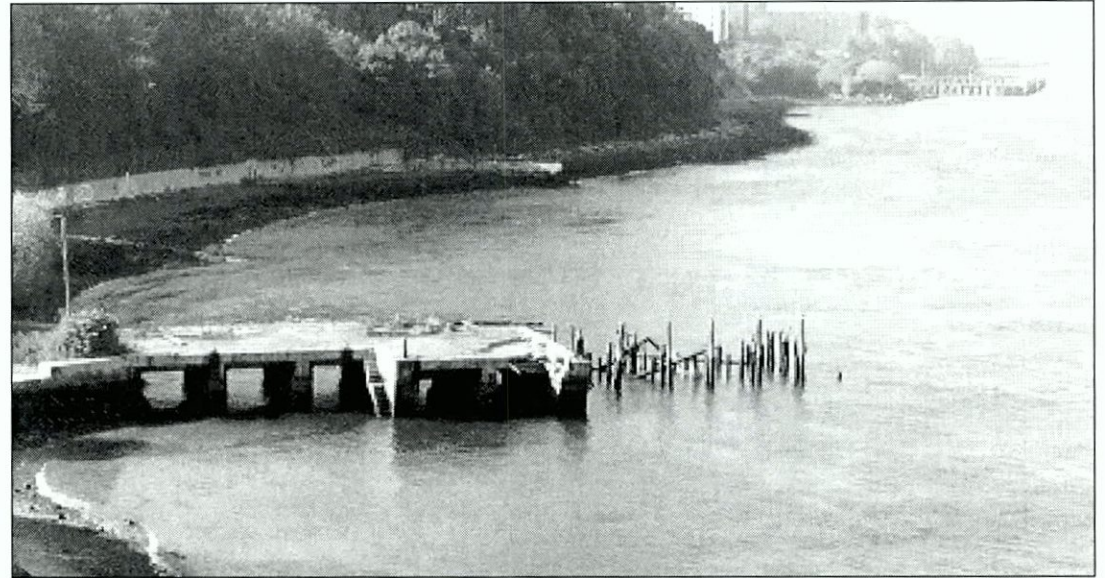
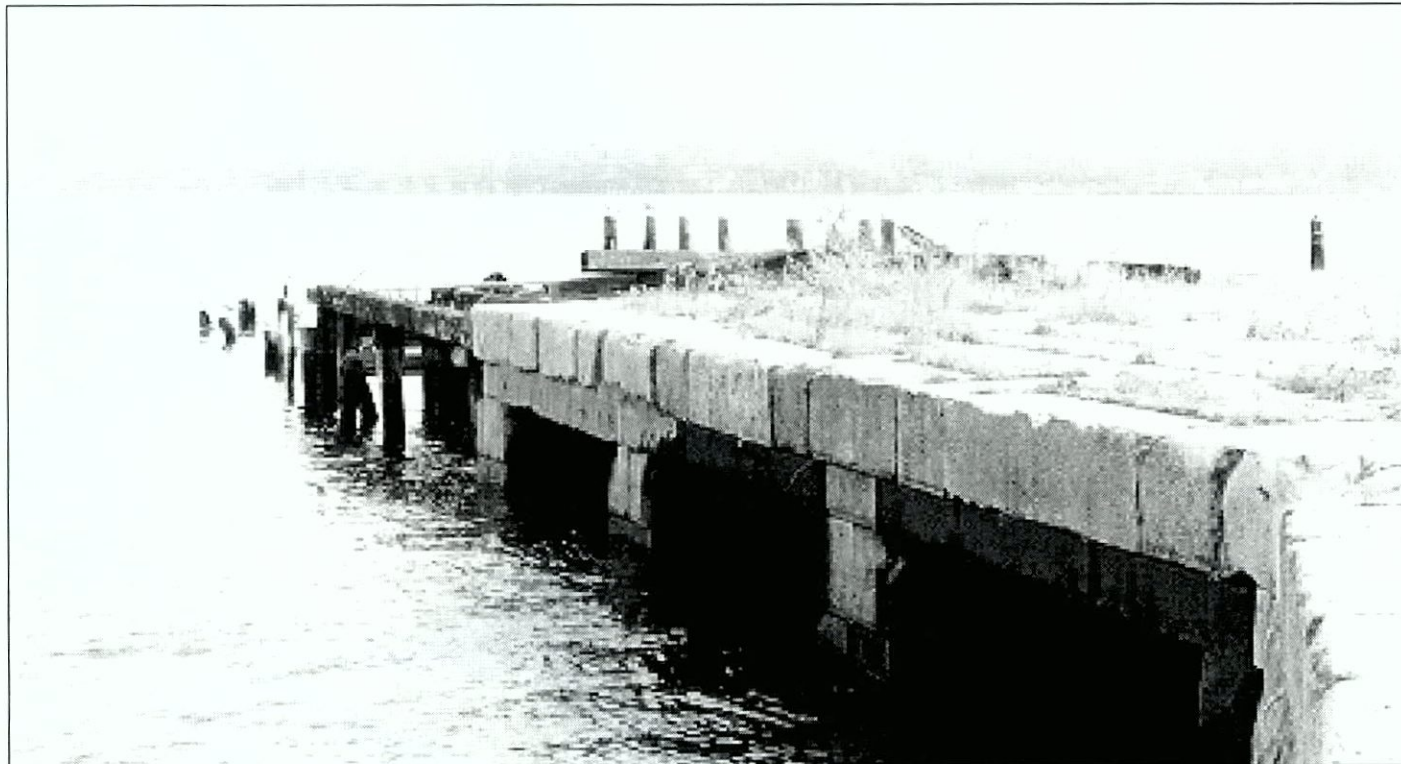
**Figure 6.45** General view of North Dock showing deteriorated condition at the end and the intrusion of vegetation through the joints in the masonry deck.

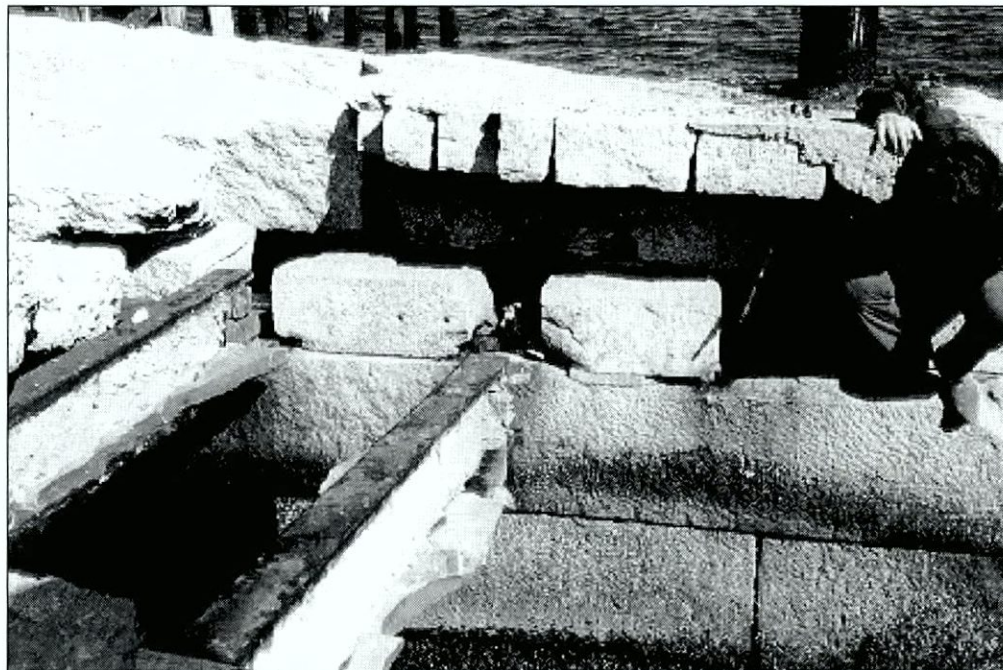
**Figure 6.47** North dock at northeast corner showing area where granite pavers have been removed. End blocks are gradually slipping into the ocean.

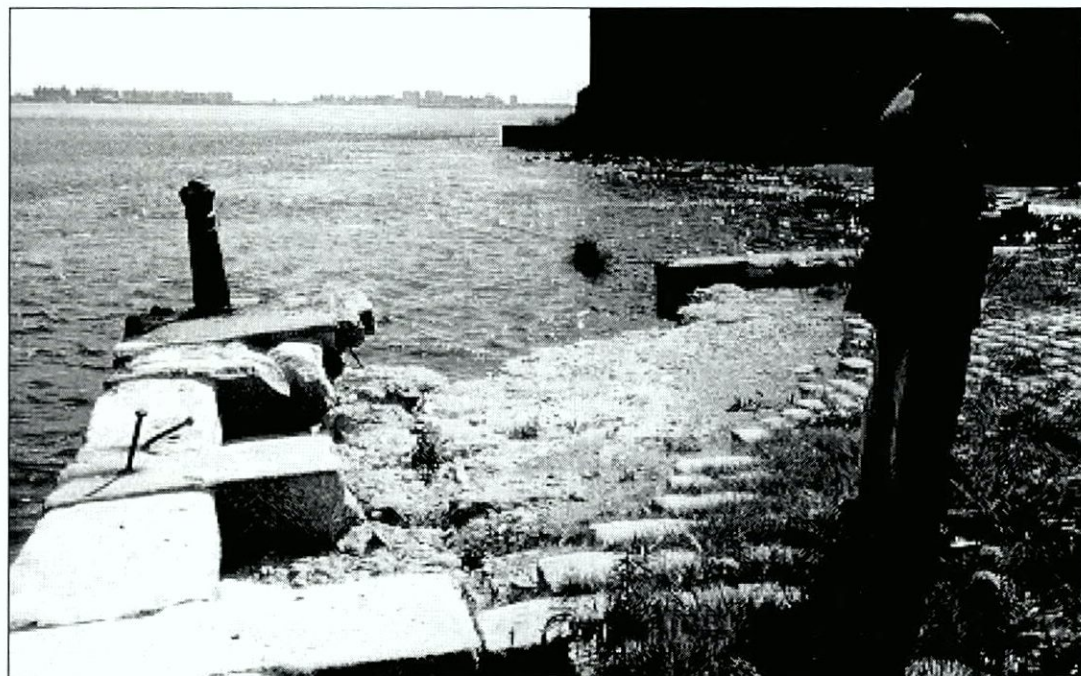
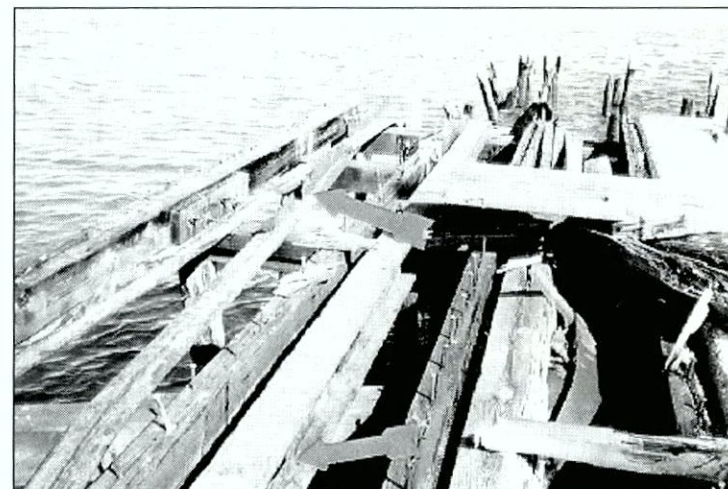
**Figure 6.48** Detail of dock end showing deteriorated and unsafe condition of decking. Arrows identify extensive corrosion of I-beams.

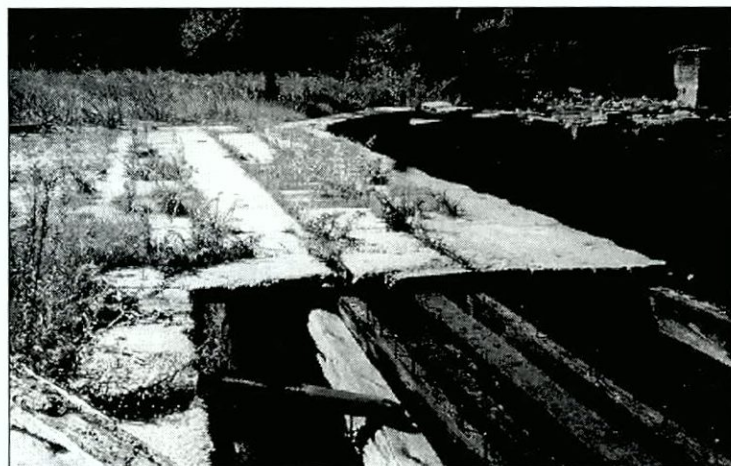
**Figure 6.50** View of seawall with dock in the distance. Note undulating shifting of capstones caused by the constant impact of ocean waves.

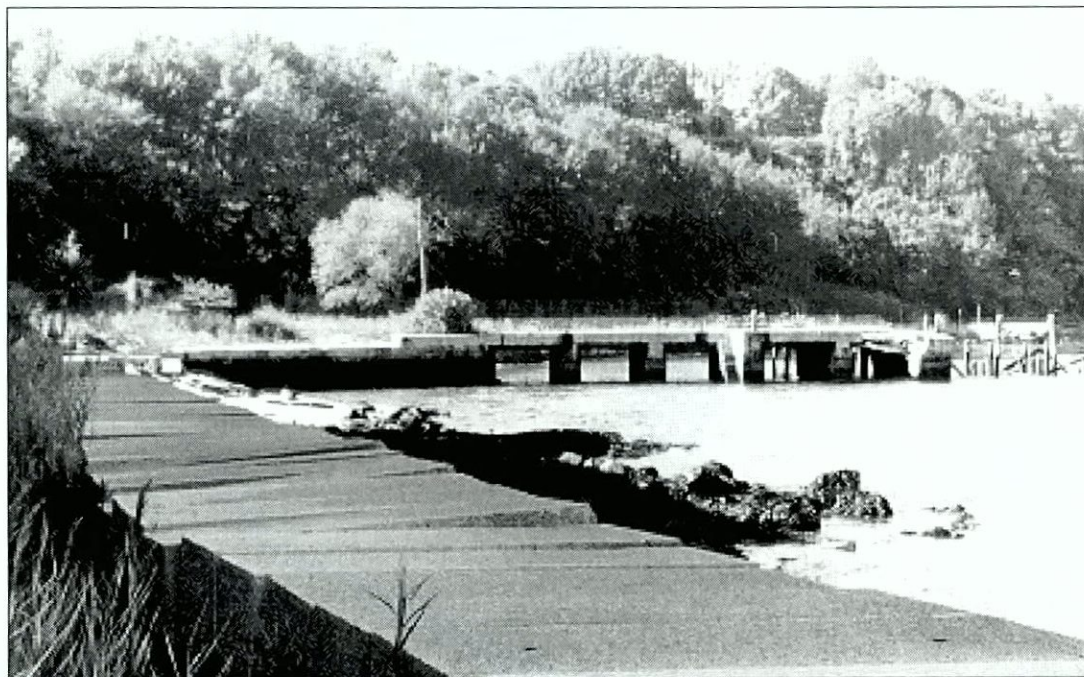
**Figure 6.51** View of seawall near dock showing complete failure and collapse of the wall system.

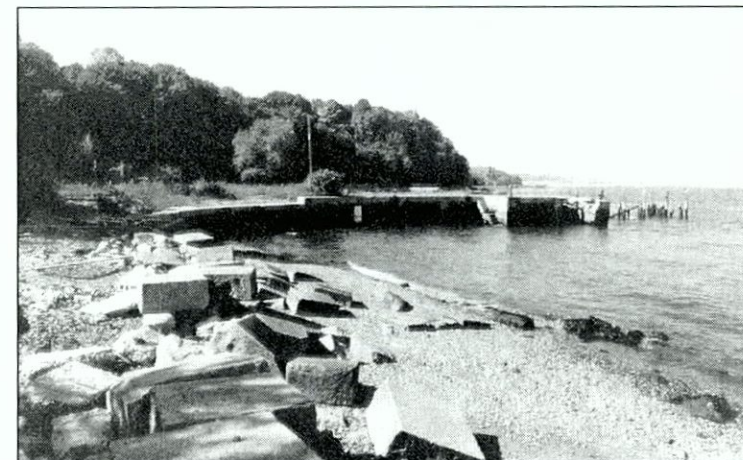
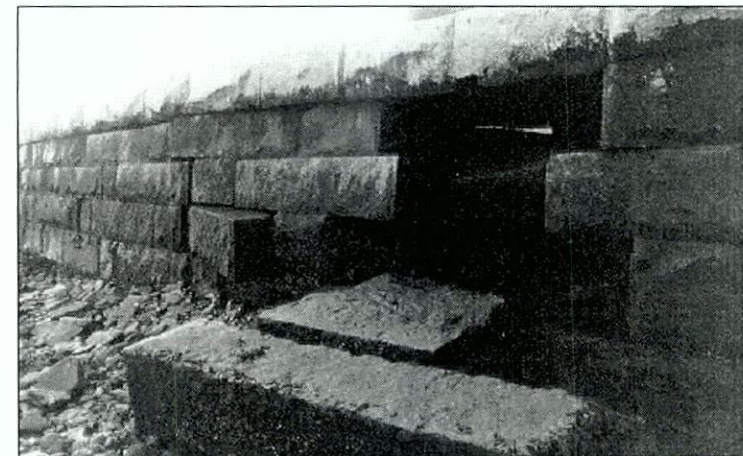
**Figure 6.52** Early stages of collapse near the SEC of the seawall.

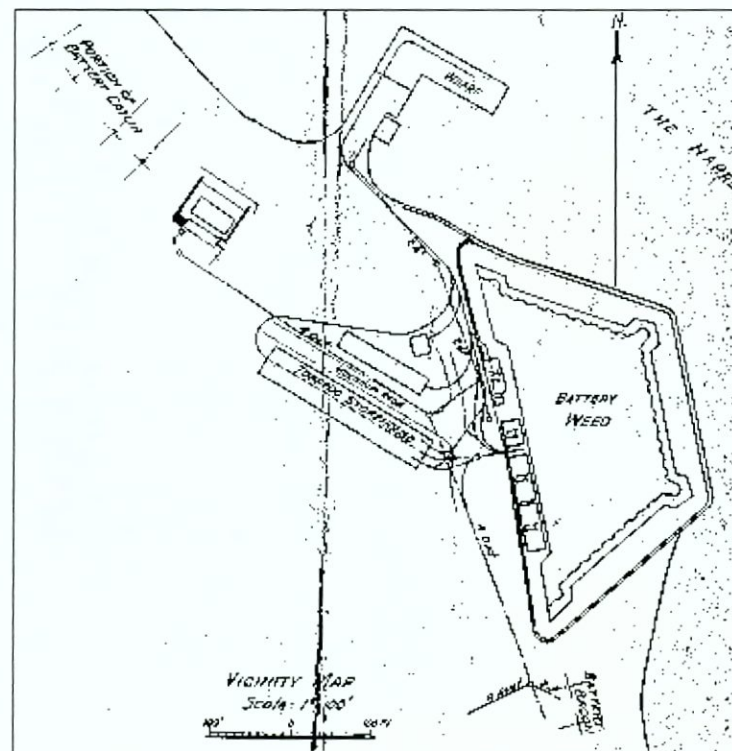
**Figure 6.57** Torpedo Storage Building  
and proposed relocation of rail tracks,  
1921.

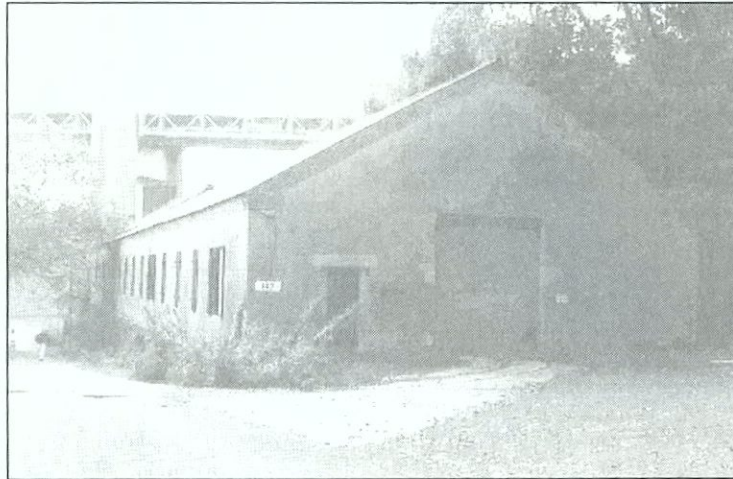
**Figure 6.58** General view of Torpedo Storage Building showing north and west facades. Verrazano Narrows Bridge is in the background.

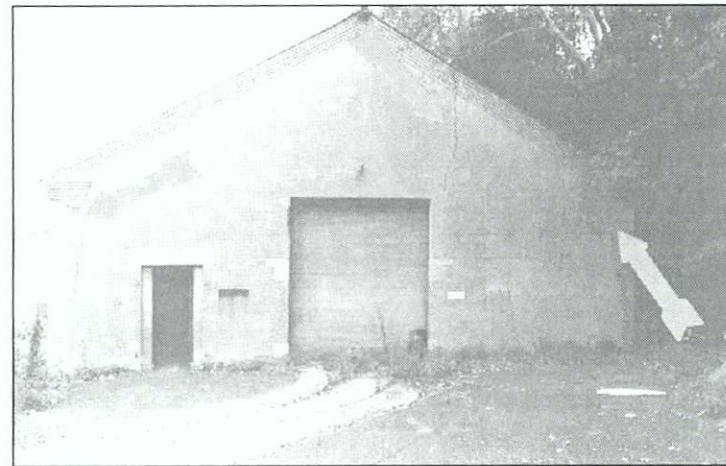
**Figure 6.59** West facade of Torpedo Storage Building. Arrows identify structural through-wall cracking.

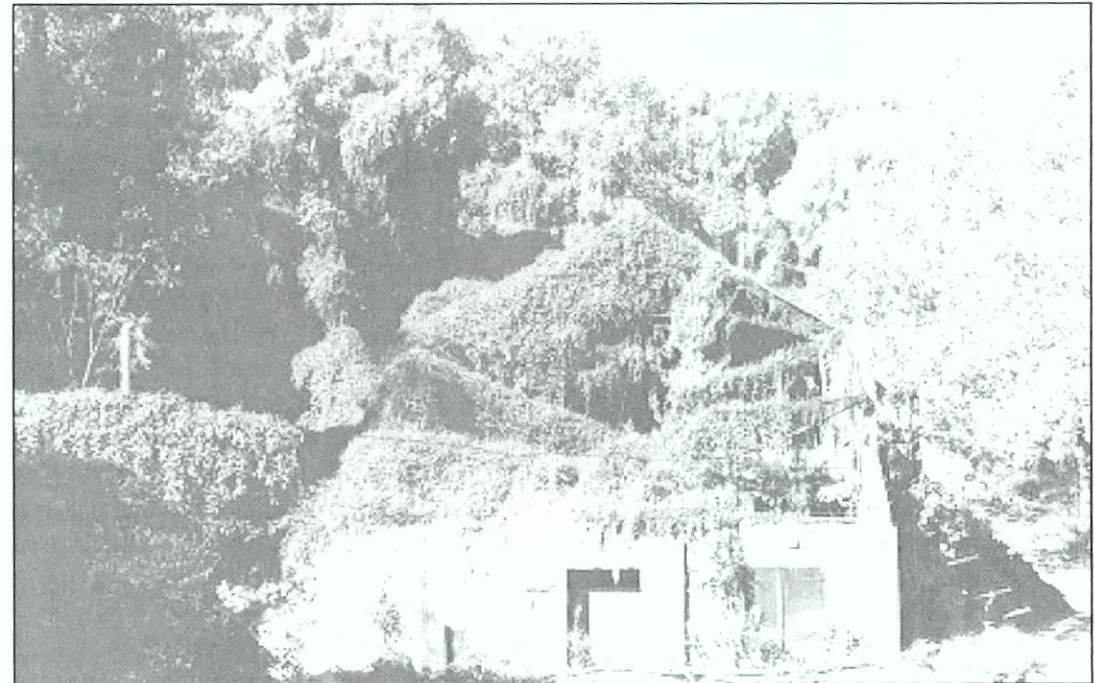
**Figure 6.60** Bird's eye view of Torpedo Storage Building looking west. Building is in ruinous state and overgrown with ivy.
