5050R  
US DOI

Cultural Resources Report for Fort Wadsworth, Staten Island, New York

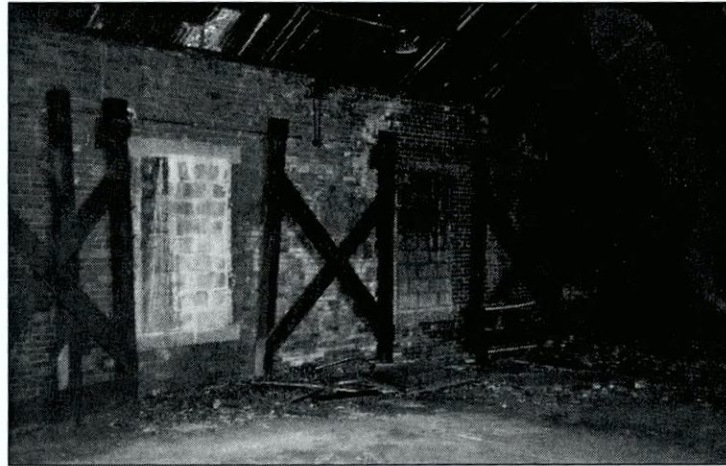
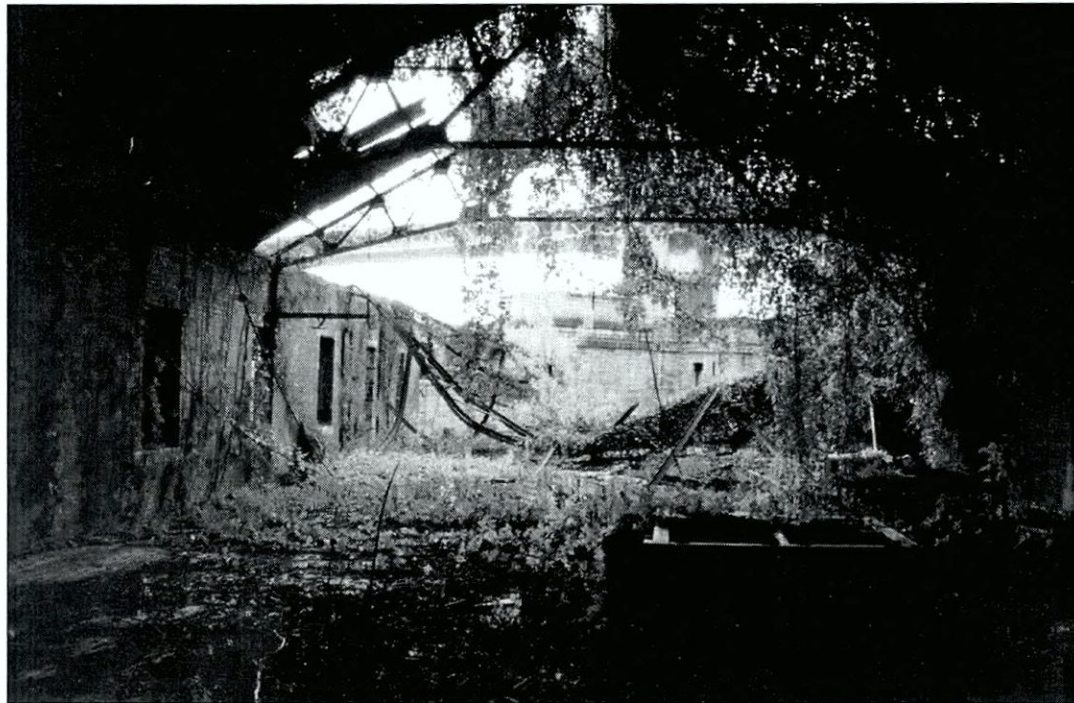
**Figure 6.62** Interior of Torpedo Storage Building looking east out the fire-damaged portion of the building. Note the structural failure and collapse of steel roof trusses and the intrusion of ivy.

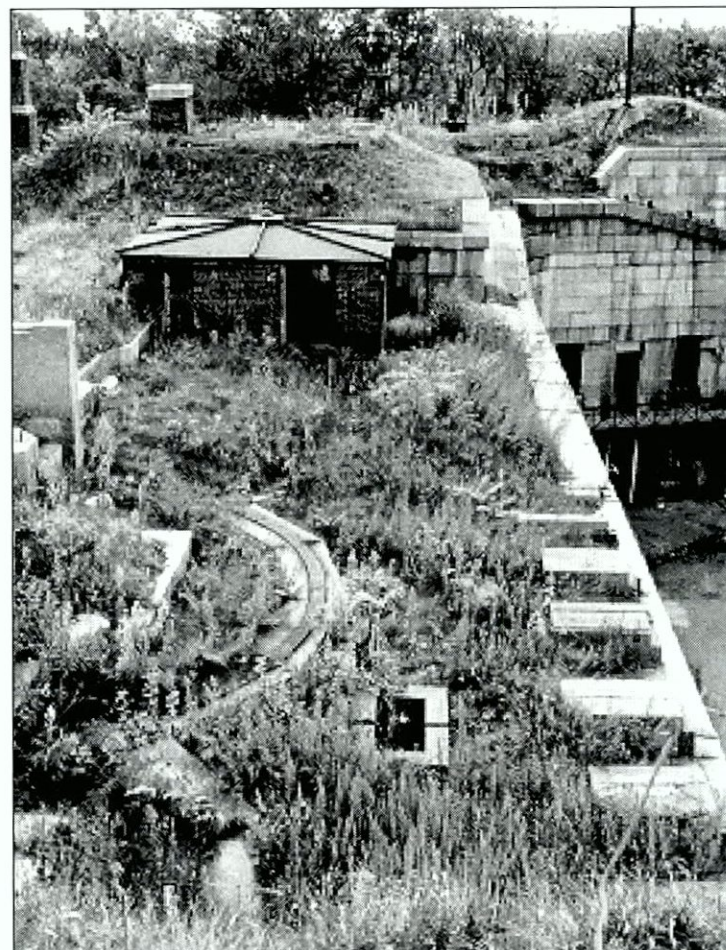
**Figure 6.63**  
Fort Tompkins, barbette.  
Looking west.

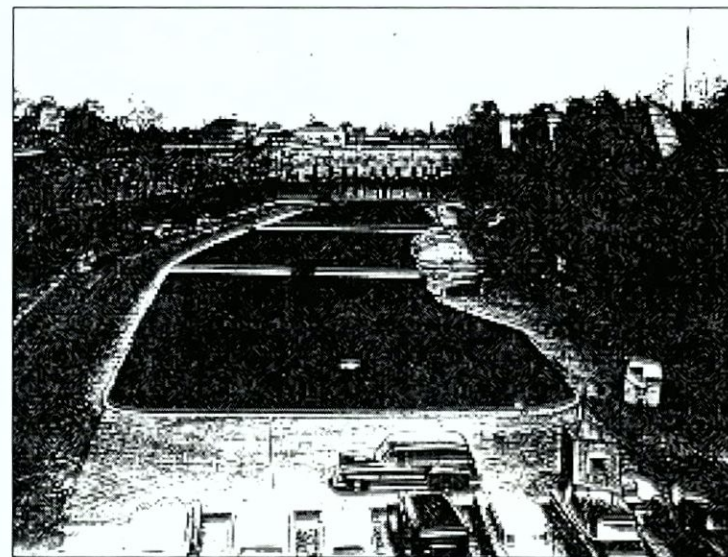
The channel front was completed last, and not structurally ready for armament until 1875, although only one barbette gun emplacement was documented as utilized during the fort’s entire history. The channel front included 17 large casemates that were constructed for storage and open to the parade ground. During the 1880s eight of these casemates were enclosed to support the torpedo mine storage system. It is not known which eight casemates were selected for this use. About this same time, the

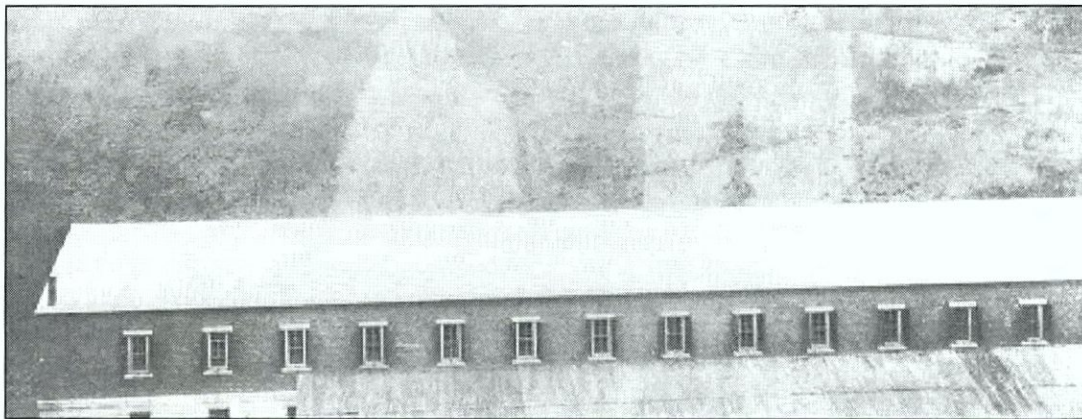
Complaints regarding the use of the casemates as barracks began to arise at the turn of the twentieth century. One piece of correspondence suggests that the casemate floors need renewal and that water closet facilities are inadequate; another proposes alternatives to the poor housing conditions, including new construction.

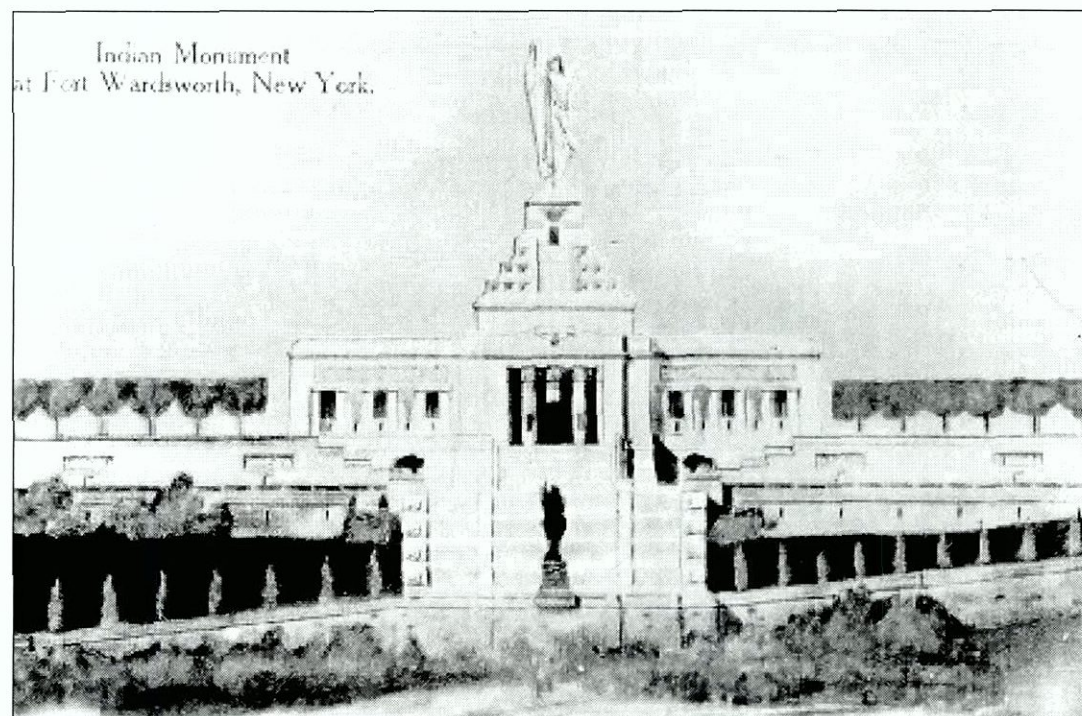
During World War I the casemates at Fort Tompkins provided quarters, a main guardhouse, storerooms, offices, and shops under the control of the quartermaster, ordnance officers and artillery

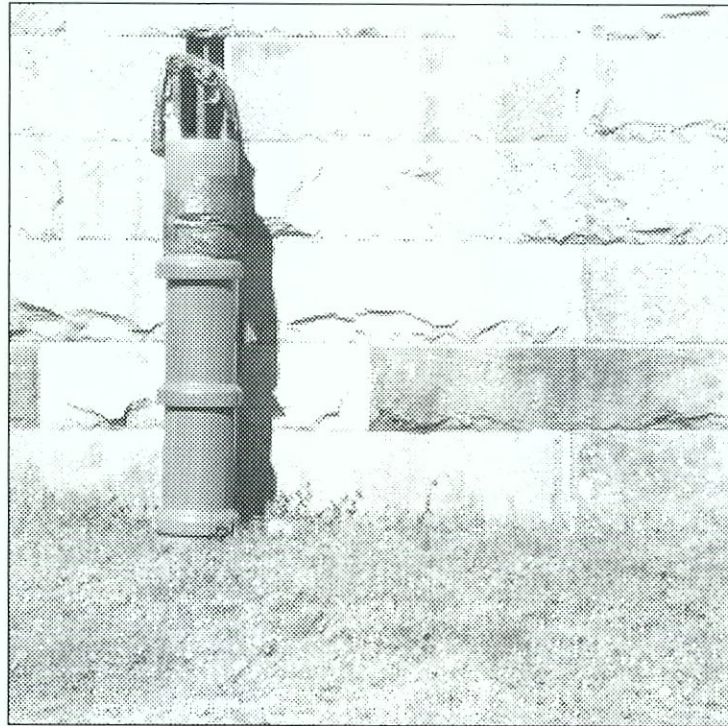
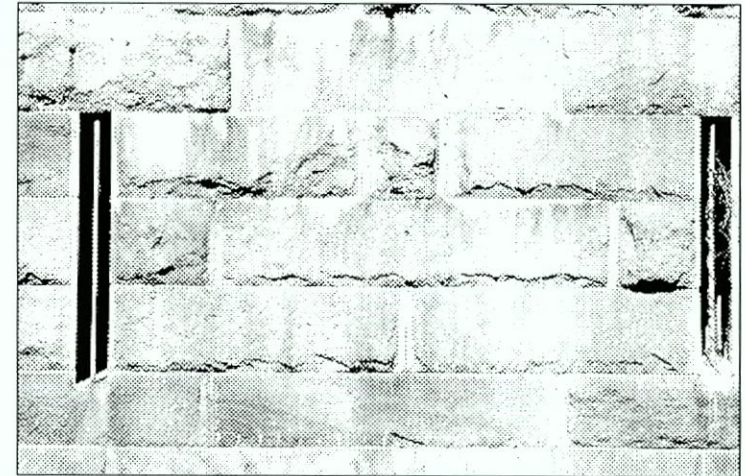
**Figure 6.80** South facade. Water-borne migration of calcite through joints and onto granite masonry leads to deterioration and weakening of joint and wall system.

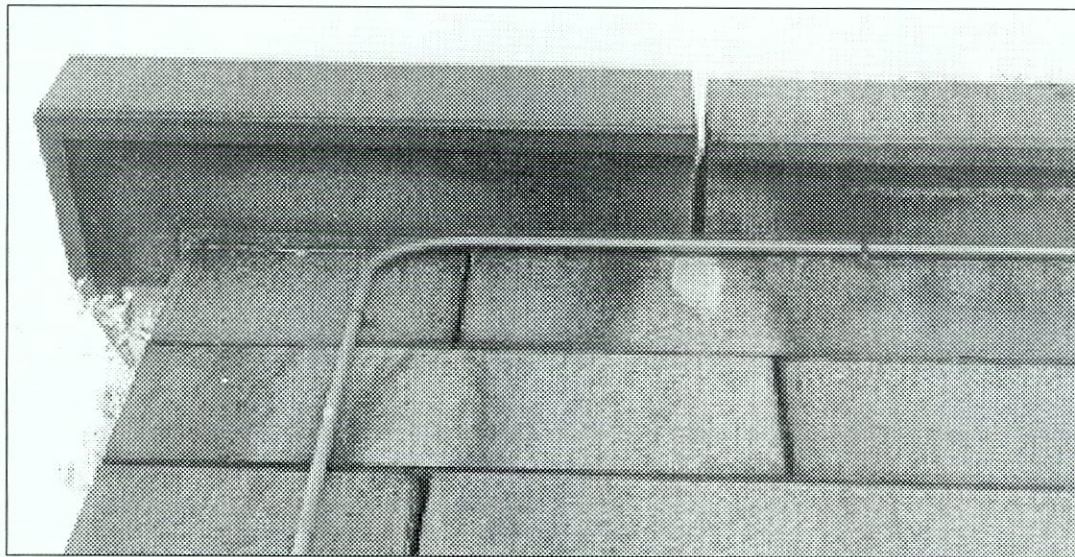
**Figure 6.81** Loss of mortar and shifting of granite capstone at the southeast corner of Tompkins. Note vegetation in joints and obtrusive newer metal conduit.

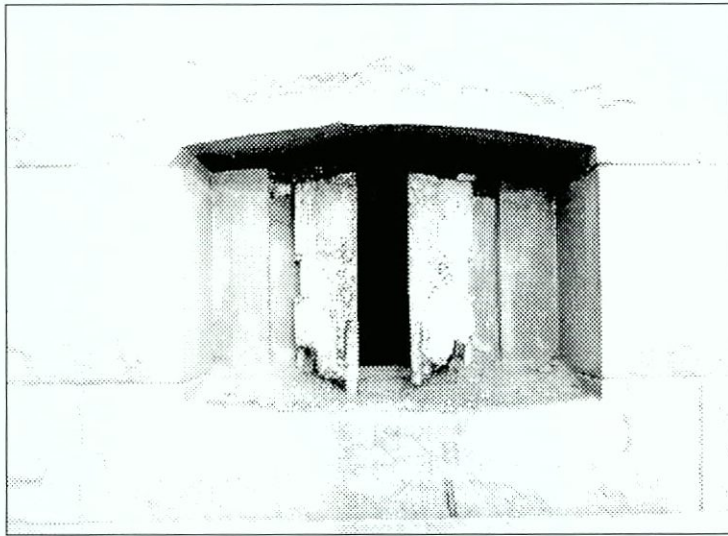
**Figure 6.82** Rusting of cast-iron shutters on the counterscarp. Arrows note major loss of original fabric due to ferrous corrosion.

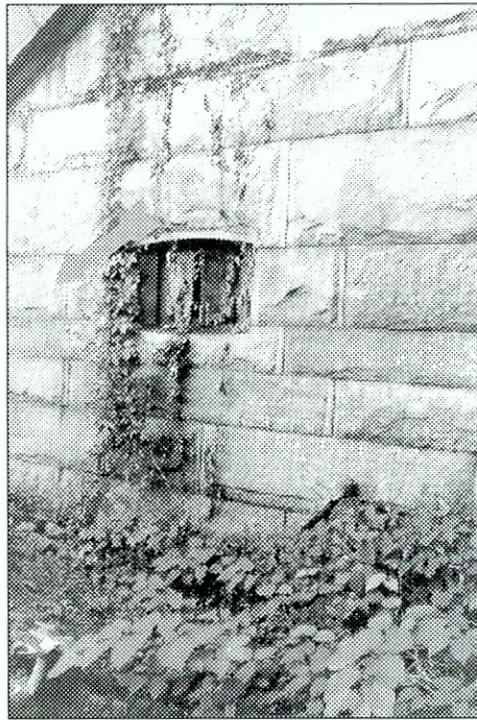
**Figure 6.83** Unwanted ivy growing on granite facade and cast-iron shutters of Fort Tompkins counterscarp. Light green biological growth evident to the left of the window (arrow).

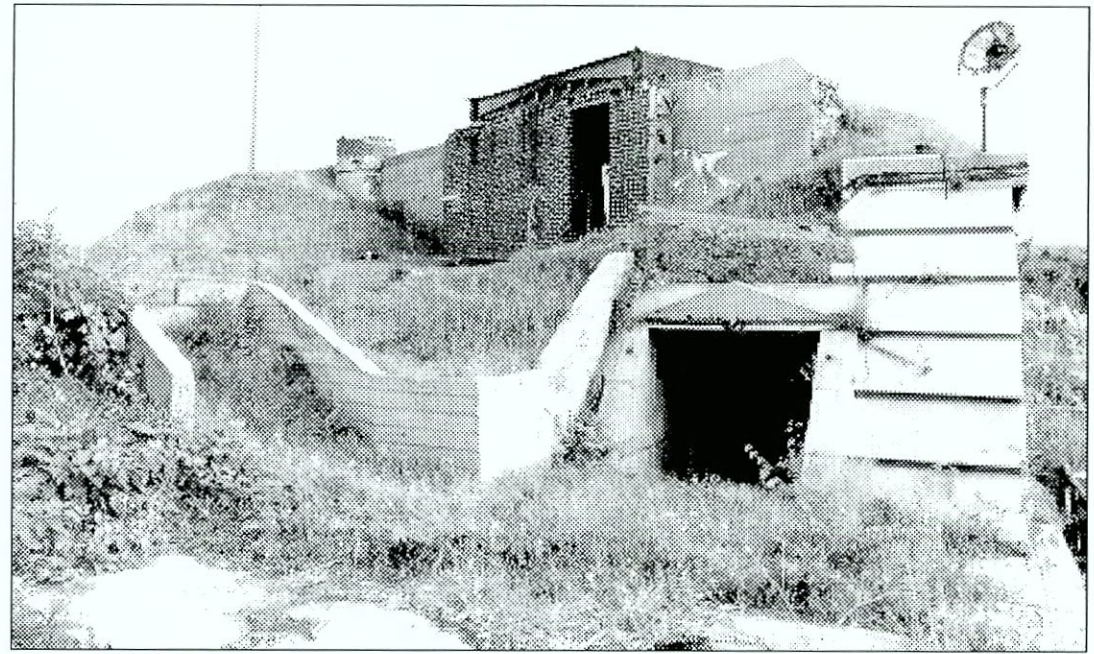
**Figure 6.86** Look-out complex located at the southeast corner of Tompkins' barbette. Portion of building removed. General deterioration of concrete and brick. Vegetation entering interior through doorway.

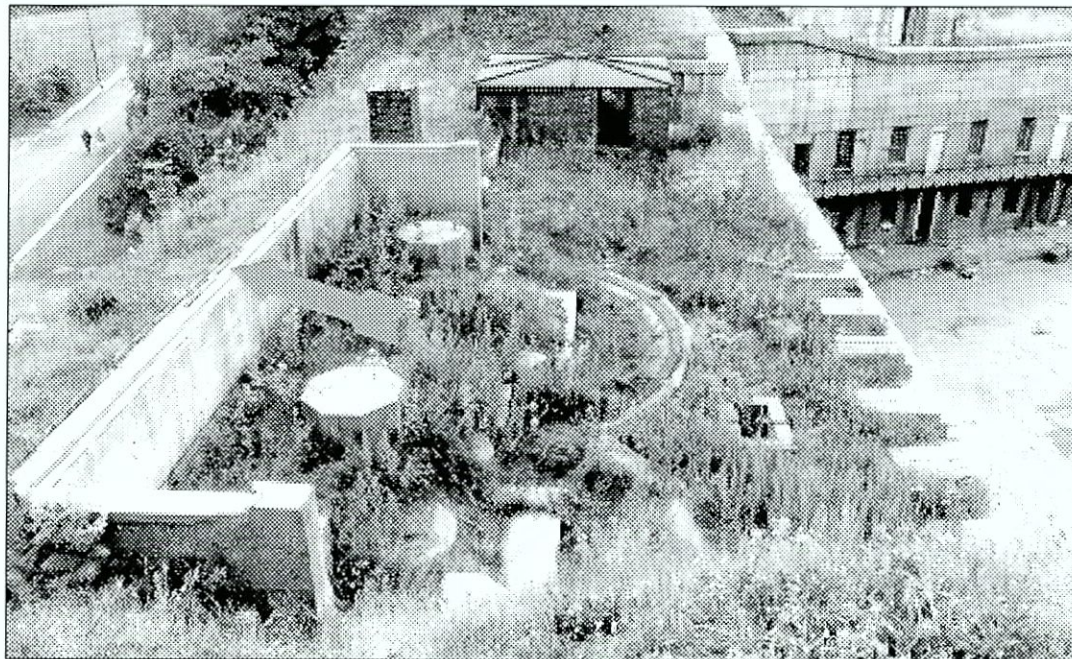
**Figure 6.87** South barbette looking west. Gunmounts concealed by vegetation. Cracking of concrete throughout. Spalling of concrete (arrow) caused by ferrous corrosion of piperail.

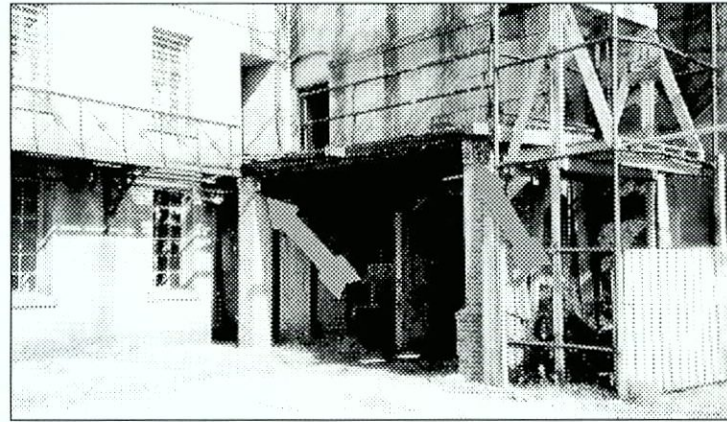
**Figure 6.88** Hoist at entrance to counterscarp. Arrows identify dislodging of brick piers. Note deterioration of second-story decking, missing handrail and poor condition of window units.

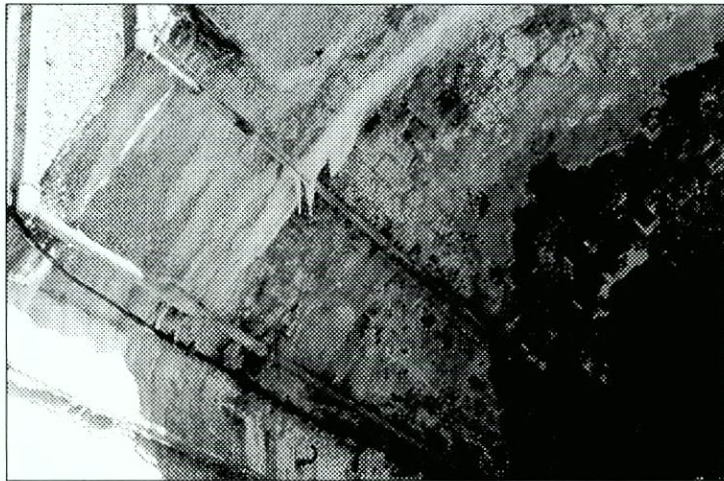
**Figure 6.89** Water-borne deterioration resulting in the formation of stalactites and extreme mortar loss through-out vaulted arcade. Note poor condition of conduit.

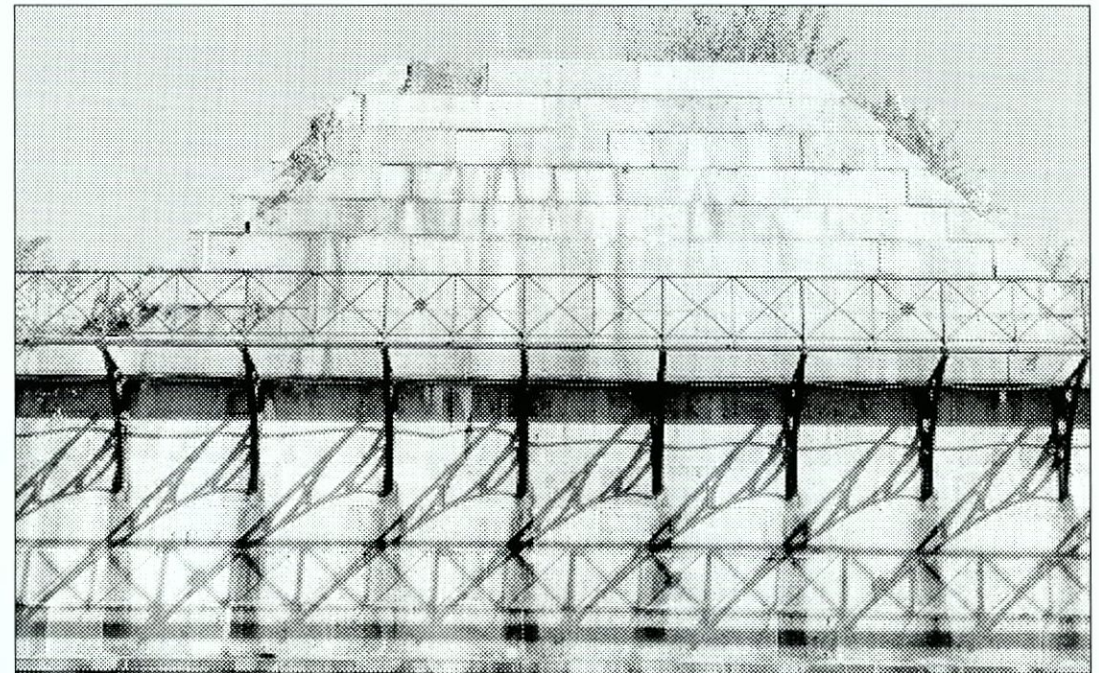
**Figure 6.90** Typical gable showing shifting of granite blocks. Brown staining caused by rusting of wrought-iron balustrade; note missing rosettes and decking.

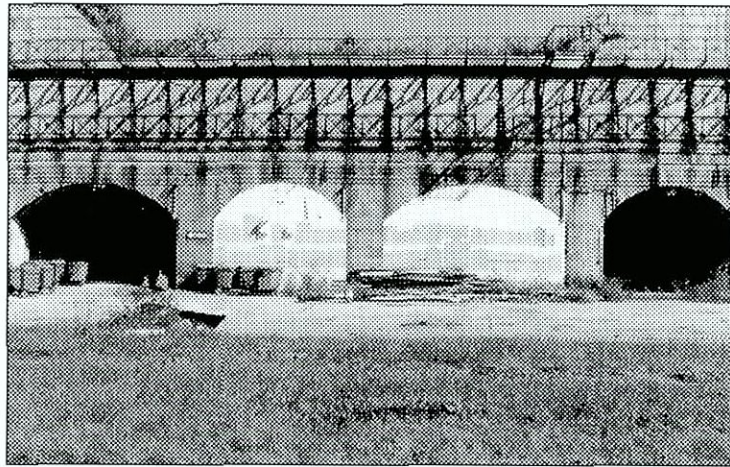
**Figure 6.91** Otrusive in-fill of arched openings prohibits visitors from walking through the arcade, as well as altering original intention and appearance.

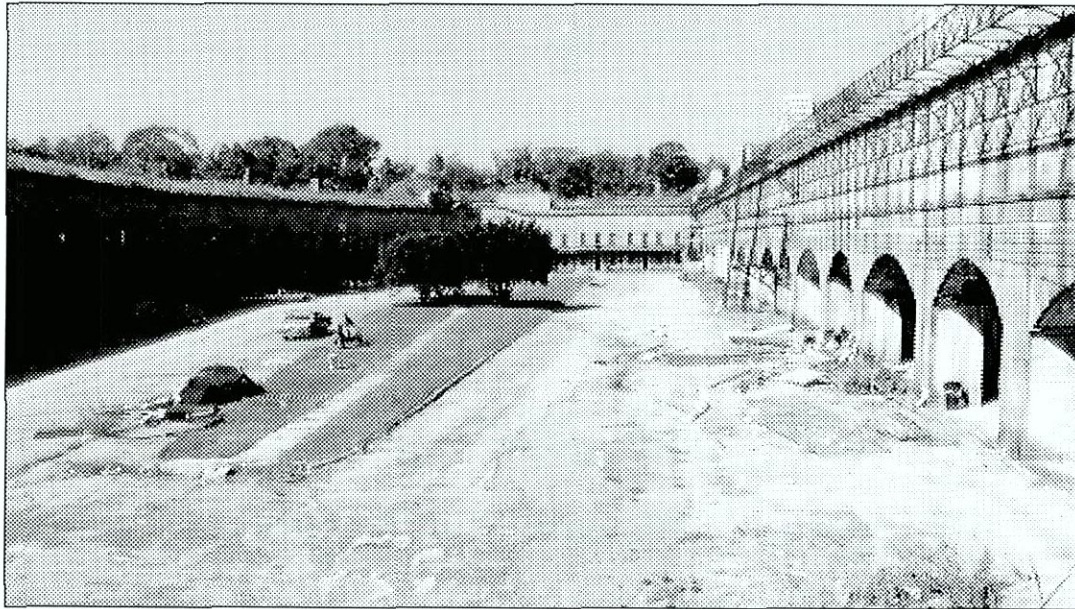
**Figure 6.92** General view of Tompkins' parade looking north. Asphalt pavement in poor condition. Debris and inappropriate storage of materials around the perimeter.

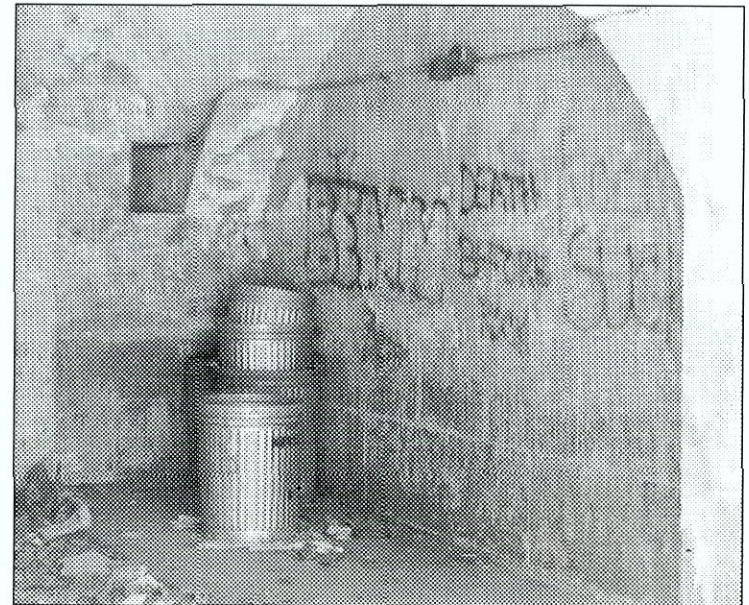
**Figure 6.93** Spray-paint graffiti on painted granite located at the entrance to the counterscarp.

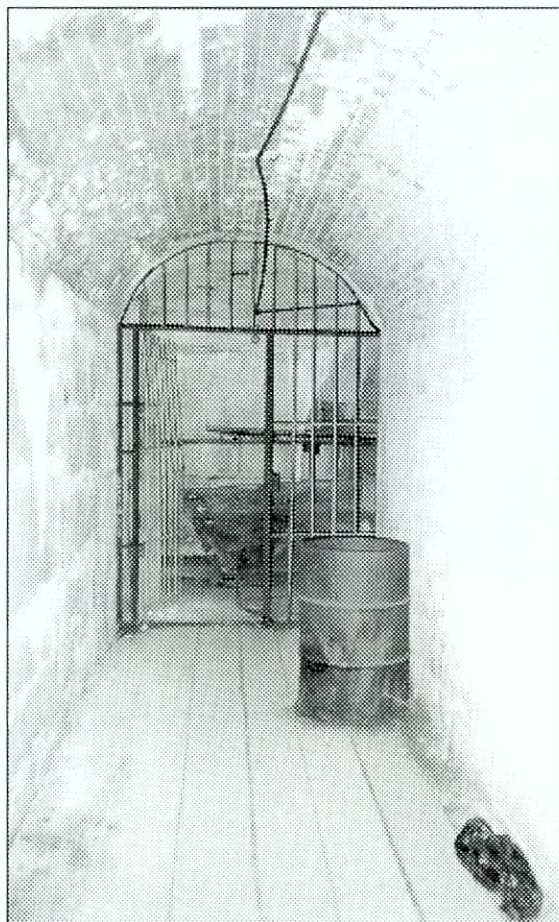
**Figure 6.94** Loose plank decking at beginning of counterscarp gallery. Note white staining on masonry walls.

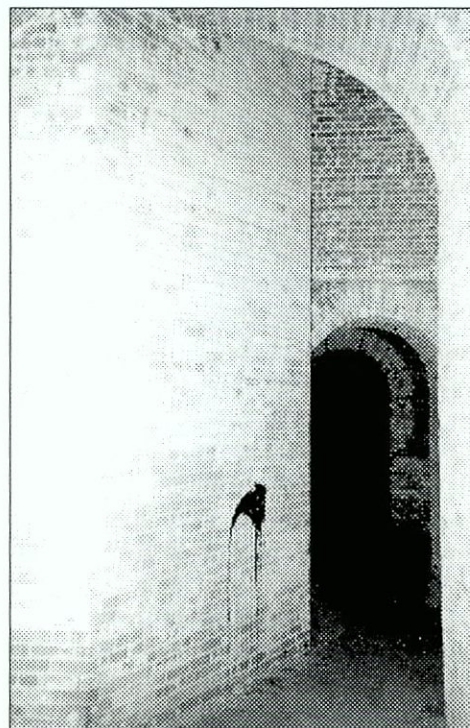
**Figure 6.95** Counterscarp gallery at northwest corner showing ghosts of white interior finish on walls and vaults. Dirt floor in this area. Isolated occurrence of bitumastic splattered on brick masonry.

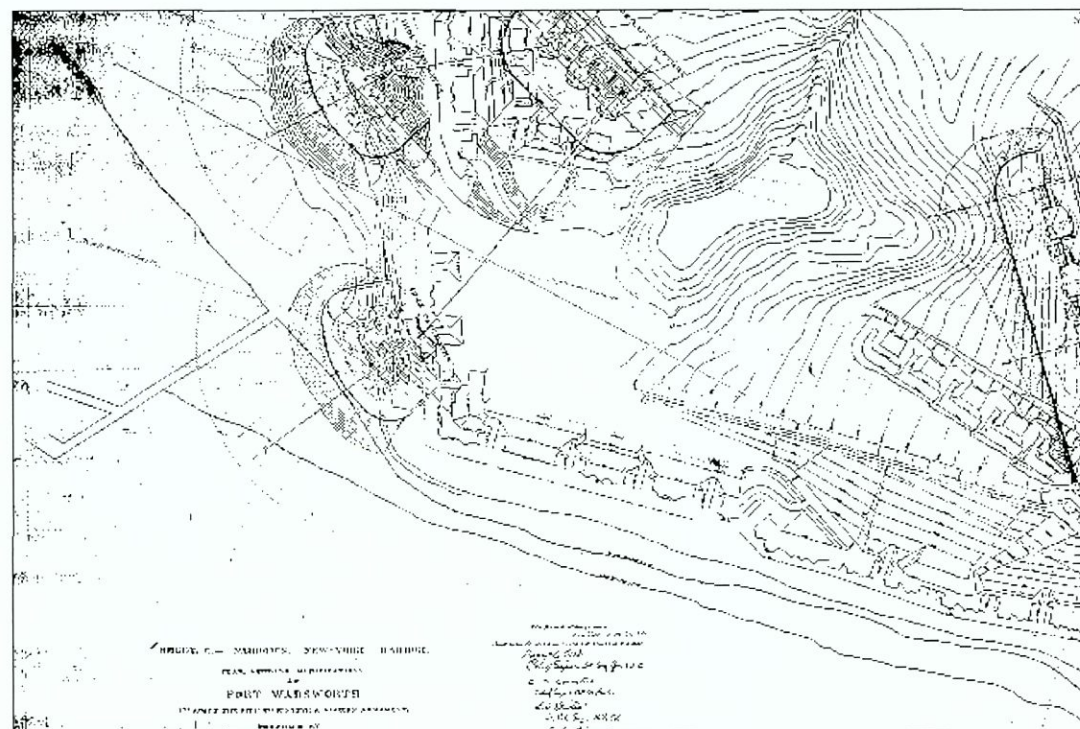
A map revised to 1962 showing the Verrazano Narrows Bridge construction lists Battery Duane as Building 132 and Coal Storage (temp.), with a separate building on the platform at the east end listed as Storage. The walk or roadway leading to the top of the embankment from the southeast corner is squared-off in this map and labeled Parking Lot No. 4. The existing condition of the latter is more consistent with that found on the 1943 plan, and the two other structures once located at either end of the battery have been demolished.

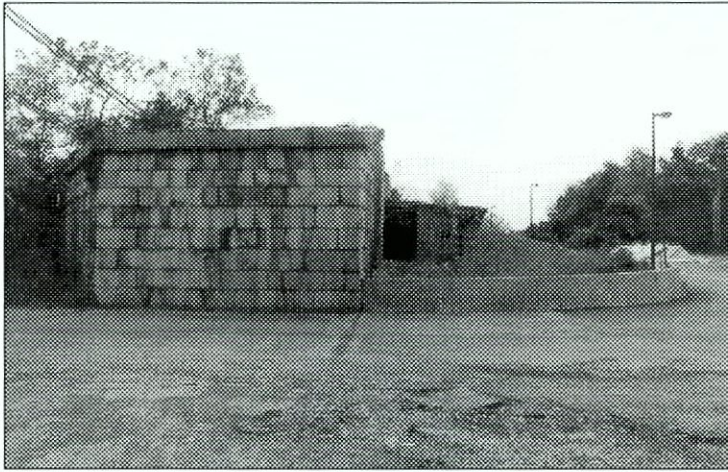
**Figure 6.103** Battery Duane, granite wall at south end. Cultural Resources Center, 1994.

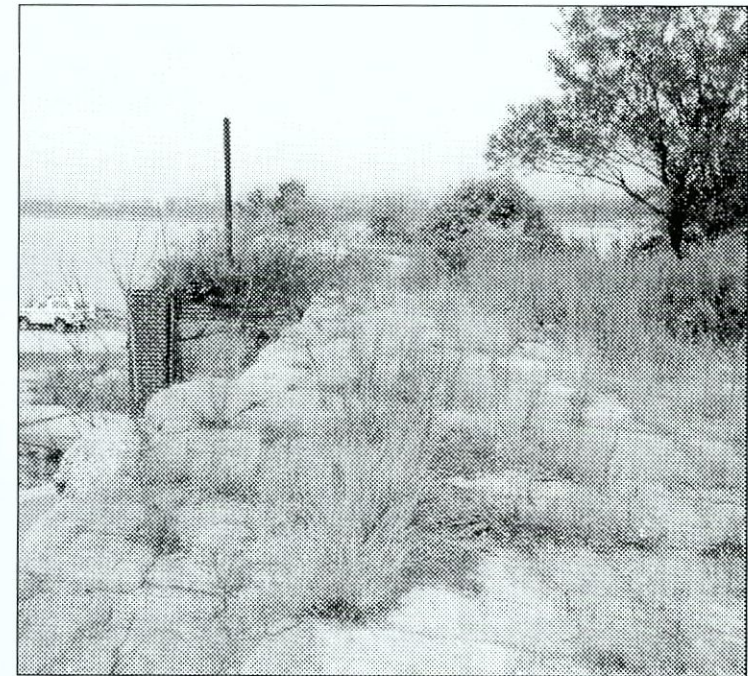
**Figure 6.108** Detail of unwanted vegetation growing out of cracks in concrete at top of battery. Wall edge is very unstable.

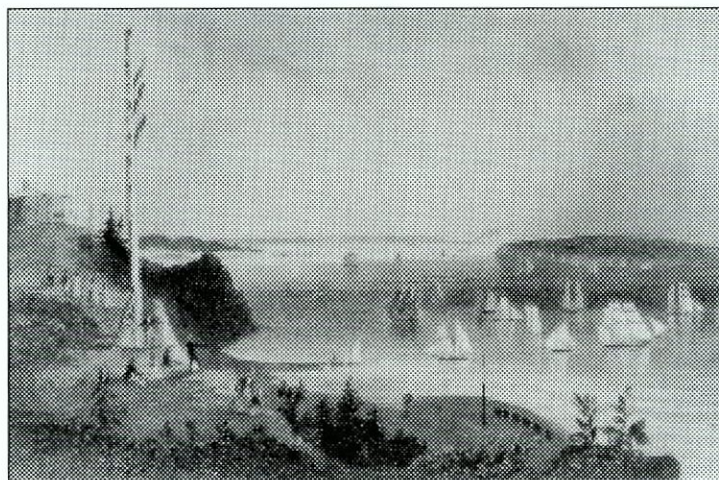
**Figure 6.109** Print, depiction ca. 1815 to 1847. Staten Island Institute of Arts & Sciences, Neg. #4.

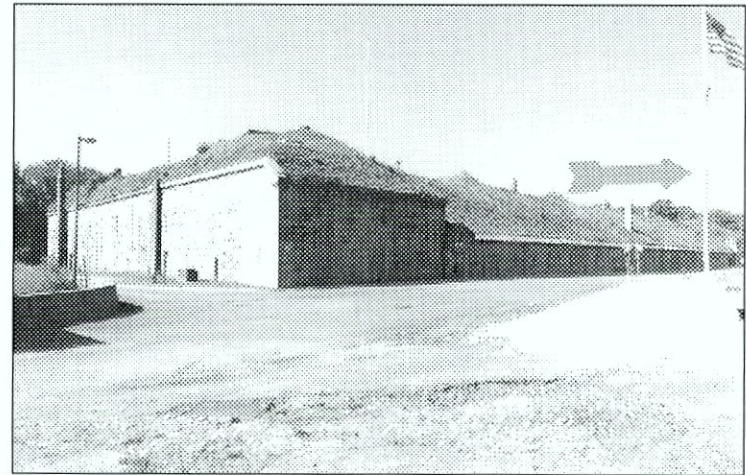
**Figure 6.110** General view of recently installed flagpole located east of Fort Tompkins' main entrance.

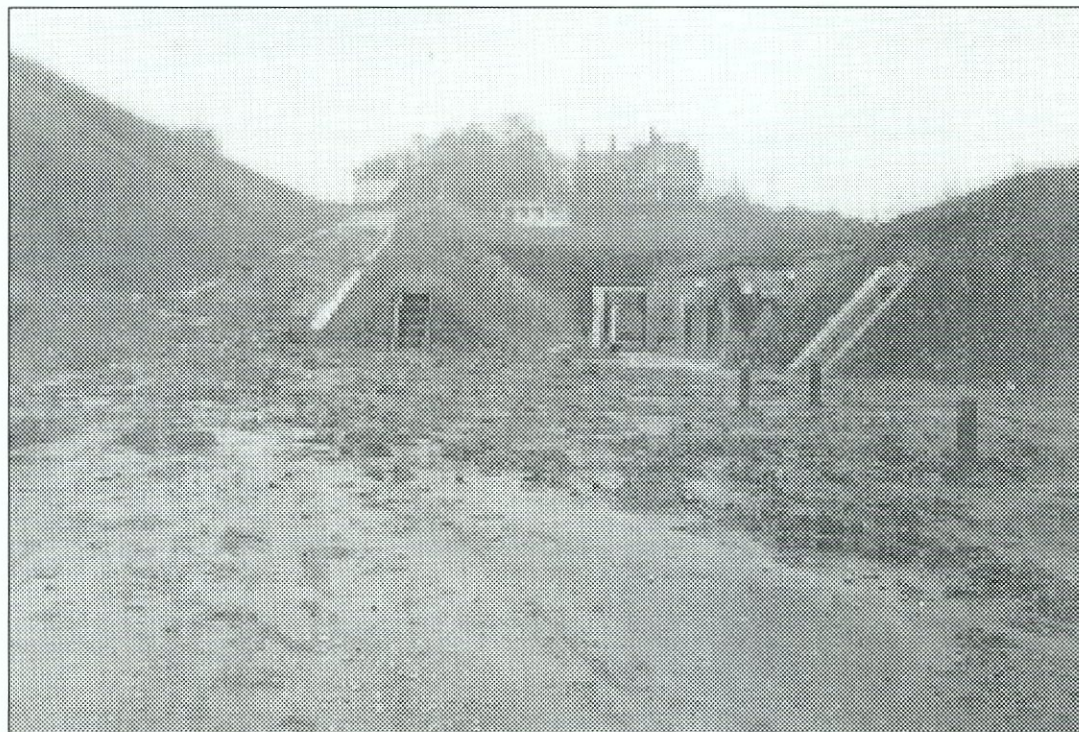
Recent discoveries of Fort Wadsworth's individual building files housed in the National Archives provide more detailed information regarding Building 109, including a clearer photograph of the

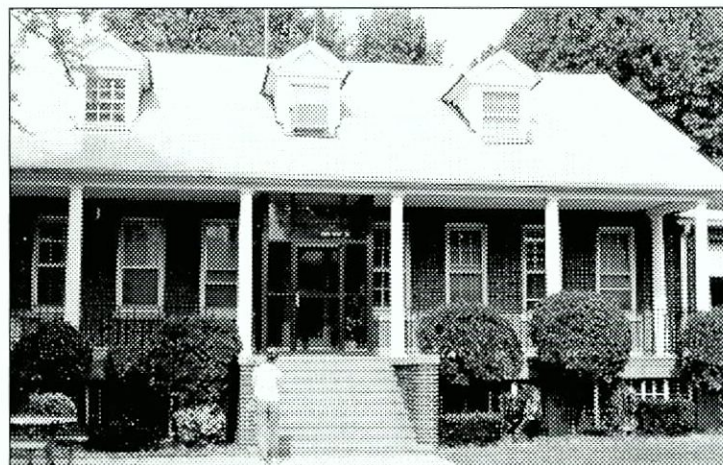
**Figure 6.117** Building 109, south facade. By Cultural Resources Center, 1994.

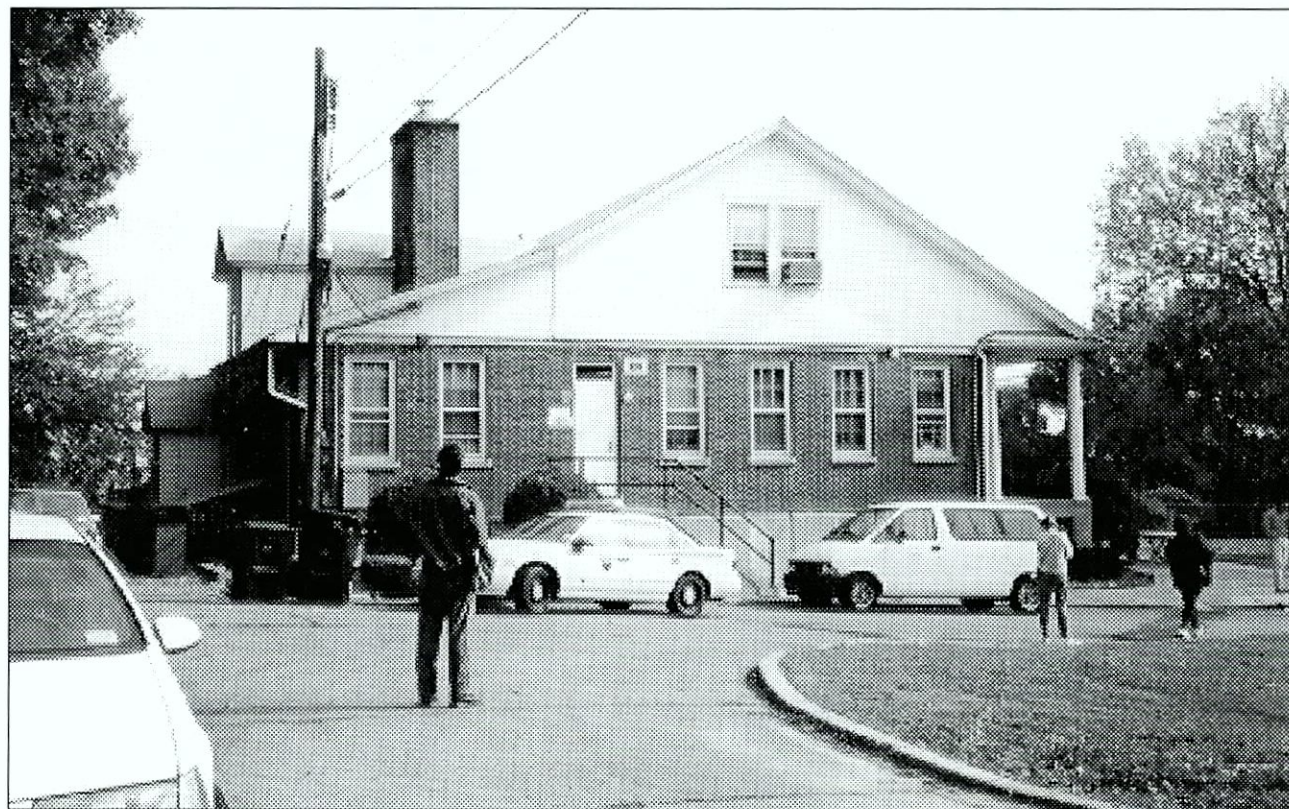
Solution: Conduct an energy audit to determine problem areas and, if necessary, replace storms with historically appropriate units.

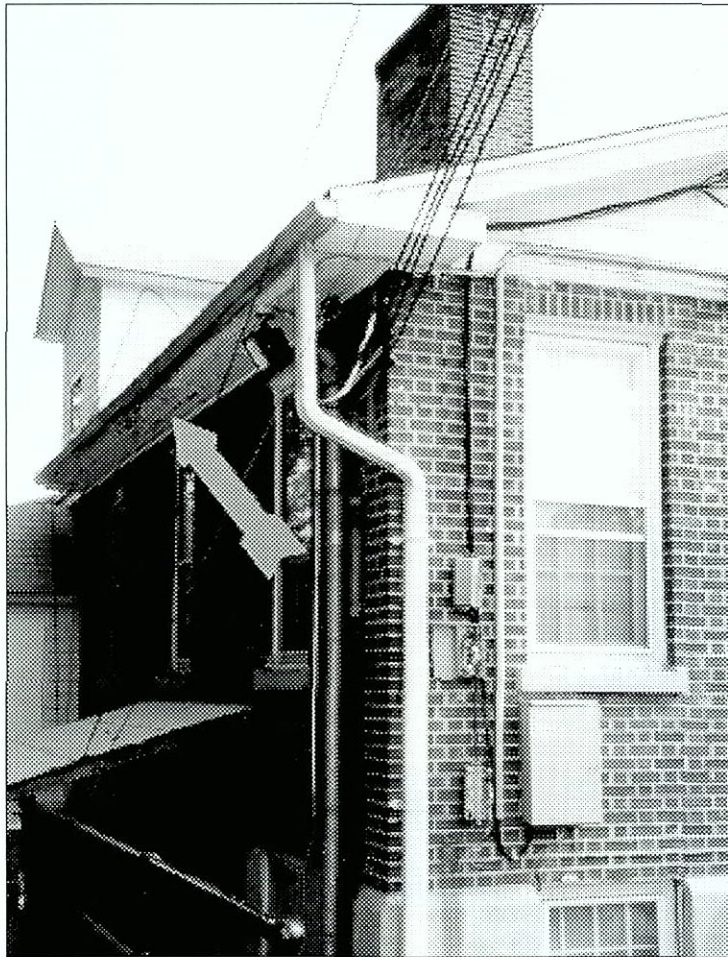
**Figure 6.119** Utility wires, control boxes haphazardly mounted, northwest corner. Arrow identifies peeling paint; signals poor water drainage from roof. Extensive reporting of chimney and rust staining seen on foundation wall.

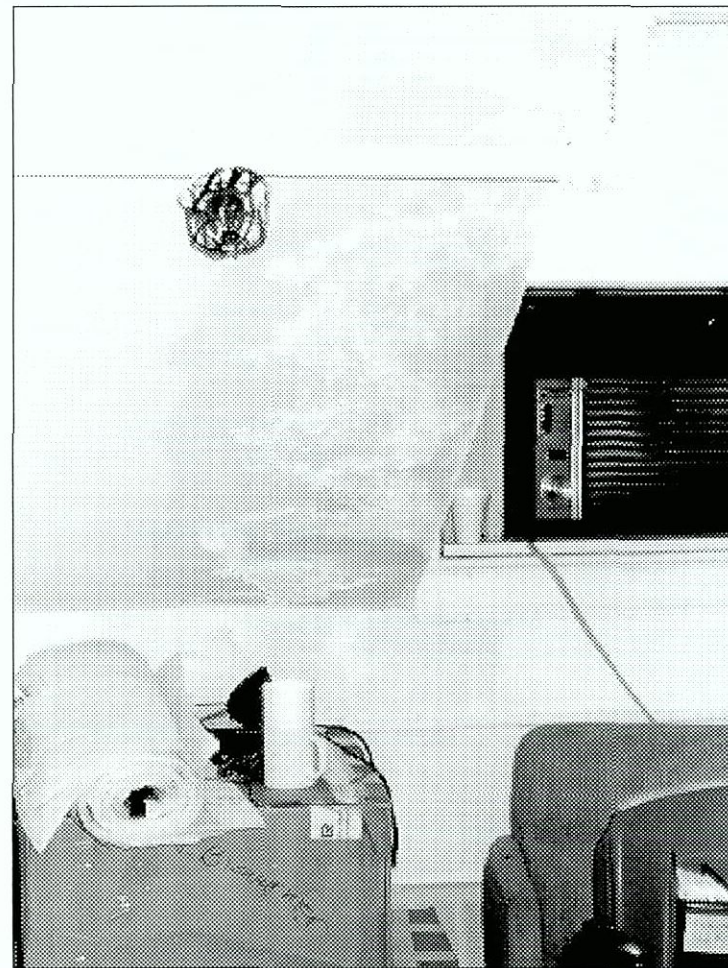
**Figure 6.120** Building 109, Lime "blooming" of interior plaster located near dormers is caused by water infiltration through faulty flashing at roof-dormer connections.

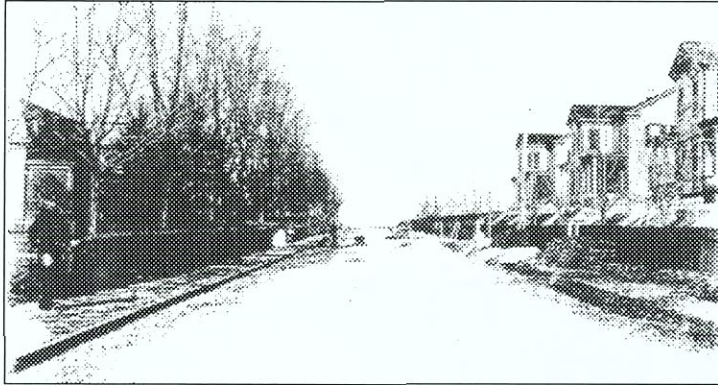
**Figure 6.121** Fort Wadsworth, Mont Sec Avenue, between 1889 and 1992. Staten Island Historical Society.

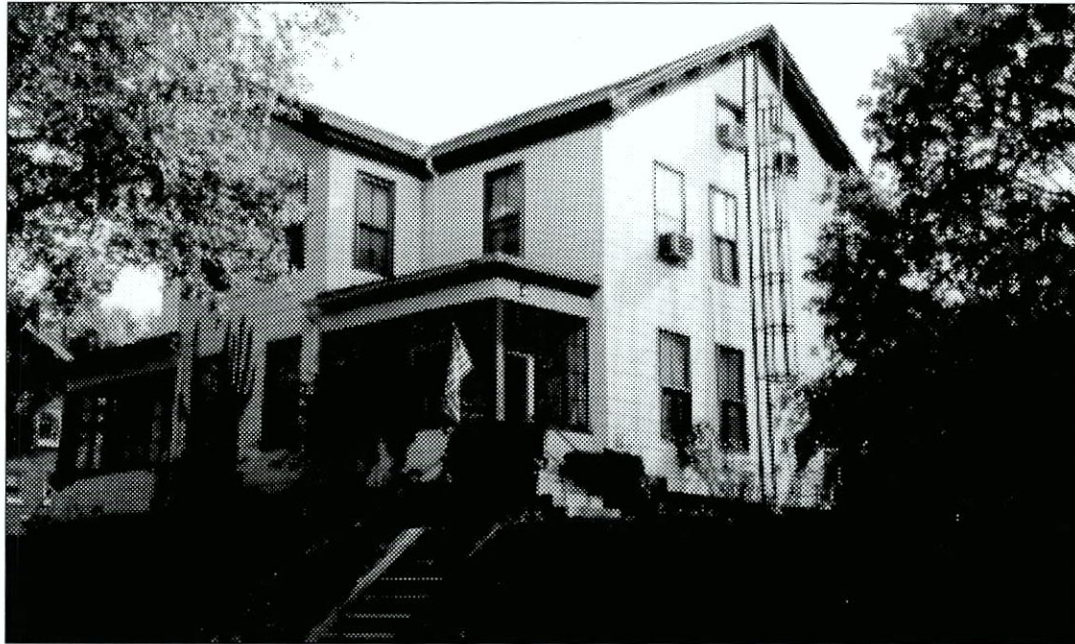
**Figure 6.124** Building 114.  
By Cultural Resources  
Center, 1994.

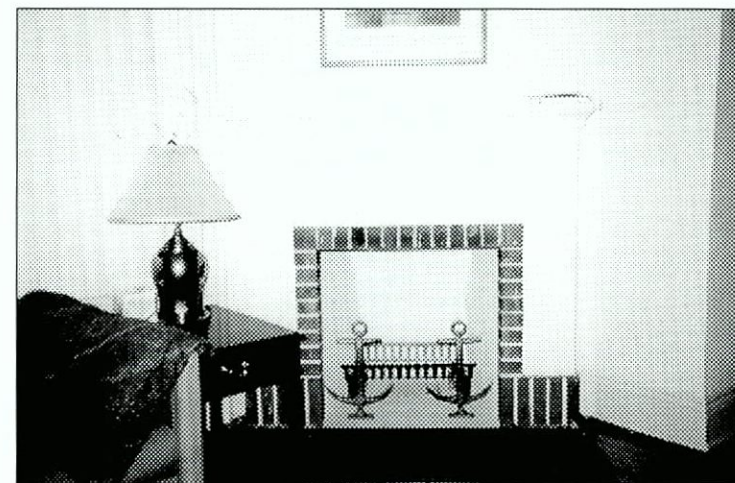
**Figure 6.129** Building 113,  
Parlor fireplace. By Cultural  
Resources Center, 1994.

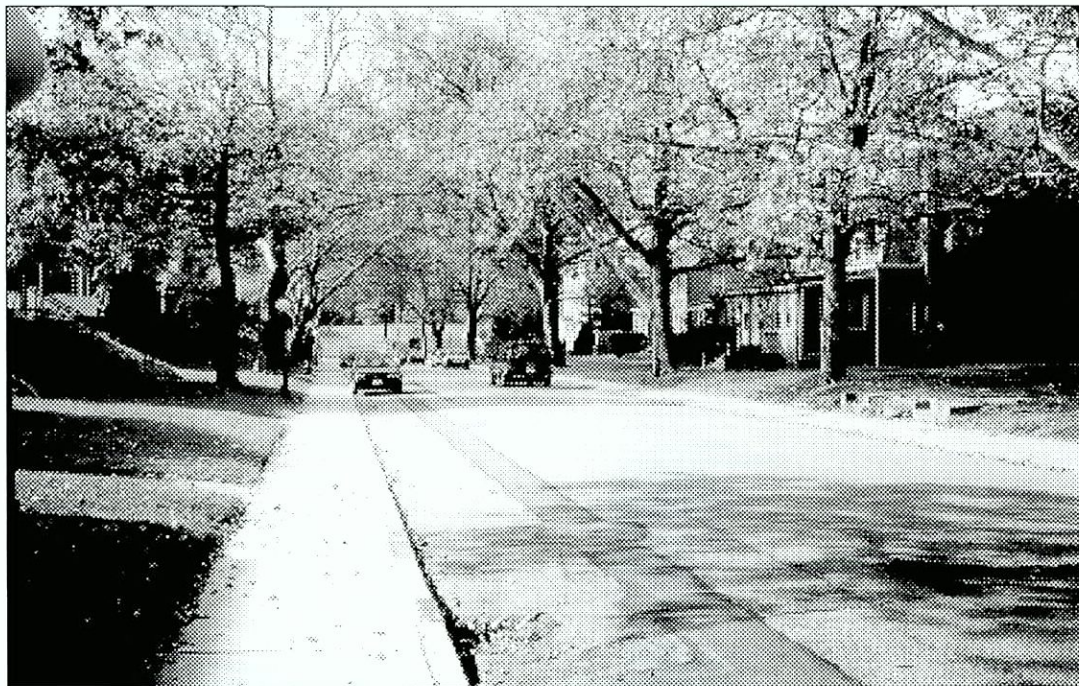
**Figure 6.130** General view of Officers' Row on Mont Sec avenue.

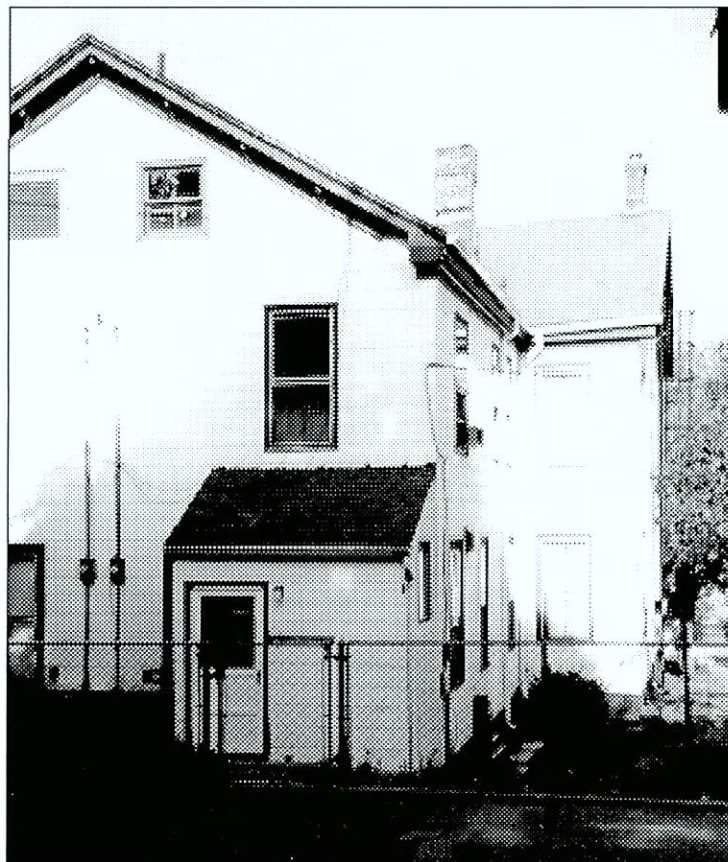
**Figure 6.133** Rear facade of duplex. Jalousie retrofitting of upper left attic window next to unaltered window unit. Replacement of all multi-paned storms (and possibly seasonal screens) with fixed metal storm units.

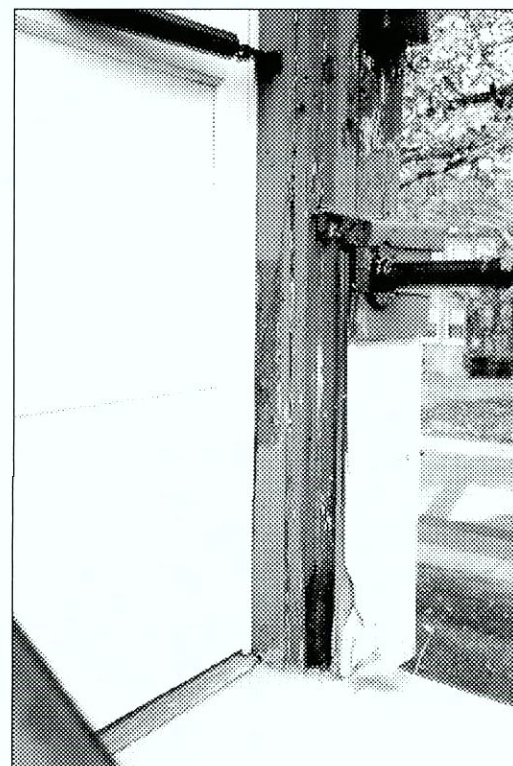
**Figure 6.136** Detail of wood roof trim showing missing area of molding on the raking eave exposing the roof to water infiltration and vermin. Note strap-metal fire escape; one located at each duplex.

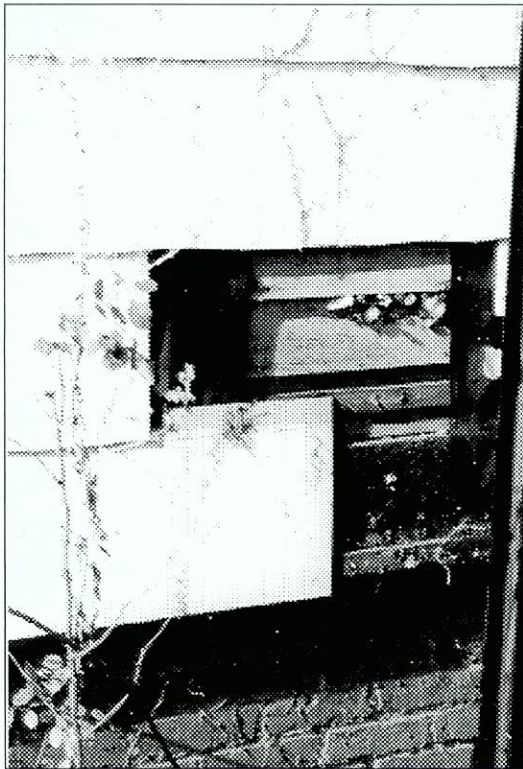
**Figure 6.135** Detail of siding where asbestos cement composite shingles have fallen thus exposing furring strips and original clapboards. Note evidence of insect infestation and plant growth.

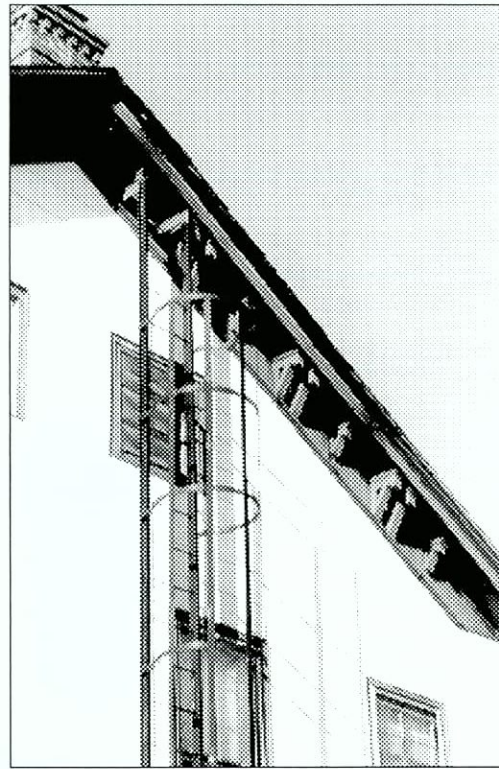
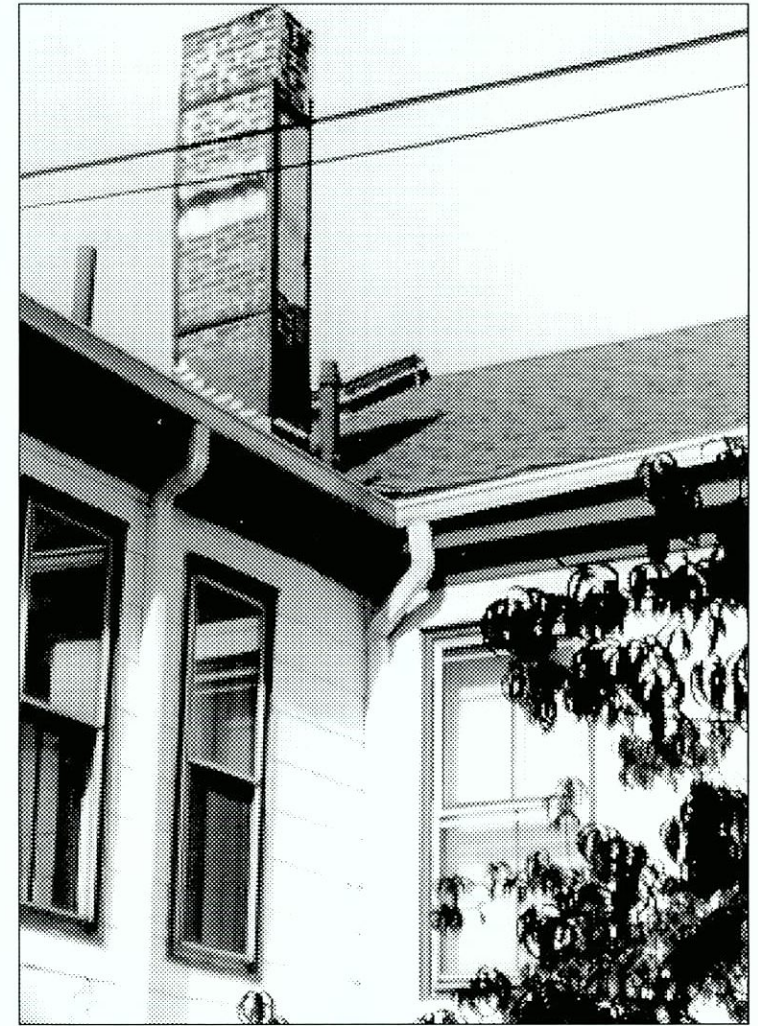
**Figure 6.137** Poor repair of typical chimney resulting in poor repointing, patching, and structural bracing with corrosive metal angles. Inappropriate and inefficient placement of down spouts.
