5050R  
US DOI

Cultural Resources Report for Fort Wadsworth, Staten Island, New York

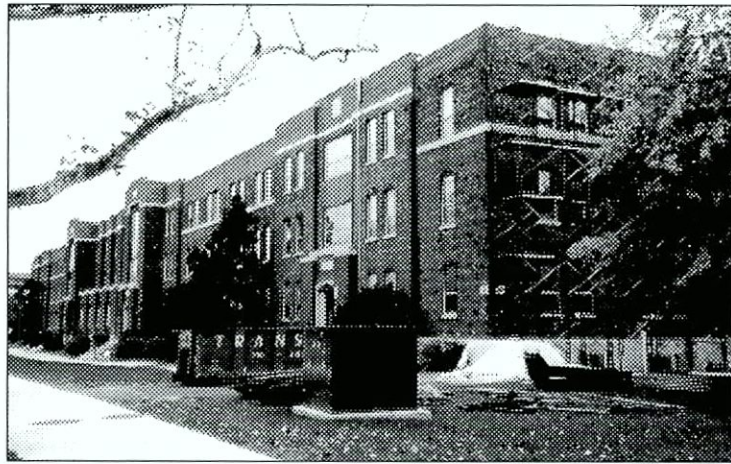
**Figure 6.142** General view of building 210 showing north and east (main) facades.

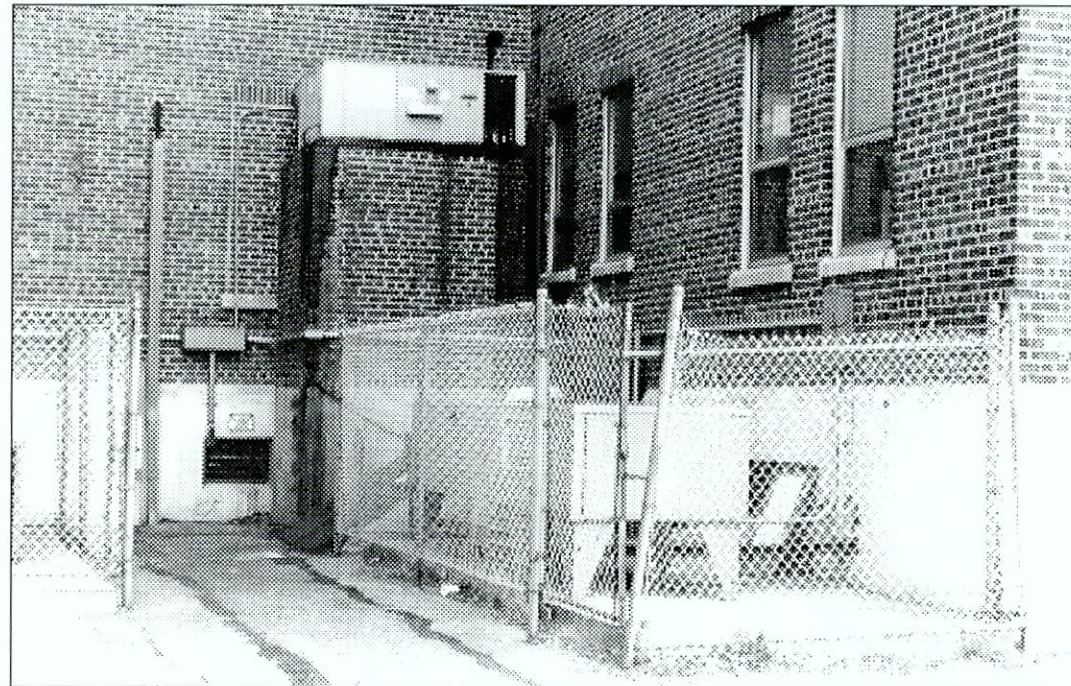
**Figure 6.144** Poor placement of mechanical systems. Note water damage to masonry caused by leading machinery.

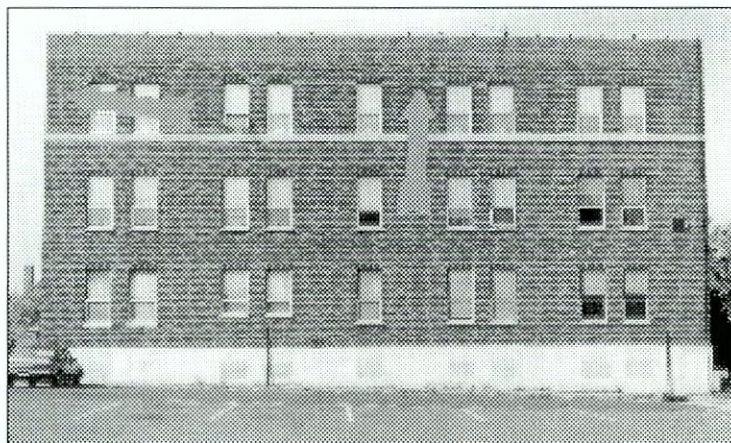
**Figure 6.145** South side of Building 210 showing difference in replacement brick at the parapet and the in-fill of basement windows. Arrows identify structural cracking and rust jacking of lintels.

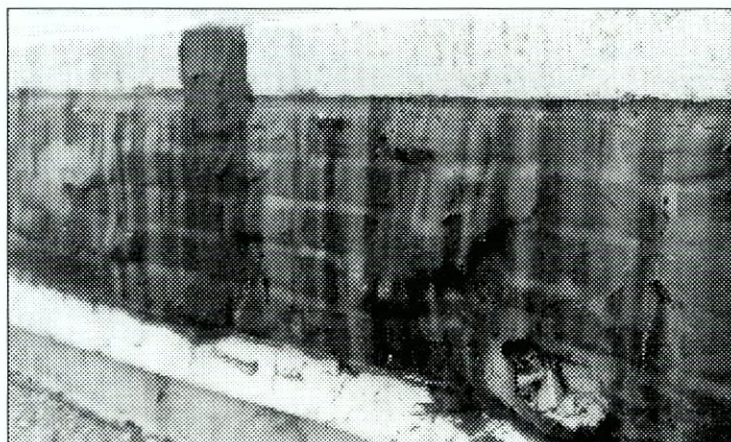
**Figure 6.146** Detail at inside face of south parapet showing poor repair and continued failure. Brickwork is crumbling due to moisture saturation and freeze-thaw conditions.

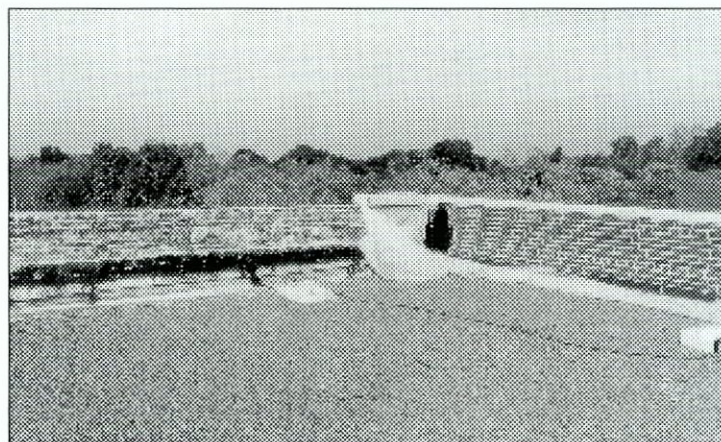
**Figure 6.147** Parapet detail at northeast corner showing 100% replacement of brickwork and copingstones.

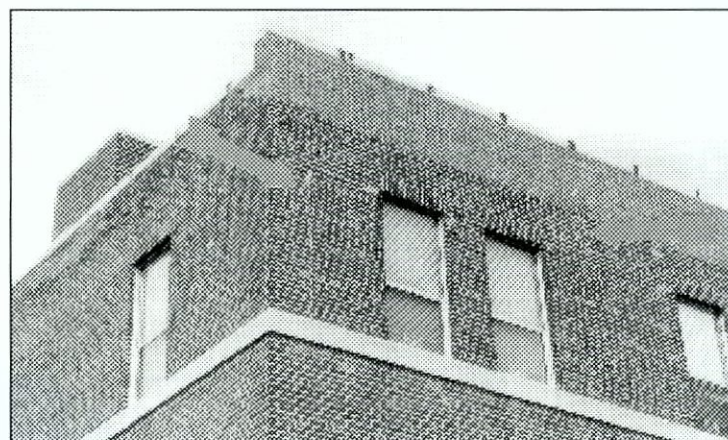
**Figure 6.148** Detail of southwest corner showing earlier rebuilt parapet with bitu-mastic repairs made to coping-stone joints. Arrows identify structural cracking (and subsequent filling).

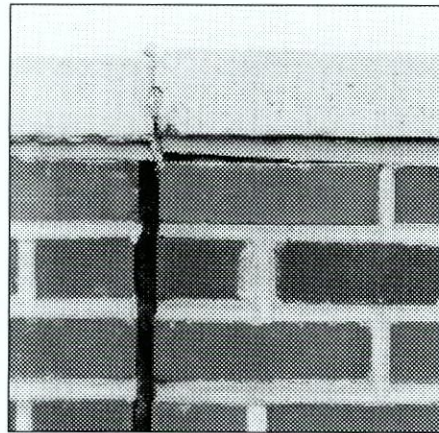
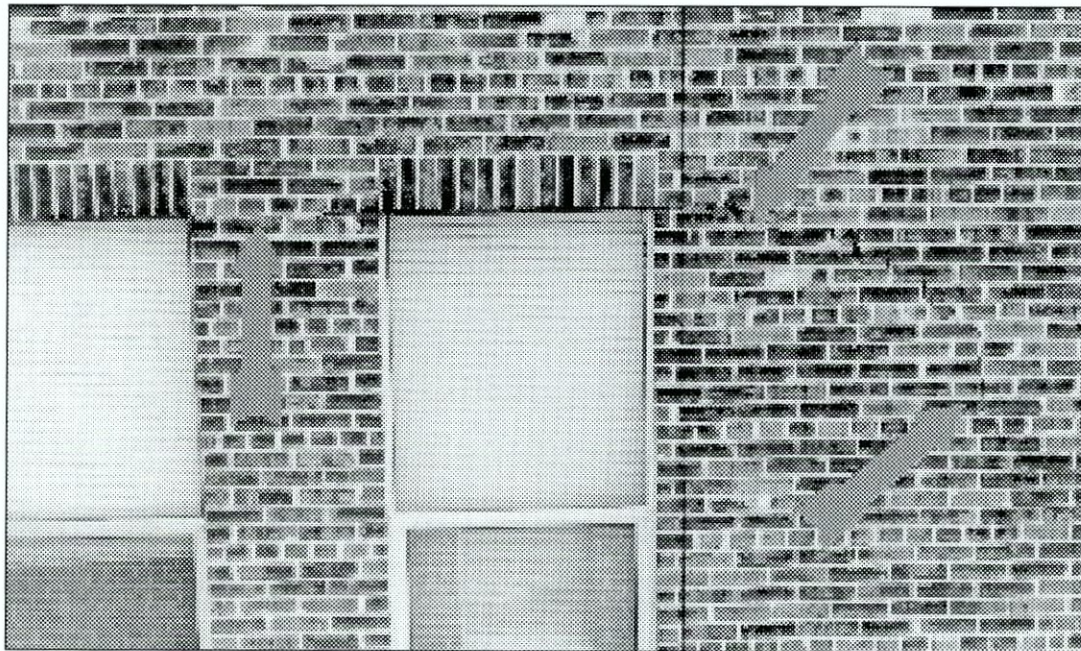
**Figure 6.150** Detail of north-east corner showing major cracking (arrow). Brickwork is beginning to spall.

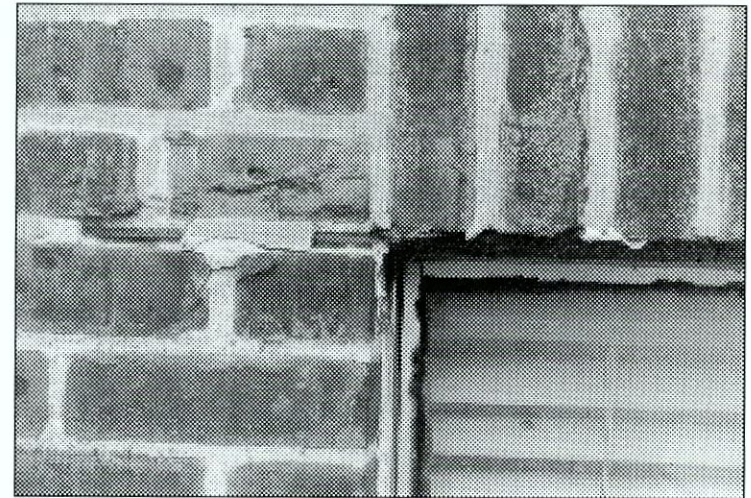
**Figure 6.151** Detail of rusting lintel showing "rust jacking" damage to the surrounding brick and mortar.

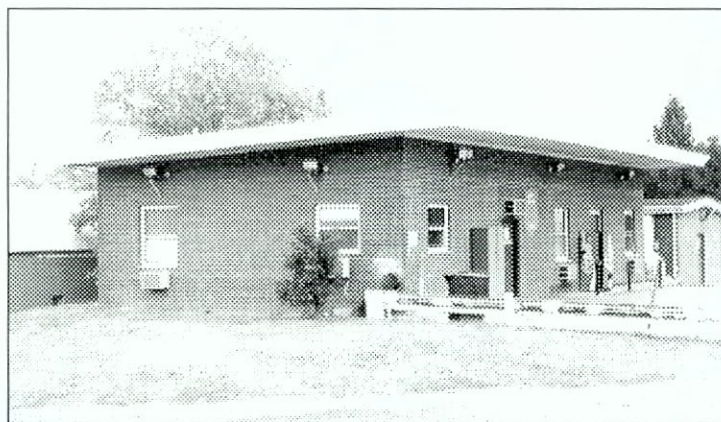
**Figure 6.153** North and west elevations of Police Building. Removal of plate glass and replacement with double-hung windows and brick in-fill during conversion from gas station.

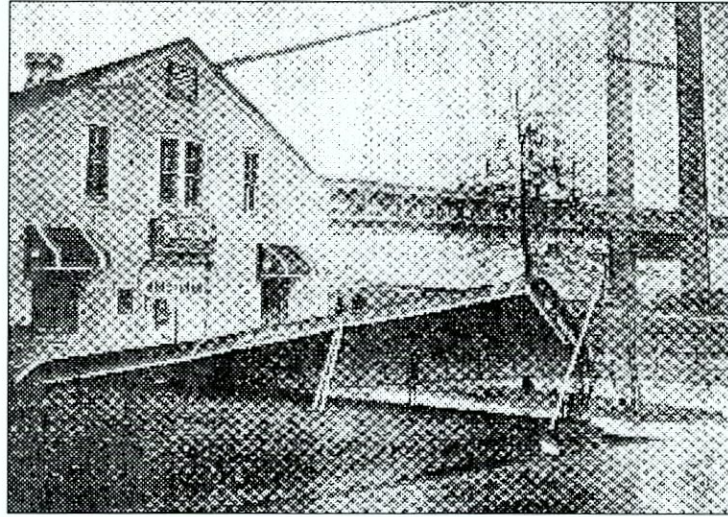
door. The roof was recovered with asphalt roofing shingles and three dormers added onto the east side (physical evidence for this addition is obvious). A frame deck was built onto the east side. Windows not covered up with siding were replaced with aluminum sash. Interior room arrangements and finishes were also altered. It is not known when the north structure was removed, nor if and when the east structure was removed (it may remain intact under the deck).

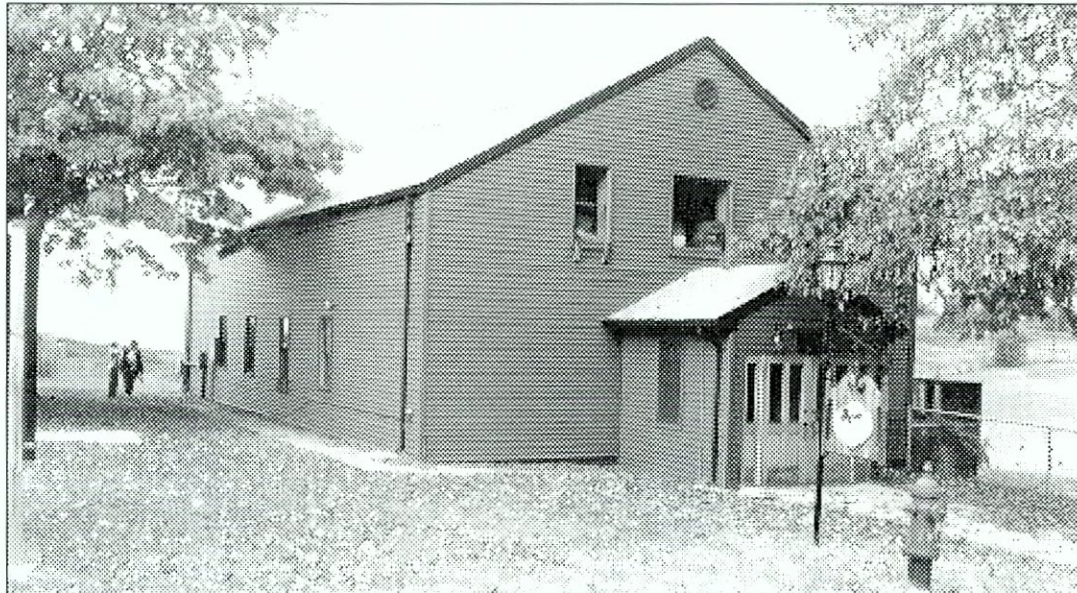
**Figure 6.156** General view of Building 352 showing south and west facades. Recent addition of central-entry wing and replacement of all window units, new vinyl siding and asphalt shingle roofing.

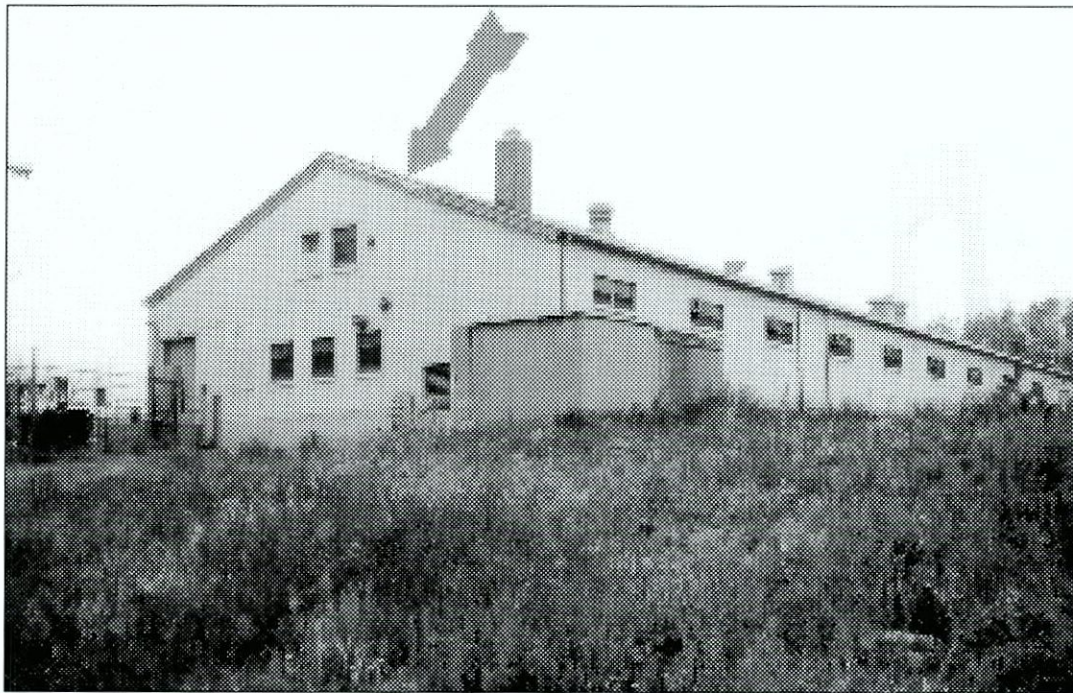
side. The building has a total of 13,134 square feet.

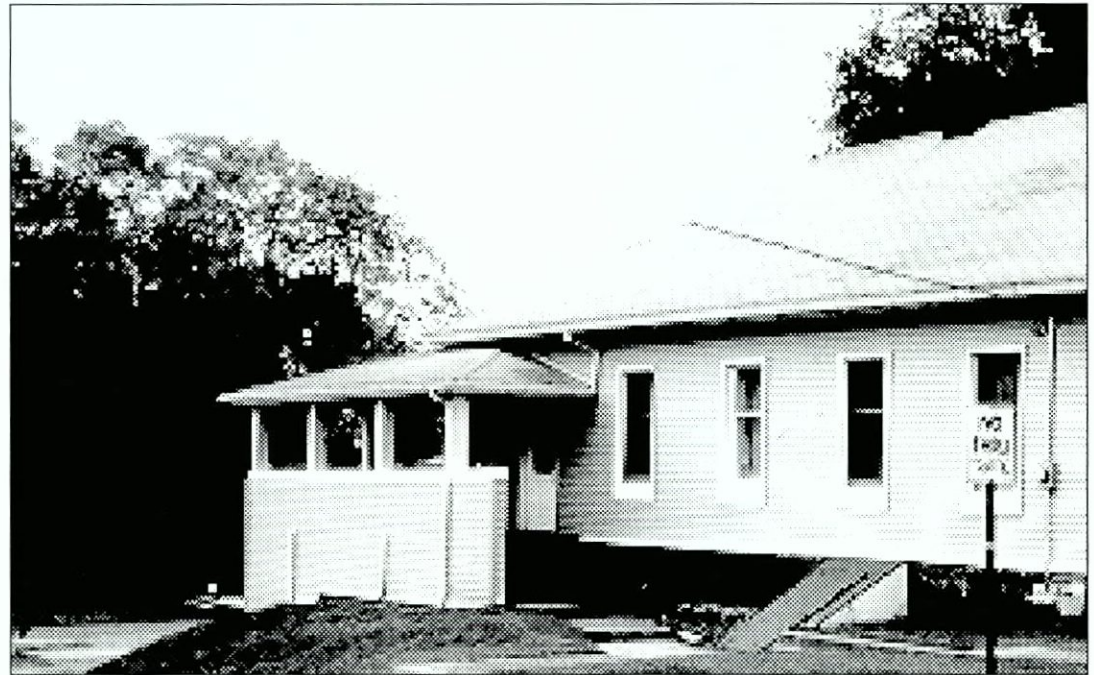
**Figure 6.162** Building 305 showing the north and east facades. Recent alteration to fenestration size, window units, and wall and roof sheathing. Note original stone foundation.

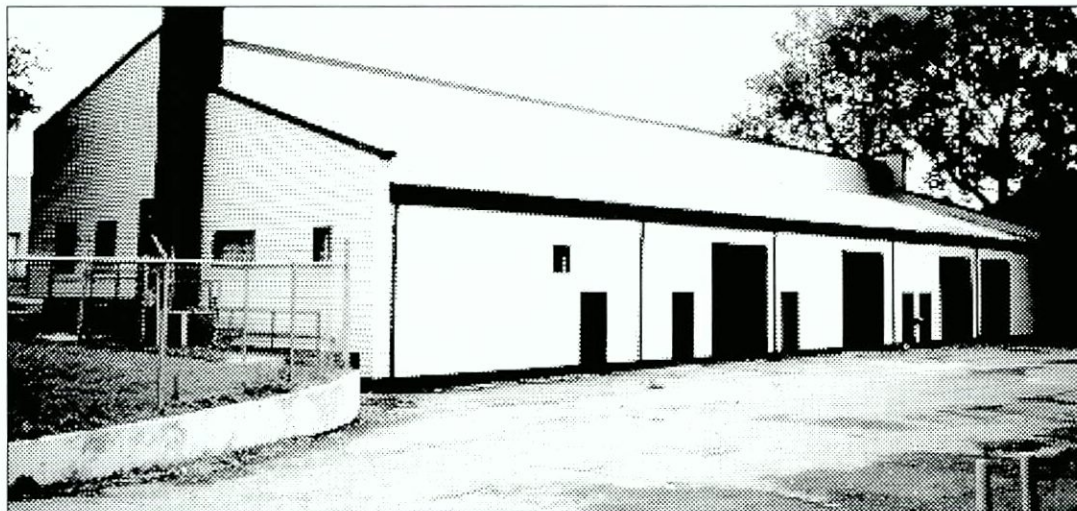
**Figure 6.163** Building 301 showing the west and south facades.. Recent sheathing with vinyl siding has altered the original fenestration and stepped gable ends.

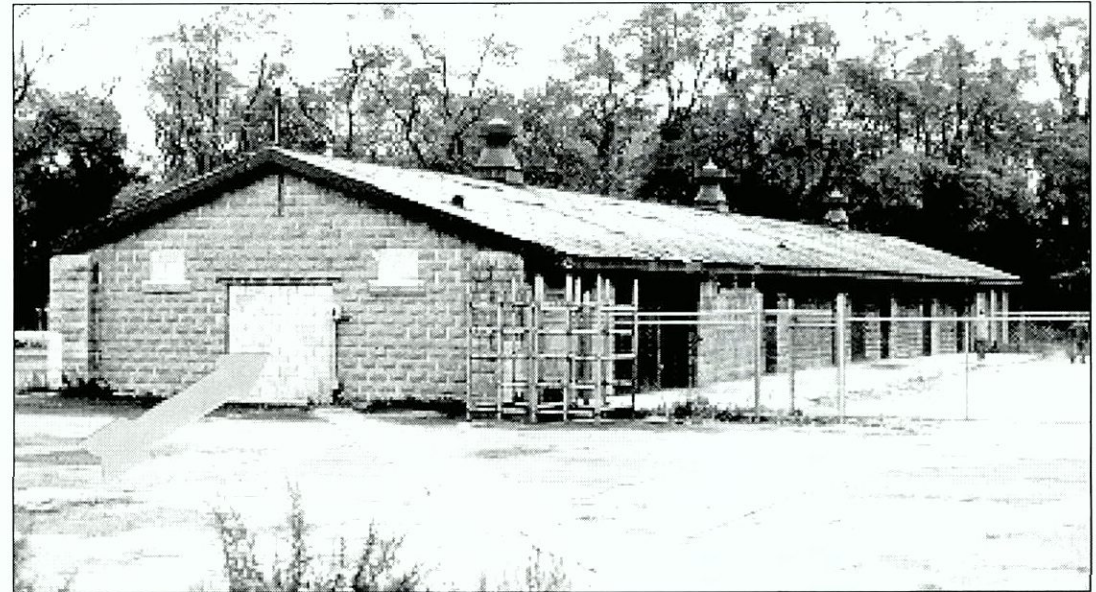
**Figure 6.167** Building 309 showing north and west facades. K Arrow identifies in-fill of original garage opening with smooth-face concrete masonry units.

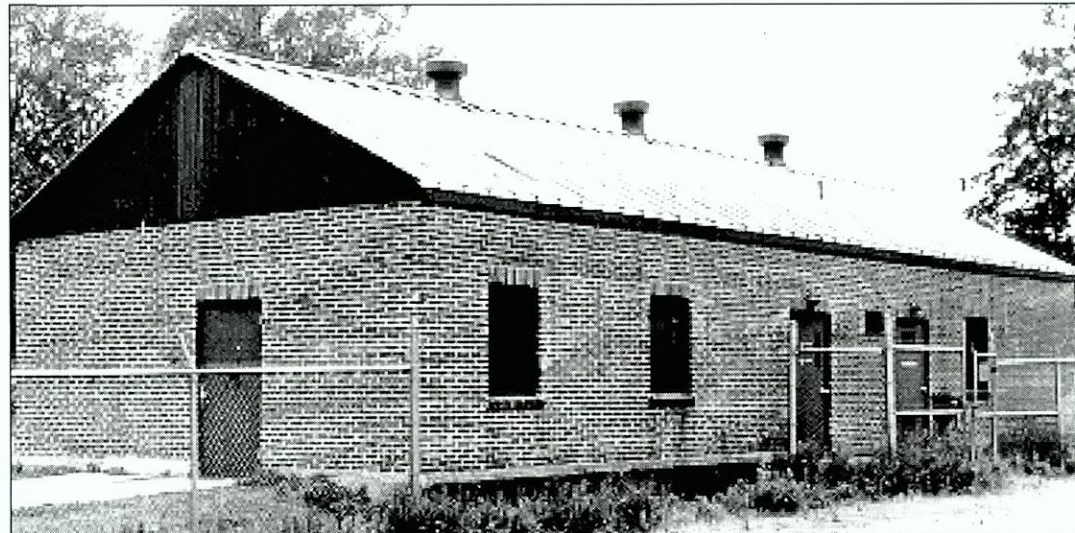
**Figure 6.168** Storage Building 310 showing south and east facades. Building exhibits very little signs of deterioration or failure of building components.

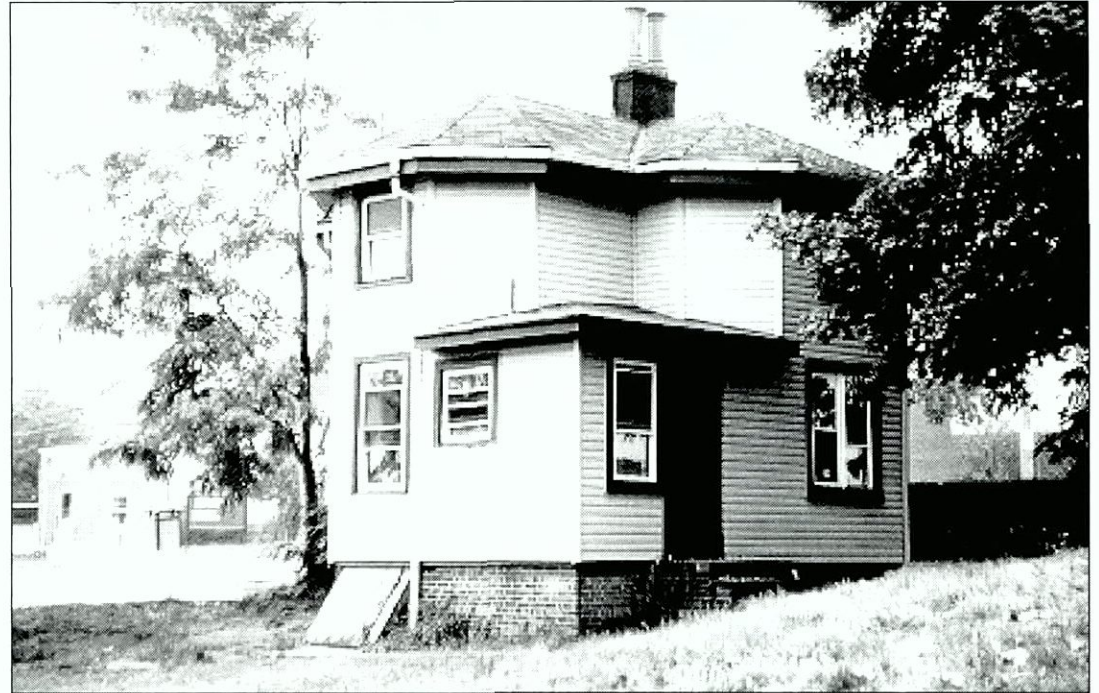
**Figure 6.169** General view of building 406 (former residence) showing south and west facades. Note recent application of vinyl siding and replacement of window units.

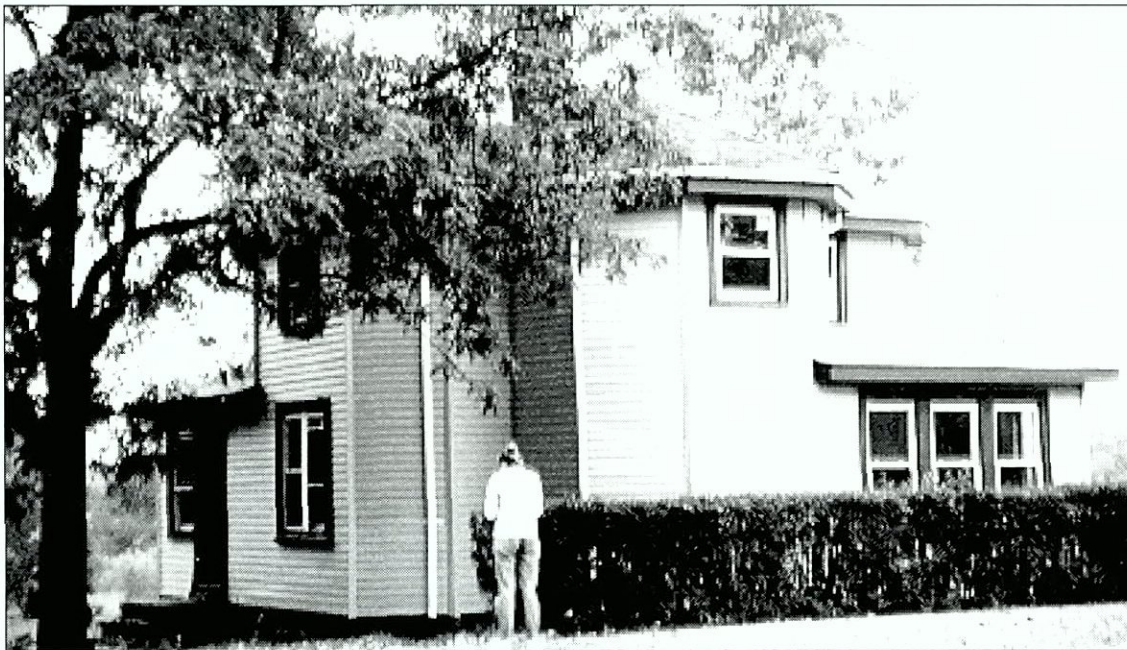
**Figure 6.170** General view of building 406 showing the north and east elevations. Note enclosure of porches and the covering of windows with vinyl siding.

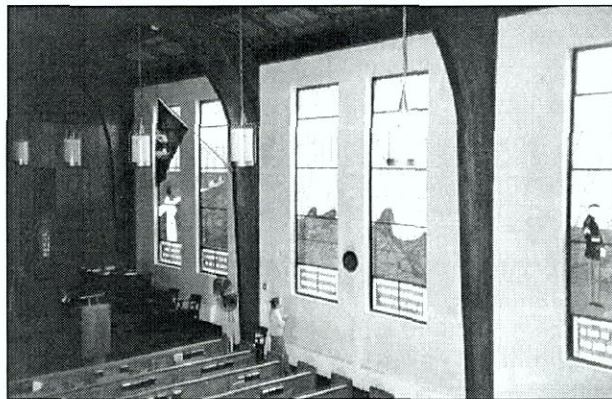
**Figure 6.172** Chapel interior, art glass windows, north side. By Cultural Resources Center, 1994.

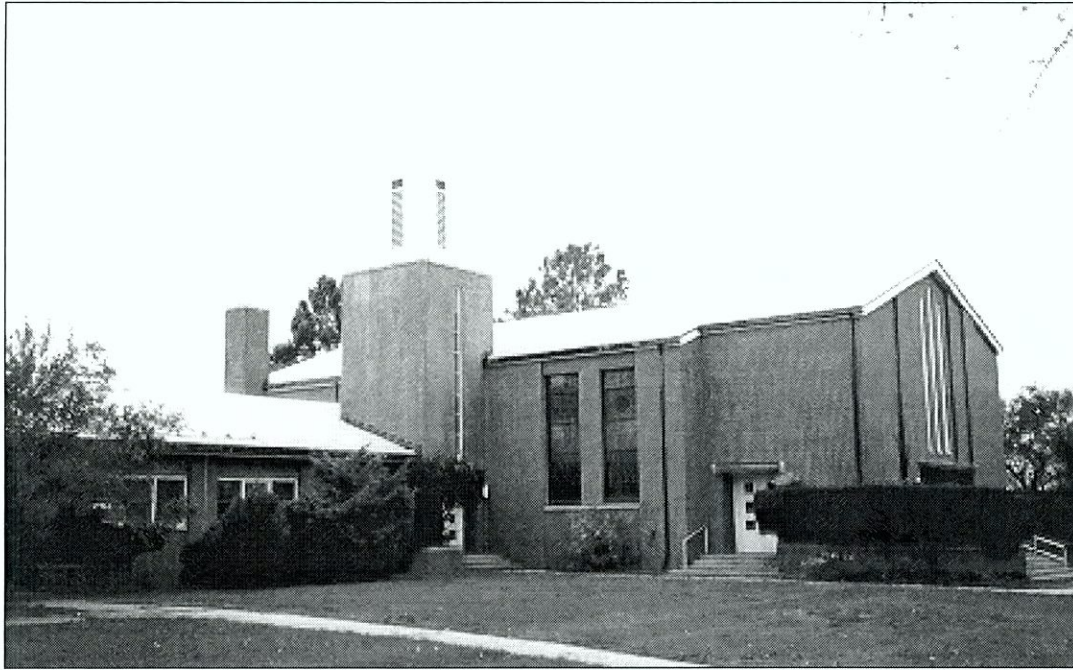
**Figure 6.173** General view of religious complex consisting of main chapel and support offices.

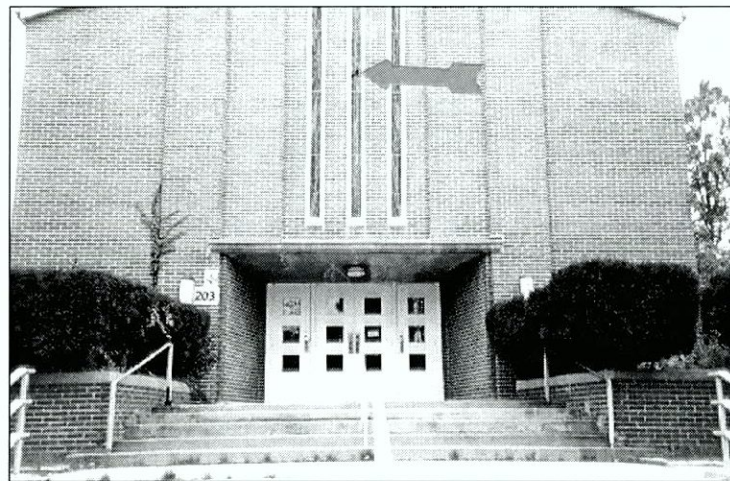
**Figure 6.175** Interior view of the chapel looking towards the altar. Exposed wood ceiling once had acoustical tile panels.

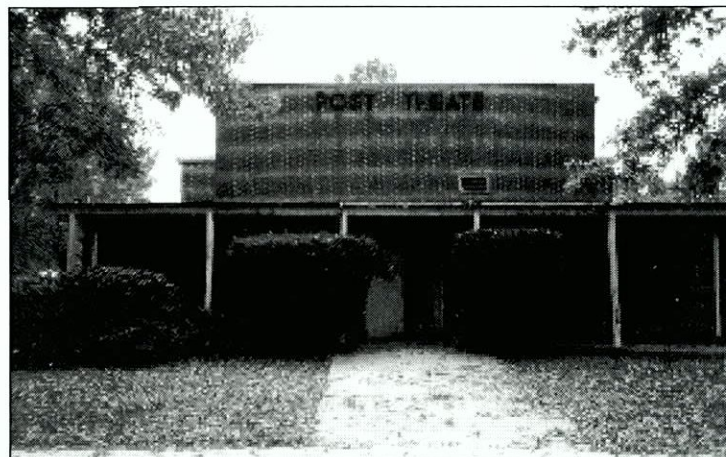
**Figure 6.176** Theater, north elevation. By Cultural Resources Center, 1994.

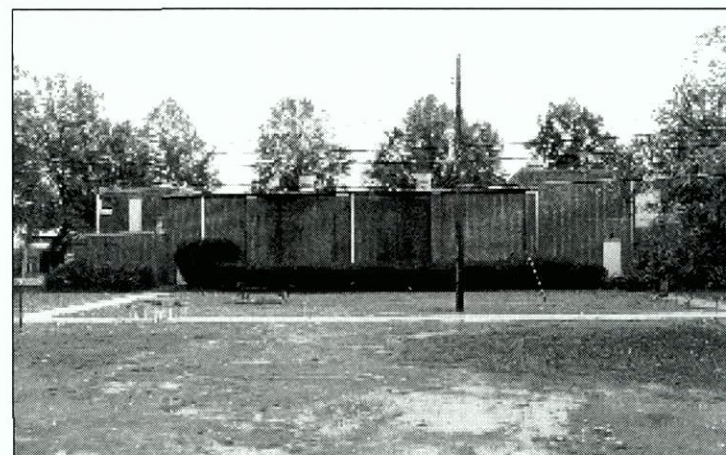
**Figure 6.177** Main facade (east) of the Theater.

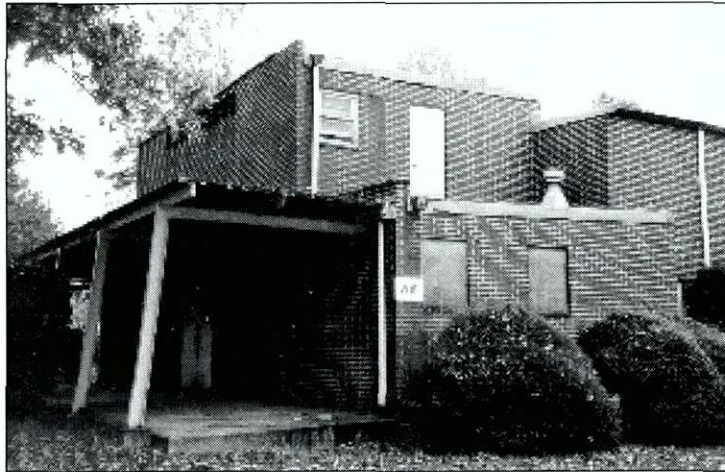
**Figure 6.179** West (rear) elevation of the Theater showing boarded windows, staining on brick caused by faulty gutter.

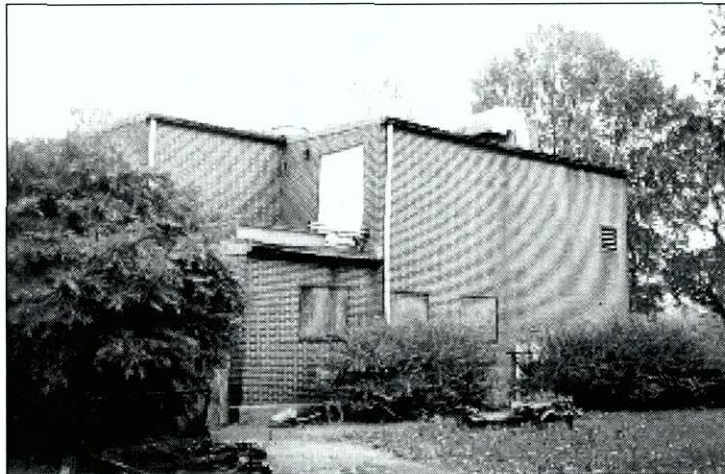
the brick masonry. The wall is forced open, through cracking, and exposes it to a whole range of further deterioration from water penetration and freeze-thaw cycles.

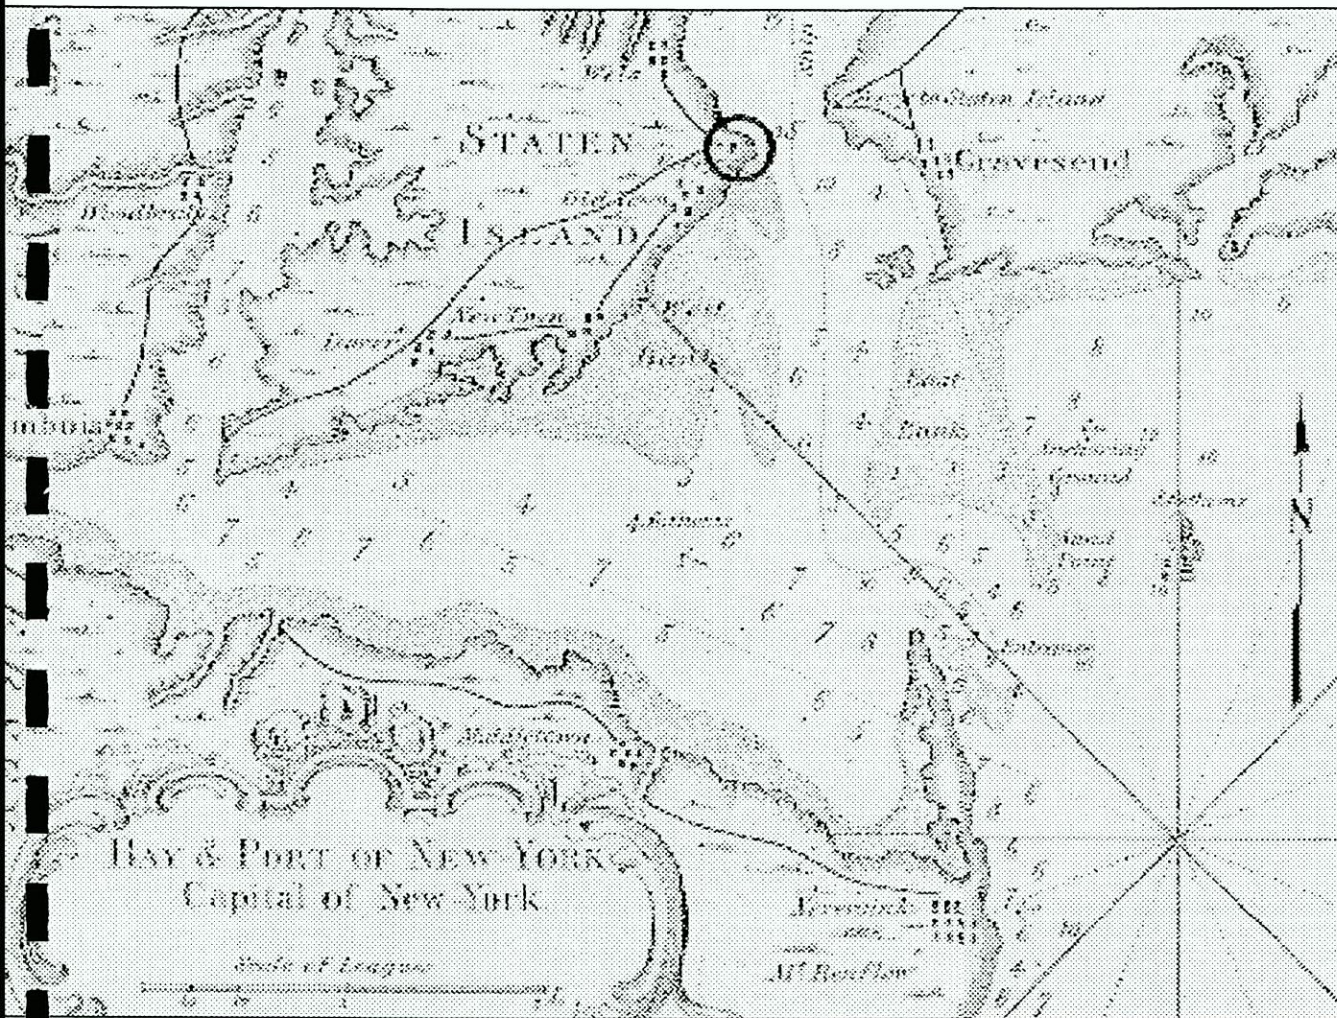
- 7.1 Introduction
- 7.2 Scope of Collection Statement
- 7.3 Survey of Objects
- 7.4 Survey of Archives
- 7.5 Collections /Storage
- 7.6 Recommendations
