#### SUMMARY OF ARCHEOLOGICAL INVESTIGATIONS **IN CONNECTION WITH THE OAKWOOD BEACH SECTION 103** STORM DAMAGE REDUCTION PROJECT OAKWOOD BEACH, STATEN ISLAND, RICHMOND COUNTY, NEW YORK

Lynn Rakos United States Army Corps of Engineers **New York District Planning Division Environmental Branch**

September 1996

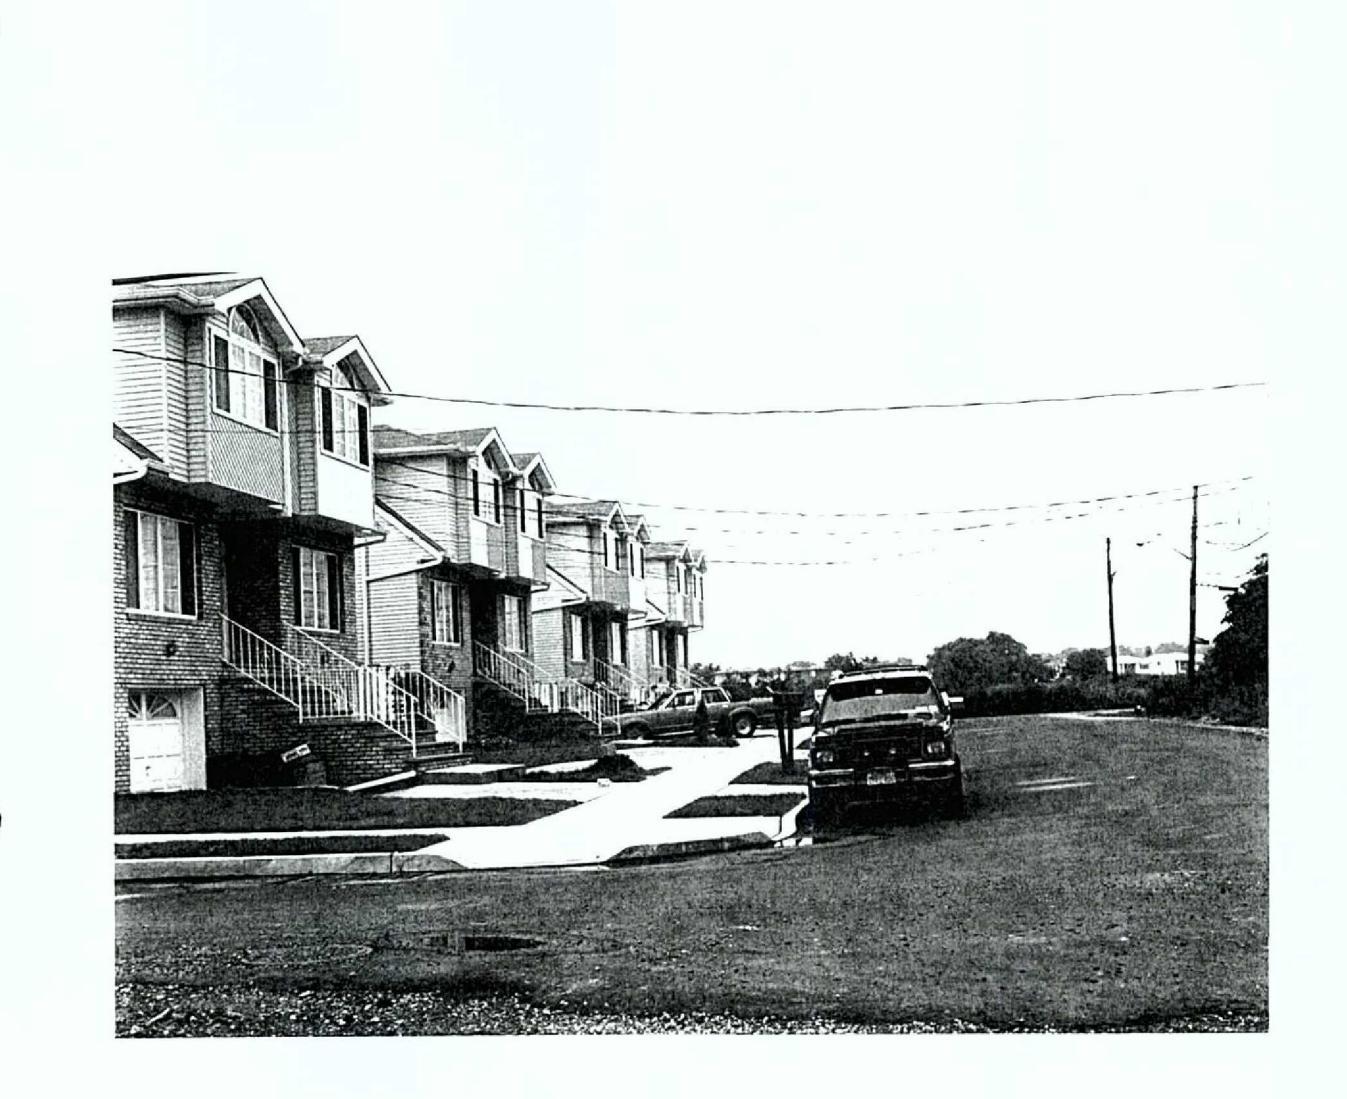
Plate 1. View looking northwest to the housing on the southwest side of Dugdale Street near its intersection with Merkle Place. These structures were under construction at the time of the initial archaeological investigations in August 1995 (Photographer: Lynn Rakos, August 1996).

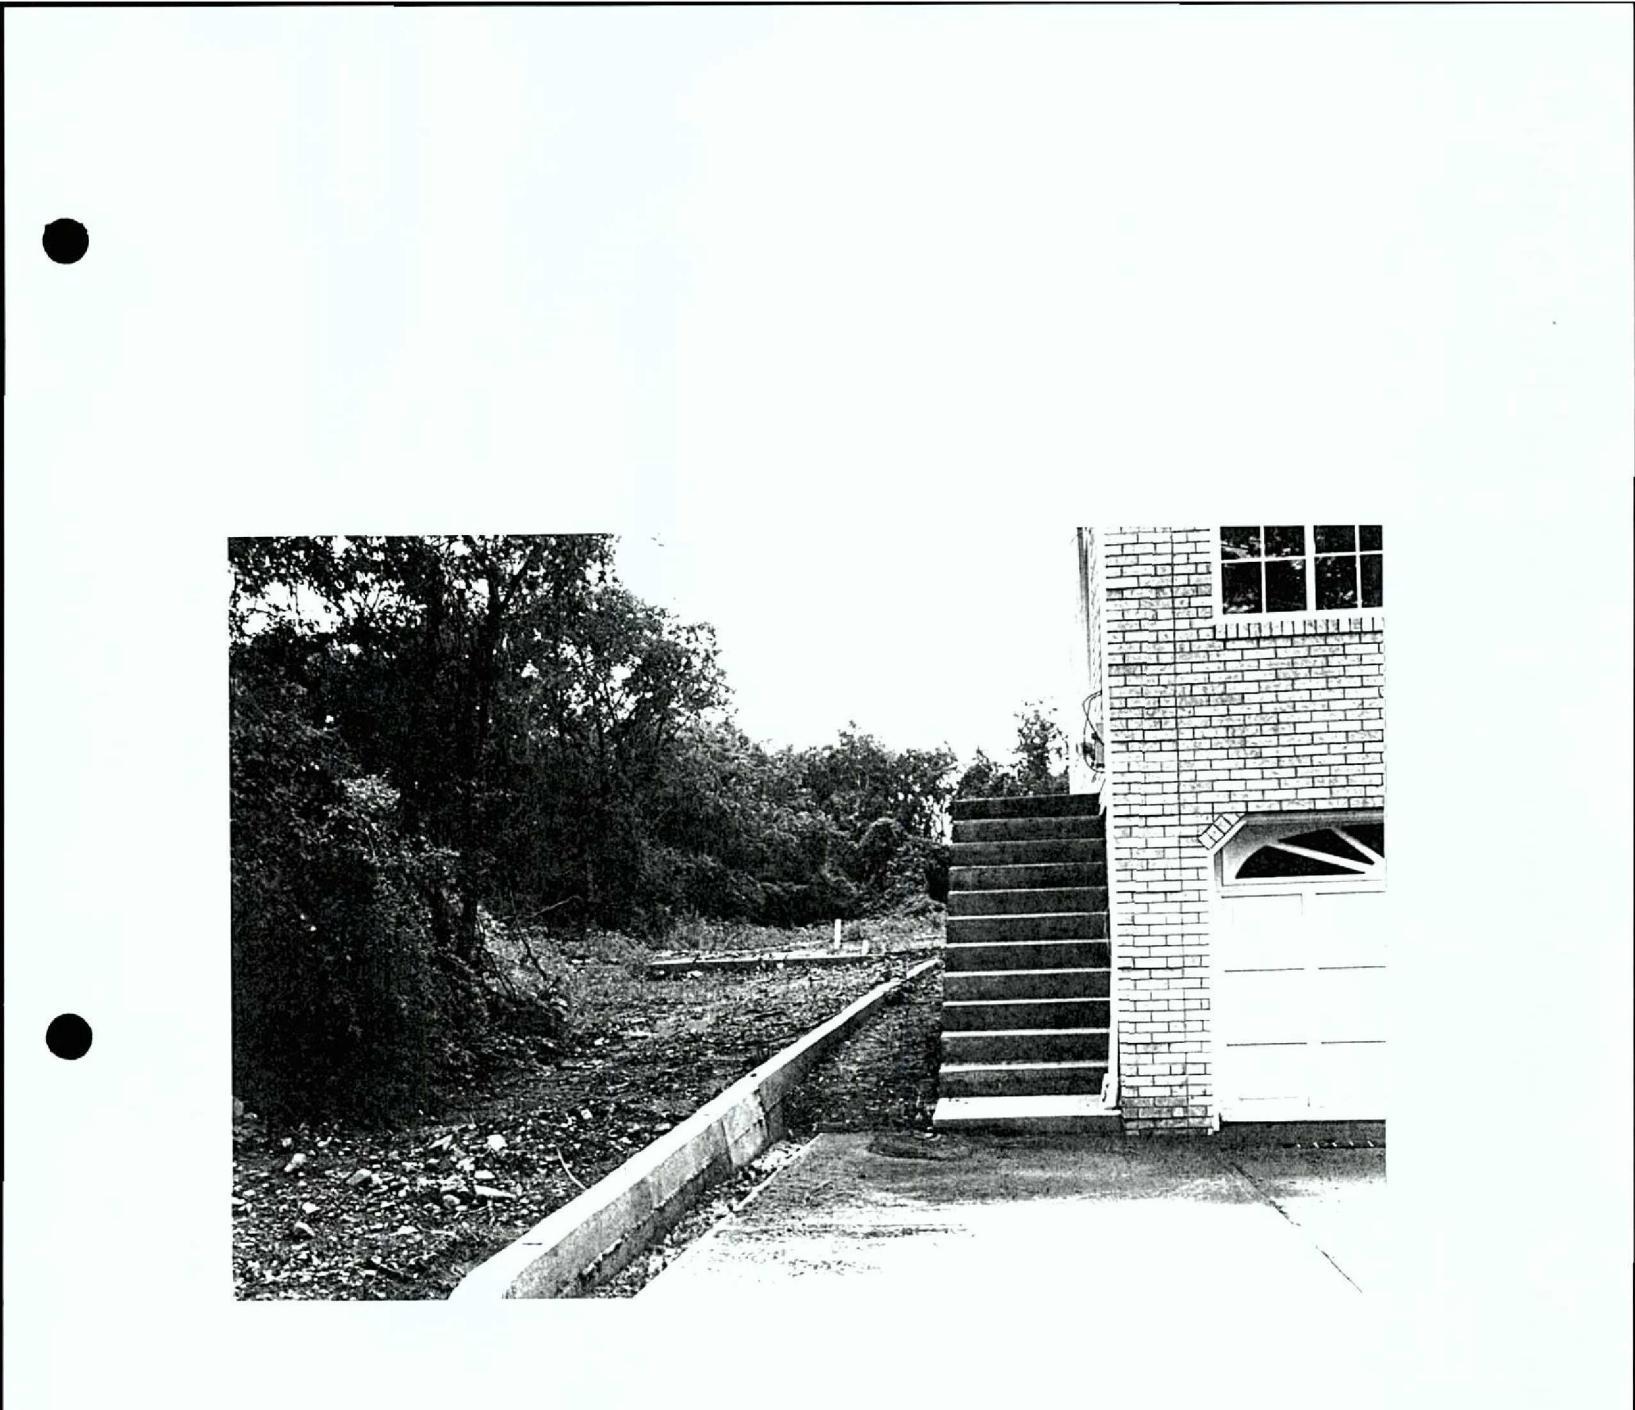
Plate 2. View looking southwest to a newly constructed house on the southwest side of Dugdale Street, just south of Merkle Place. Prehistoric materials were encountered on this site (Photographer: Lynn Rakos, August 1996).

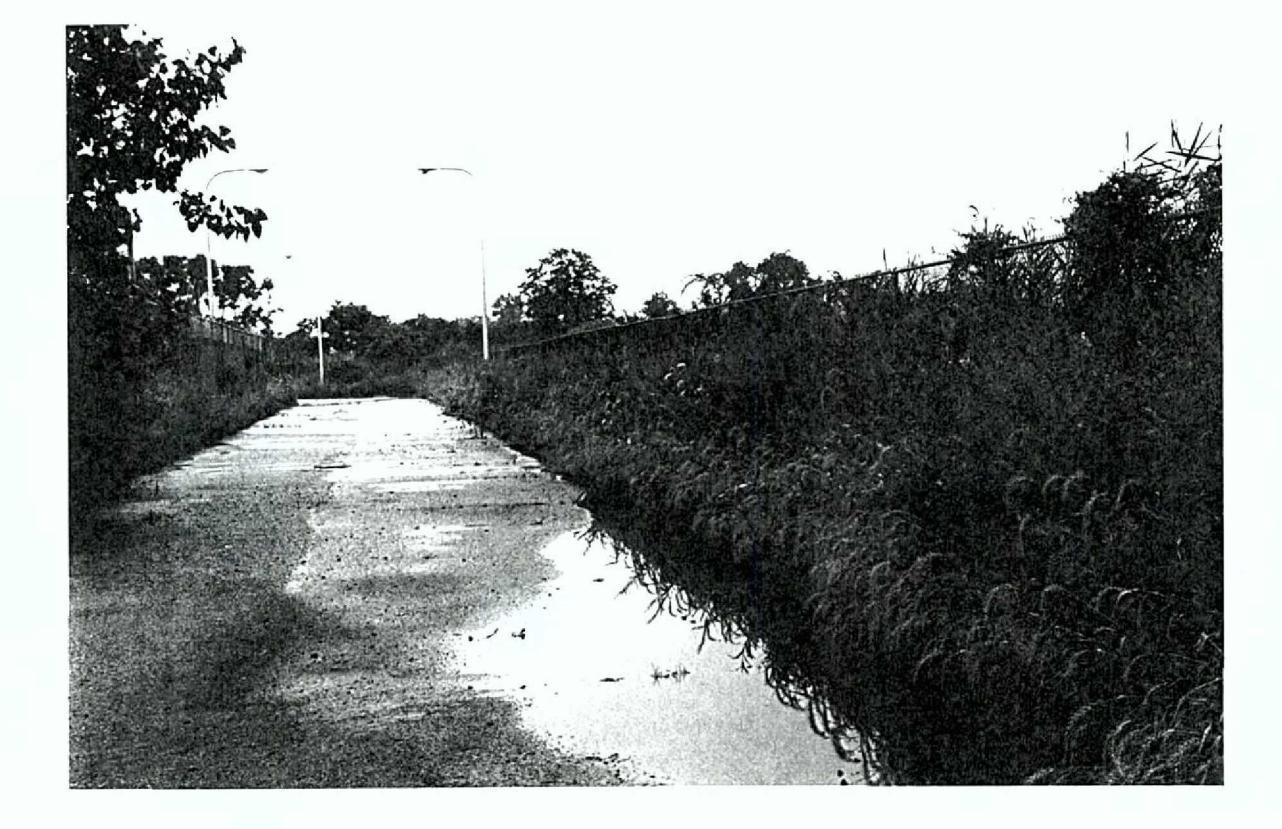
Additional fieldwork was conducted on August 1, 1996 to examine the area that will potentially be impacted by the proposed new plan. Two shovel tests were excavated along the northern side of the access road to the septic tank discharge area within Oakwood Beach Waste Water Treatment Facility (Plate 3). These tests, ST 16 and 17, contained dense clayey rocky fill to at least 2 feet below surface. The fill was too compact to penetrate and natural soils were not encountered. Standing water was encountered at 27 inches below surface in ST 17. Modern bottle glass and fragments of a chain-link fence were recovered from these tests and discarded in the field.

Figure 3. View looking southwest along the access road to the septic tank discharge area at the Oakwood Beach Waste Water Treatment Plant (Photographer: Lynn Rakos, August 1996).

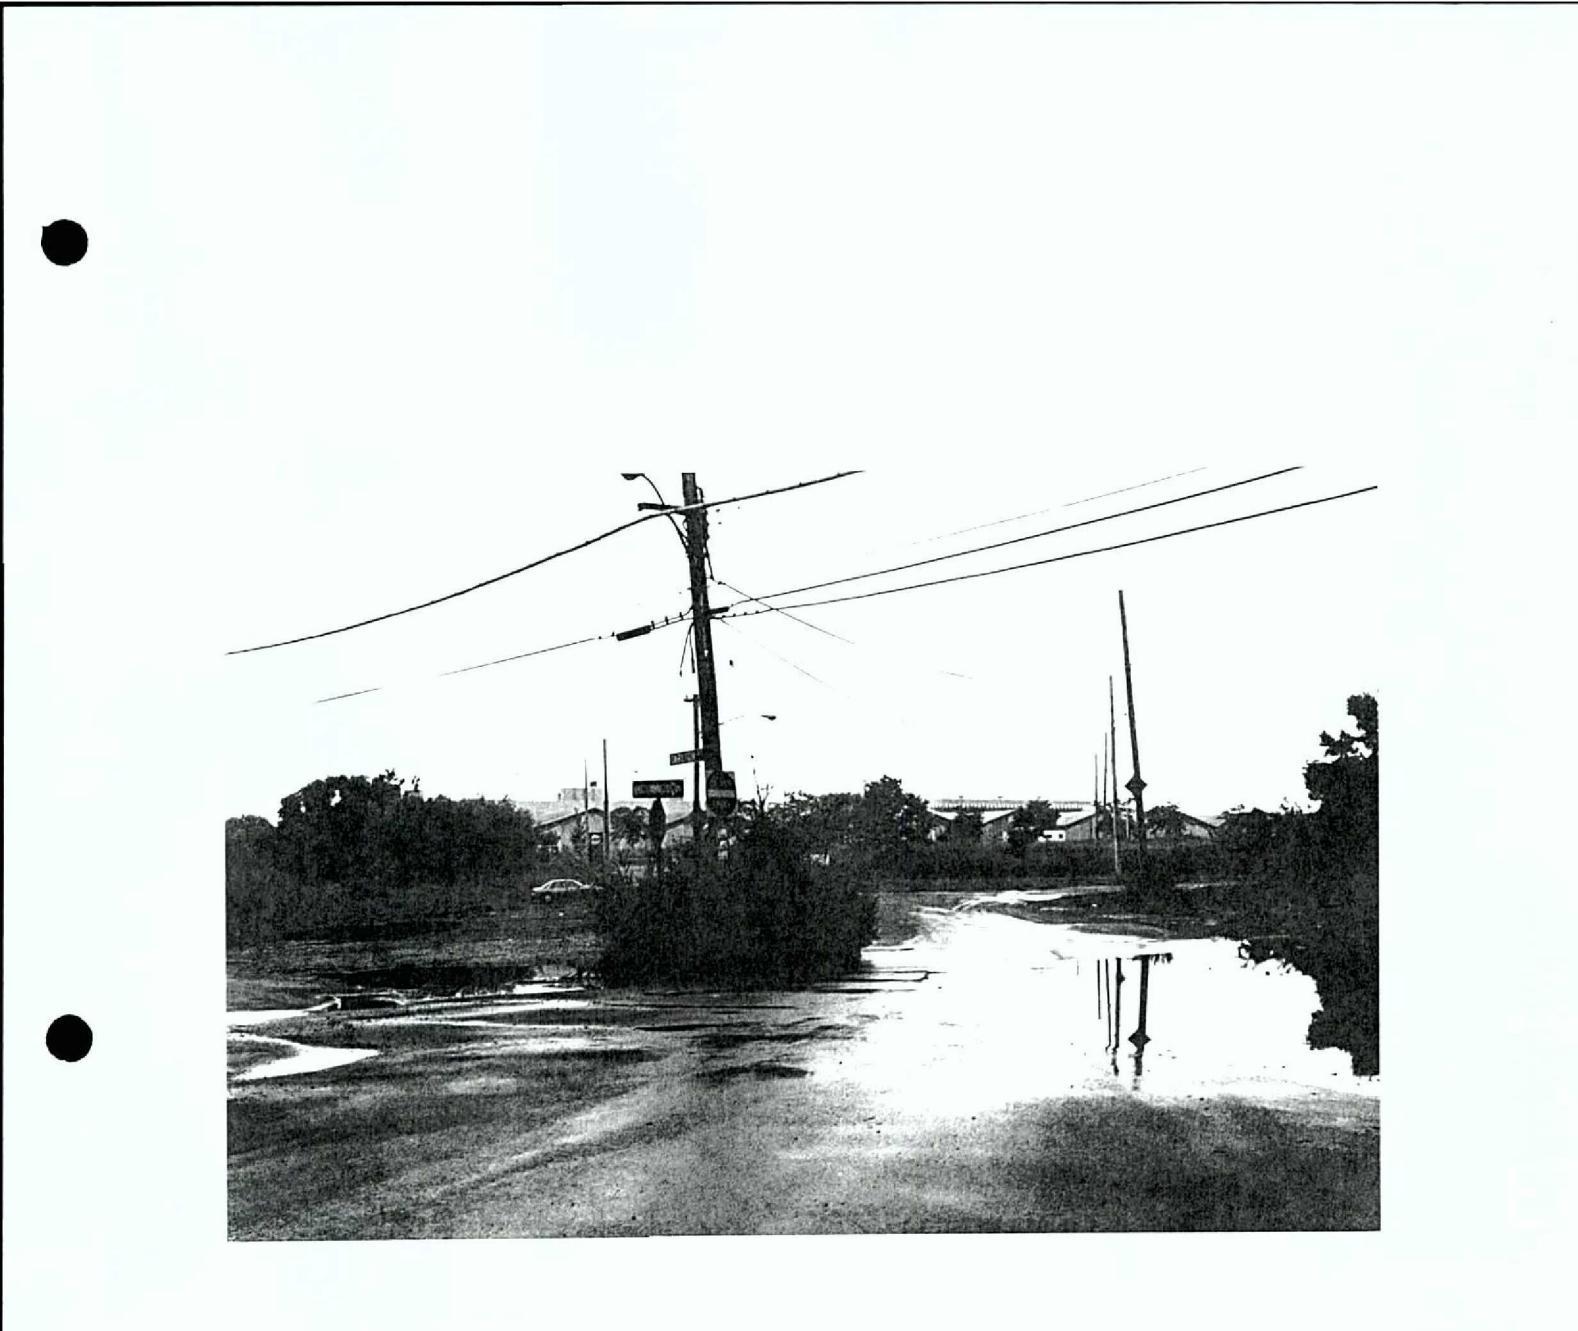
A sewer line was recently installed along the northern end of the access road. The area at the intersection of Mill Road with the access road was very disturbed by the construction activity (Plates 4 and 5). Phragmites line the western edge of the Mill Road - Tarlton Street intersection. No subsurface testing was undertaken in these areas due to the presence of standing water (Plate 6).

Plate 4. View looking southwest at the southwest corner of the Mill Road and Tarlton Street intersection. The Oakwood Beach Water Treatment Facility is visible in the background (Photographer: Lynn Rakos, August 1996).

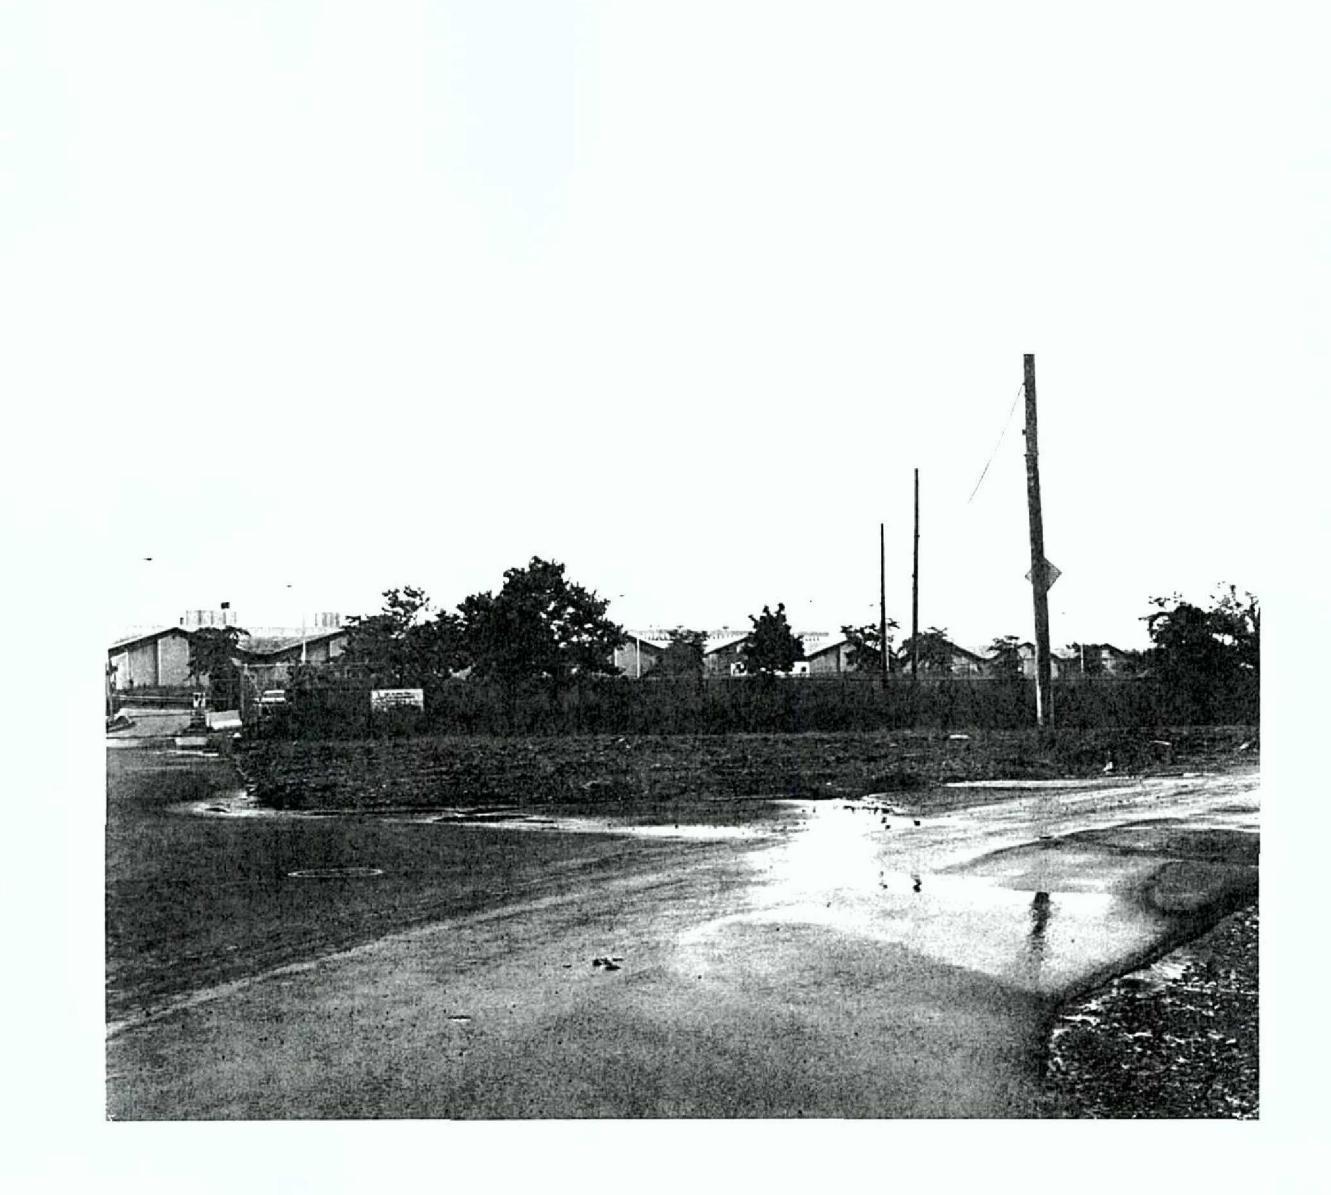
Plate 5. View looking southwest to the intersection of Mill Road with the access road to the septic tank discharge area at the Oakwood Beach Waste Water Treatment Facility which is visible in the background. This area was graded recently when a sewer line was installed (Photographer: Lynn Rakos, August 1996).

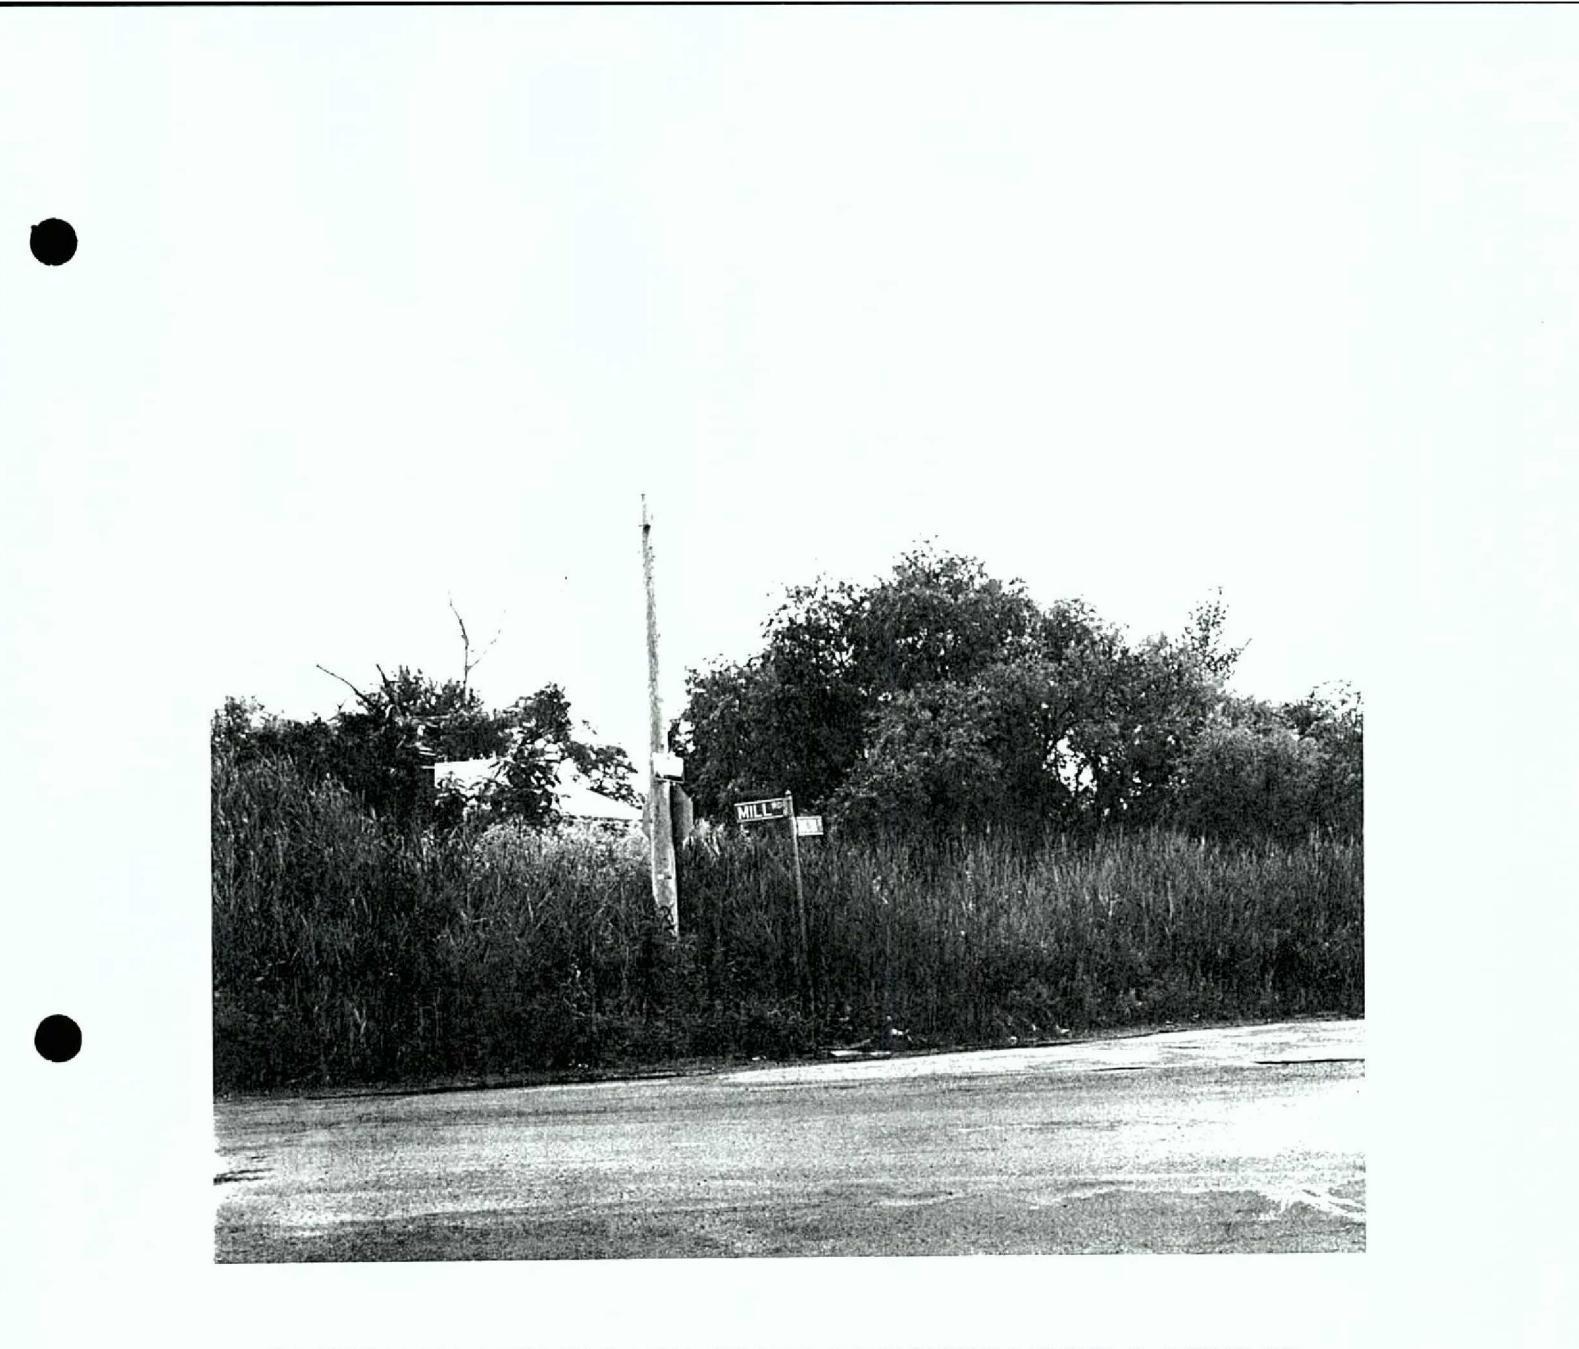
Plate 6. View looking east at the southeast corner of the Mill Road and Tarlton Street intersection. (Photographer: Lynn Rakos, August 1996).
