ARCHAEOLOGICAL MONITORING OF TEST TRENCH EXCAVATIONS AT SAILORS' SNUG HARBOR, STATEN ISLAND, NEW YORK

1981

Ulana D. Zakalak, Archaeologist Meadows/Woll Architects 211 Front Street New York, NY 10038

ARCHAEOLOGICAL MONITORING OF TEST TRENCH EXCAVATIONS AT SAILORS' SNUG HARBOR

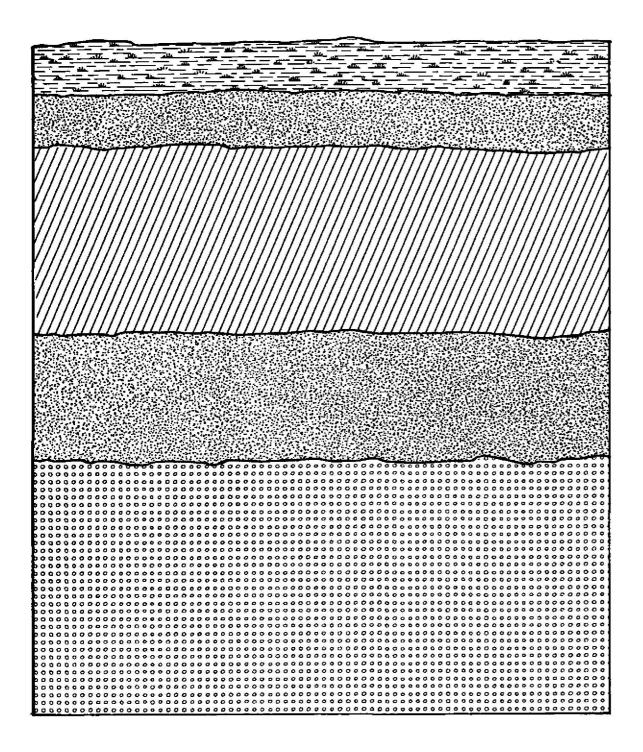
TEST PIT NO. 2
EAST ELEVATION

This test pit is located at the northeast corner of the Music Hall, immediately against the monumental stairs, parallel and tangent to the east elevation. Below the turf is a grayish-brown organic silty loam topsoil layer with roots extending 12"-14". Below this is a layer of orange-brown clayey silt with some inclusions of fine sand extending to 3'2". This is followed by a dark band of grayish-brown compact silt ending at 4'4" and a reddish brown silt to 7'4". The north wall contains large chunks of limestone. Some of the pieces have polished sides. These pieces could possibly be connected to the Randall Memorial Church or to the Music Hall as both buildings were constructed at the same time. Pieces could have been unsuitable for finishing and therefore discarded as backfill.

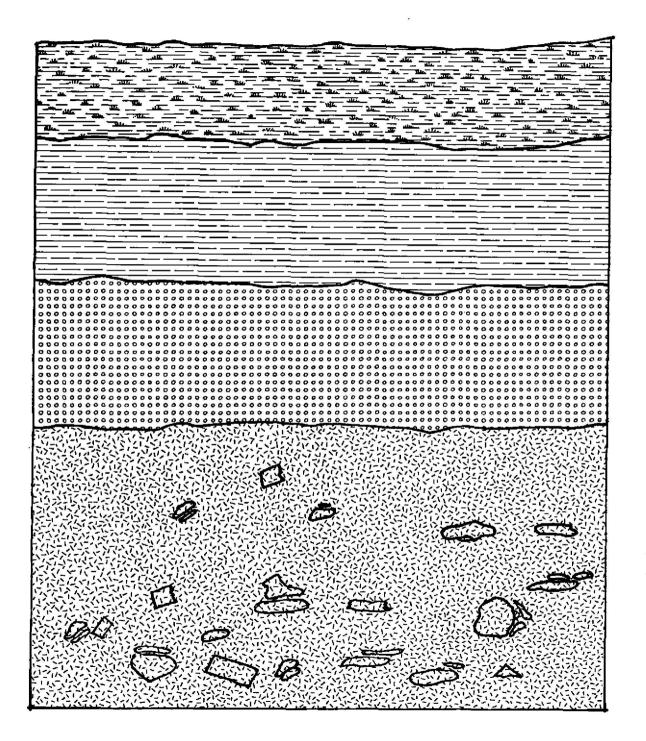
> TEST PIT NO. 3 NORTH ELEVATION

This test pit is located at the northeast corner of the Chapel and dug parallel and tangent to the north (main) chapel facade. The topsoil is a dark brown silt with a heavy root mat extending to about 12". Below this is a series of layers of dry sandy silt, extremely fine and lighter in color with depth. Immediately below the topsoil is an orange brown layer of sandy silt to about 30". Below this is a layer of light orange brown sandy silt extending to about 4'. The layer to the footing is of tan sandy silt. The back dirt is very loose, fine and silty, almost the quality of very fine beach sand but contains fill such as pieces of brick, whole bricks and rocks.

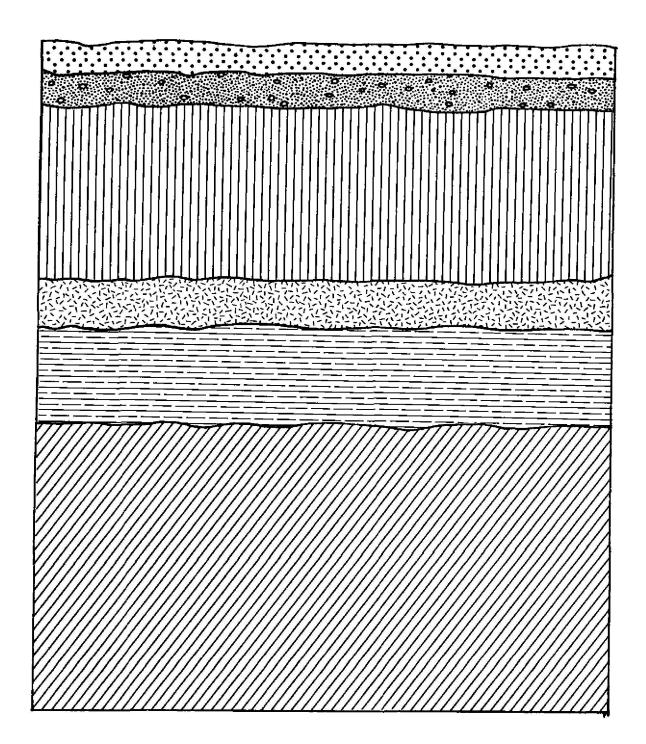
TEST PIT NO. 5
SOUTH ELEVATION

This test pit is located at the southeast corner of the retaining wall of Building H. The top layer is gravel with a bituminous binder to 4". Below this is an almost black layer of silt and gravel which is very moist and clay-like and extends to 2'6". At this depth a layer of cinder appears to 3'. This is a combination of coal, burnt shell, ash, cinders and bone ash. At about 3' there is evidence of a possible original dark brown topsoil layer. Above this layer is all fill. The topsoil layer is 12" thick. Below this is an orange brown clayey silt subsoil to the footing.

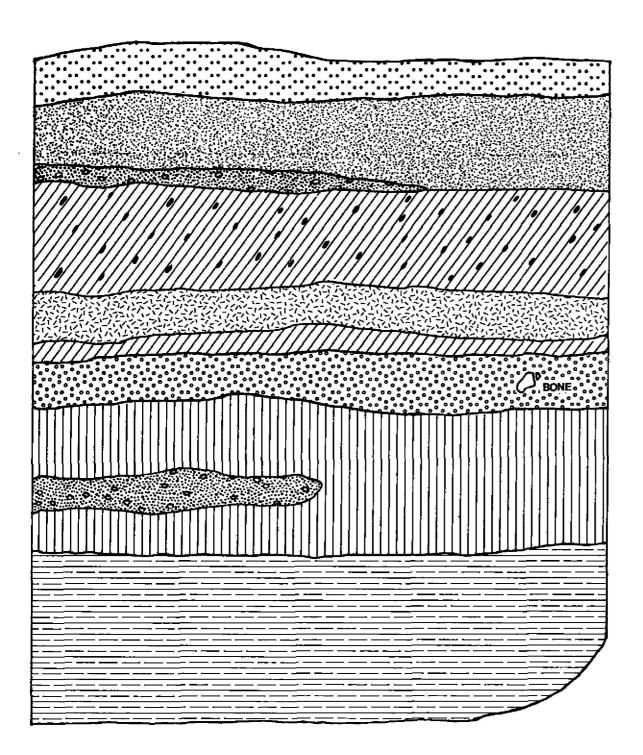
TEST PIT NO. 6
EAST ELEVATION

This test pit is located at the center of the south retaining wall for the areaway directly behind the south elevation of hyphen G-H. Thetop layer is 4"-6" of gravel with abituminous binder followed by a 10"-12" layer of dark gray brown silt separated from the orange brown claying silt layer of 14" by a gravel lens. At 2'6" a gray brown sandy silt mixed with cinders appears for 6". At 3' there is a layer of orange-brown silt followed by a dark brown clayey silt with traces of burnt shell, charcoal and bone ash to 3'10" below grade. This is followed by a 18" layer of brown-black clayey silt extending to 5'-2" and interrupted by a 4" gravel lens at 4'5". The last layer is of orange-brown sandy silt to 7'.

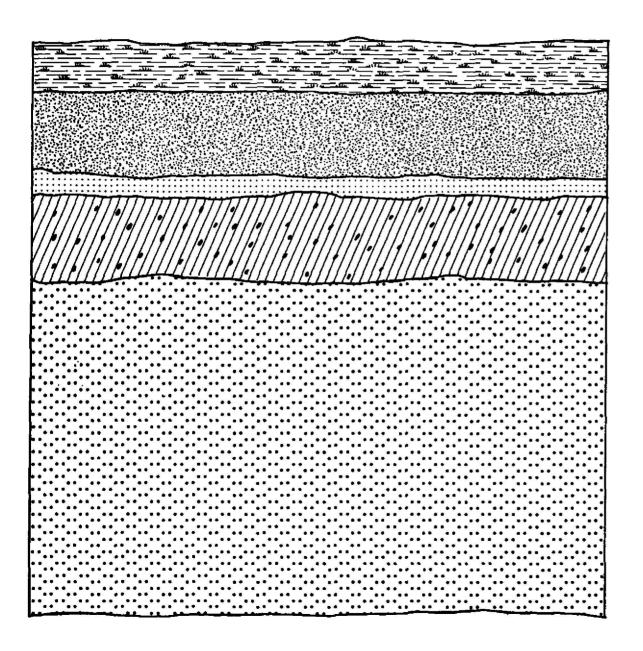
TEST PIT NO. 9
SOUTH ELEVATION

This pit is located in the southwest corner of the retaining wall at F. The profile consists of a dark gray brown silty topsoil with a root mat extending from 16"-18". This is followed by an orange-brown fine silt with traces of fine sand and brown mottling to 2'6". Below this is reddish brown glacial till consisting of very fine silt with some pebbles, very dense to the bottom of the trench at 6'. There is a narrow cinder lens located below the topsoil. The fill is extremely clean and with almost no rocks.

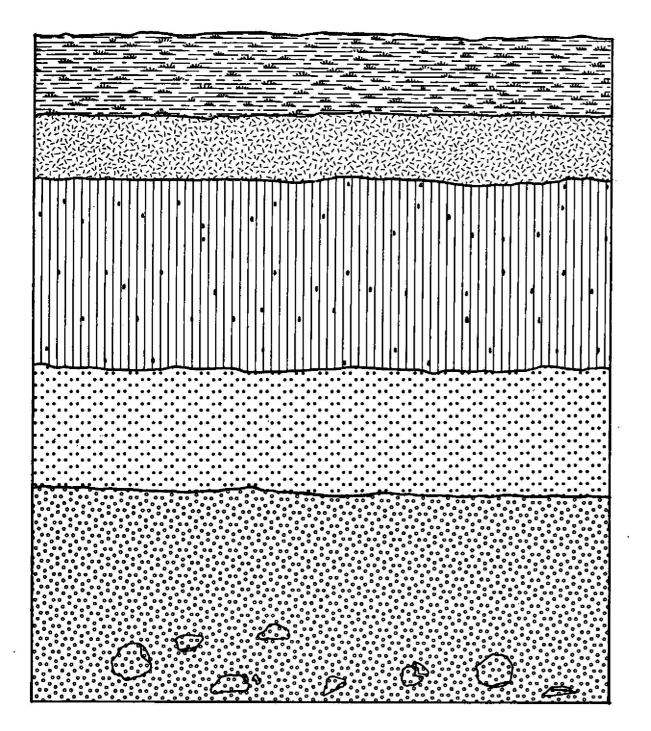
> TEST PIT NO. 10 SOUTH ELEVATION

This test pit is located at the southeast corner of the retaining wall at Building F. The soil profile consists of a dark brown silty topsoil win root hairs to 10", a layer of cinder and ash to 18", light brown silt with traces of fine sand to 3'6" and reddish brown glacial till (silty sand and gravel with boulders and cobbles) to 7'. Soil becomes more purple with depth.

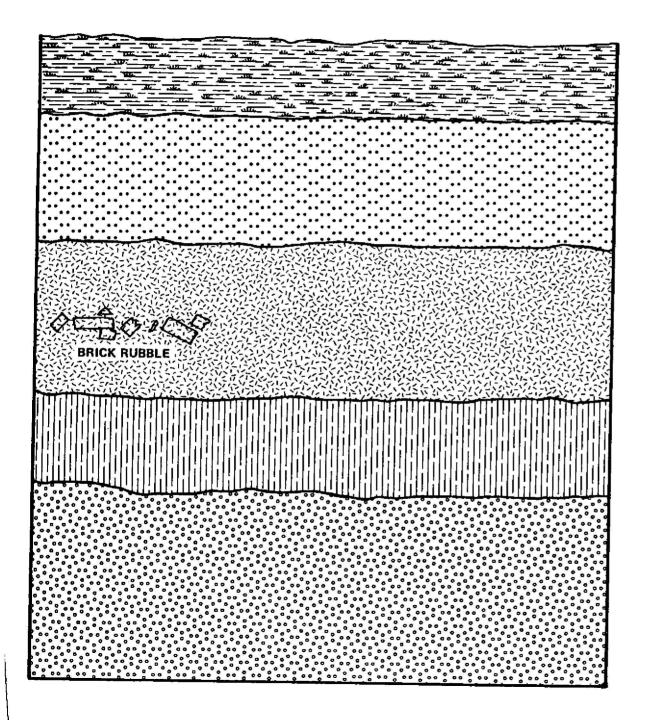
> TEST PIT NO. 11 NORTH ELEVATION

This pit is located in the dumpster area of Building G, next to the southeast retaining wall. The first layer is a grayish brown silty topsoil with many roots, to 10" followed by a brownish black layer of silt with gravel to 2'2". This is followed by a light beige very fine silty sand to 3'9". The next layer is of orange clayey silt to 4'9" and a more brown layer of dense silt to 6'9". The soil contains some broken brick and rock fill. Some brick rubble is evident in the north wall of the pit, about 30" down.
