90 HAVEMEYER STREET Block 2368, lots 27 and 28 Brooklyn, New York Report on Phase IB Archaeological Testing 04B5A015 K

Prepared for:Martini Real Estate ConsultantsPrepared by:Celia J. Bergoffen, Ph.D., R.P.A.Date:January 3, 2005

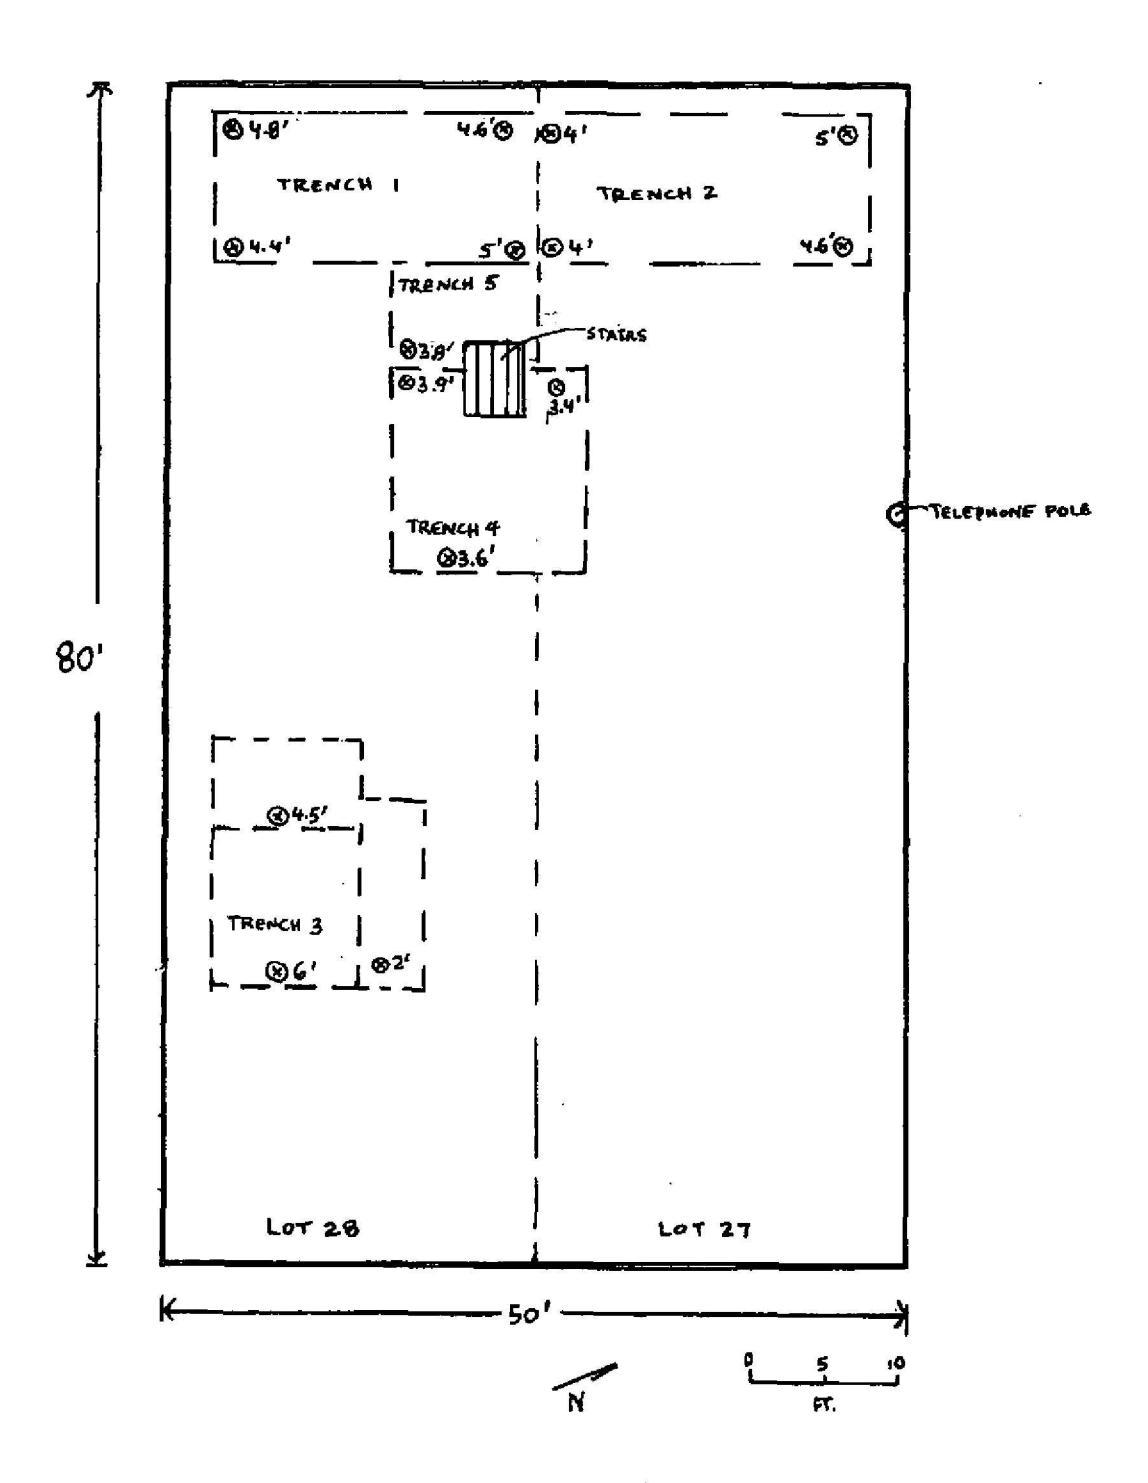
Fig. 1 Plan of Block 2368, lots 27 and 28 showing the location of the excavation trenches and closing depths

Trenches 1, 2, 4 and 5 tested for the presence of a privy at the rear of both former yards and found no evidence for such; trenches 3 and 4 showed that there was no cistern in the yard immediately behind the main wing or the rear extension of the former building at 92 Havemeyer Street. This building had brick foundation walls 1.5 ft. thick. The burnt wood debris from either or both of this brick-clad frame building and its extension were packed down in the yard behind the extension. The concrete stair foundation must have been moved from its original position. Although the building was some 53 feet deep and trench 4 began 47 feet from the east lot line, we did not locate the building's foundation, or any part of its walls. The quantity and size of metal debris in the former yard, as well as the extent of the ash layer and the depth of the charred wood layer in trench 4, suggest a period of neglect. Asphalt was spread above these fills of destruction debris and industrial refuse. At a later date, the parking lot was re-asphalted.

Whichever the reason, it is the determination of this report that the 90 Havemeyer Street site is not sensitive for archaeological remains, and that neither further archaeological testing, nor mitigation is indicated.

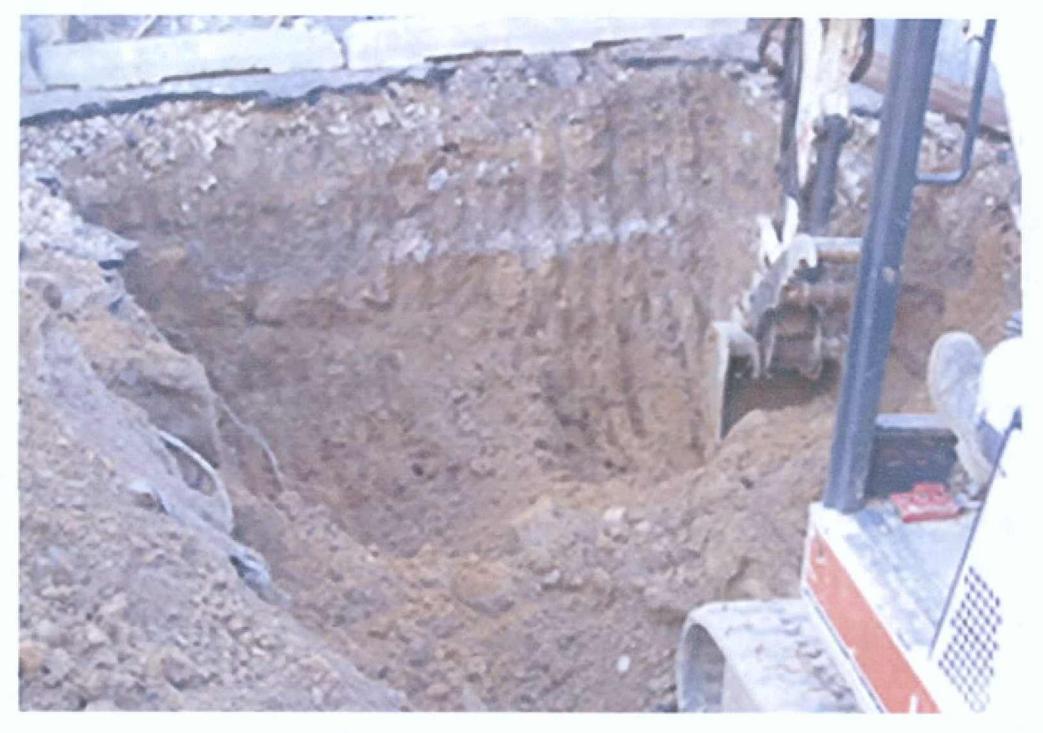
Fig. 6 View of the west balk of trench 1

We began with the excavation of trench 1 at the rear of lot 28, working from south to north about 1 ft. from the property line. This trench measured ca. 11.6 feet west/east by ca. 23 ft. north/south. The parking lot is covered by a ca. 0.25 ft. layer of asphalt over a ca. 0.25 ft. deep gravel bed. There were some traces of ash below the gravel layer, but the next ca. 1.5 to 2.0 ft. of deposit consisted of yellowish-brown sandy soil filled with refuse, mostly metal, but very little building debris (Fig. 6). Beneath this was a ca. 0.3 ft. thick layer of powdery whitish-grey ash. This was followed by a deep layer, down to ca. 5 ft. below grade, of brown sand. The refuse deposits ended ca. 4 ft. below grade and at 5 ft., we encountered a clean layer of reddish-brown sand.

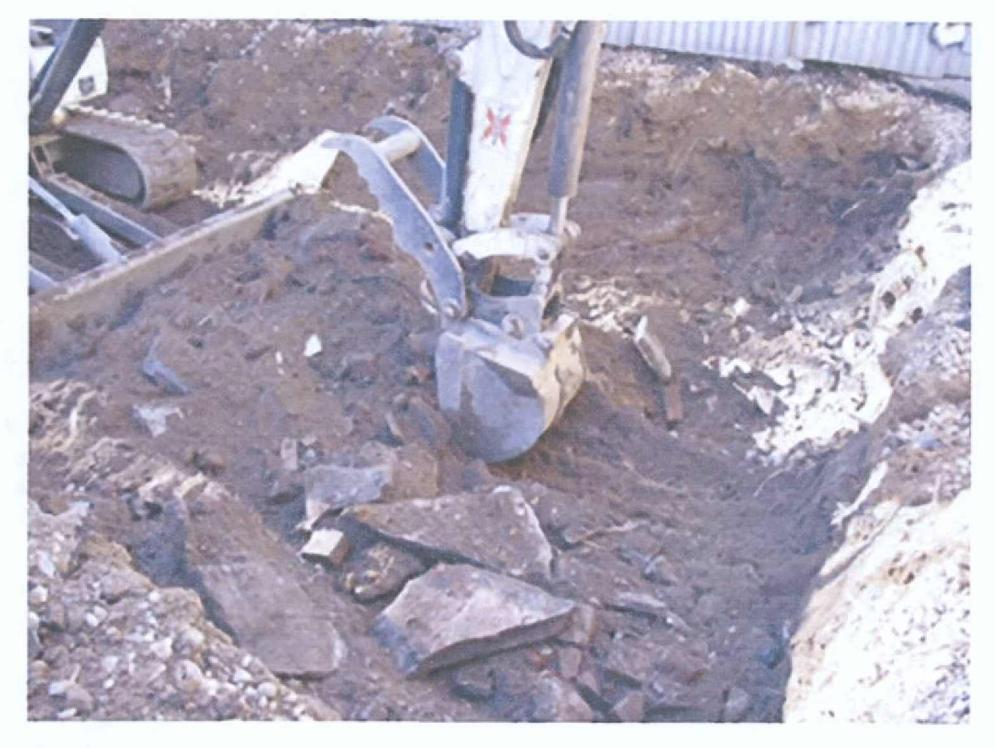
Fig. 7 View of the north end of trench 2 showing building detritus

In the afternoon, we continued along the same line excavating trench 2, at the rear of lot 27. This trench was 13.0 ft. west/east and ca. 22.0 ft. north/south. Below the asphalt and gravel layers was a shallow ca. 0.2 ft. deposit of yellowish-brown silty soil followed by ca. 0.2 ft. of ash, and then very dark brown loosely packed soil, down to ca. 4.0 ft. in depth. This layer was packed with building debris, including many sections of ceramic pipe and a few of floor tiling, a couple of marble paving slabs and concrete, and a small amount of brick (Fig. 7). We also noted

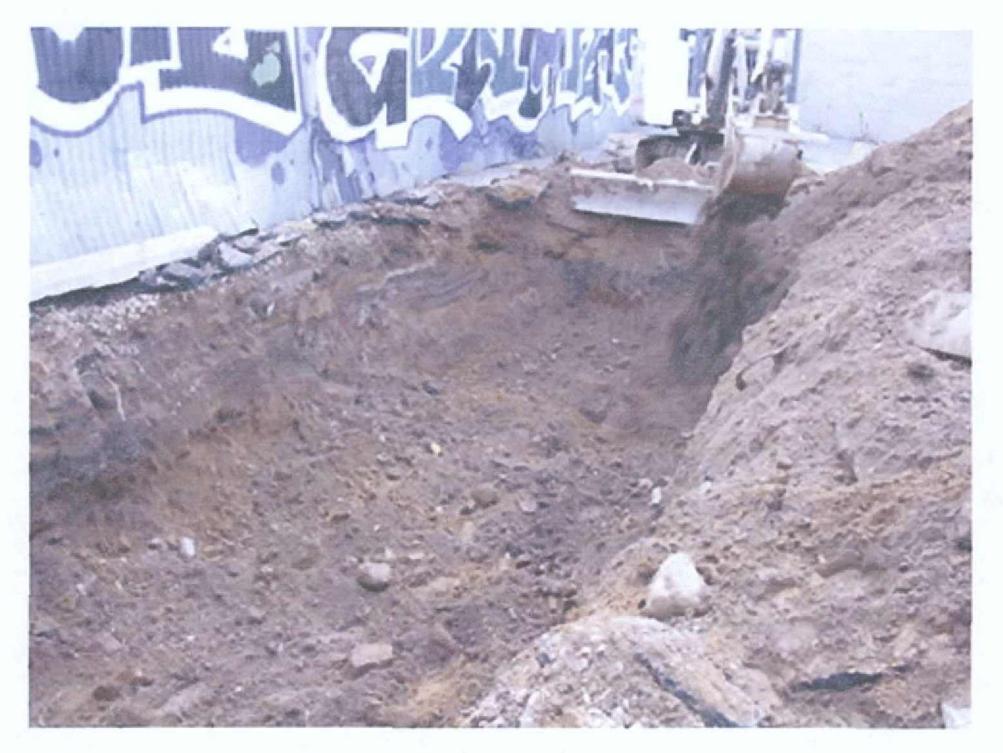
Fig. 8 View of trench 2 looking north

two pieces of butchered beef bones and a couple of oyster shells. At ca. 4.0 ft. depth, the dark brown layer gave way to an orange-brown silty soil devoid of cultural remains (Fig. 8).

There was no indication that a privy had existed In either trench, and both were backfilled by the end of the day.

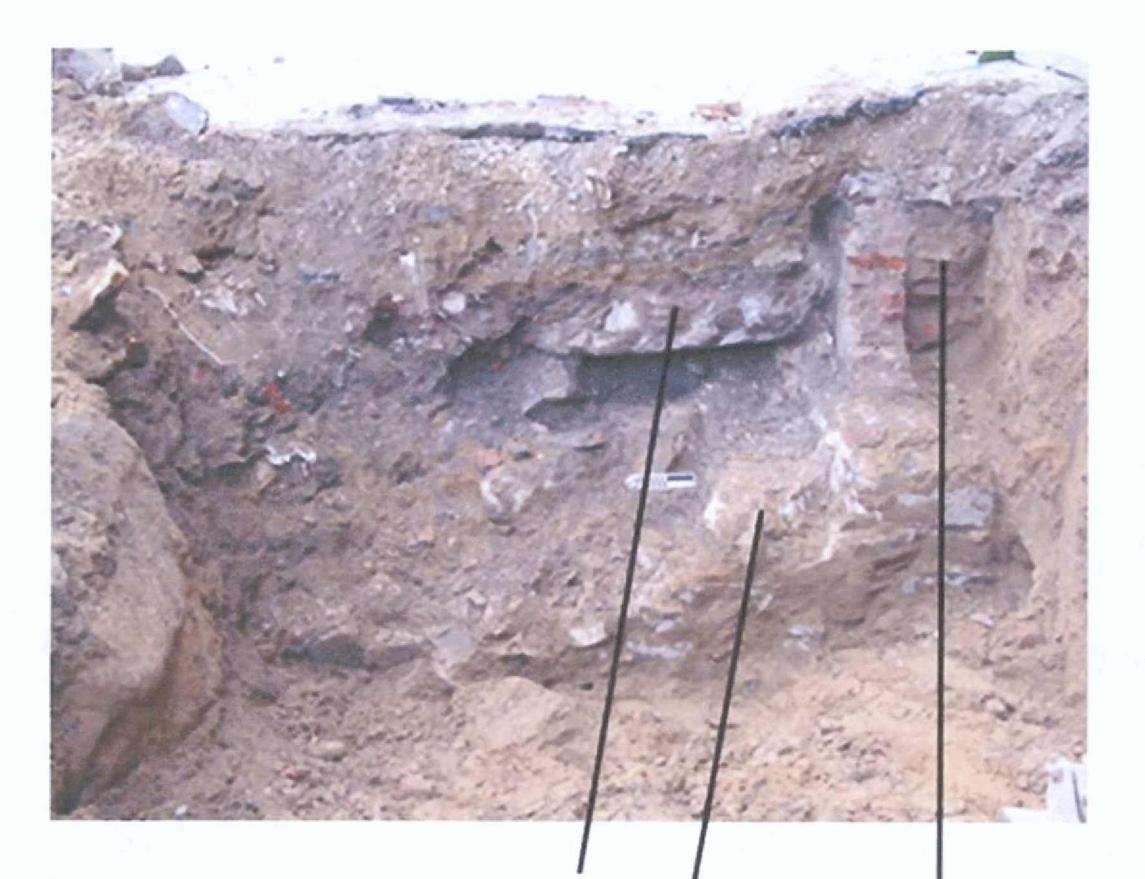
Fig. 9 View of the east balk of trench 3

Trench 3 was opened at the rear of the main wing of the former building at 92 Have meyer Street (lot 27), beginning approximately 19 ft. west of the east property line, on the southern half of the lot. The main part of this trench was ca. 10 ft. north/south by ca. 17 ft. east/west. It was extended a further ca. 4.0 ft. to the north, but this part was excavated to a depth of only ca. 2 ft., whereas we excavated to 6.0 ft. below grade in the main trench. Below the asphalt and gravel was a shallow deposit of fine brown soil that contained almost no cultural remains. But at ca. 1.0 ft. below grade at the eastern end of the trench, we encountered many large stones and cobbles in a denser, clayey brown soil. We took these at first to be a possible feature, such as the covering of a cistern, but determined that they were merely collapse from the adjacent building. There were many sections here of wide ceramic pipes. In the 24- to 36 inch diameter range. Along the northern edge of trench 3, ca. 2.0 ft. below grade, we encountered a boulder that could not be dislodged by the excavator. The boulder ran alongside a void that evidently marked the south face of the rear extension of 92 Havemeyer Street, ca. 12.0 ft. north of the south lot line. We continued excavating south of this line. A very large slab of concrete In our eastern balk proved eventually to be building collapse (perhaps a section of flooring, Fig. 9). This slab of concrete rested above the west foundation wall of the former building on this site. The preserved top of the 1.5 ft. thick wall lay ca. 4.5 ft. below grade. There was a large amount of brick collapse in the fill immediately west of the building line, but no refuse or other cultural remains. The southern corner and end of the foundation's south wall, ca. 1.0 ft. below grade, were also exposed.

There was no trace of a cistern along the back wall of the former building's main wing, or in its immediate backyard. This trench was backfilled.

fallen concrete floor slab

brick south wall of 92 Havemeyer Street

brick west wall of 92 Havemeyer Street

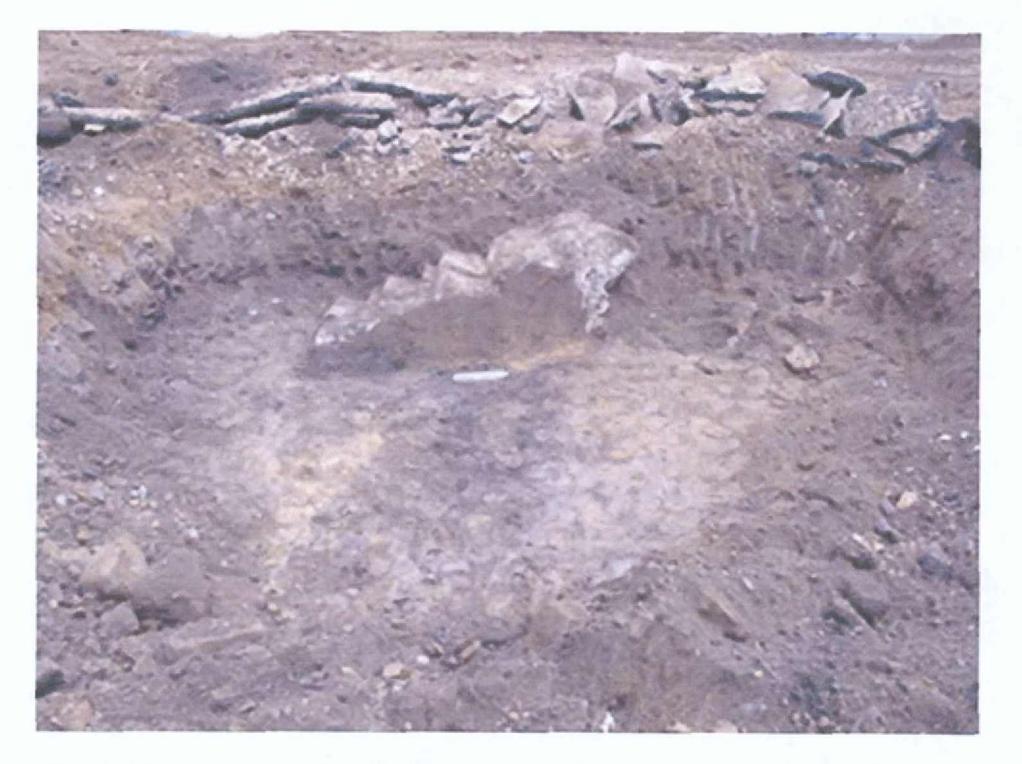
Fig. 10 View of trench 4 looking west, with concrete stair foundation

At the western edge of the opening, ca. 0.6 ft. below surface, we hit the top of a colossal slab built of concrete with some brick "trim", that proved to be the foundation of a staircase. It was tipped up slightly to the west, although it cannot have traveled far from its original position. The excavator was unable to dislodge it. In the blackened soil around it was quantities of metal refuse.
