Archaeological Monitoring Report

**Fulton Street Corridor Revitalization Project:
DeLury Square and Gold Street Drainage Pipes**

New York, New York

March 2010

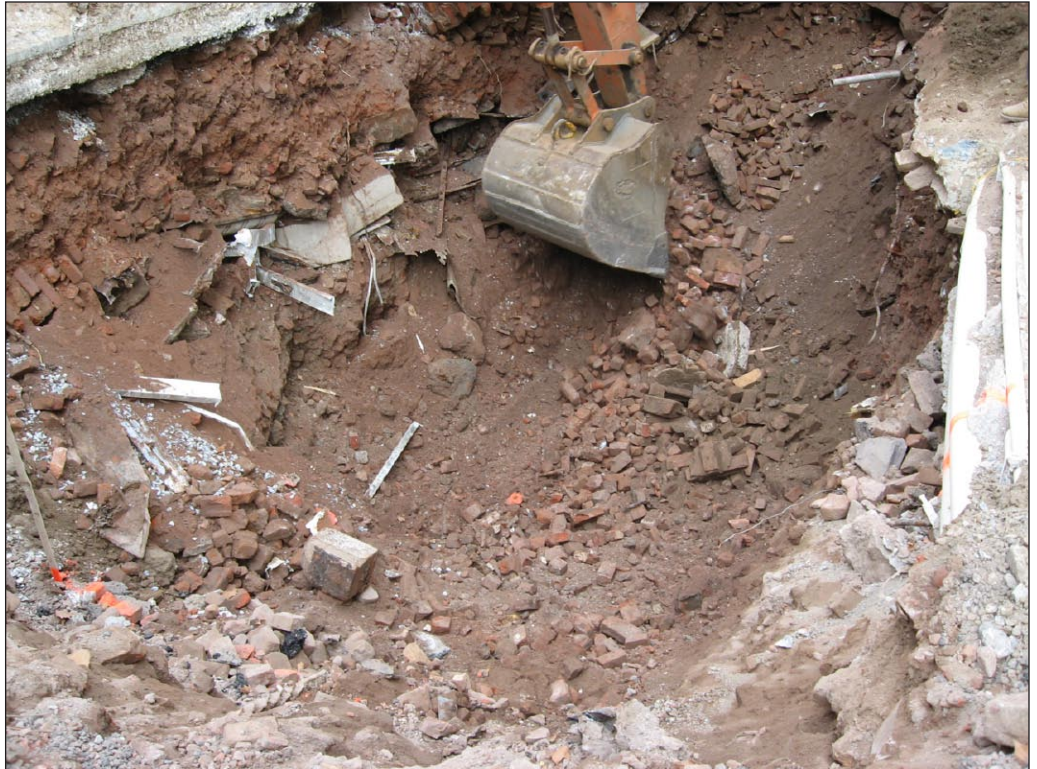
1

The archaeologist monitoring excavation within former Lots 10 and 11 observed disturbed architectural materials, including large quantities of brick, steel beams, metal sheeting, metal pipes, and glass (see Figure 6, and Figure 7, Photo 1). No *in situ* brick walls were observed. The disturbed architectural materials appeared to be late 19th or early 20th century in date, based in part on the large quantity of stamped bricks and the hard cementitious nature of the mortar used.

A view looking west from the southeast edge of the DeLury Square APE, towards the eastern portion of DeLury Square, within former Lots 10 and 11. Note the brick, stone, and metal rubble associated with demolished late 19th and early 20th century structures that previously occupied the site

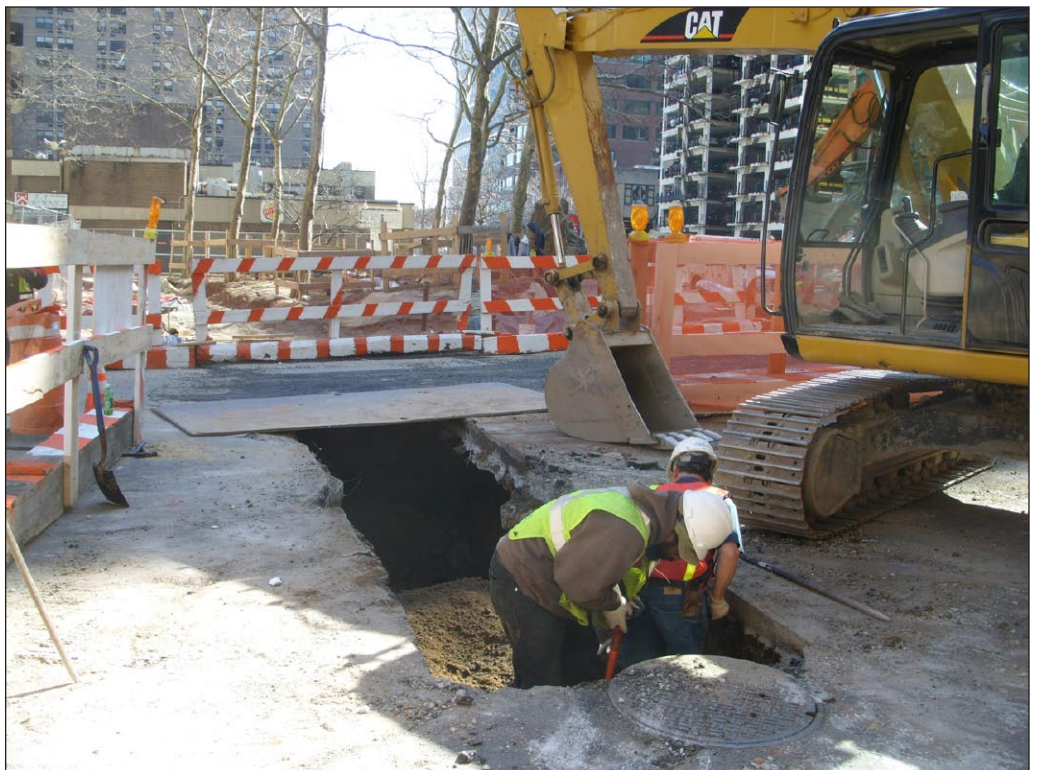
2

Excavation within the Gold Street sidewalk and streetbed progressed relatively slowly due to the presence of myriad existing utilities (including gas, telephone, electrical, and water lines). An archaeologist was on-site to monitor excavation of this area for approximately 7 days. Excavation beneath the Gold Street sidewalk extended to approximately 12 feet below ground surface (an area considered sensitive at depths greater than 10 feet below ground surface). The excavation angled downwards to approximately 14 feet below ground surface on the western side of Gold Street (through an area considered sensitive at depths greater than 3 feet below ground surface). Excavation terminated to the west at an existing brick manhole vault near the western curb of Gold Street (see Figure 6 and Figure 7, Photo 2).

From the west side of Gold Street just south of Ann Street, a view looking west across Gold Street towards DeLury Square. The trench for drainage conduit installation is being excavated across Gold Street to connect with the existing sewer vault (sewer manhole shown in foreground)

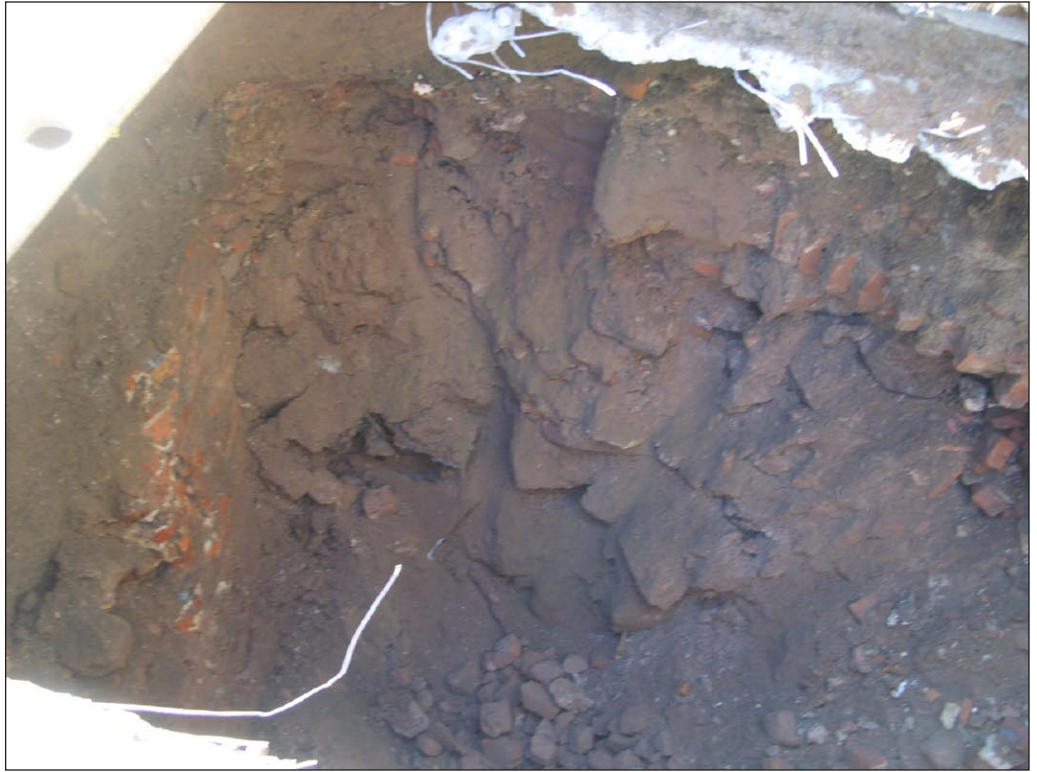
Two *in situ* features were encountered beneath the street and sidewalk of Gold Street, both relating to the late 19th century buildings that formerly occupied the east side of Gold Street. These included an intact brick foundation wall, and a brick sidewalk vault (see Figures 6 and 8). The brick wall was oriented north-south, roughly perpendicular to the trajectory of Gold Street. Its east edge was located 21 feet west of the existing eastern curb of Gold Street. The disturbed upper portion of the wall was encountered between 3 and 4 feet below ground surface, and the feature extended beyond the depth of excavation approximately 12 feet below ground surface. The lower portion of the wall had a simple brick plinth. The wall was apparently relatively modern, incorporating stamped bricks and hard cementitious mortar. Both the east and west faces of the brick wall were exposed, and a portion of the wall was removed in order to lay the drainage conduit. Based on historic maps presented in the Phase IA for DeLury Square (see, for example, Figure 4), the wall was likely the west foundation wall of the structure that occupied former Lot 15 in the late 19th and 20th centuries.

A view of the drainage conduit excavation beneath Gold Street, looking east from the approximate center of Gold Street. The east façade of a brick wall encountered below ground surface is shown on the left. The arched ceiling of a sidewalk vault is visible to the right. These features appeared to be remnants of the building which stood on former Lot 15 in the late 19th and early 20th century

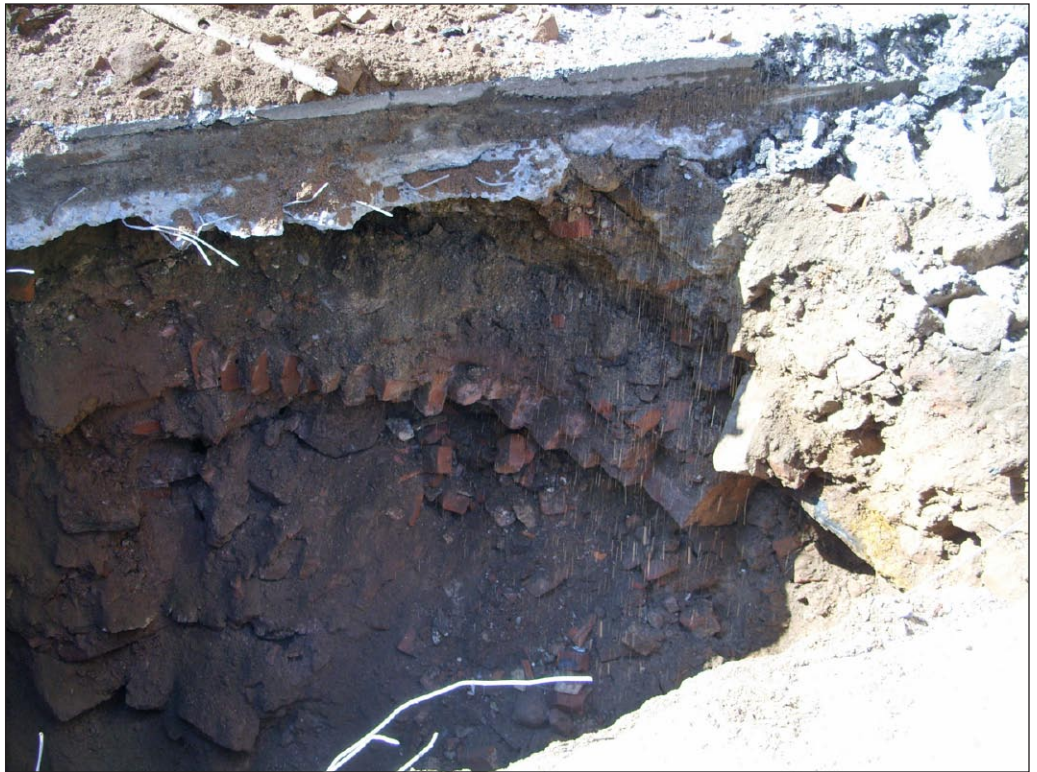
4

The remains of a brick vault, likely a sidewalk vault associated with the building that occupied former Lot 15 in the late 19th century, were encountered beneath the streetbed of Gold Street. The largely intact arched ceiling of the vault abutted the brick wall to the east, and extended approximately 9 feet to the west. It was encountered at approximately 3 feet below ground surface. The void beneath the vault was filled with architectural demolition rubble similar in nature to that described above. The vault appeared to have been previously disturbed through the construction of several existing utilities. Sections of the arched ceiling were observed in both the north and south walls of the trench; however, neither walls nor a floor associated with the vault were encountered. Excavation reached a maximum depth of approximately 12 feet below ground surface in this area.

The brick arch of the vault shown in Photo 3, looking south from the approximate center of Gold Street, south of Ann Street
