# Memorandum

Subject: **End of Field Summary, Phase 1B Archaeological Testing, Atlantic Yards Arena and Redevelopment Project, Blocks 1127, Lots 48 and 50, Brooklyn, New York**  
**05PR04690**  
**ESD/SEQRA-K**

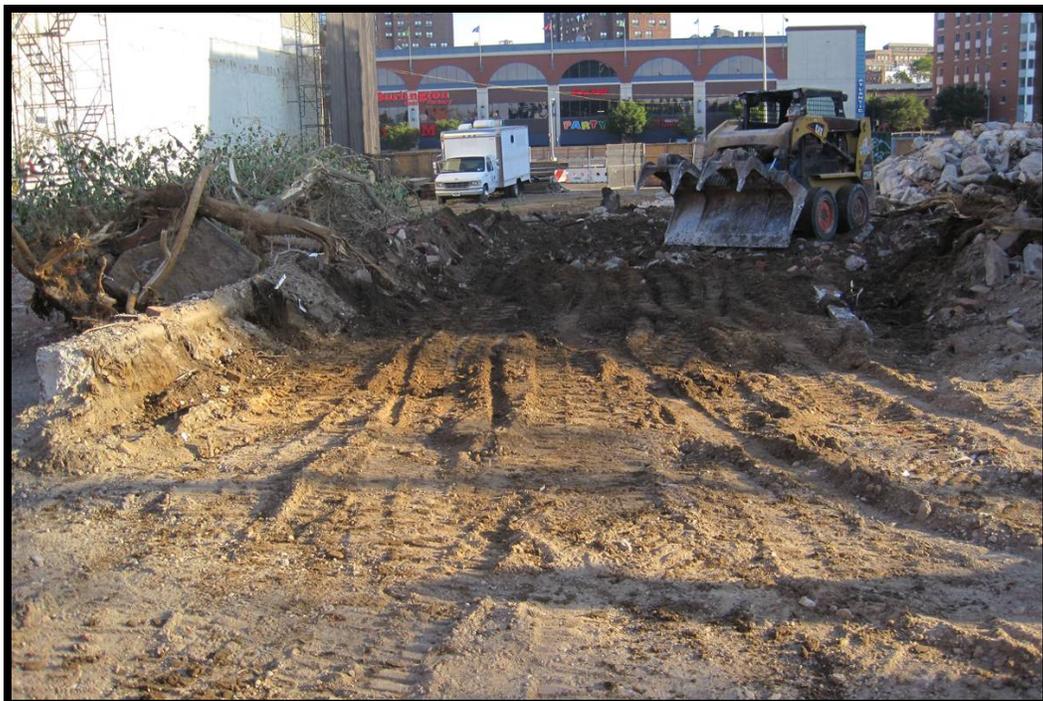
The Phase 1B archaeological testing of Block 1127, Lots 48 and 50, revealed significant and widespread disturbance of this area. Prior to the archaeological testing, the contractor was asked to scrape and remove 18–24 inches of rubble from the site. Test trenches, on average, involved the excavation of 5 additional feet, for a total excavation depth averaging 7 feet. Many of the STPs could not be fully excavated due to impassable rubble, leading to a shift in the testing strategy. Machine-excavated test trenches revealed significant disturbance and a high volume of building debris and rubble. No intact surfaces, features, or artifact deposits were uncovered. No further archaeological testing is recommended for these areas.

Photograph 4 Block 1127, Lots 48 and 50, post-demolition and removal of 18 to 24" of rubble fill.

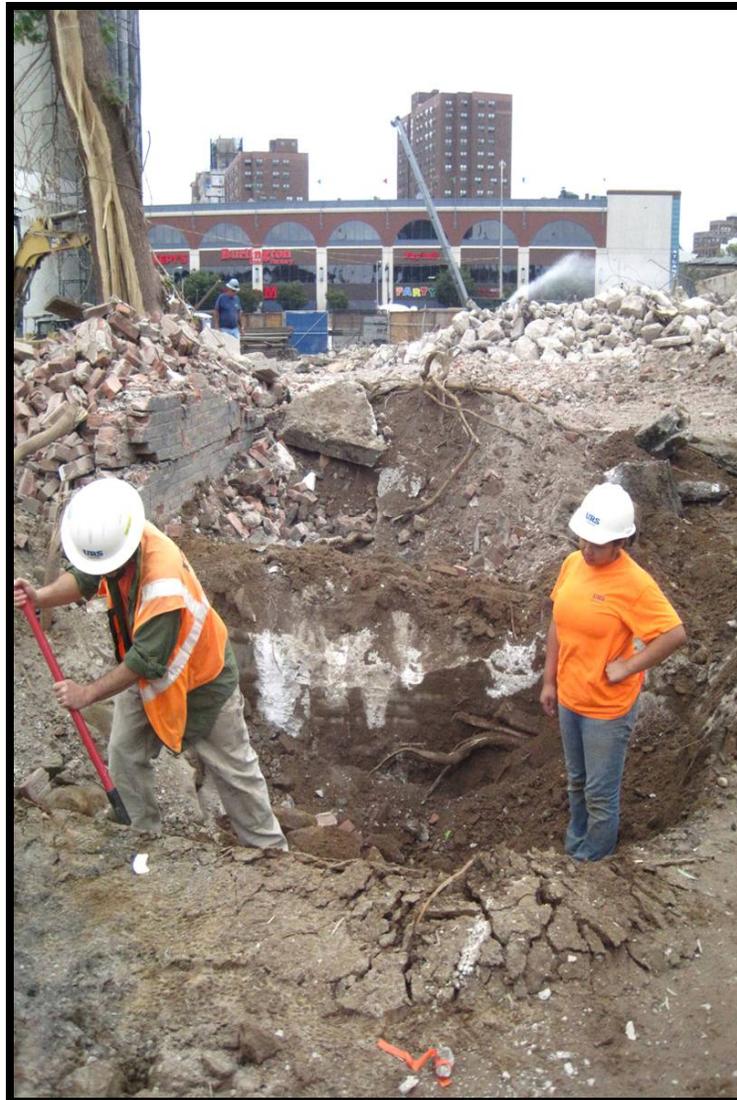
Photograph 5 Block 1127, Lot 48, uncovering concrete foundation.

The backhoe test trench was positioned in the northern half of the test area in the vicinity of the former stair (see Figure 4). This trench measured 9 x 26 feet and was excavated to a depth of 5 feet. In this area, a 2-foot-thick concrete foundation was uncovered, extending beyond the 5-foot excavation depth (Photograph 5). The area north of the foundation wall was filled with brick and concrete building rubble and metal pipes. The area south of the foundation wall also contained a significant degree of rubble, as well as some disassociated large cobbles.

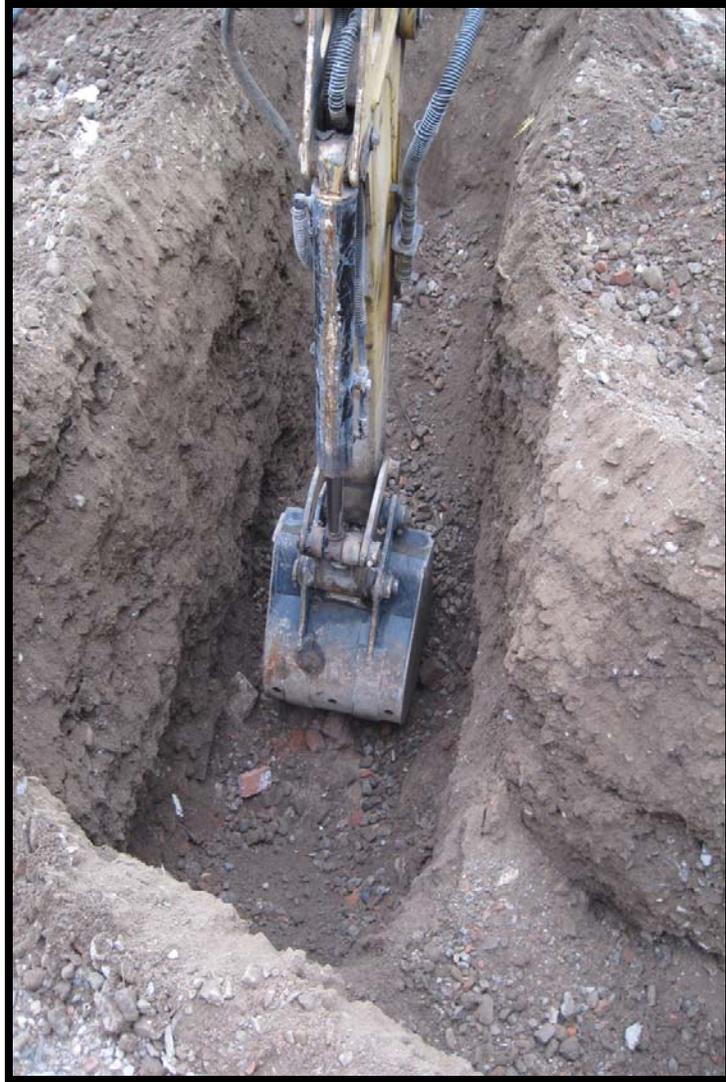
Photograph 6 Test Trench 5, Block 1127, Lot 48.

Subsurface investigations consisted of two machine-excavated trenches—measuring 2 x 16 feet and oriented north-south, and 3 x 10 feet and oriented east-west (Figure 5). Both trenches consisted of redeposited fill materials composed of rubble and recycled concrete aggregate (RCA) (Photograph 6). The brick within the

rubble dated post-1875. At 4 feet, modern plastic caution tape was exposed. The trenches were excavated to 5 feet, when the walls began to collapse. Safety concerns prohibited further excavation.

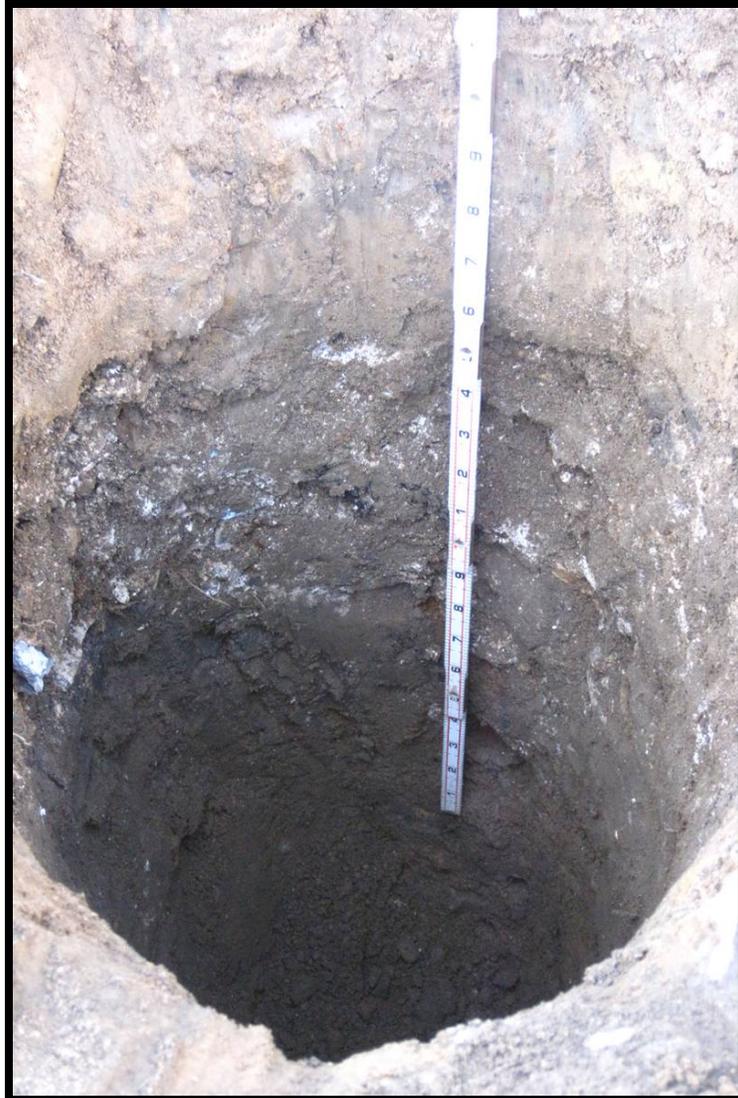
Photograph 7 Block 1127, Lot 50, STP A3.

All of the STPs showed evidence of disturbance. All the STPs were excavated to approximately 3 feet below starting grade and contained small amounts of artifacts, including nails, glass, pearlware, and modern debris. Soils within the STPs ranged from rubble fill to silty sandy clay at approximately 3 feet below grade (Photograph 7). STP A4 was adjacent to the remains of a raised concrete flowerbed. STP A4 was excavated to 2.8 feet below surface and contained brick fragments, nails, glass, and pearlware. Within STP A5, the remnant of a narrow brick wall was uncovered (Photograph 8).

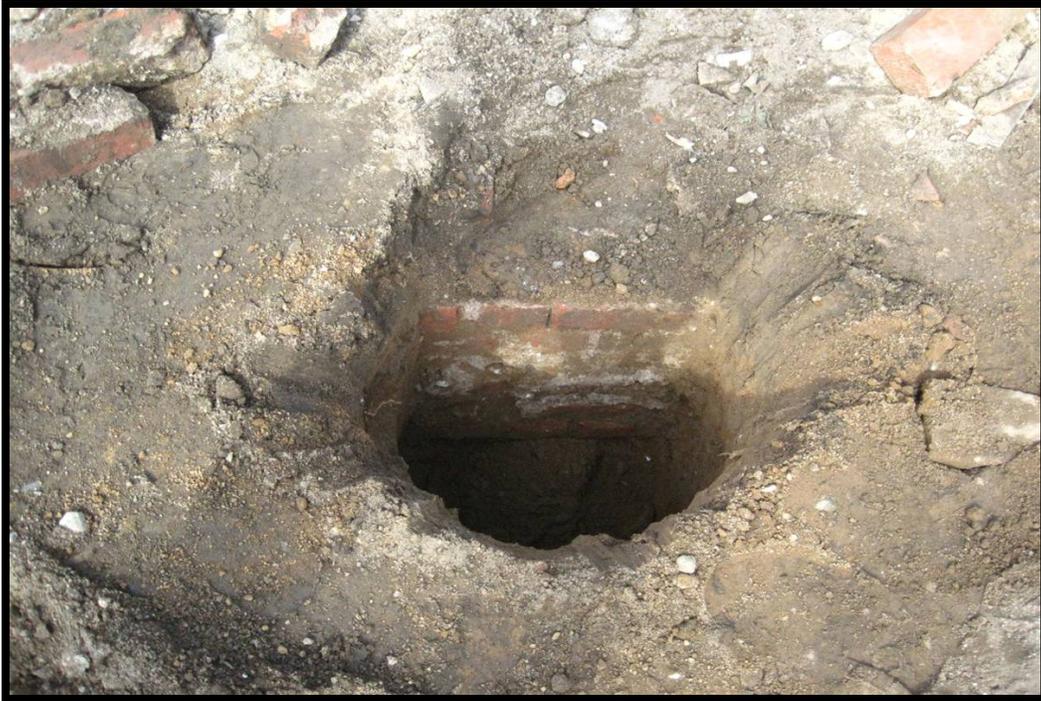
Photograph 8 Block 1127, Lot 50, STP A5.

Trench 1 was oriented north-south and was excavated to 5 feet below surface. The trench, measuring 10 feet long by 2 feet wide, exposed a 4-foot-long brick wall segment, previously located in STP A5. The wall is a modern construction that was two courses wide and 13 courses deep, or 6 feet wide by 3 feet deep. The surrounding soils consisted of clean sand.

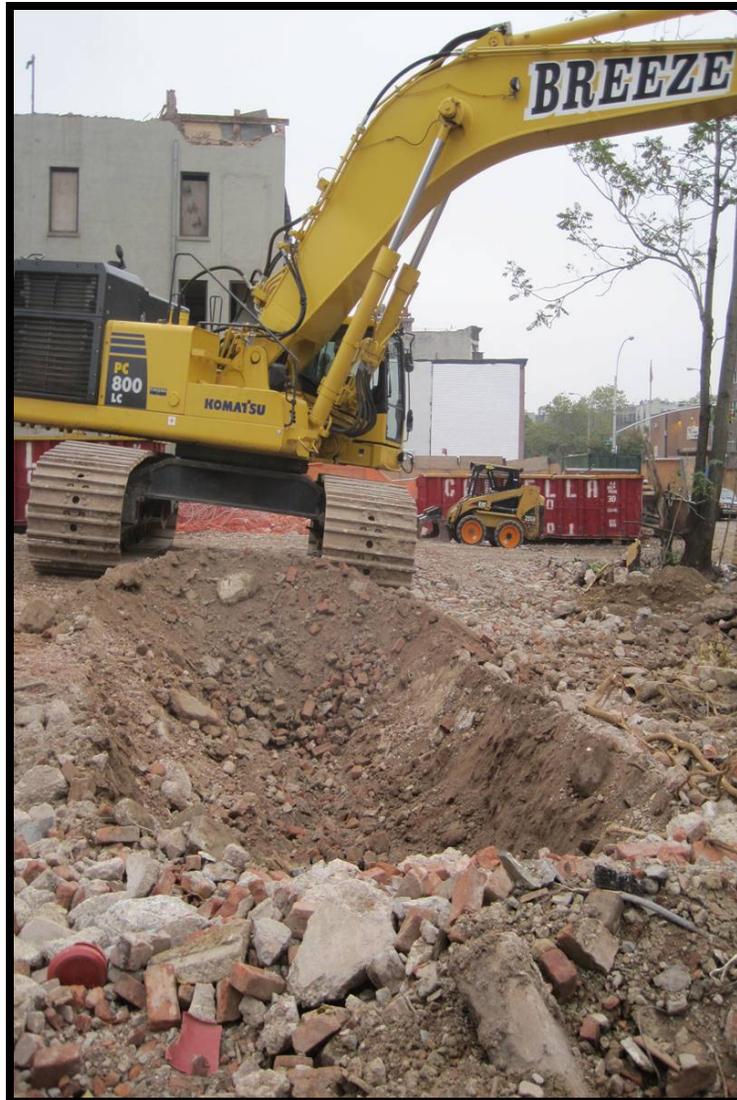
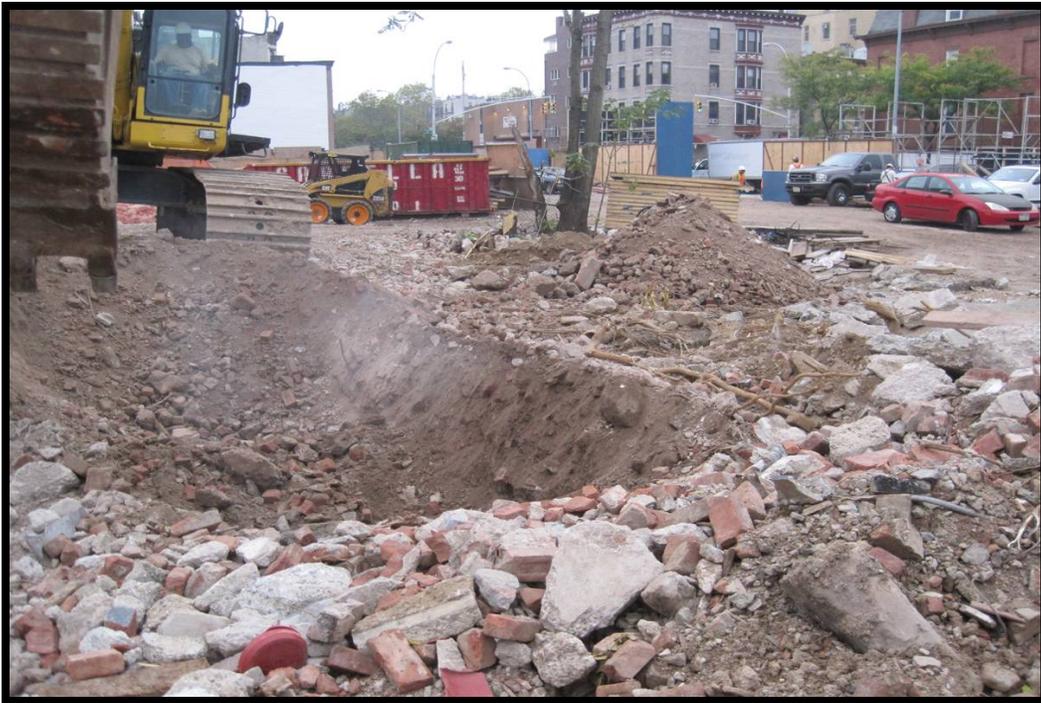
Trench 2, measuring 2 x 12 feet, was oriented east-west at the northern end of the test area. Excavated to 5 feet below surface, the trench consisted of modern rubble and debris. The loose soils collapsed easily beyond 4 feet and further excavation in this area is not possible (Photographs 9 and 10).

Photograph 9 Test Trench 2, Block 1127, Lots 48 and 50.

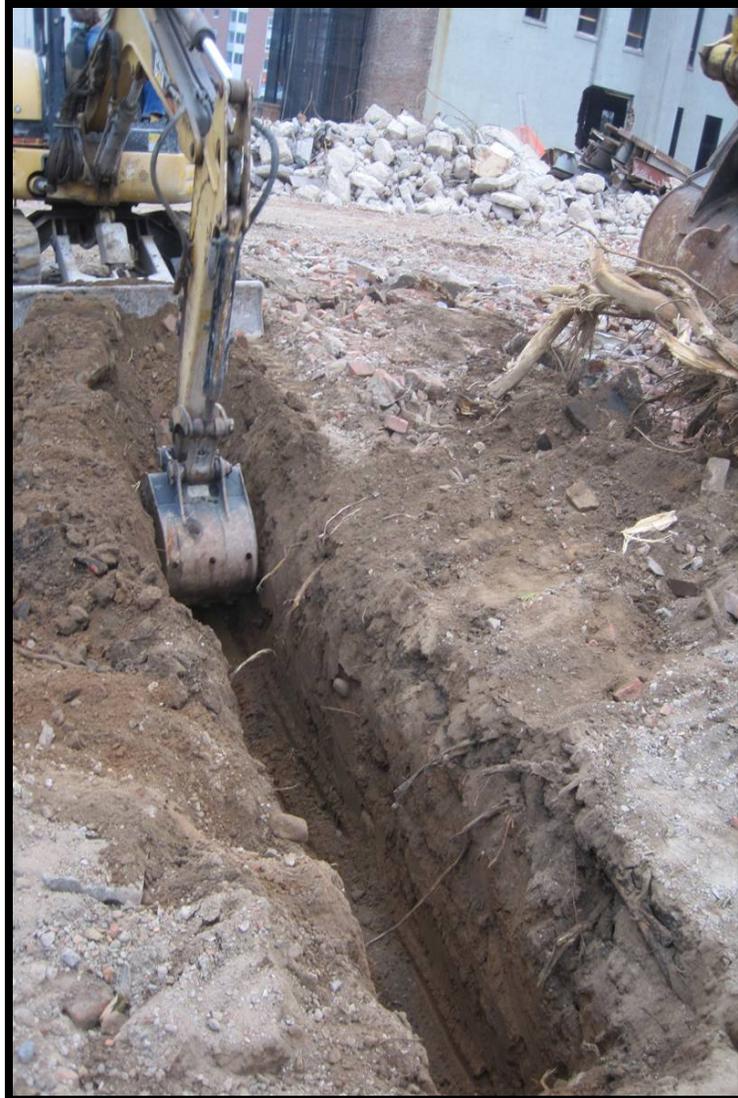
Photograph 11 Test Trench 3, Block 1127, Lot 50.

Trench 3 was located in the area of a raised concrete flowerbed and associated 2-x-2-foot stone slabs, which had been removed; these were remnants of the modern garden/courtyard area. The trench measured 2 x 17 feet and was on a north-south orientation. Excavated to 4.5 feet below surface, the only materials observed were brick fragments, rubble, and metal pipes (Photograph 11).
