# Saratoga Square Urban Renewal Area, Brooklyn, New York Field Testing June 1994

CEQR No. 89-232K

Prepared for the City of New York Department of Housing Preservation and Development

Prepared by Joan H. Geismar, Ph.D. August 1994

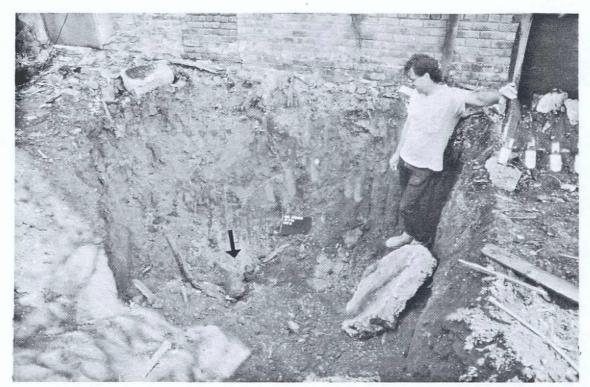
126 Sumpter Street (Block 1524, Lot 43). As noted in the documentary study (Geismar 1993), the former building on this lot was home to transient German-born immigrants throughout the nineteenth century. In the 1870s, it was also home to at least two African-American families (Geismar 1993/1994 Addendum:5-6). Testing in October 1993 had uncovered a filled beehive cistern with its domed top missing (F12). In June, a test pit (P11) was placed in the rear portion of the yard where a cement slab, the remnant of a former shed, had been removed to facilitate testing. Virtually clean sand devoid of features was found under an ashy deposit (see Exhibit 3).

**3** Pit (P) 11 partially excavated, looking south. A cement floor, the remnant of a shed, was removed to access this part of the yard at 126 Sumpter St., but no evidence of a privy pit was found although the excavation extended into sterile yellow soil (arrow). (photo Geismar 6/7/94)

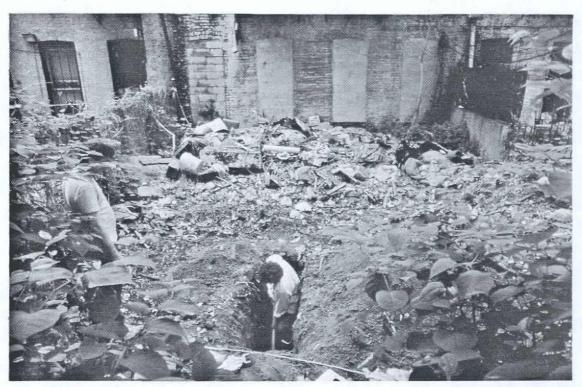
194 MacDougal (Block 1533, Lot 16). A vacant tenement building stands on this lot, and the yard was full of building debris that had to be consolidated to permit testing. Moreover, the yard configuration precluded use of the backhoe to excavate the proposed trench intended to determine stratigraphy and the likelihood of finding Native American deposits here or elsewhere in the immediate Consequently hand excavation was called for (Exhibit 4). The resulting 7-ft. by 2.5 ft. trench, which was 4 ft. deep, revealed the absence of the original yard surface (the "A Horizon"), the soil level most likely to contain Native American deposits. This level was undoubtedly eliminated during construction of the tenement now on the lot. Ground disturbance, in the form of isolated artifacts and a concentration of "modern" debris at a depth of about 2 1/2 ft. (see Exhibit 5), was documented; sterile soil was reached at a depth of about 3 3/4 ft. Subsurface conditions suggested that Native American deposits were not an issue.

4 Test Trench (TT) 20 at 194 MacDougal St. during hand excavation. This testing revealed that the yard, located in the vicinity of a spring documented in deeds, had been highly disturbed and would not harbor evidence of any prehistoric Native American use. Note the trash concentrated near the building in the background. The test area had been cleared prior to testing to facilitate the archaeological investigation. (photo Geismar 6/8/94)

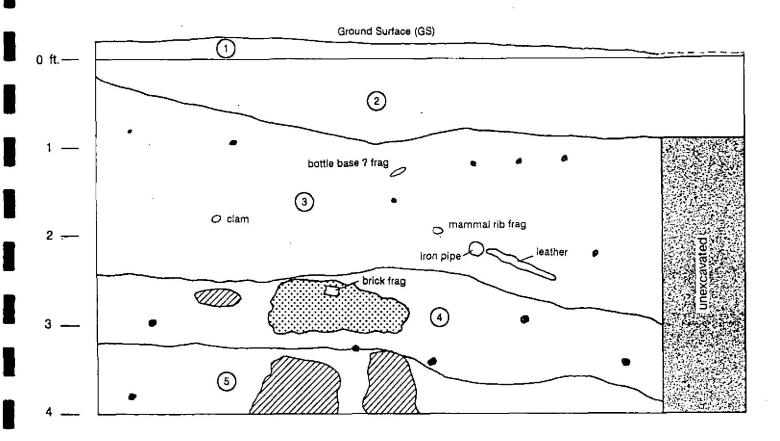
Address/Block/Lot	Unit	Dimensions (in ft) [LxWxD]	Soil Description/Remarks
194 MacDougal/Block 1533/ Lot 16	ТТ20	7 x 2.3 x 4	Disturbed soil under trash cover and humus; "modern" artifact concentration at c 2.5 BGS; "A Horizon" (original GS) eliminated in the past; natural soil a tan/orange, orange/tan, or brown sandy silt; see profile, Exhibit 5.
