Fulton Houses Redevelopment

401 West 18th Street

Phase 1B Archaeological Survey Report

JULY 2016

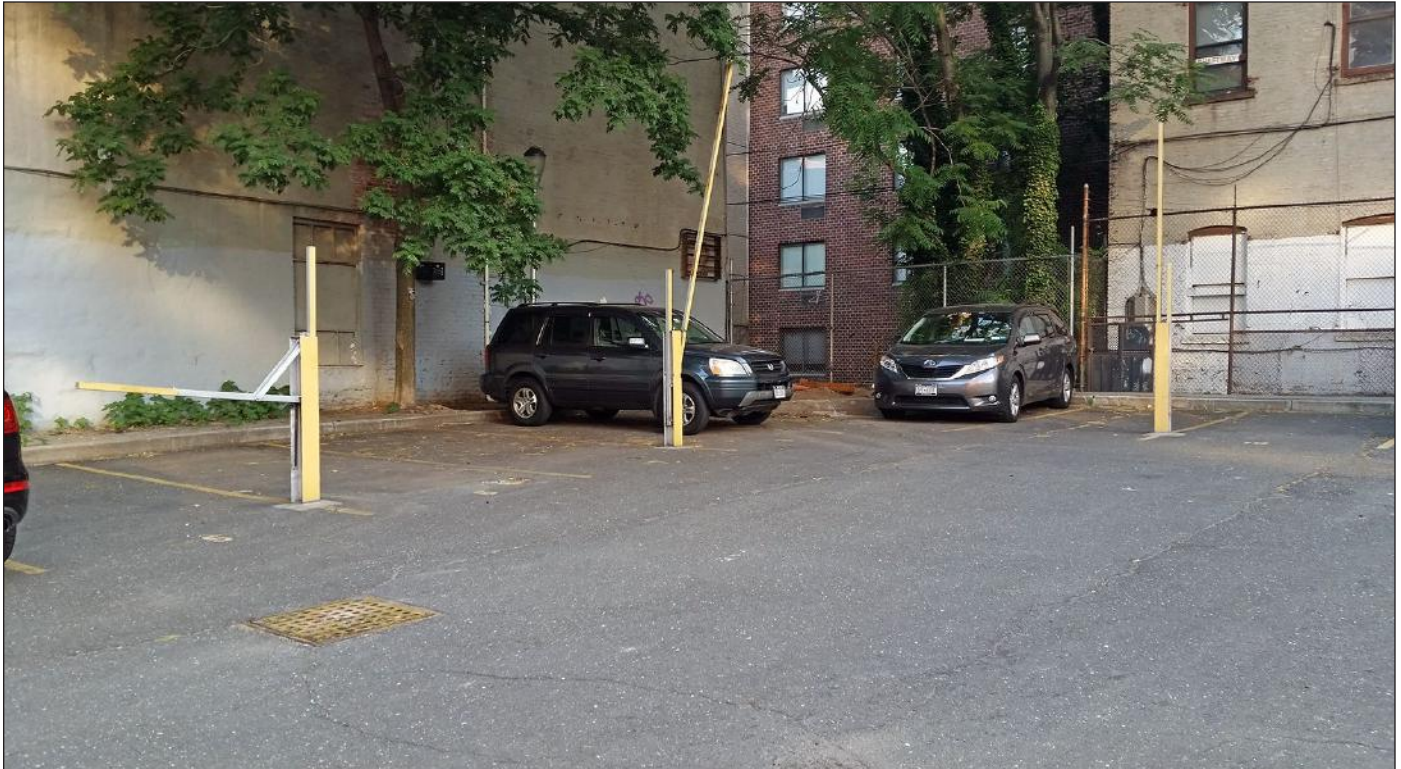
1

Looking northwest at the area of archaeological sensitivity identified in the 2007 Phase 1A. Electrical lines connect to the lamppost in the background through this portion of the site.

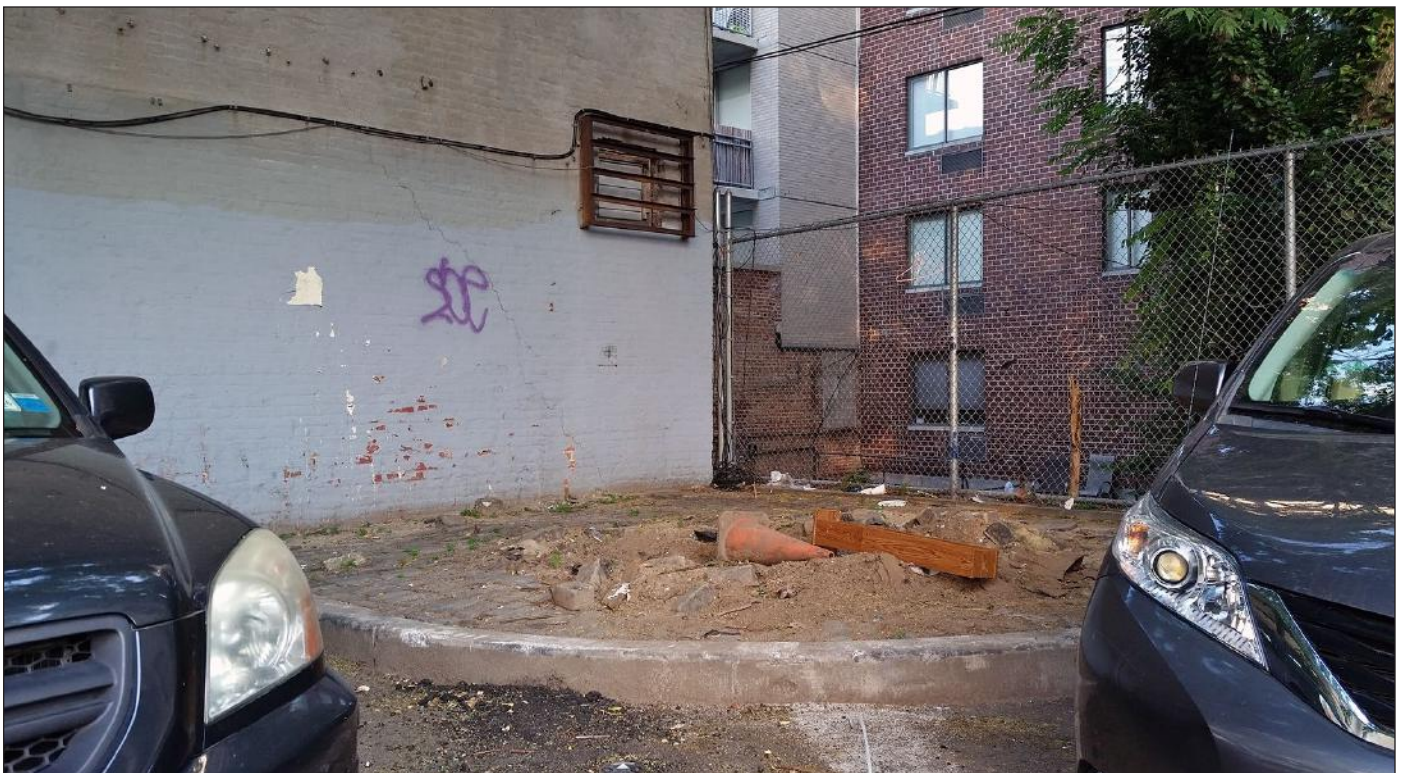
2

The location of Trench 1 prior to excavation. The Belgian block surface had recently been disturbed, but the underlying soils were intact. On the opposite side of the fence at the right of the photograph is an excavated rear yard at a lower elevation.

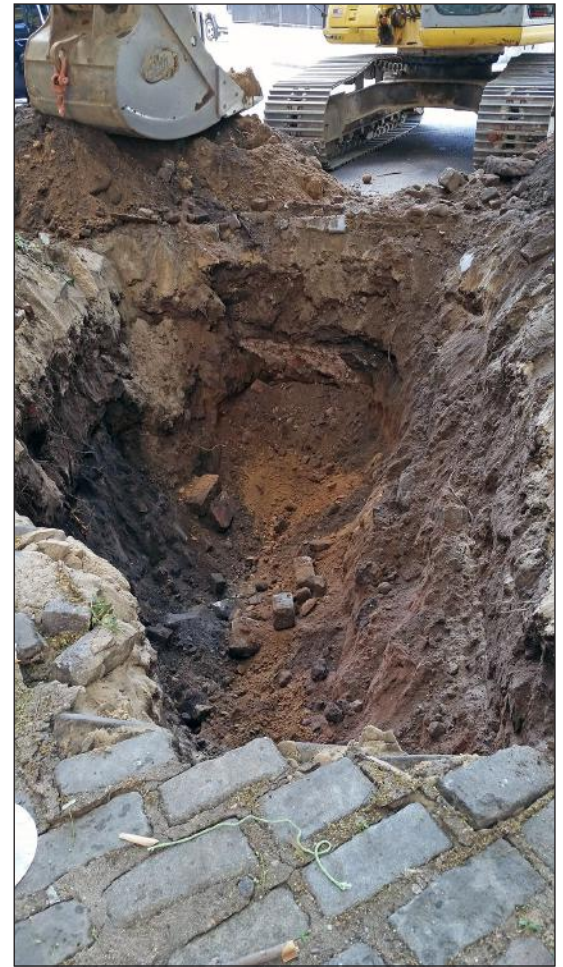
3

Looking southeast at Trench 1, showing dark black fill to the north (left) and clean subsoil at the bottom of the trench (center).

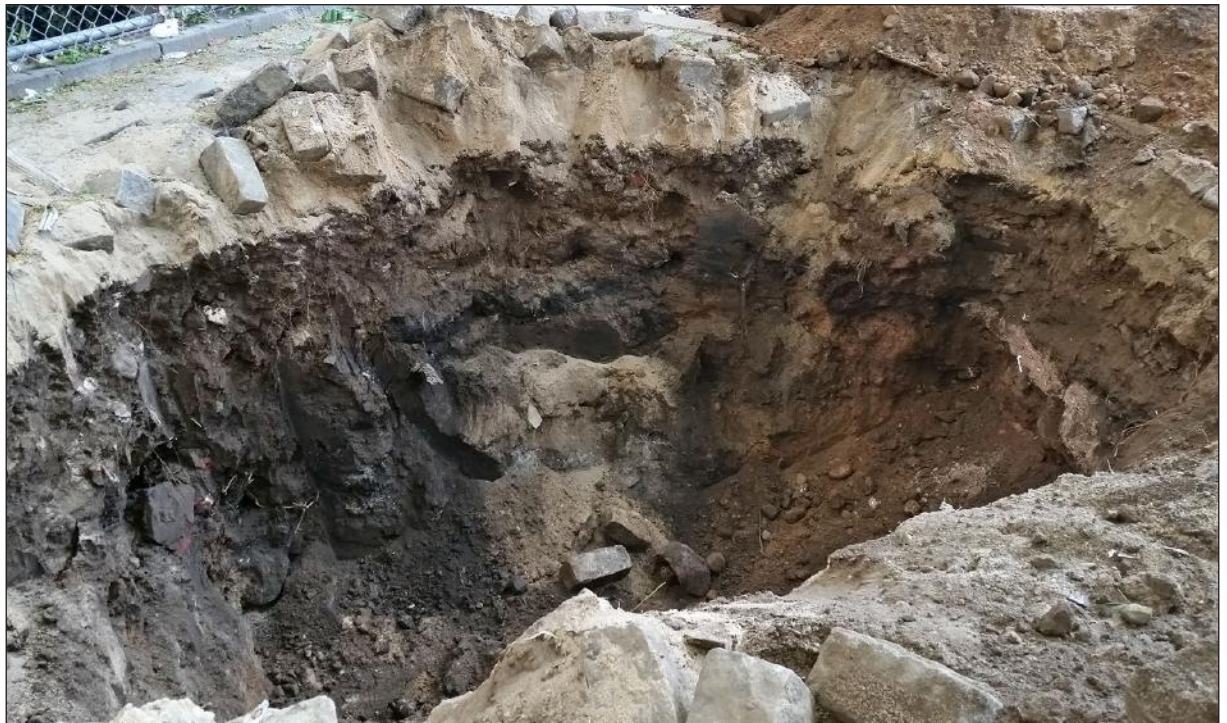
4

No intact features were observed in this location and no intact soil levels were observed that would suggest that shaft features could be present.

The dark black fill in the northern wall of Trench 1. The excavator was later used to scrape down this wall and no features were observed.

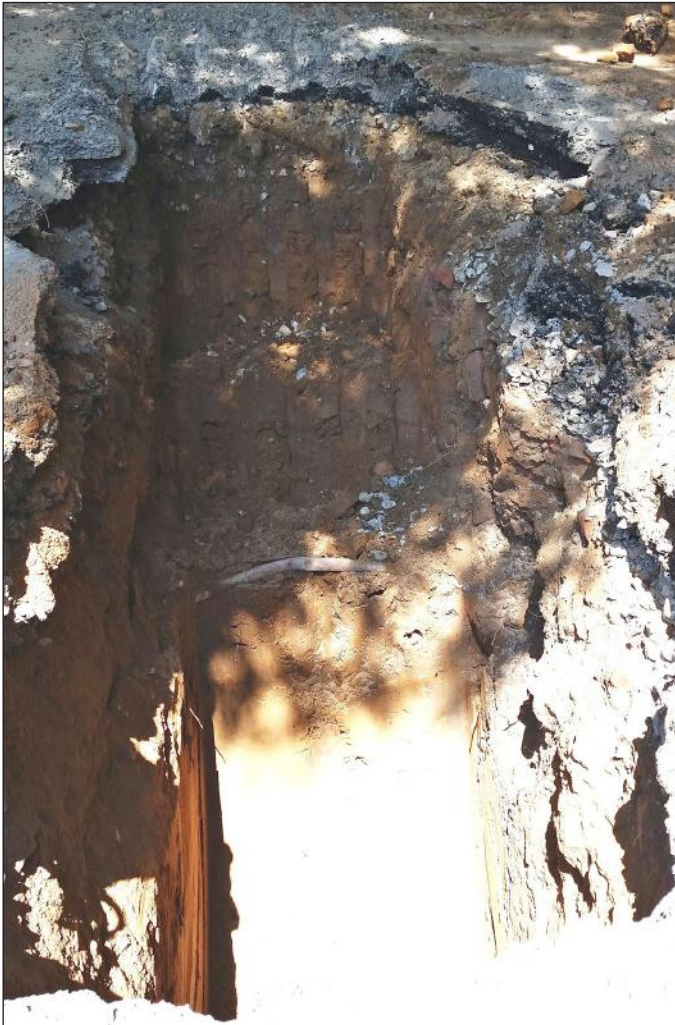
5

Looking west at the western half of Trench 2, showing the metal utility pipe at the center and the excavated western portion of the trench.

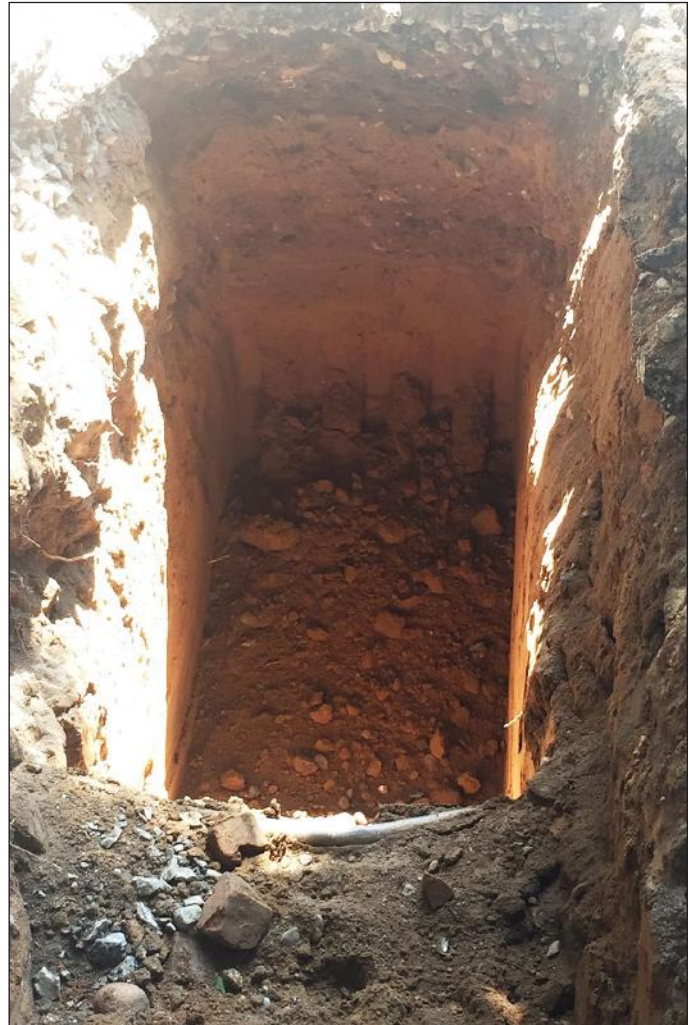
The trench was covered with a thick layer of asphalt and asphalt bedding immediately below the paved surface. Underlying the asphalt was a layer of brown sandy silt with brick rubble. A copper utility pipe running north-south through the trench was encountered at a depth of 4 feet below the ground surface and 5 feet 2 inches east of the trench's western wall (see **Photograph 5** on **Figure 5**). Excavation was terminated west of this pipe and continued only to the east. Dark yellowish brown (10YR4/6) damp, sandy, silty subsoil was encountered at a depth of approximately 6 feet below the ground surface. The upper levels of the subsoil contained 19th century artifacts and root material of various sizes. The trench was excavated to a depth of 7.5 feet and the lower levels of the subsoil did not contain any artifacts or cultural material of any kind (see **Photograph 6** on **Figure 5**).

No intact features were observed in this location and no intact soil levels were observed that would suggest that shaft features could be present.

The eastern half of Trench 2, showing the depth of clean subsoil at the end of the excavation.

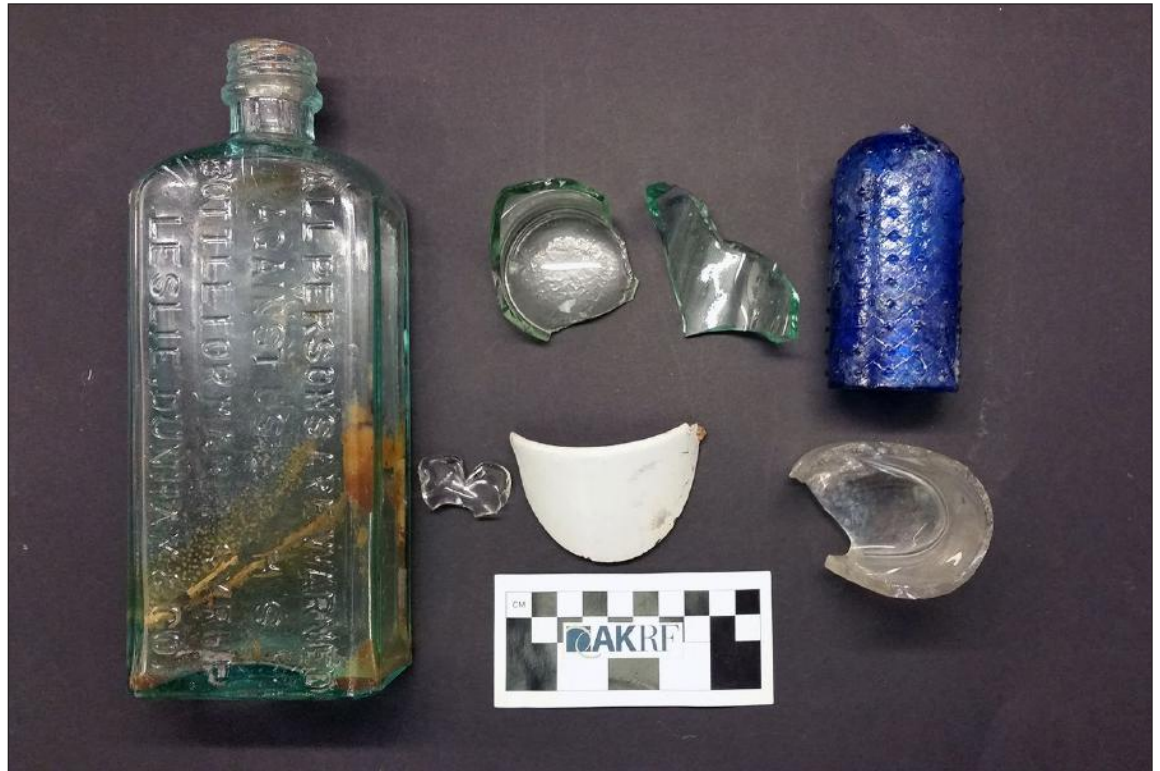
The artifacts from Trench 1 were collected from the backdirt pile and originated within fill deposits inside the trench (see **Photograph 7** on **Figure 6**). The artifacts were representative of late-19th or early 20th century domestic life and included an undecorated white ironstone cup or jar fragment; three fragments from different aqua or clear glass bottles; and a fragment from a glass lamp or decorative dish or vase. One large, rectangular aqua glass bottle was recovered that was produced by Leslie, Dunham & Co., a producer of syrups and honey, was embossed with the phrase, "All persons are warned against using this bottle for maple syrup" and was likely produced between 1880 and 1920 (Corning Glass Museum n.d.). Finally, a small cobalt blue glass bottle was recovered that was embossed with a series of diamond patterns and dots typical of poison bottles that were produced beginning in the 1870s (Lindsay 2016).

Artifacts recovered from Trench 1 7

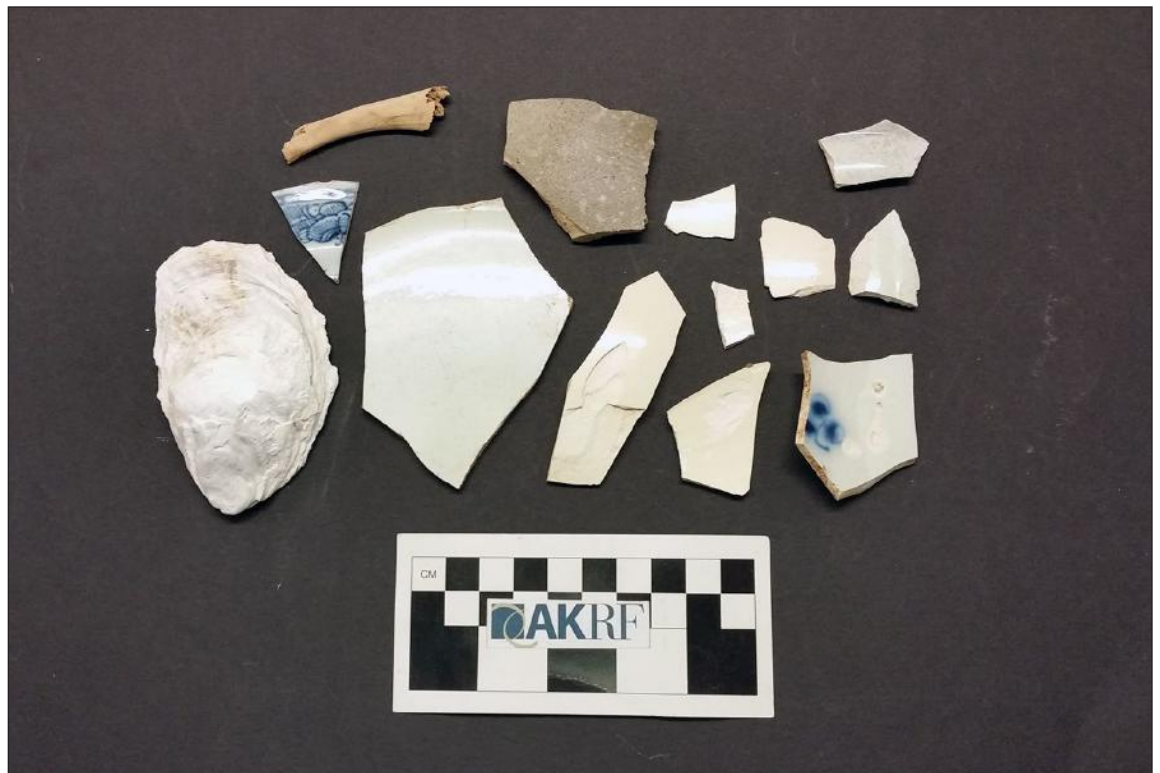
The artifacts recovered from Trench 2 were collected from the upper levels of subsoil; approximately 6 to 6.5 feet below the paved ground surface (see **Photograph 8** on **Figure 6**). The artifacts do not appear to have been intentionally deposited within the subsoil and were not associated with a feature. The artifacts were likely deposited in the subsoil through bioturbation, root activity, rodent burrowing, or redeposition. The artifacts were typical of those associated with 19th century domestic life, and included a highly weathered oyster shell; a painted porcelain dish fragment with a blue floral pattern; a possible Pearlware plate fragment with a hand painted blue floral motif; two white earthenware dish fragments; a buff-bodied stoneware bottle fragment; five highly fragmented creamware sherds; and a fragmented and weathered animal bone. The artifacts were observed in low concentrations within the upper levels of the subsoil only. Below a depth of approximately 6.5 feet, the subsoil contained no cultural material.

Artifacts recovered from Trench 2 8
