BARTOW-PELL ESTATE CARRIAGE HOUSE SITE ARCHAEOLOGICAL REPORT

Prepared by HISTORICAL PERSPECTIVES For the International Garden Club And Beyer Blinder Belle September 10, 1985

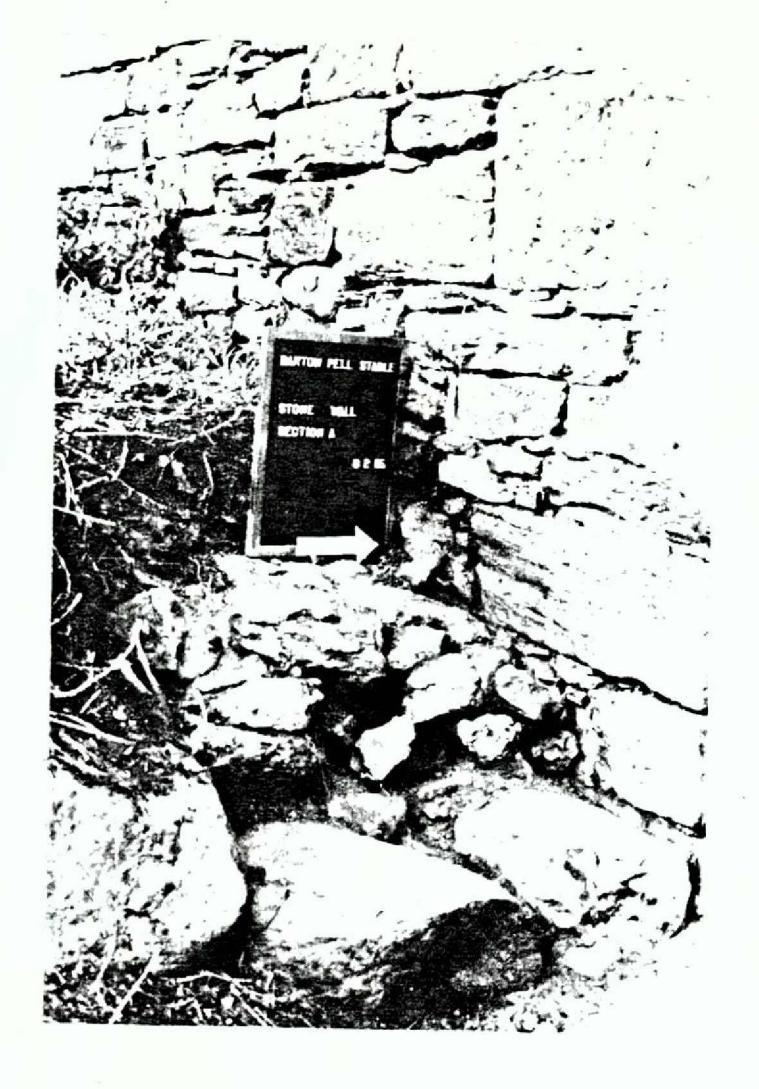
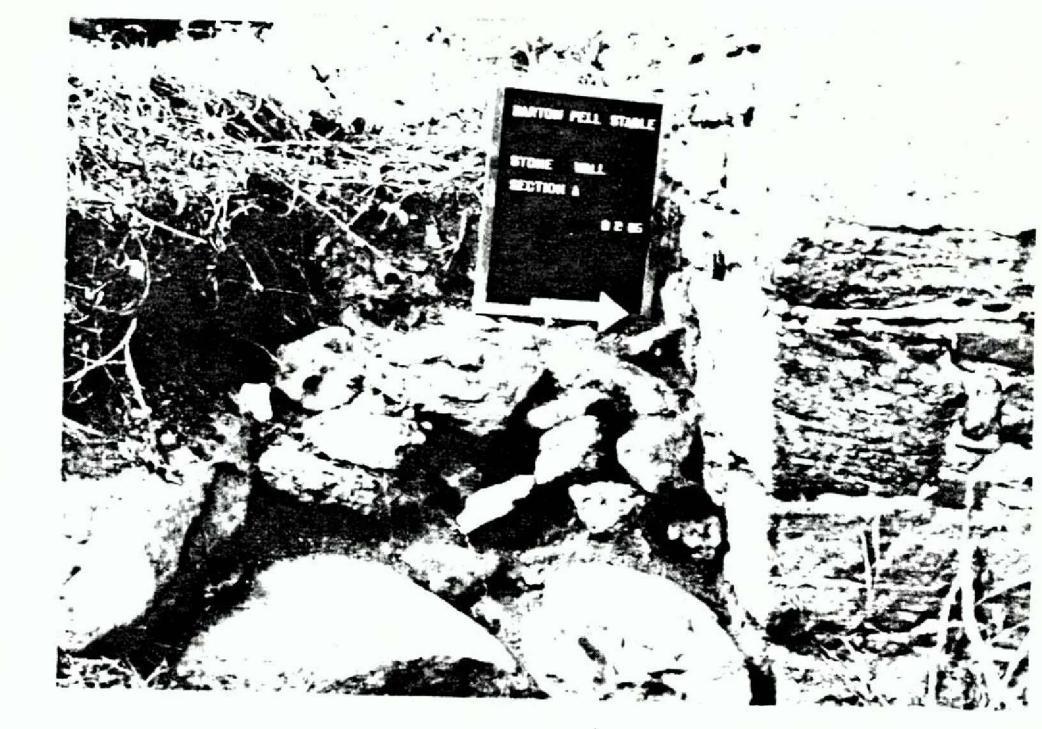
Photographs 1 and 2 also show the southeast corner of the carriage house before a portion of the wall was exposed. The cleaned portion of the wall - Area A - is shown in Photographs 3 and 4. The wall abuts the structure at this point, but is not attached to it. What appears in the photographs to be a step and, indeed what was at first thought to be so during excavation, is apparently only a gap caused by the loss of the original stones. Probes revealed no further evidence of steps, and the topmost layer of stone is very loose and unstable. Surrounding and mingled with the large stones of the dry-laid wall is fill. Cultural refuse contained in this fill included sherds of glass and ceramic, metal, shell, bone, and one small glass medicine container of the type used with hypodermic needles. The soil matrix varied from loose to densely packed, but with no discernable stratigraphy.

Area A Looking West Photograph 4

Area A Looking Northwest Photograph 3

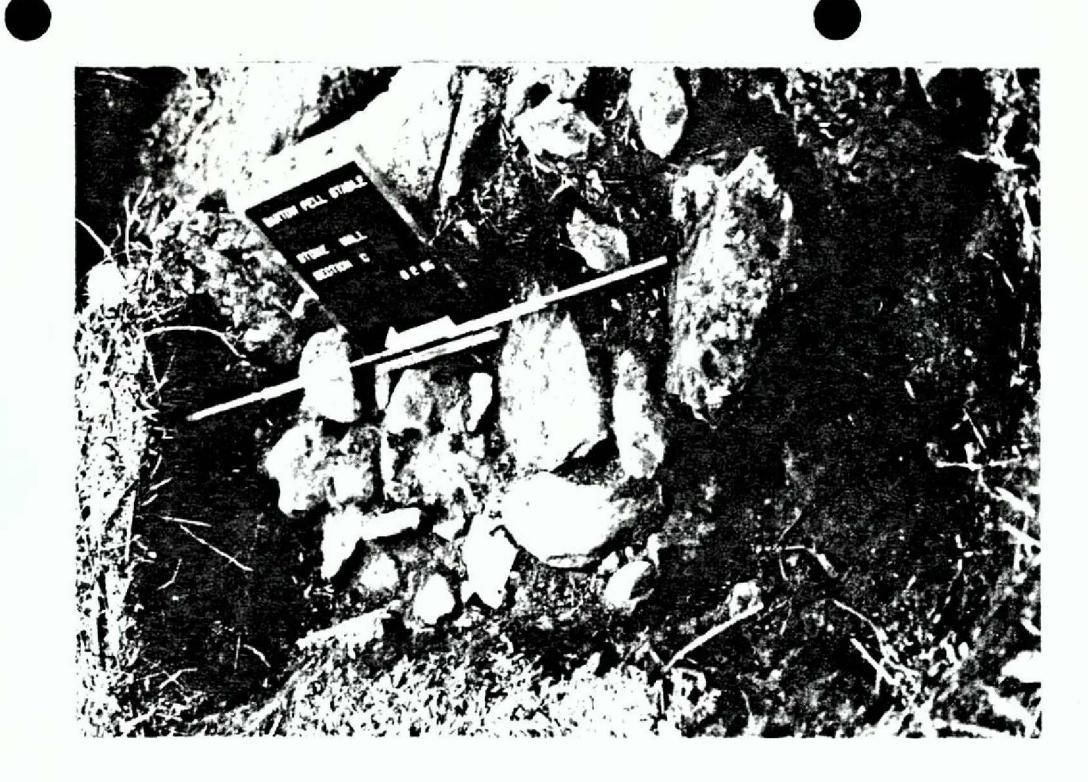
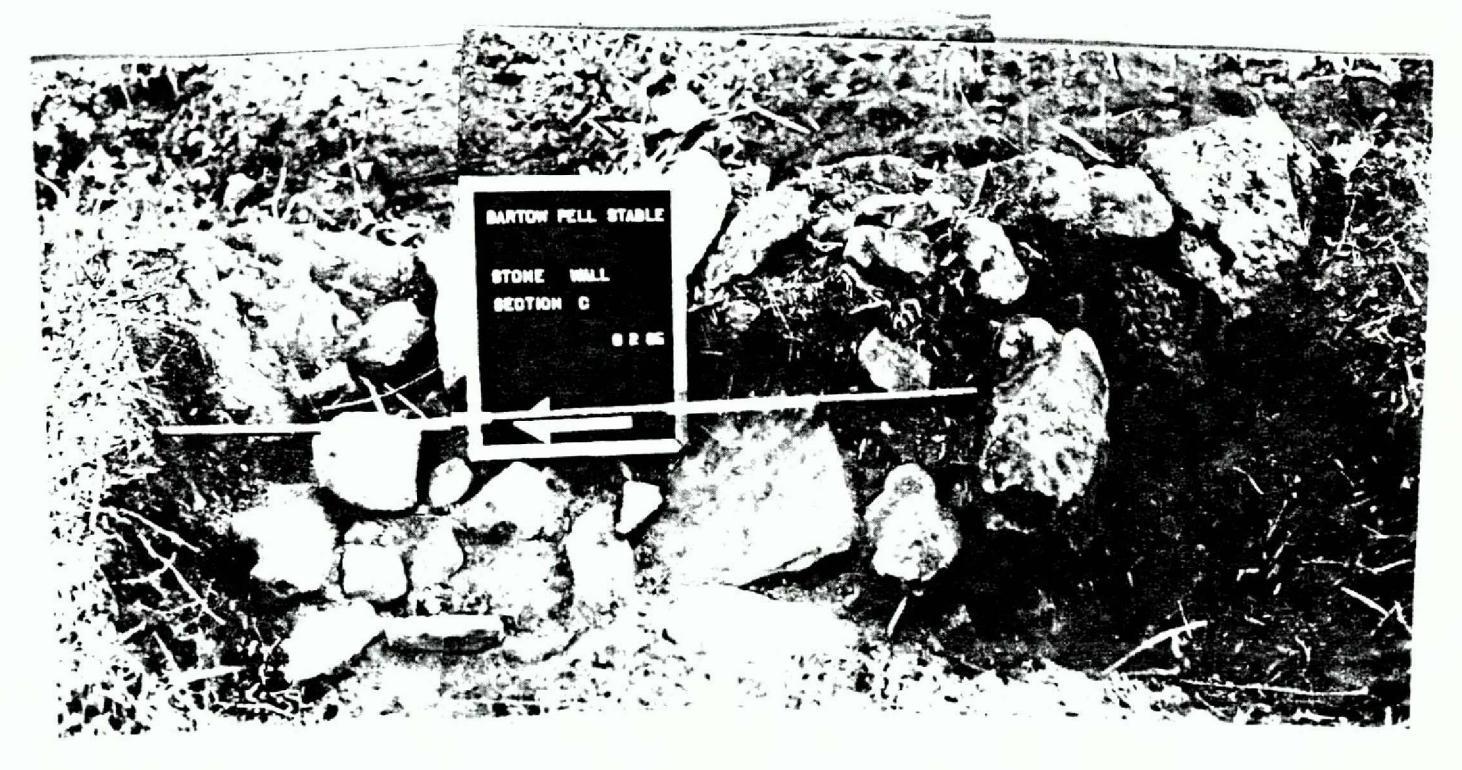
After exposing more stones for four feet along the south face of the carriage house, it was realized that what was being uncovered was the ramp built to support the drive way into the carriage house; what had been referred to as 'wall' was simply the outer face of the ramp. A unit in Area C was opened to test this theory. The test trench was four feet (E-W) by eight (N-S). (See Figure 2 and Photographs 5 and 6 ) What was found confirmed information suggesting a ramp on the 1934 topographic map, though its configuration today is somewhat different from what was shown. This difference is not surprising considering the numerous episodes of fill which obviously have taken place over time.

This portion of the ramp - along its southeast line - was either poorly constructed (see comparison with Area D which follows) to begin with or has undergone cycles of damage and repair. The entire surface is covered with dense plant growth with destructive root systems and is underlain with horse manure compost. Mixed with and under the compost is evidence of other kinds of fill, but because the stones are dry laid, loose, and have been dislodged by various forces such as heavy machinery and plant roots, all strata are hopelessly mixed. For example, a German made bisque doll's head, cl900, was found in the same level as a plastic wrapper for carrots.

- LEFT: Area C Looking northeast Photograph 5
- BELOW: Area C Looking east Photograph 6

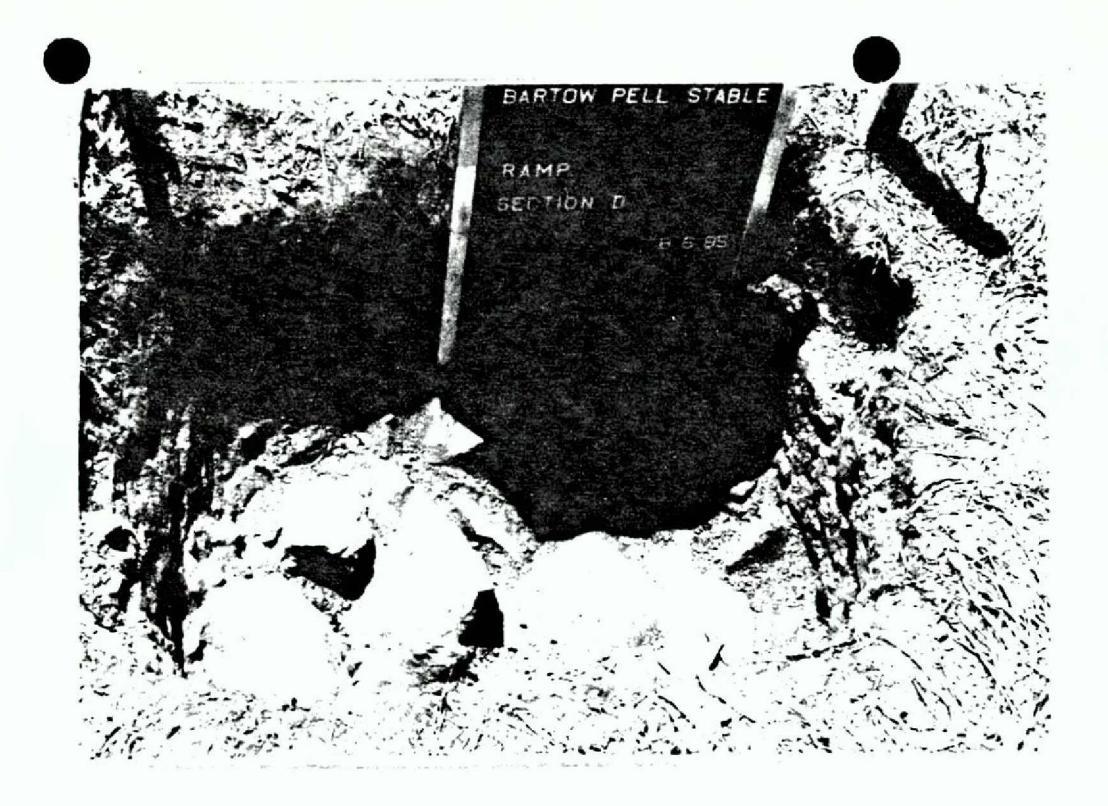
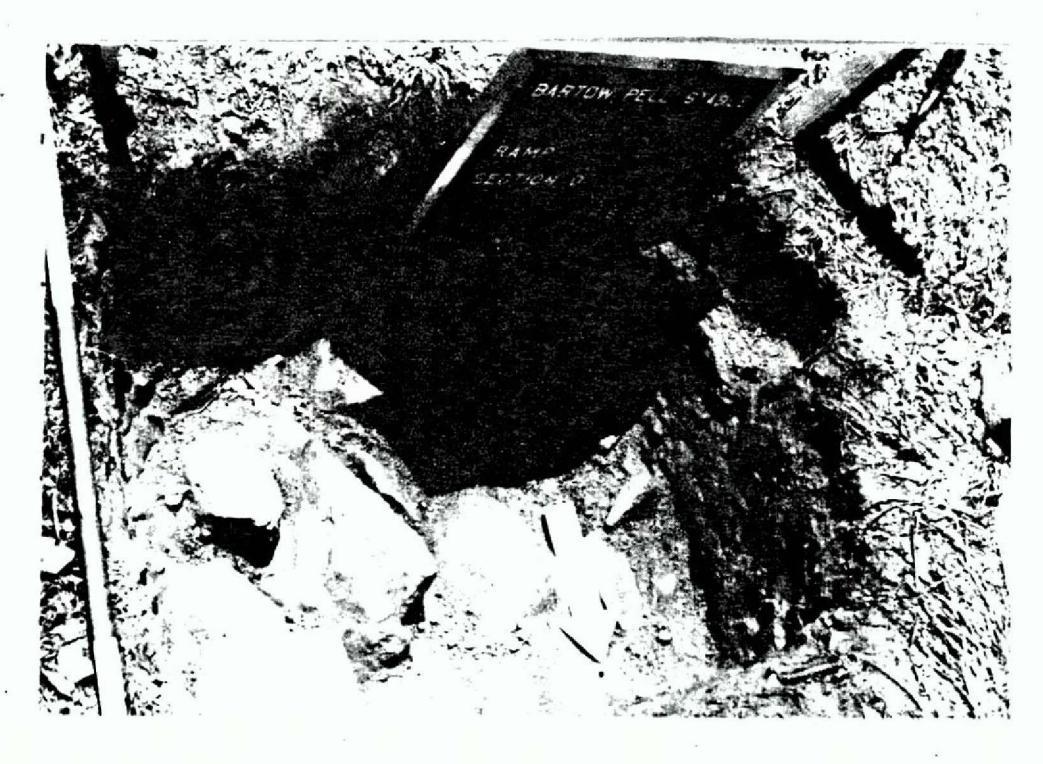
Area D was excavated to determine what the composition of the ramp was in the section which would have had to bear the most weight. It would have been surprising to find the unstable, unsafe conditions there as occur along the outer portion of the ramp, and indeed that was not the case. Instead, under a two inch cover of sod and grass there were two to four inches of densely packed traprock, 1 to 3 inches in diameter, in a thin matrix of soil and ash. Below that was a layer of orange-brown soft clayey soil. Under the clayey material, there were large stones, surrounded by the same clay, ranging in size from six to eleven inches at an average depth of 13 inches below grade. These stones, while obviously deliberately deposited, are definitely not a cobblestone pavement; they are of varying sizes and form a very irregular surface. (See Photographs 7 and 8) Material culture remains were quite **a**parse in this unit; two ceramic sherds, one nail and a piece of coal were retrieved.

Area D Looking South Photograph 7

Area D Looking South Photograph 8

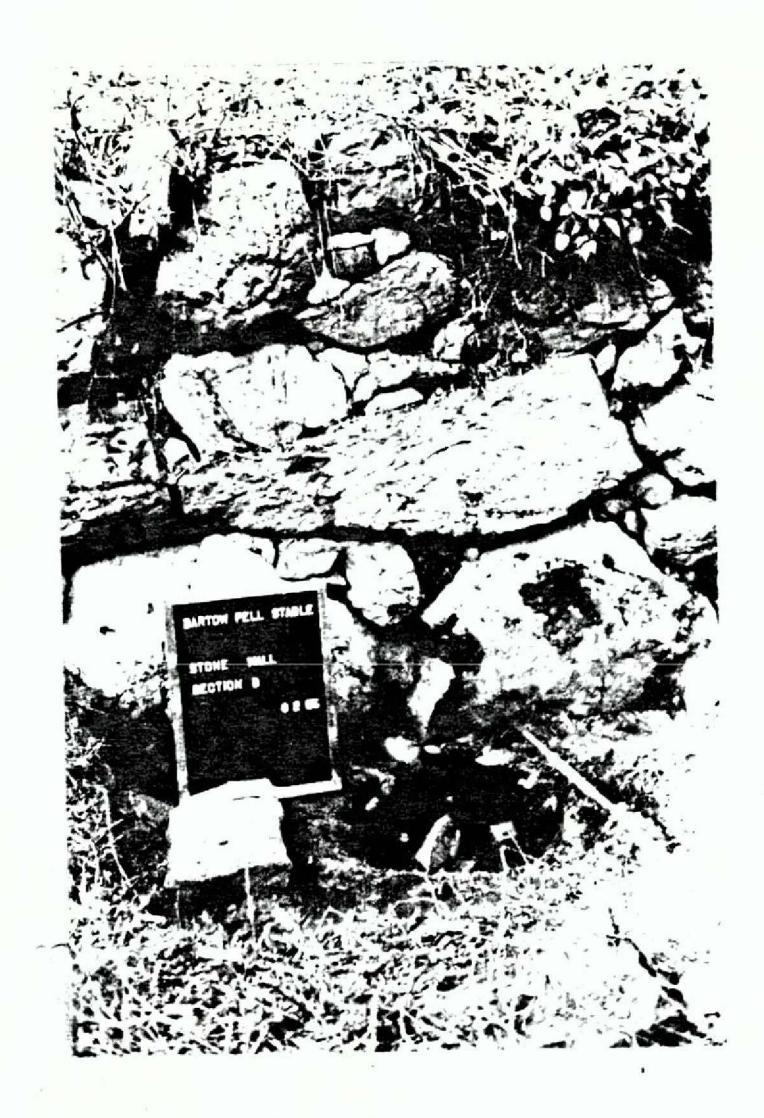
Even at a depth of five feet below the grade level of the ramp leading to the carriage house, the Area B test trench was considerably above the existing grade level outside the cellar entrances which presumably is close to the original grade along side the stone wall. Therefore, a shovel probe of ten inches depth was dug in the test unit to see if the same fill layer continued, which was the case. (See Photographs 11 and 12) It is concluded that if desired to recreate the style of the original carriage house area, the east face of the stone retaining wall may be exposed to a depth of no more than five and a half feet below the top of the wall (i.e. 119 inches below datum plane). Mechanical equipment might be cautiously used because the original surface/builder's trench is secure beneath later fill and large stones that could have originally been part of upper courses of the wall. One of these stones is visible in Photographs 11 and 12.

Area B Looking West Photographs 11 and 12

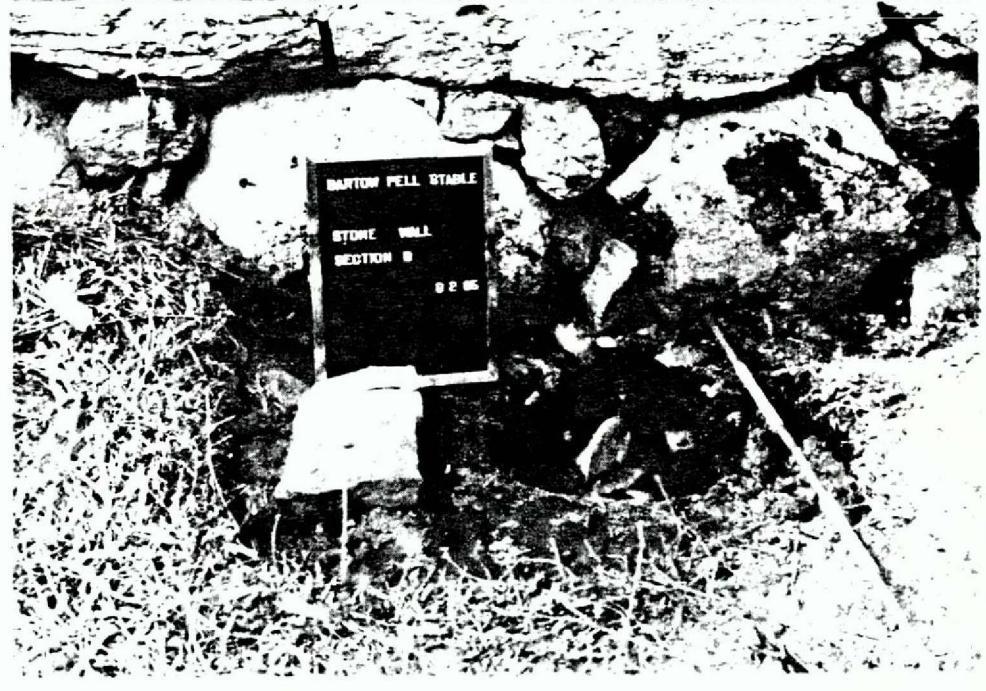
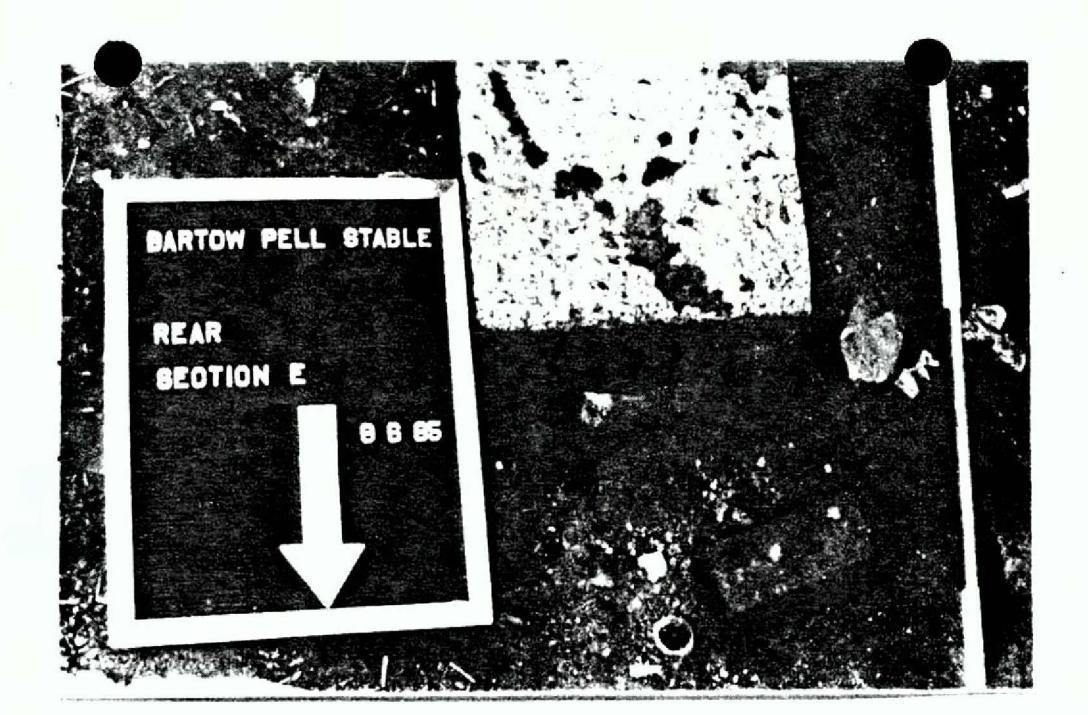
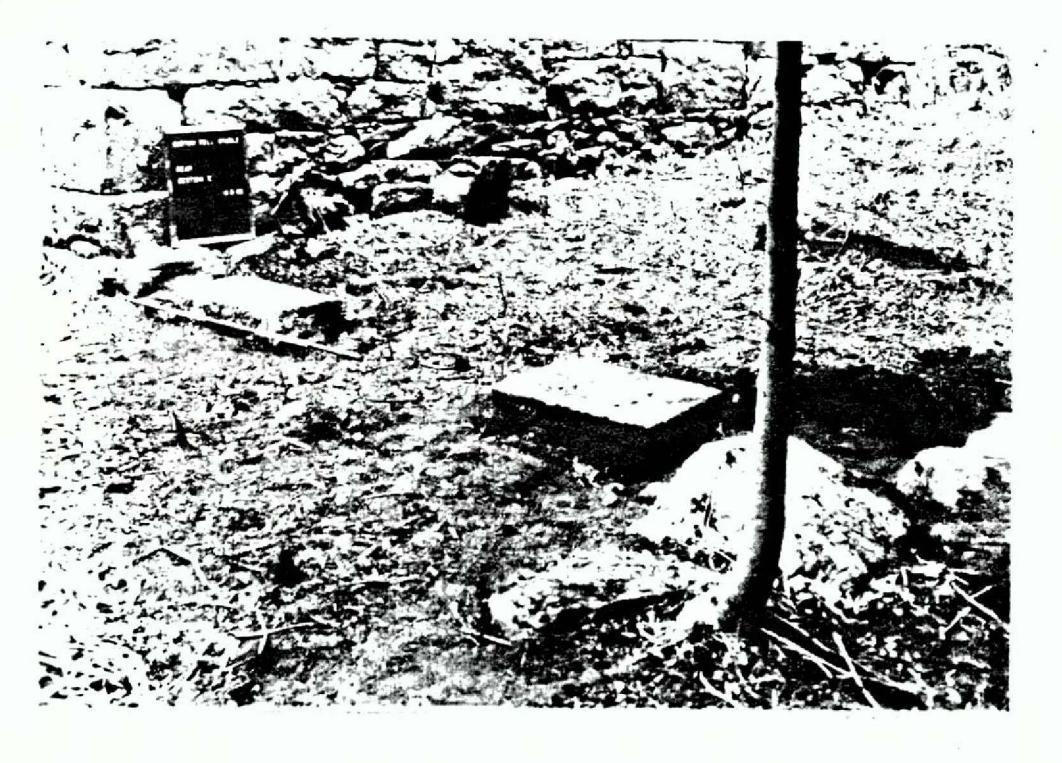
Frank Matero, one of the preservation consultants who prepared the Historic Structure Report of 1980, pointed out the location of what he thought to be a possible stoneplinthed pen at the northeast corner of the carriage house. Therefore, a large area (Area E, See Figure <sup>3</sup>) was cleared in order to find whatever pattern might exist. Two large fine quality, dressed granite slabs in line with the eastern wall of the building were uncovered. Excavation around these two blocks revealed brick and twentieth century glass sherds, coal, brick, and mortar. Photograph 13 is a close-up view of these in situ artifacts. See also Photographs 14 and 15. Mortar affixed on the corner of the southernmost granite block implied it had been placed here after original use somewhere else, which the findly dressed condition would seem to corroborate. Also, there is no evidence of any form of fencing being attached to either of the blocks. Exposure of other stones of many sizes and shapes extending westward behind the carriage house suggested that they were placed randomly rather than in a pattern. They were perhaps used to facilitate drainage rather than as a formal path or fencing arrangement.

Area E LEFT TOP: Close-up from above Photograph 13 LEFT BOTTOM: Looking Southwest Photograph 14 BELOW: Looking South Photograph 15

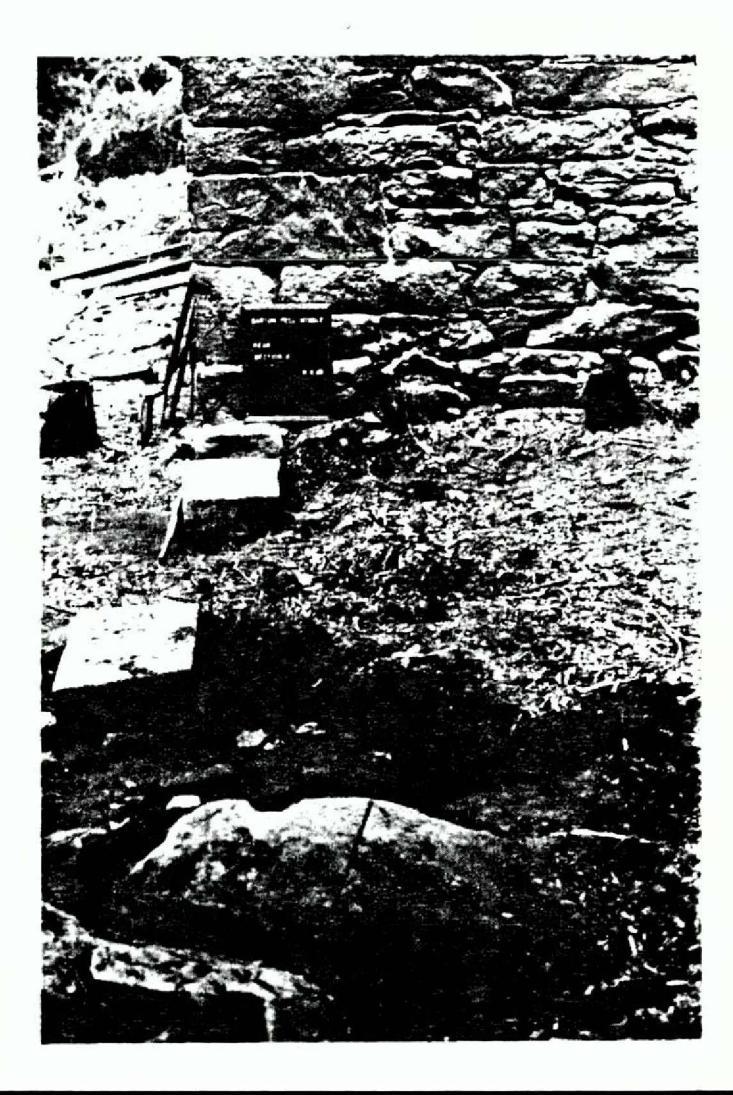
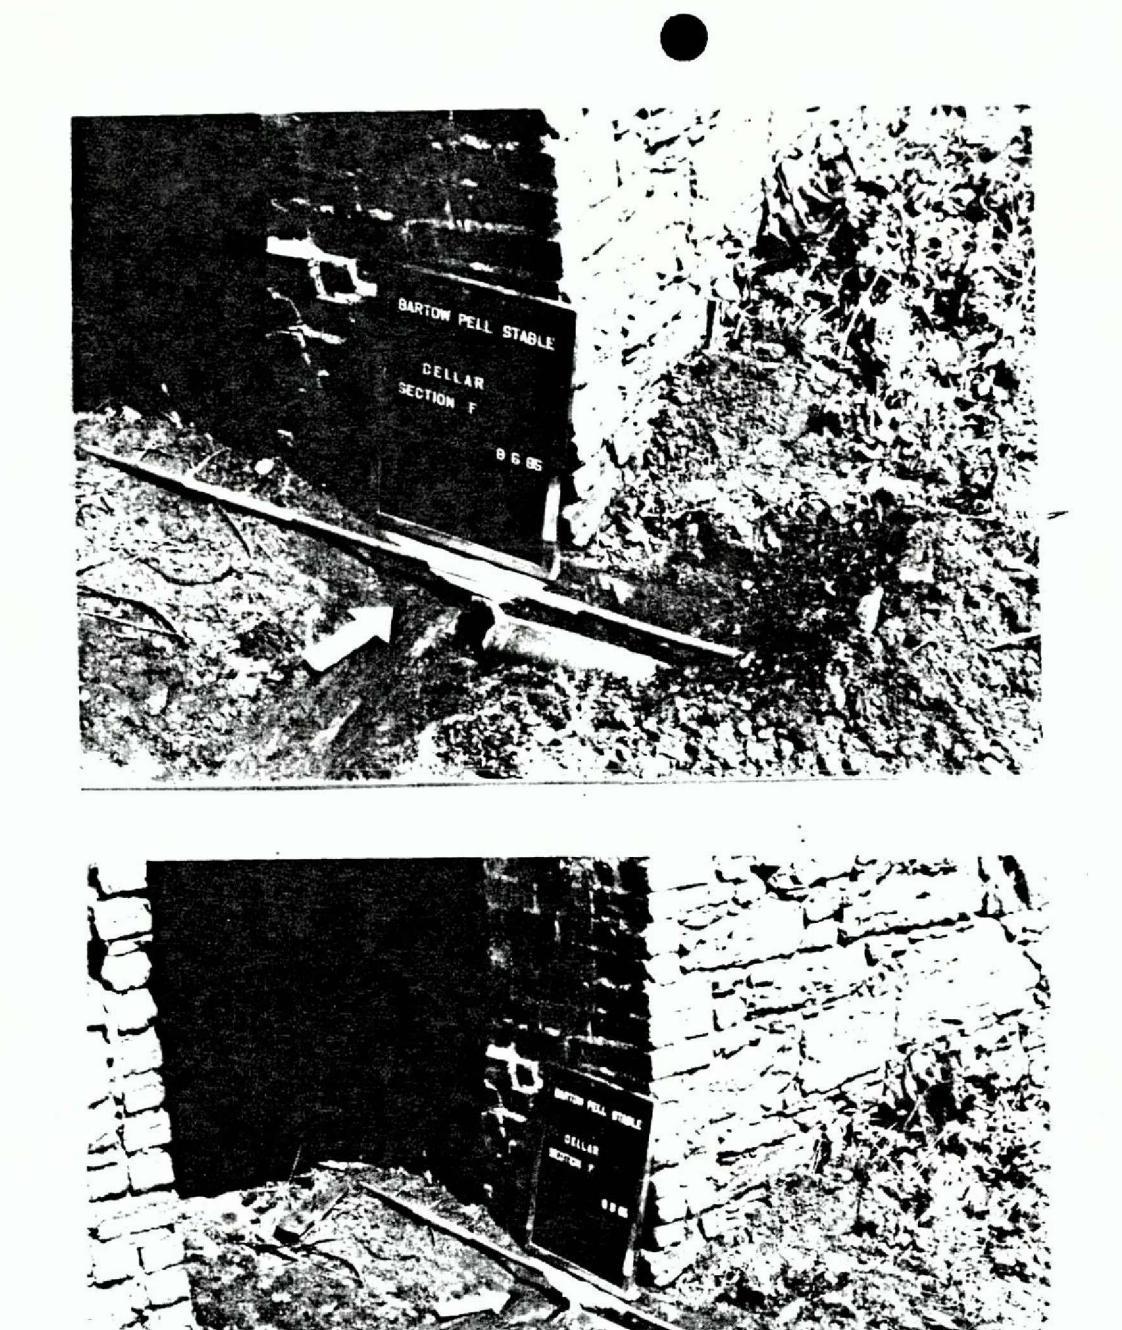
Informant Leo Megio noticed that in times of heavy rainfall the floor of cobbles and flattish stones in the northern section of the basement - which slopes from west to east - served as a kind of drain. He recalled that at one time the basement door sills were lower than now and that the large flat stones continued outside the building. A confirmation of this continuing problem with water run-off was discovered by Ted Ewen during some of his masonry restoration activities. He called attention to the drain pipe which he saw outside the door of the southern section of the cellar. The feature was exposed further, along with the wooden members running perpendicular to and under the pipe, and photographed as Area F. (See Figure 1 and Photographs 16 and 17.)

Area F Looking Northwest Photographs 16 and 17

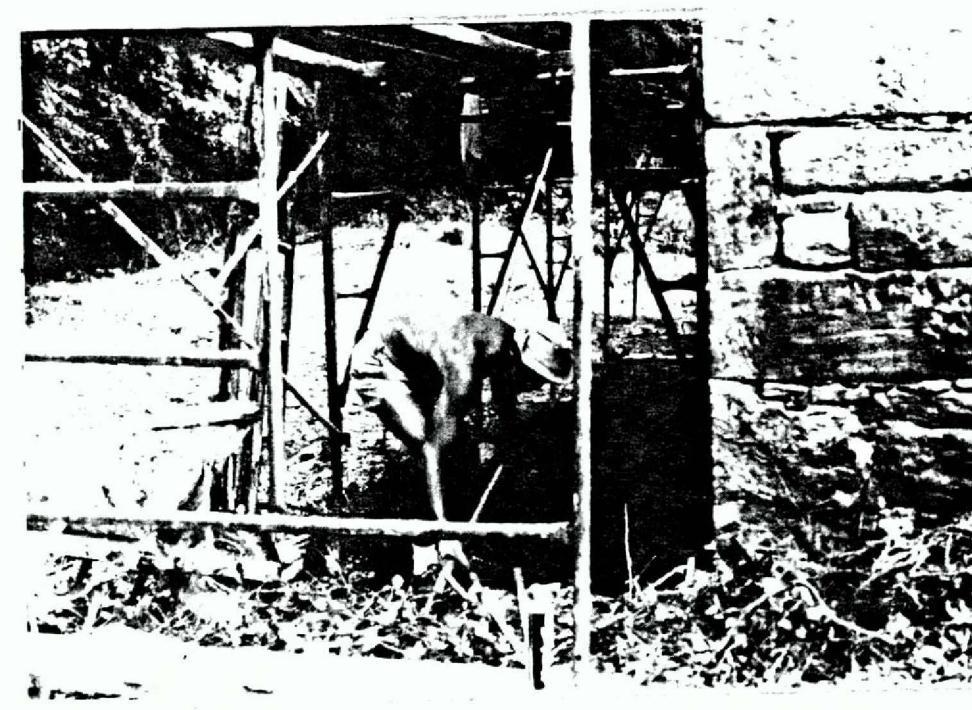
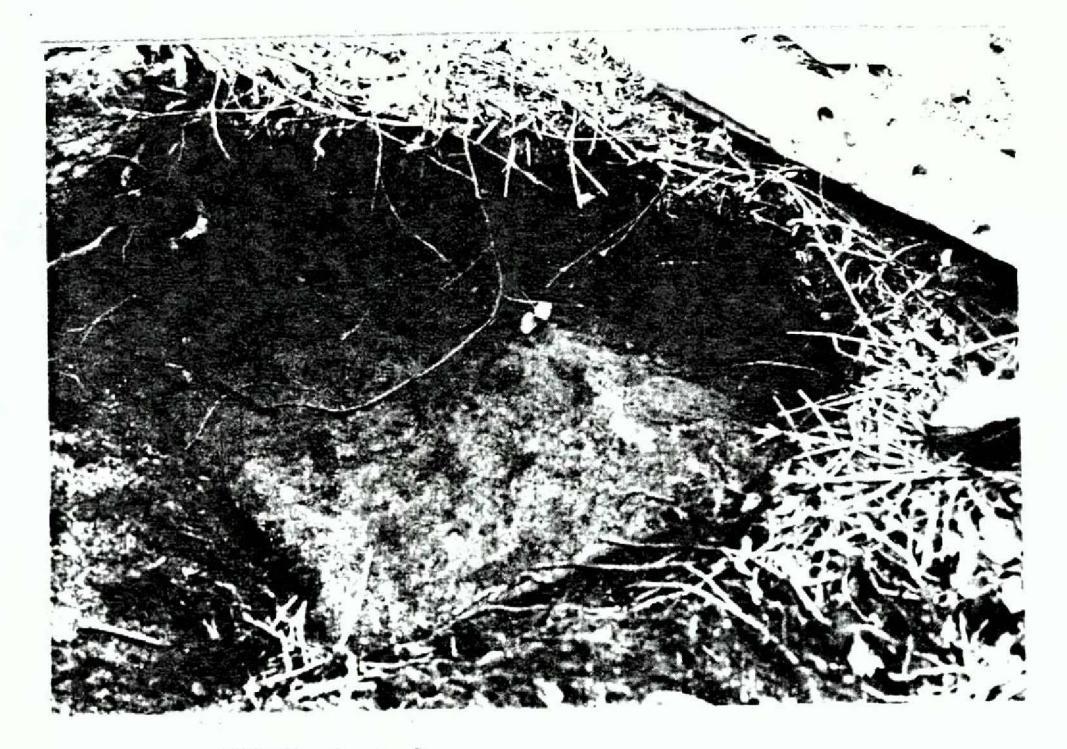
What is apparently a natural rock outcropping was found at the southwest corner of the carriage house. (See Photographs 22 and 23) It begins 8 inches west of the southwest corner of the building and extends 32 inches directly west and at least 42 inches south - the southern extremity could not be uncovered because of the scaffolding. The northwest corner of the rock may have been dressed, but the surface is uneven and there is no indication of anything having affixed to it.

ABOVE: Area J Close-up of rock outcropping Looking Southeast Photograph 22

RIGHT: Area J Looking Southeast Photograph 23
