FINAL REPORT

UNDERWATER INSPECTION OF TARGETS BORROW AREA 2 ATLANTIC COAST OF LONG ISLAND EAST ROCKAWAY INLET TO ROCKAWAY INLET QUEENS COUNTY, NEW YORK STORM DAMAGE REDUCTION PROJECT

Prepared for: Environmental Analysis Section U.S. Army Corps of Engineers, New York District 26 Federal Plaza • New York, New York 10278

September 2003

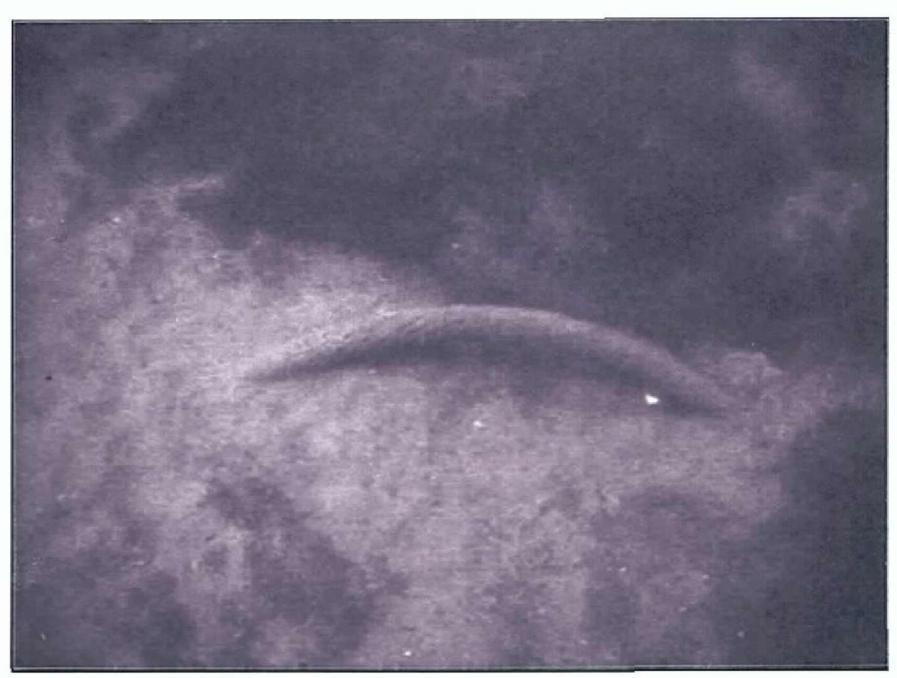
Diver investigation of the target site identified the source of the as three anomaly exposed sections of 2.5 inch diameter armored cable protruding from the sea bed (Figure 19). Each exposed section of cable was approximately 2 to 7.5 feet in length. The cable appears to be heavily-armored, likely associated with a telephone/telegraph line. Exposure of the cable is likely due to active trawling in the area or snagging by anchors. The diver placed a refinement buoy for exact positioning which was shot in with the DGPS before leaving the

Figure 19. Exposed section of 2.5 inch-diameter armored cable identified as Target 1.

site. The cable was recorded with an underwater video camera. Side-scan sonar investigation of the area did not indicate any exposed sections of the cable. This site is not considered significant.

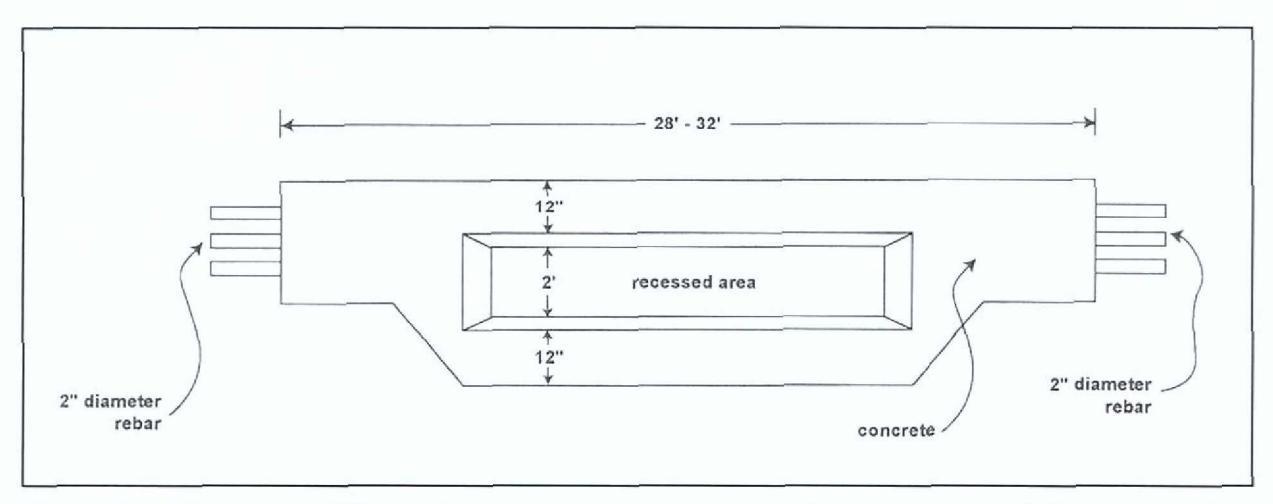
Figure 25. This drawing of Target 4 represents a close approximation (not to scale) of the concrete/rebar bridge spans identified throughout the project area during the current investigations.

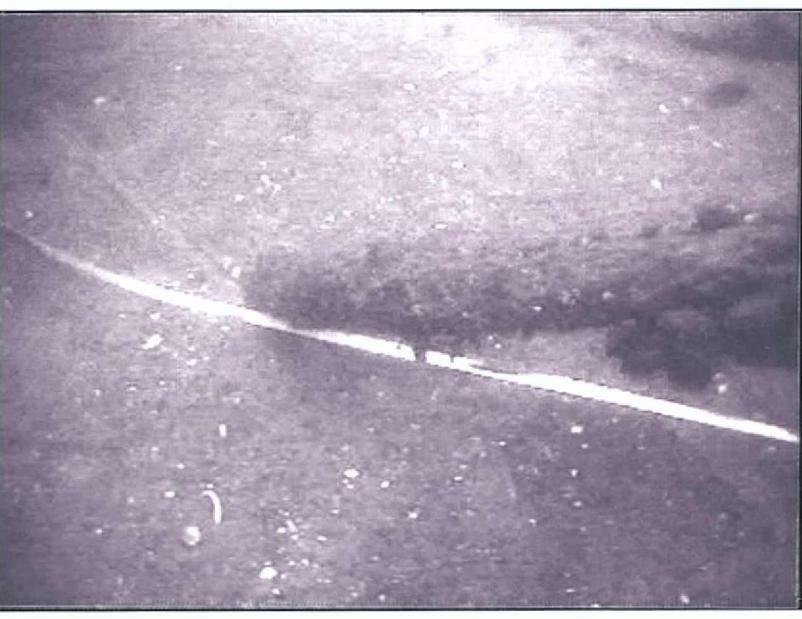
off the bottom approximately Figure 28. Underwater video image of Target 5.

of seven feet. It appears that a dragged anchor is the cause of this portion of cable being exposed.

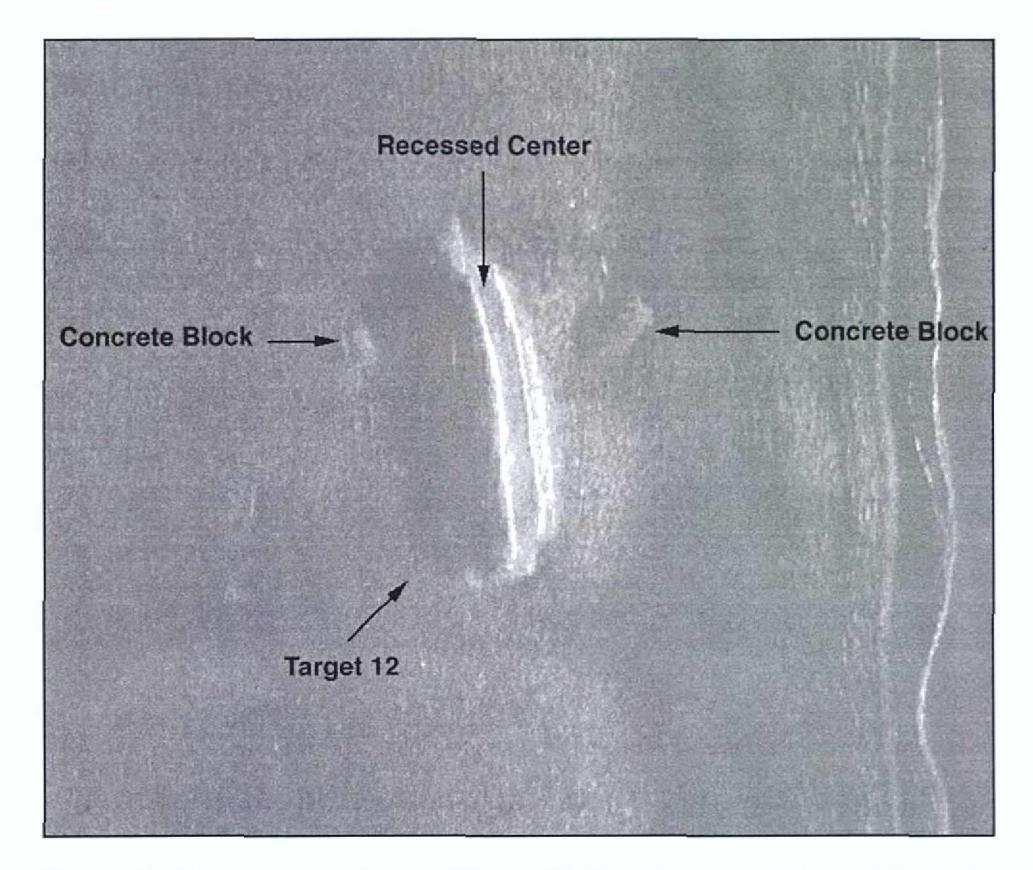
Figure 41. Side-scan sonar image of Target 12. Note the general shape of the bridge span as well as the recessed center and the smaller associated blocks of concrete.

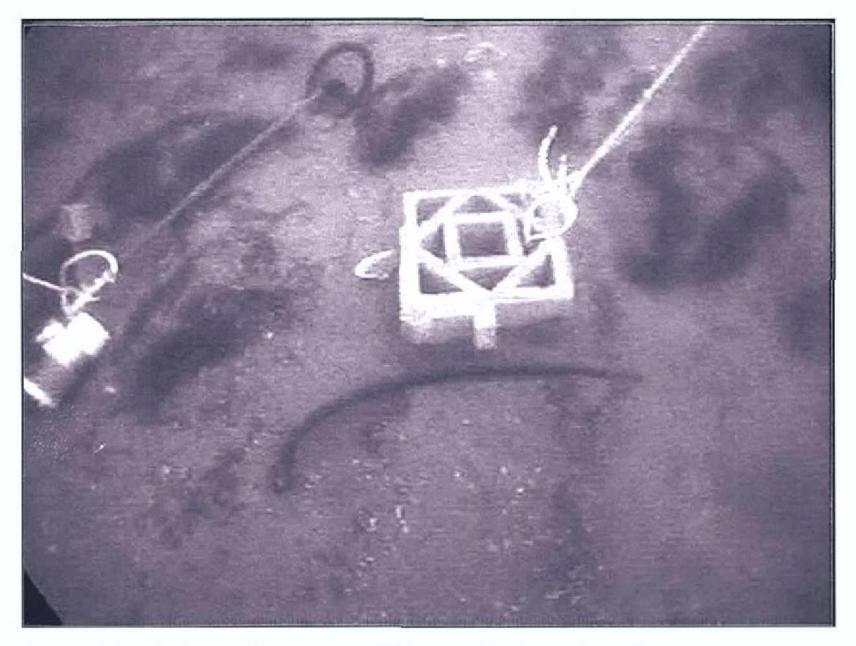
Figure 60. Underwater image of Target 25. Note the Fisher underwater metal detector and refinement buoy next to the exposed cable.

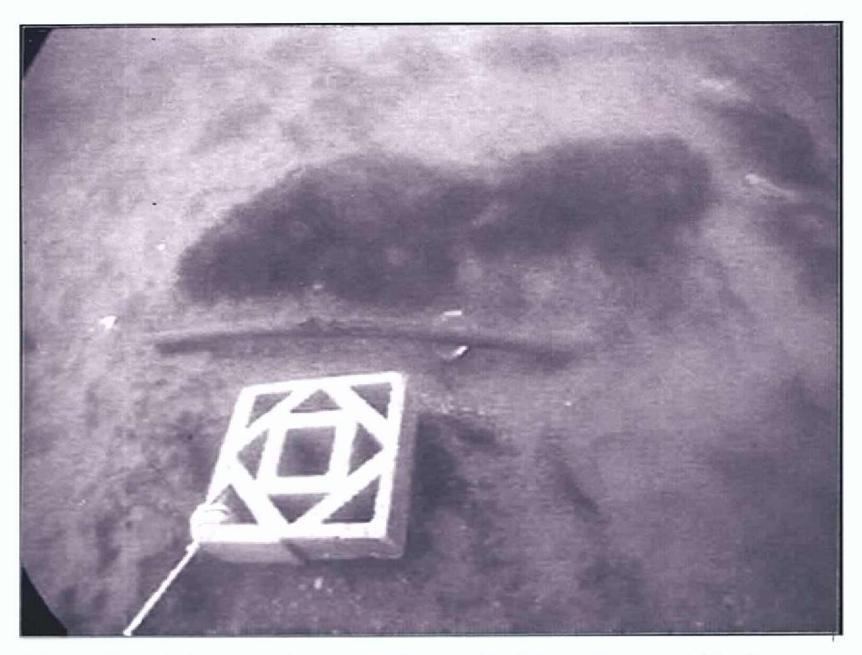
Figure 64. Underwater image of Target 28. The refinement block next to the exposed cable is 12 inches square for reference.
