PHASE IB ARCHAEOLOGICAL INVESTIGATION
OF THE
ALLENTOWN LANE PORTION OF THE
CHARLESTON BUS ANNEX - STORMWATER SEWER PROJECT
CHARLESTON, RICHMOND COUNTY, NEW YORK

Eugene J. Boesch Ph.D., R.P.A.
Principal Investigator

June 14, 2007

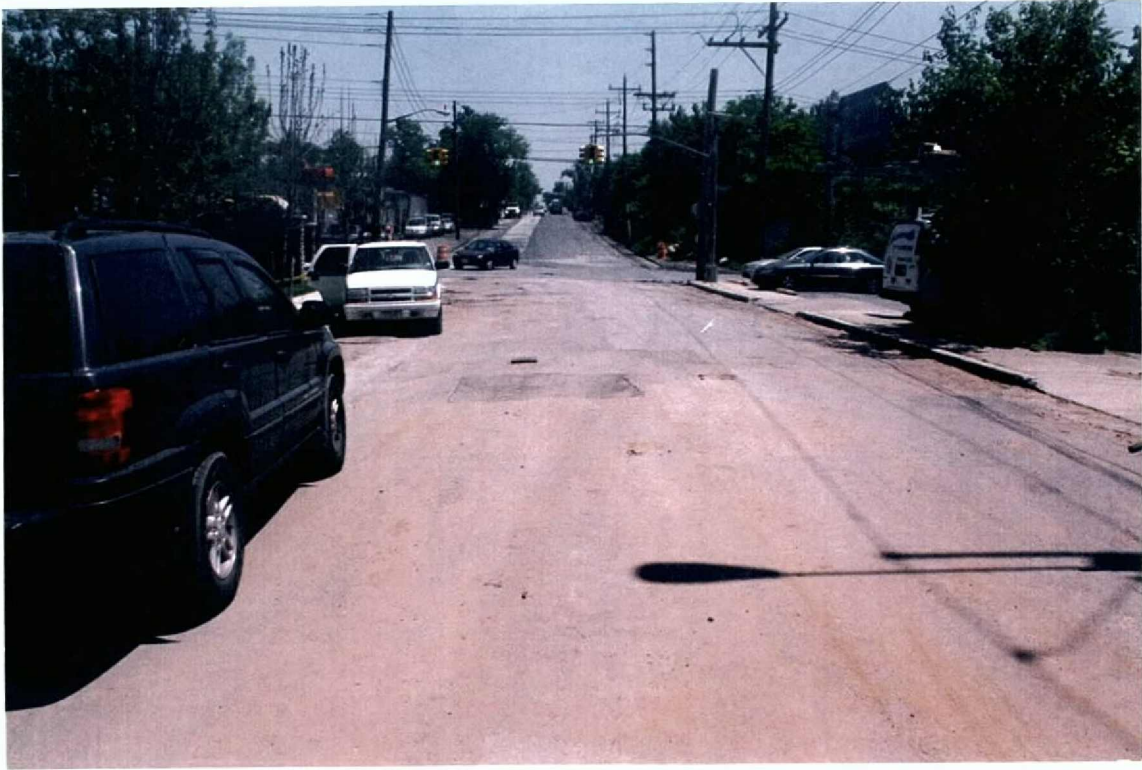
Photograph 1
Allentown Lane (Foreground): View is to the East Towards Arthur Kill Road

Allentown Lane extends westward from Arthur Kill Road for approximately 255 meters (840 feet; Photographs 1 and 2). The road is paved with curbs along its north and south sides. A sidewalk extends down its northern side and borders its western end adjacent to the slope leading to the Arthur Kill. A buried water main extends down the center of Allentown Lane (see above) with lateral connections leading to fire hydrants along its north side. An existing sewer line extends east to west south of Allentown Lane. Construction of Allentown Lane apparently included grading for the roadbed, in places cutting substantially below the surrounding grade. The extent of the cutting of the roadbed increases as one moves west along the Lane from Arthur Kill Road. At Arthur Kill Road, Allentown Lane and the surround terrain are at roughly the same elevation (Photograph 1). The road's elevation decreases gradually relative to the surrounding terrain due to grading as one moves west along Allentown Lane with the western most approximately one third of the Lane having been substantially cut and recessed by over 1.1 meters (four feet) into the surrounding landscape (Photograph 3).

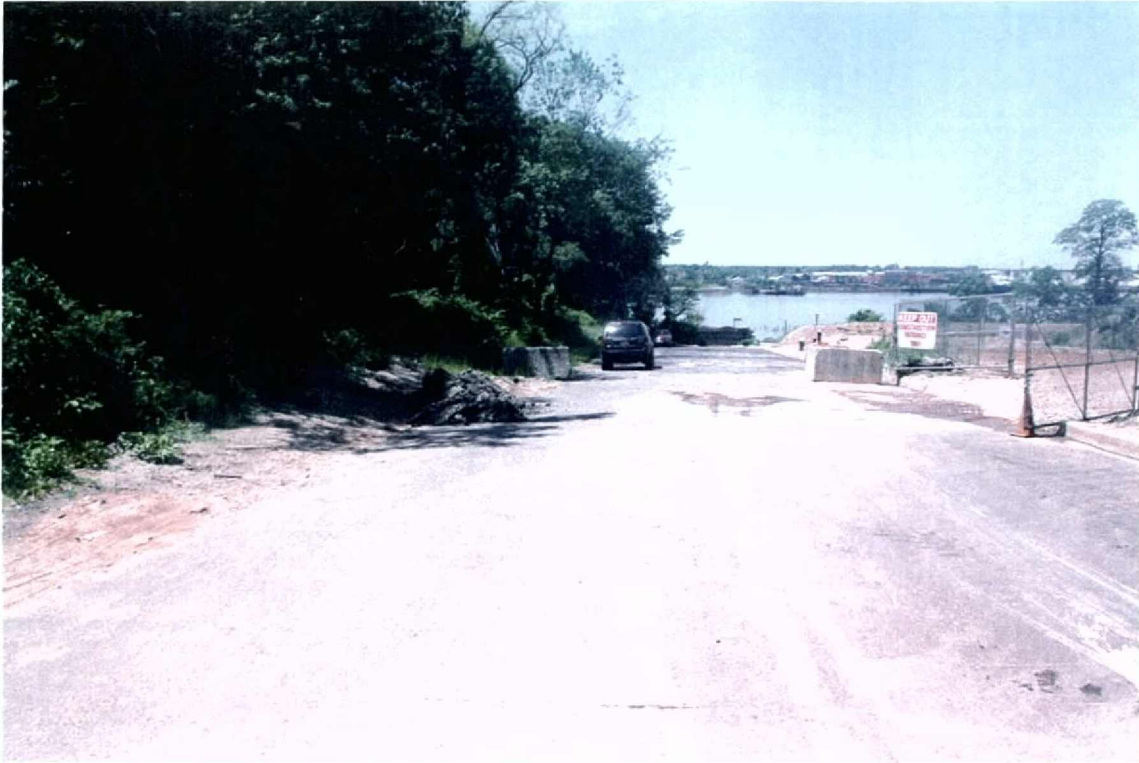
Photograph 2
Allentown Lane: View is to the West Towards the Arthur Kill

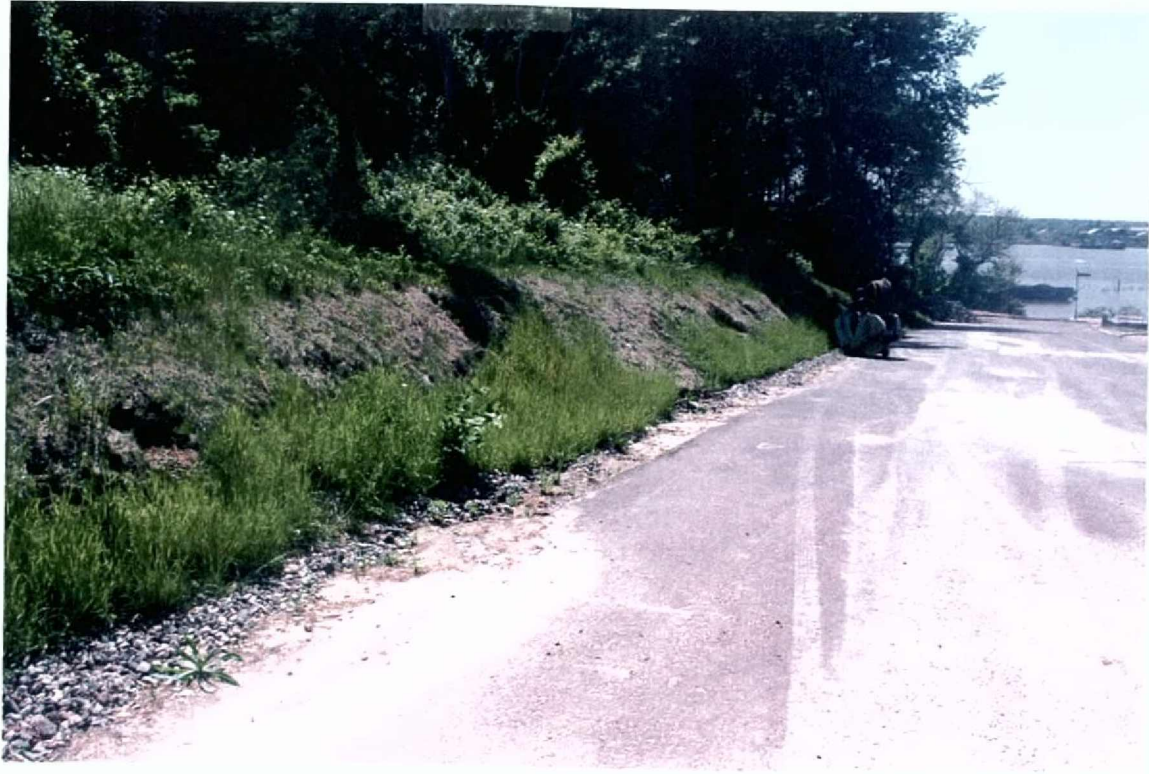
Photograph 3
View to West Along Allentown Lane Showing Extent of Grading and
Height of Adjoining Ground to the South

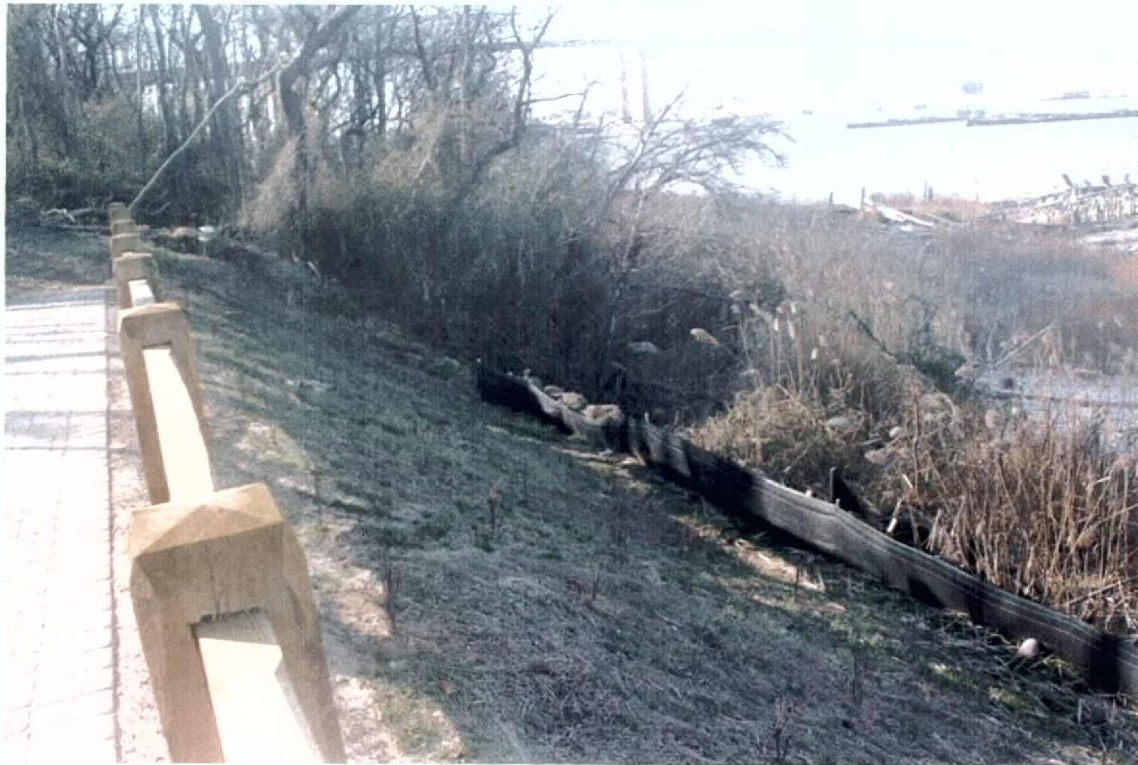
Photograph 4
Steeply Sloping Ground West Of Allentown Lane – View is to the Southwest

West of Allentown Lane and the bordering sidewalk is the steeply sloping ground that leads to the Arthur Kill (Photograph 4). The APE along the slope is approximately nine by nine meters (30 by 30 feet) in size. The slope decreases in elevation by approximately four meters (14 feet) from east to west over that distance. The slope extends from a recently constructed sidewalk west of Allentown Lane to a salt marsh bordering a section of mud flat along the Arthur Kill (Photograph 5). The slope, as well as a portion of the salt marsh, has been filled. Recent landscaping along the length of the slope has included the planting of small shrubs.

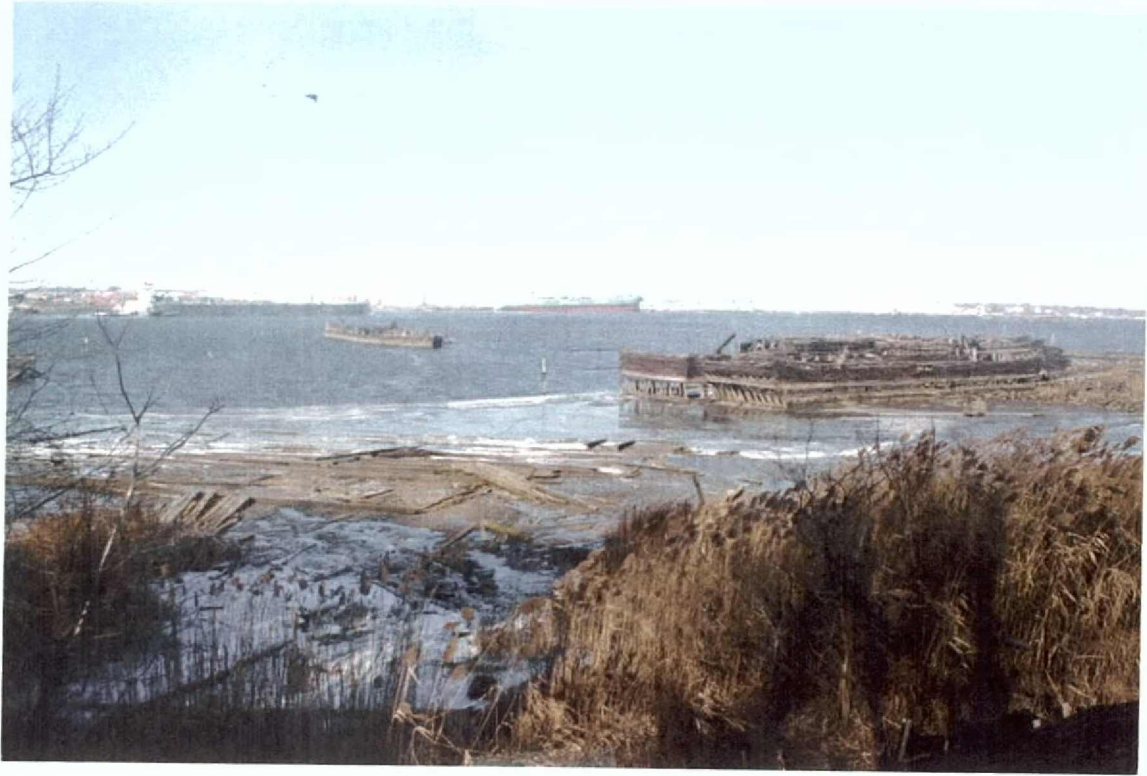
Photograph 5
Salt Marsh Along Shoreline of the Arthur Kill – View is to the Northwest

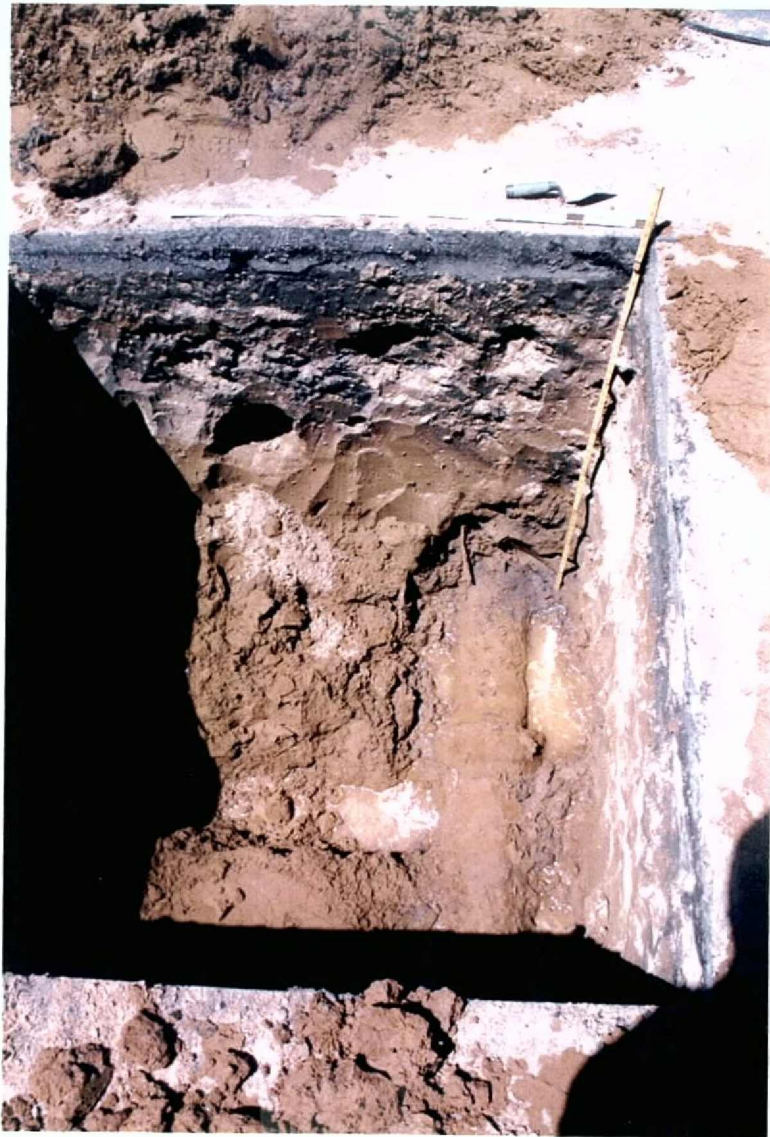
Photograph 6
Test Pit A – North Wall Profile; Water Main on North Side (Right) at Base of Test Pit

In addition to the shovel tests, one project construction related test pit (Test Pit A) was archaeologically monitored as it was manually excavated by construction workers (Figure 2). The encountered stratigraphy was recorded (see Figure 3, Photograph 6, and Appendix A).
