Phase 1B Archaeological Testing Report

New York City Wireless Network (NYCWiN)

Site SI-007B:

4414 Arthur Kill Road

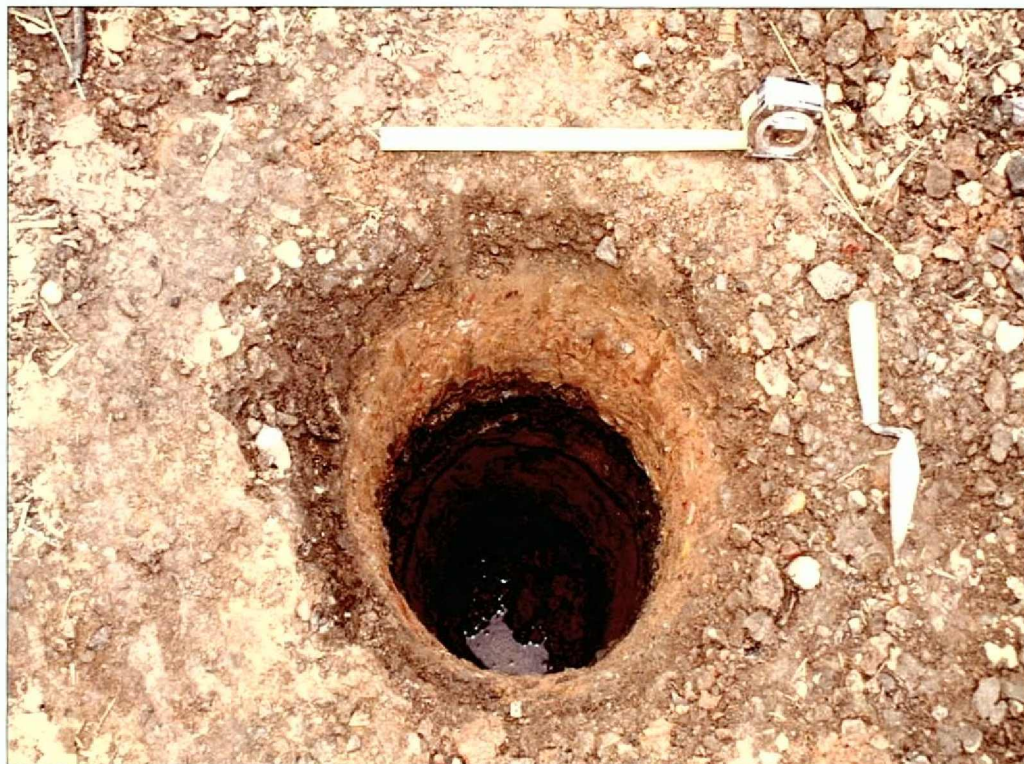
STP1, showing groundwater accumulation at bottom

Level #	Depth Below Ground Surface (inches)	Soil Classification	Color	Remarks
1	0 to 4	Large heavy gravel with silty sand	10 YR 3/3: Dark Brown	Fill containing modern artifacts.
2	4 to 13	Very dense compact sandy silty clay	7.5 YR 4/4: Very Dark Gray	Disturbed fill containing modern artifacts.
3	13 to 20	Sandy silty clay containing a large quantity of gravel	10 YR 3/1: Very Dark Gray	Fill containing modern artifacts; possibly represents an older driveway surface.
4	20 to 22	Silty loam	10 YR 2/2: Very Dark Brown	Disturbed remnant of possible original ground surface; contained roots.
5	22 to 30	Silty clayey loam	7.5 YR 4/3: Brown	Clayey subsoil.
6	30 to 36	Very wet silty loam	10 YR 4/2: Dark Grayish Brown	Clayey subsoil.
7	36 to 40	Sandy loam	10 YR 5/3: Brown	Clayey subsoil, groundwater accumulated at bottom (see Figure 3).

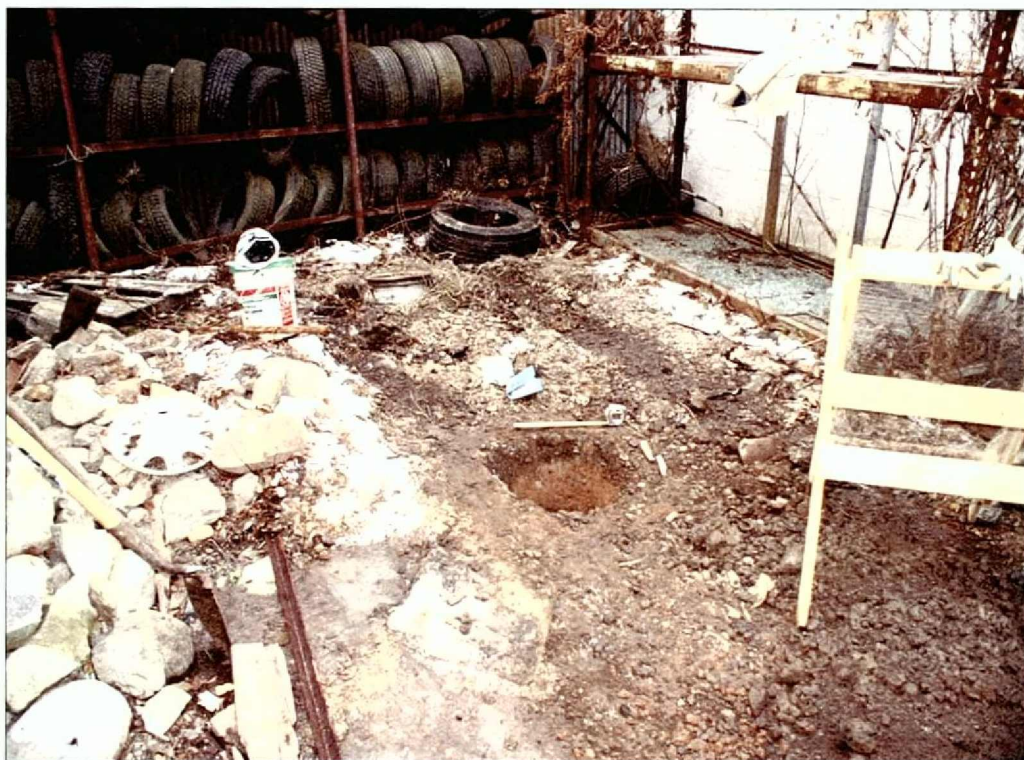
2

STP1 and southern portion of project area, looking southwest

Level 4 of STP1 appeared to represent the original ground surface, although it was disturbed. The approximately seven inch thick level immediately above it (Level 3) was mostly composed of large pieces of gravel, which appears to have been part of a former driveway surface. Virgin subsoil was identified beginning with Level 5. It is possible that this area had been graded in association with the construction of the gravel drive and was later re-covered with fill or was covered with naturally accumulating sediments and debris over time. It is also possible that this area was disturbed during the construction of the garage bordering the western end of the project site. The garage appears to have been constructed in an area that was graded significantly. While STP1 was located more than 10 feet to the east of the garage, well outside of the area which was visibly graded, it is possible that additional disturbance in this area could have occurred as a result of the garage's construction. Photographs of STP1 can be seen in Figure 3.
