Archaeological Monitoring Report  
Red Hook Water Pollution Control Plant System Upgrade  
Brooklyn, Kings County, New York City, New York

January 2008

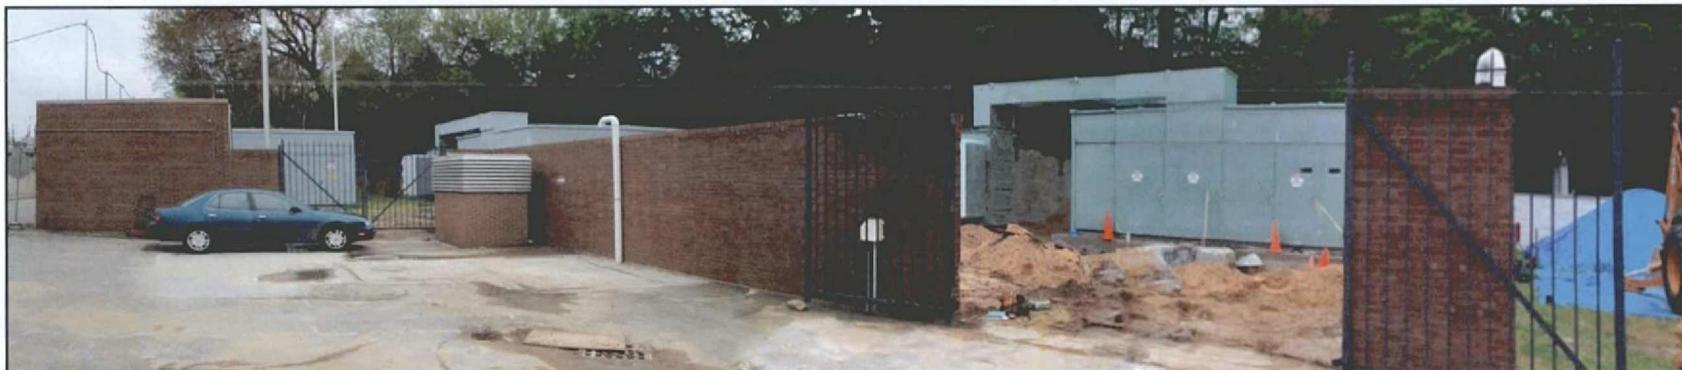
**Photo 1.** Panoramic view of the Red Hook WPCP substation during system upgrade, facing southwest. Note the existing generator and switching equipment.

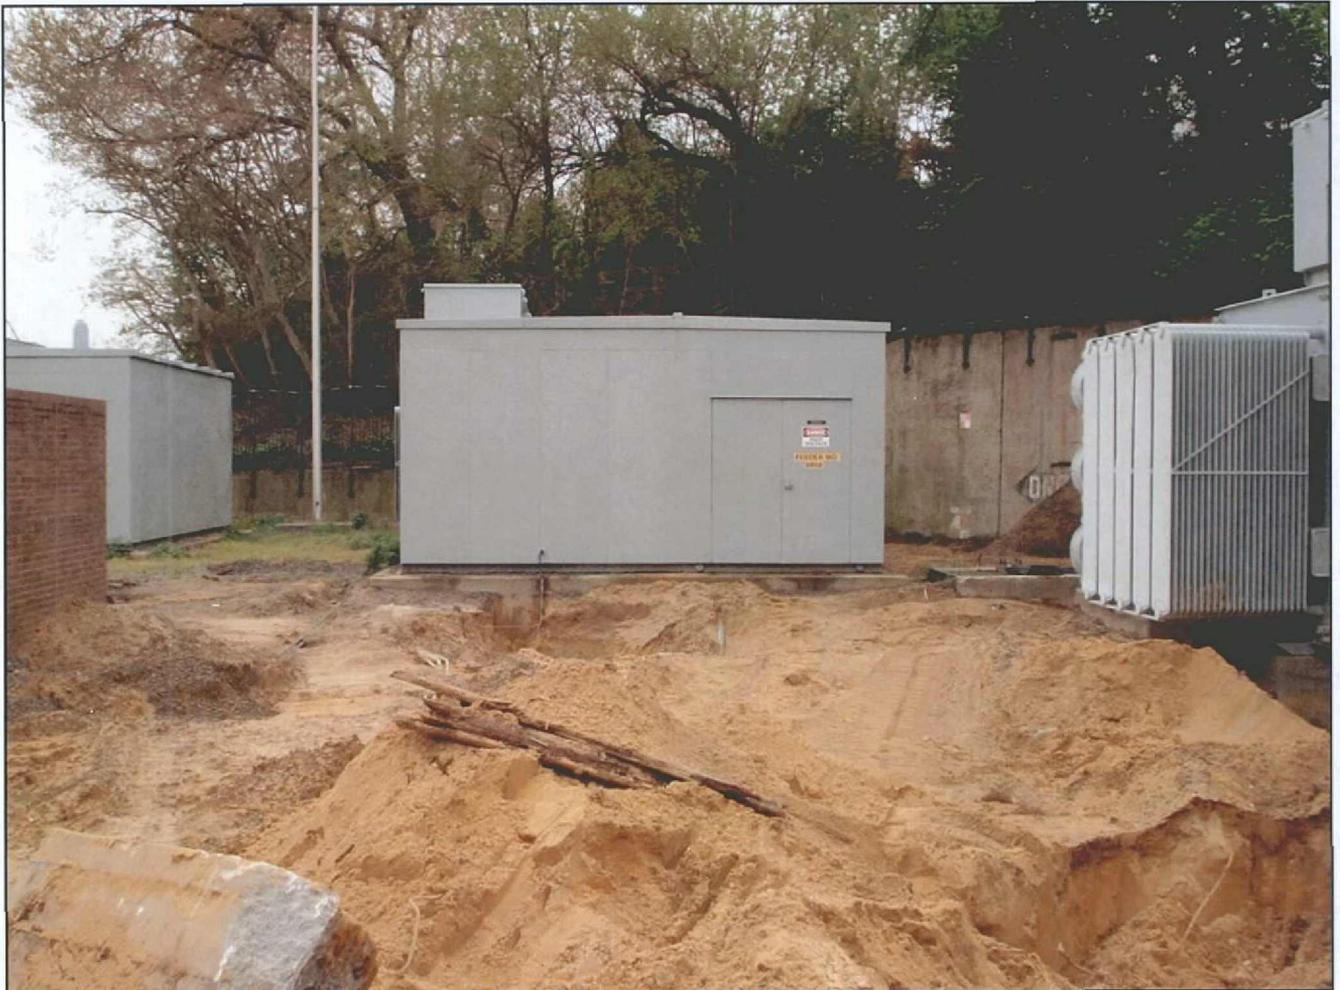
Monitoring fieldwork confirmed that the original construction of the WPCP substation during the 1980s resulted in significant ground disturbance (Photo 2). The large concrete foundations that currently support the existing generators and switching equipment extend at least 4 feet (1.2 m) beneath the modern ground surface, and the tops of metal conduits were visible beneath these foundations (Photos 3 and 5). The concrete foundations rest on treated wood pilings. This subsurface disturbance was documented in the WPCP substation as-built drawings, and confirmed by field monitoring (NYPA 2006). Based on the information compiled in the previous Phase IA report and the archaeological field monitoring, subsurface disturbance appears to extend to a minimum depth of 6 feet (1.8 m) beneath the modern ground surface for the entire extent of the APE (NYPA 2006). Ground disturbance appears to extend to a maximum depth of 8 feet (2.4 m) in some areas.

Photo 2. General view of construction activities within the APE, facing south. Note the concrete and wooden construction debris from the original 1980s construction of the substation present in the fill.

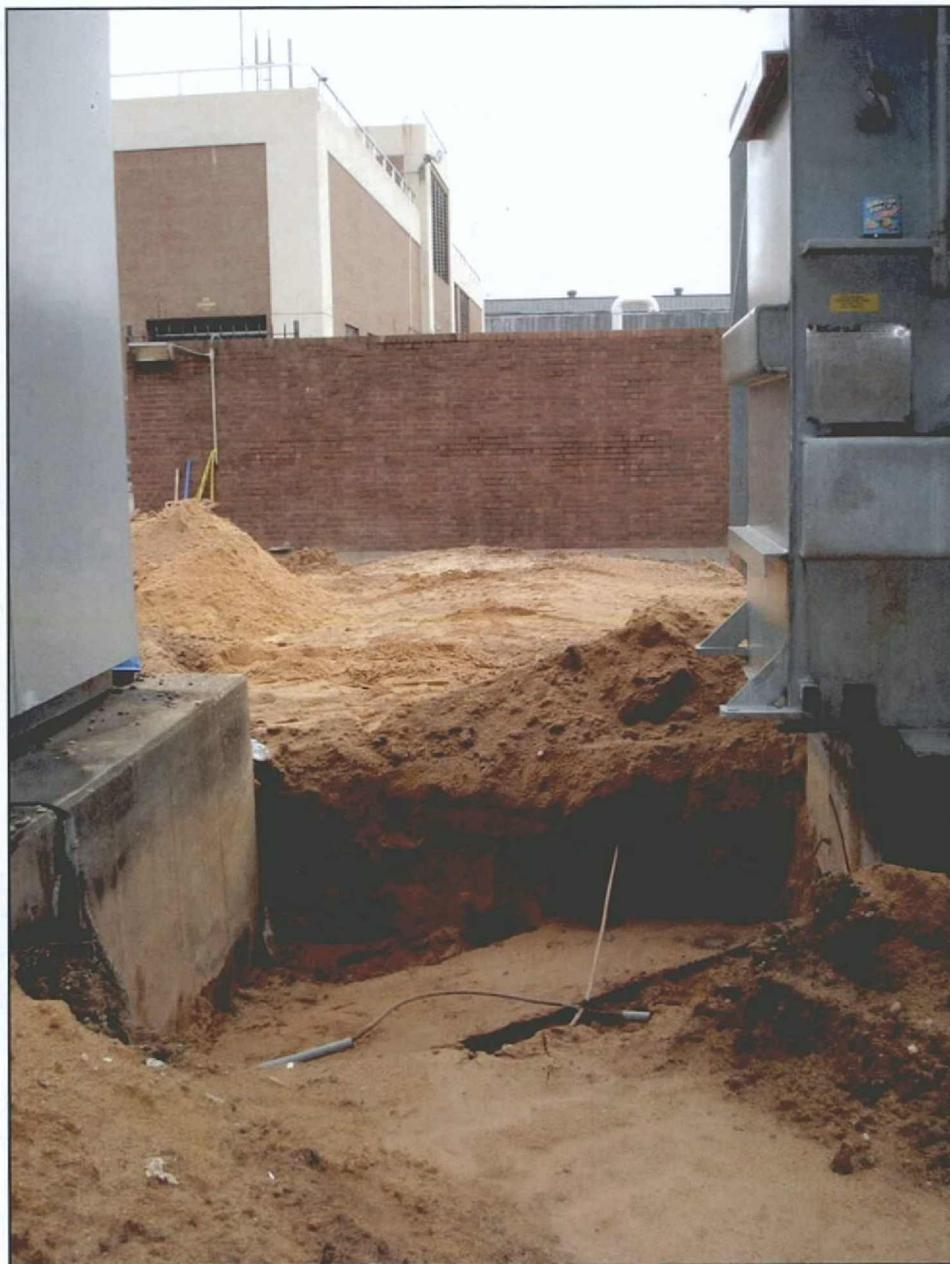
**Photo 3. Detail of construction disturbance within the APE, facing east. The foundations of the existing generating and switching equipment at the site are visible, and the surface of an existing metal conduit box connecting the equipment has been exposed in the center of the frame. The bottom of the conduit is approximately 152 cm (60 in) beneath the modern ground surface.**

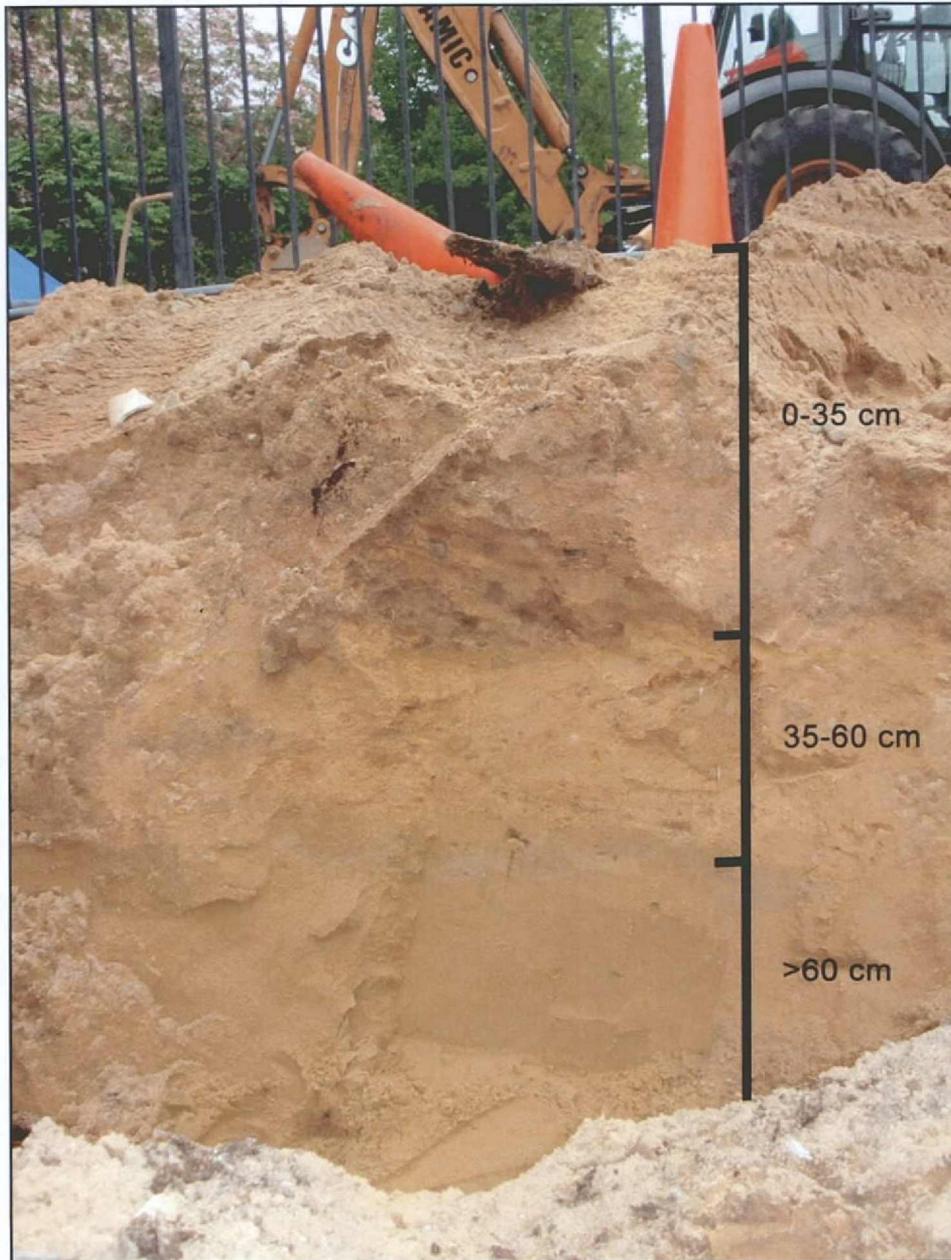
Strictly speaking, a developed soil sequence was not encountered during monitoring, as the profile appeared to consist entirely of unaltered, unweathered, anthropogenic fill material (Waters 1992). Excavations reached a depth of approximately 5 feet (1.2 m), and three different stratigraphic levels were encountered. The depth, Munsell Soil color chart description (Munsell 2000), and the texture of each level were recorded in the field (Photo 4). The typical profile observed across the APE is detailed in Table 1, below.

The different levels of anthropogenic fill material represented in the observed profile likely represent filling episodes associated with the original construction of the WPCP substation. It is likely that the denser, medium sand visible in level three was deposited to form a suitable base for the existing concrete foundations and conduits which were installed in the 1980s. The remaining fill material in level two was likely deposited to fill the space between the foundations and the conduits, and the gravelly coarse sand which forms the modern ground surface within the existing WPCP substation (level one) was deposited to facilitate drainage. All levels contained scattered construction debris which was not collected.

Photo 4. Detail of a typical profile exposed during construction, facing north. The three stratigraphic fill levels encountered across the extent of the APE and their approximate depths below the modern ground surface are marked in the photograph. The excavation terminated approximately 85 cm (33.5 in) below the modern ground surface.

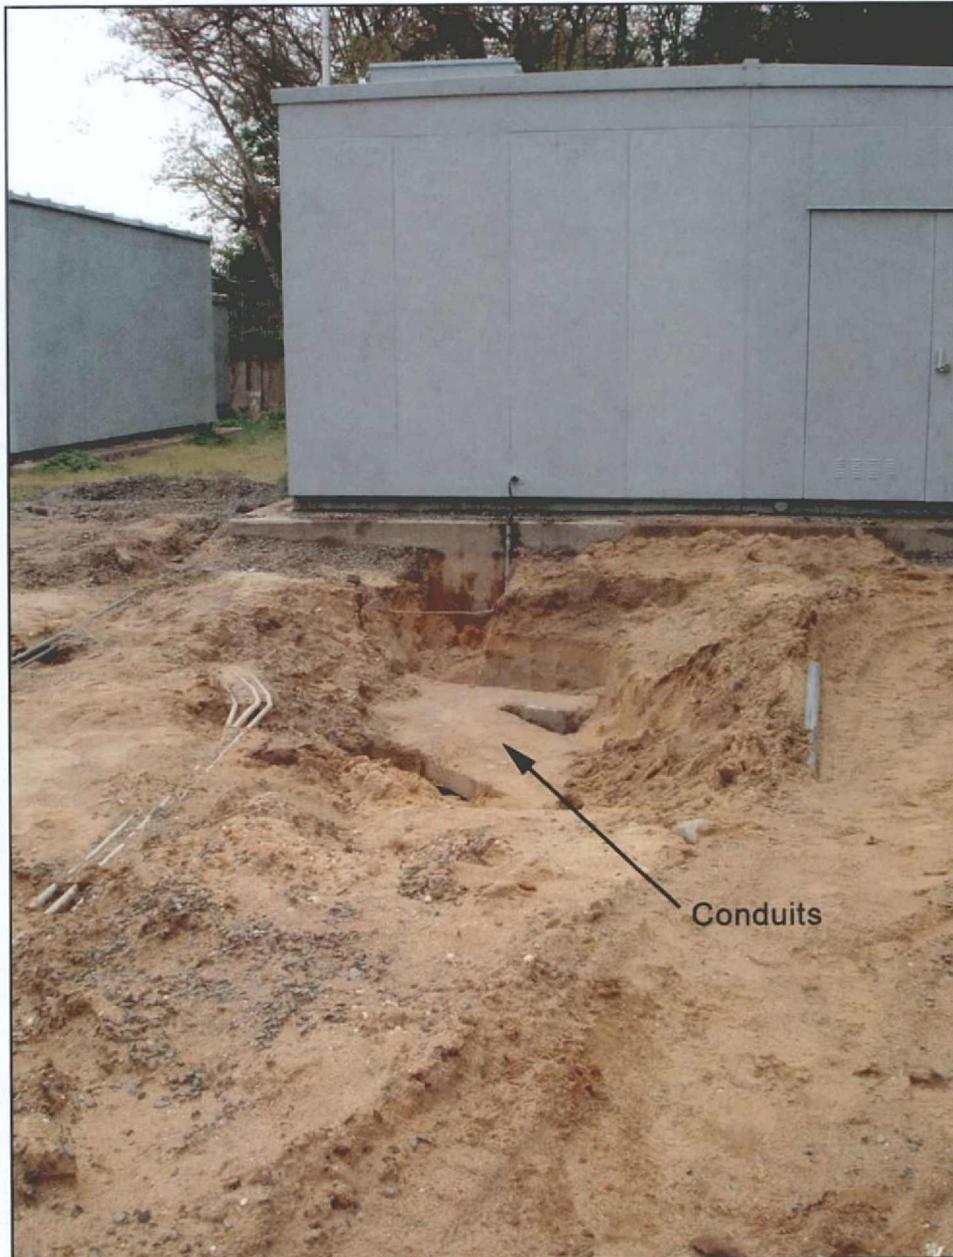
**Photo 5. View of construction activities, facing southwest. Note the existing generating and switching equipment in the background and the exposed conduits visible in the foreground.**
