# The History and Archaeology of City Hall Park

# *The History and Archaeology of City Hall Park, New York*

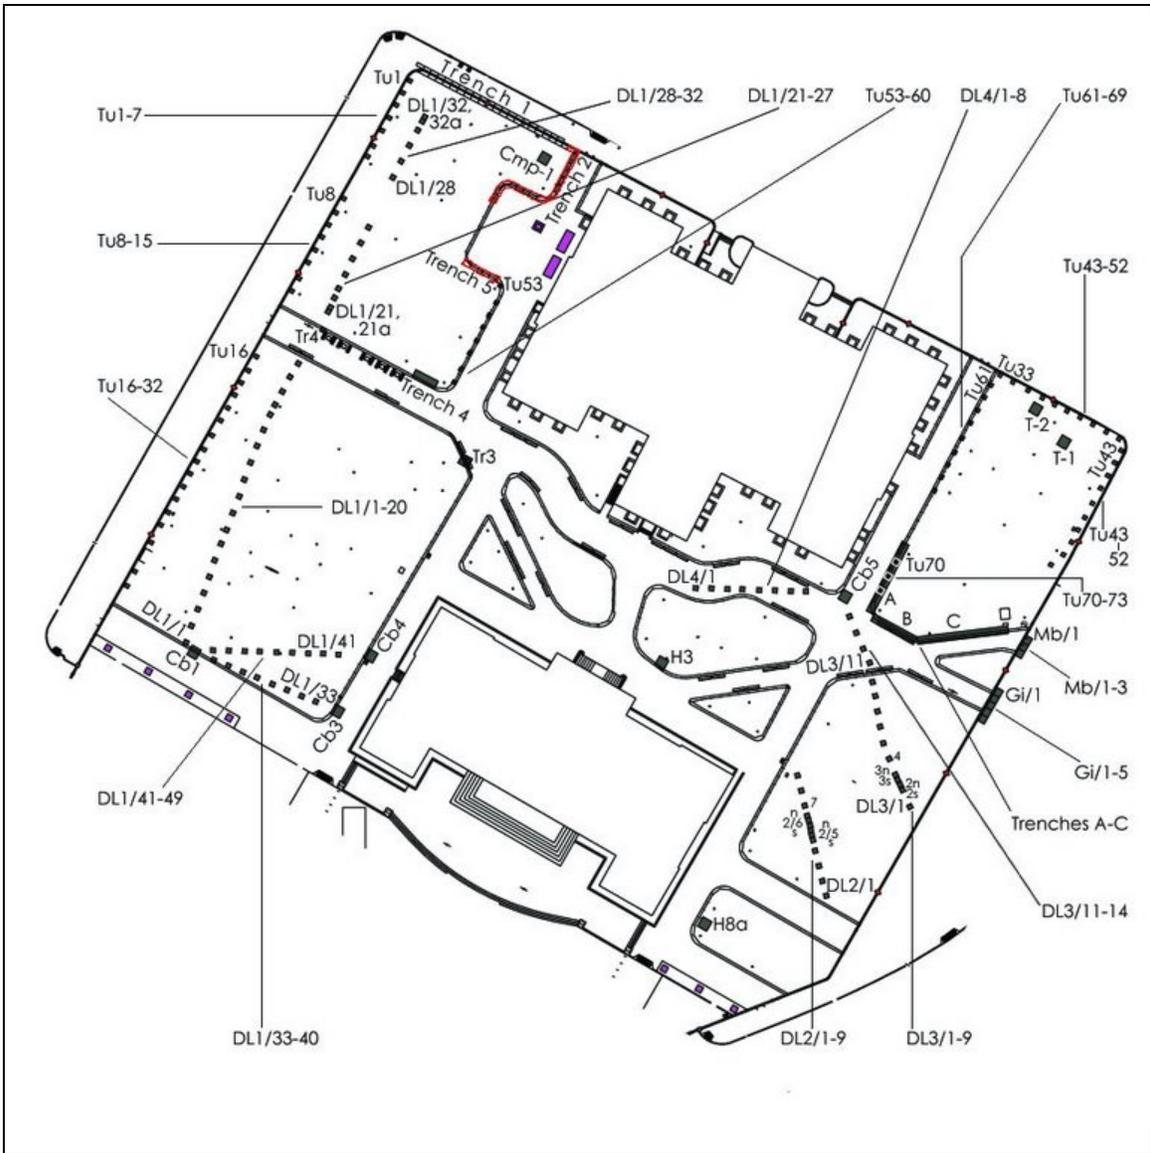
Fig. 2-1: Excavation operations in the northern half of City Hall Park, 1999.

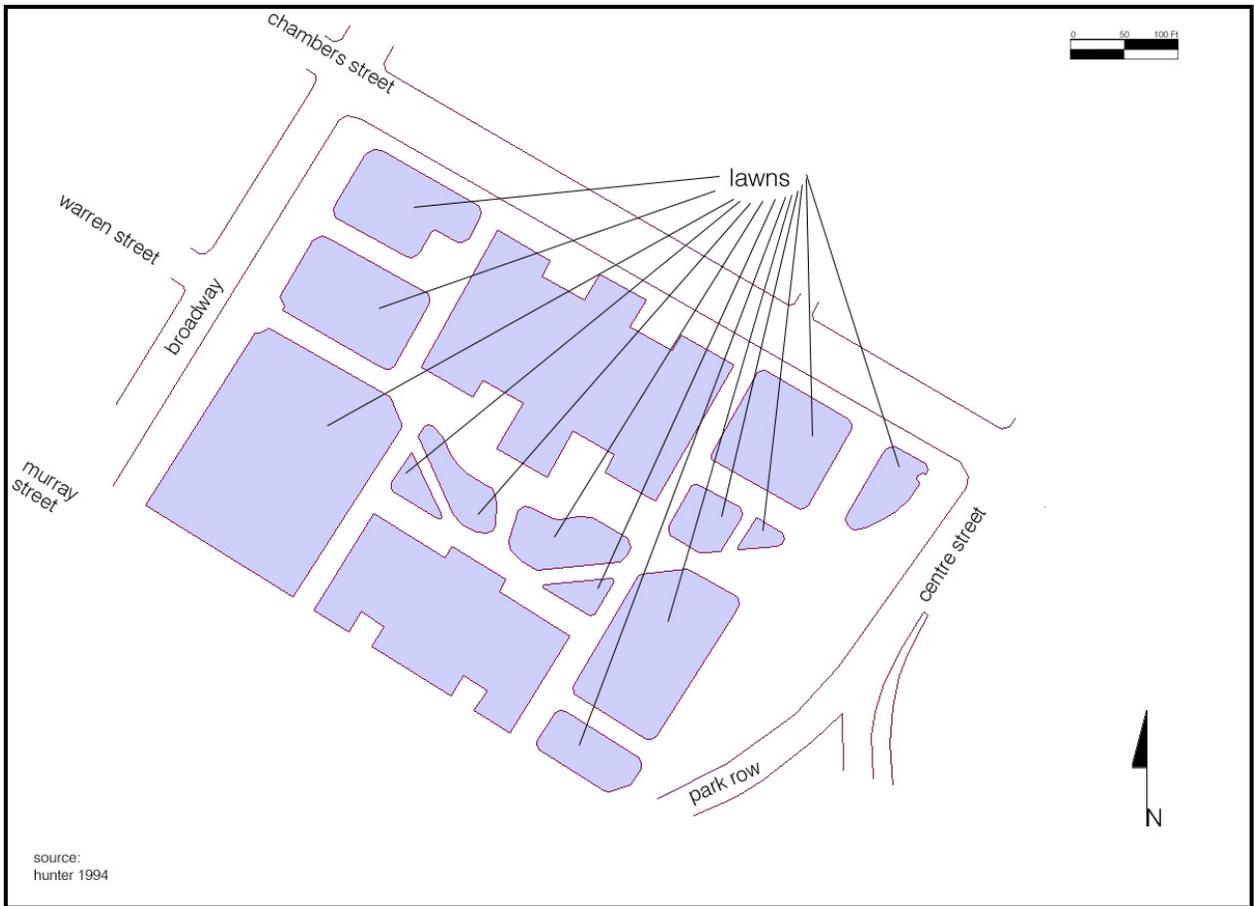
*Fig. 2-2: Lawns (“Islands”) and paved areas in the norther half of City HallPark*

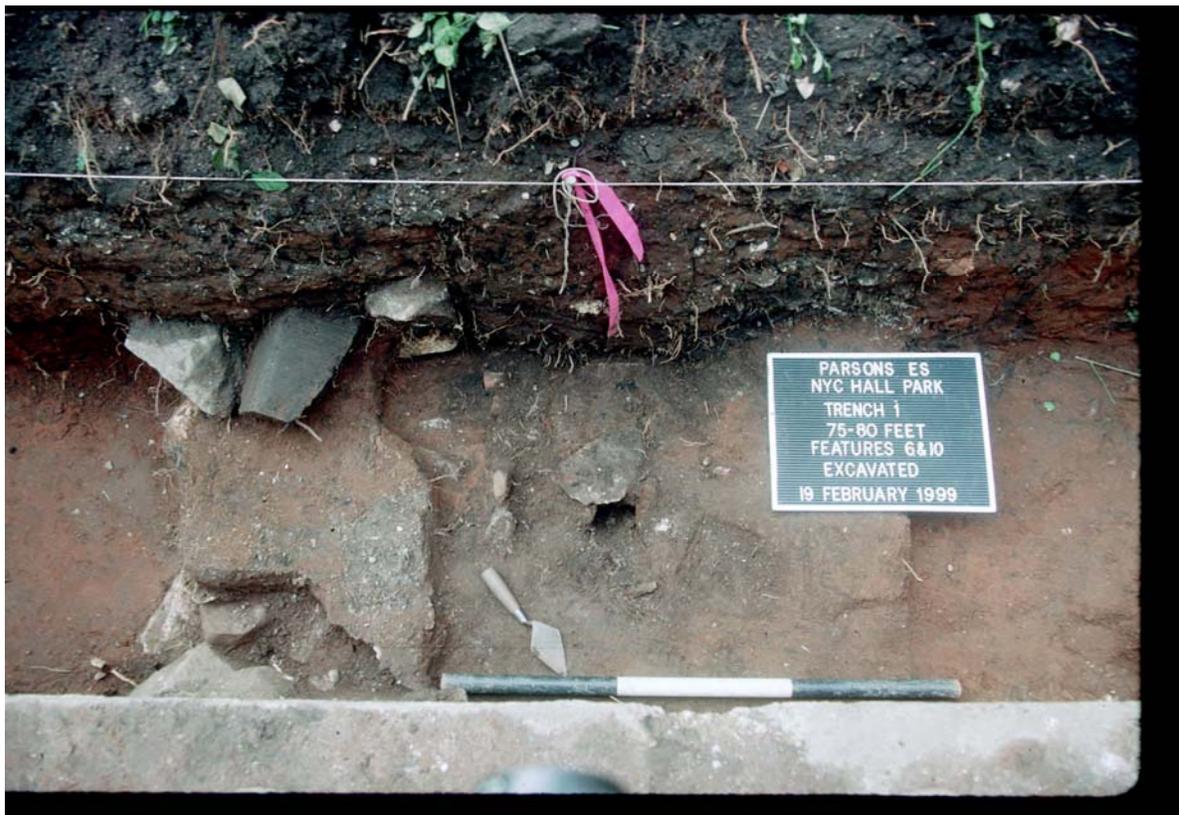
*Fig. 2-3: Trench 1, 75-80', Features 6 and 10*

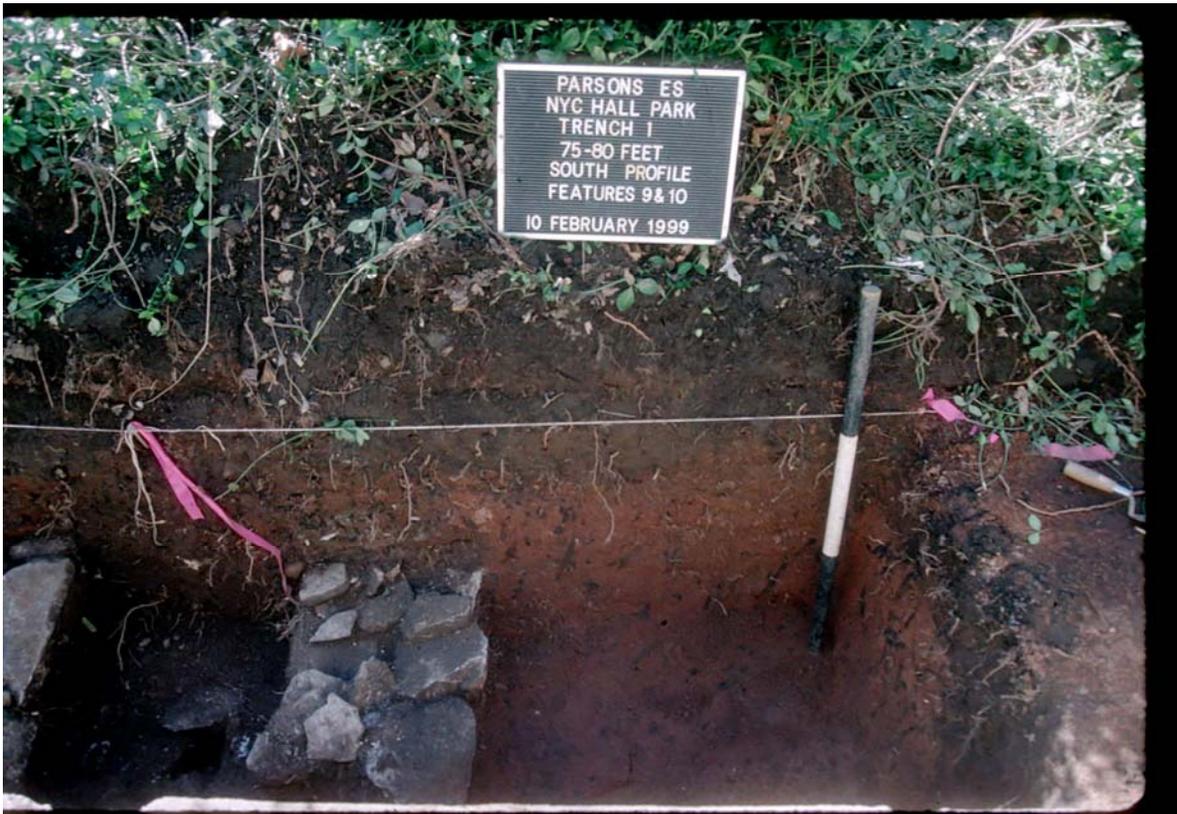
Fig. 2-4 : Trench 1, 75-80', Features 9 and 10

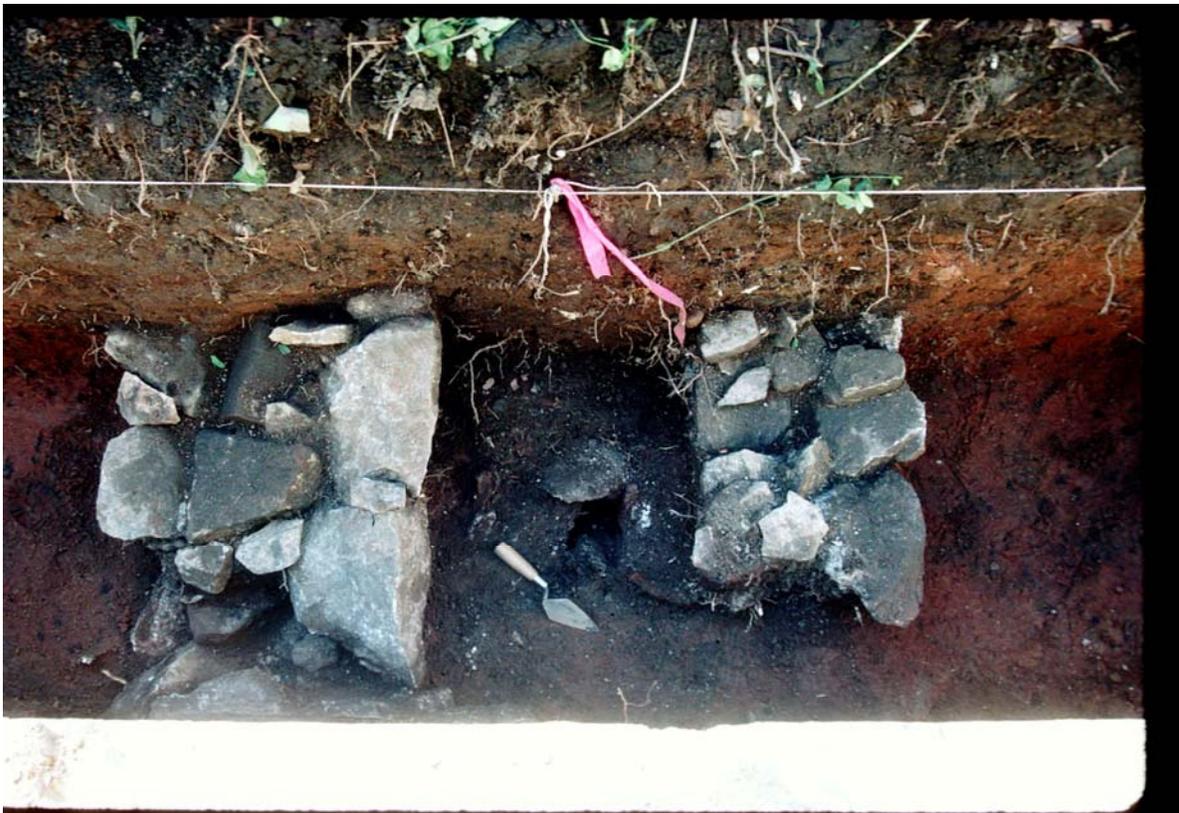
*Fig. 2-5 : Features 6, 9, and 10*

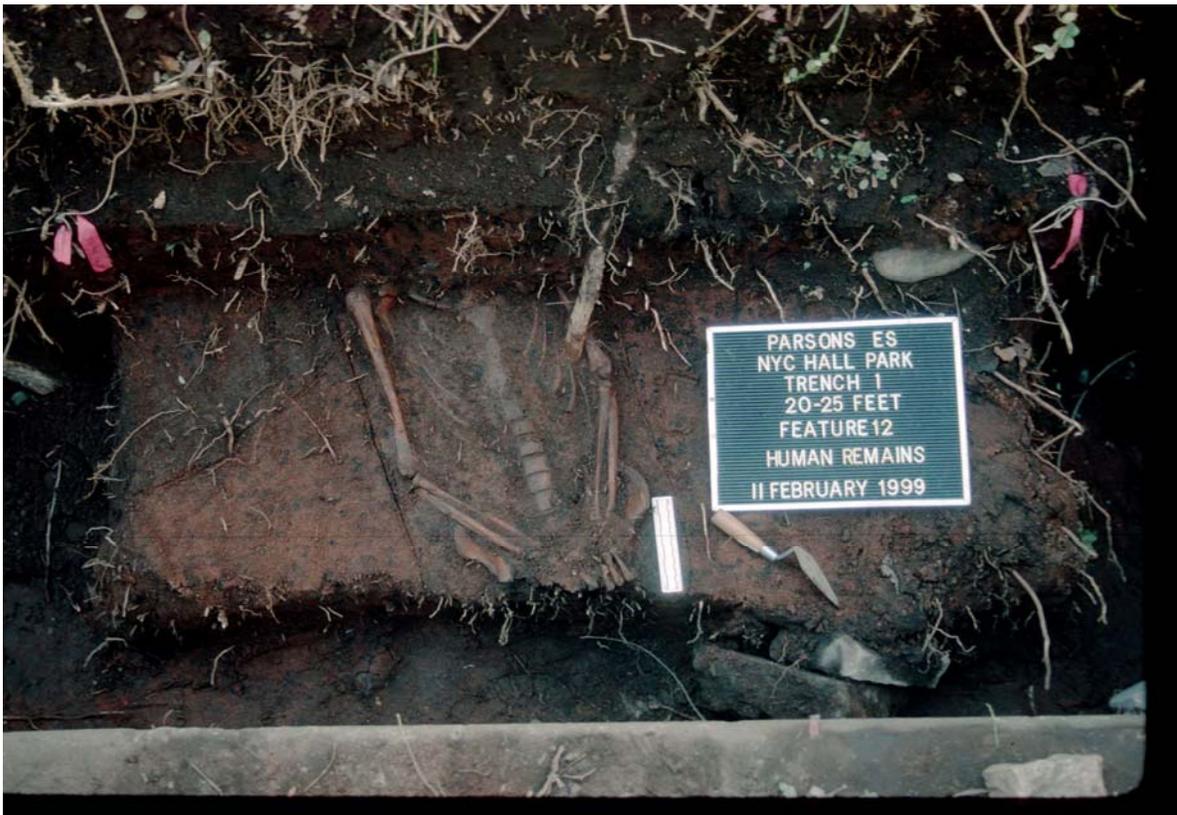
*Fig. 2-6 : Feature 12*

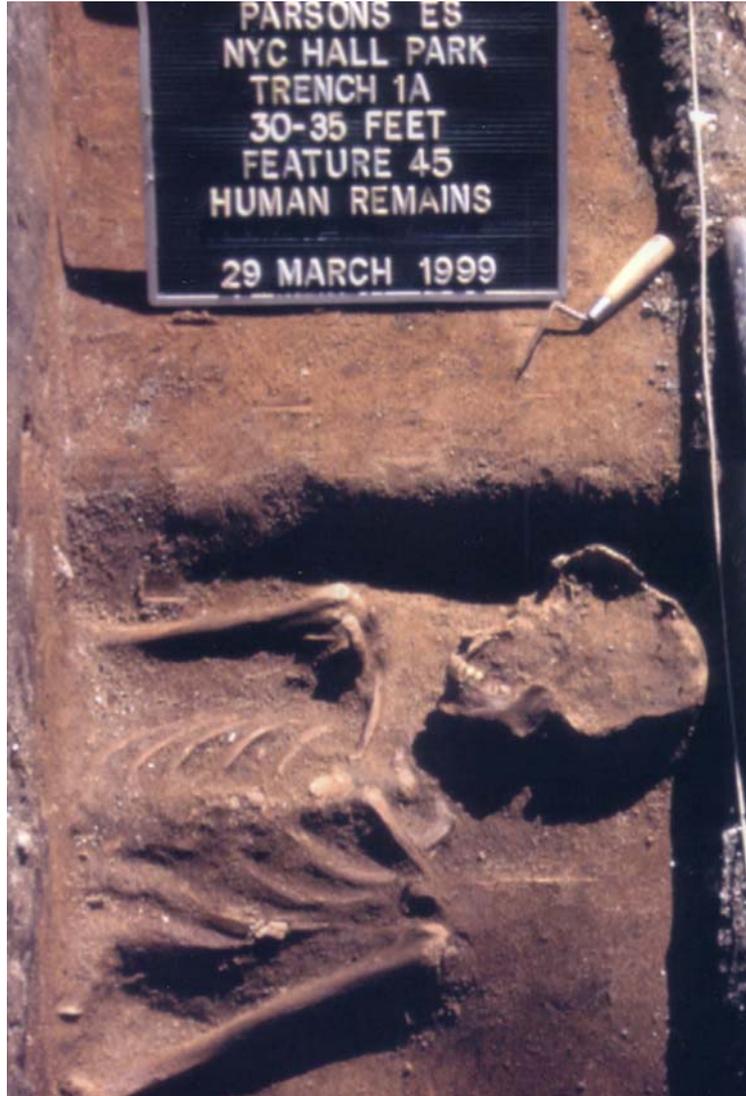
*Fig. 2-7 : Feature 45*

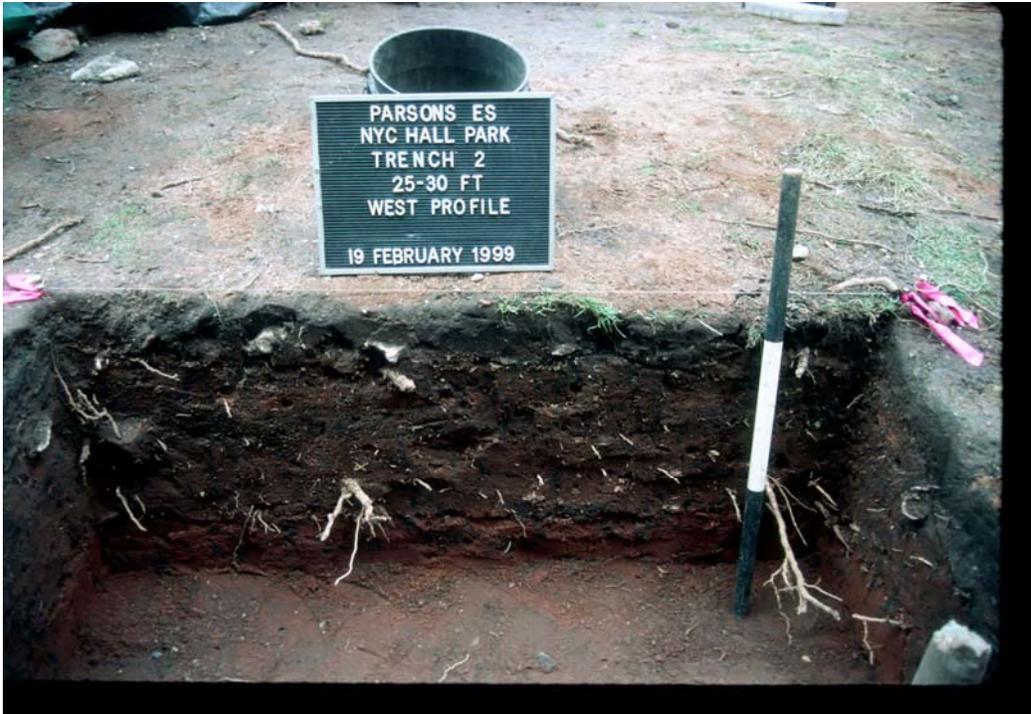
*Fig. 2-8 :Trench 2 stratigraphy*

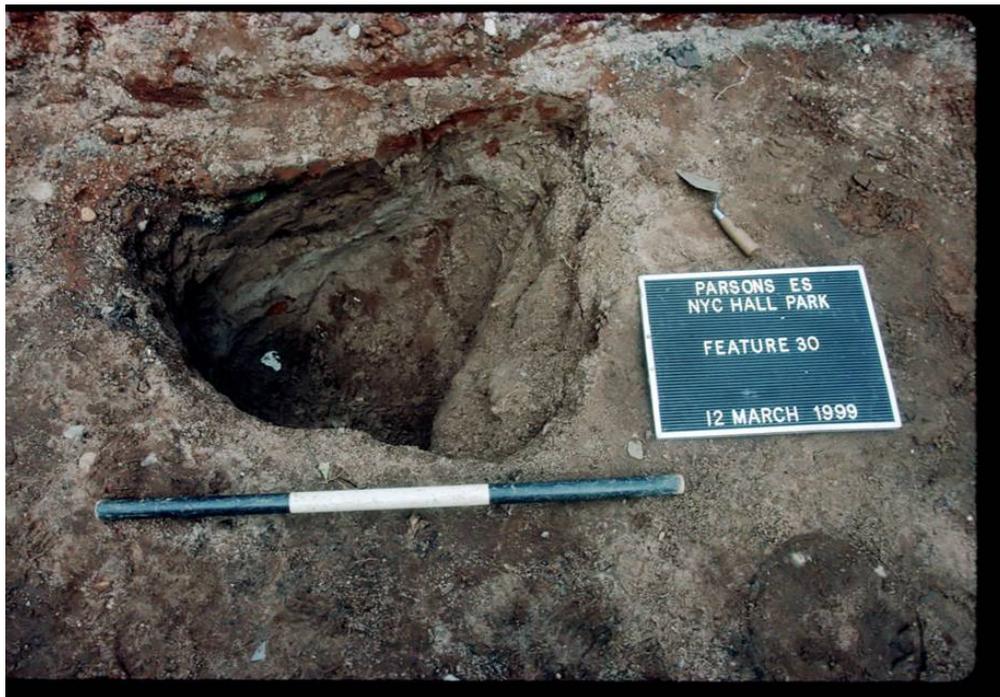
*Fig. 2-9 : Feature 30*

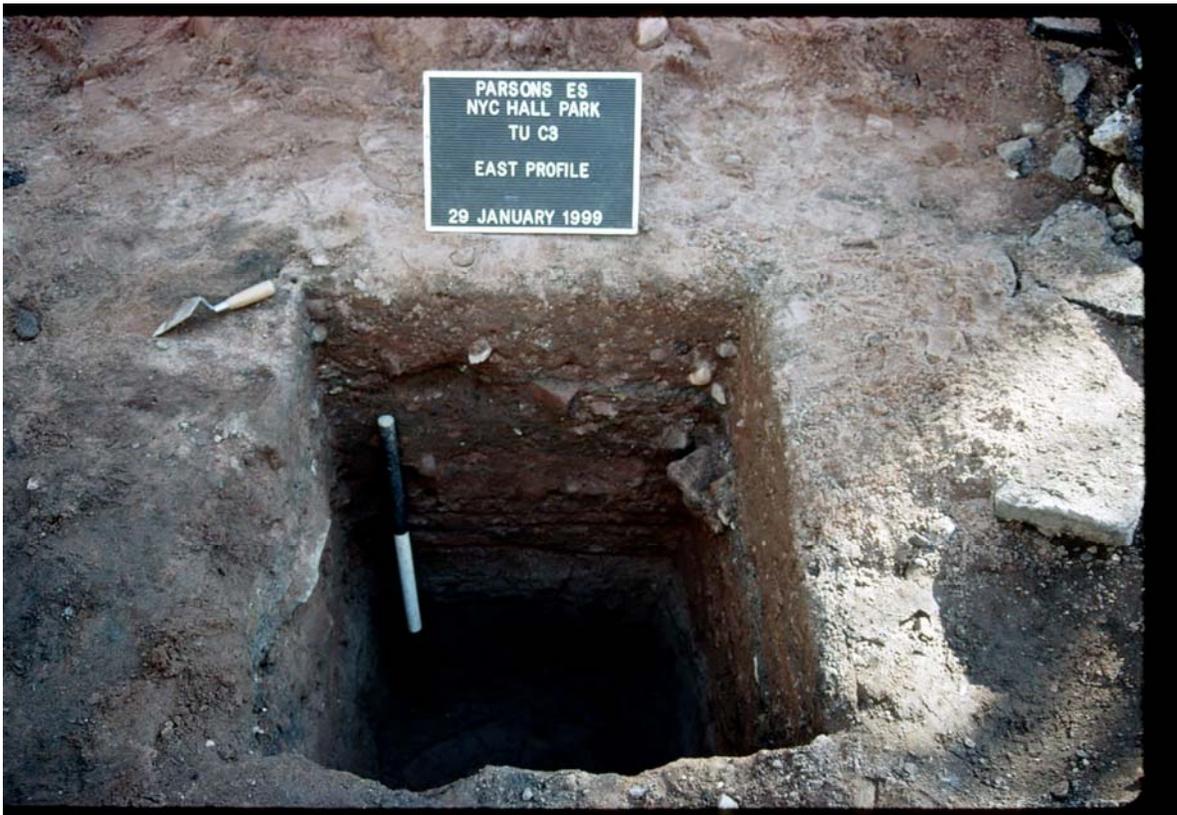
*Fig. 2-10 : Test Unit C3*

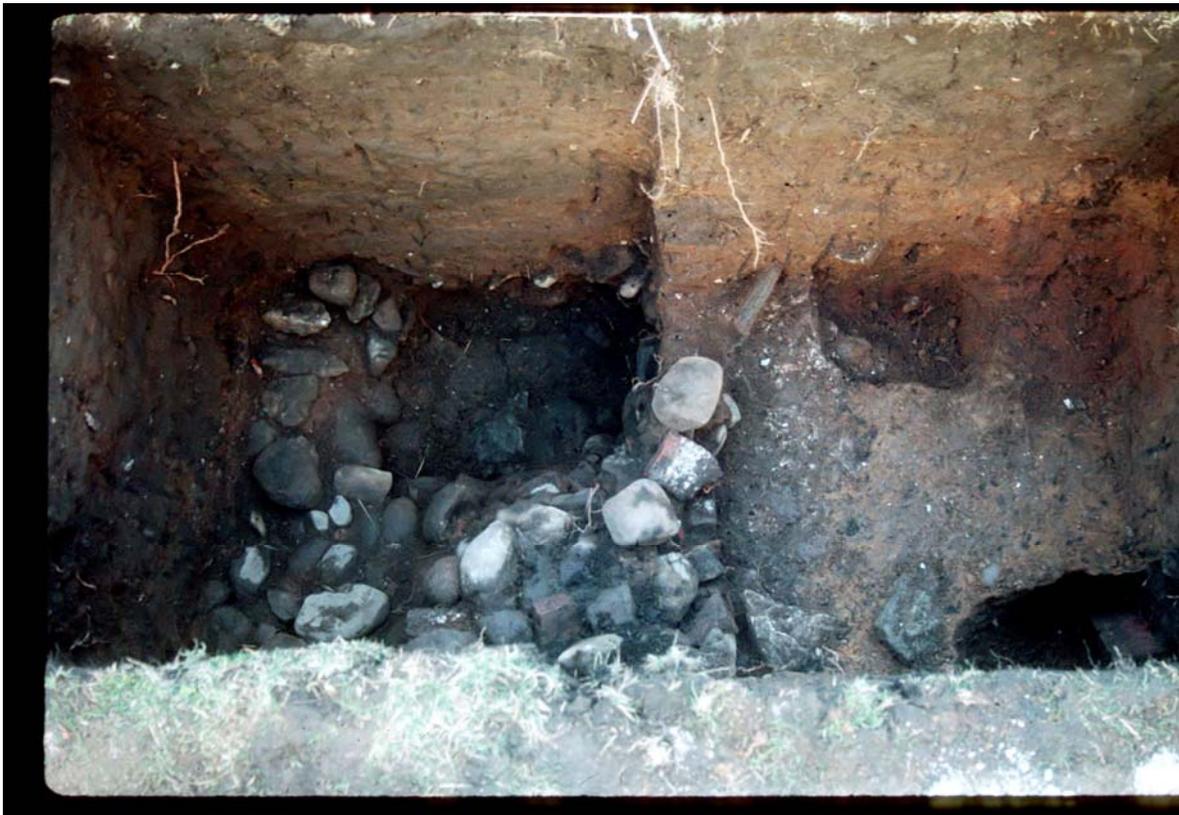
*Fig. 2-13 :DL1-21 and 21A, Features 28, 34 and 35*

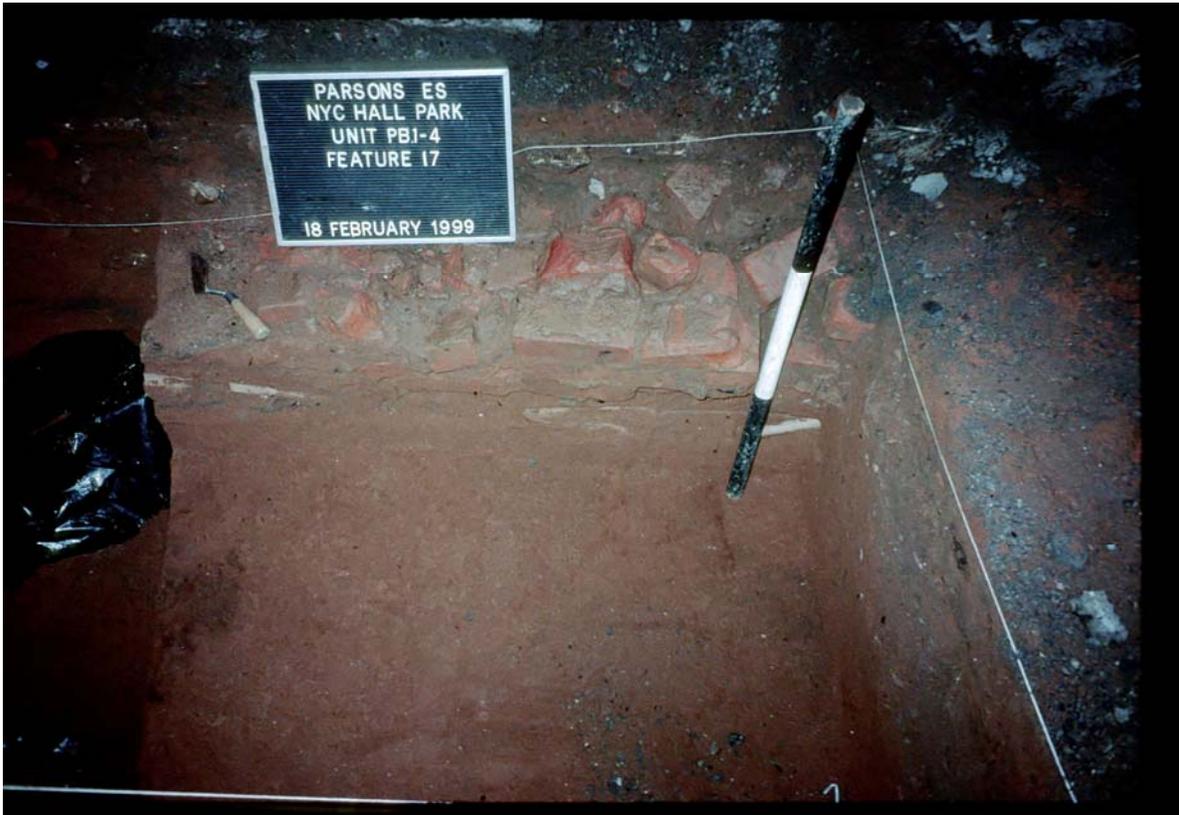
*Fig. 2-15 : PB1-4, Feature 17*

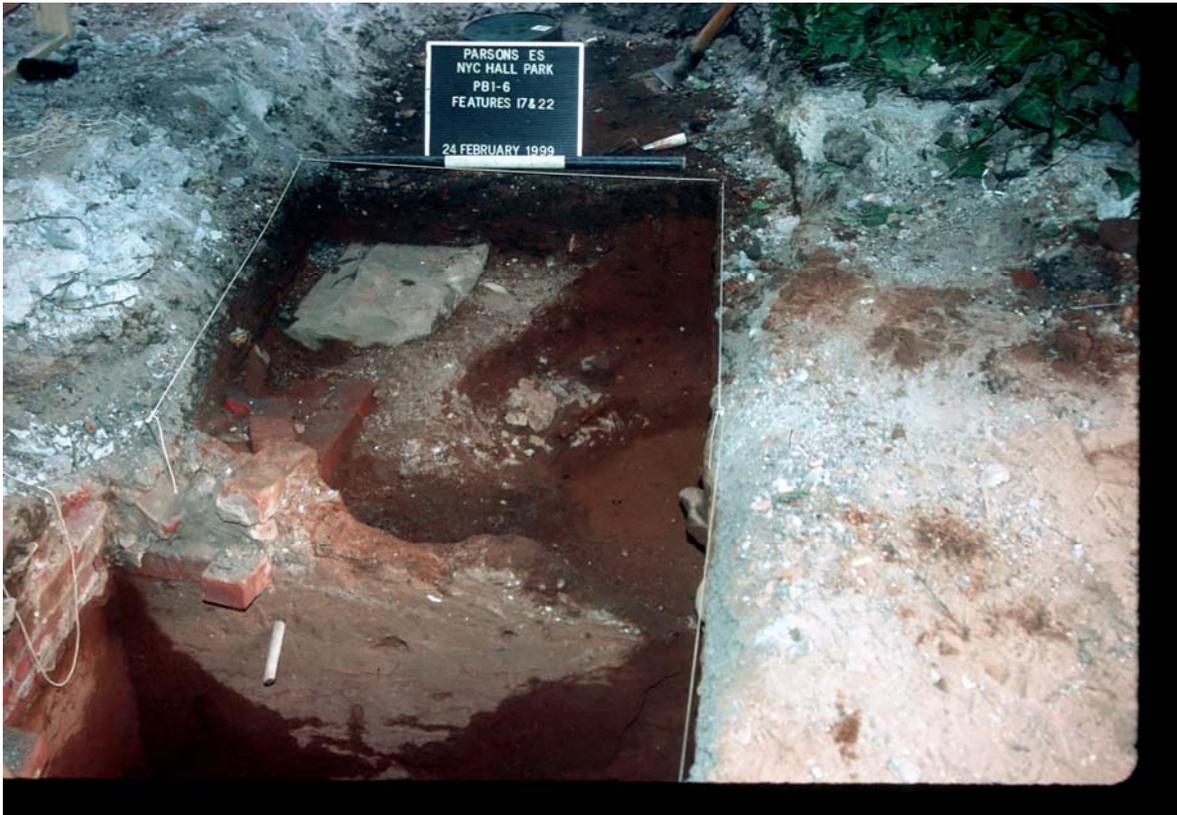
*Fig.2-16 : PB1-6, Features 17 and 22.*

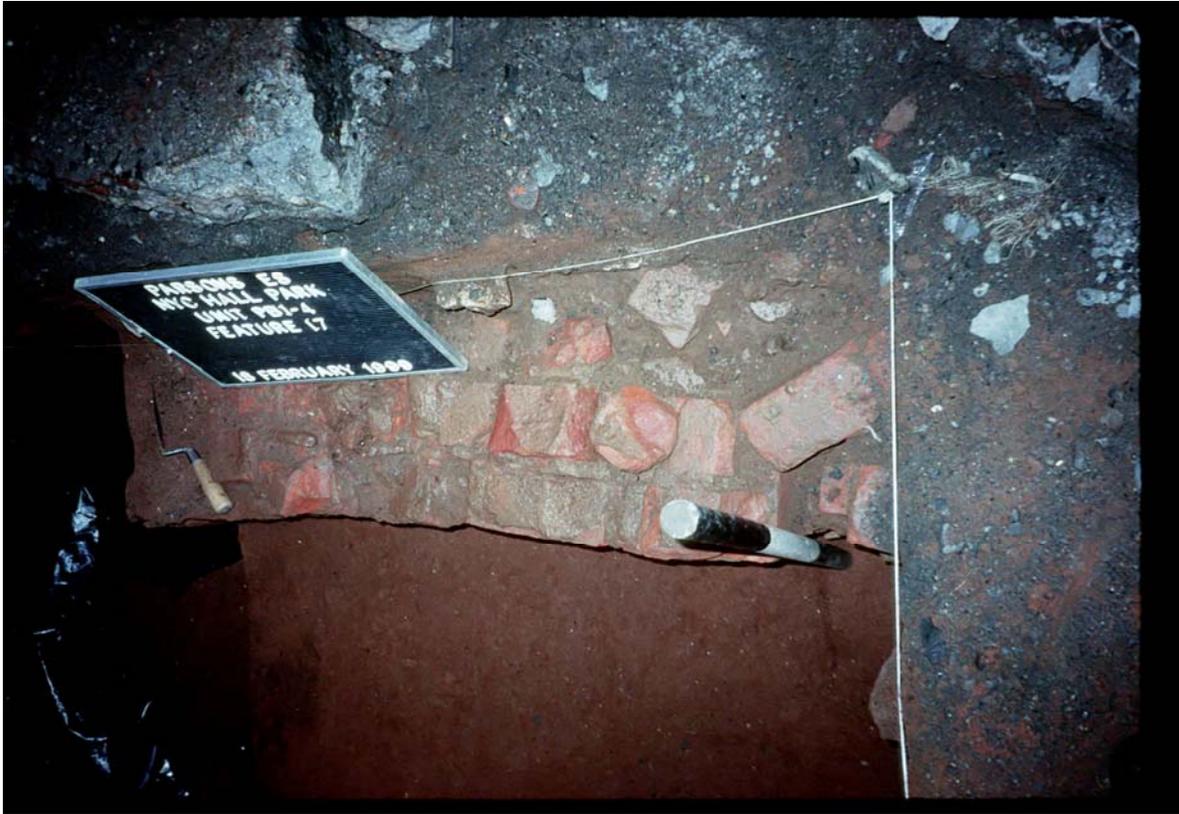
*Fig. 2-17 : PB1-4, Feature 17 from above*

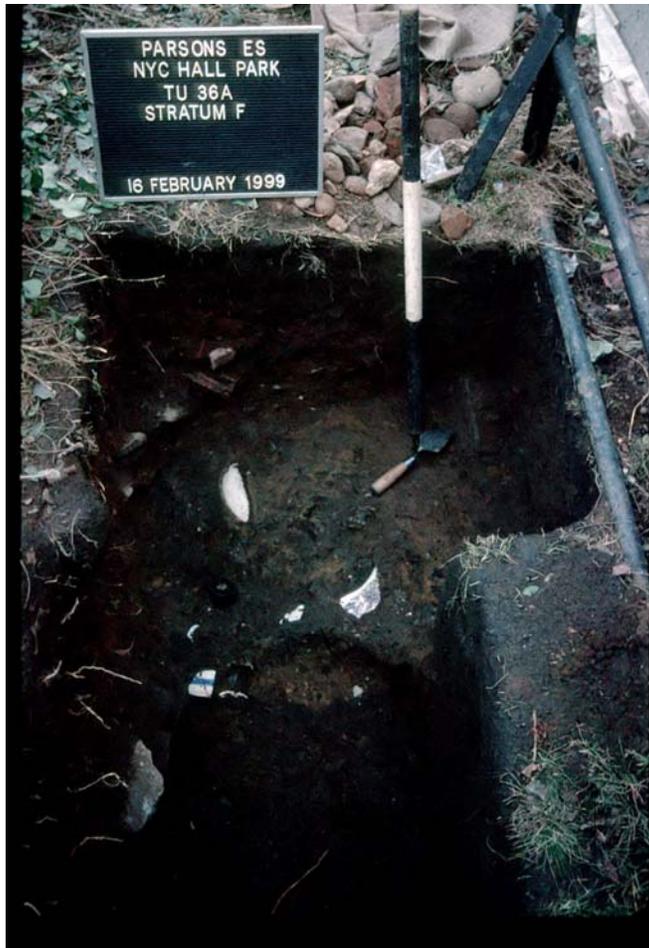
Test Unit 36 contained somewhat different deposits from the remainder of the Test Units surrounding Island #8. The lowest stratum within the 18-inch impact zone contained large fragments of mid-19<sup>th</sup> century ceramics, including blue, brown, and black printed whiteware and undecorated ironstone, as well as large portions of glass bottles. The size of the ceramics and the glass suggested that this deposit could be part of an intact feature rather than redeposited fill. LPC staff gave archaeologists permission to open additional, contiguous test units to the east and west of Test Unit 36 (in 2-foot blocks), until they reached the edge of the cultural deposit.

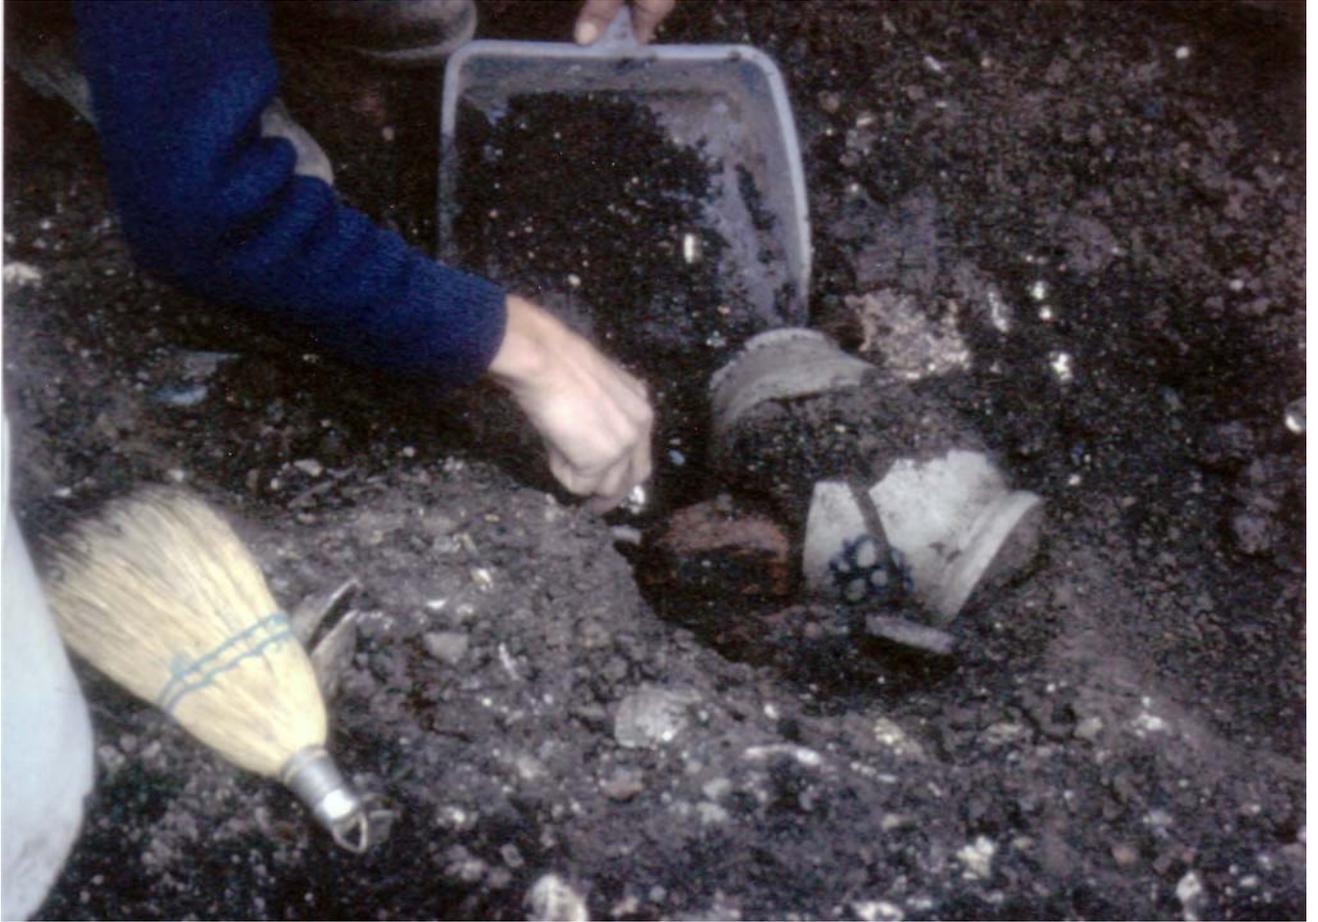
*Fig.2-19 : Feature 88 in course of excavation*

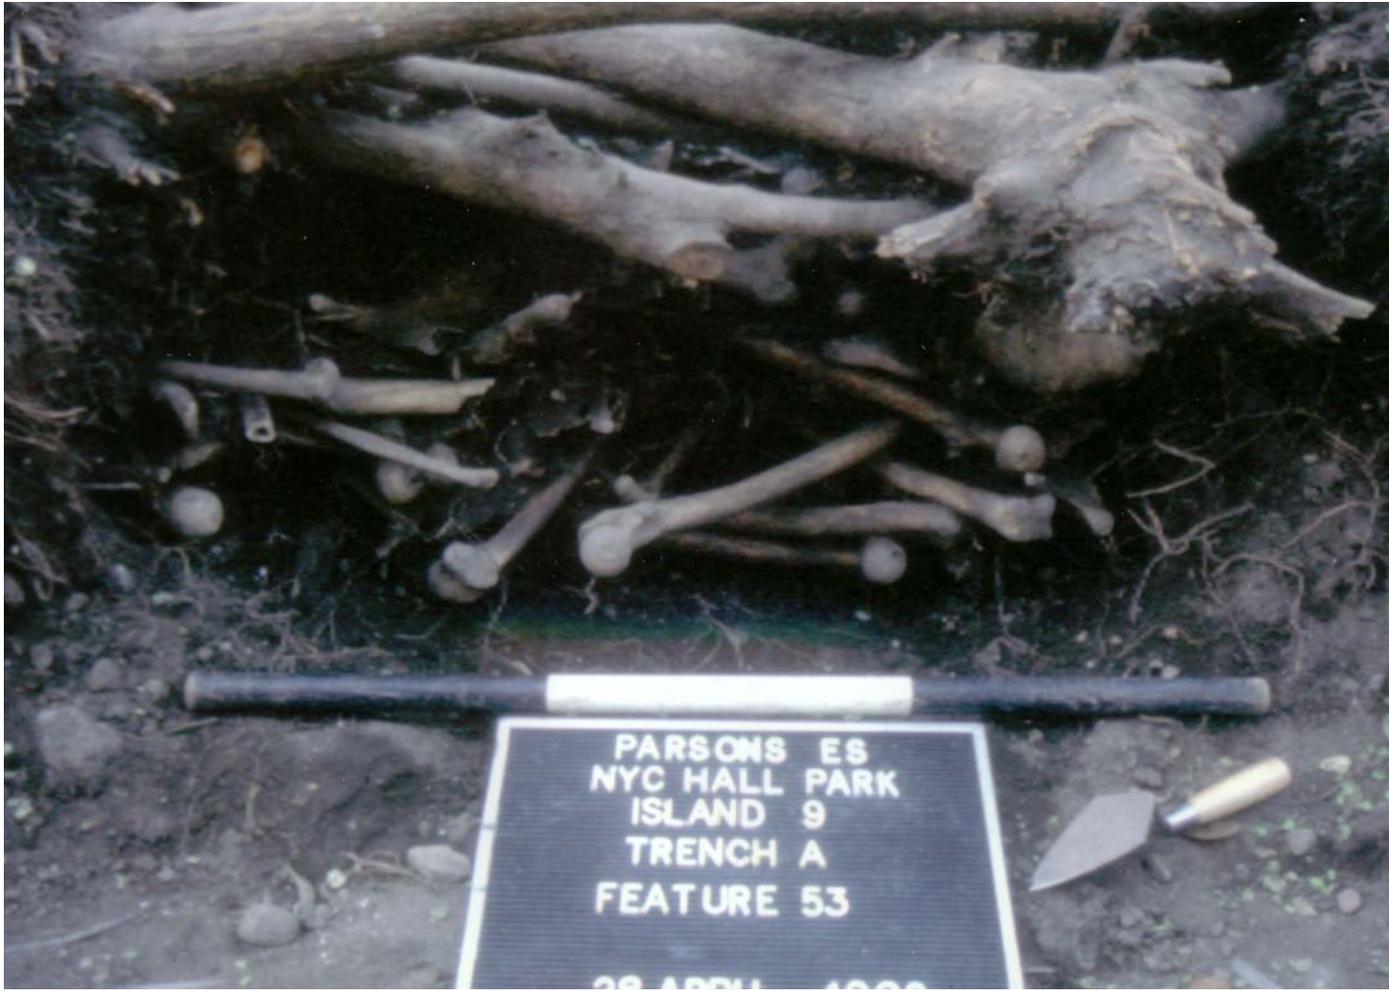
*Fig.2-20 : Feature 53*

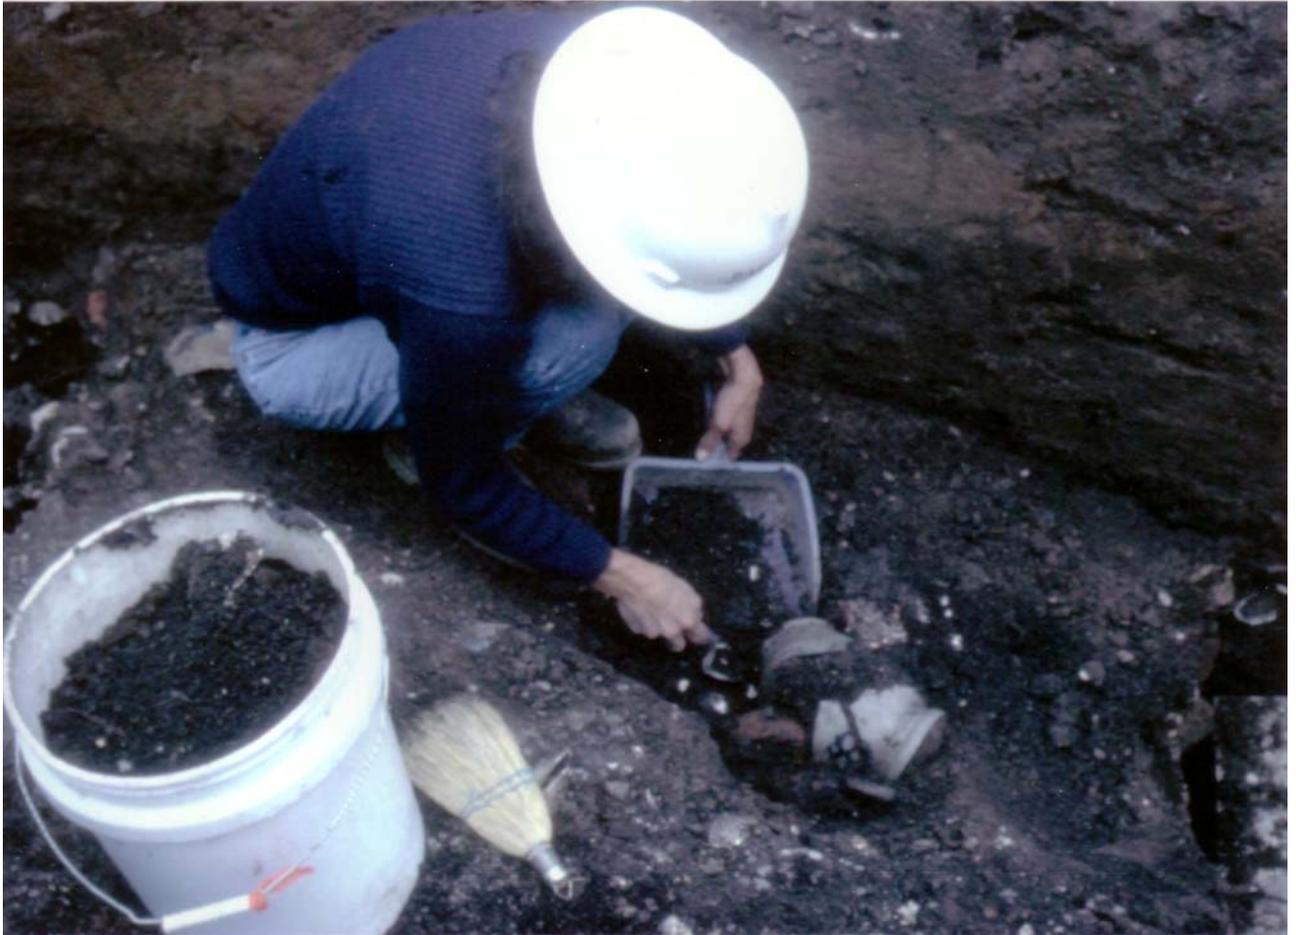
*Fig.2-22 : Feature 88*
