**U.S. Army
Corps of Engineers
New York District**

**ASSESSMENT OF POTENTIAL WRECK IN AMBROSE CHANNEL TO
DETERMINE HISTORIC SIGNIFICANCE AND UNDERTAKE SELECTED
RECORDATION OF REMAINS ENCOUNTERED IN CONNECTION WITH
THE NEW YORK AND NEW JERSEY HARBOR NAVIGATION PROJECT**

FINAL REPORT

APRIL 2008

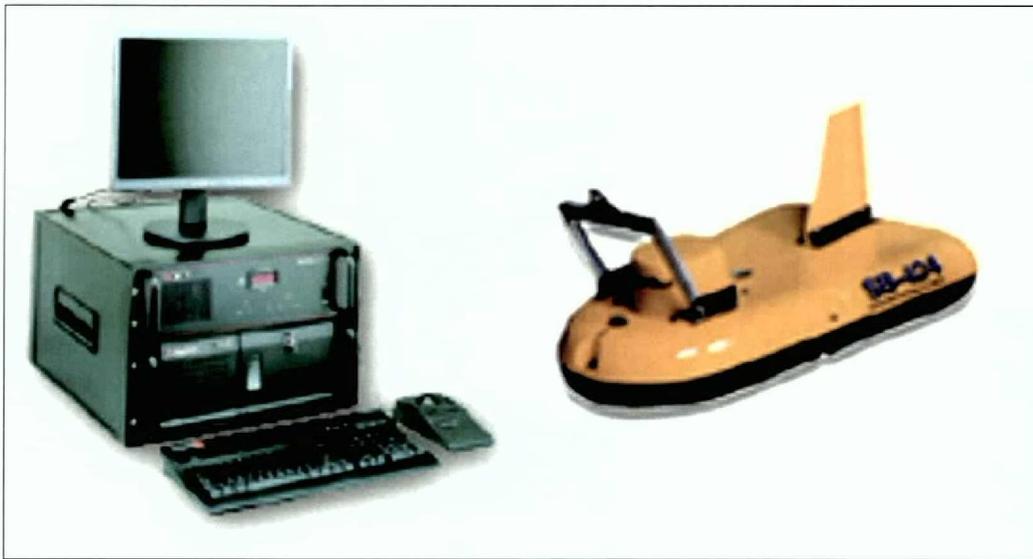
Figure 3-05. The Edgetech subbottom processor and 424 towfish used in the survey.

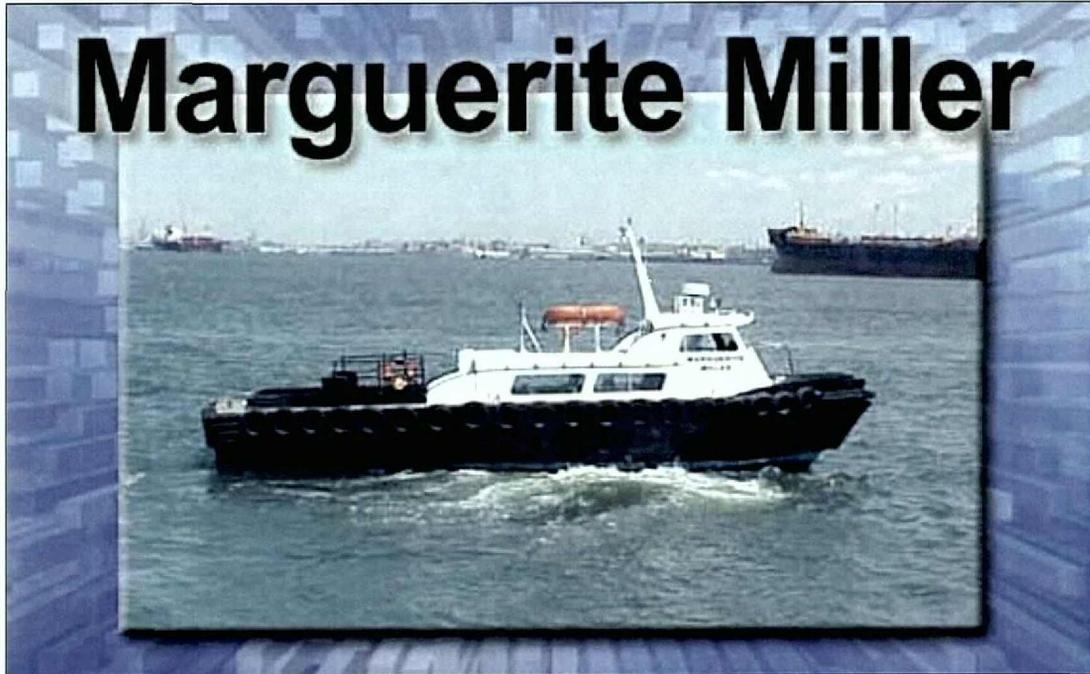
Figure 3-06. Survey vessel *Marguerite Miller*.

The survey vessel *Marguerite Miller*, a 45-foot crew boat powered by twin diesel engines, was employed for the initial survey (Figure 3-06), while the work vessel *Sorenson Miller*, a 130-foot work vessel, was employed during diving operations (Figure 3-07). The vessels conformed to all U.S. Coast Guard specifications according to class and have a full compliment of safety equipment. The vessels carried appropriate emergency supplies including life jackets, a spare parts kit, a tool kit, first aid materials, and potable water.

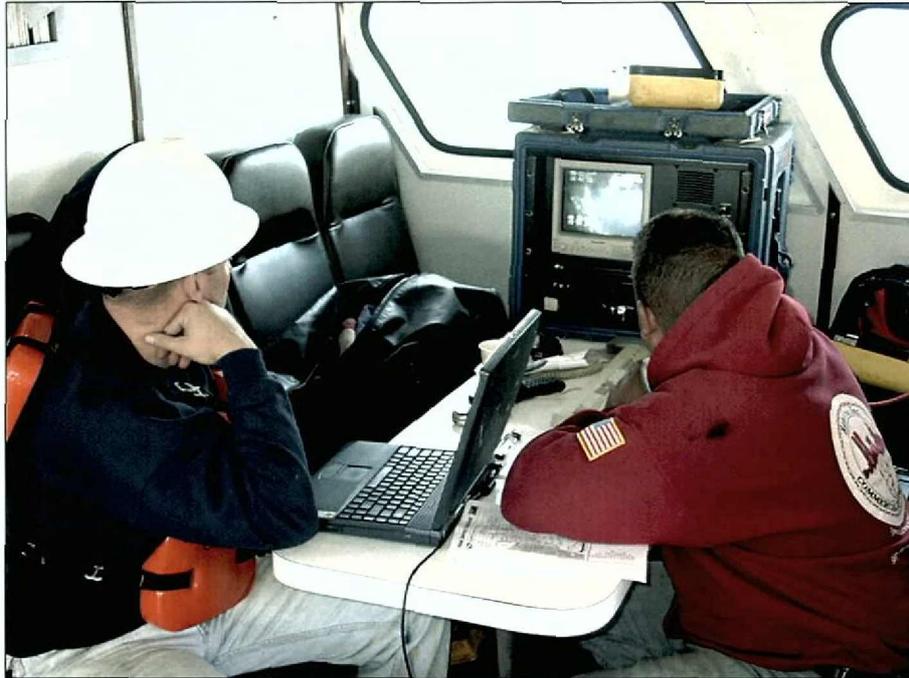
Figure 3-08. Video system.

All divers were recorded using a Kongsberg submersible video system (Figure 3-08). This system consists of a handheld diver video camera with the transmission cable integrated into the diver's umbilical. A topside monitor and controls allow the timekeeper to see the video and record comments, as well as control lighting.

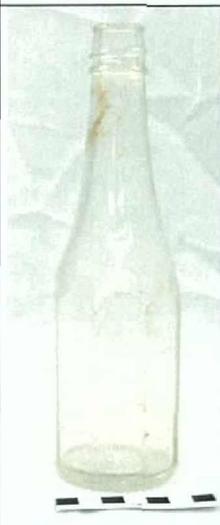
Type	Contents	Manufacturer	Identified Marks	Date	Description	Photo
Bottle	catsup	Owens Bottle Company, Toledo, Ohio	H.J. Heinz Co/255/PATD	1904-1929	H.J. Heinz Company introduced catsup in 1875. Since 1888 bottles have been embossed "H.J. Heinz Co.". ABM (automated bottle machine) lip indicates a post-1904 date of manufacture. Owens Bottle Company merged with Illinois Glass Company in 1929.

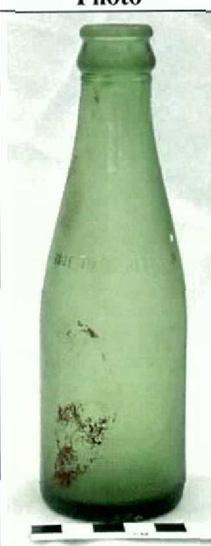
Type	Contents	Manufacturer	Identified Marks	Date	Description	Photo
Bottle	Soda	Owens Illinois Glass Company	CONTENTS 7 FL OZS99 61 (factory mark)/ GK-1627	Post-1954	ABM lip with crown cap indicates post-1904 DOM. "I" in a circle logo indicates post-1954 DOM.

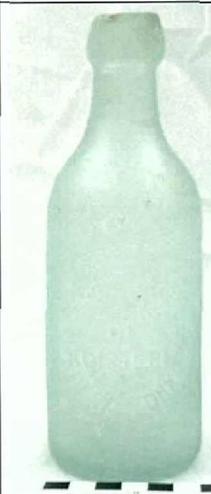
Bottle	Mineral water	unknown	JOHN HAAG/ 417 E. 113 th ST/ REGISTERED/ NEW YORK/ NOT TO BE SOLD	Early 1870s - ca. 1880	Three-piece mold indicates 1830s - 1905. Blob top indicates 1870-1880. Plate mold indicates pre 1910.

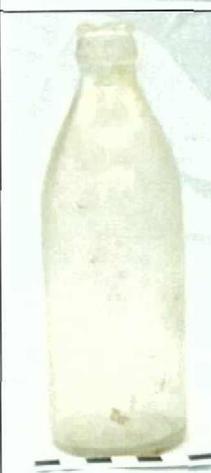
Bottle	Soda	unknown	None	Post-1904
