**Phase IB Archaeological
Field Investigation**

**New York City Transit
Arthur Kill Station and Parking Lot
Staten Island Railway**

**Block 8020, Lots 6, 80, and 86
Richmond County, New York**

July 2008

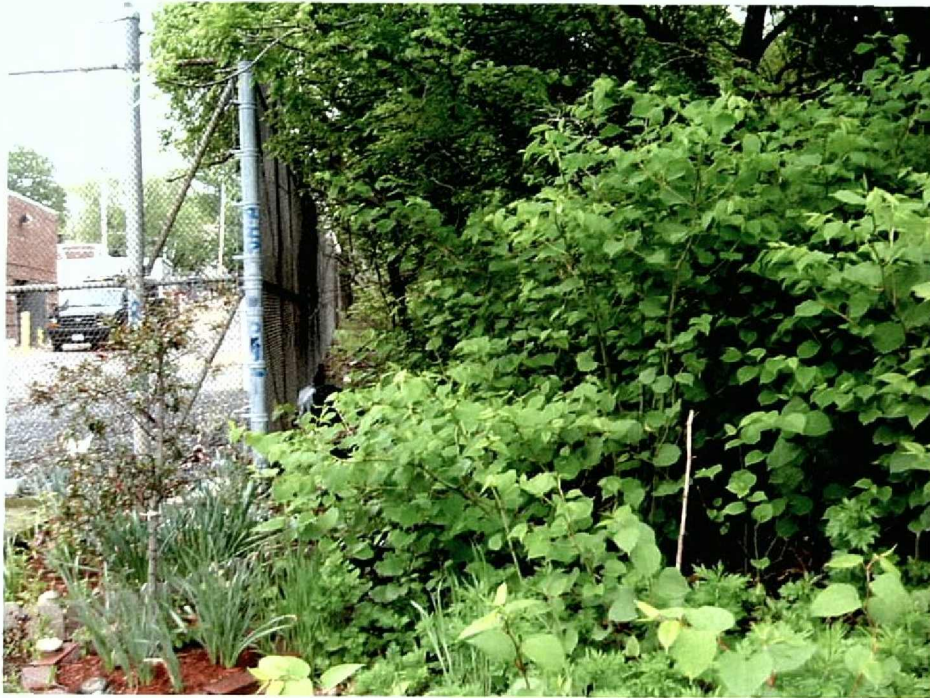
Photograph 1. Northeast boundary (fence line) of proposed Arthur Kill Road Station Parking Lot site.

A chain link fence runs along the northern boundary of this portion of the project site (Photograph 1). A Staten Island Edison substation is located on the adjacent property. The majority of the proposed Arthur Kill Station Parking Lot site is covered with young trees, mixed brush, and poison ivy, an opportunistic plant that often grows in disturbed wooded and/or rocky areas (Photographs 2 and 3). A small clearing is located on the southeast section of the APE adjacent to the properties on the southern boundary (Photographs 4 and 5). A former entry road, now covered with gravel, extends from Arthur Kill Road into the center of the site (Photograph 6). Across the site, extensive evidence of past earth moving and dumping activity was noted (Photographs 7-9). To the north, Arthur Kill Road (Photograph 10) separates the proposed Parking Lot and Station sites. According to Stone, the elevation of the proposed parking lot APE in the northern side of Lot 6 is 10-20 feet above sea level (1995: 2).

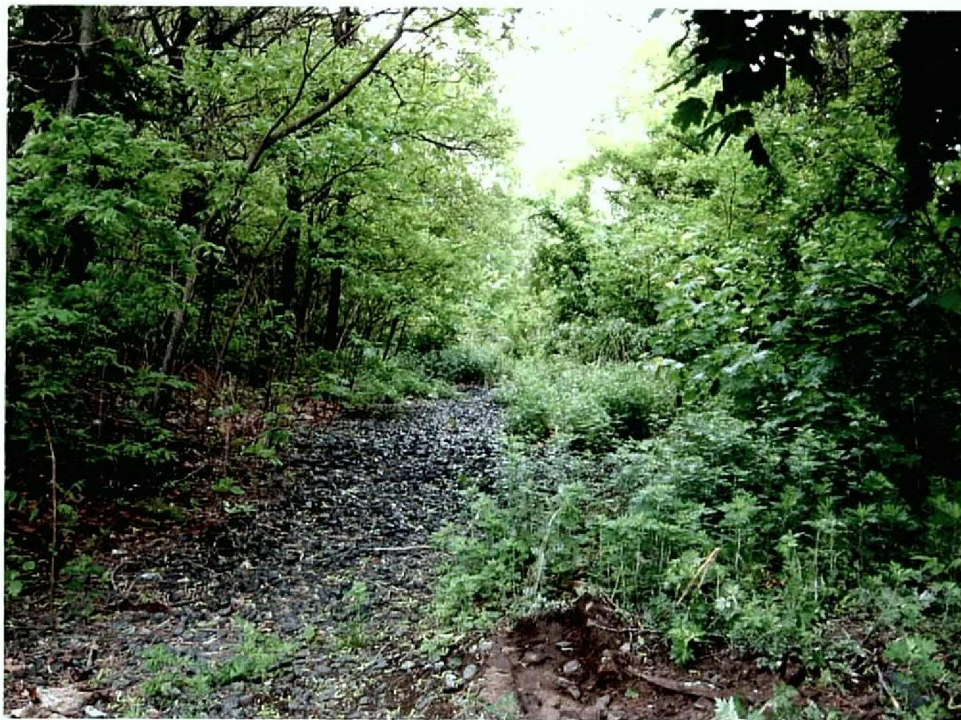
Photograph 6. Gravel entry of property. Proposed Arthur Kill Road Station Parking Lot site.

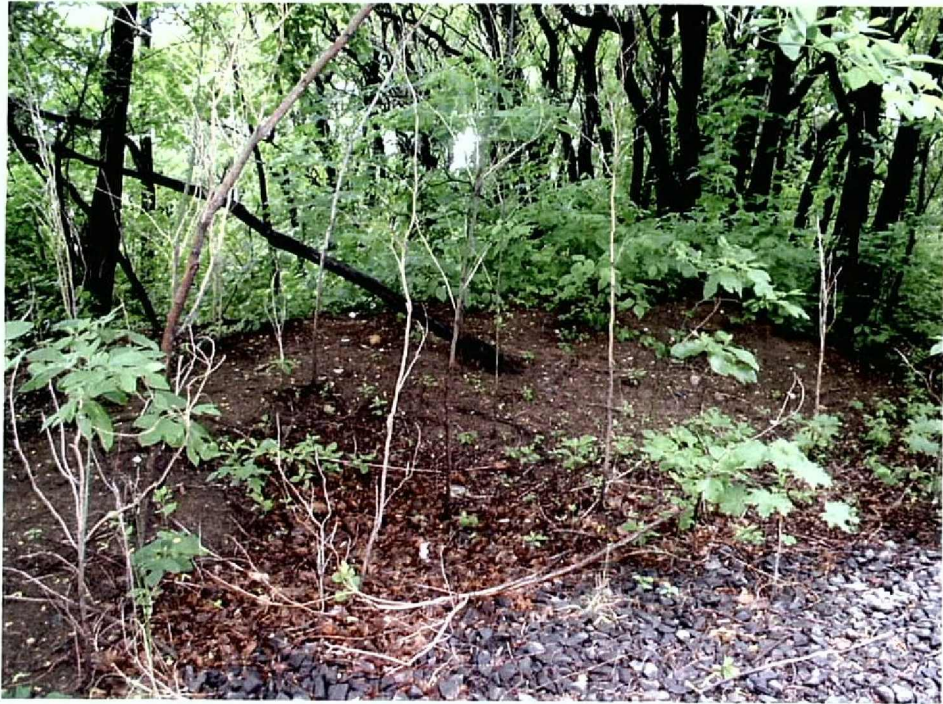
Photograph 7. Bulldozed mound on property. Proposed Arthur Kill Road Station Parking Lot site.
